Martins Creek Power Plant Regional Map Showing the Management Unit(s) in Relationship to Critical Infrastructure (Photo Locations of Documents A1.3-A1.10)

***DEP comment # 6: PPL asserts that certain portions of the basin are susceptible to leaching dissolved selenium when ash remains saturated for a period of time. Please provide estimates of the amount of continuous precipitation that could result in the saturation of fly ash within the basin and the increase in water level within the aquifer beneath the basin such that it contacts the ash and affects groundwater.***

**Martins Creek SES Ash Basin #4 Release**  
Martins Creek SES Site Layout

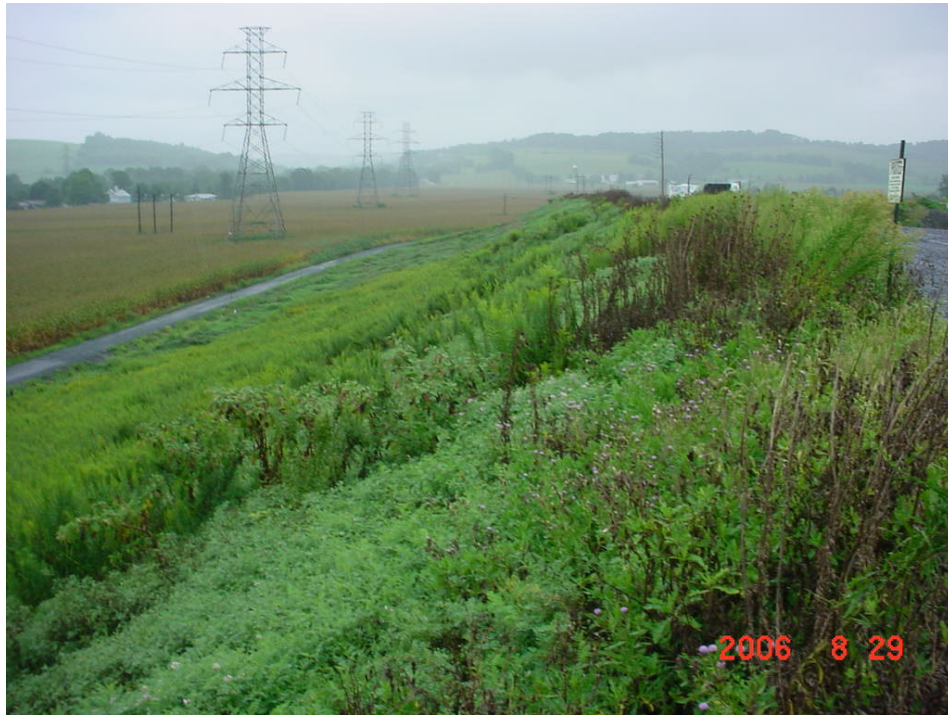
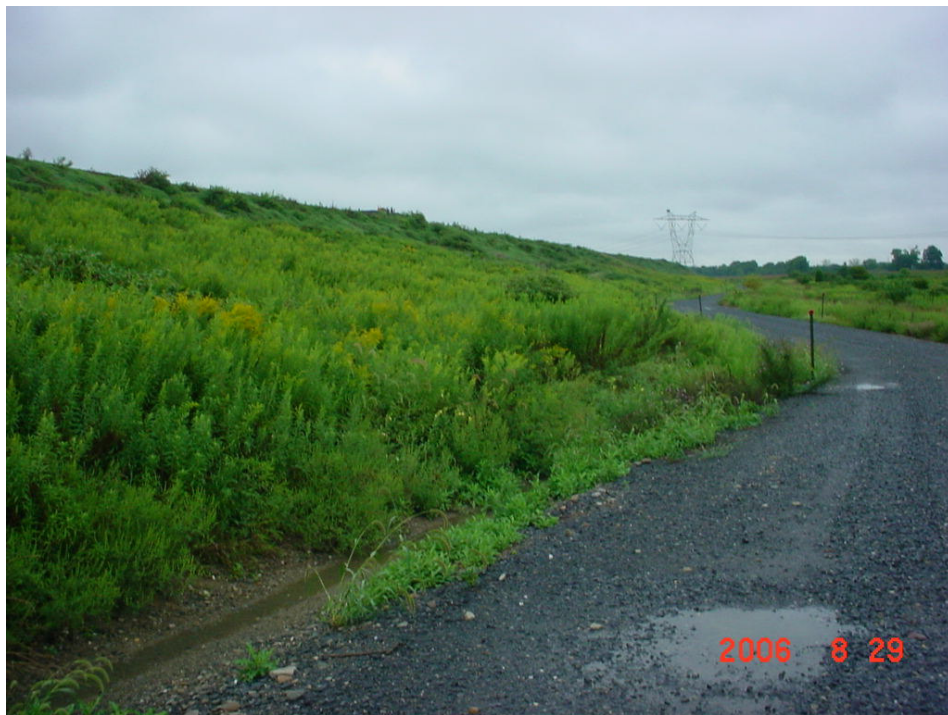
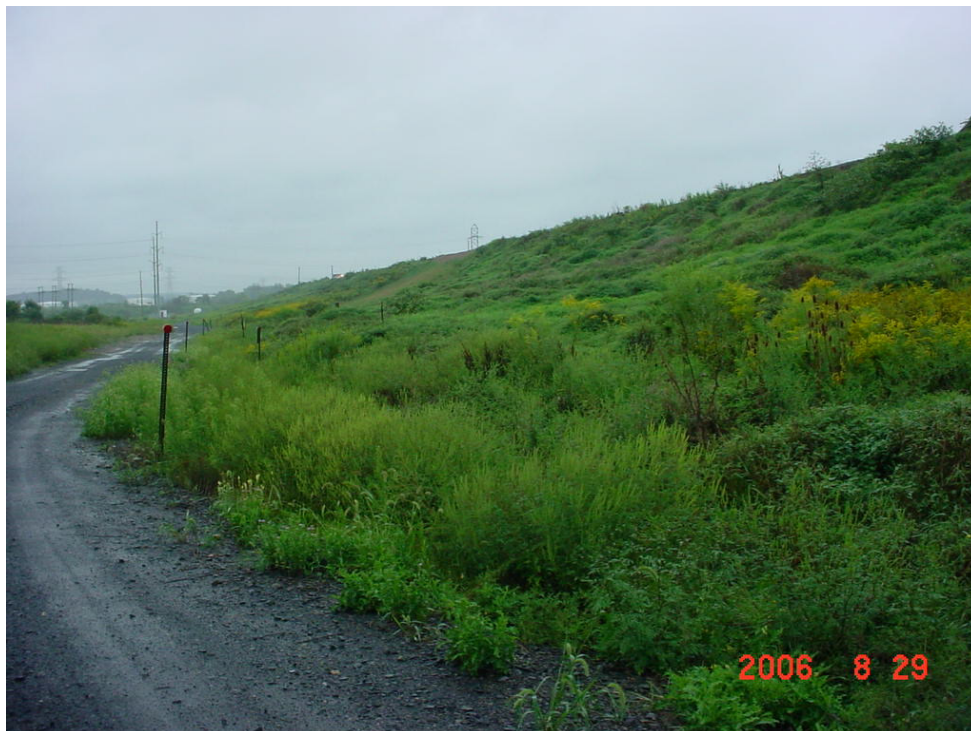
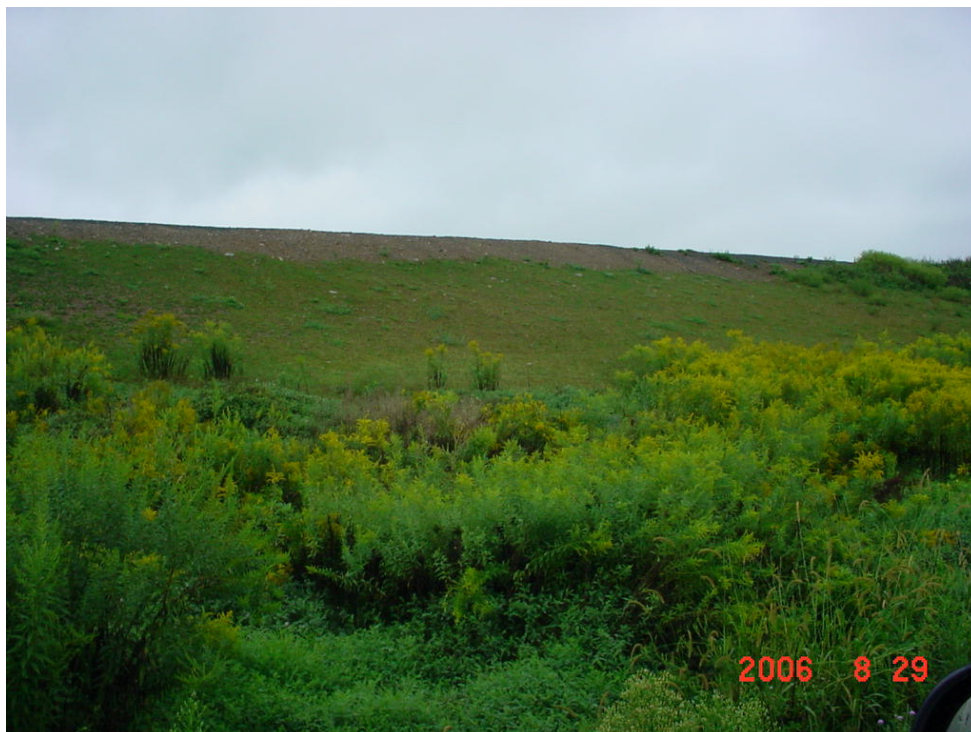
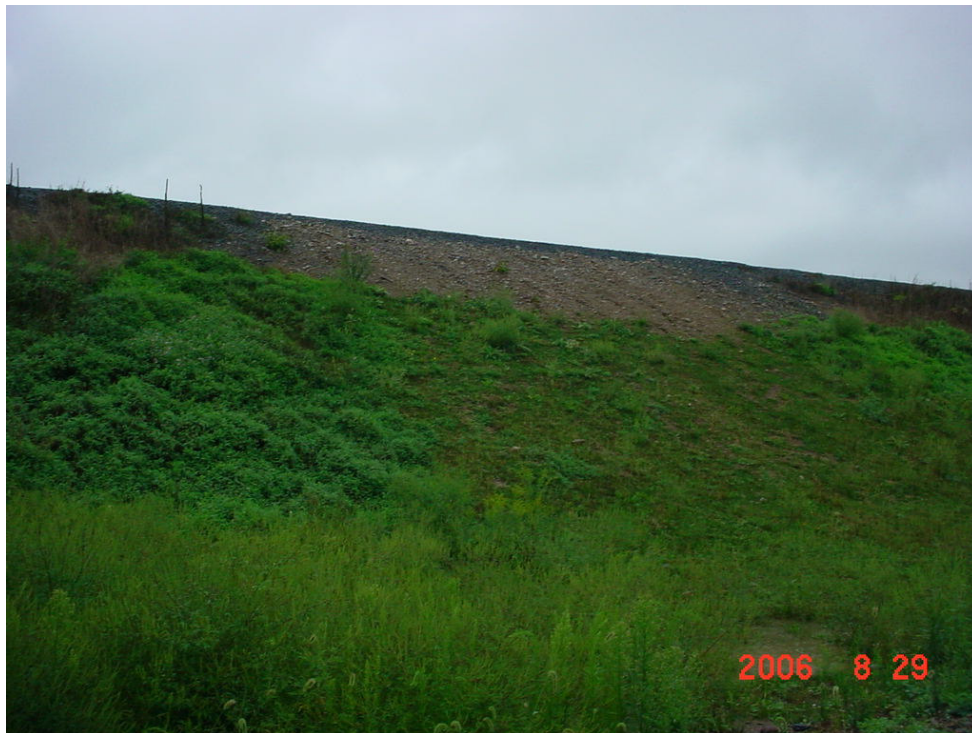
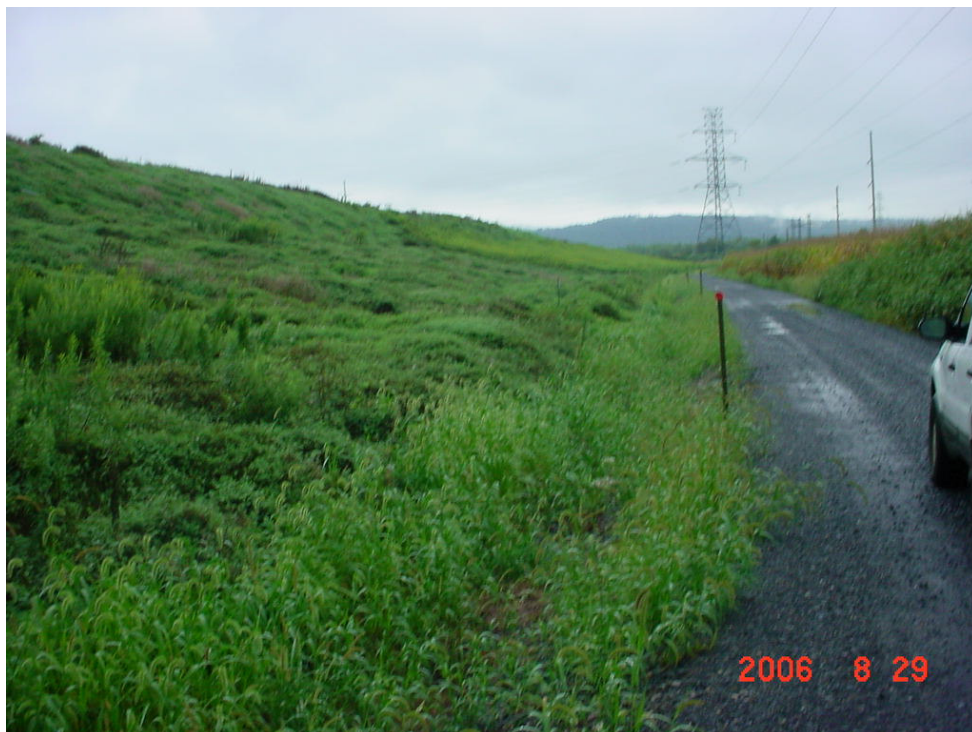
Downstream Face

**Downstream Face:** The downstream face consists of an approximate 2H:1V slope with a dense vegetative cover consisting mostly of crown vetch. The dense cover hindered a close inspection of the face. The face is in fair condition.

**Comments:** The dam is in good condition. The owner should consider establishment of a maintenance program which includes the routine cutting of vegetation on the downstream face and along the toe. The goal should be the establishment of a controlled grass cover in these areas. There is no low flow release required at this dam.

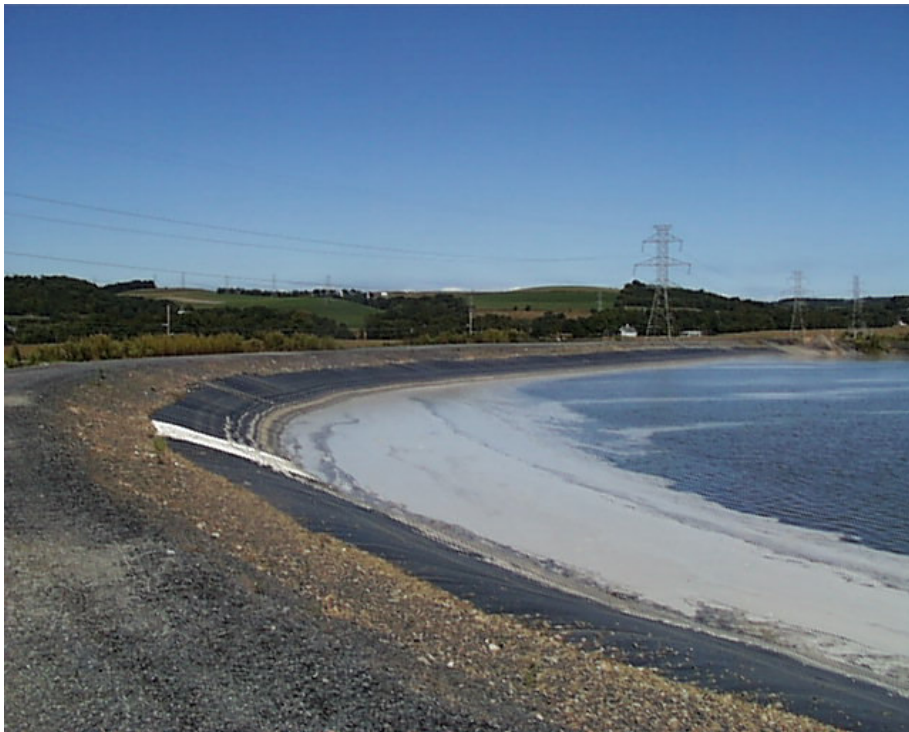
D48-149

**Upstream Face:** The majority of the upstream face consists of a PVC liner which extends throughout the entire basin area. The liner is in good condition. Above the liner, the face consists of a gravel cover. The face is in good condition.

Upstream Face

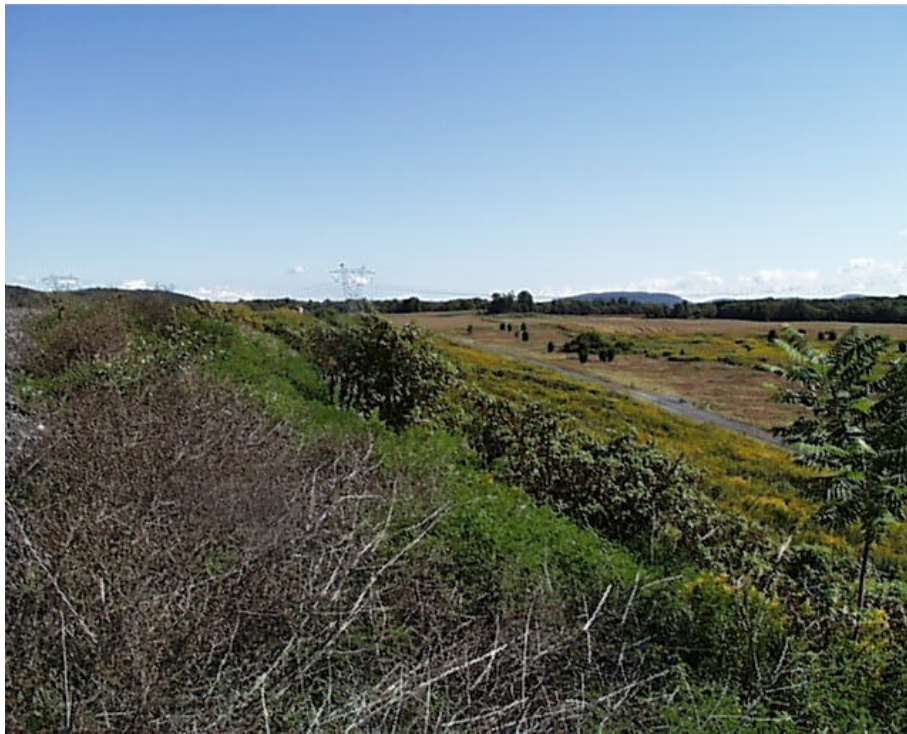
D48-149

Downstream Face

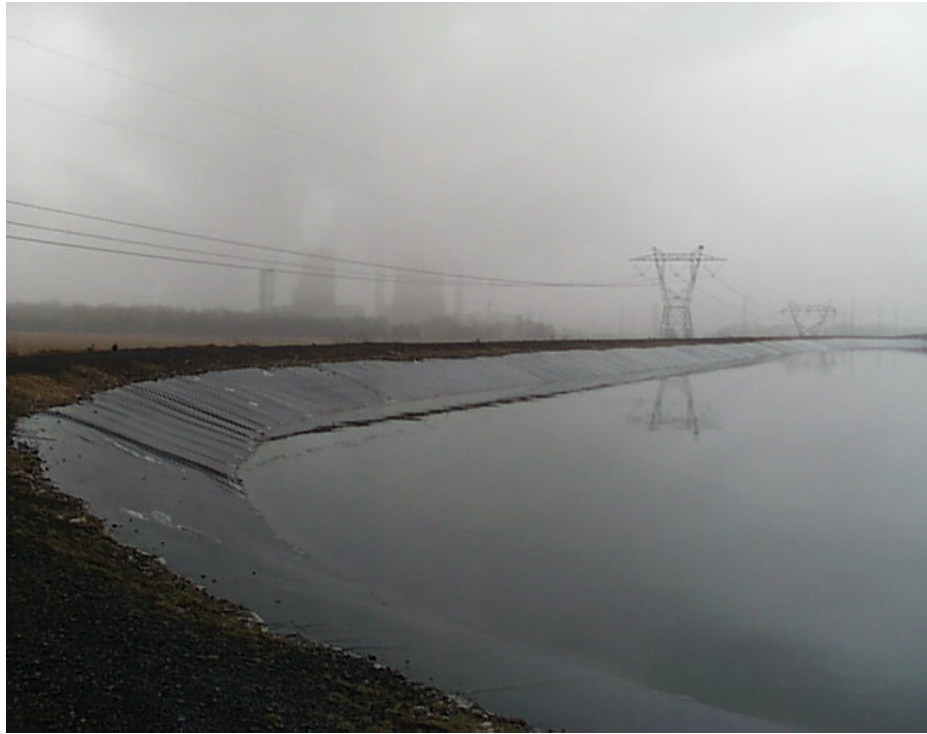
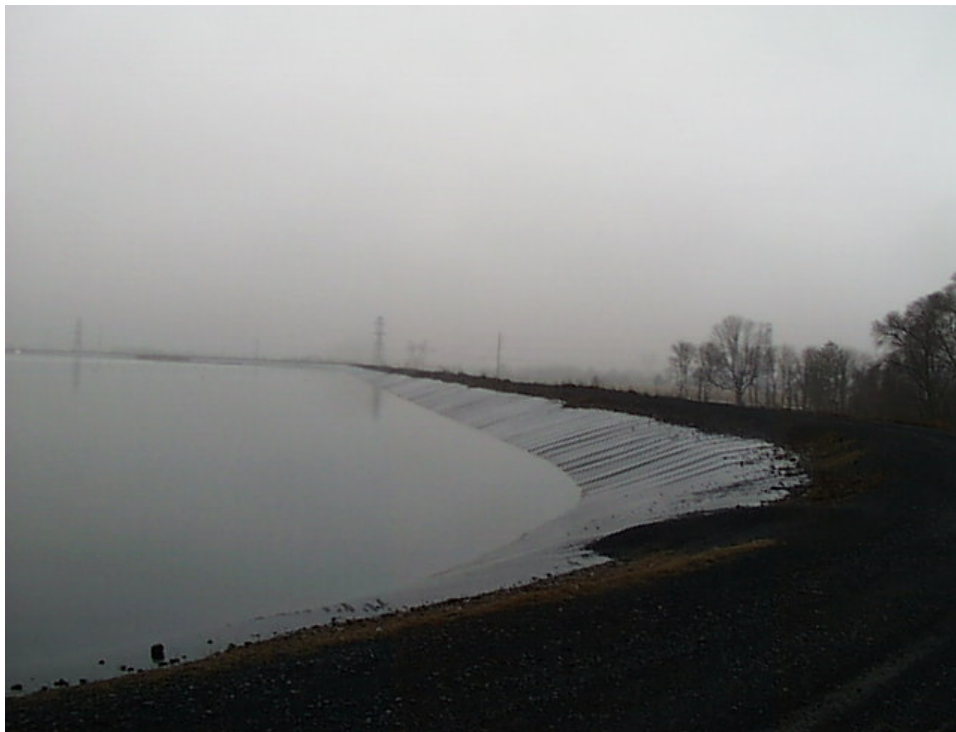
**Upstream Face:** The slope of the upstream face of the dam was estimated at 2H:1V that consists of a rubberized liner that overlays the earthen fill. The liner extends from below the normal pool to approximately 2 feet below the crest. Above this, the face consists of the gravel road surface. One vegetated fill area extends from the crest into the reservoir and is located approximately 300 feet to the right of the concrete riser structure. Several repair patches were noted throughout the liner.

Crest/Upstream Face – Left Side

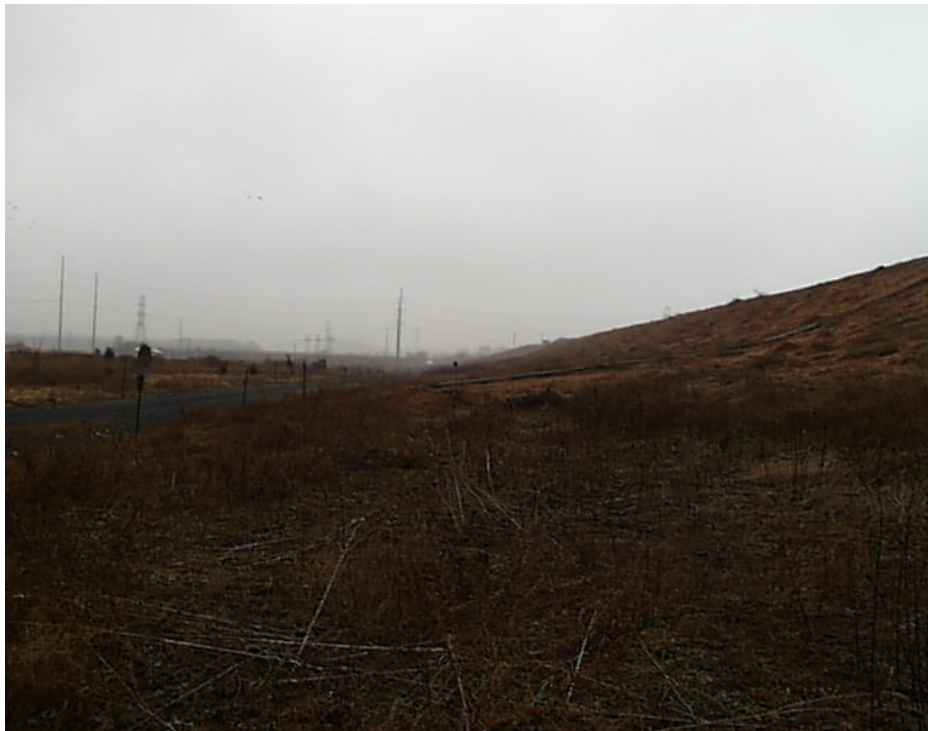
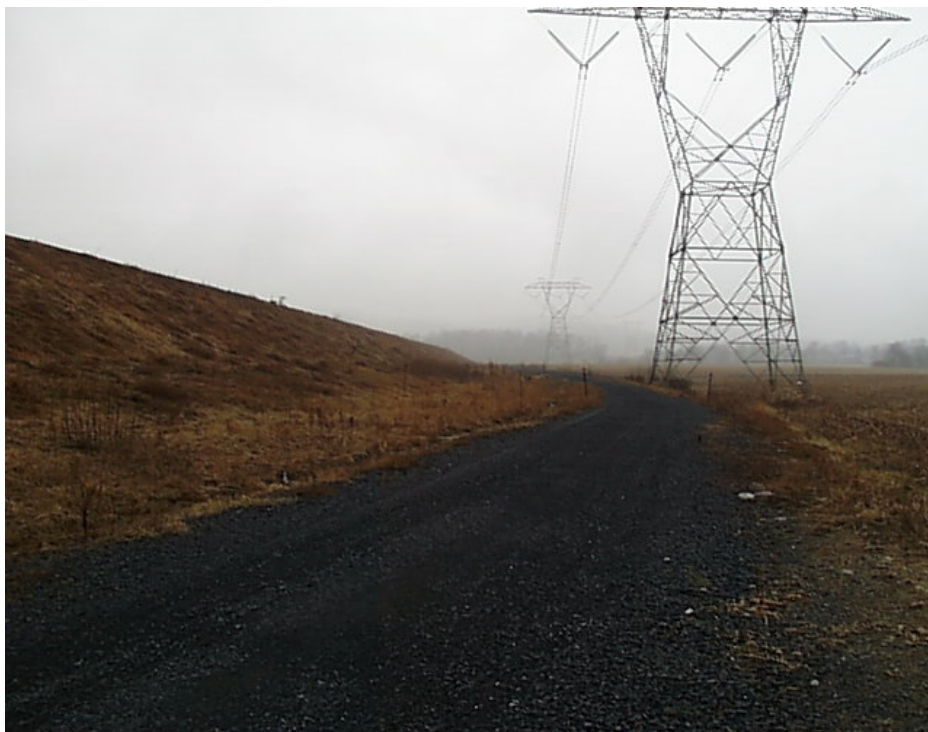
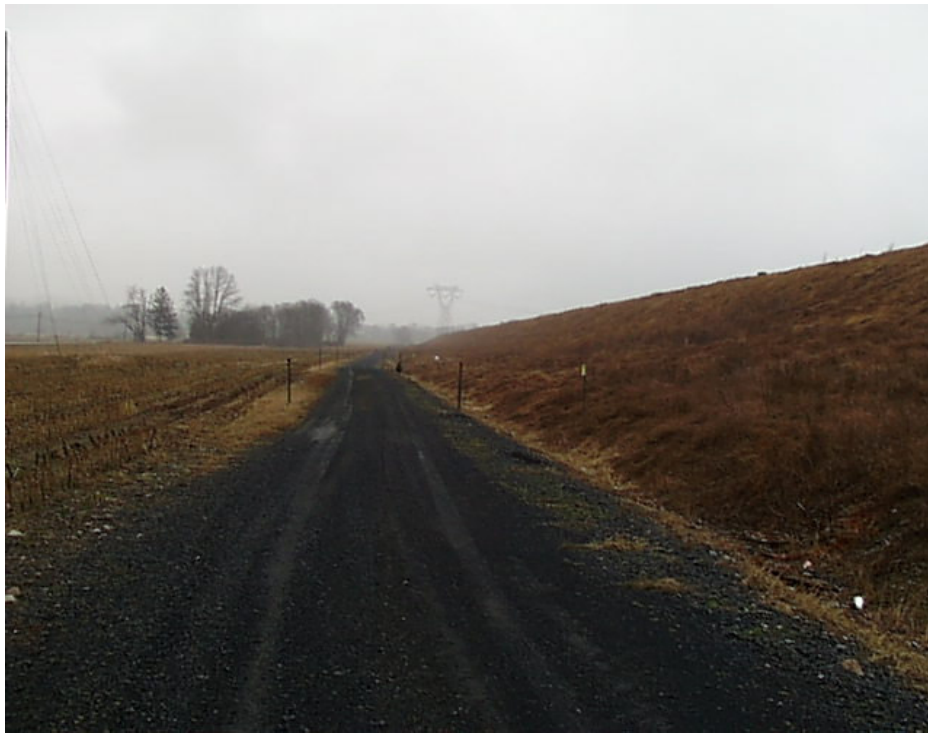
**Downstream Face:** The slope of the downstream face of the dam was estimated at 2H:1V. The face mostly consists of a moderate crown vetch cover. Two access roads extend from the toe area to the crest, one on each side of the riser structure. Both access roads consist of a gravel surface. The two ash discharge pipes on the left side of the face are exposed. Some sporadic sapling and brush growth was noted throughout the face.

Downstream Face/Toe Area – Left Side

**Comments:** Overall, the dam is in good condition. The overgrowth on the downstream face should be cut on a routine basis. The roadside swales along the toe of the dam should be graded to alleviate standing water so any potential seepage could be observed.

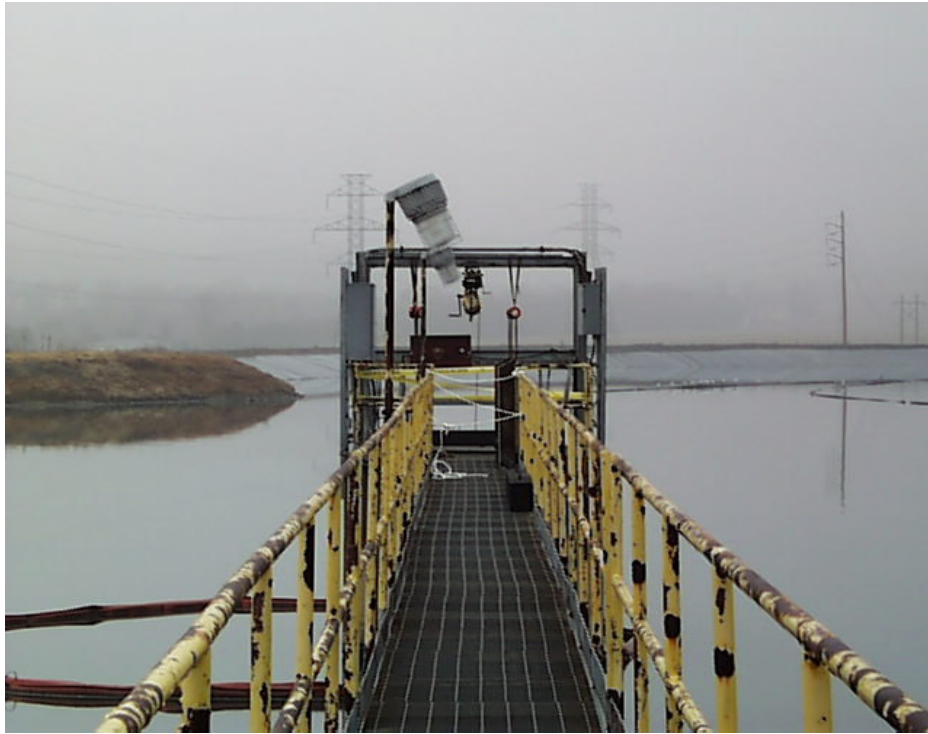
The riser structure could only be inspected from the embankment because the pedestrian bridge was caution-taped off for unknown reasons. Because of this, the wooden stop logs within the riser structure were not observed and the depth of flow could not be determined. No outlet was located.

Steel Pedestrian Access Bridge to Primary  
Spillway Intake Structure

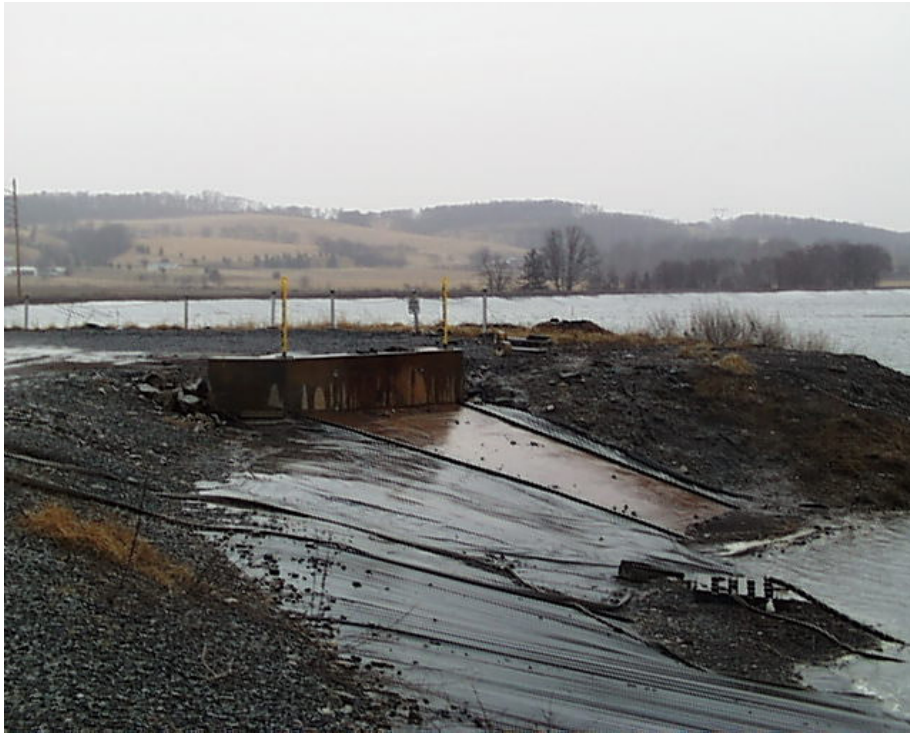
D48-149                      New Concrete Pad & Headwall Structure –  
Ash Unloading Area on Right Side of                      03/23/05  
Upstream Face

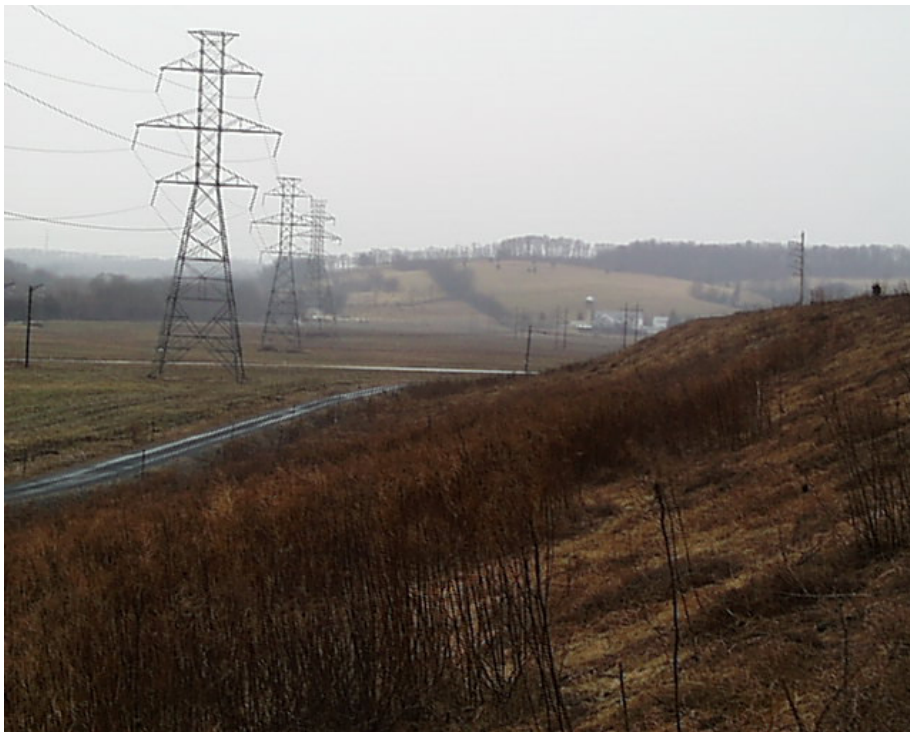
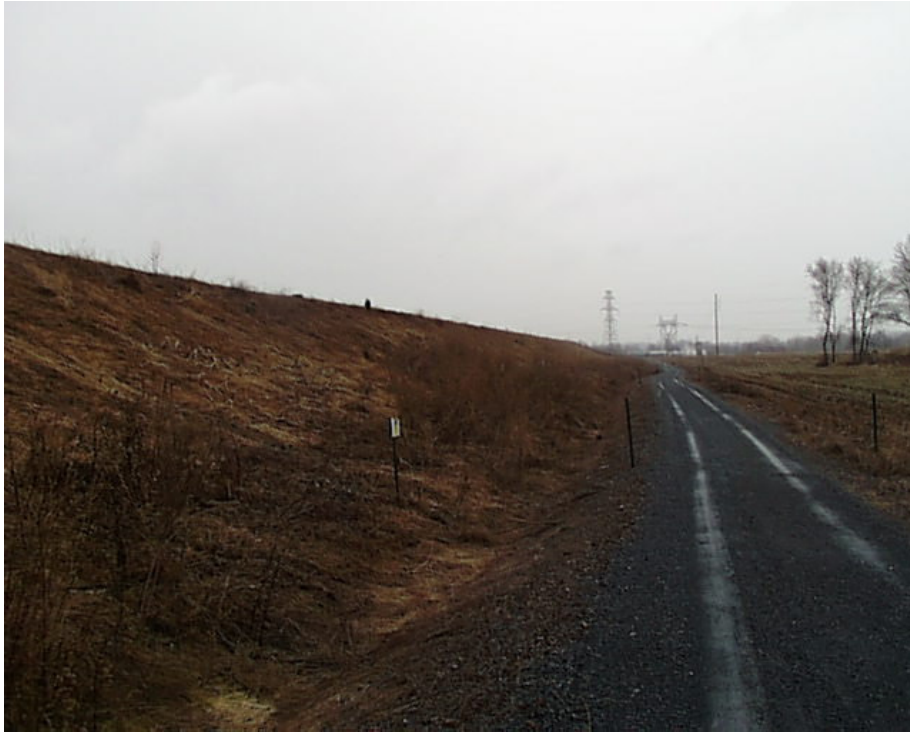
Downstream Face/Toe Area – Right Side

**Downstream Toe and Areas Beyond (Seepage, toe, drain, vegetation, etc.):** The downstream toe area of the dam consists of a roadside swales leading to a one-lane gravel access roadway that traverses the perimeter of the toe area. The ash discharge pipe from the power station exists on the left toe area.. The left toe area also had standing water. This standing water appears to be from poor drainage. The roadside swales had standing water with minor flow noted. A Liquid Carbon Dioxide storage tank within a barbed wire fenced-in area is at the toe just to the left of the access road to the dam.

**Comments:** The dam is in good condition. The overgrowth on the embankment and along the downstream toe should be cut on a regular basis. The roadside swales along the toe should be graded to promote flow and prevent standing water so that any seepage could be observed.

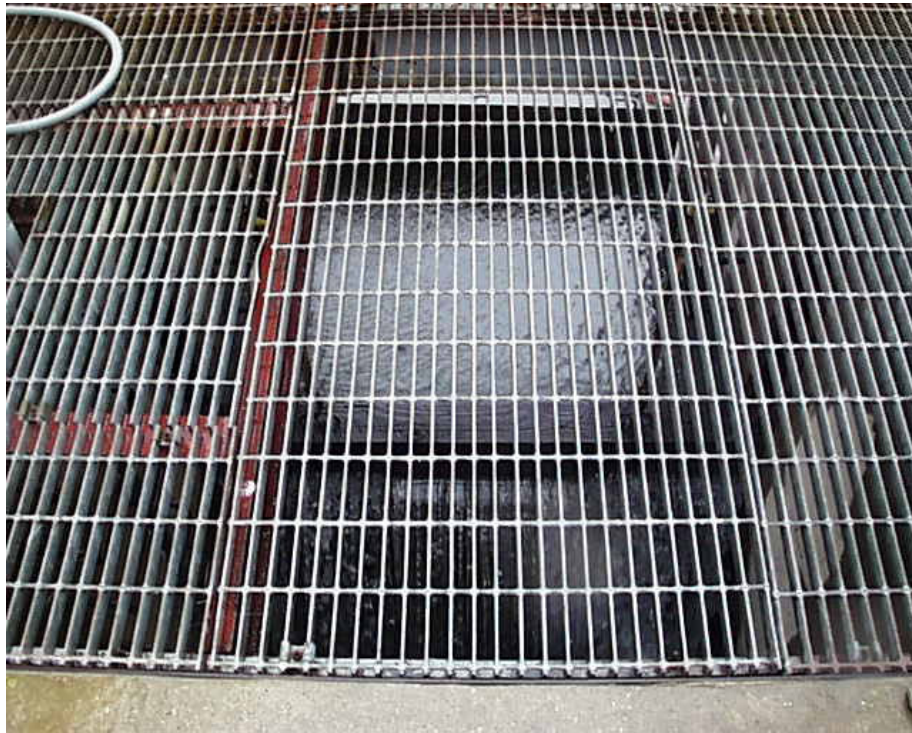
Primary Spillway & Wooden Stop  
Log Structure

The pool elevation is controlled by wooden stop logs within the riser structure. The stoplog structure could only be inspected from the pedestrian bridge. The top log was barely visible due to the estimated 2-inch flow depth to the concrete box structure. Several inches of flow was noted over the stop logs. The outlet could not be located.

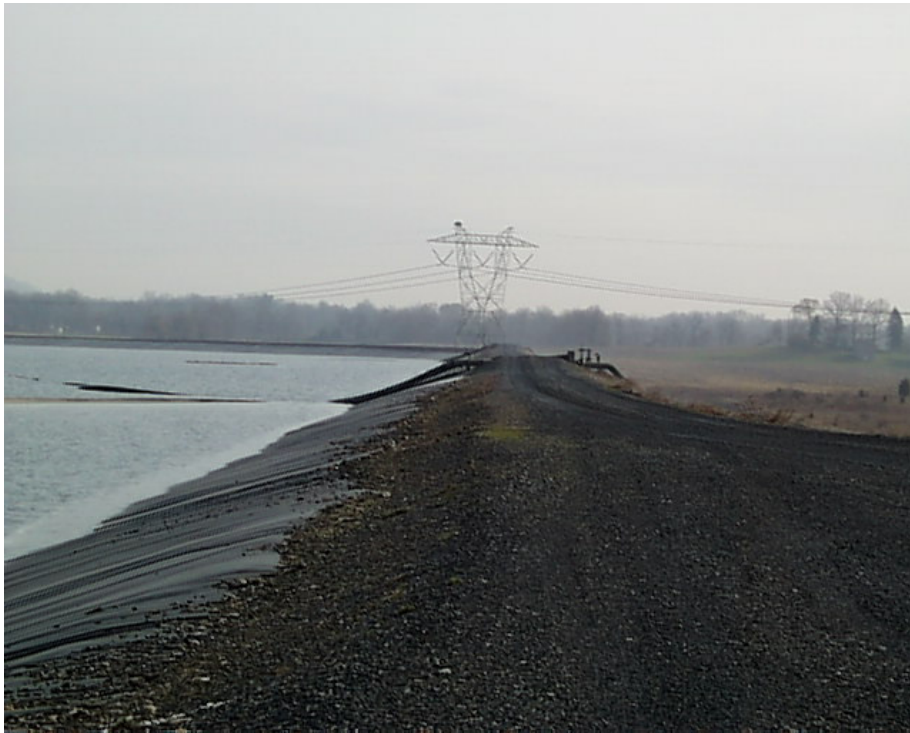
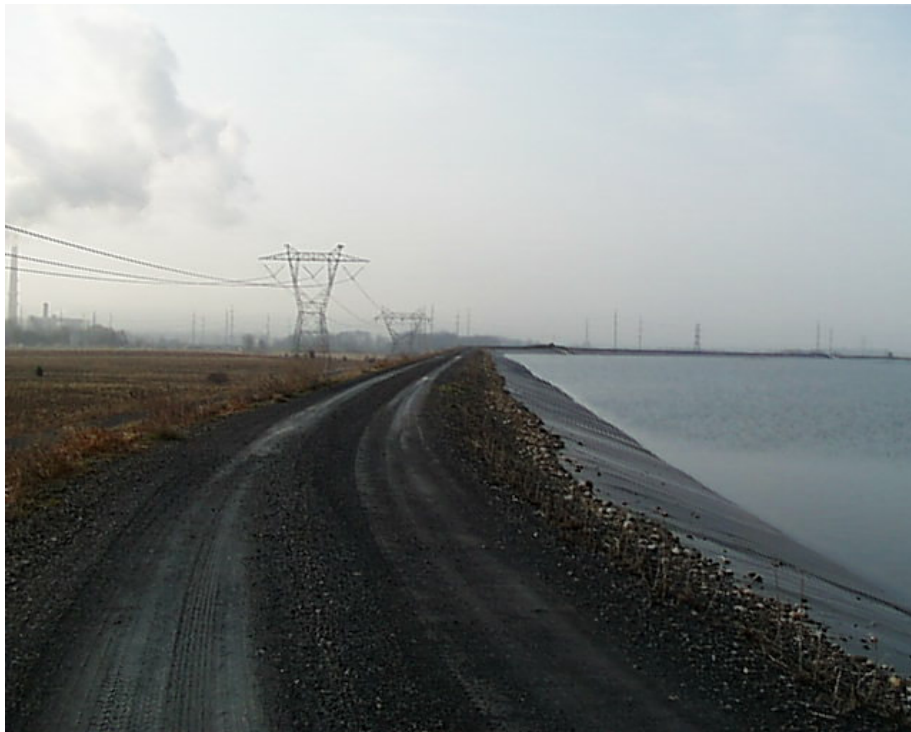
Crest/Upstream Face – Left Side

**Upstream Face:** The upstream face is on even slope and consists of a rubberized liner that overlays the earthen fill from below the normal pool to approximately 2 ft. below the crest. From the liner to the crest, the upstream face consists of a gravel surface. A vegetated fill area extends from the crest into the reservoir. This fill area is located approximately 300 ft. to the right of the concrete riser structure. A few areas of liner are patched and the remainder of the liner appears in good condition with no holes or tearing noted. A minor amount of knee to waist-high brush growth was noted along the top portion of the face.

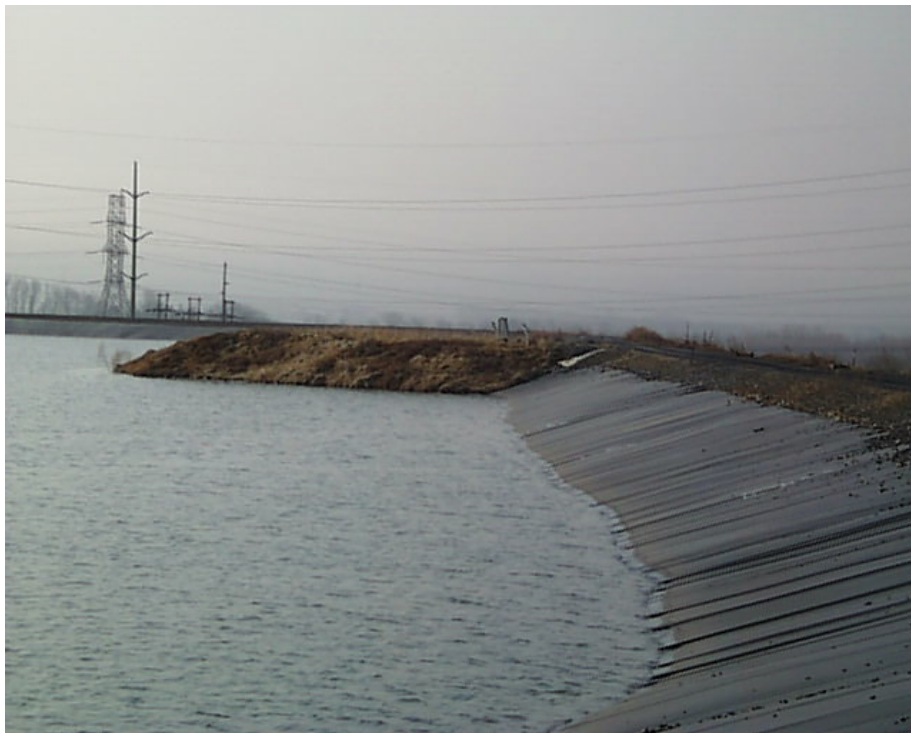
Vegetated Area on Right Side of Upstream  
Face

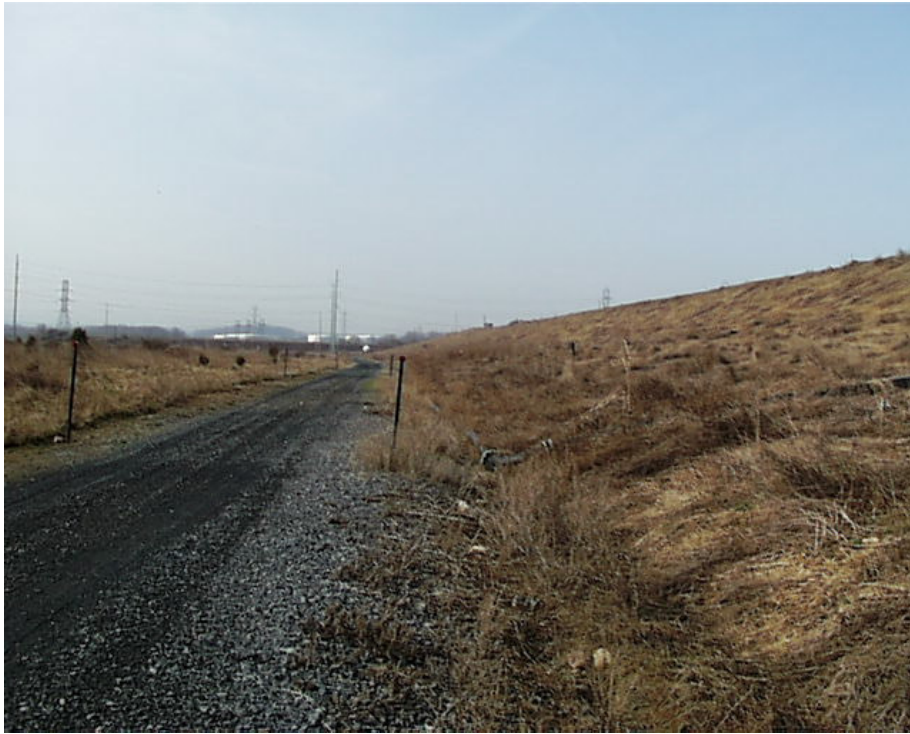
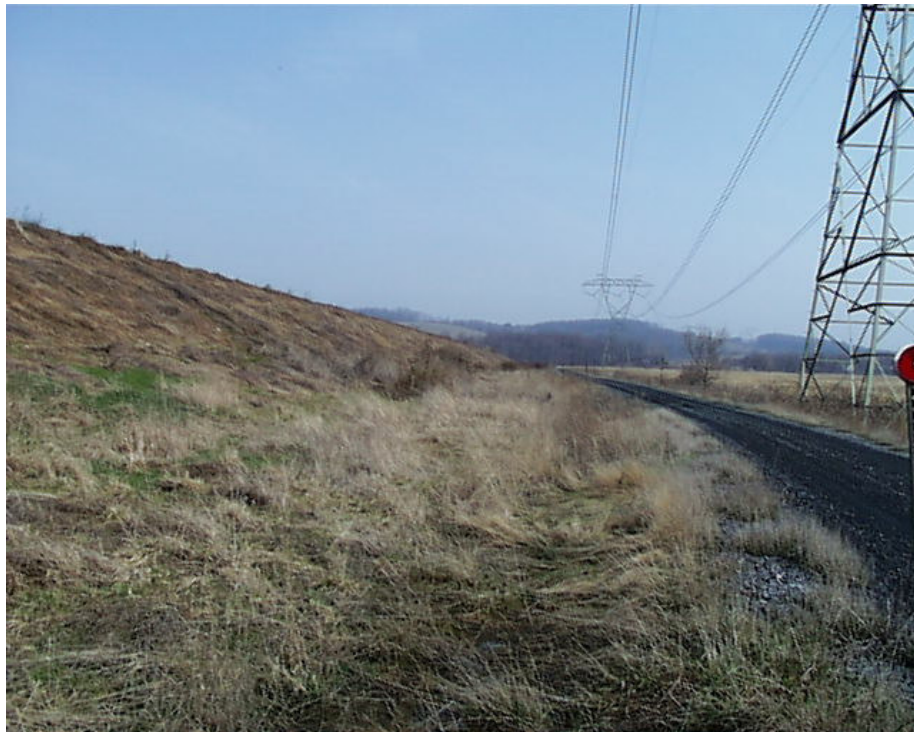
Downstream Face & Toe Area – Left Side

**Downstream Toe and Areas Beyond (Seepage, toe, drain, vegetation, etc.):** The downstream toe of the dam consists of a roadside swale and a one-lane gravel access roadway that traverses the perimeter of the toe area. The toe area to the left of the primary spillway consists of the ash discharge pipe from the power station. The left toe area had standing water. This appeared to be from poor drainage of this area. The roadside swales had standing water with minor flow noted. A section of the roadway has eroded due to run-off of a farm field. The erosion does not prevent access around the toe. This area is on the right toe area. A Liquid Carbon Dioxide storage tank within a barbed wire fenced-in area is at the toe just to the left of the entrance access road to the dam.

**Comments:** Overall, the dam appears in good condition. The overgrowth on the embankment and along the downstream toe should be cut on a regular basis. The roadside swales along the toe should be graded to promote flow and prevent standing water so that any seepage could be noted.

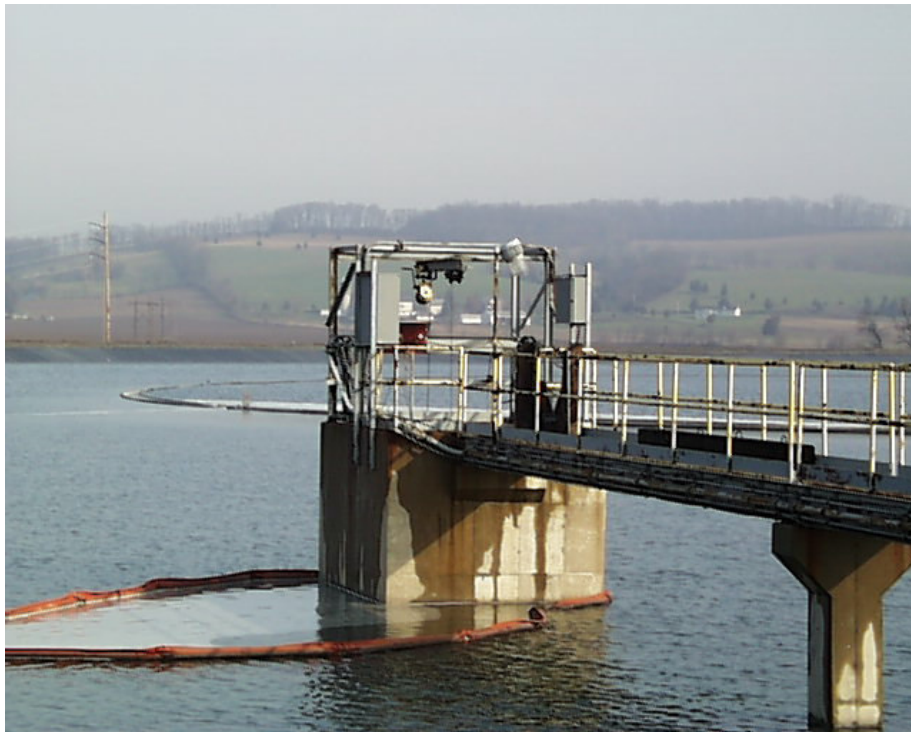
Primary Spillway

**Primary Spillway (Approach, crest, outlet, abutments, etc.):** The approach to the primary spillway is clear and unobstructed. The primary spillway consists of a concrete riser structure located in the reservoir near the center of the dam approximately 80 ft. from the upstream face. Access to the riser structure is by a steel pedestrian bridge, which appears in good condition.

The pool elevation is controlled by wooden stop logs within the riser structure. Several inches of flow was noted over the stop logs. The outlet could not be located. The intake structure appears in good condition.

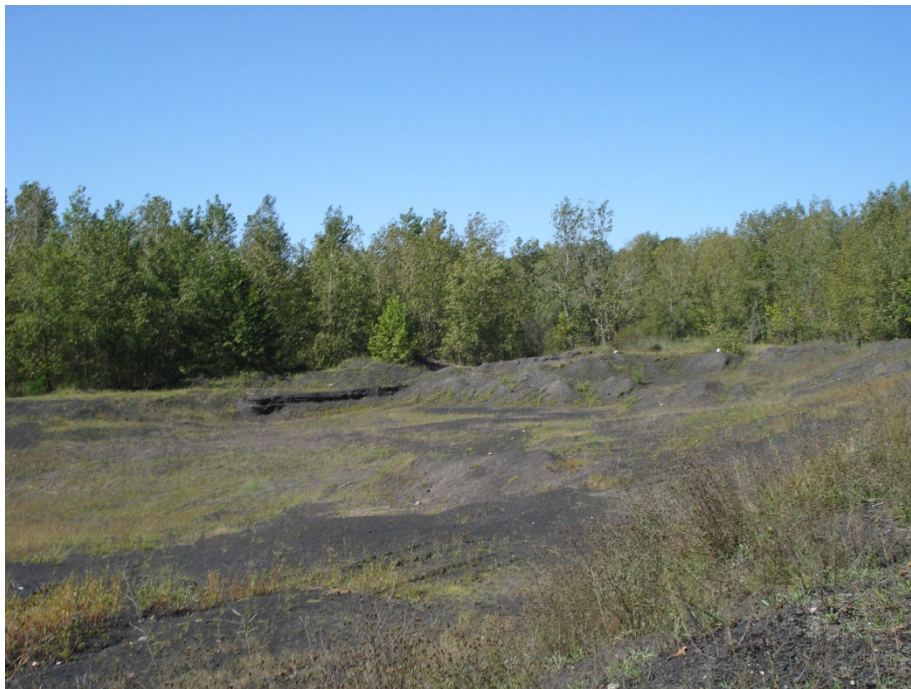
(Basin I) Berms to be Flattened Before Closure (black gravel=bottom ash; white objects are buckets), Martins Creek Power Plant, Bangor, PA, 09.01.09.

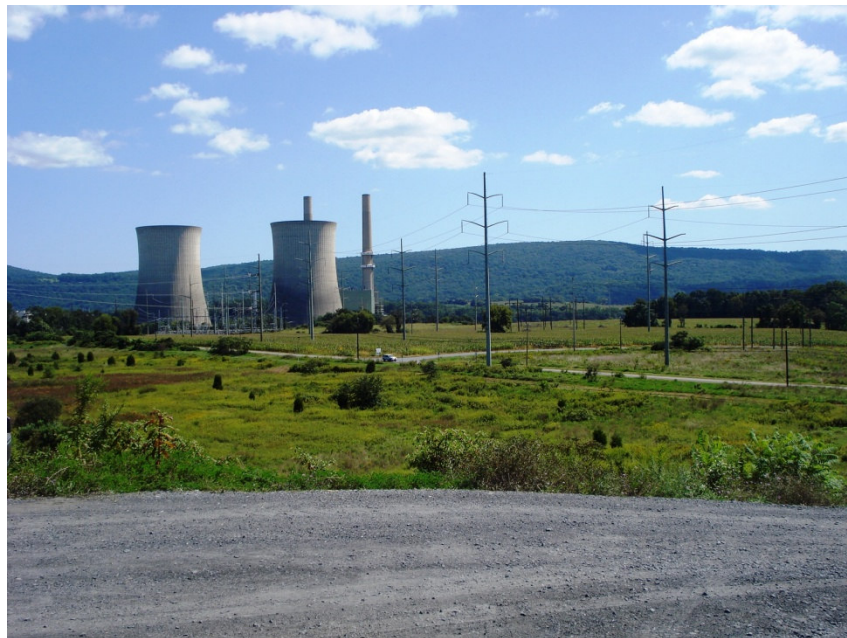
(Basin 4) Colling Towers, Martins Creek Power Plant, Bangor, PA, 09.01.09.

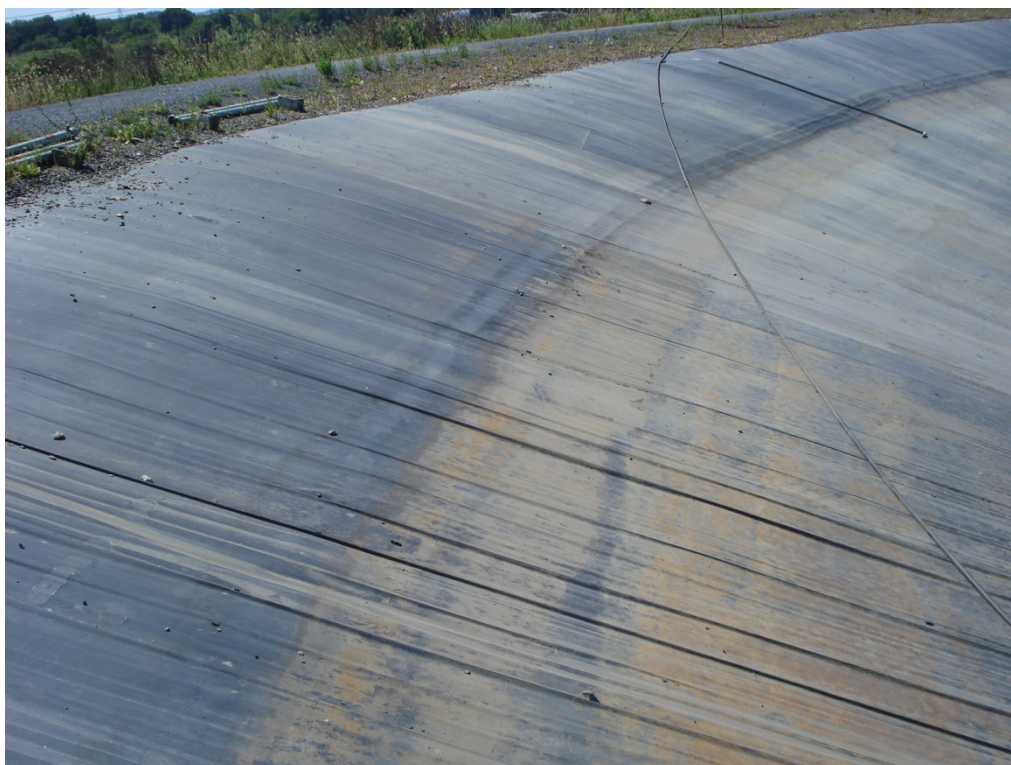
(Basin 4) Watermark on Liner (view from outfall structure), Martins Creek Power Plant, Bangor, PA, 09.01.09.

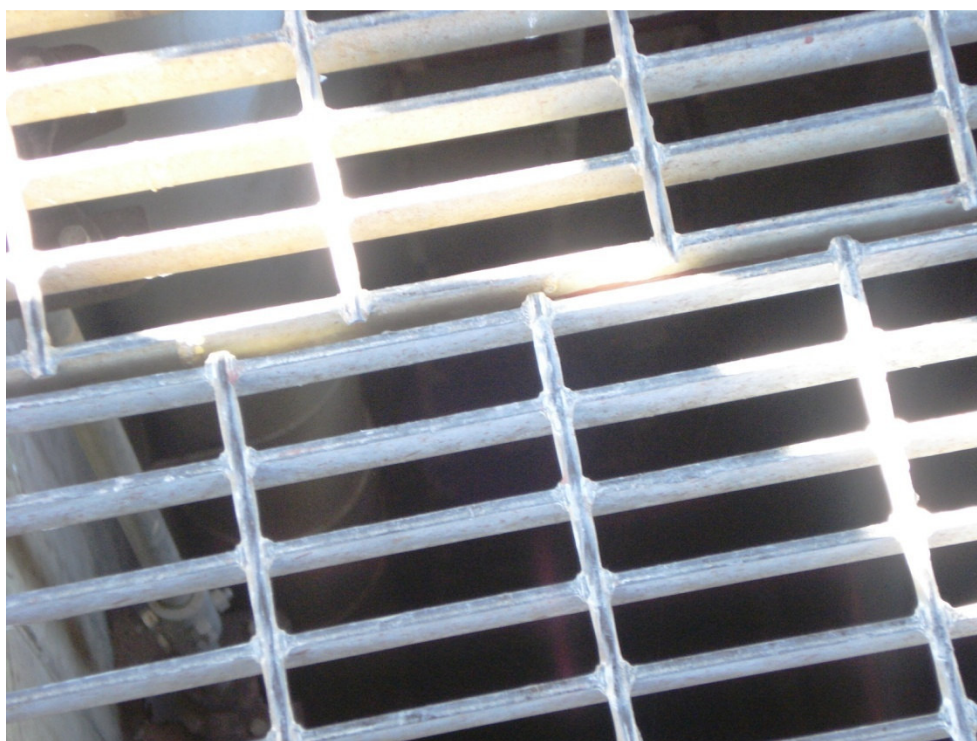
(Basin 4) Looking Down Outfall Structure, Martins Creek Power Plant, Bangor, PA, 09.01.09.

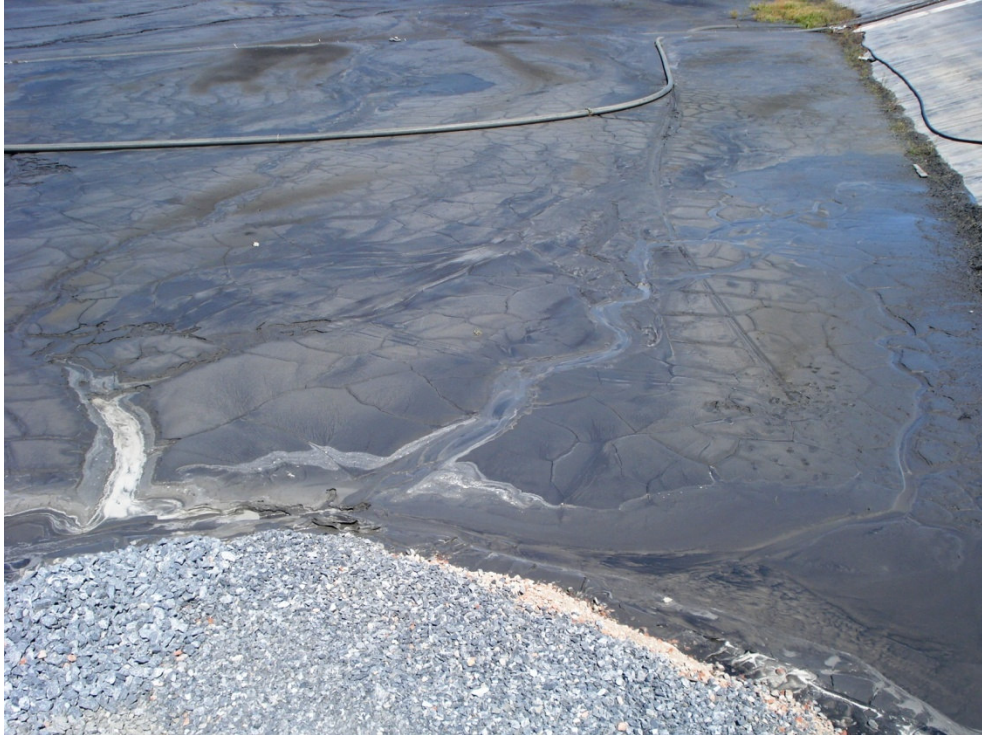
(Basin 4) Ash from Outfall, Martins Creek Power Plant, Bangor, PA, 09.01.09.

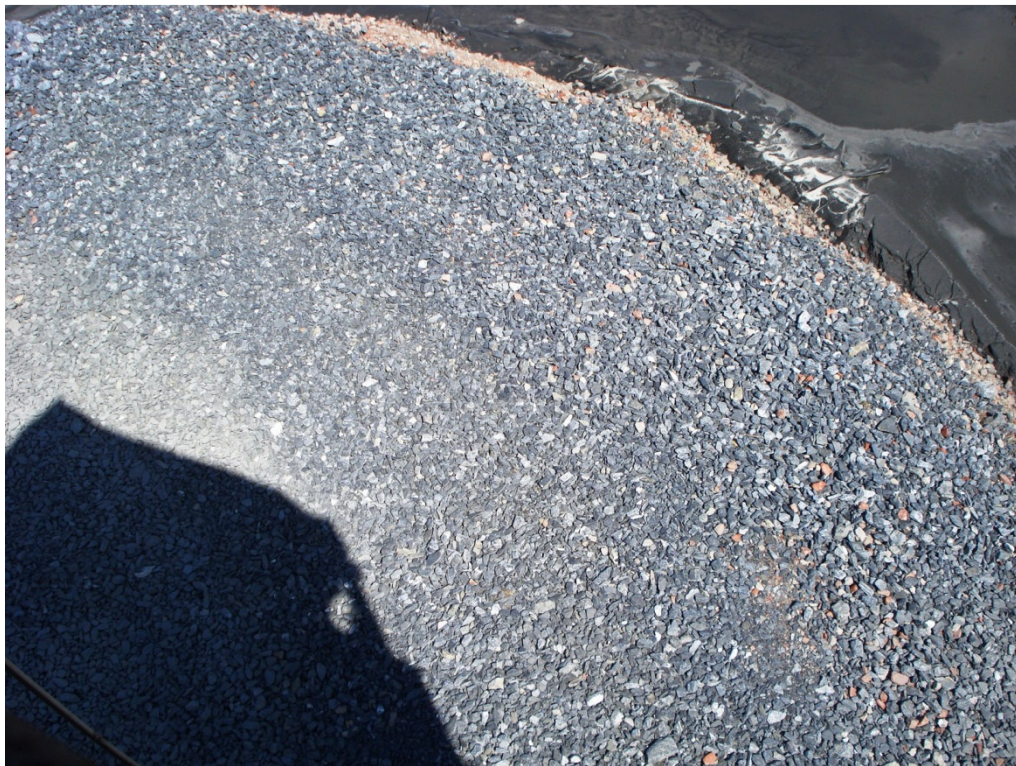
(Basin 4) 10' Deep of Rip Rap from Outfall, Martins Creek Power Plant, Bangor, PA, 09.01.09.

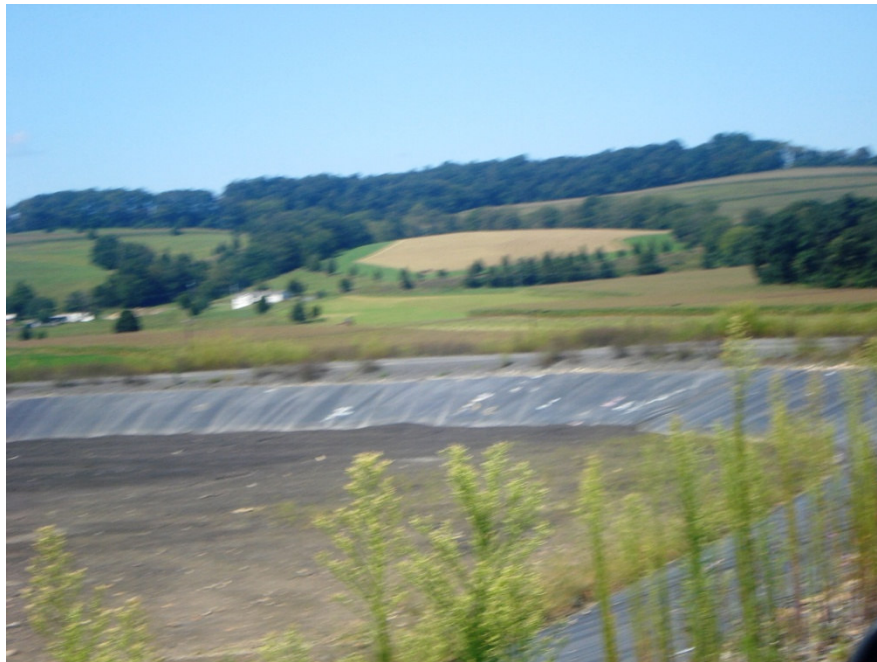
(Basin 4) Markings from Previous Inspections Where Liner Needs Maintenance, Martins Creek Power Plant, Bangor, PA, 09.01.09.
