Martins Creek Power Plant Regional Map Showing the Management Unit(s) in Relationship to Critical Infrastructure (Photo Locations of Documents A1.3-A1.10)

***DEP comment # 6: PPL asserts that certain portions of the basin are susceptible to leaching dissolved selenium when ash remains saturated for a period of time. Please provide estimates of the amount of continuous precipitation that could result in the saturation of fly ash within the basin and the increase in water level within the aquifer beneath the basin such that it contacts the ash and affects groundwater.***

**Martins Creek SES Ash Basin #4 Release**  
Martins Creek SES Site Layout

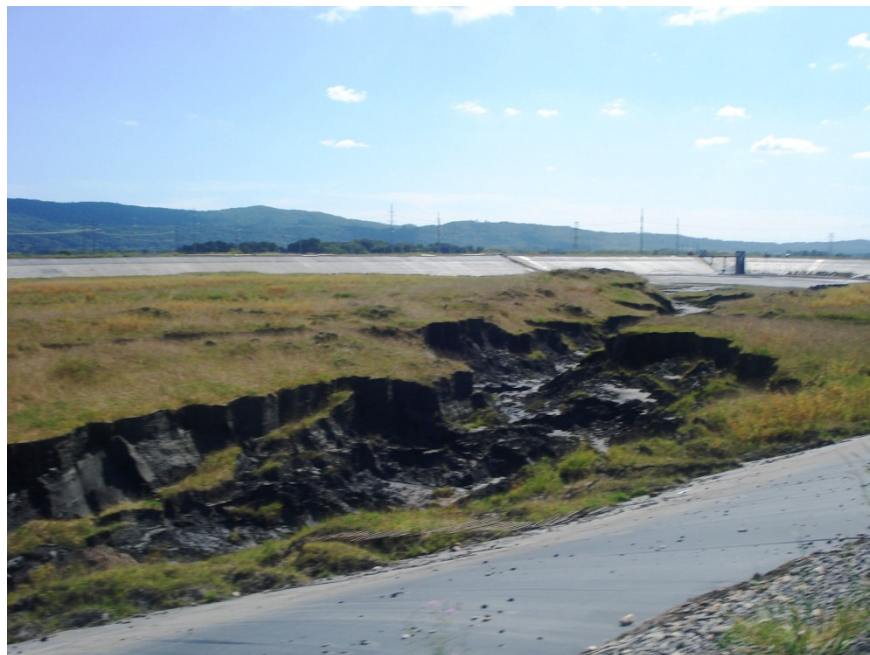
(Basin 4) Grass On Top of Coal Ash (nothing holding ash together, so subject to sloughing), Martins Creek Power Plant, Bangor, PA, 09.01.09.

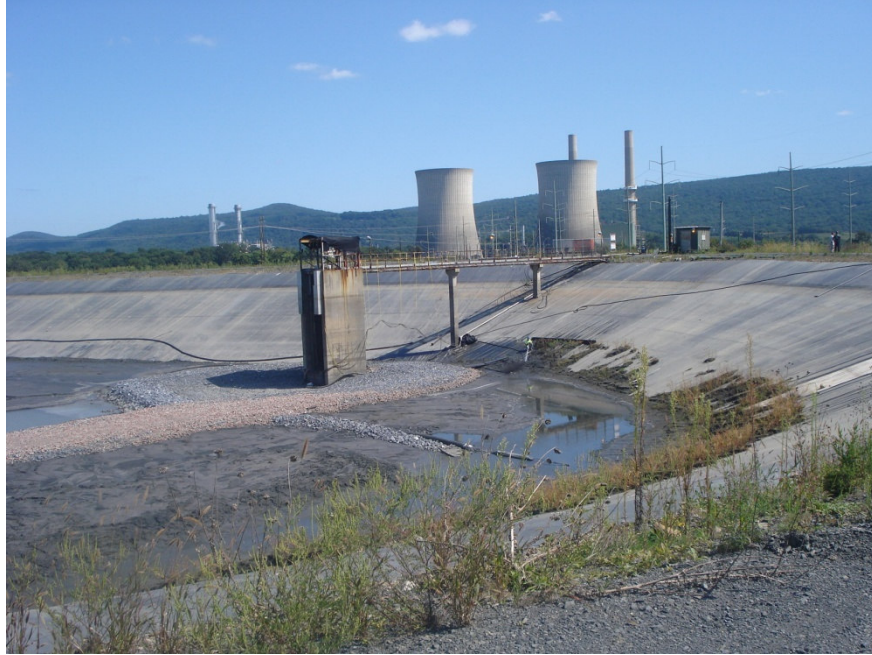
(Basin 4) Power Washing Fly Ash Off Liner, Martins Creek Power Plant, Bangor, PA, 09.01.09.

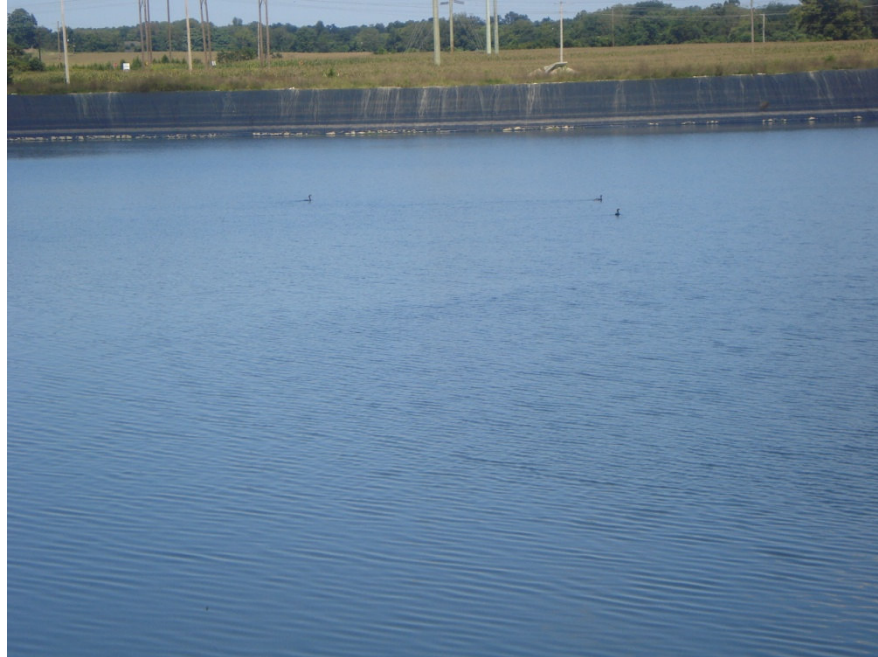
(IWTB) Ducks Indicating Presence of Fish in Basin, (from discharge structure), Martins Creek Power Plant, Bangor, PA, 09.01.09.

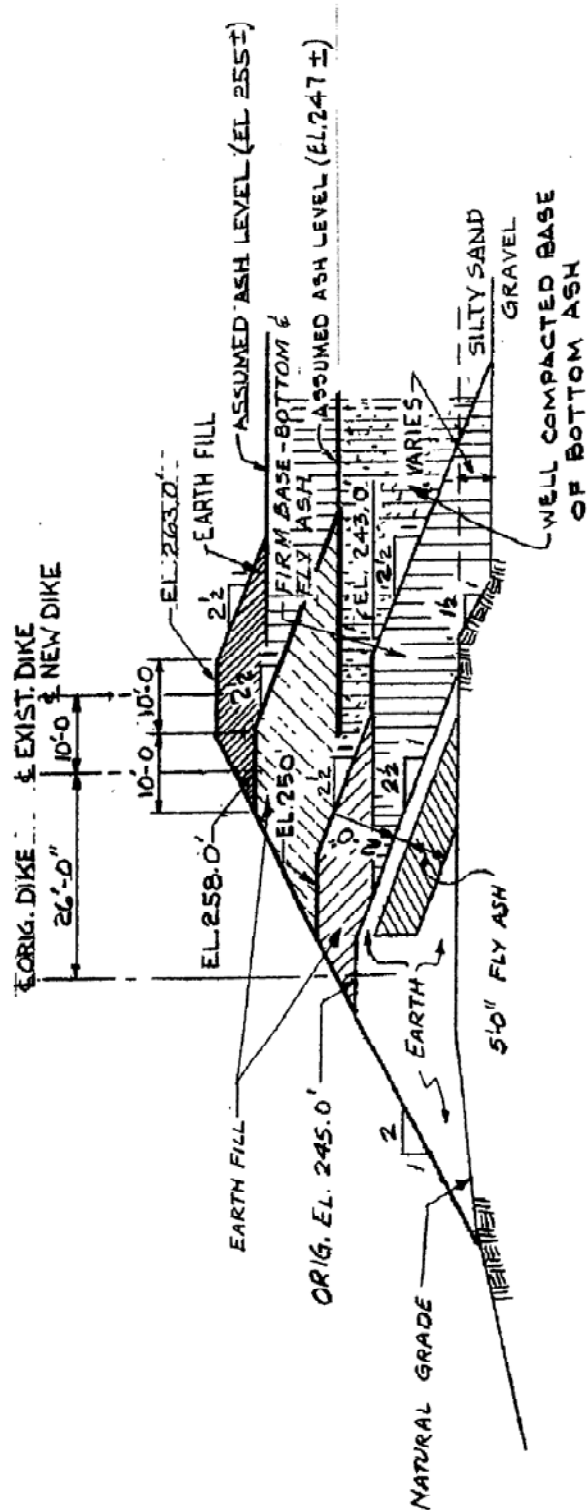
EXHIBIT 1:

ASH BASIN NO. 1 - REPRESENTATIVE SECTION OF EMBANKMENT DAM

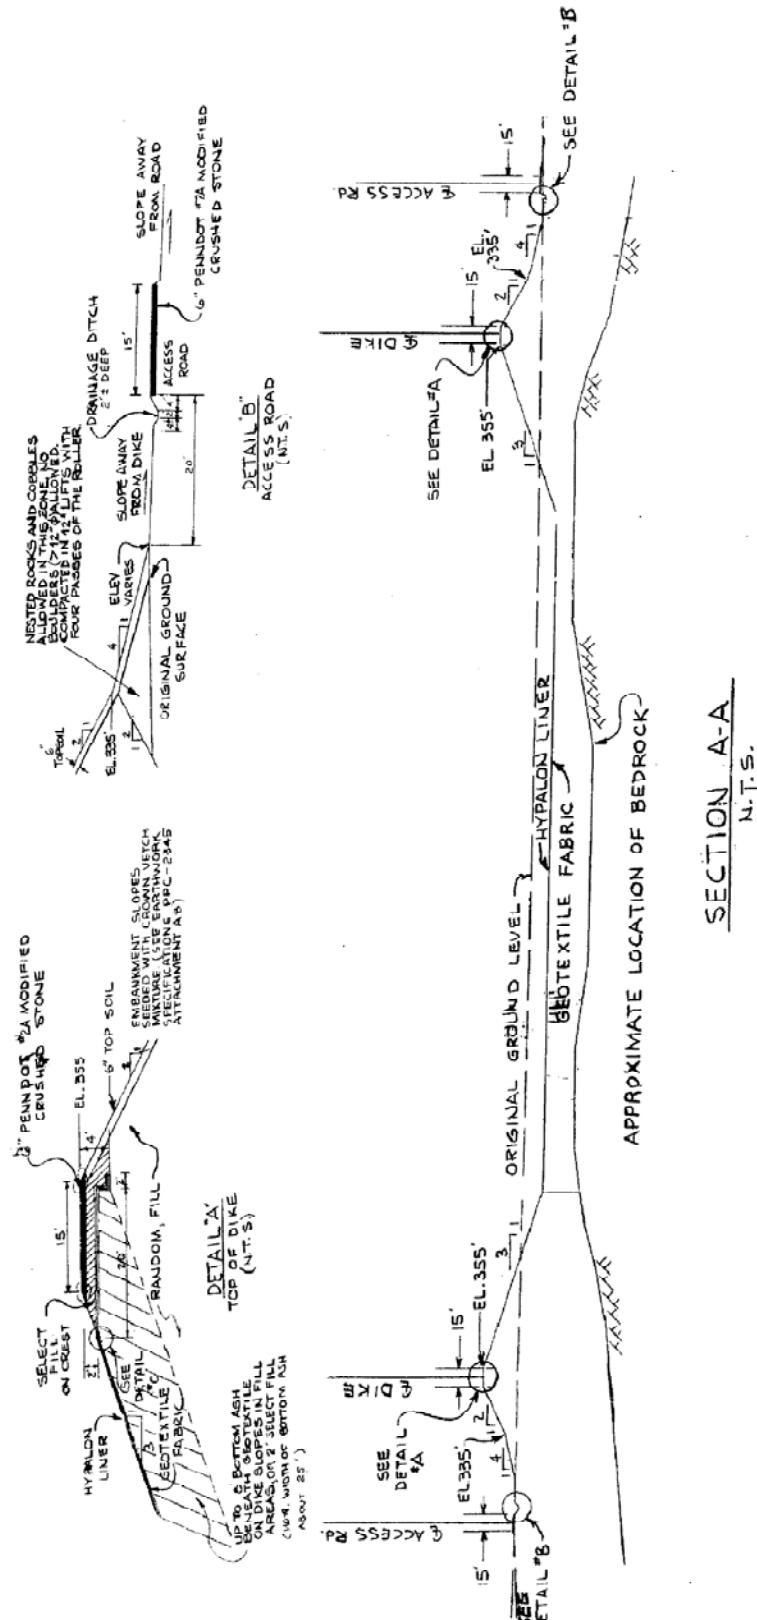
**EXHIBIT 2:**

**ASH BASIN NO. 4 – REPRESENTATIVE SECTION AND DETAILS OF EMBANKMENT DAM AND BASIN**

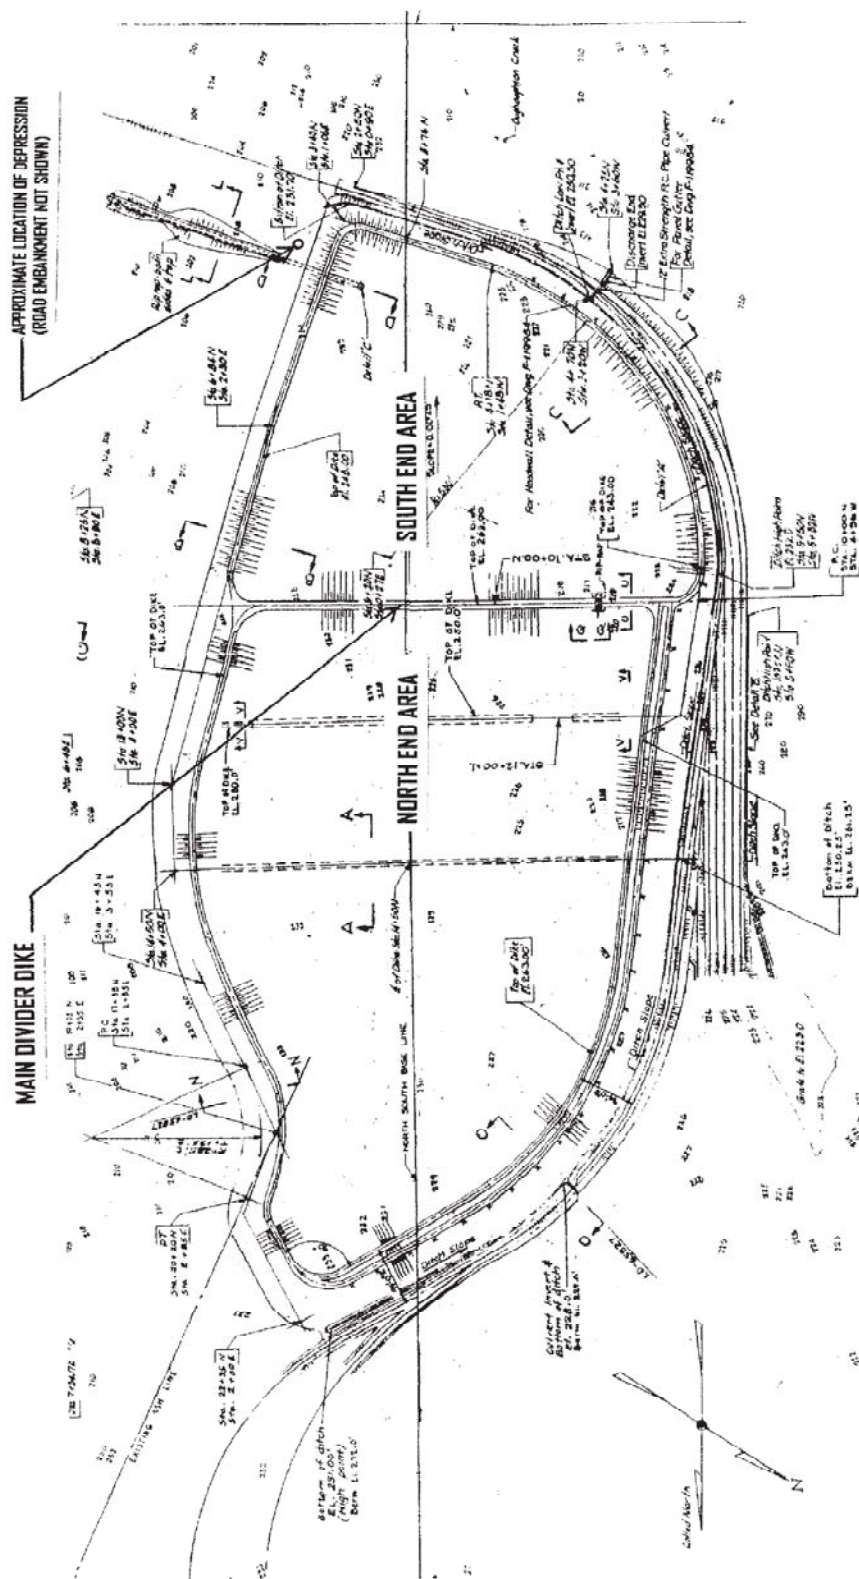
EXHIBIT 3:

ASH BASIN NO. 1 - PLAN VIEW SHOWING BASIN LAYOUT AND LOCATION OF OUTLET STRUCTURE

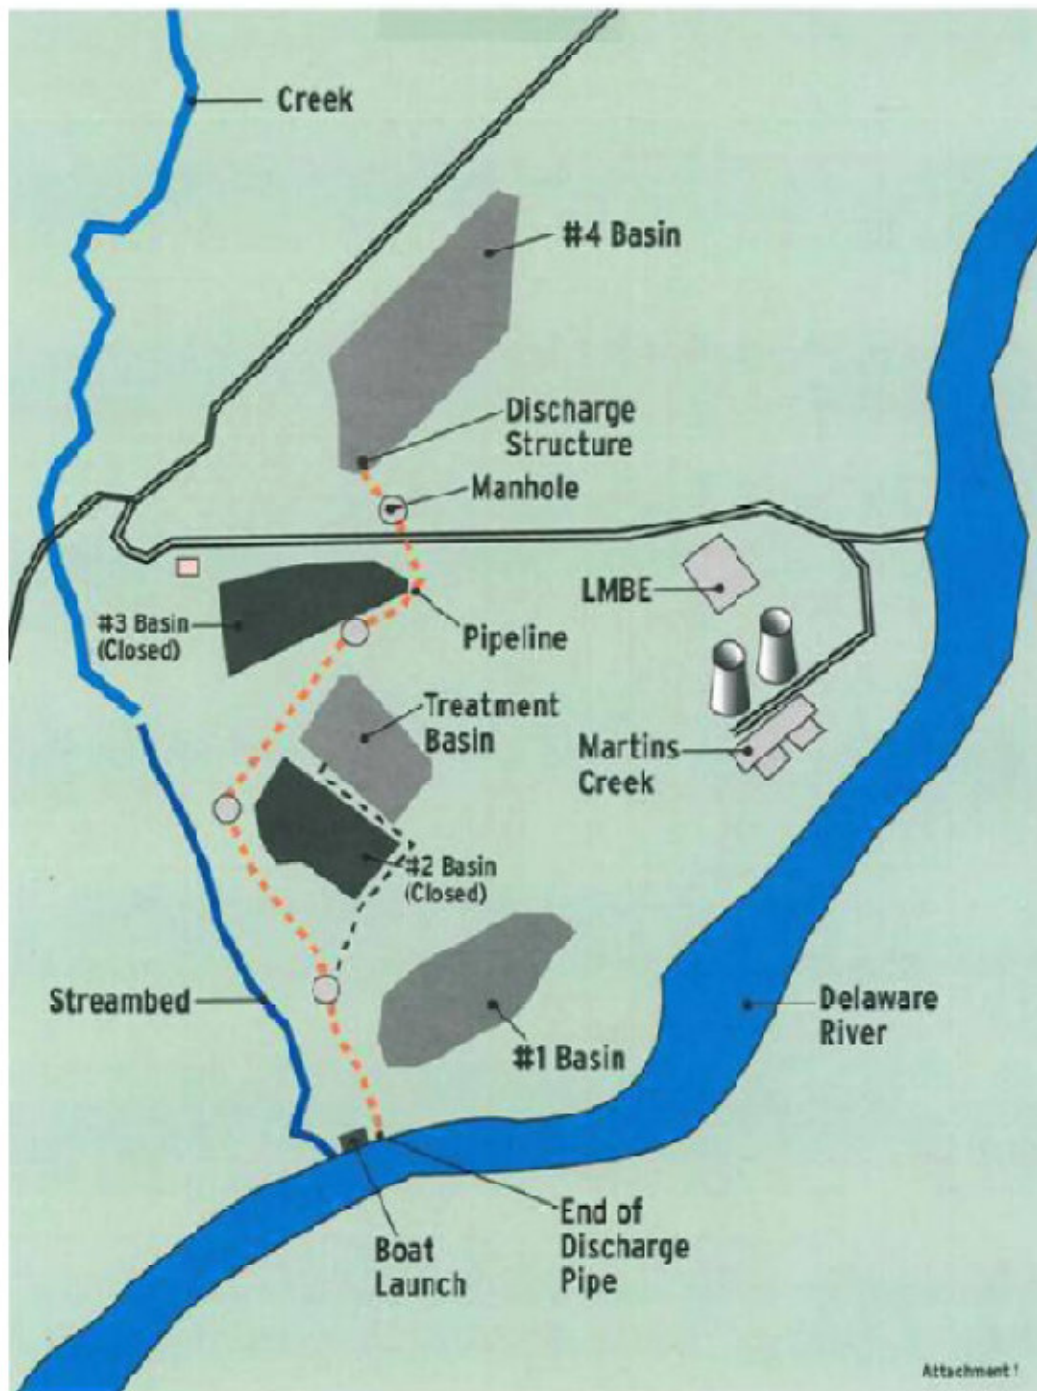
EXHIBIT 5:

SCHEMATIC PLAN VIEW OF MARTINS CREEK SES SHOWING LAYOUT OF BASINS AND DISCHARGE PIPING

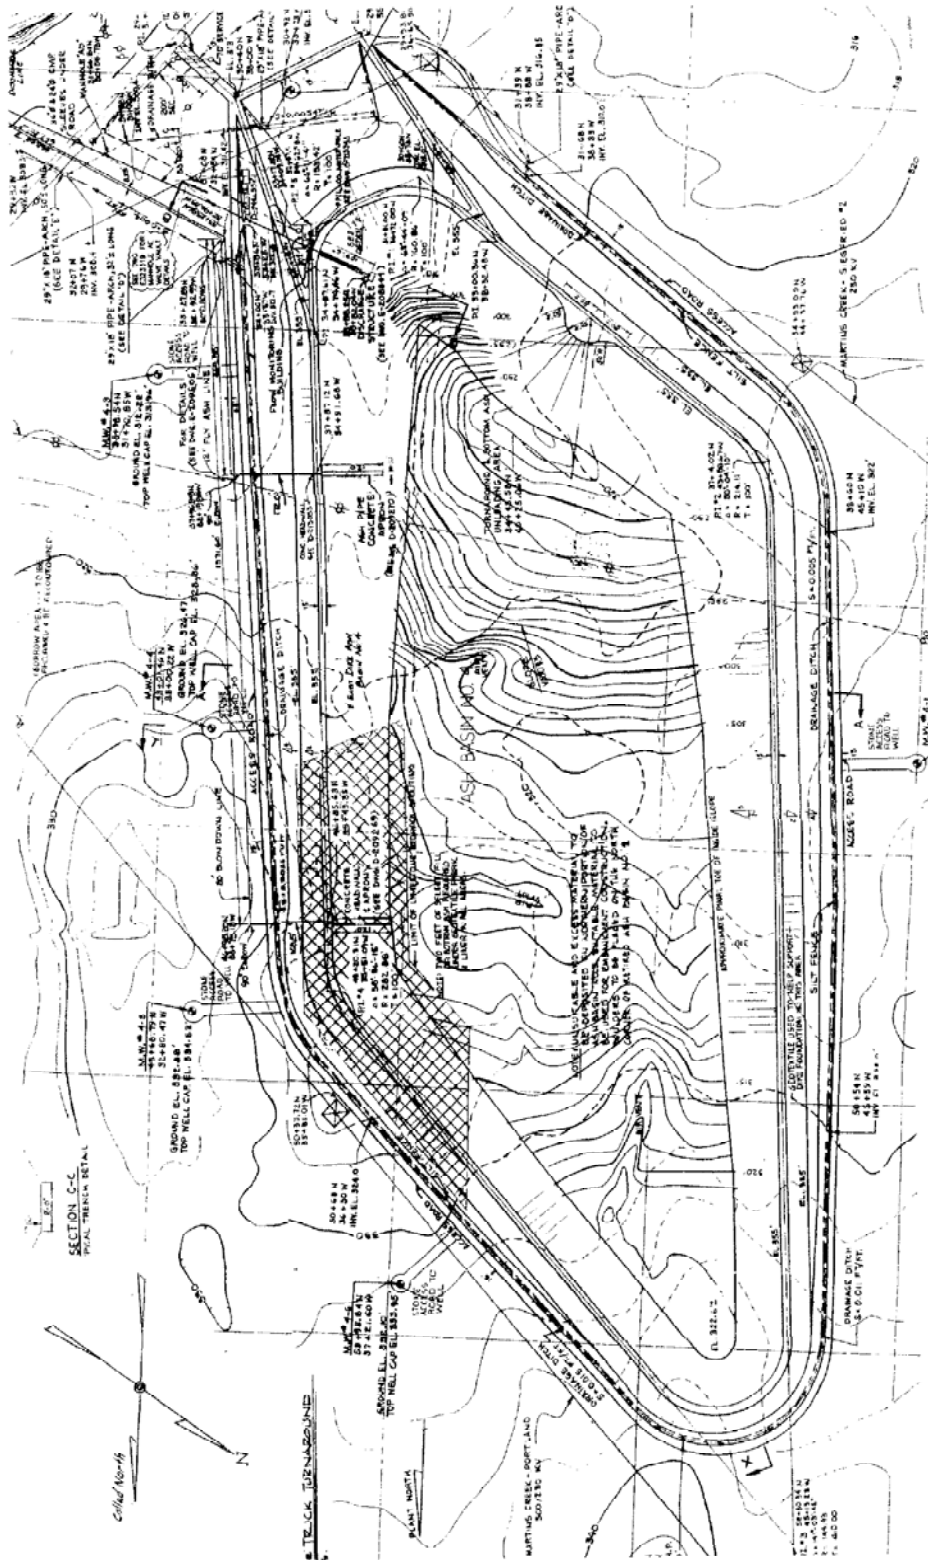
EXHIBIT 6:

ASH BASIN NO. 4 – PLAN VIEW SHOWING BASIN LAYOUT AND LOCATION OF OUTLET STRUCTURE

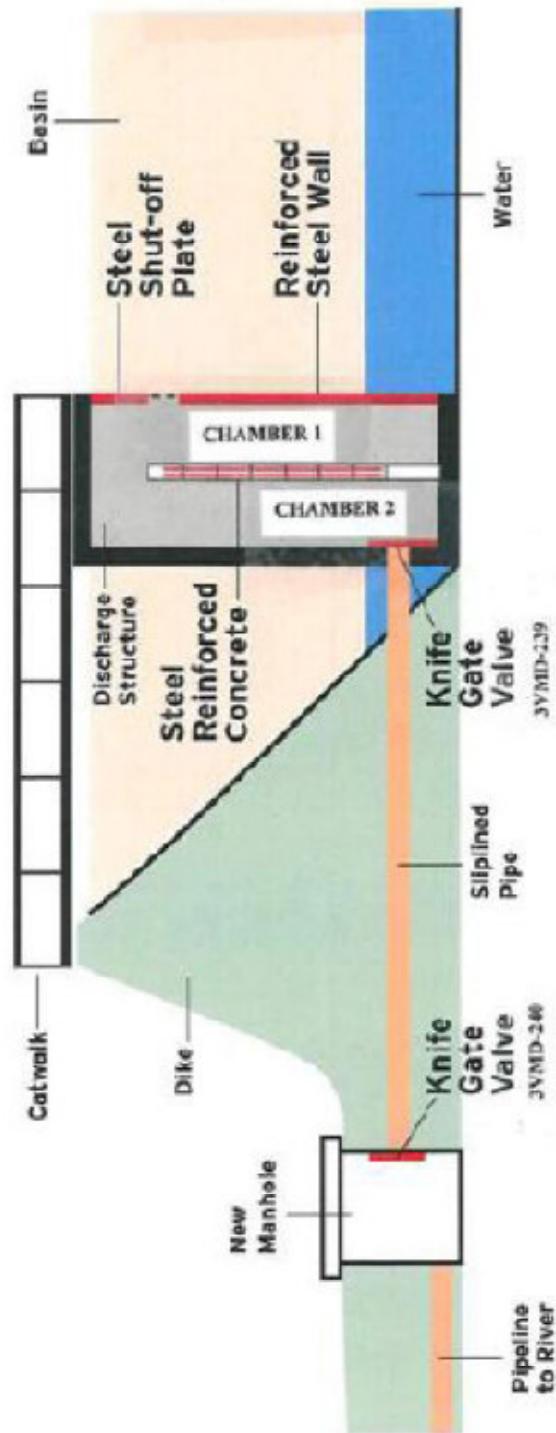
EXHIBIT 7:

ASH BASIN NO. 4- SCHEMATIC SECTION OF OUTLET STRUCTURE SHOWING PRINCIPAL  
MODIFICATIONS MADE AFTER RELEASE INCIDENT IN 2005
