# **Assessment of Dam Safety of Coal Combustion Surface Impoundments**

**PowerSouth Energy Cooperative**

**Charles R. Lowman Power Plant**

**March 30, 2011**

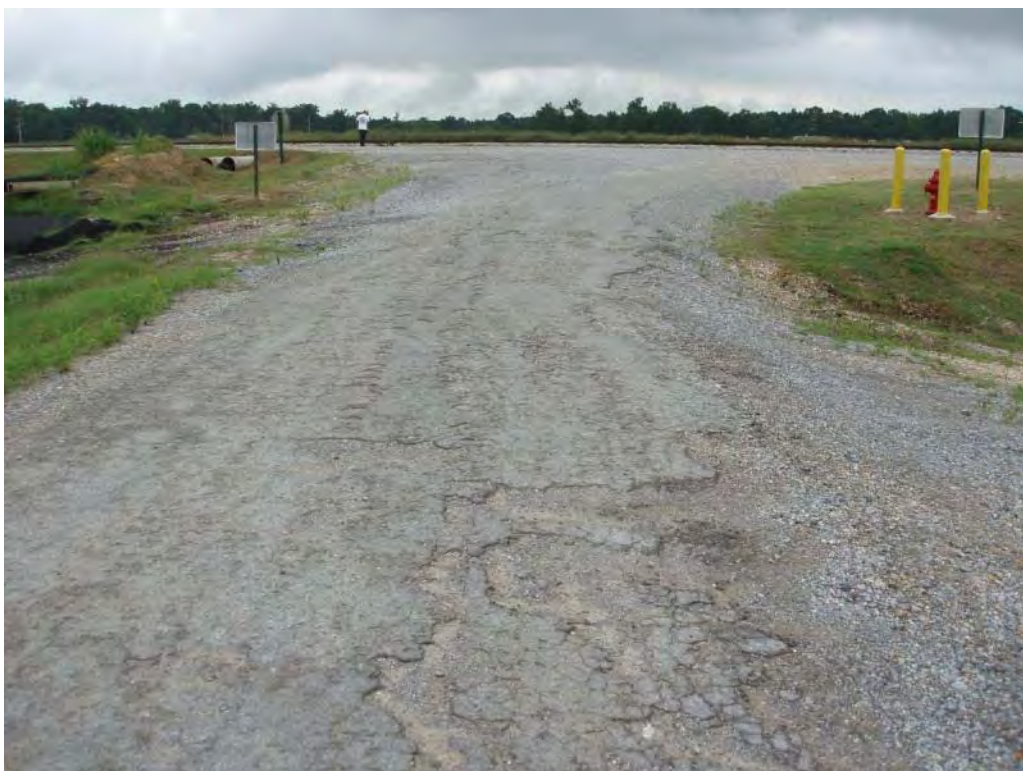
**Photo No. 1: #1 Bottom Ash Pond – North embankment crest looking west.**

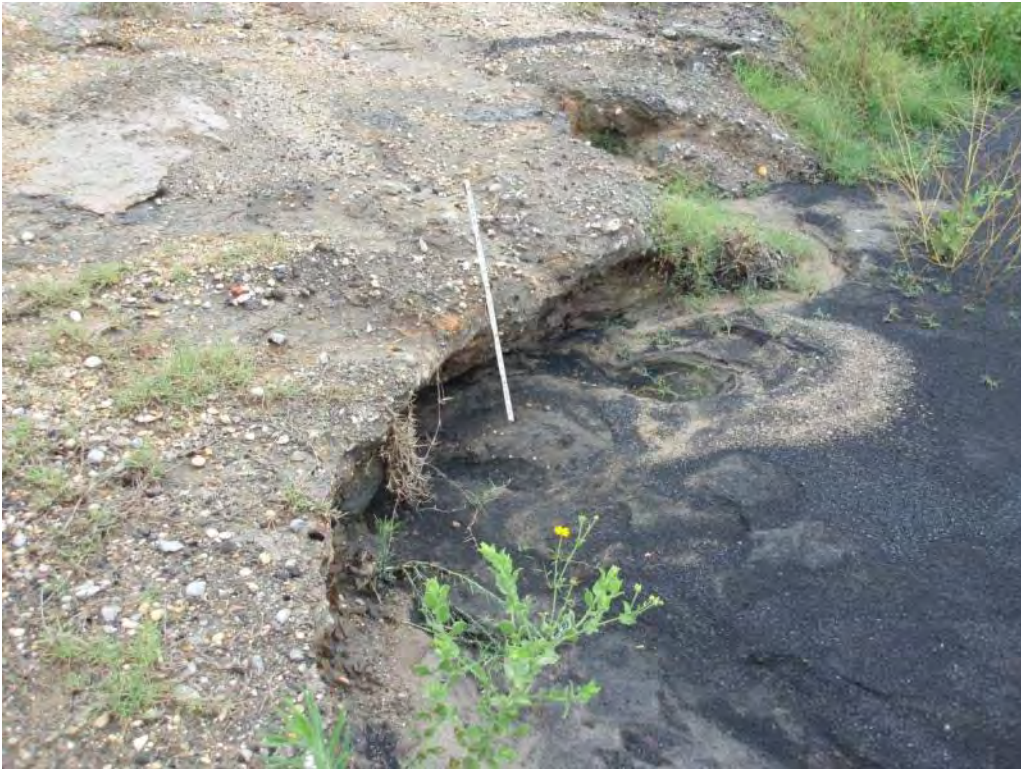
**Photo No. 3: #1 Bottom Ash Pond – North embankment interior slope, looking east. Ash product covering slope.**

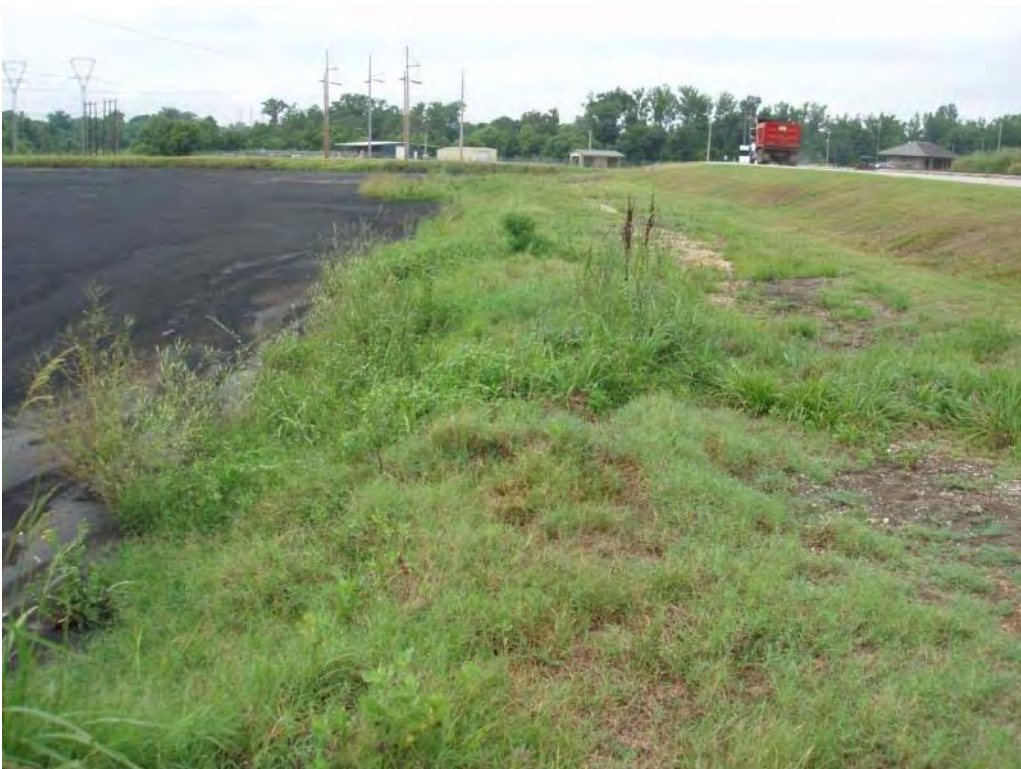
**Photo No. 4: #1 Bottom Ash Pond – West embankment interior slope, looking south.**

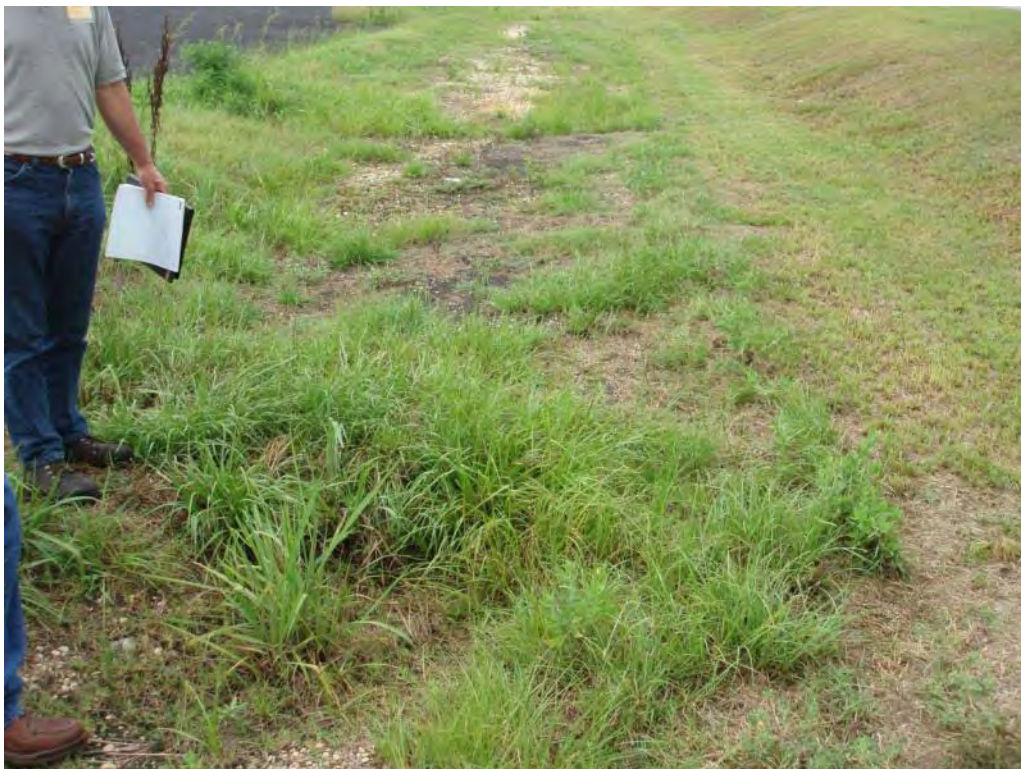
**Photo No. 5: #1 Bottom Ash Pond – West embankment interior slope, looking south, typical vegetation.**

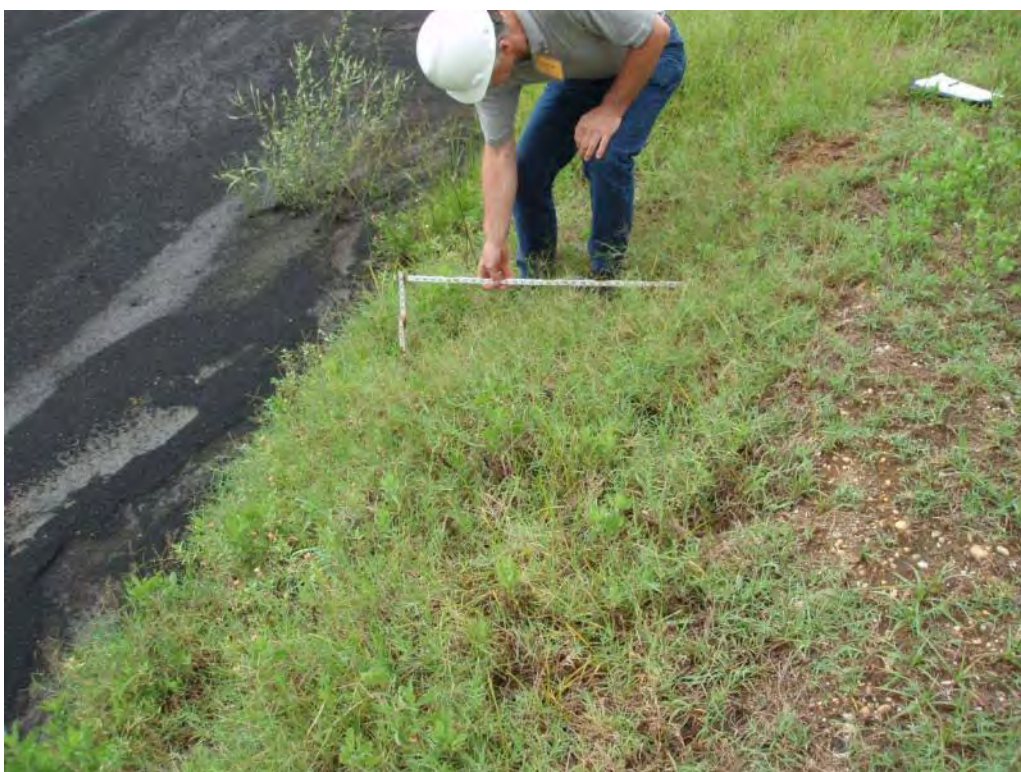
The interior slopes appear to be in poor condition. The upper 8 to 10 feet of the embankment interior slopes are approximately 2H:1V and 3H:1V towards the bottom of the slope (Photograph 6). Light vegetation less than 6 inches tall covers the interior embankments to the high water line, where the surface is void of protective cover and embankment fill materials are subject to erosion (Photographs 3, 4, 15, and 25). No armoring of the interior slope is present, and approximately half of the pond's interior surface consists of exposed ash product.

**Photo No. 6: #1 Bottom Ash Pond – West embankment interior slope. 3H:1V slope measured toward bottom of slope, 2H:1V measured on upper 8 to 10 feet.**

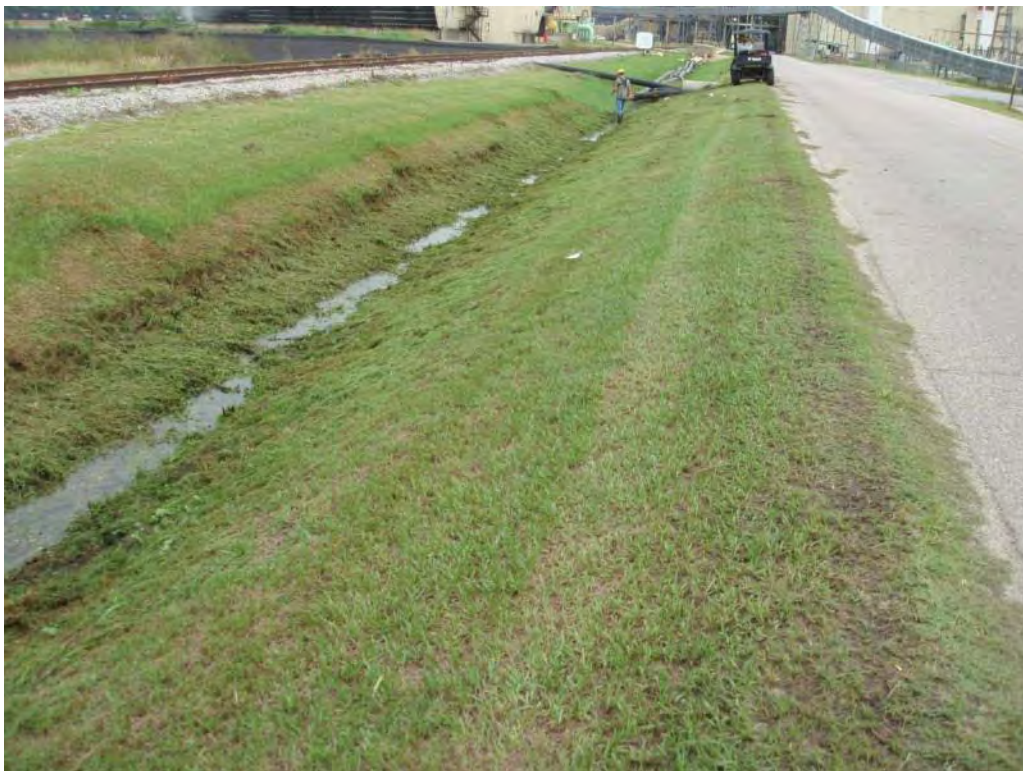
**Photo No. 7: #1 Bottom Ash Pond – West embankment exterior slope, looking north. Note standing water in drainage ditch at toe.**

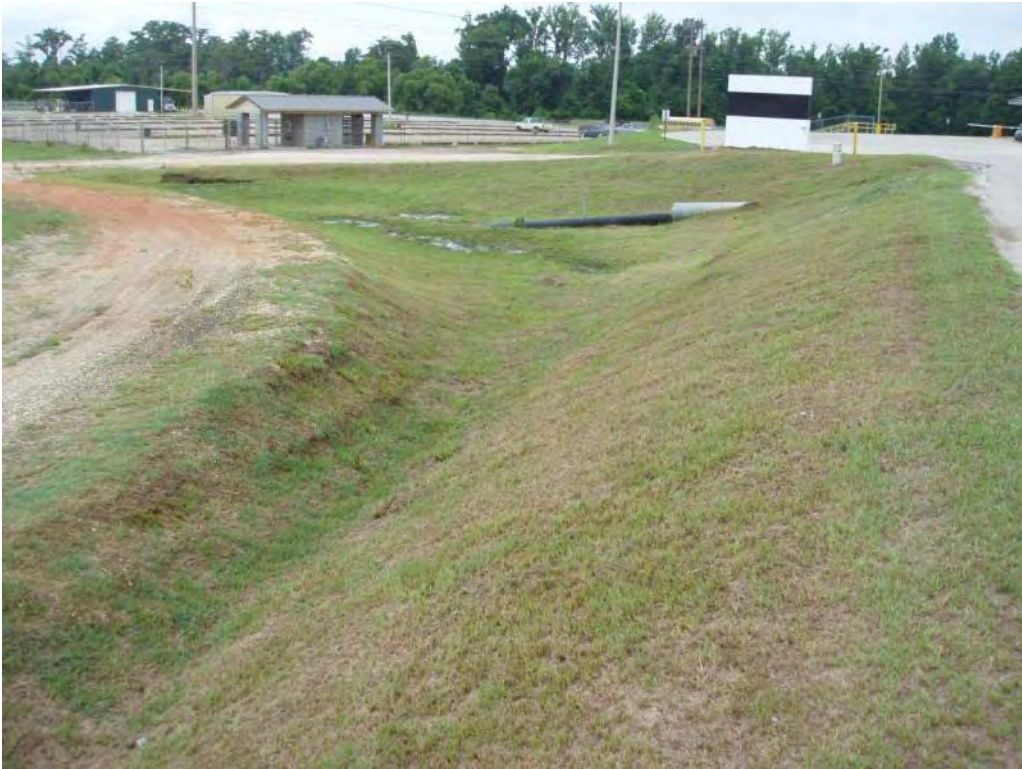
**Photo No. 9: #1 Bottom Ash Pond – West embankment crest, looking south.**

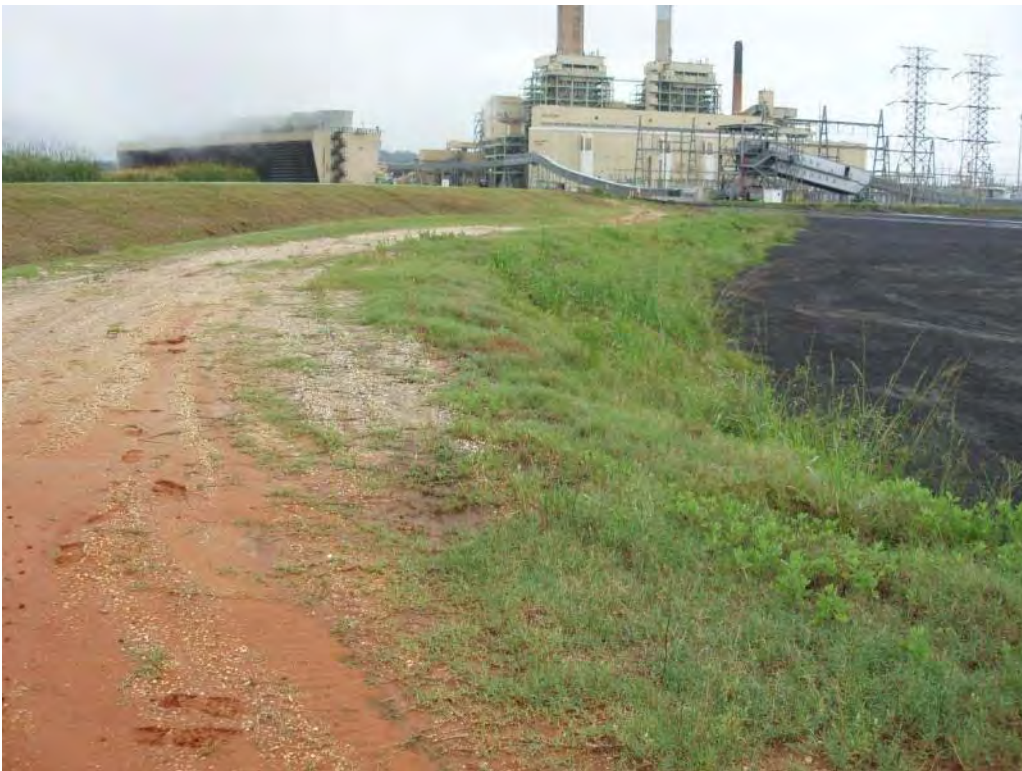
**Photo No. 10: #1 Bottom Ash Pond – West embankment interior slope, looking north.**

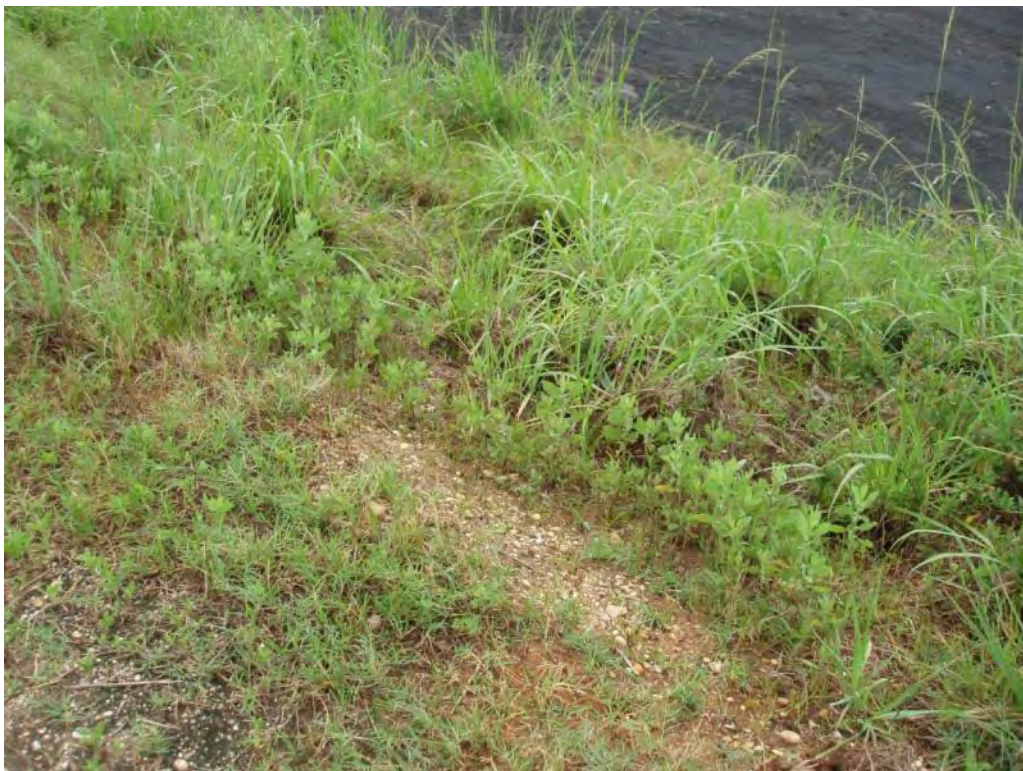
**Photo No. 11: #1 Bottom Ash Pond – South embankment crest. Looking at granular road.**

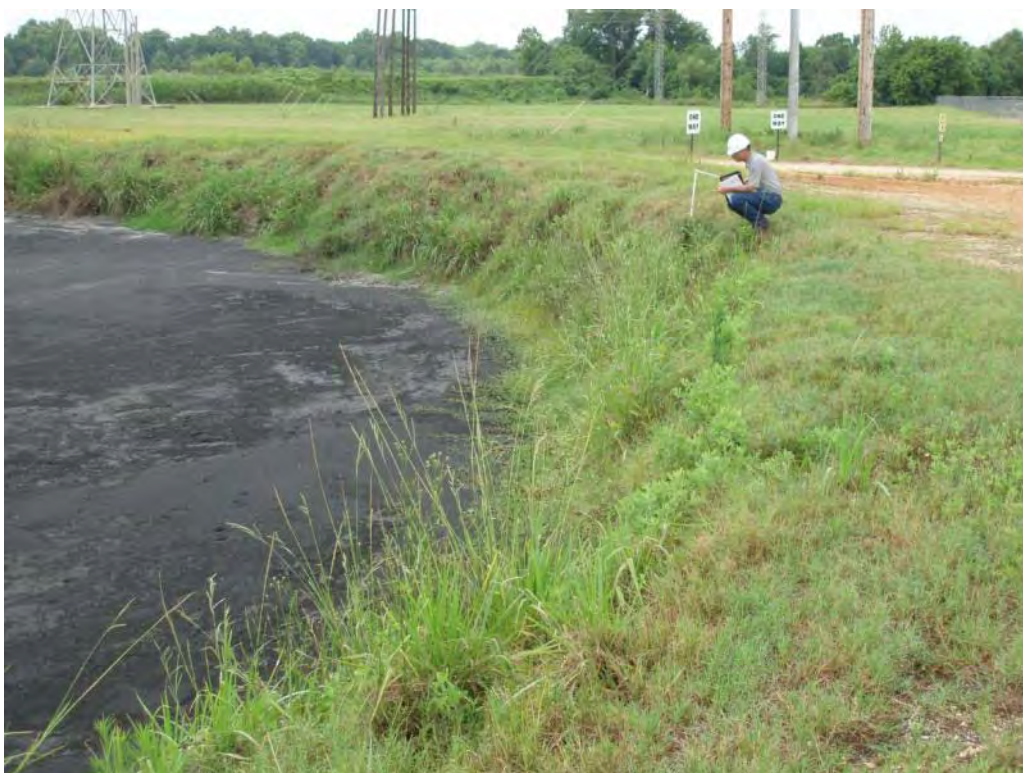
**Photo No. 12: #1 Bottom Ash Pond – Southwest corner interior slope, looking south.**

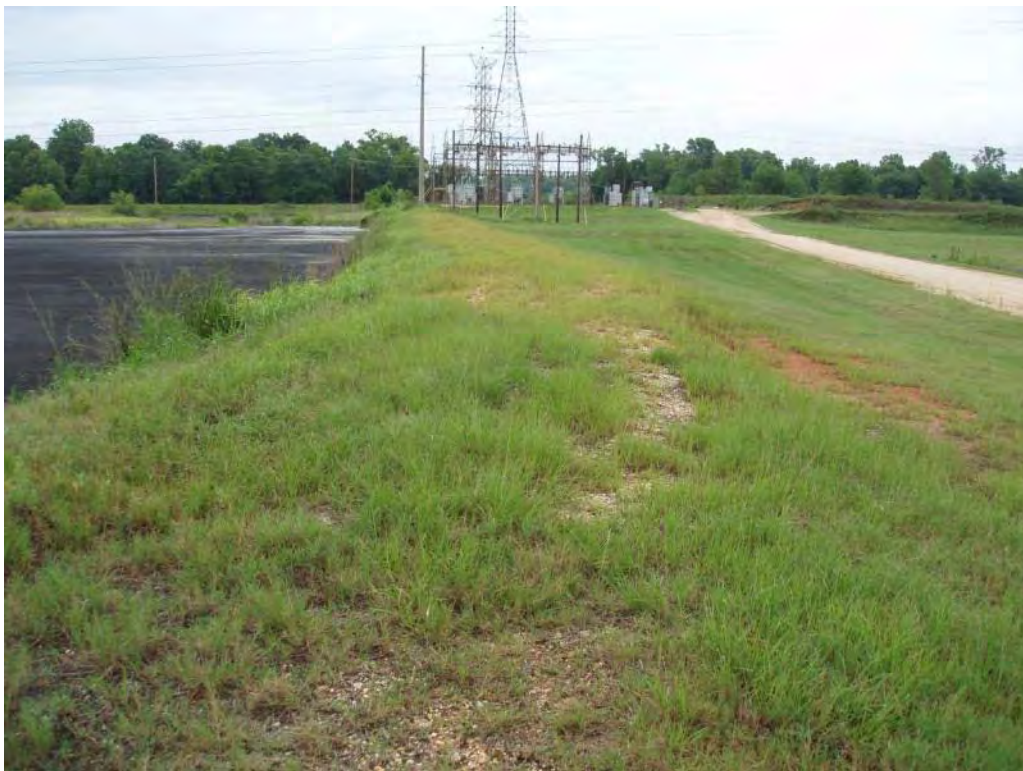
The crest of the #1 Bottom Ash Pond appeared to be in good condition (Photographs 40, 8, 13, and 30). The crest was approximately 20 feet wide with the exception of the west embankment that was approximately 35 feet wide. The north, west, and east crests are exposed to vehicle traffic. The surface of the crests, exposed to traffic, consists of compacted granular soils on the north and east embankments, and asphalt paving on the west embankment.

**Photo No. 13: #1 Bottom Ash Pond – South embankment crest, looking east.**

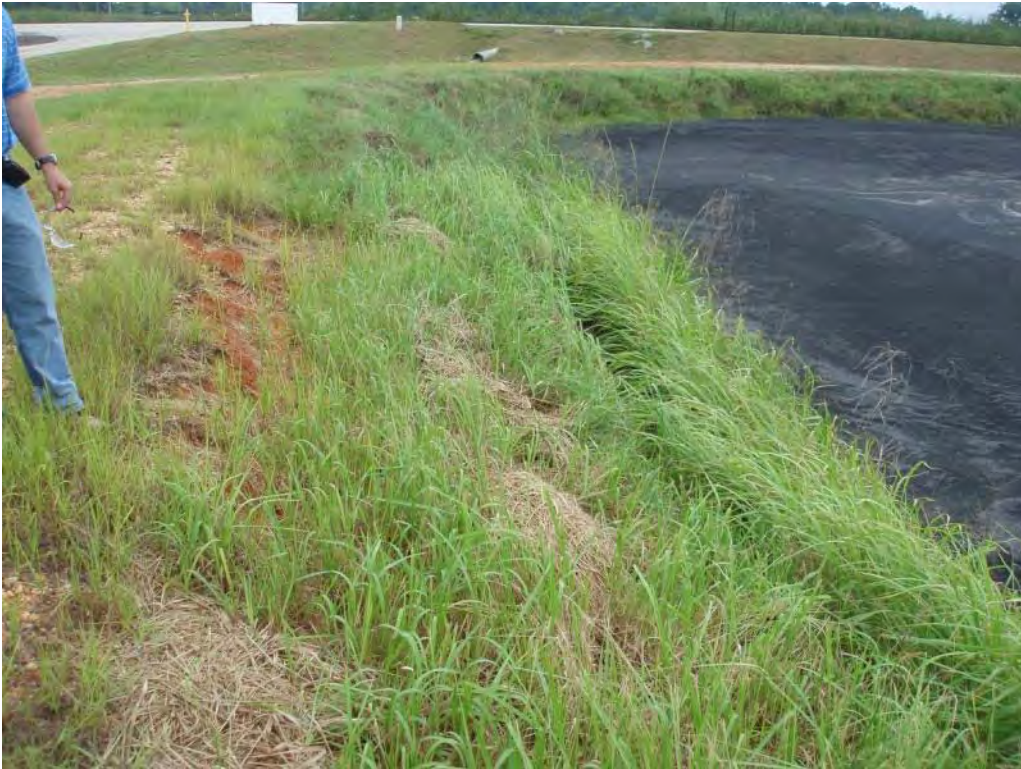
**Photo No. 15: #1 Bottom Ash Pond – South embankment interior slope, looking west. Note minor surface erosion.**

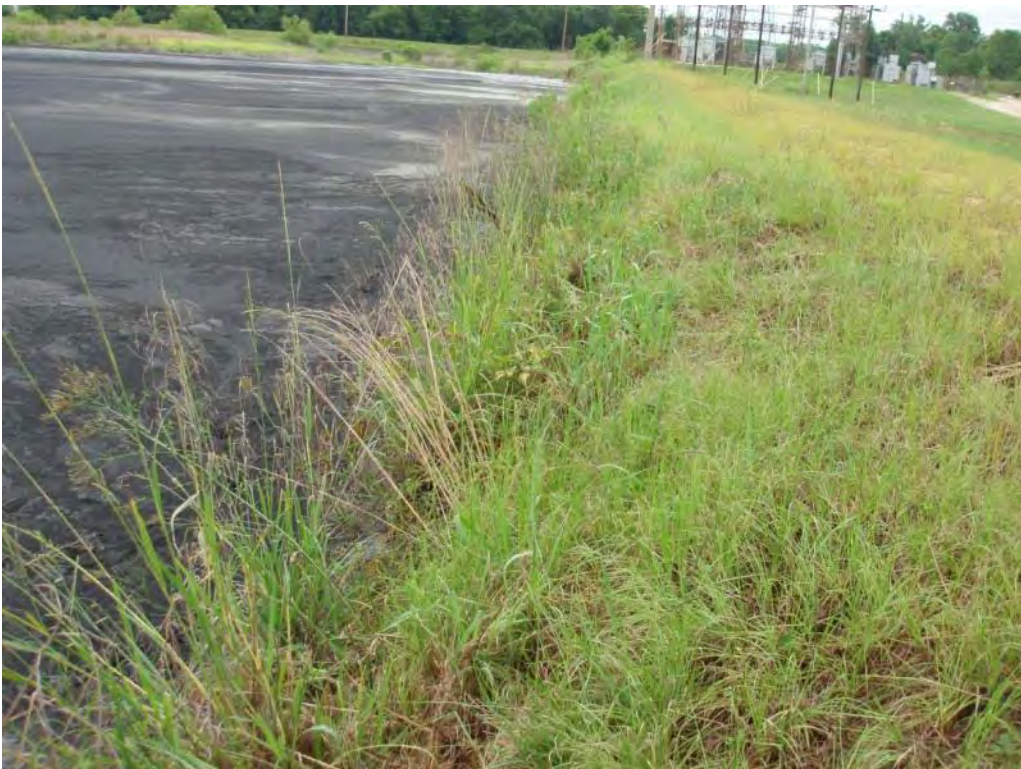
**Photo No. 16: #1 Bottom Ash Pond – South embankment interior slope, looking east.**

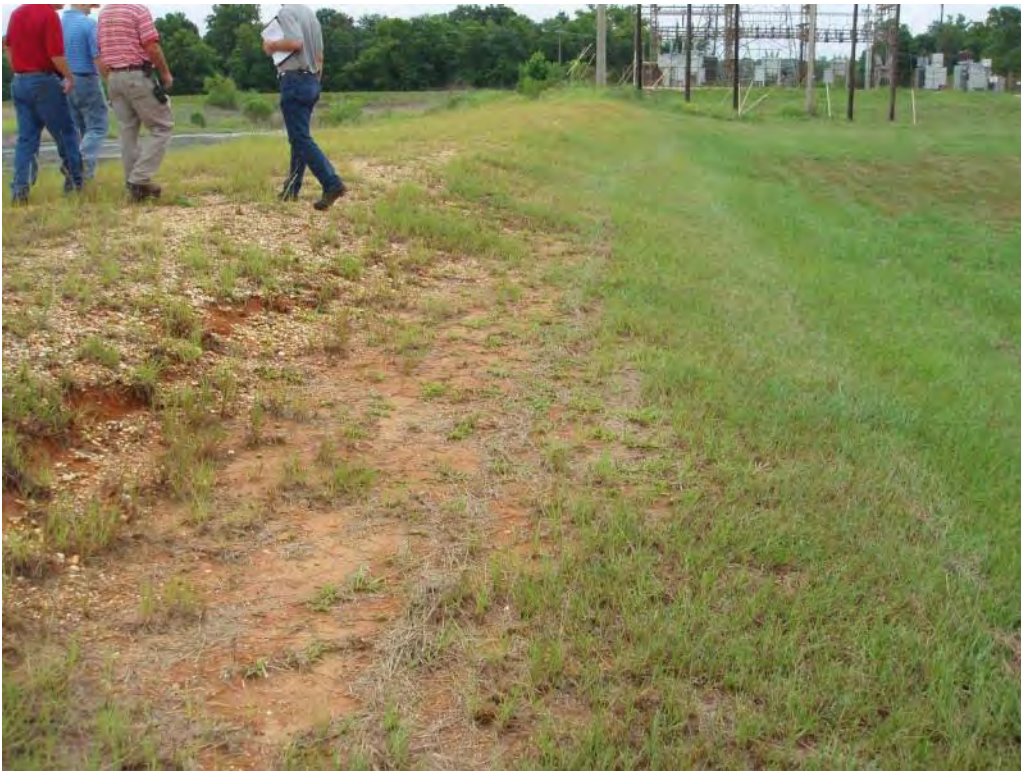
**Photo No. 17: #1 Bottom Ash Pond – South embankment exterior slope, looking east. Note surface erosion.**

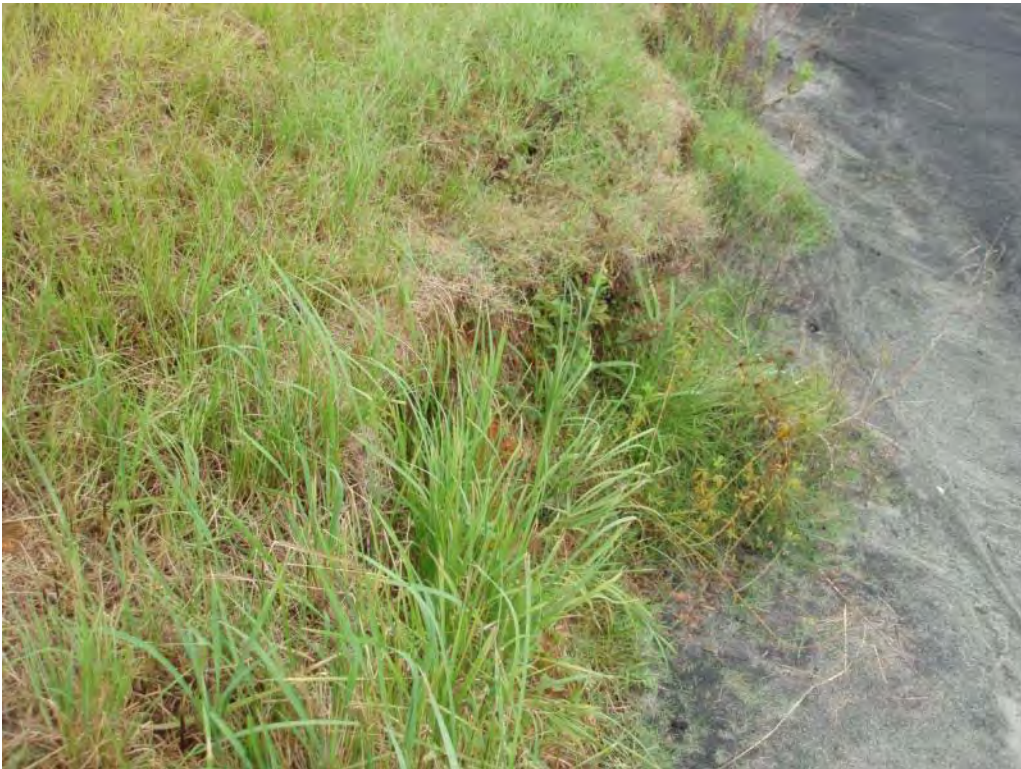
**Photo No. 18: #1 Bottom Ash Pond – South embankment interior slope, looking west. Note erosion and undercut of slope.**

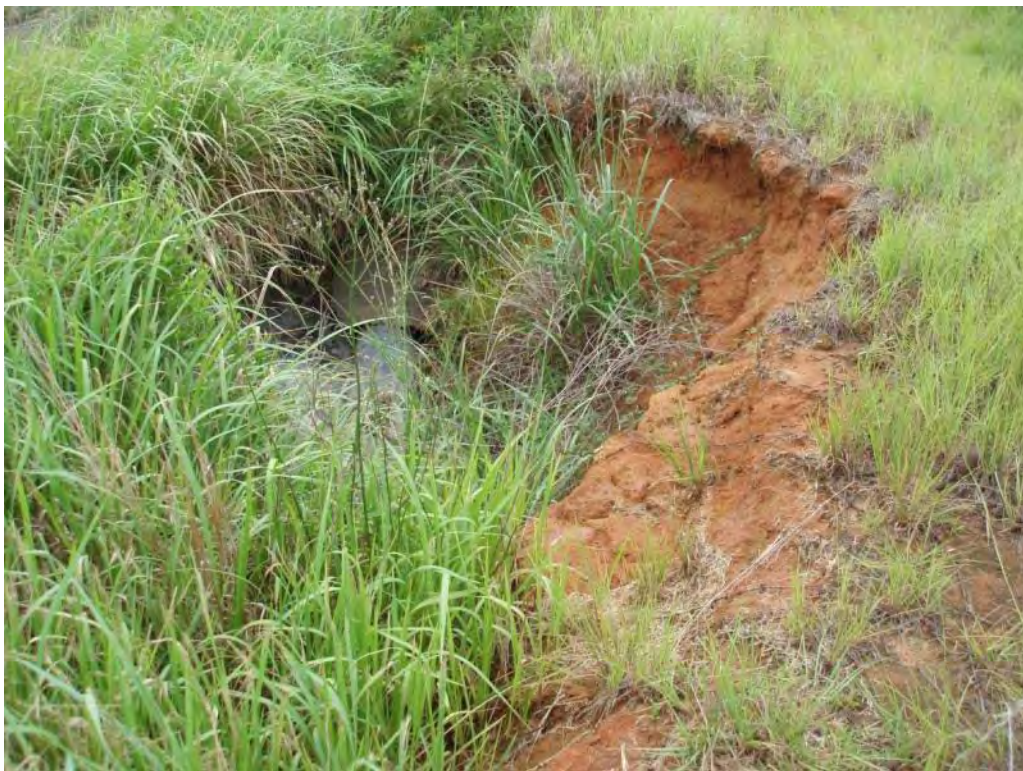
A section of the crest and interior slope of the south embankment has been excavated and remains open, apparently to facilitate the repair of the discharge pipe (Photograph 19). This created a localized area of erosion that has cut into the crest's width by approximately 3 feet.

A section of the interior slope of the south embankment has been excavated and remains open, apparently to facilitate the repair of the discharge pipe (Photograph 19). Erosion features, including minor sloughing and erosion rills, were observed on portions of the interior slopes (Photographs 22, 24, 25, 28, 31, 47, and 48).

**Photo No. 19: #1 Bottom Ash Pond – South embankment interior slope. Location of excavation into slope/crest and subsequent erosion.**

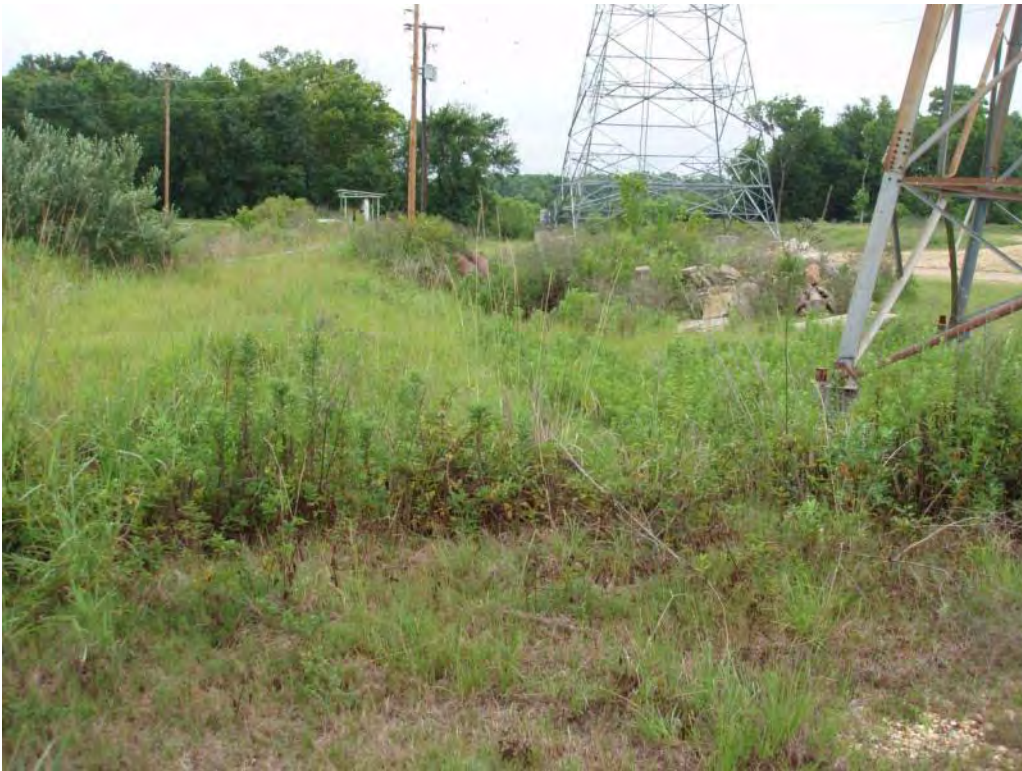
**Photo No. 21: #1 Bottom Ash Pond – South embankment exterior slope, looking east.  
Looking at vegetation around transmission towers.**

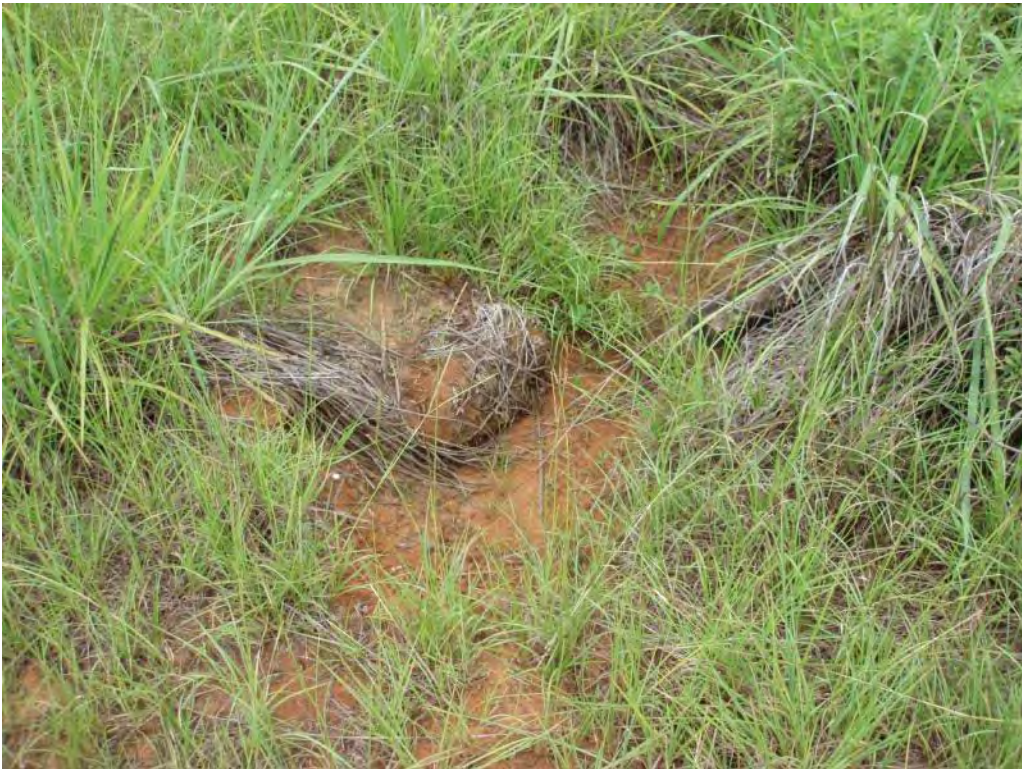
Minor surface erosion was observed along portions of the exterior slope of the north and east embankments (Photographs 22 and 43).

**Photo No. 22: #1 Bottom Ash Pond – South embankment exterior slope. Looking at minor  
erosion rill.**

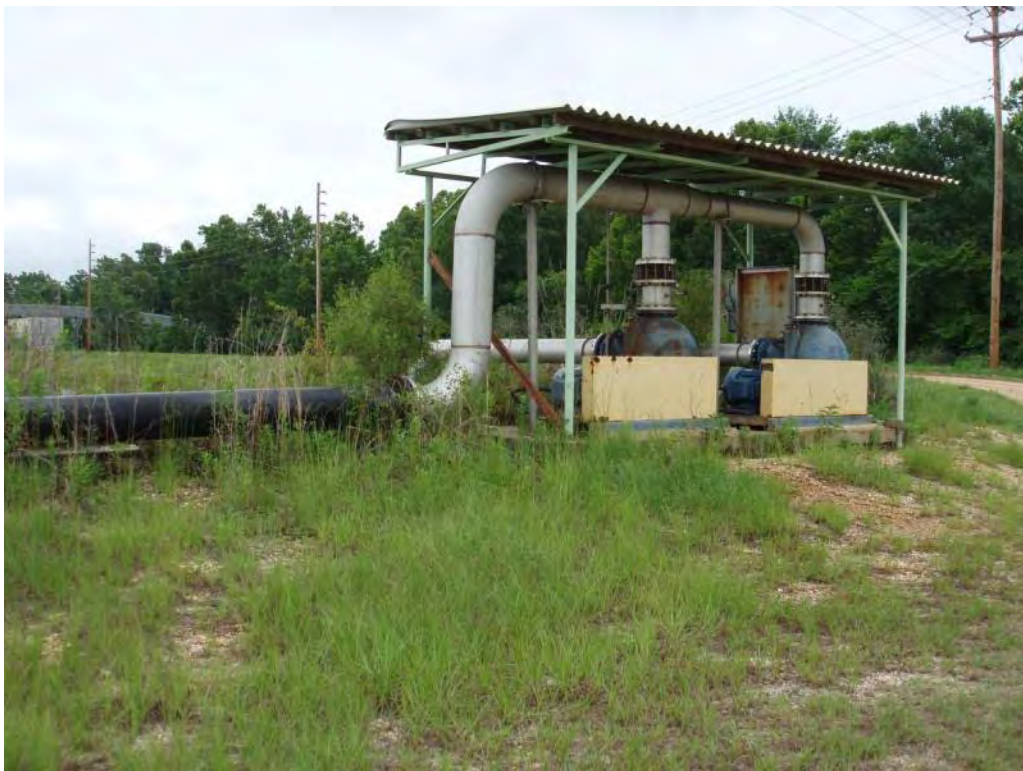
The outlet pipes in the #1 Bottom Ash Pond appear to be in good condition. Two 10-inch-diameter pipes, located at the southwestern end of the pond, intake water that is pumped to the #2/#3 Bottom Ash Pond through one 14-inch-diameter HDPE pipe (Photographs 23 and 24). No unusual movement was observed around the pumps or piping.

**Photo No. 23: #1 Bottom Ash Pond – South embankment exterior slope, looking north.  
Looking at outlet pumps.**

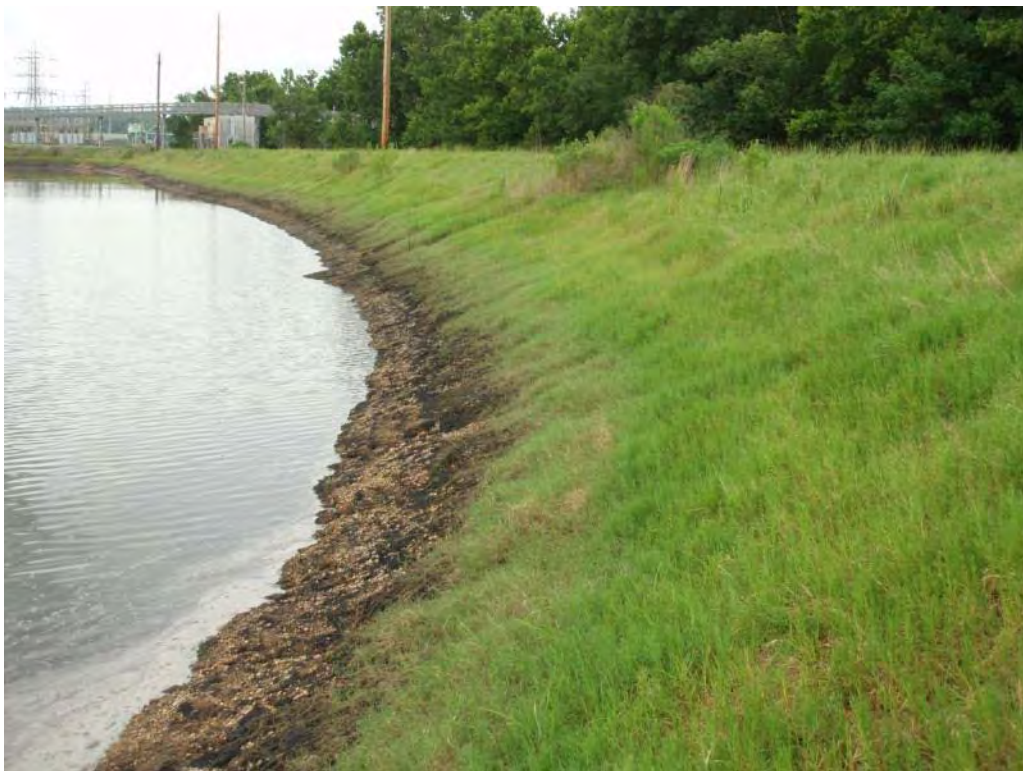
**Photo No. 25: #1 Bottom Ash Pond – East embankment interior slope, looking north. Note surface erosion near water line.**

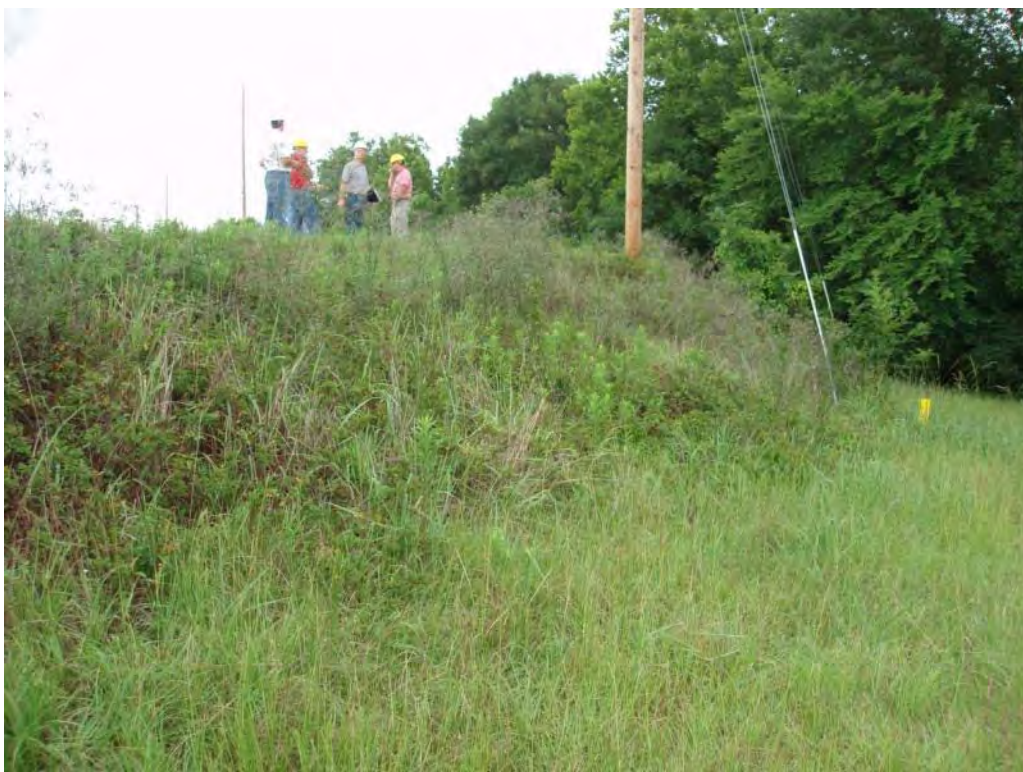
**Photo No. 26: #1 Bottom Ash Pond – South embankment exterior slope, looking north.**

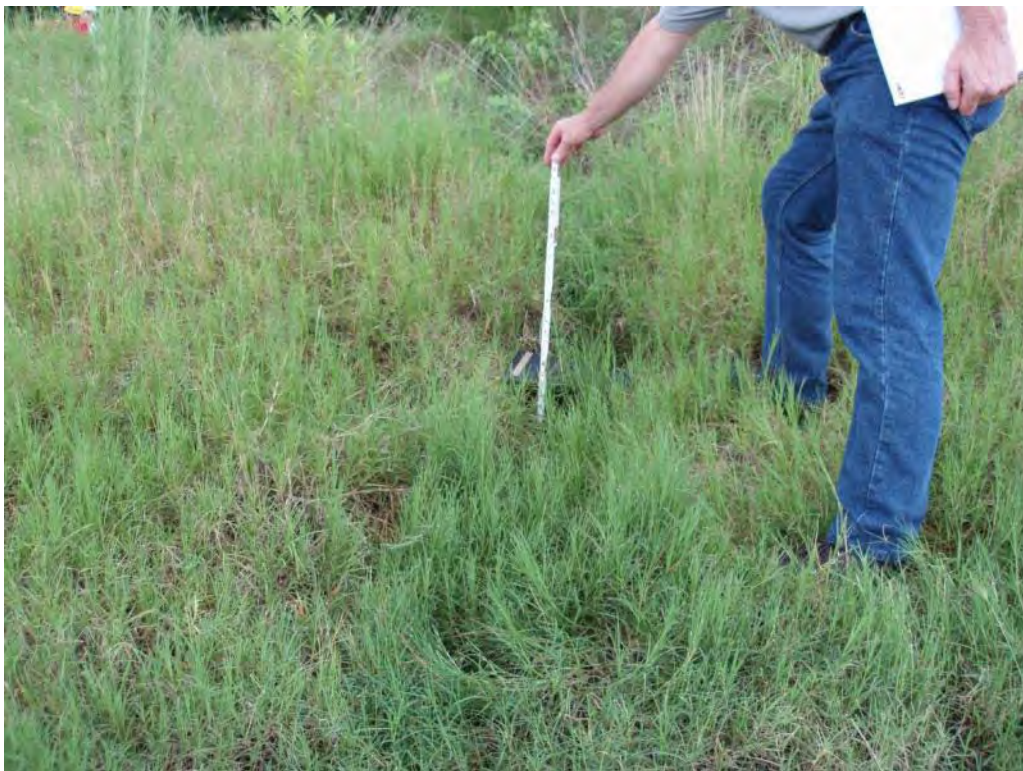
**Photo No. 27: #1 Bottom Ash Pond – East embankment interior slope. Looking at minor erosion rills.**

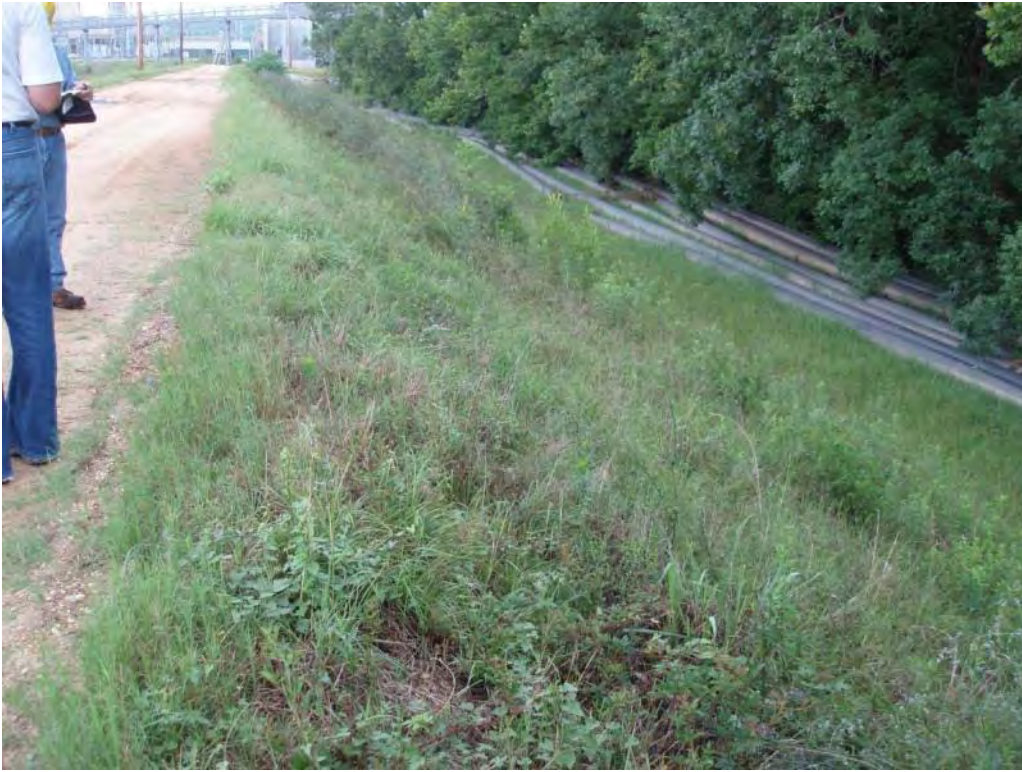
**Photo No. 29: #1 Bottom Ash Pond – East embankment exterior slope, looking north.**

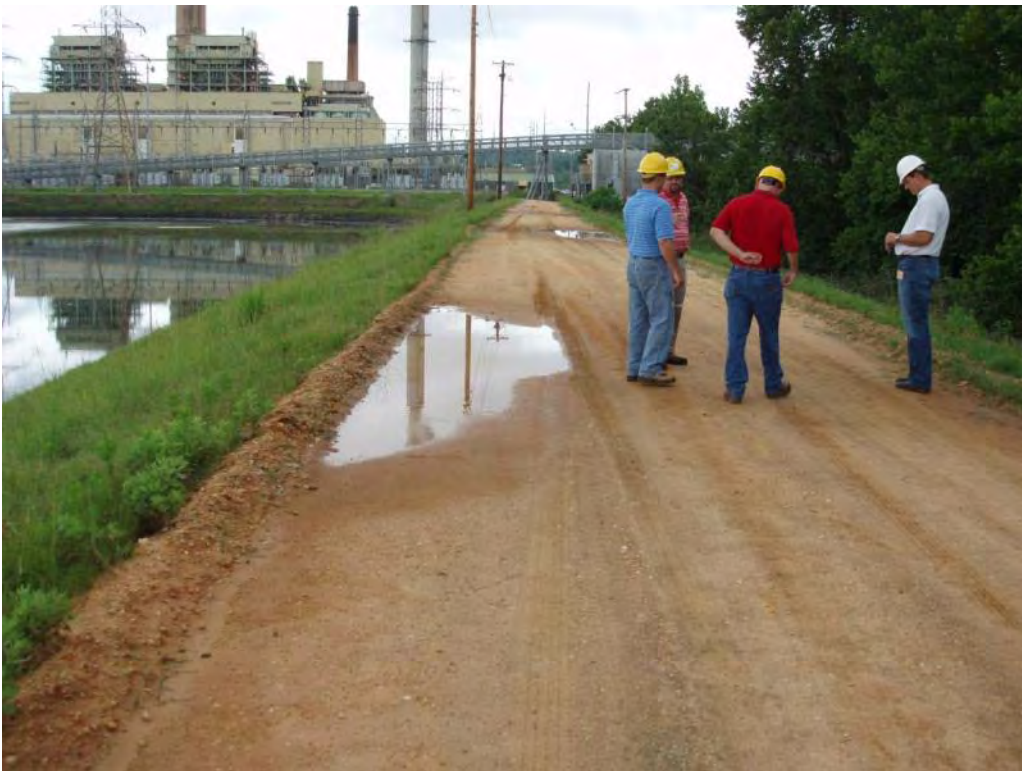
**Photo No. 30: #1 Bottom Ash Pond – East embankment crest, looking north.**

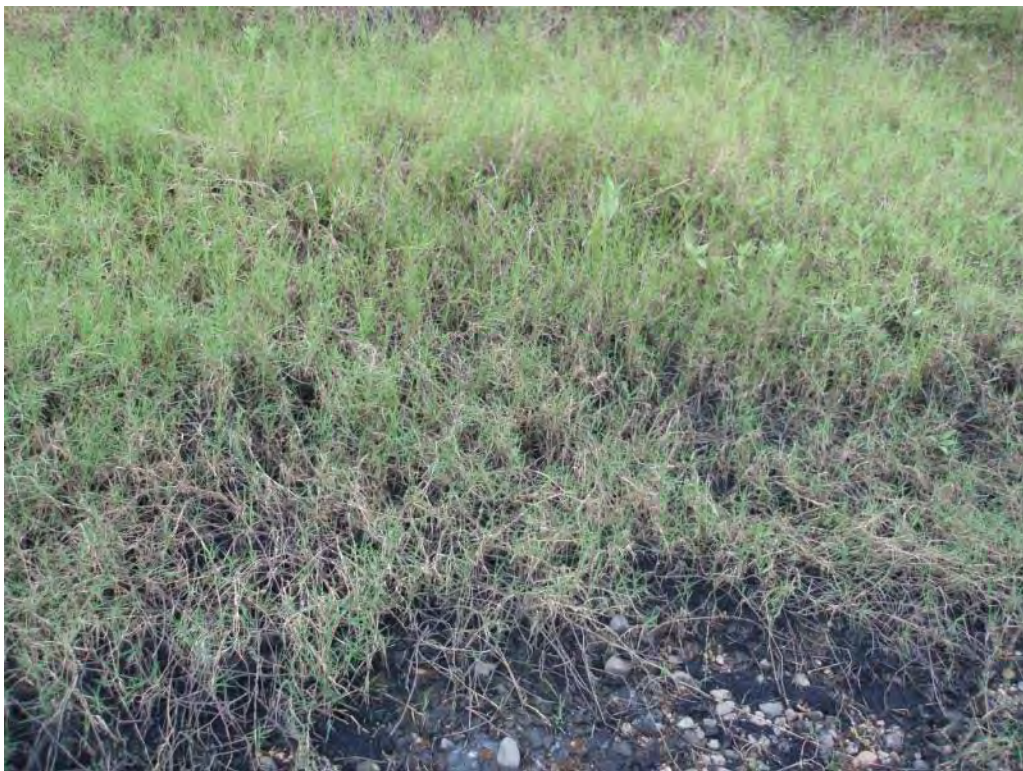
**Photo No. 31: #1 Bottom Ash Pond – East embankment interior slope. Note vegetation and surface erosion.**

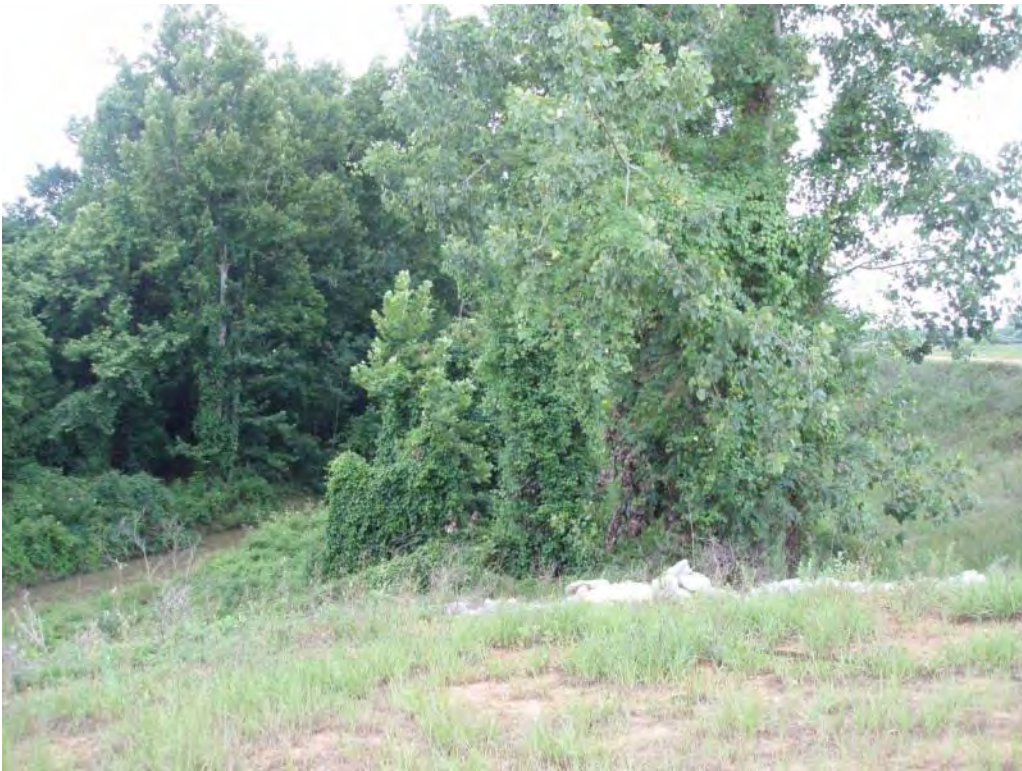
**Photo No. 33: #1 Bottom Ash Pond – Drainage ditch running along east embankment, looking south.**

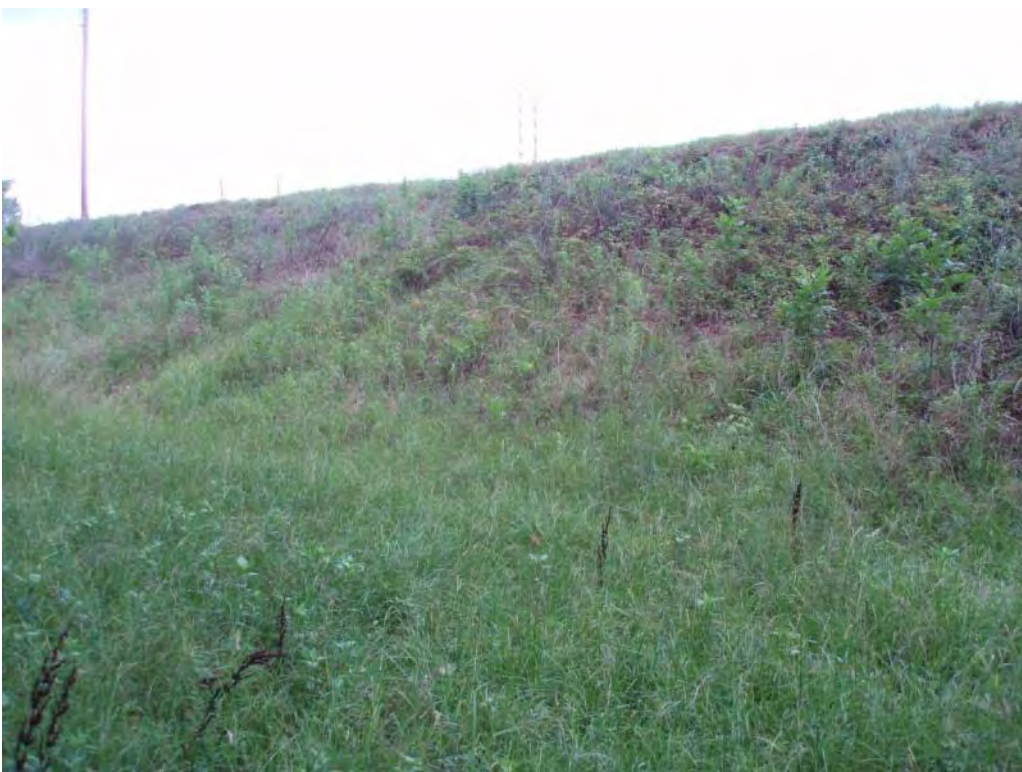
**Photo No. 34: #1 Bottom Ash Pond – East embankment exterior slope, looking southwest.**
