# **Assessment of Dam Safety of Coal Combustion Surface Impoundments**

**PowerSouth Energy Cooperative**

**Charles R. Lowman Power Plant**

**March 30, 2011**

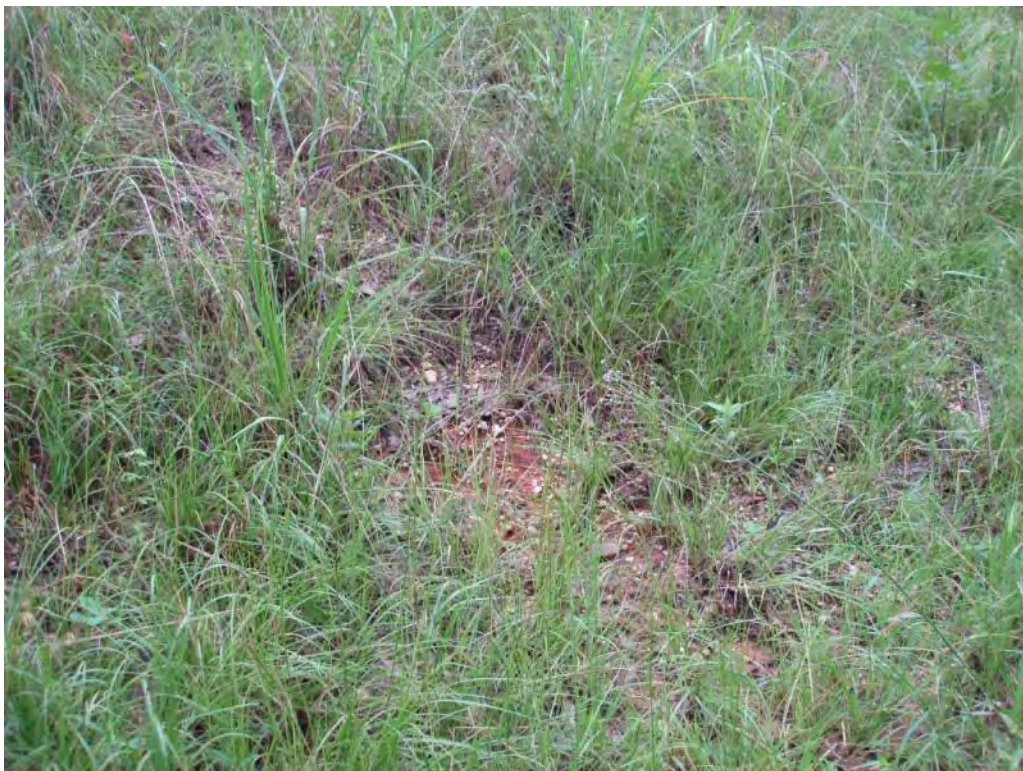
**Photo No. 35: #1 Bottom Ash Pond – East embankment exterior slope. Looking at minor surface erosion.**

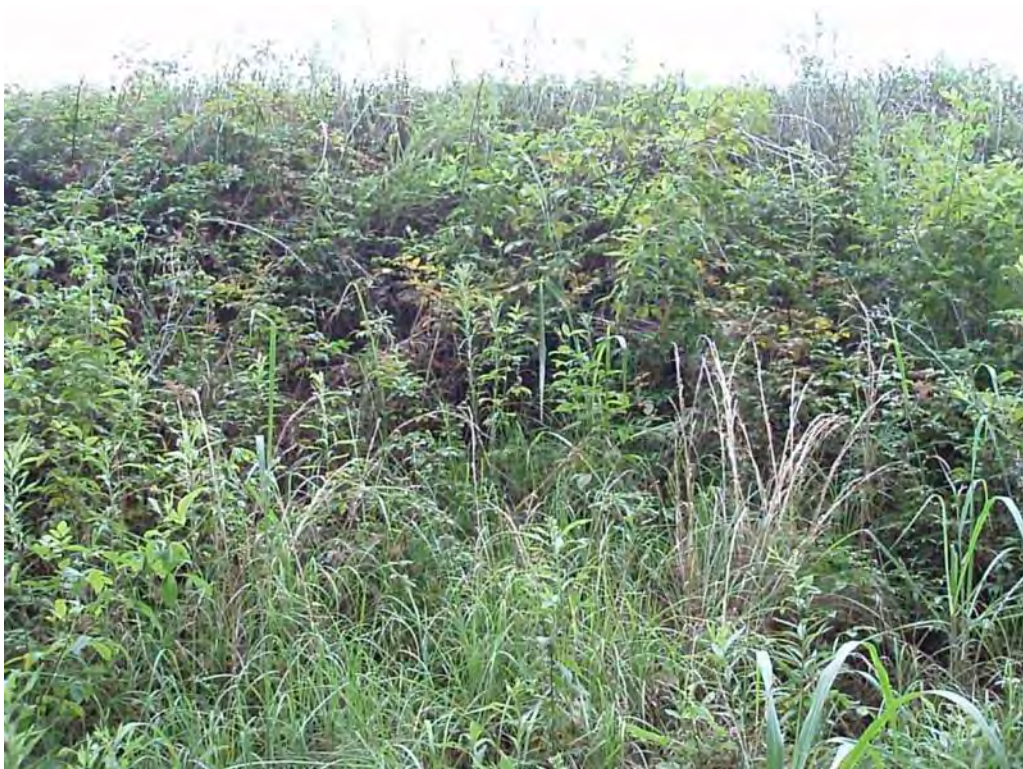
**Photo No. 36: #1 Bottom Ash Pond – East embankment exterior slope. Looking at typical vegetation.**

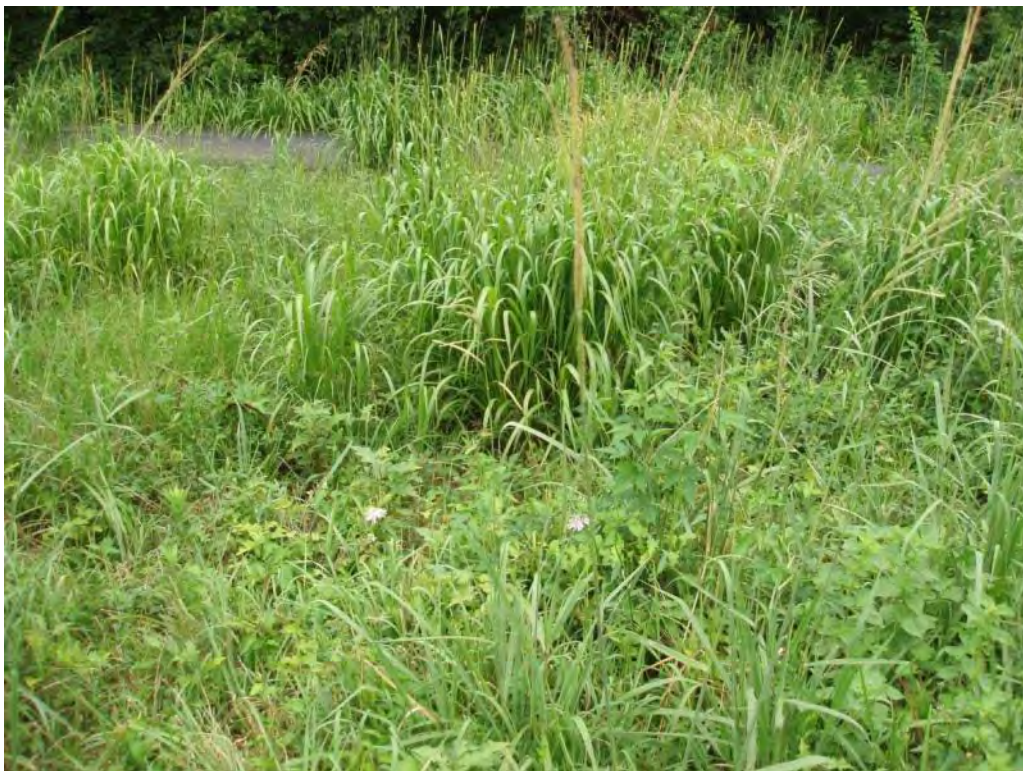
**Photo No. 37: #1 Bottom Ash Pond – East embankment exterior slope, looking east.**

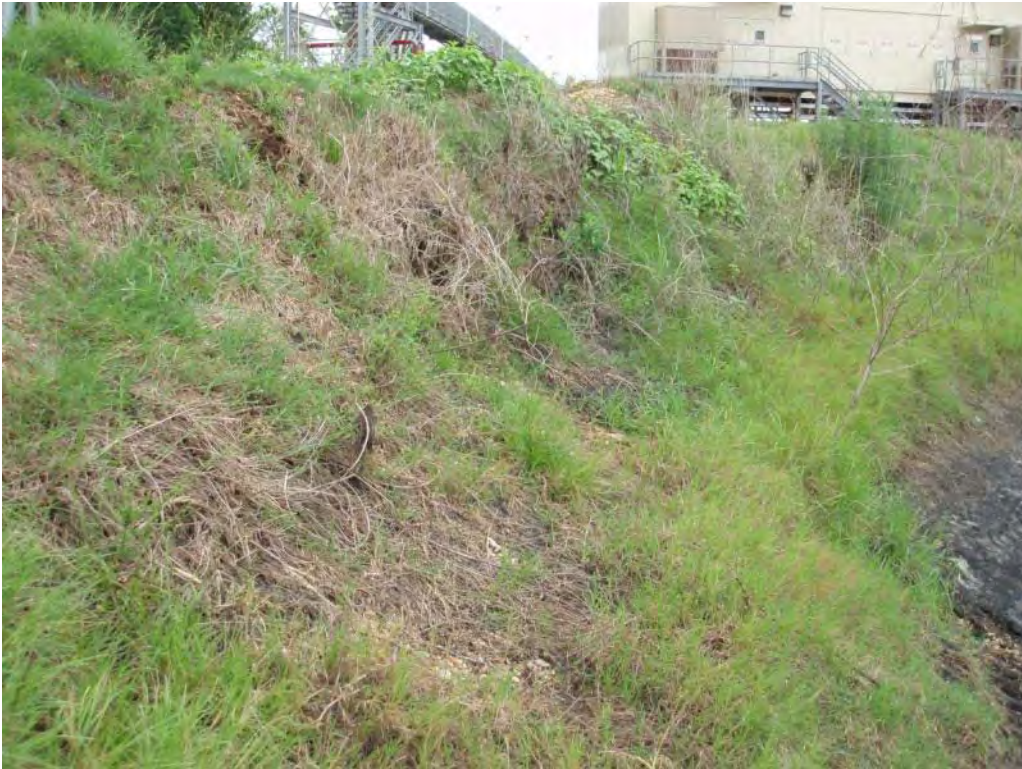
**Photo No. 39: #1 Bottom Ash Pond – North embankment interior slope, looking east.**

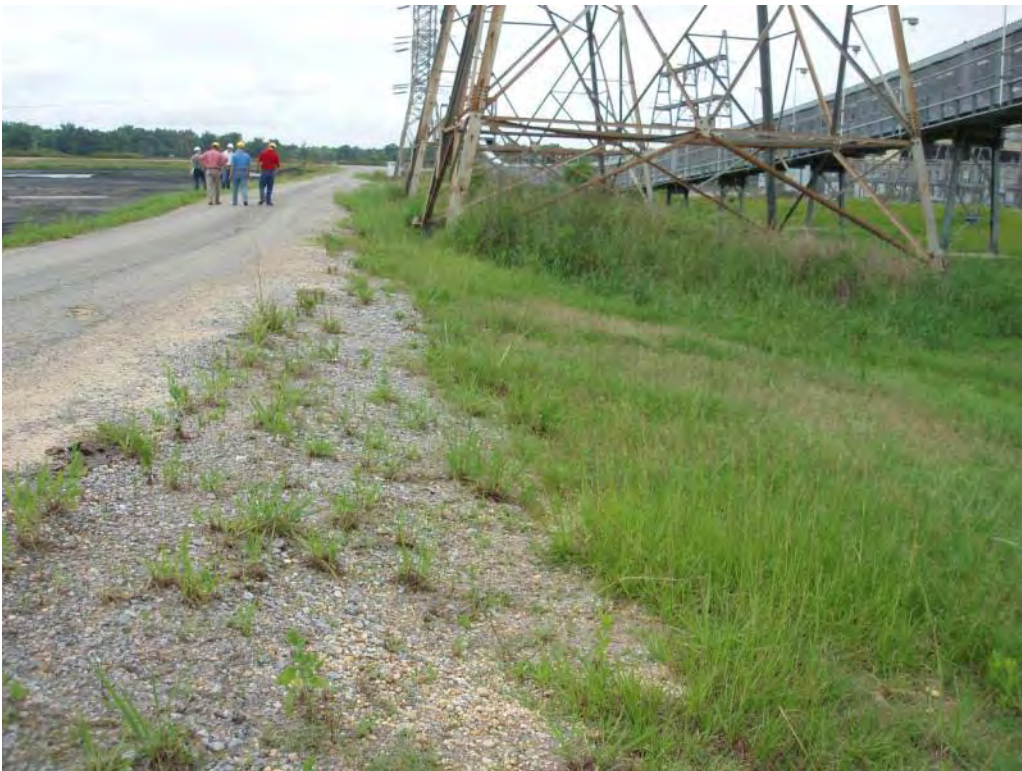
The crest of the #1 Bottom Ash Pond appeared to be in good condition (Photographs 40, 8, 13, and 30). The crest was approximately 20 feet wide with the exception of the west embankment that was approximately 35 feet wide. The north, west, and east crests are exposed to vehicle traffic. The surface of the crests, exposed to traffic, consists of compacted granular soils on the north and east embankments, and asphalt paving on the west embankment.

**Photo No. 40: #1 Bottom Ash Pond – North embankment crest and exterior slope, looking west. Note transmission towers on slope.**

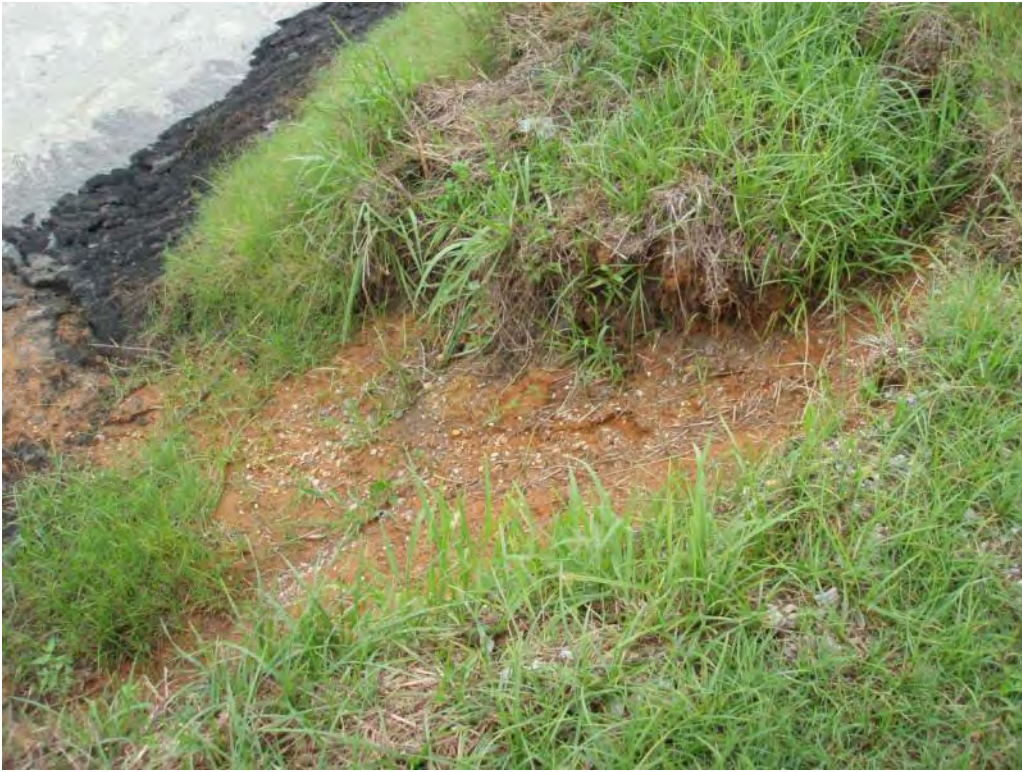
**Photo No. 41: #1 Bottom Ash Pond – North embankment interior slope. Looking at erosion rill.**

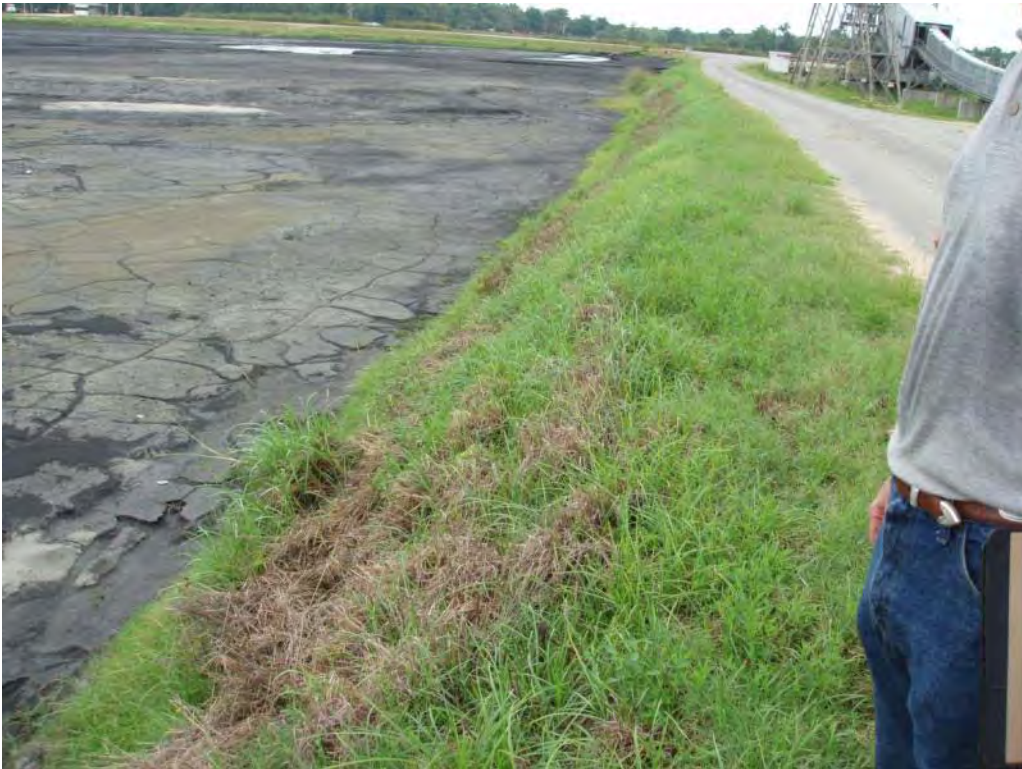
**Photo No. 42: #1 Bottom Ash Pond – North embankment interior slope, looking west.**

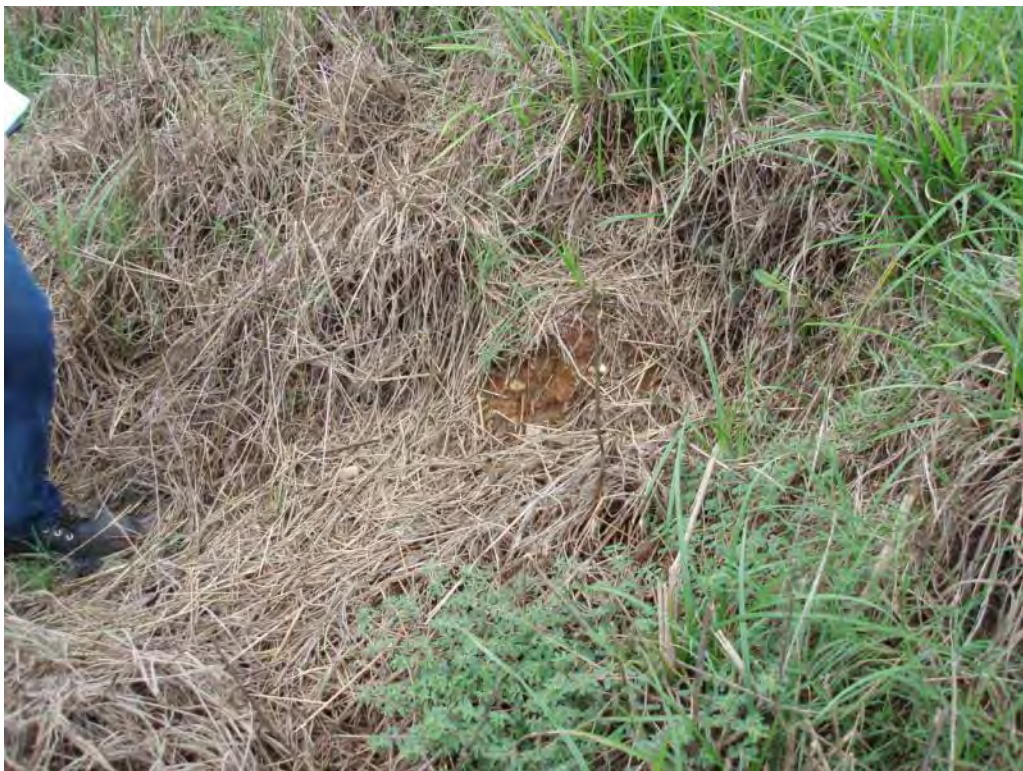
Minor surface erosion was observed along portions of the exterior slope of the north and east embankments (Photographs 22 and 43).

**Photo No. 43: #1 Bottom Ash Pond - North embankment interior slope. Looking at surface erosion.**

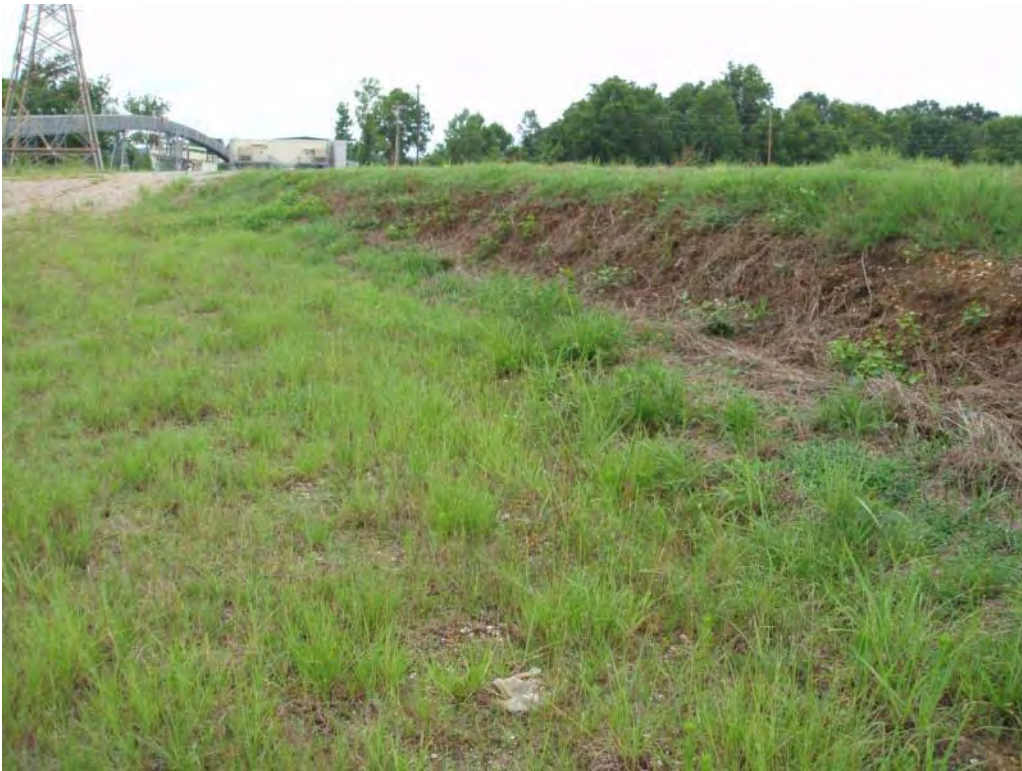
**Photo No. 45: #1 Bottom Ash Pond - North embankment exterior slope, looking east. Note surface erosion on upper slope.**

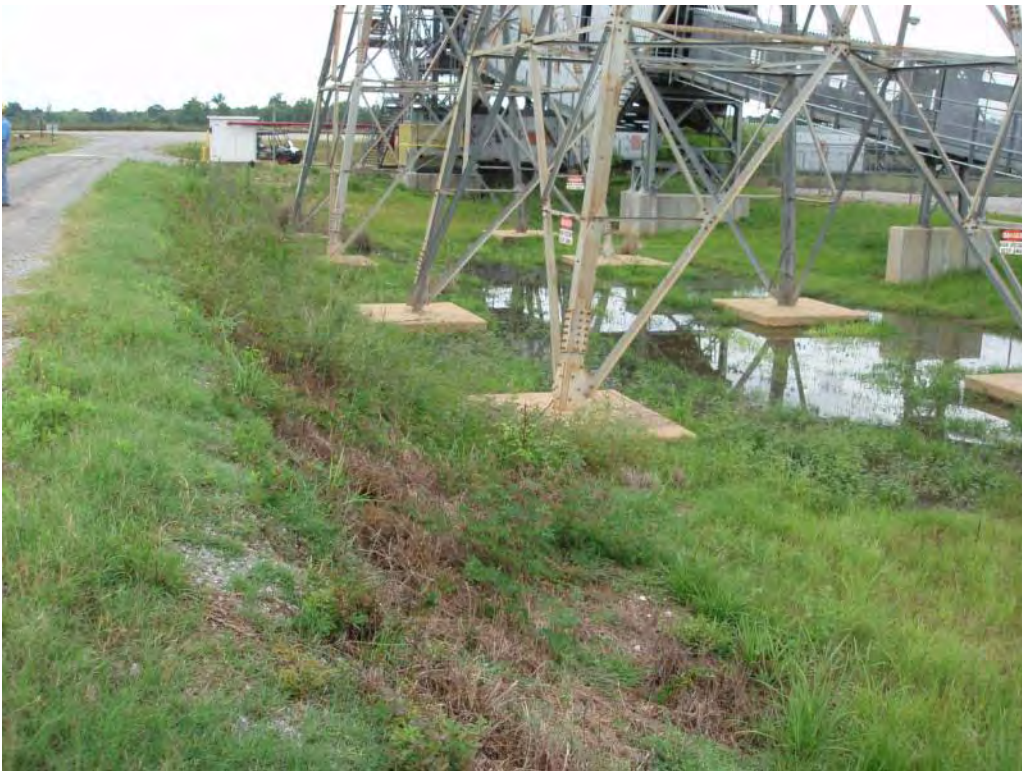
An electric substation was located approximately 85 feet north of the exterior slope of the south embankment, and square-base transmission towers were located near the toe of the exterior slope of the north and south embankments. The north embankment exterior slope, in the vicinity of the towers, was approximately 1.5H:1V. Standing water was observed within the base area of two of the towers located at the north embankment, and grassy vegetation 24 to 36 inches in height was observed at the base of the south embankment towers (Photographs 46 and 21). Due to the significant recent rainfall, the observed standing water could not be clearly identified as seepage or surface runoff.

**Photo No. 46: #1 Bottom Ash Pond - North embankment exterior slope, looking west. Note standing water near transmission tower base.**

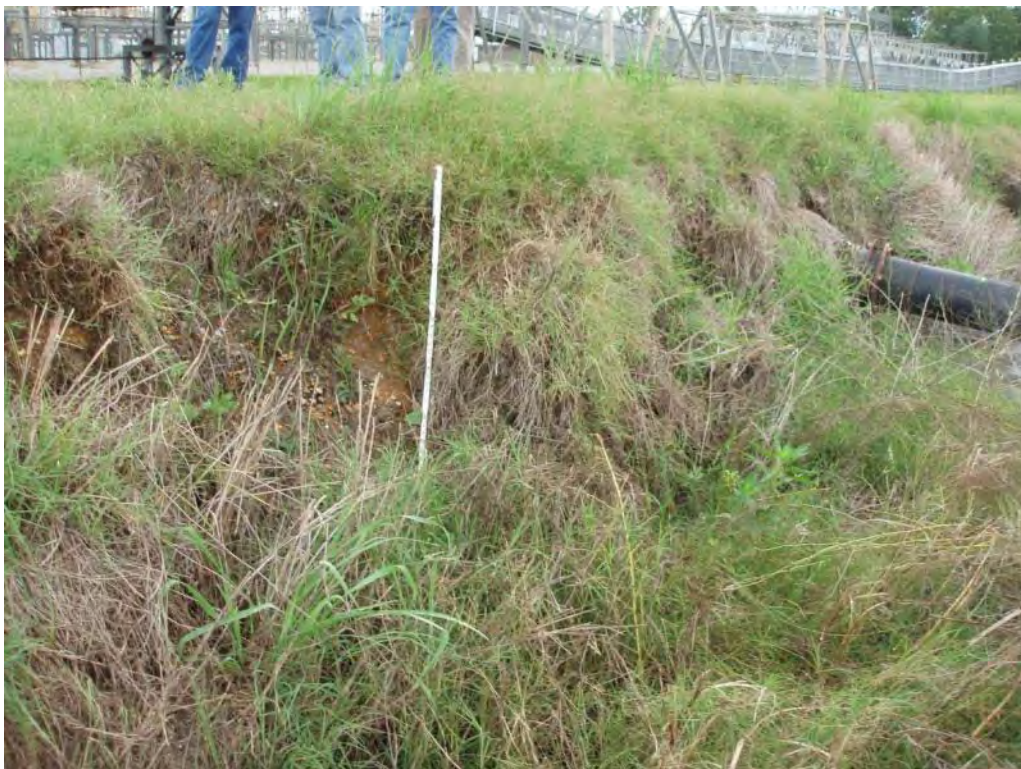
A section of the interior slope of the south embankment has been excavated and remains open, apparently to facilitate the repair of the discharge pipe (Photograph 19). Erosion features, including minor sloughing and erosion rills, were observed on portions of the interior slopes (Photographs 22, 24, 25, 28, 31, 47, and 48).

**Photo No. 47: North embankment interior slope, looking northeast. Looking at erosion rill. Sluice line from Unit 1 to the right.**

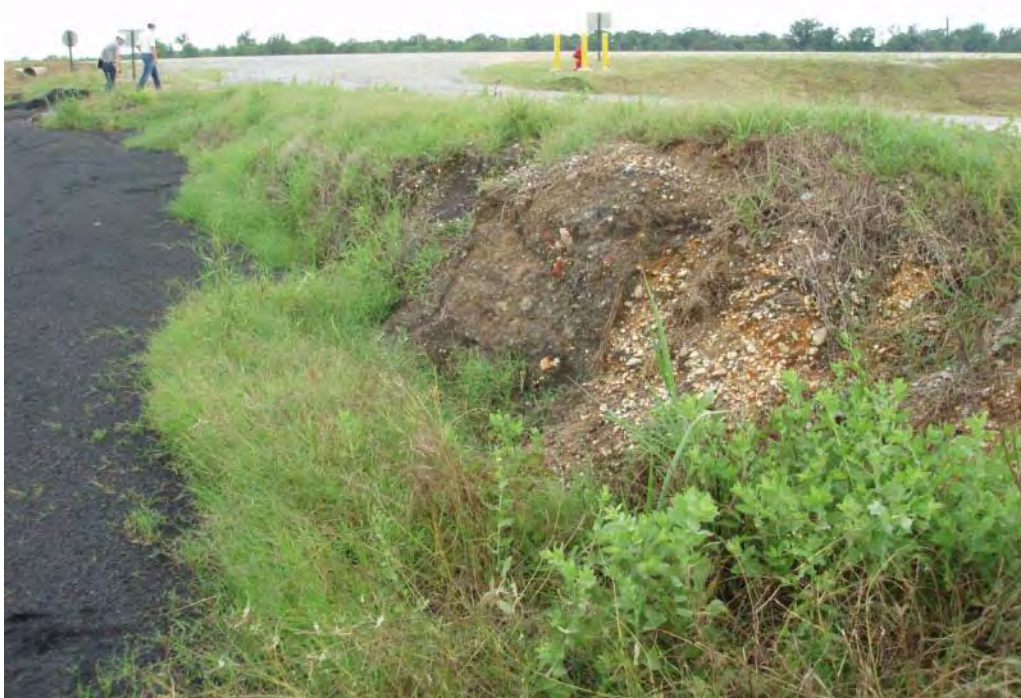
**Photo No. 48: #1 Bottom Ash Pond – North embankment interior slope, looking northwest. Looking at surface erosion.**

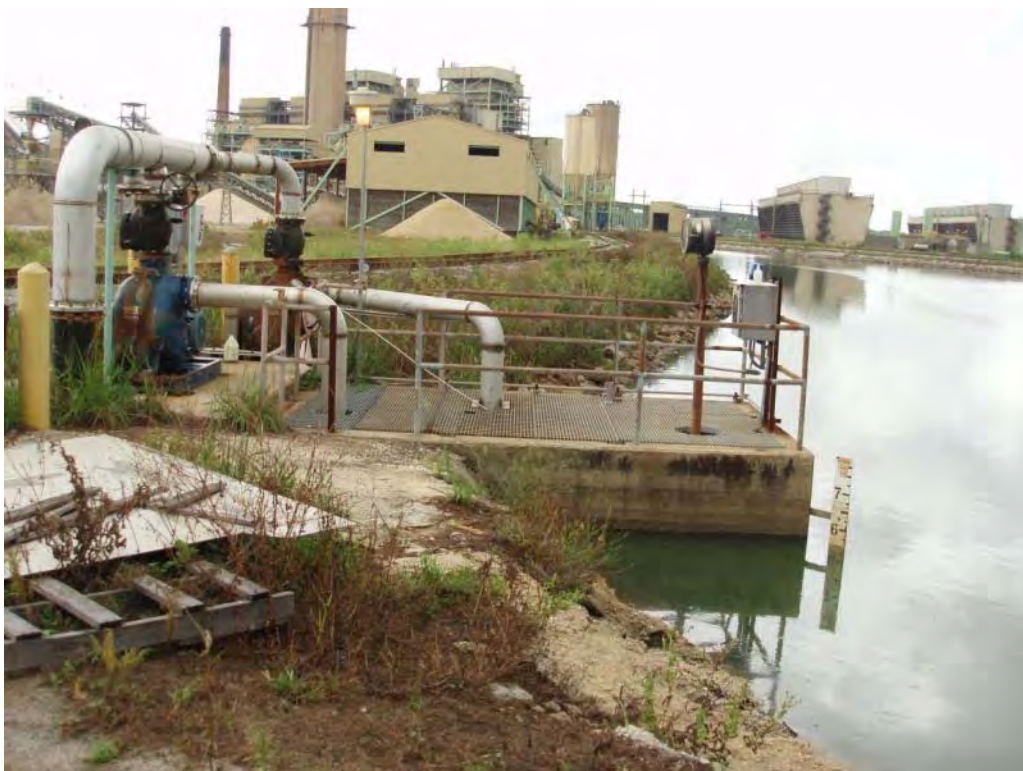
A staff gauge is located within each pond to measure the impoundment water level (Photographs 49 and 75). Based on information provided by PSEC personnel, the pond water levels are monitored and recorded daily.

**Photo No. 49: Process Waste Pond – North embankment interior slope. Looking at intake pumps.**

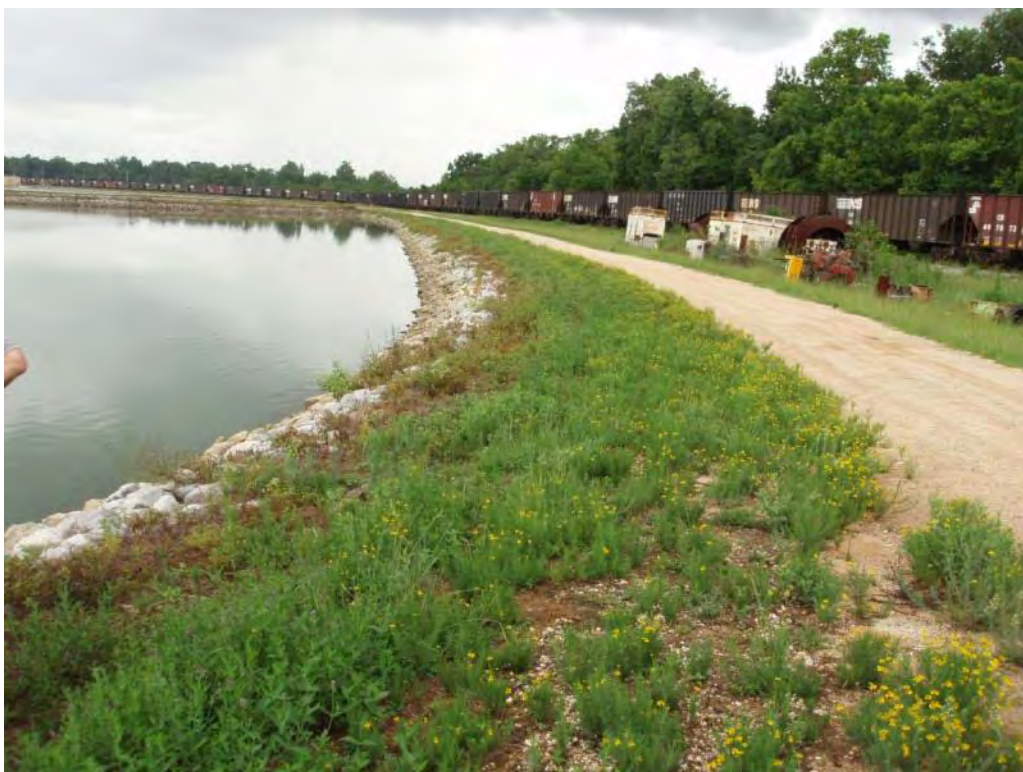
**Photo No. 50: Process Waste Pond – West embankment interior slope, looking south.**

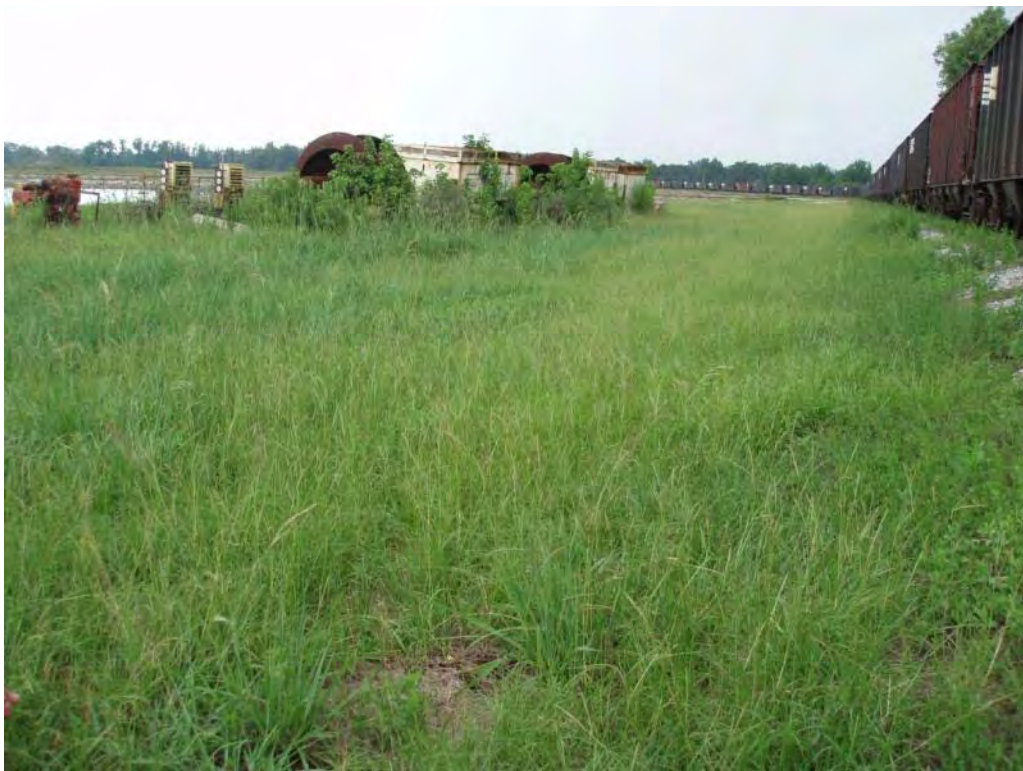
**Photo No. 51: Process Waste Pond – West embankment crest, looking south.**

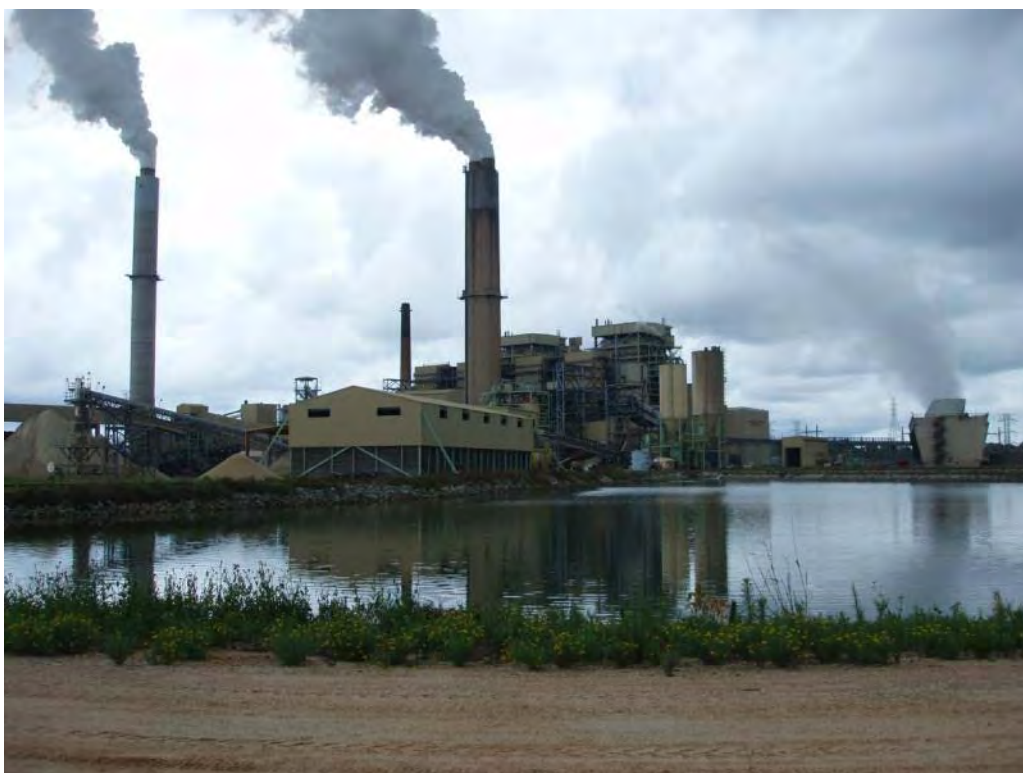
**Photo No. 52: Process Waste Pond – West embankment crest, looking east.**

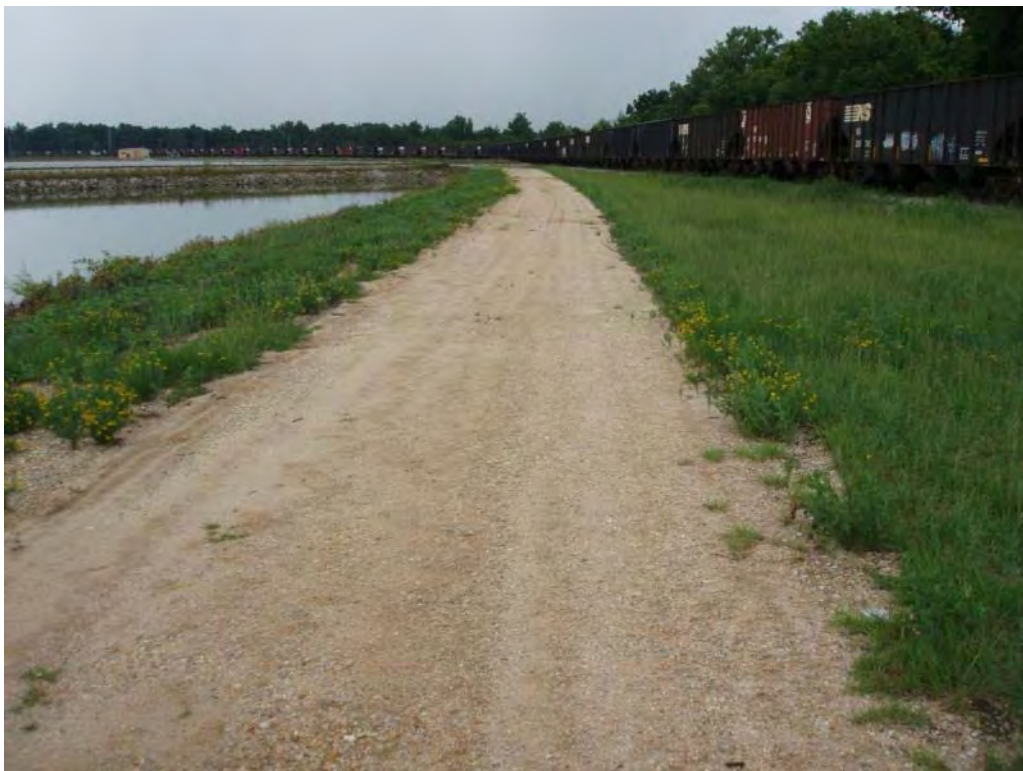
The crest appeared to be in good condition (Photographs 53, 60, and 64). All three of the embankment crests include a PSEC-owned railroad spur on crushed stone railroad ballast. The north embankment extends nearly horizontal to the plant. The west embankment crest is approximately 100 feet wide. The south embankment crest is approximately 15 feet wide. No depressions, ruts, or evidence of settlement were observed on the crests.

**Photo No. 53: Process Waste Pond – West embankment crest, looking south.**

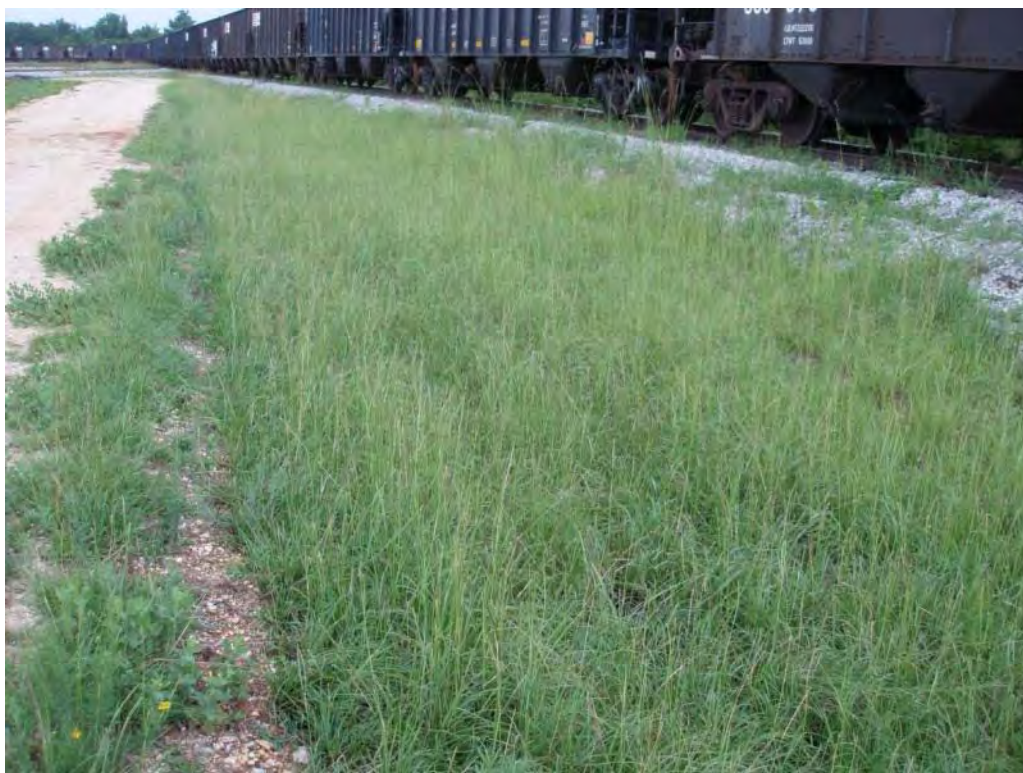
**Photo No. 54: Process Waste Pond – West embankment crest, looking south.**

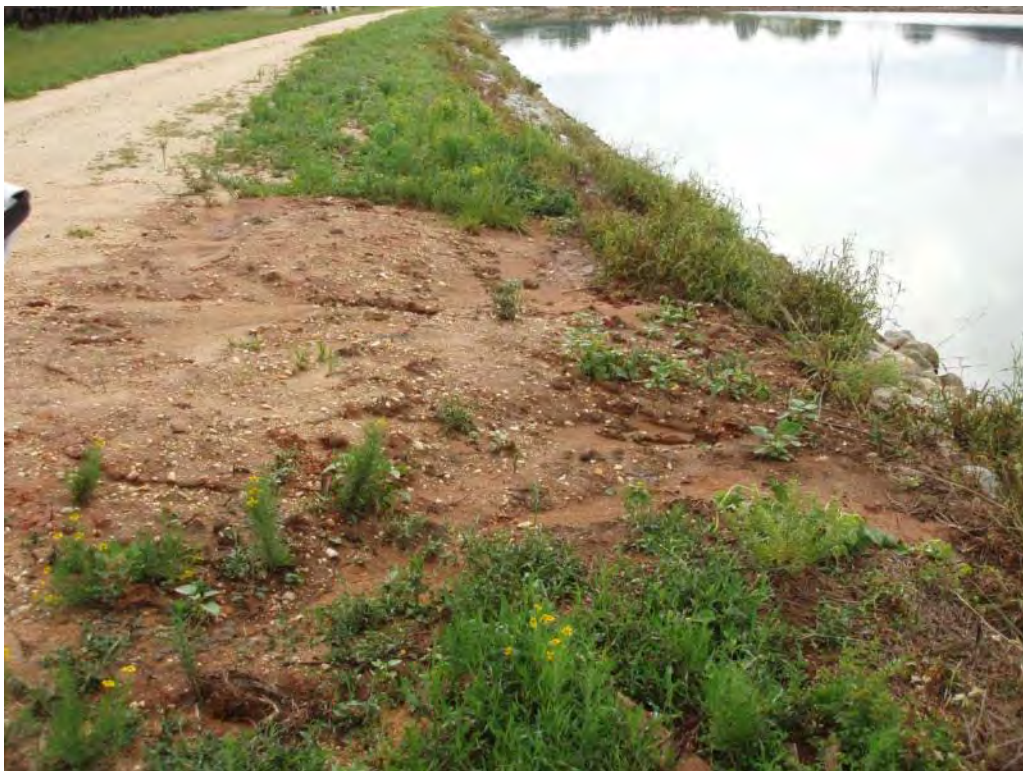
Minor surface erosion was observed on the interior slope of the west embankment (Photograph 55).

**Photo No. 55: Process Waste Pond – West embankment interior slope, looking north. Note surface erosion.**

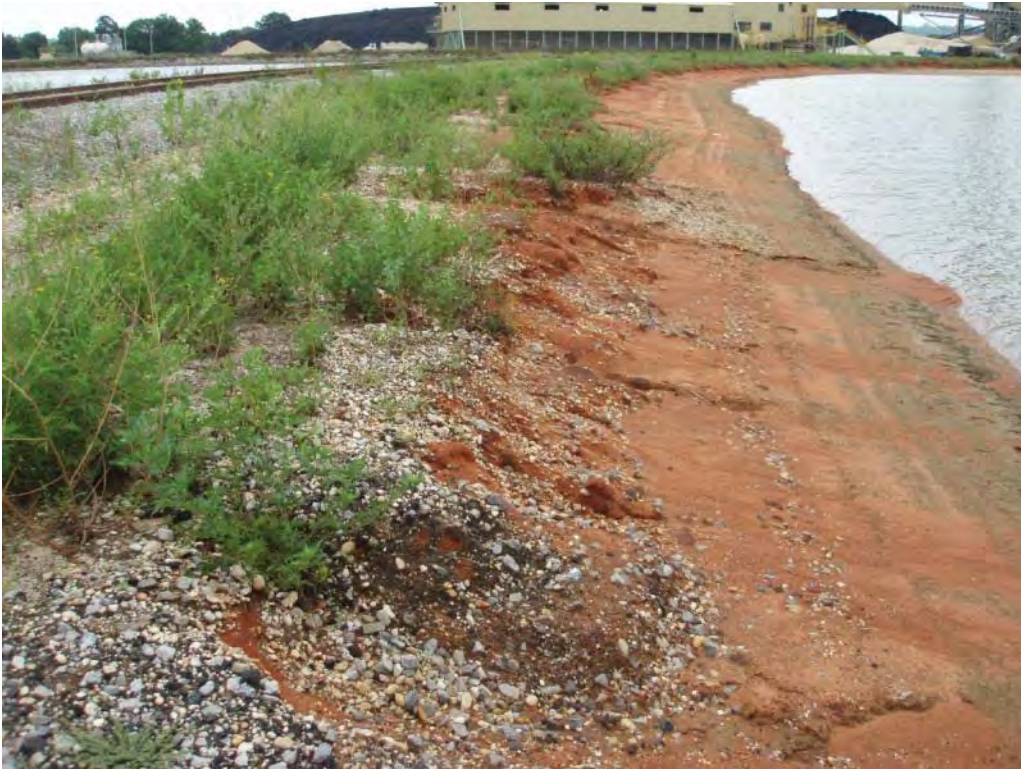
**Photo No. 56: Process Waste Pond – West embankment interior slope, looking northeast.**

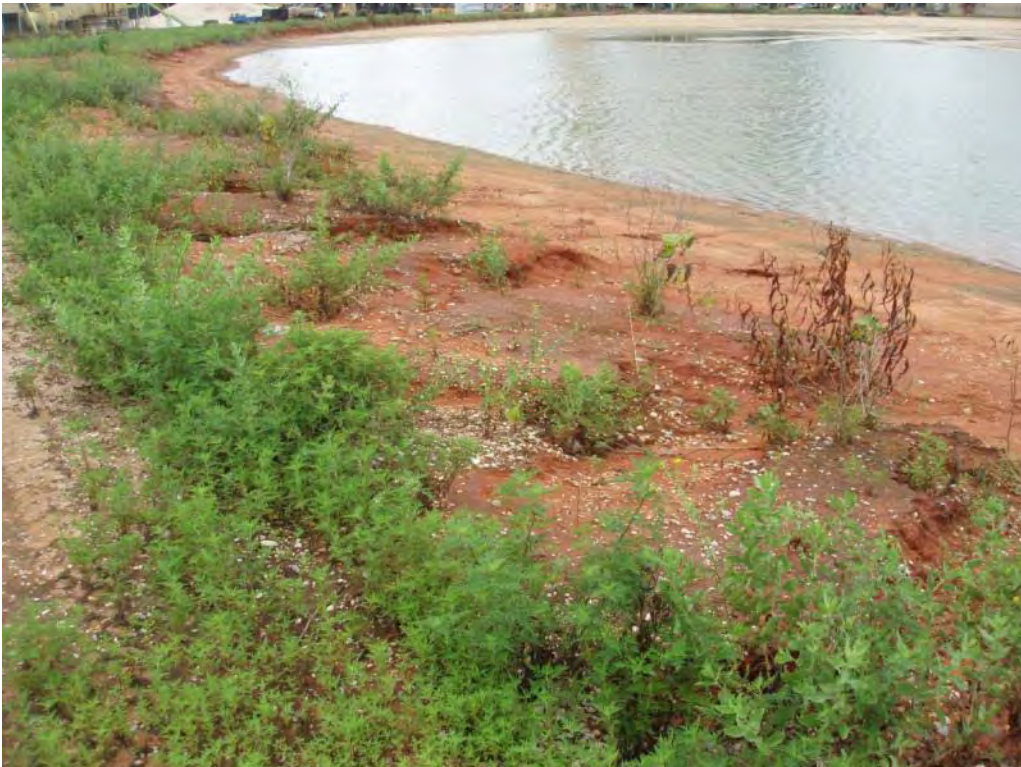
The west embankment exterior slope appears to be in poor condition. The south embankment exterior slope appears to be in fair condition. The north embankment is incised into the finished yard grade, so there is effectively no north embankment exterior slope (Photograph 64). The west embankment exterior slope is approximately 2H:1V. Heavy vegetation with trees up to 18 inches in diameter covers the exterior slope of the west embankment (Photograph 162). The exterior slope of the south (divider) embankment, covered by fill, is the interior slope of the Scrubber Waste Pond (Photograph 57).

**Photo No. 57: Process Waste Pond – South (divider) embankment exterior slope, looking east.  
Note erosion rills in fill material, placed in the past for construction access road.**

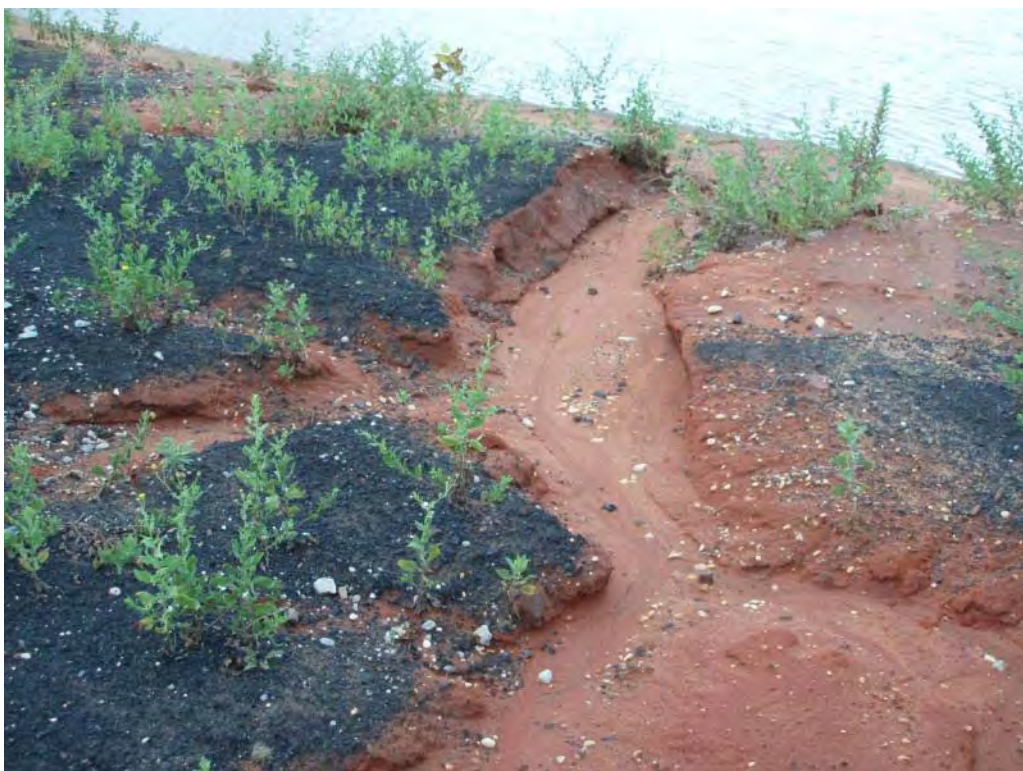
**Photo No. 58: Process Waste Pond – South (divider) embankment exterior slope, looking southeast. Looking at erosion rills in fill material.**

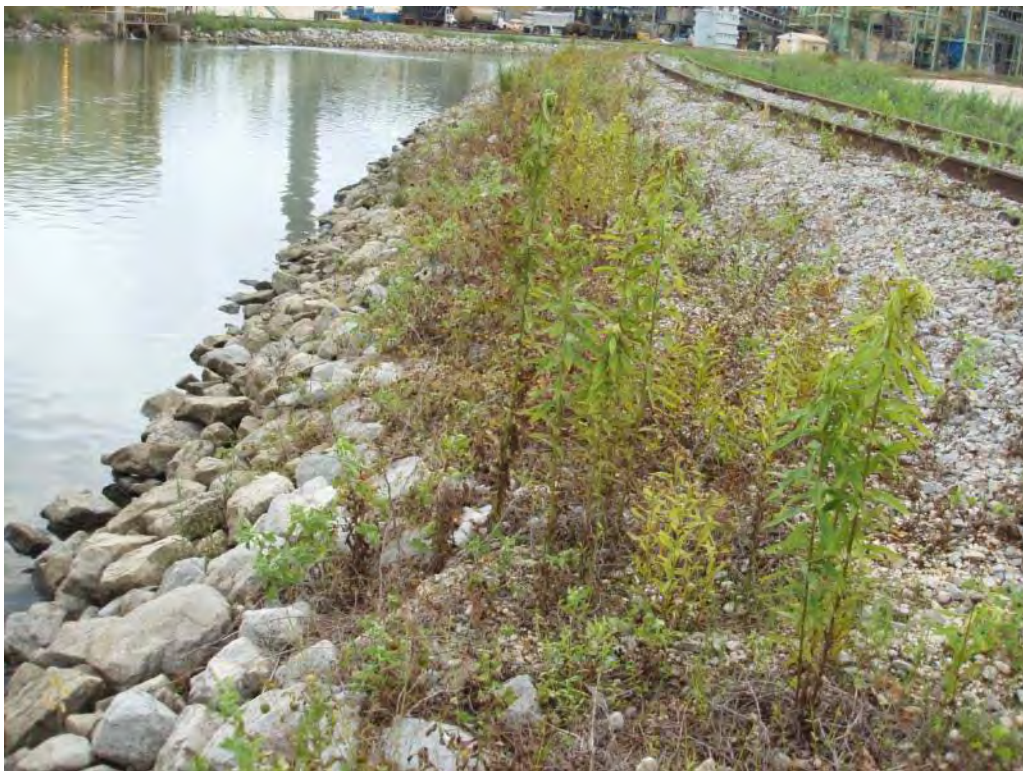
**Photo No. 59: Process Waste Pond – South (divider) embankment exterior slope. Looking at erosion rills in fill material.**

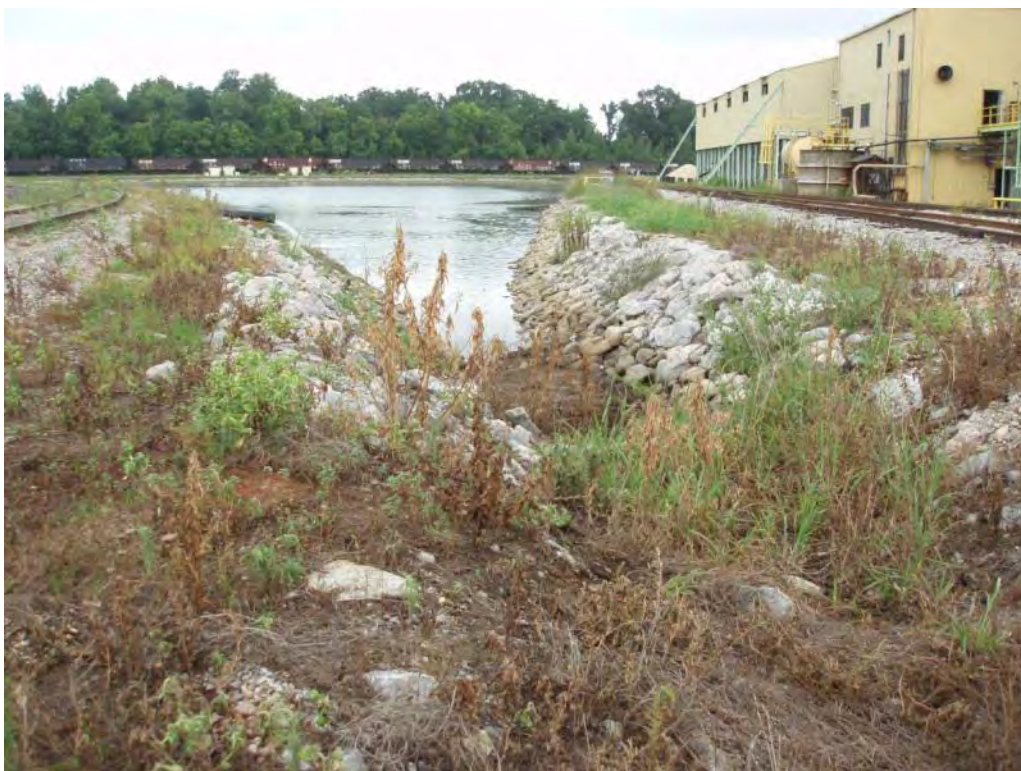
Vegetation, consisting primarily of brush less than 24 inches tall, was observed on the interior slopes of the north and south embankments (Photographs 61 and 67).

**Photo No. 61: Process Waste Pond – South embankment interior slope, looking east. Note vegetation growing within riprap**

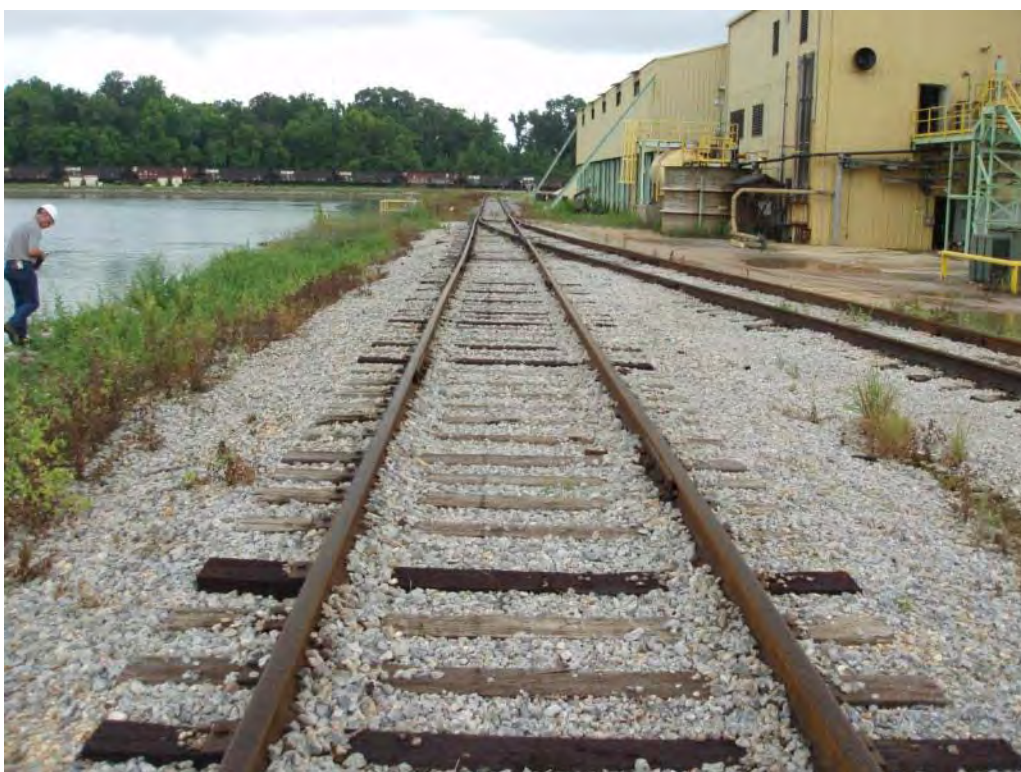
**Photo No. 63: Process Waste Pond – South and north embankment interior slopes, looking northwest. Note vegetation growing within riprap.**

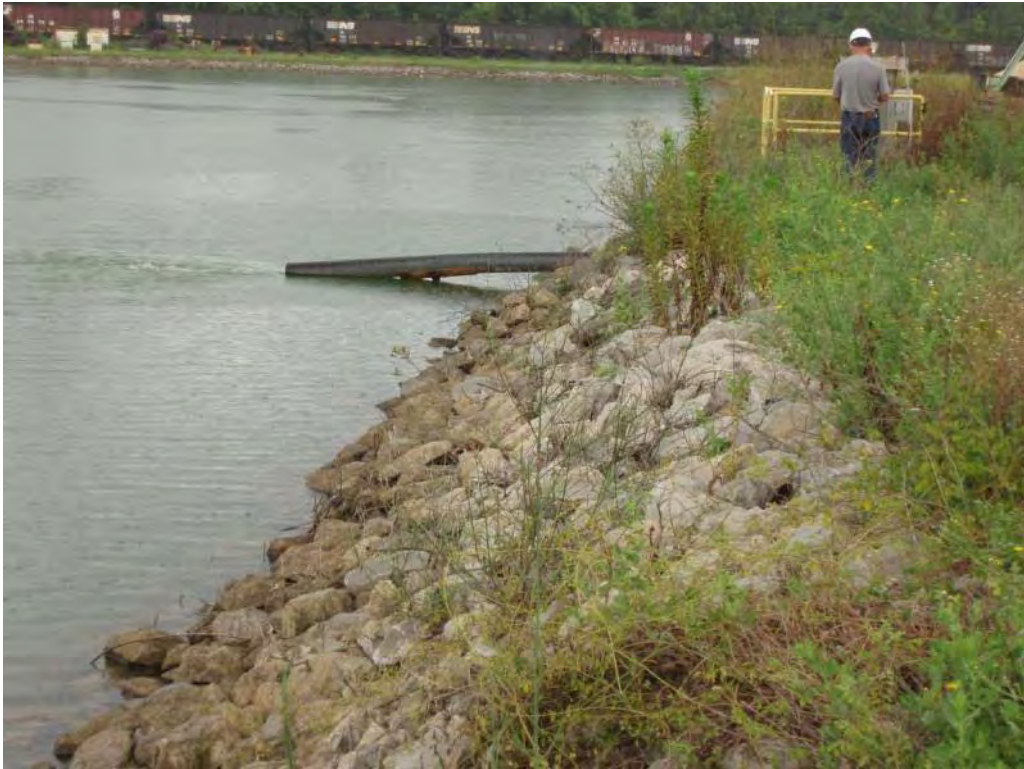
**Photo No. 64: Process Waste Pond – North embankment crest, looking north.**

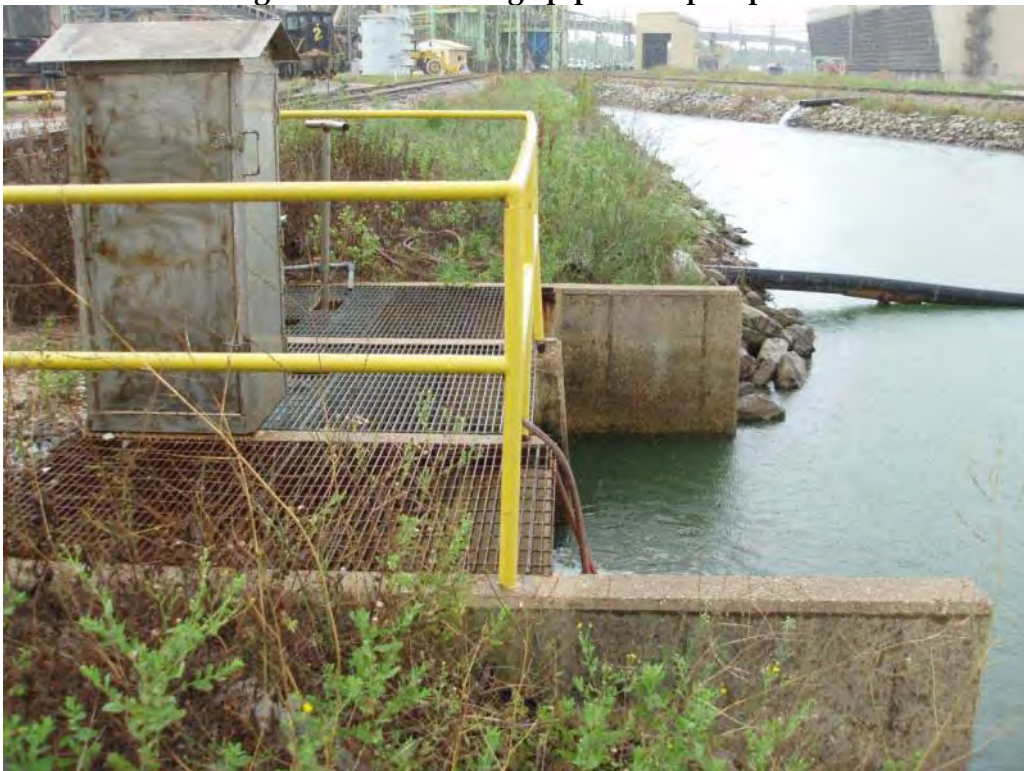
**Photo No. 65: Process Waste Pond – North embankment interior slope, looking north.  
Looking at second discharge pipe from pump station.**
