# **Assessment of Dam Safety of Coal Combustion Surface Impoundments**

**PowerSouth Energy Cooperative**

**Charles R. Lowman Power Plant**

**March 30, 2011**

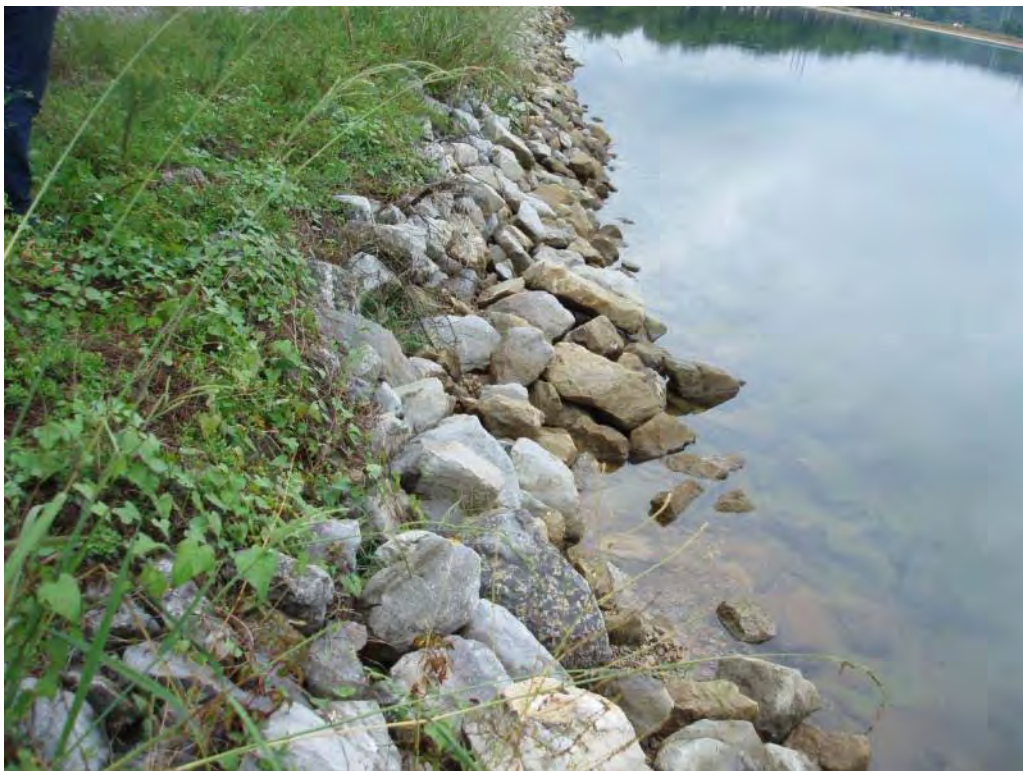
The embankment interior slopes appear to be in poor condition. The interior slopes generally appear to be approximately 3H:1V, except at areas on the south embankment that are approximately 2H:1V. The west and south interior slopes are armored with riprap (Photographs 73 and 78). The east embankment interior slope is sparsely vegetated with grass and vegetation generally less than 8 inches tall and some small saplings up to one inch in diameter. The east embankment did not have armoring (Photograph 89). Bare fill material placed to create a haul road is covering the north embankment interior slope (Photograph 100).

**Photo No. 73: Scrubber Waste Pond – West embankment interior slope, looking north. Note erosion of riprap.**

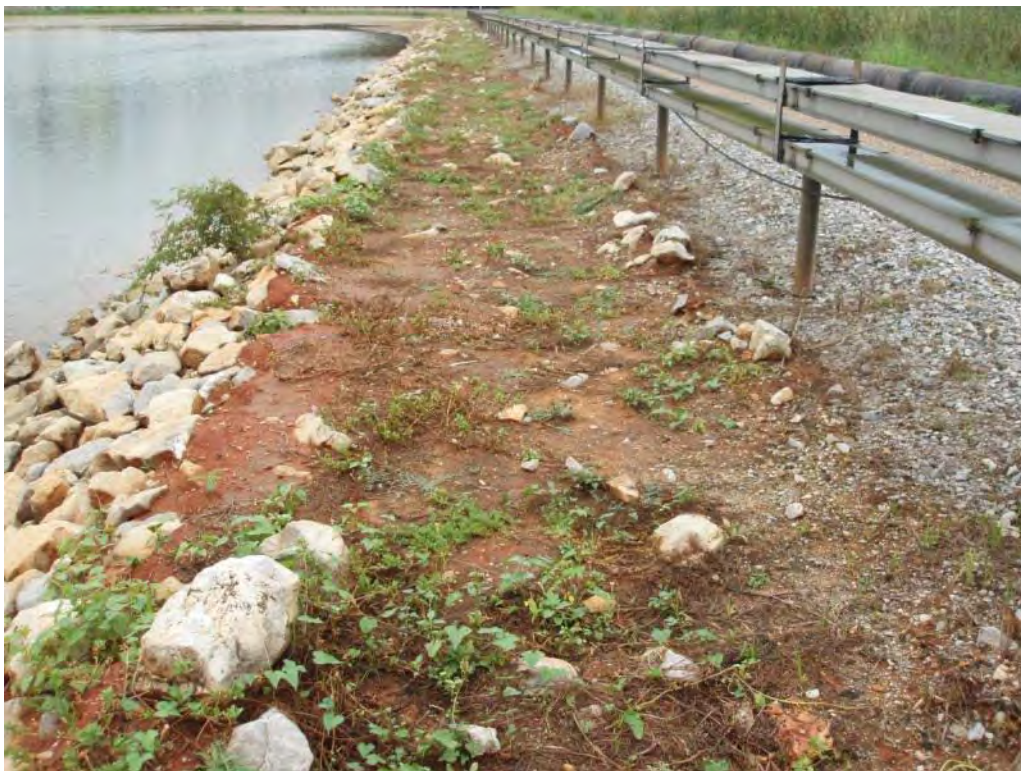
Surface erosion features were observed on the interior slopes of the south and east embankments (Photograph 82 and 84). Spongy soils, sloughing, and voids were observed along the length of the south embankment in the location of a buried pipeline (Photograph 77).

**Photo No. 77: Scrubber Waste Pond – South embankment interior slope, looking east.  
Looking at location of spongy soils in area of buried pipeline.**

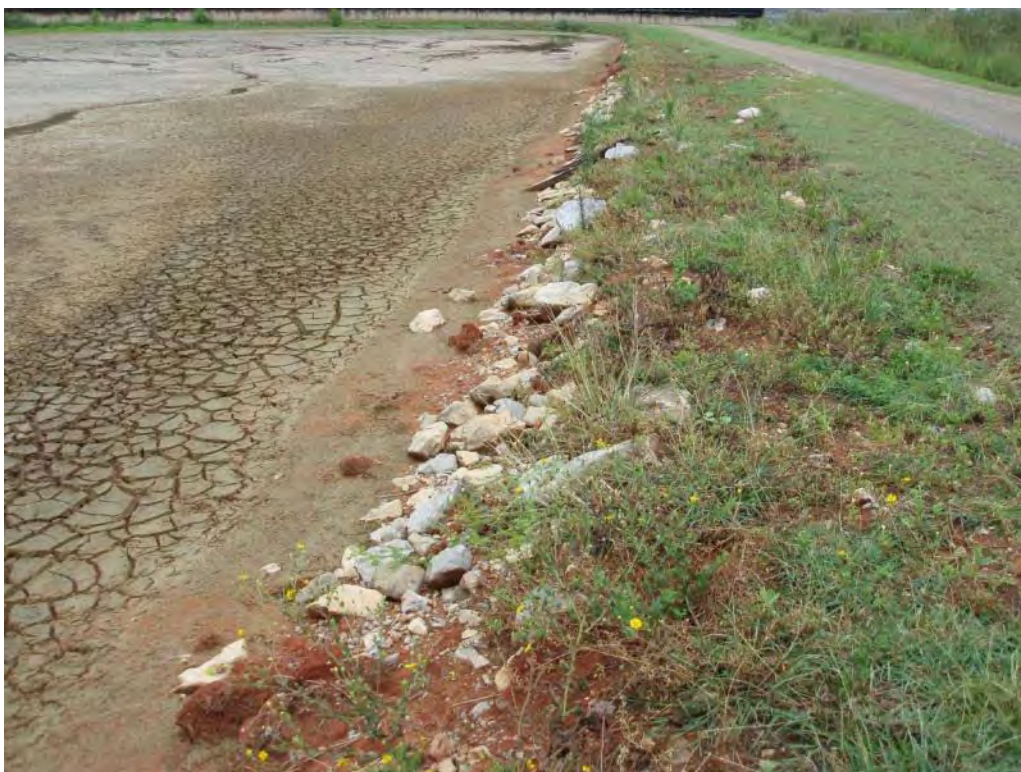
**Photo No. 78: Scrubber Waste Pond – South embankment interior slope, looking east. Note  
surface erosion and sparse riprap.**

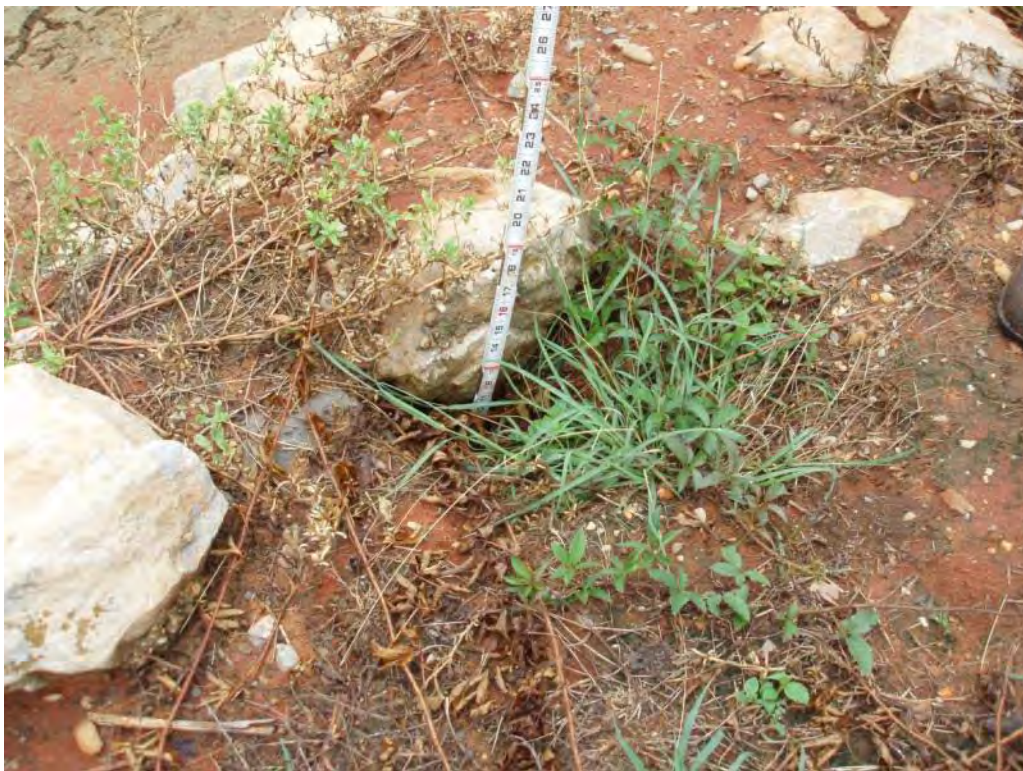
**Photo No. 79: Scrubber Waste Pond – South embankment exterior slope. Looking at 10-inch-deep void beneath riprap.**

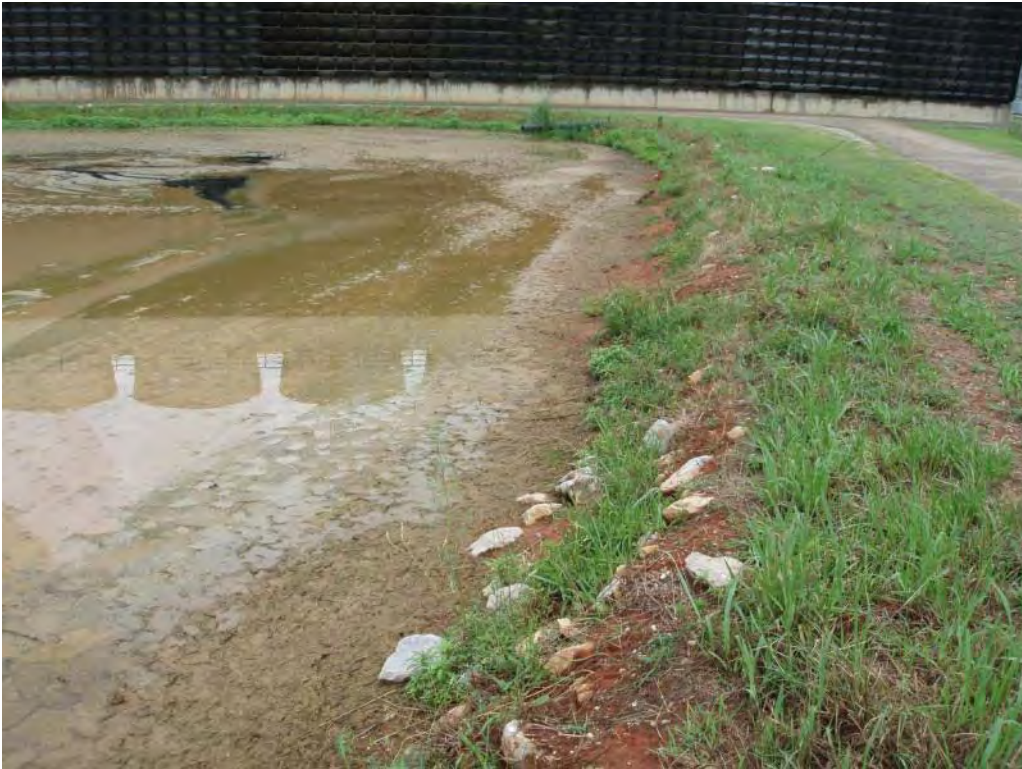
**Photo No. 81: Scrubber Waste Pond – South embankment interior slope, looking east. Note sparse riprap and surface erosion.**

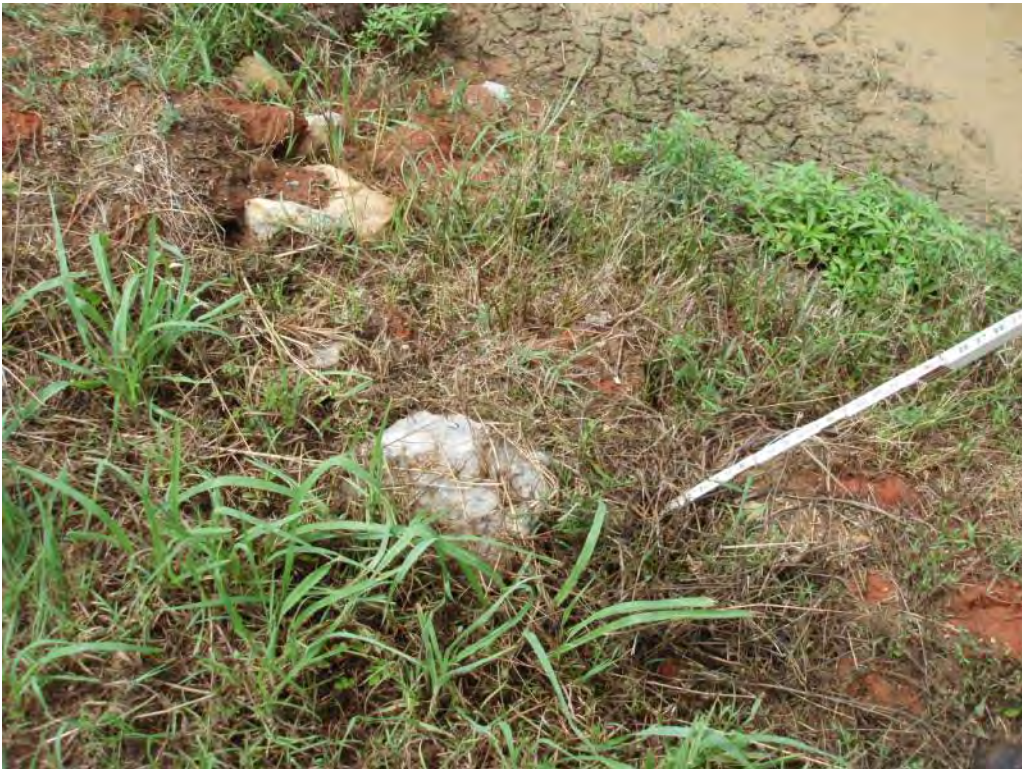
**Photo No. 82: Scrubber Waste Pond – South embankment interior slope. Looking at 8-inch-deep void.**

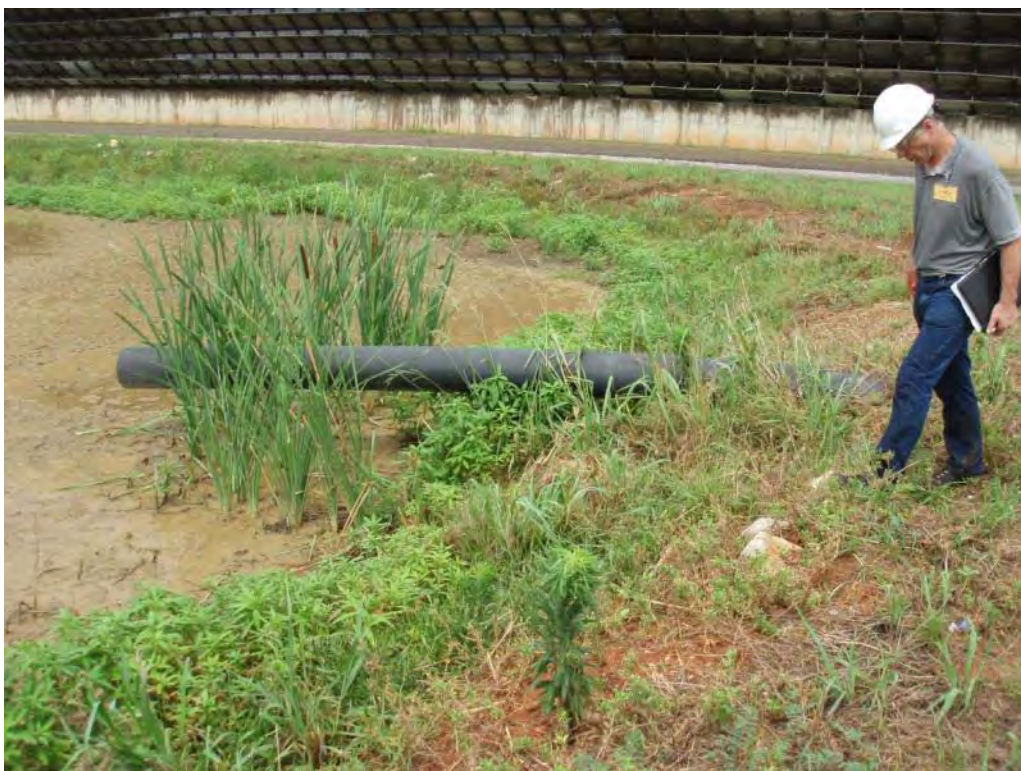
**Photo No. 83: Scrubber Waste Pond – South embankment interior slope, looking northeast.  
Dredge pipe left in place after pond cleanout.**

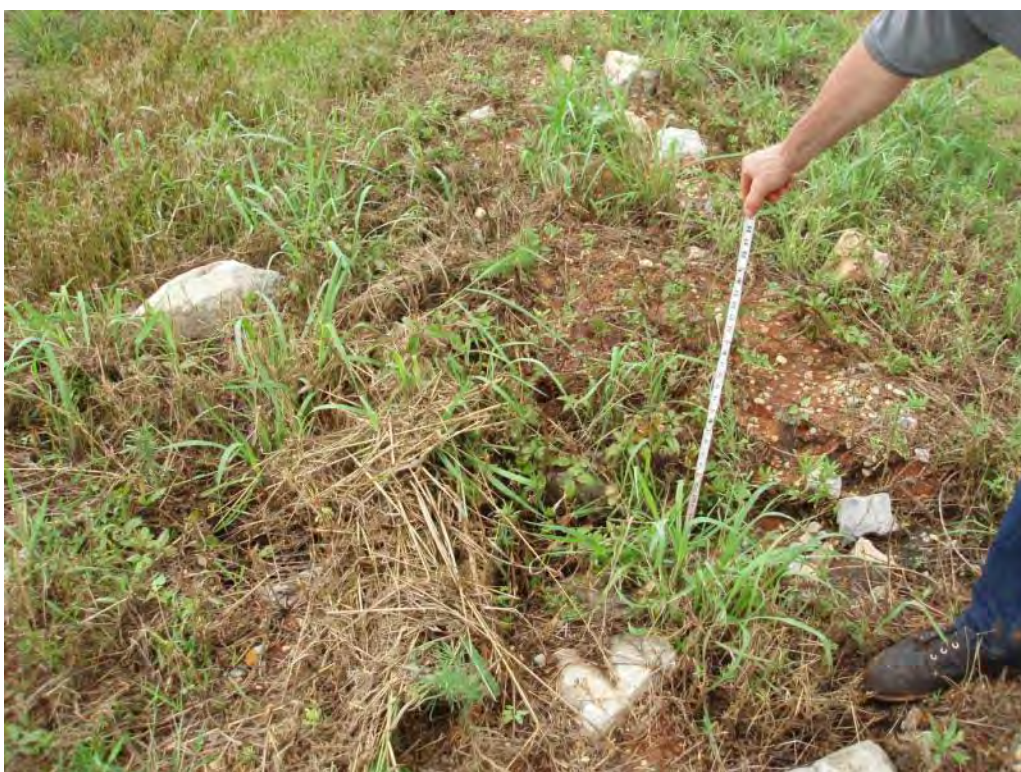
**Photo No. 84: Scrubber Waste Pond – East embankment interior slope. Looking at surface erosion and sparse riprap.**

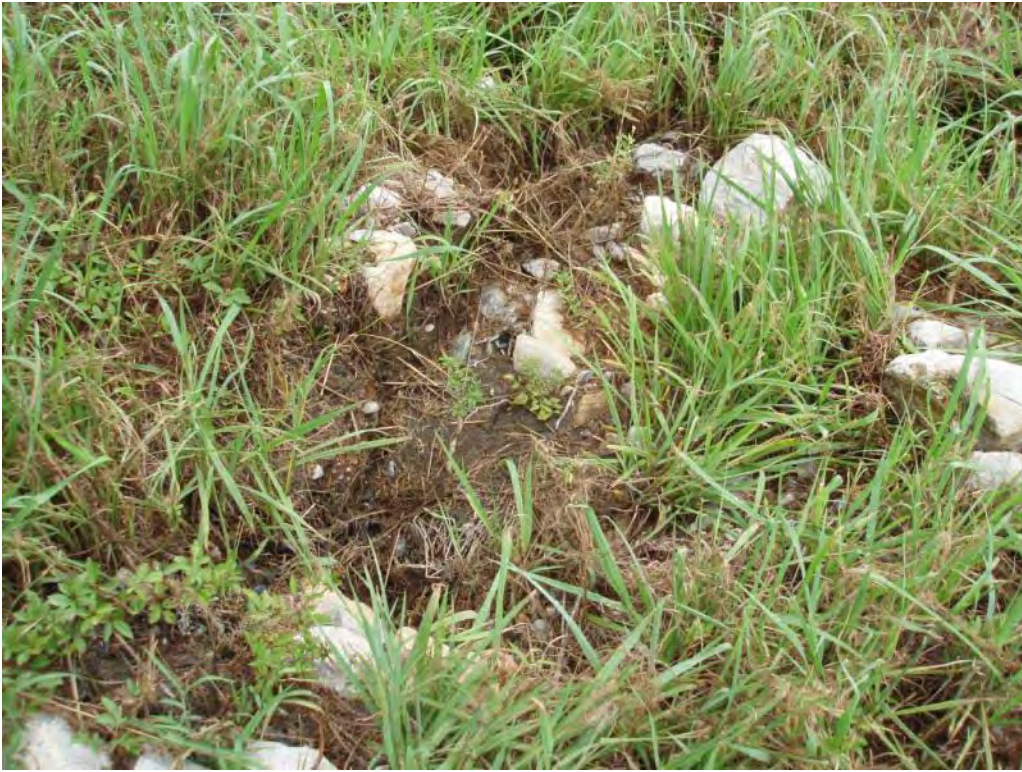
**Photo No. 87: Scrubber Waste Pond – East embankment interior slope. Looking at surface erosion, sparse riprap and vegetation within riprap.**

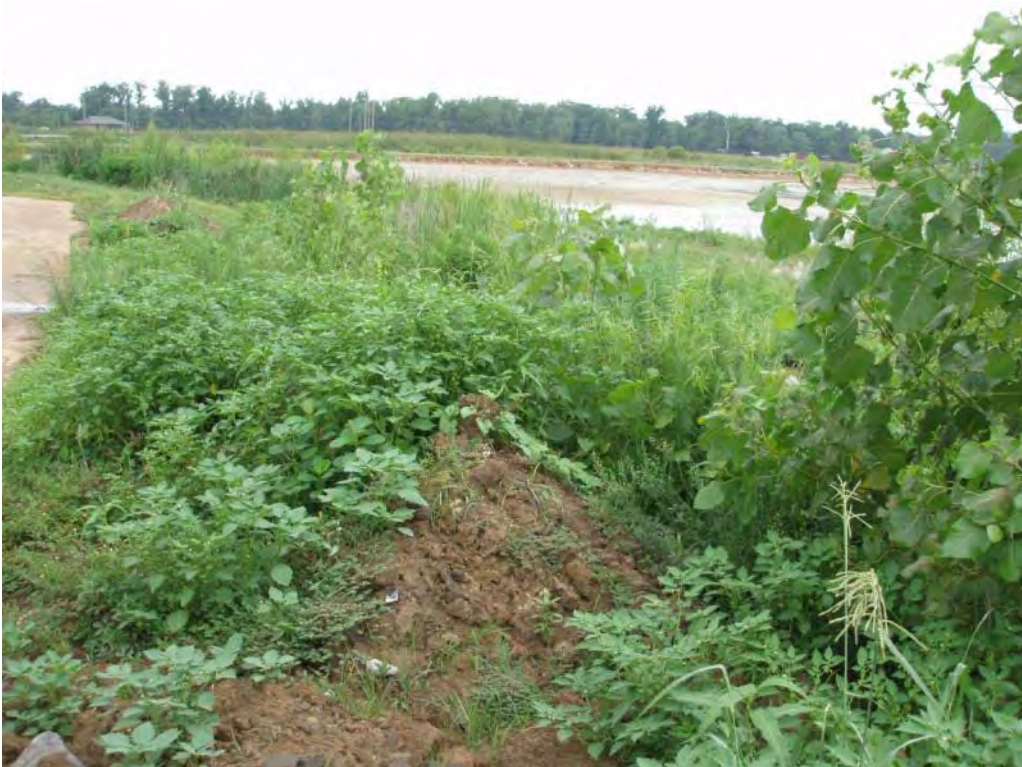
**Photo No. 88: Scrubber Waste Pond – East embankment interior slope, looking south. Looking at vegetation and fill material.**

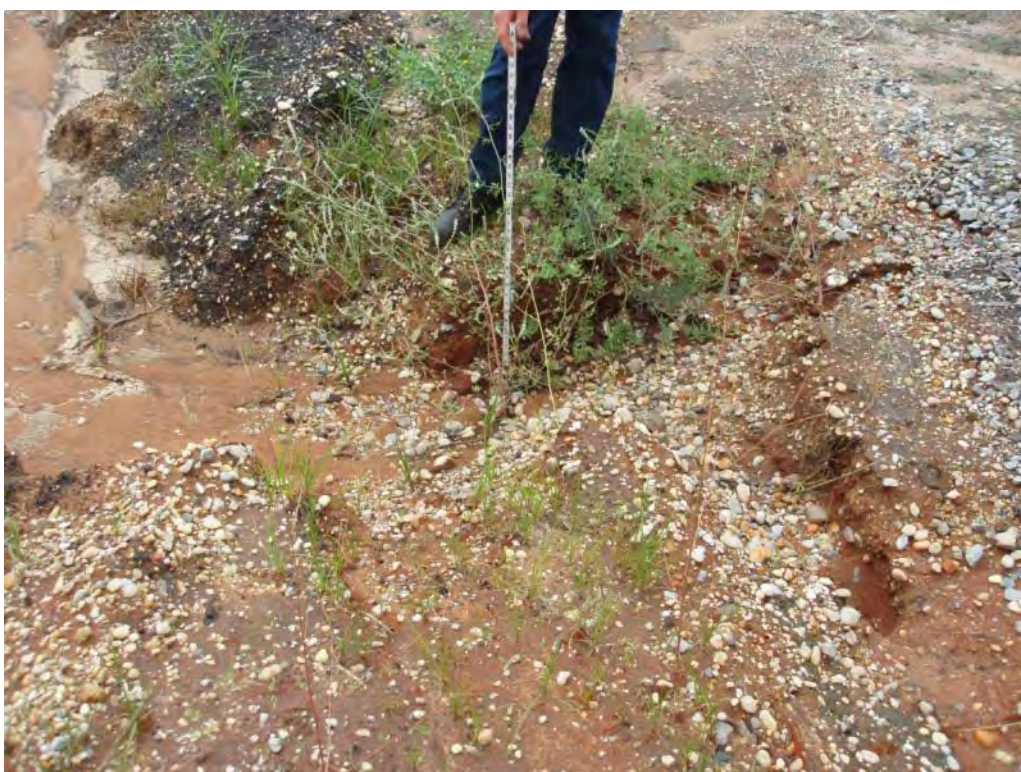
**Photo No. 96: Scrubber Waste Pond – North (divider) embankment interior slope. Looking at erosion rills in fill material.**

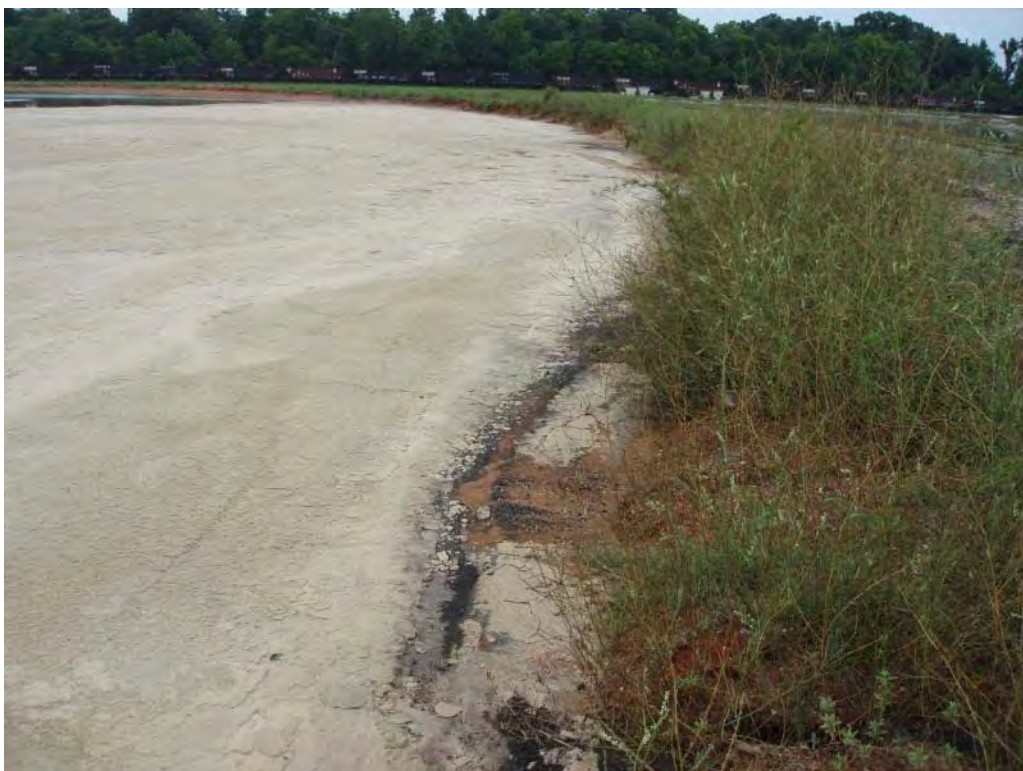
**Photo No. 97: Scrubber Waste Pond – North (divider) embankment interior slope, looking west. Note ash product and vegetation on slope.**

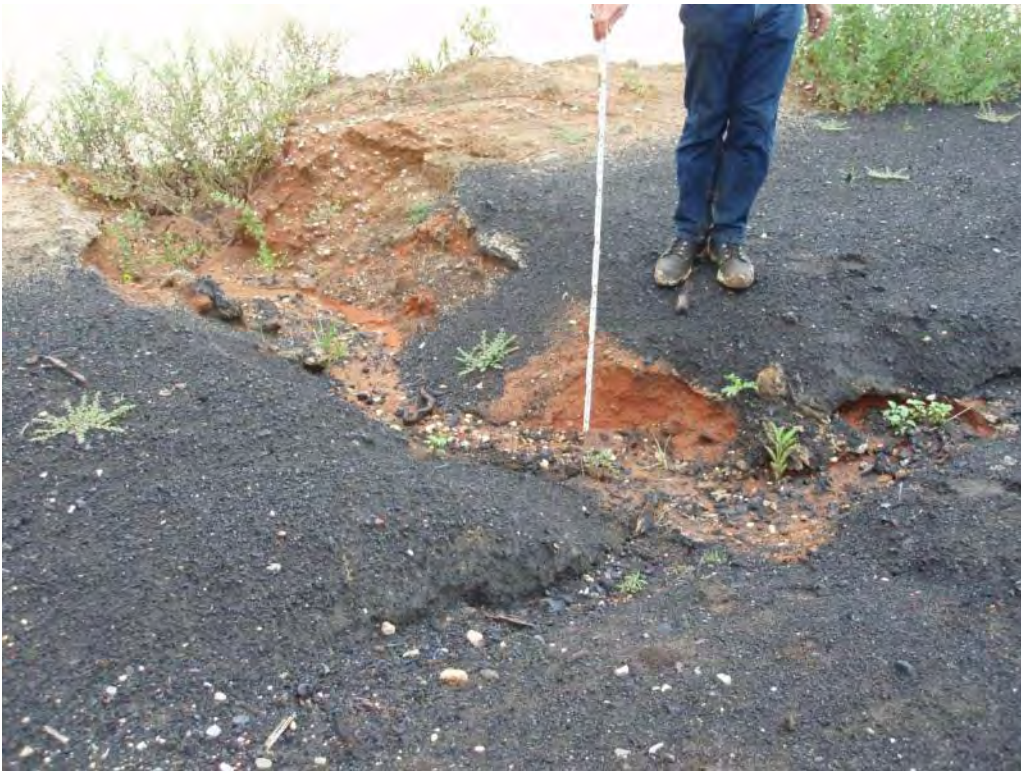
**Photo No. 99: Scrubber Waste Pond – North embankment interior slope. Looking at erosion rill in fill material.**

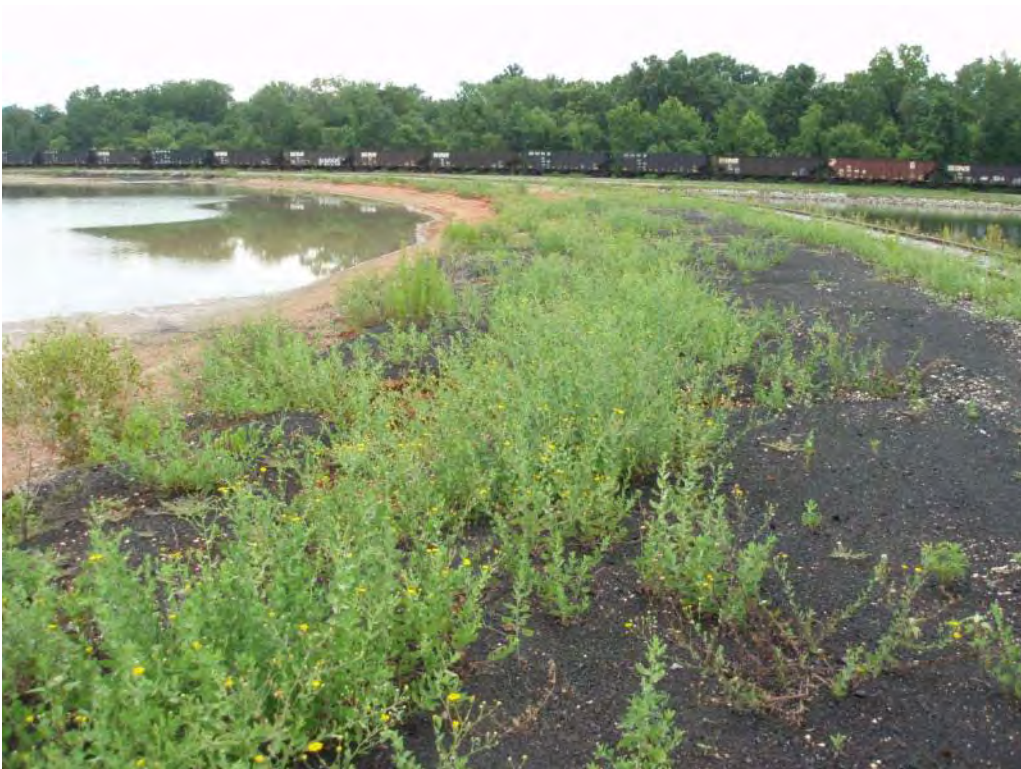
**Photo No. 100: Scrubber Waste Pond – North (divider) embankment interior slope, looking west. Looking at haul road fill material.**

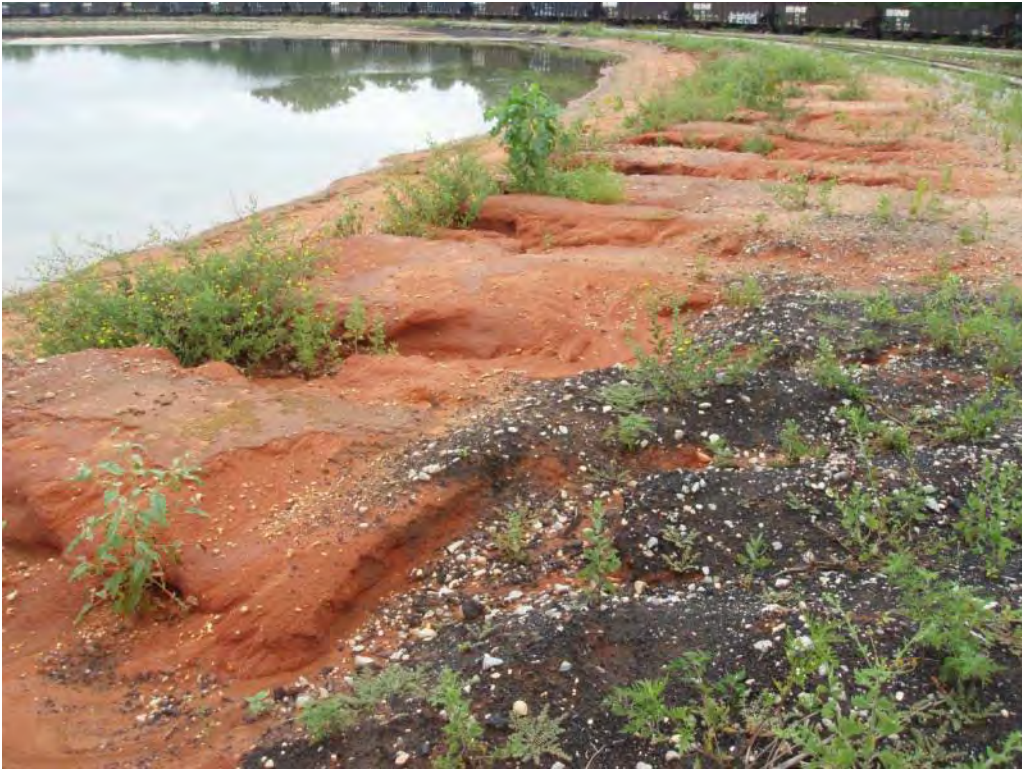
Erosion rills observed along the north embankment interior slope appeared to only extend into the haul road fill materials (Photograph 101).

**Photo No. 101: Scrubber Waste Pond – North embankment interior slope. Looking at erosion rills in fill material.**

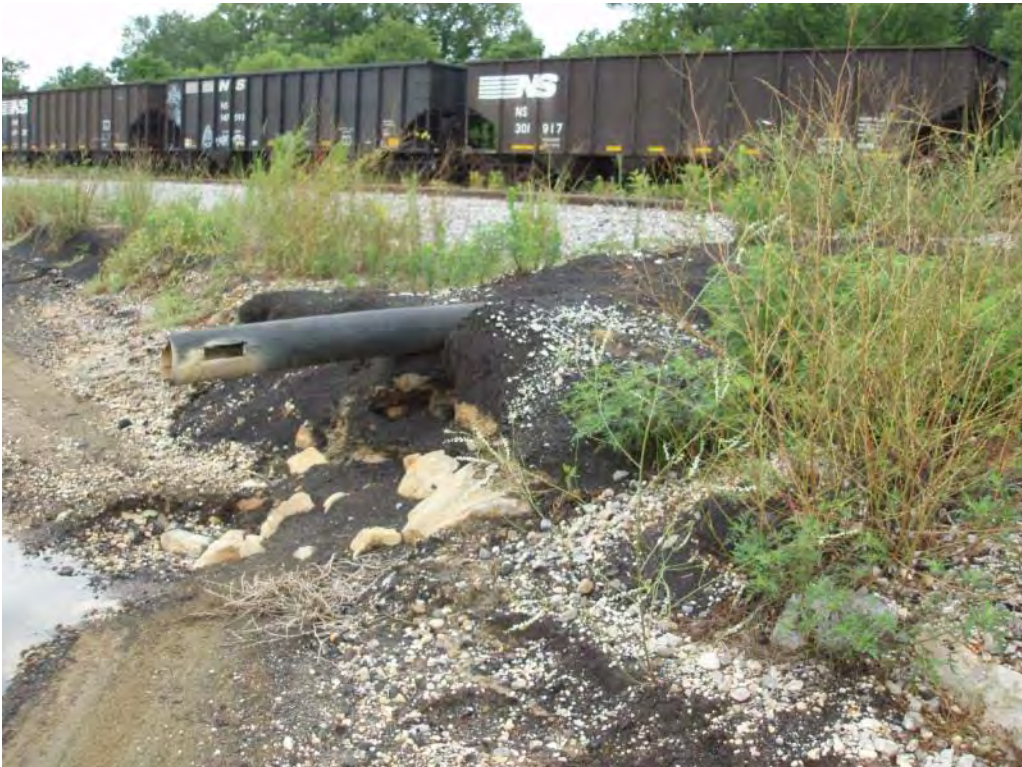
**Photo No. 102: Scrubber Waste Pond – North embankment interior slope, looking southwest. Looking at unknown pipe.**

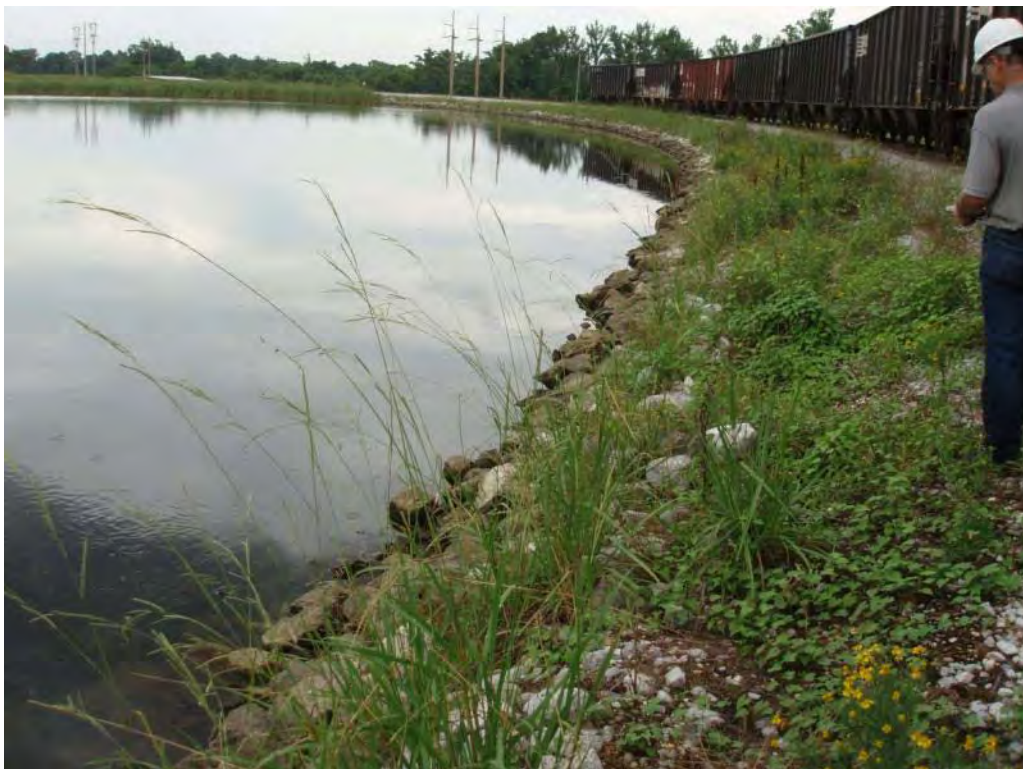
**Photo No. 107: #2/#3 Bottom Ash Pond – West embankment interior slope, looking south.**

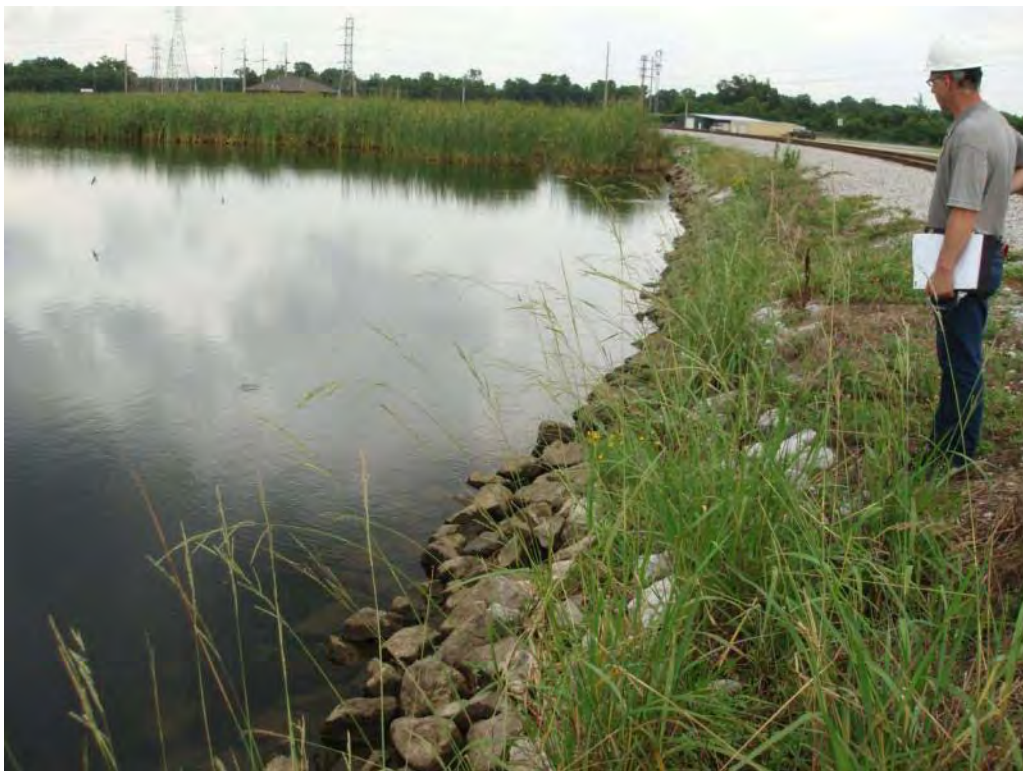
**Photo No. 109: #2/#3 Bottom Ash Pond – South embankment interior slope, looking southeast. Note cattails growing within impoundment in background.**

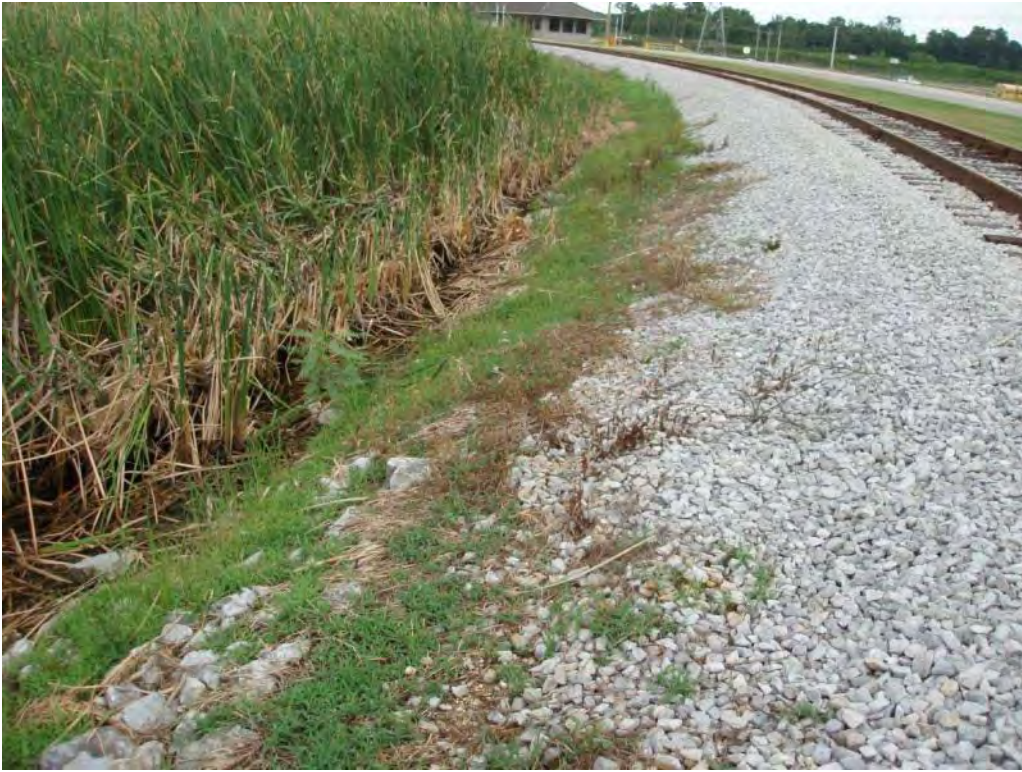
**Photo No. 111: #2/#3 Bottom Ash Pond – South embankment interior slope, looking east.**

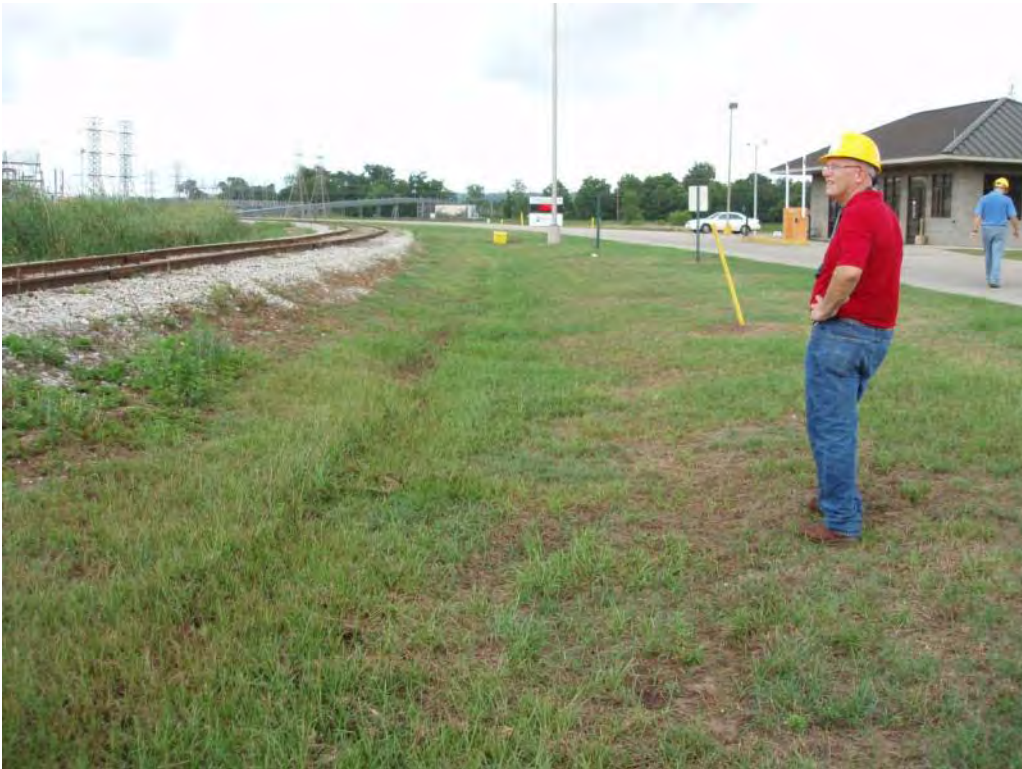
**Photo No. 112: #2/#3 Bottom Ash Pond – South embankment exterior slope, looking east.**

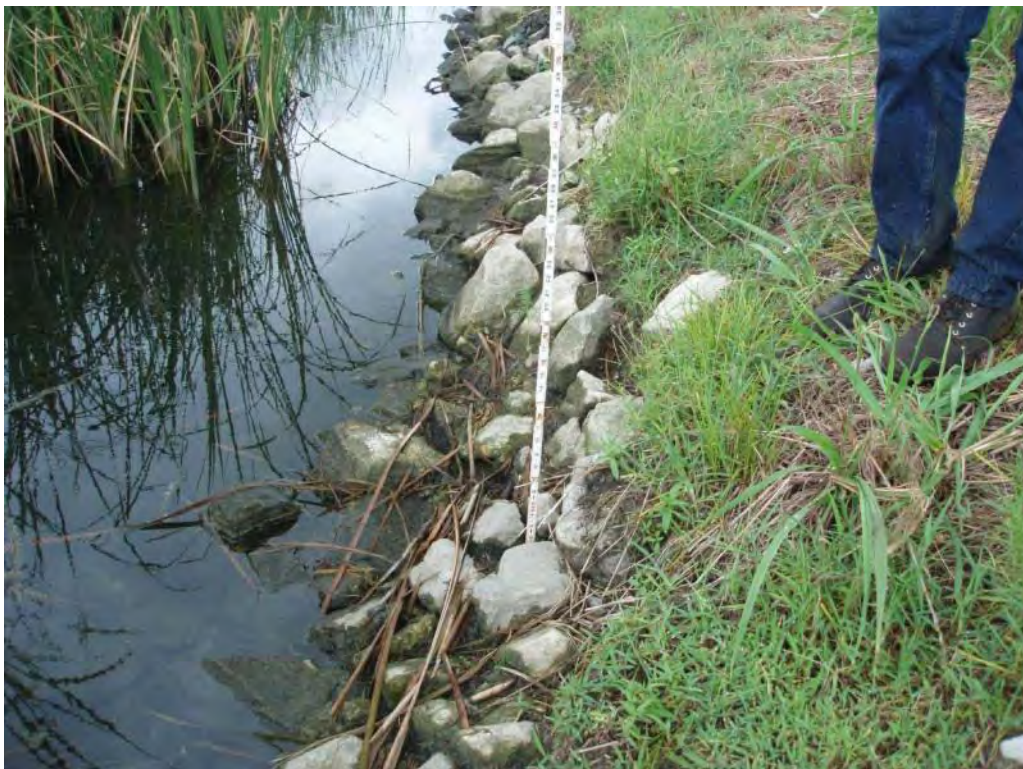
**Photo No. 113: #2/#3 Bottom Ash Pond – South embankment interior slope, looking northeast.**

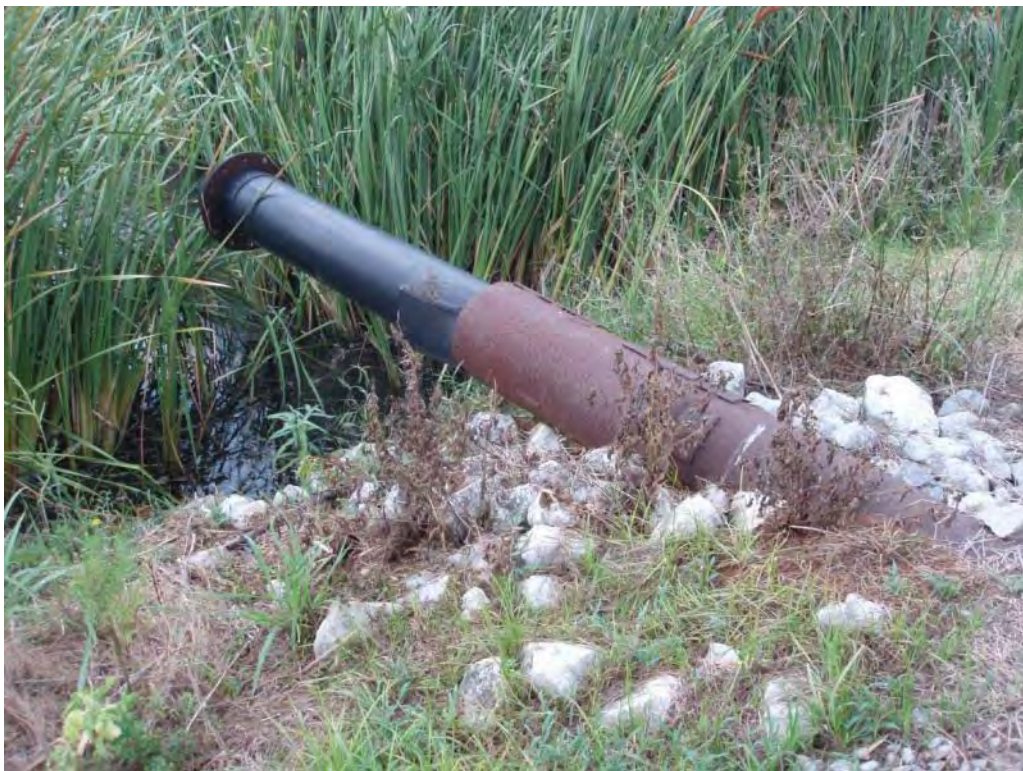
**Photo No. 115: #2/#3 Bottom Ash Pond – East embankment interior slope. Looking at discharge pipe from #1 Bottom Ash Pond.**

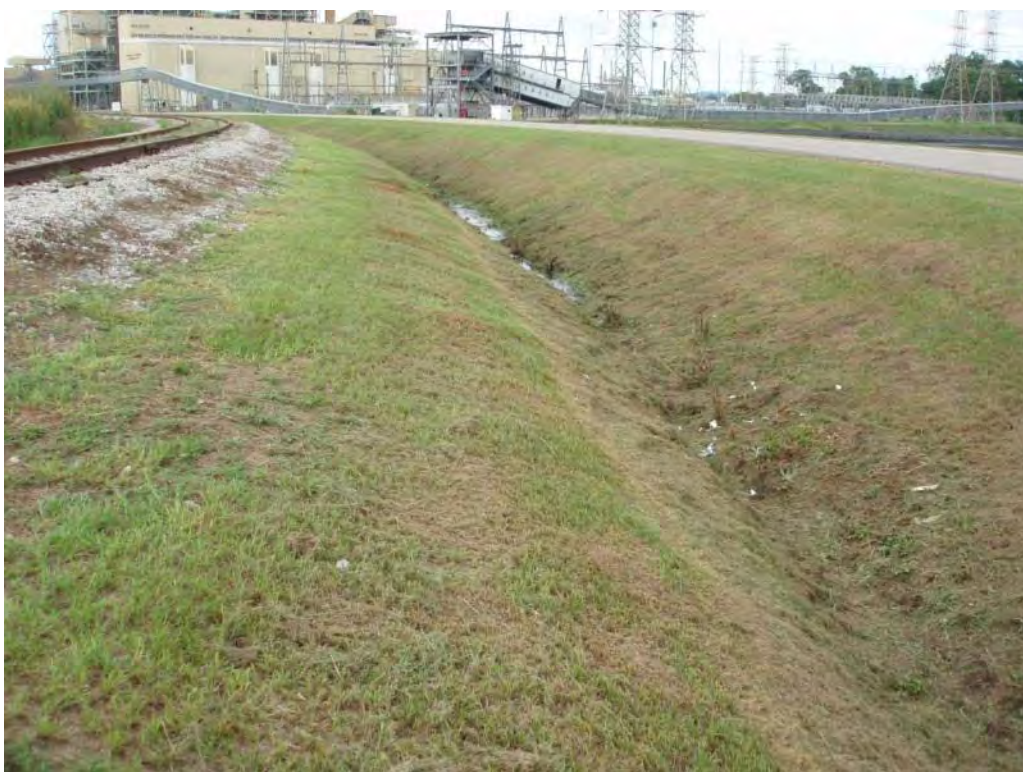
The embankment exterior slopes appear to be in fair condition. The exterior slopes are approximately 2H:1V. Grass, ranging from 3 to 6 inches tall covers the south and east embankment exterior slopes (Photographs 144 and 116). The majority of the west embankment exterior slope is covered in dense, vegetation including trees and saplings (Photographs 139 and 141). The exterior slope of the north (divider) embankment is sparsely covered with riprap (Photograph 78).

**Photo No. 116: #2/#3 Bottom Ash Pond – East embankment exterior slope, looking north.**

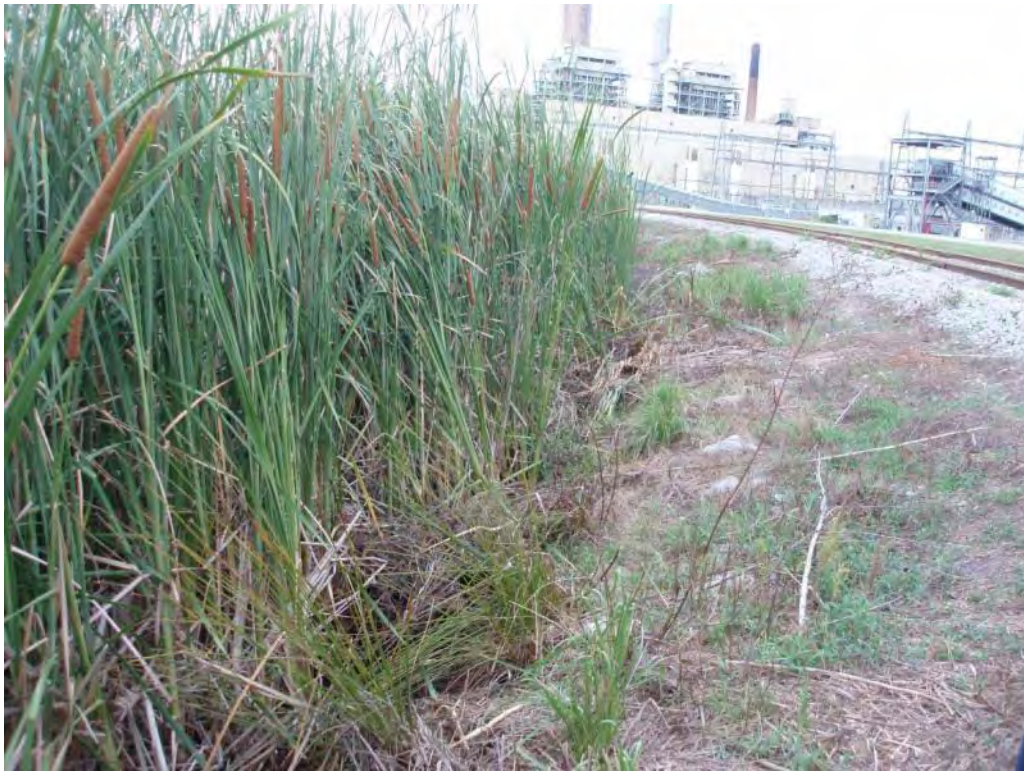
**Photo No. 117: #2/#3 Bottom Ash Pond – East embankment interior slope, looking north.  
Note sparse riprap and cattails growing on slope.**

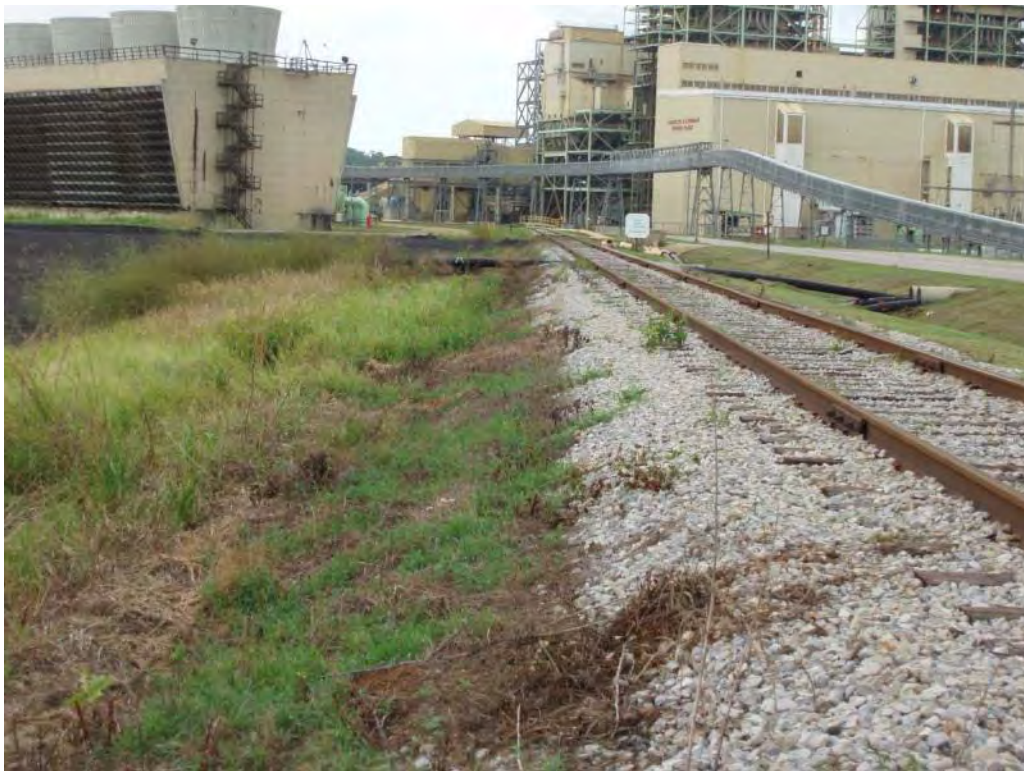
The crest appears to be in good condition (Photographs 110 and 130). The average crest width is approximately 20 feet, except at the east embankment, where the crest is approximately 30 feet wide. A Norfolk Southern railroad spur is located on the west, south, and east embankment crests that are covered with crushed stone railroad ballast (Photographs 110 and 118). The north embankment crest is covered with asphalt paving and subject to vehicle traffic (Photograph 133). No depressions, ruts, or evidence of settlement were observed on the crests (Photographs 110, 118, and 130).

**Photo No. 118: #2/#3 Bottom Ash Pond – East embankment crest, looking north.**

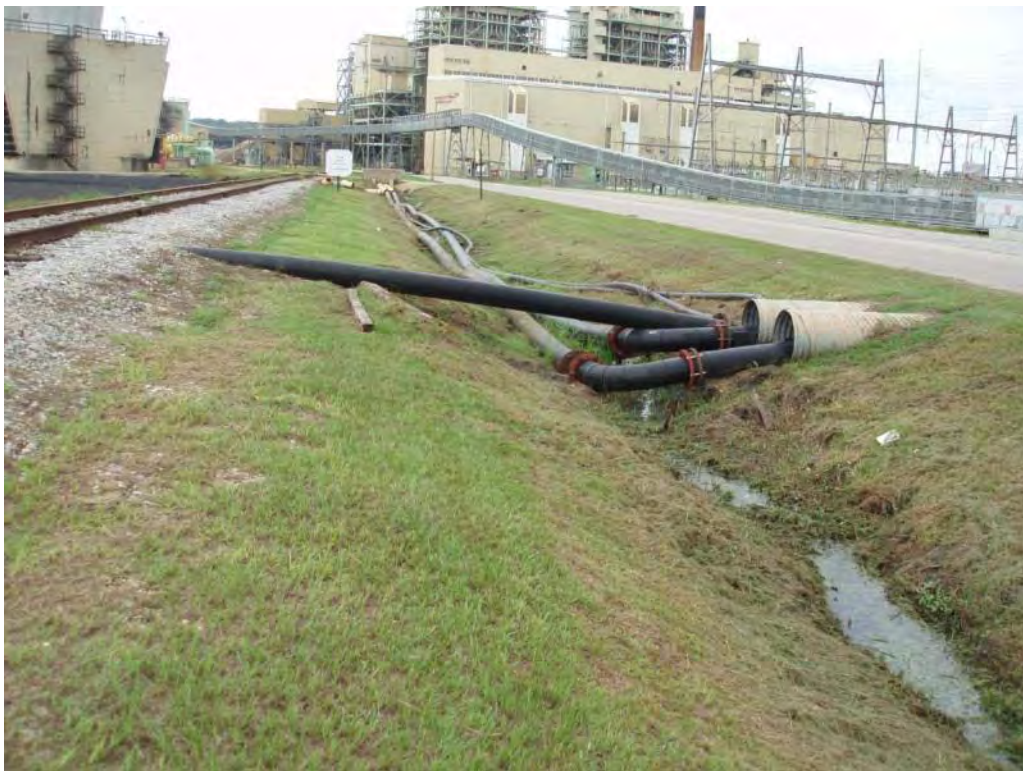
The #2/#3 Bottom Ash Pond has piping configured to allow receiving CCW from Units 1, 2, and 3, through two 10-inch-diameter HDPE pipes; though this pipe was not connected during the assessment (Photograph 119, 120, and 121). The pond receives water from the #1 Bottom Ash Pond through a 14-inch-diameter HDPE pipe. The pump station located on the northwest corner of the pond can pump water to and from the #2/#3 Bottom Ash Pond. Water may be pumped into the pond from the Scrubber Waste Pond and discharged through a 10-inch-diameter HDPE pipe. A 36-inch-diameter iron pipe intakes water from the #2/#3 Bottom Ash Pond to the pump house where it can be pumped to the Scrubber Waste Pond, the Process Waste Pond, or to the Plant for use as process water.

**Photo No. 119: #2/#3 Bottom Ash Pond – East embankment exterior slope, looking north.  
Looking at piping from Units 1, 2, & 3.**

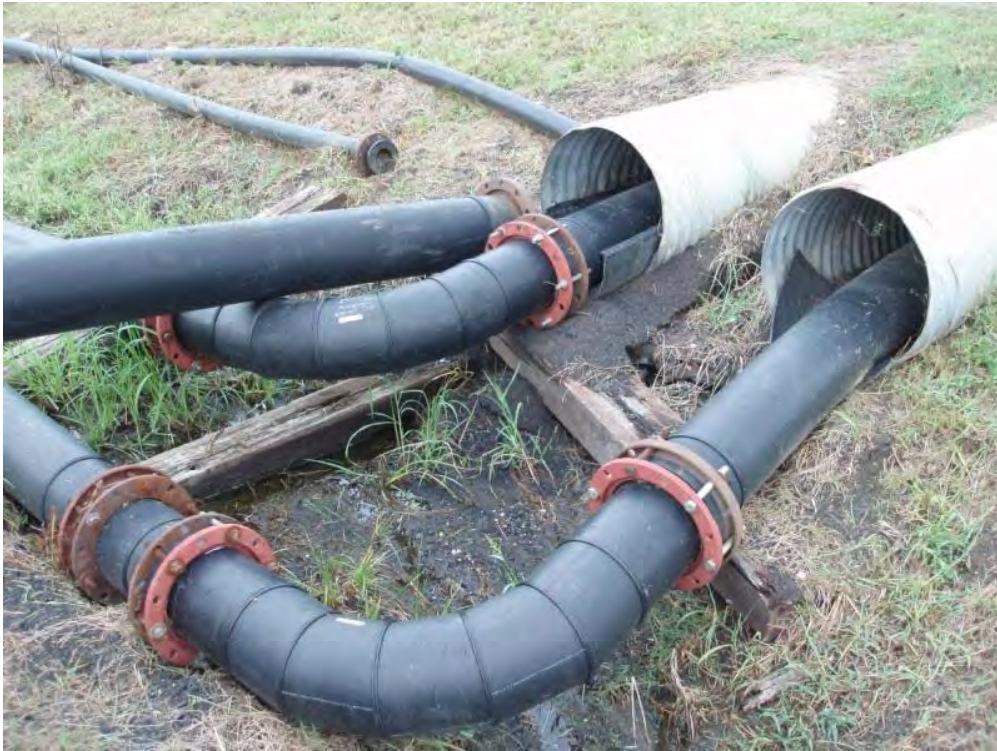
**Photo No. 121: #2/#3 Bottom Ash Pond – East embankment exterior slope. Looking at piping used to divert Units 1, 2, & 3 CCW from the #1 Bottom Ash Pond into the #2/#3 Bottom Ash Pond.**
