# **Assessment of Dam Safety of Coal Combustion Surface Impoundments**

**PowerSouth Energy Cooperative**

**Charles R. Lowman Power Plant**

**March 30, 2011**

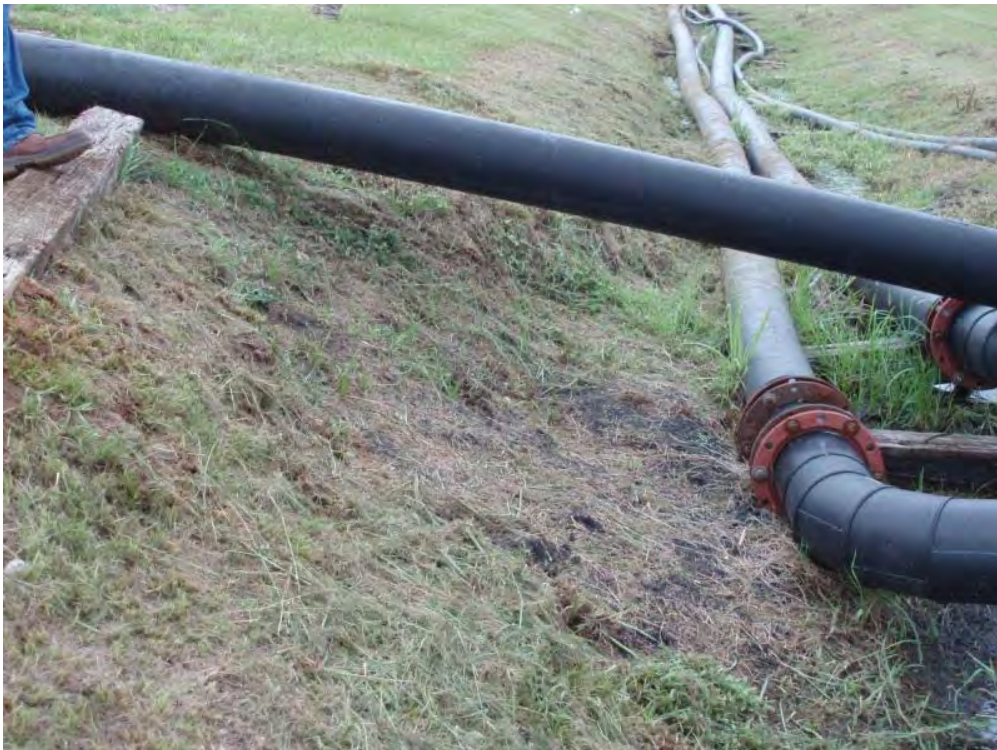
**Photo No. 122: #2/#3 Bottom Ash Pond – East embankment exterior slope. Looking at piping used to divert Units 1, 2, & 3 CCW from the #1 Bottom Ash Pond into the #2/#3 Bottom Ash Pond.**

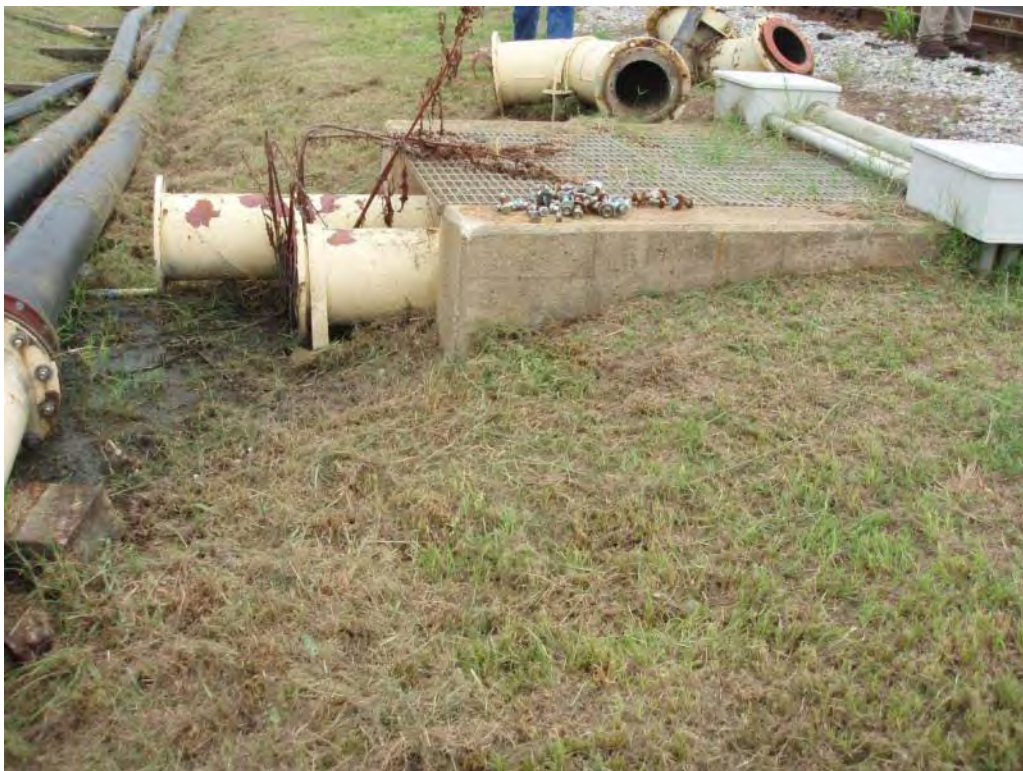
**Photo No. 123: #2/#3 Bottom Ash Pond - East embankment exterior slope, looking south. Looking at piping used to divert Units 1, 2, & 3 CCW from the #1 Bottom Ash Pond into the #2/#3 Bottom Ash Pond.**

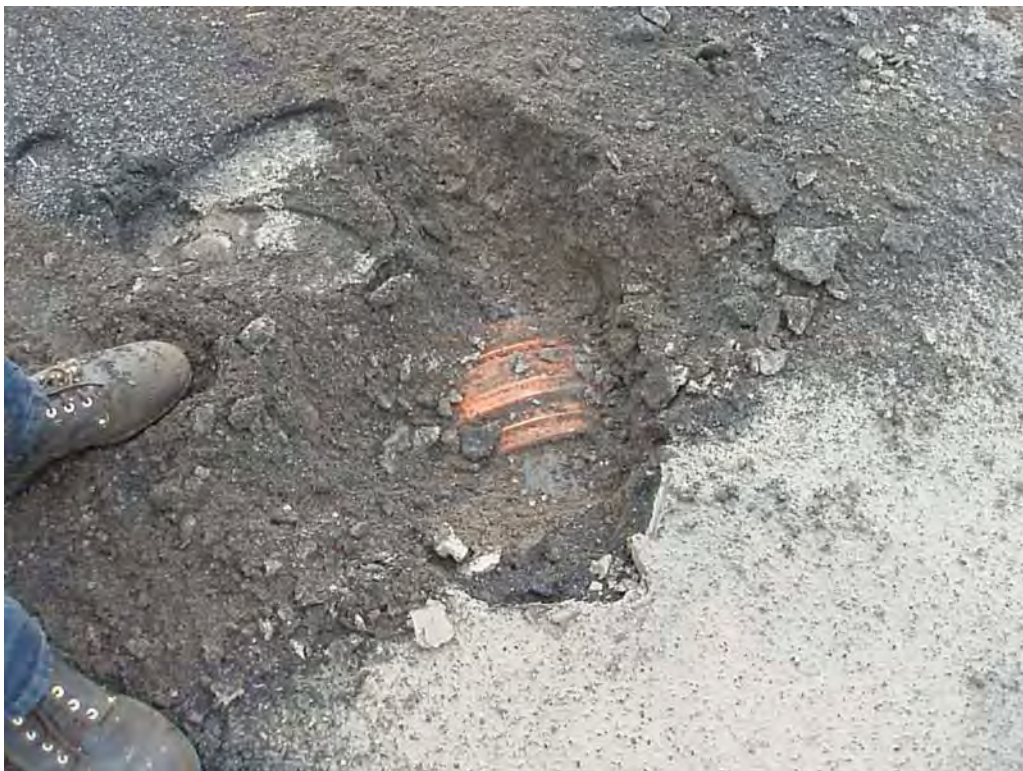
**Photo No. 125: #2/#3 Bottom Ash Pond – East embankment interior slope. Looking at buried piping within ash product.**

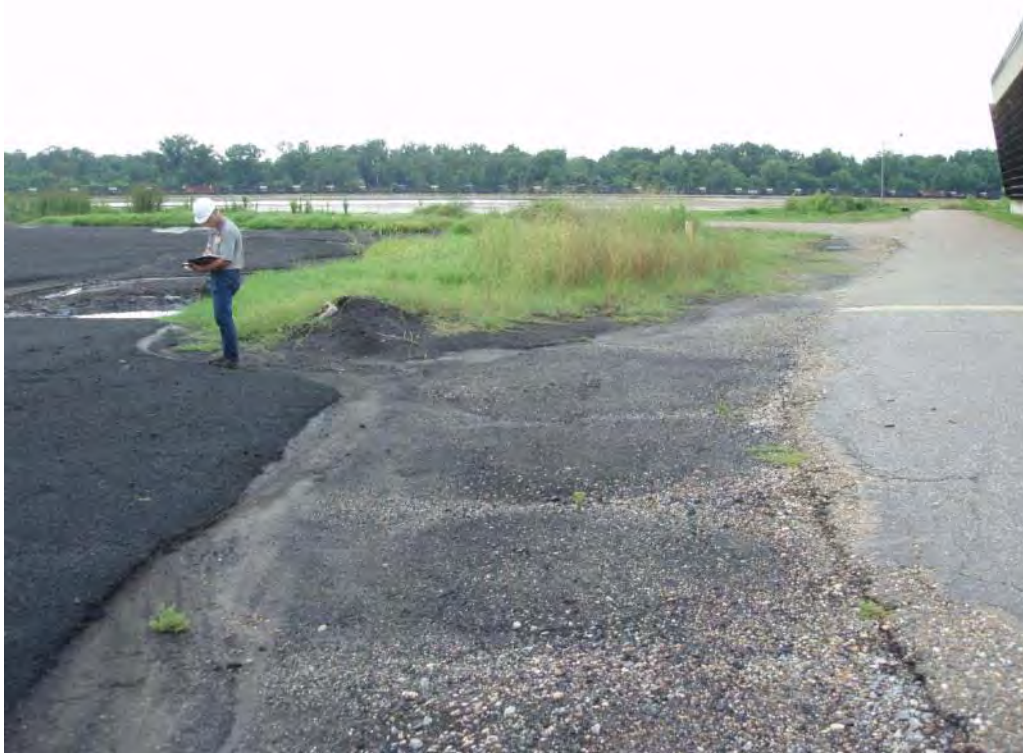
**Photo No. 126: #2/#3 Bottom Ash Pond – East embankment interior slope and crest, looking north.**

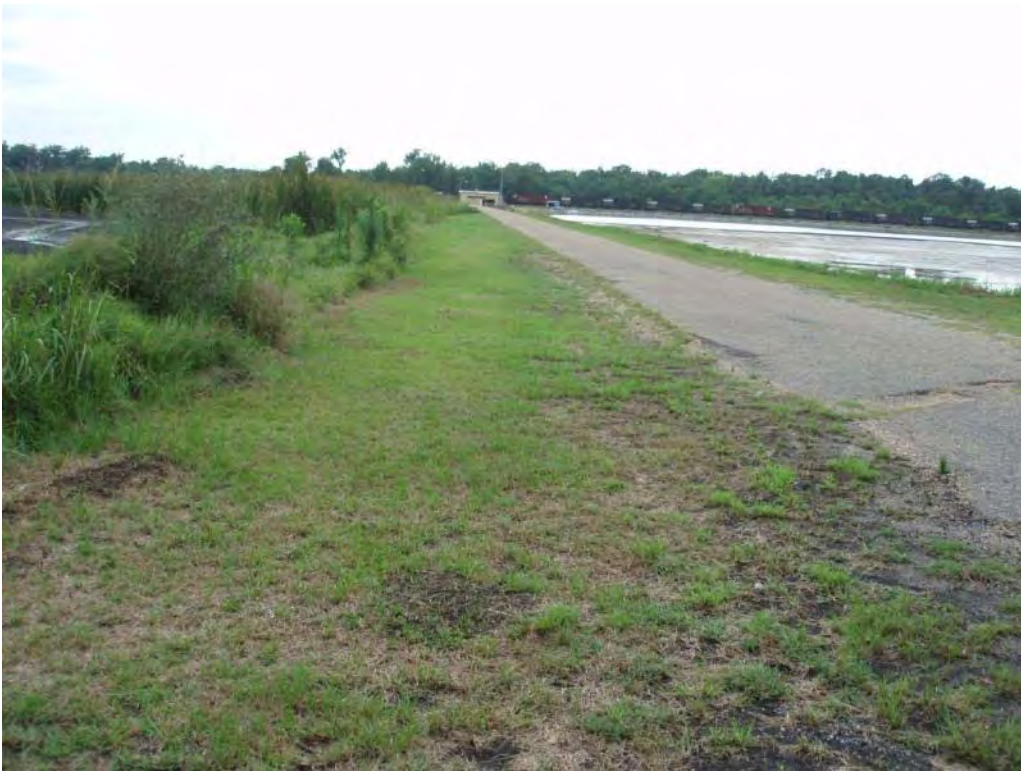
**Photo No. 127: #2/#3 Bottom Ash Pond – North (divider) embankment interior slope and crest, looking west.**

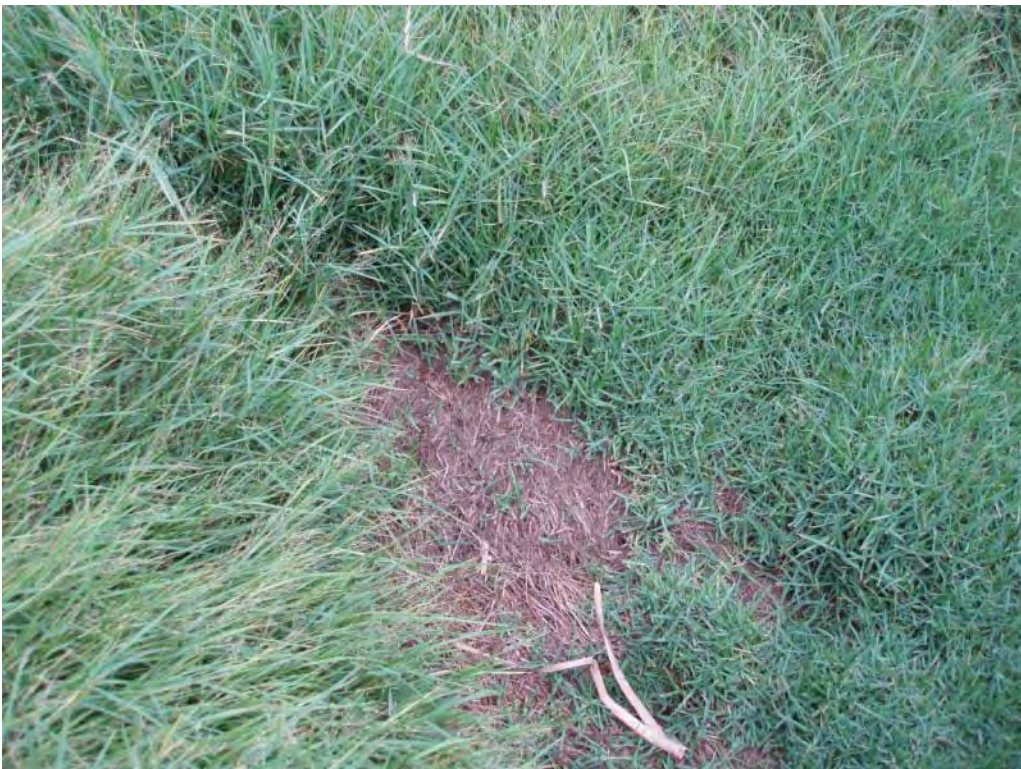
**Photo No. 128: #2/#3 Bottom Ash Pond – North embankment interior slope. Looking at rut or inactive erosion rill.**

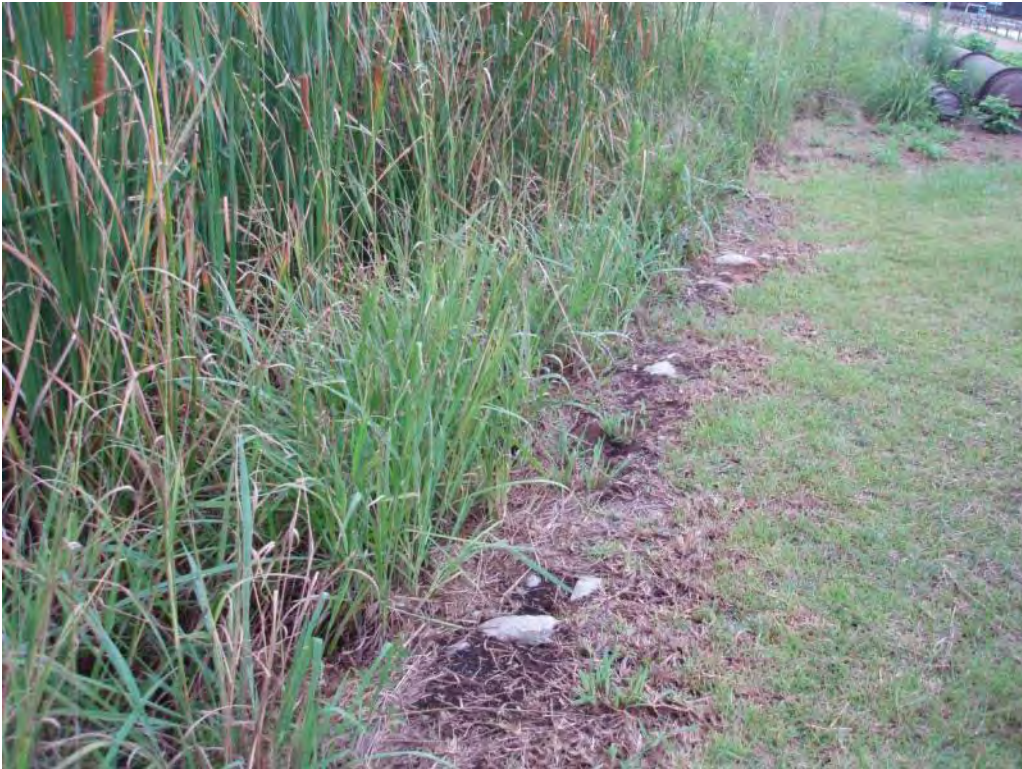
The interior slopes appear to be in satisfactory condition. The embankment interior slopes are approximately 2H:1V. Riprap armor was observed on each of the interior slopes, with the exception of the north embankment. The north embankment interior slope is heavily vegetated with grass and brush starting at a point approximately 350 feet east of the edge of the pond and continuing to the west embankment. The vegetation, ranging in height from 24 to 48 inches, was growing within riprap armoring (Photographs 129 and 132). Clearing and cutting of vegetation in this area appears to be adversely impacted by three above-grade sluice lines running along the edge of the embankment. The 350-foot-long section of the south exterior embankment (between the east embankment and the beginning of the sluice lines) is obscured from view by an accumulation of sediment and vegetation. Some partially exposed (riprap) stones were observed on the surface of the embankment (Photograph 129).

The south embankment (divider) exterior slope is heavily vegetated with grass and brush starting at a point approximately 350 feet east of the edge of the pond and continuing to the west embankment. The vegetation, ranging in height from 24 to 48 inches, was growing within riprap armoring (Photographs 129 and 132). Clearing and cutting of vegetation in this area appears to be adversely impacted by three above-grade sluice lines running along the edge of the embankment. The 350-foot-long section of the south exterior embankment (between the east embankment and the beginning of the sluice lines) is obscured from view by an accumulation of sediment and vegetation. Some partially exposed (riprap) stones were observed on the surface of the embankment (Photograph 129).

**Photo No. 129: #2/#3 Bottom Ash Pond – North embankment interior slope. Looking at vegetation and sparse riprap.**

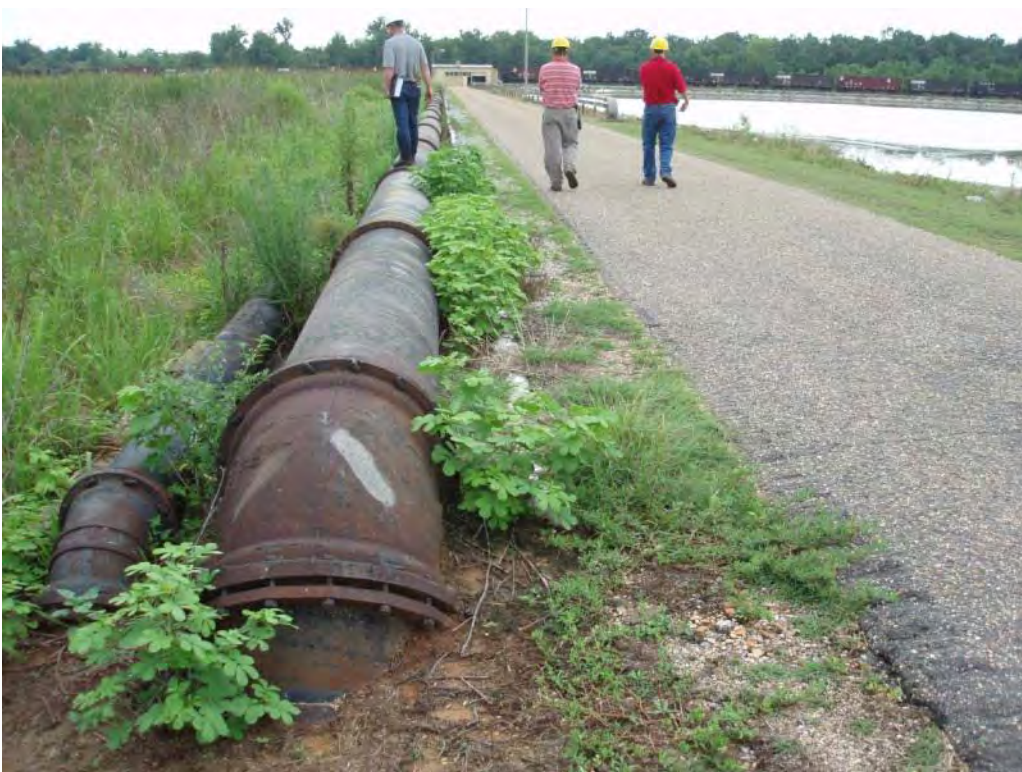
The crest appears to be in good condition (Photographs 110 and 130). The average crest width is approximately 20 feet, except at the east embankment, where the crest is approximately 30 feet wide. A Norfolk Southern railroad spur is located on the west, south, and east embankment crests that are covered with crushed stone railroad ballast (Photographs 110 and 118). The north embankment crest is covered with asphalt paving and subject to vehicle traffic (Photograph 133). No depressions, ruts, or evidence of settlement were observed on the crests (Photographs 110, 118, and 130).

**Photo No. 130: #2/#3 Bottom Ash Pond – North (divider) embankment interior slope and crest, looking west. Note vegetation around sluice lines.**

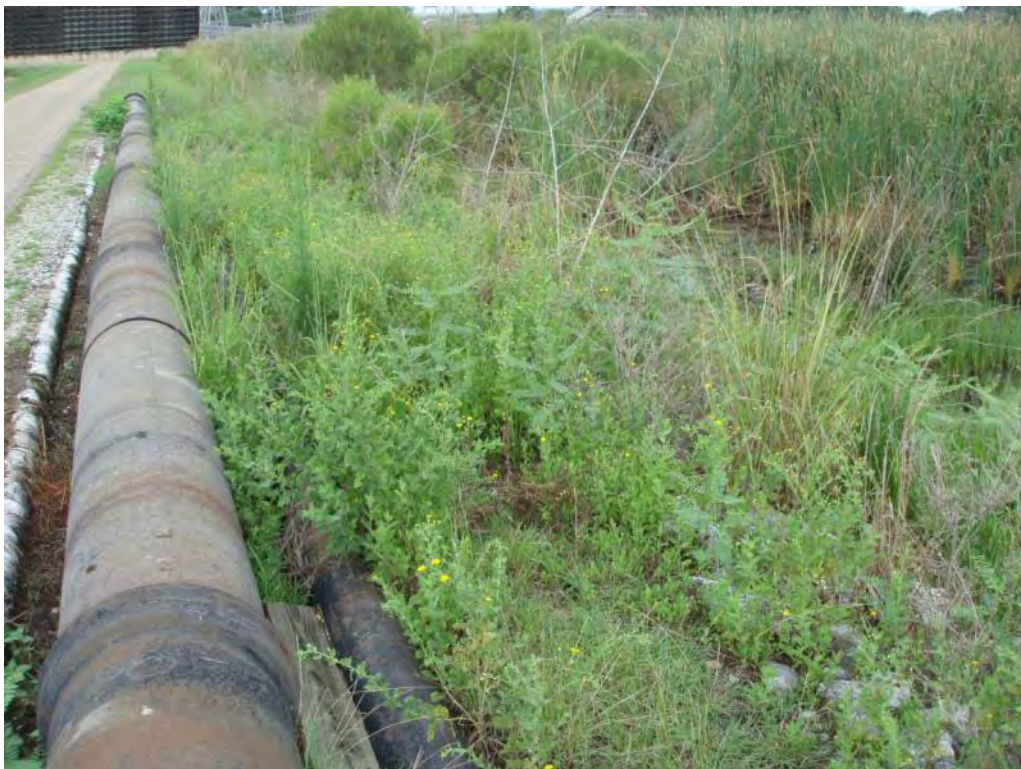
**Photo No. 131: #2/#3 Bottom Ash Pond – North embankment interior slope, looking east.  
Note vegetation growing on slope and cattails within pond.**

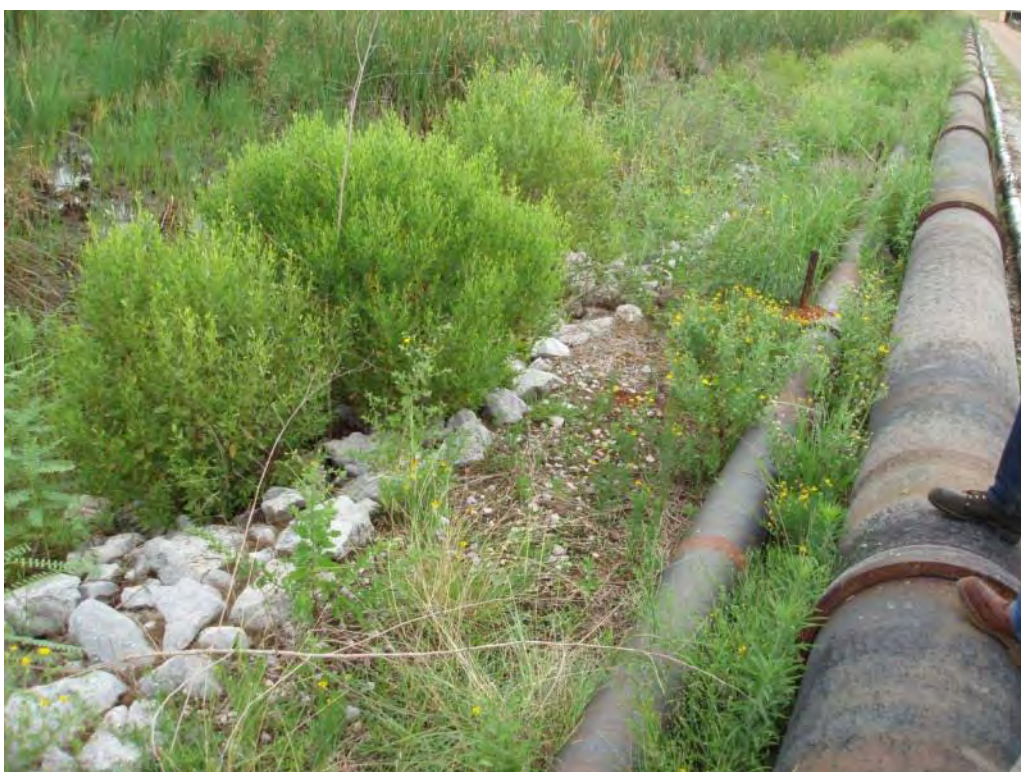
**Photo No. 132: #2/#3 Bottom Ash Pond – North embankment interior slope, looking west.  
Note vegetation growing within riprap.**

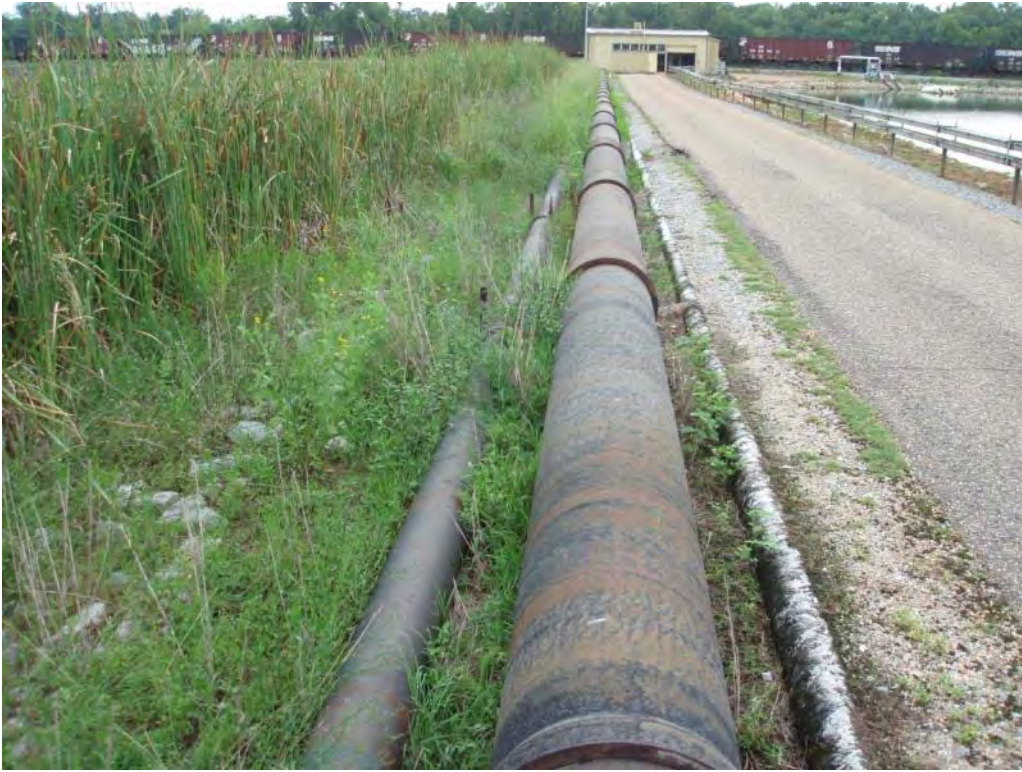
**Photo No. 133: #2/#3 Bottom Ash Pond – North (divider) embankment interior slope and crest, looking west. Note dense vegetation covering slope.**

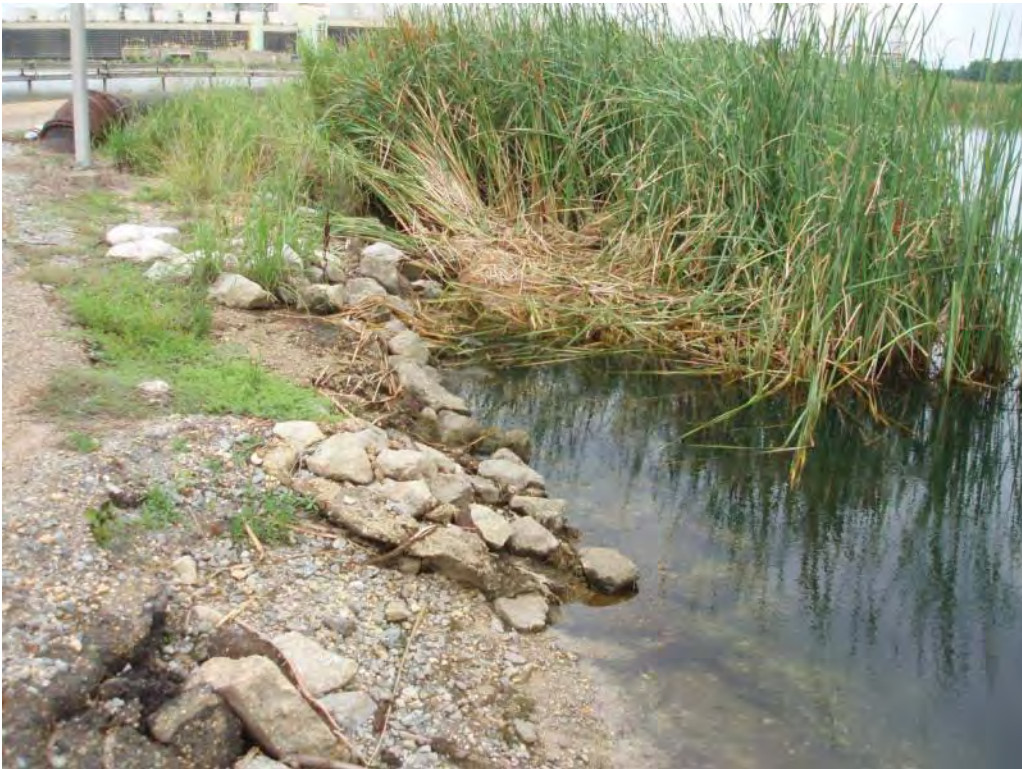
**Photo No. 134: #2/#3 Bottom Ash Pond – North embankment interior slope, looking east.**

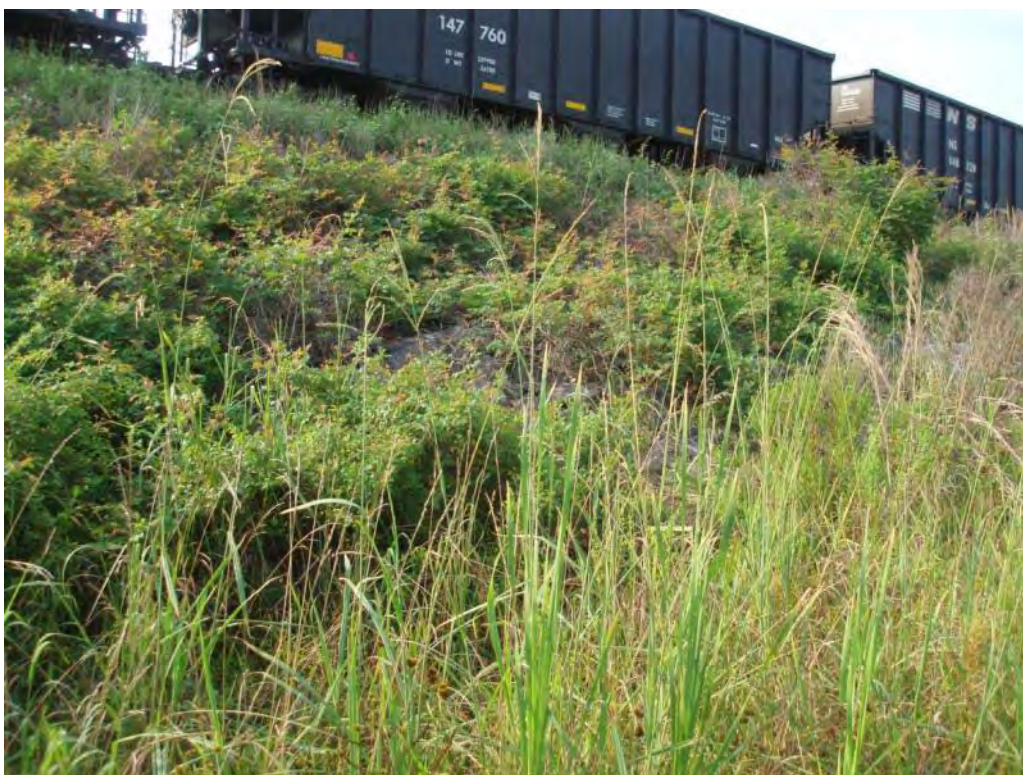
**Photo No. 136: #2/#3 Bottom Ash Pond – West embankment exterior slope, looking southeast.**

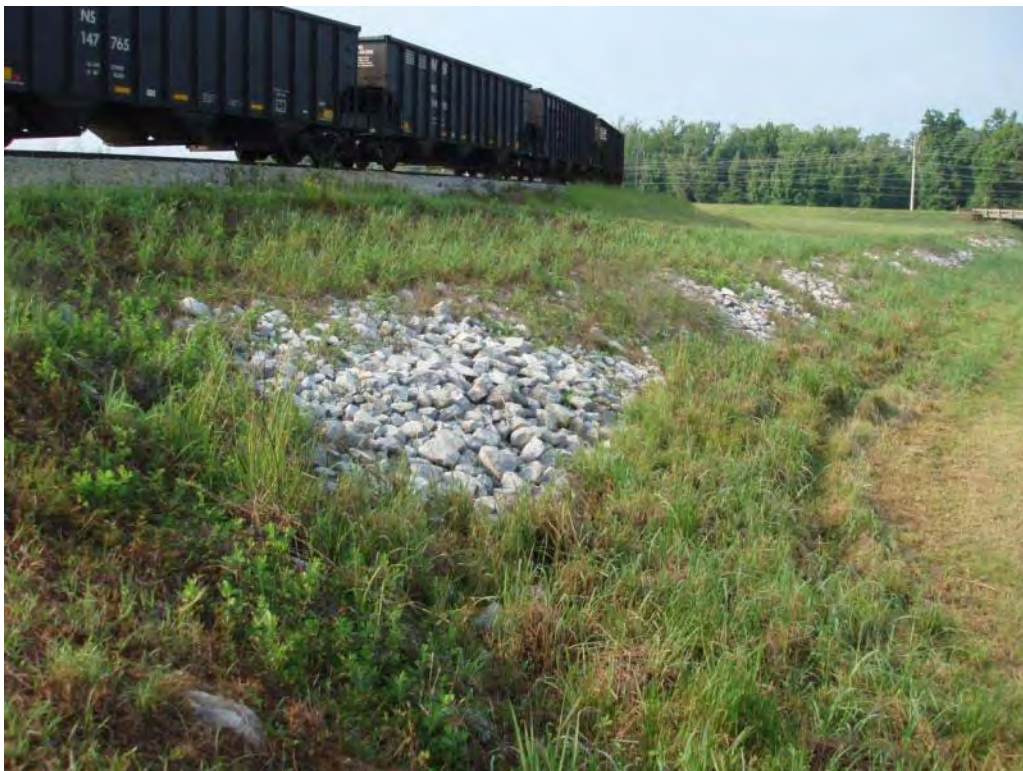
**Photo No. 137: #2/#3 Bottom Ash Pond – West embankment exterior slope, looking southeast.**

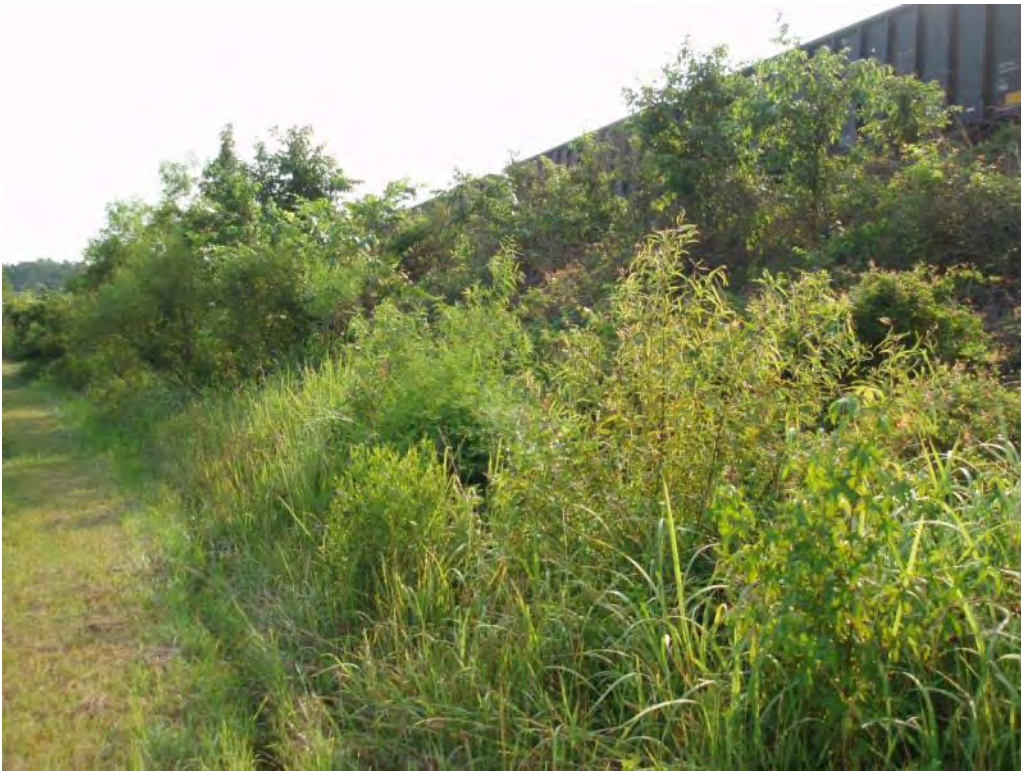
**Photo No. 139: #2/#3 Bottom Ash Pond – West embankment exterior slope, looking north.  
Note dense vegetation on slope.**

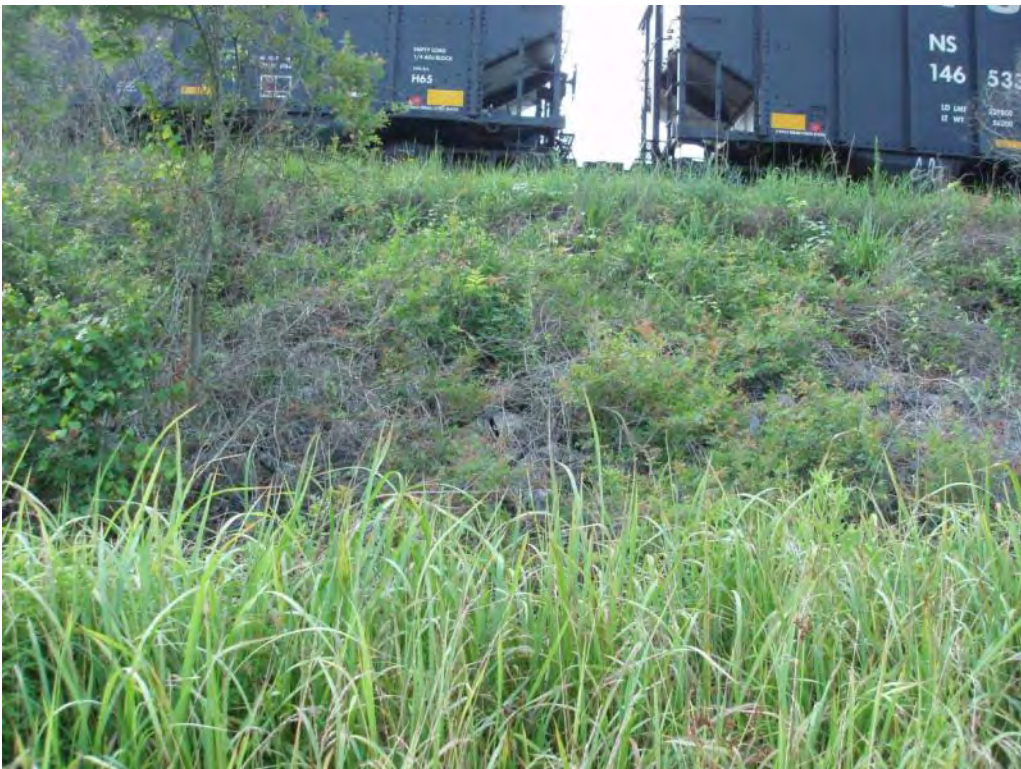
**Photo No. 140: #2/#3 Bottom Ash Pond – West embankment exterior slope, looking east.**

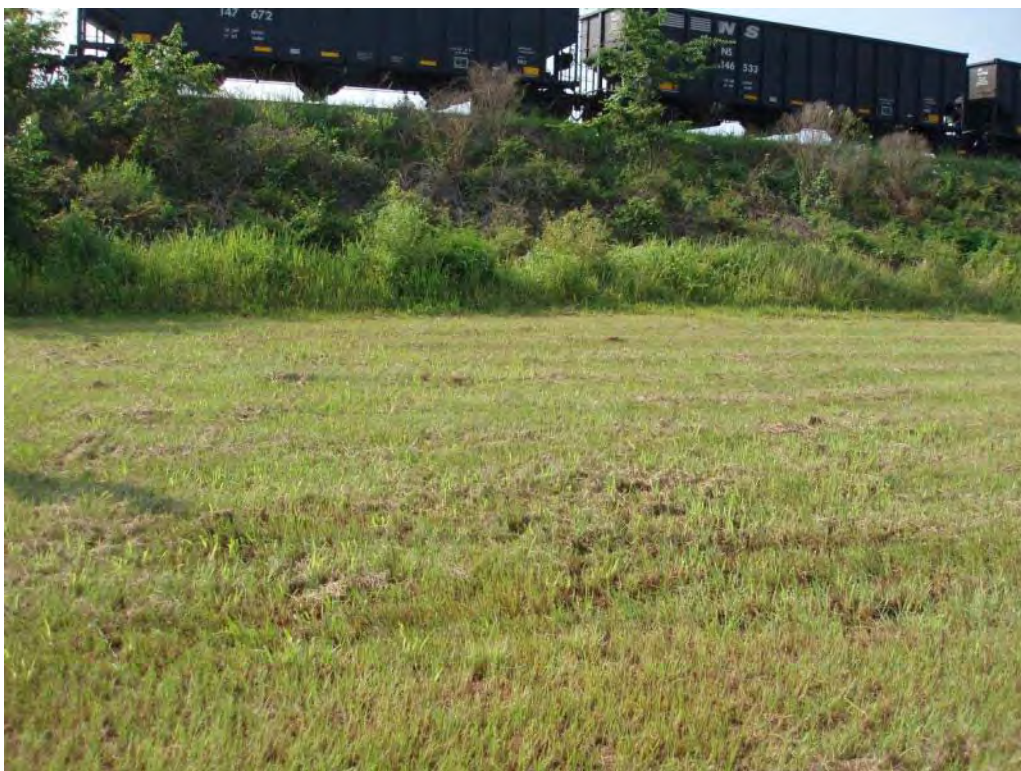
An area of possible seepage was observed near the toe of the west embankment exterior slope, near the northwest corner of the impoundment (Photograph 141). The area consisted of damp, spongy ground that extended approximately 55 feet out from the toe. CDG reported that active water seepage was observed in this area during a site visit conducted on March 25 and 26, 2009.

An area of possible seepage was observed near the toe of the west embankment, near the southwest corner (Photograph 141). The area consisted of damp, spongy ground

**Photo No. 141: #2/#3 Bottom Ash Pond – West embankment exterior slope, looking east.  
Looking at extent of spongy material in area of possible seepage.**

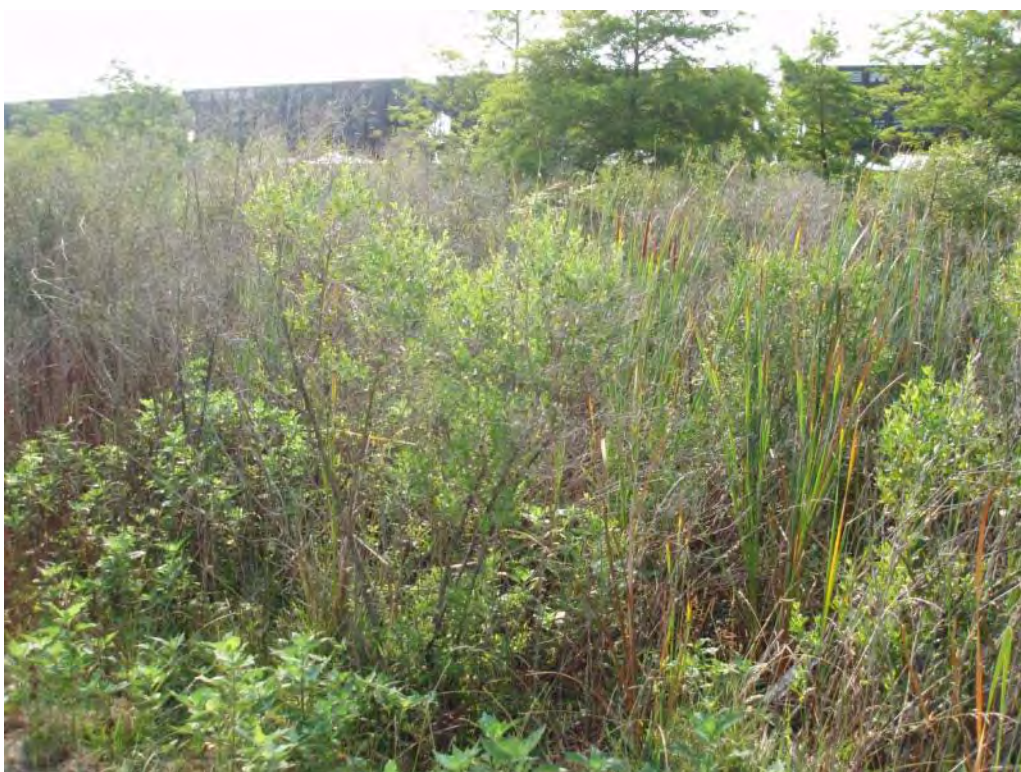
**Photo No. 142: Scrubber Waste Pond – West embankment exterior slope. Note dense vegetation on slope.**

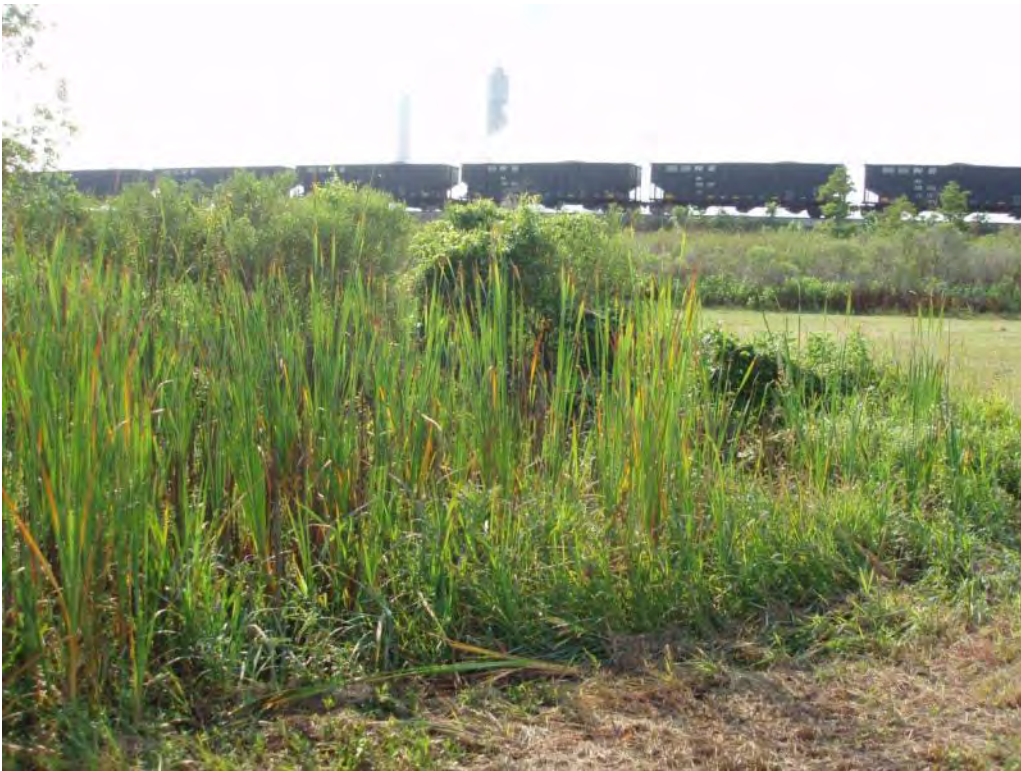
According to CDG Engineers & Associates, seepage was observed at the southernmost end of the west embankment exterior toe in March 2009 during field investigations. According to the CDG report dated November 23, 2009 the seepage was not observed in September 2009, and suggests that the seepage observed in March 2009 may have been resulted from relatively high precipitation levels.

**Photo No. 143: Scrubber Waste Pond – Outside west embankment toe. Looking at cattails in area of possible seepage.**

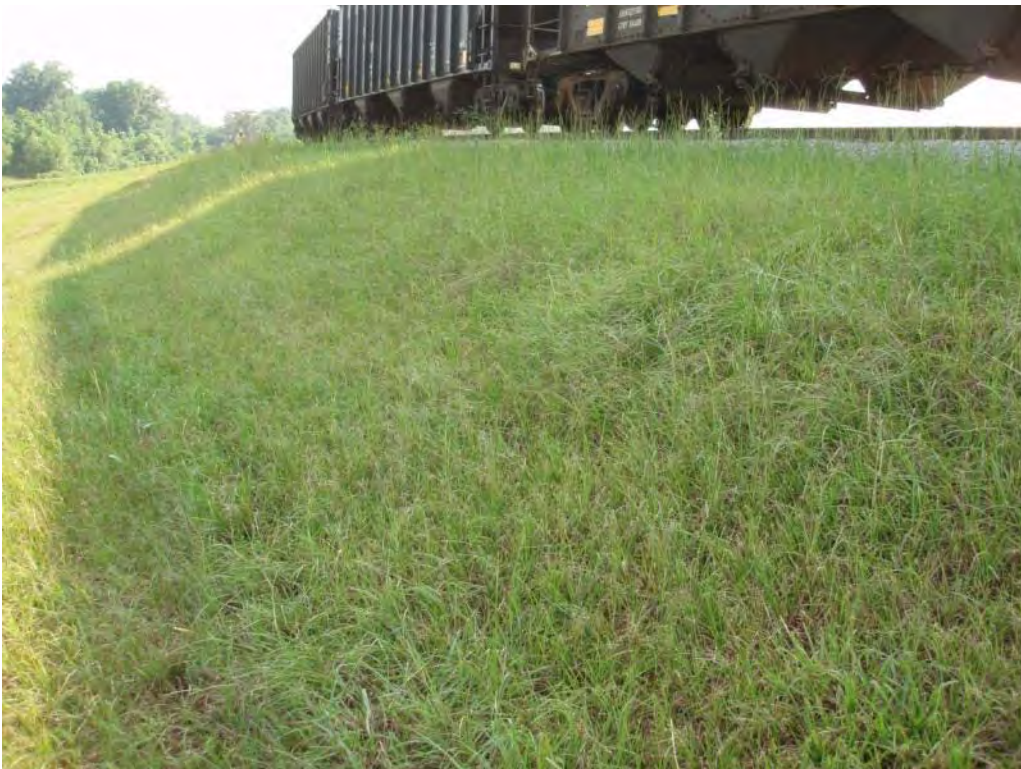
The embankment exterior slopes appear to be in fair condition. The exterior slopes are approximately 2H:1V. Grass, ranging from 3 to 6 inches tall covers the south and east embankment exterior slopes (Photographs 144 and 116). The majority of the west embankment exterior slope is covered in dense, vegetation including trees and saplings (Photographs 139 and 141). The exterior slope of the north (divider) embankment is sparsely covered with riprap (Photograph 78).

**Photo No. 144: #2/#3 Bottom Ash Pond – West embankment exterior slope, looking north.**

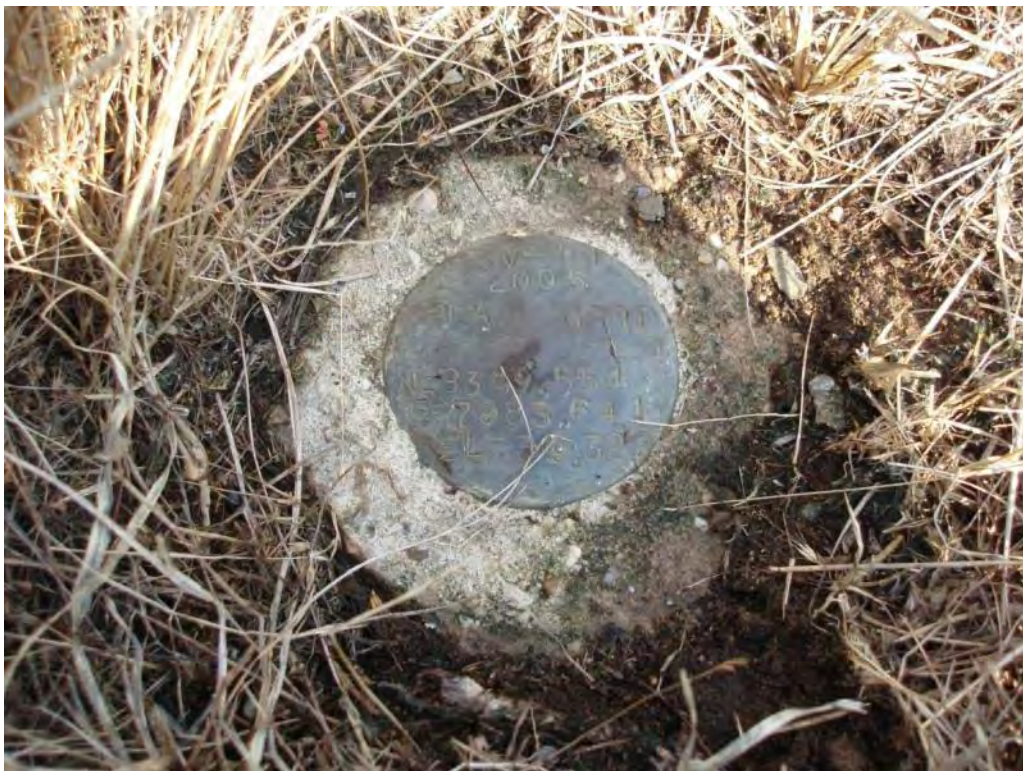
Photo No. 145: #2/#3 Bottom Ash Pond – South embankment exterior slope. Looking at plant survey monument.

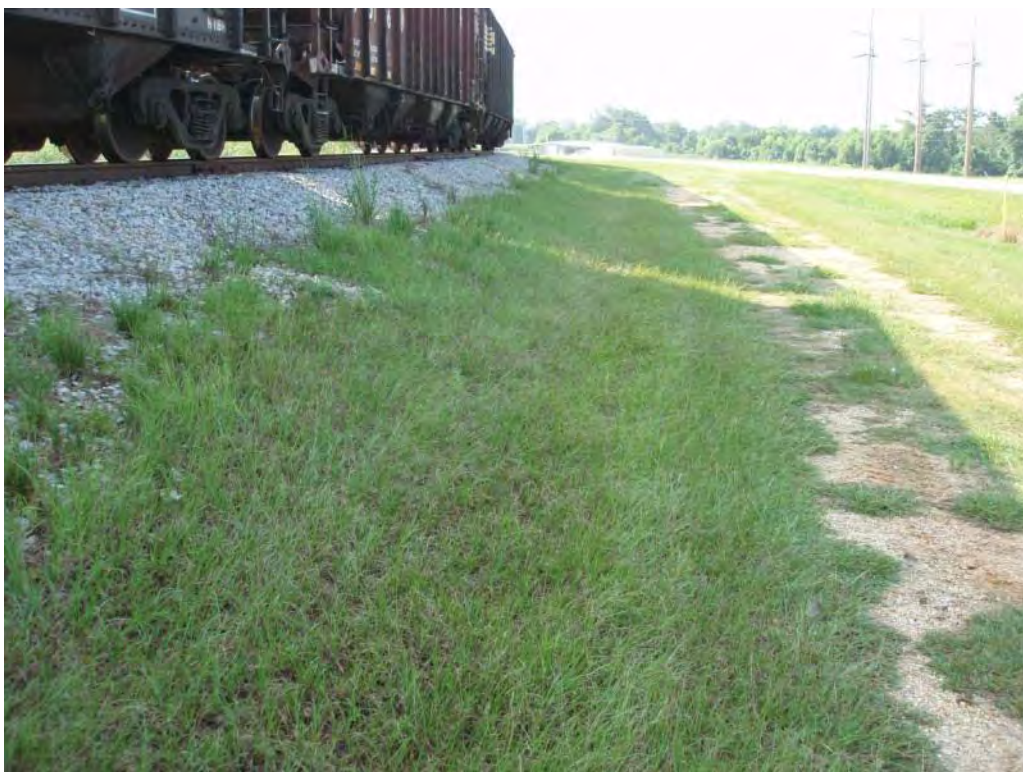
Photo No. 146: #2/#3 Bottom Ash Pond – South embankment exterior slope, looking east.

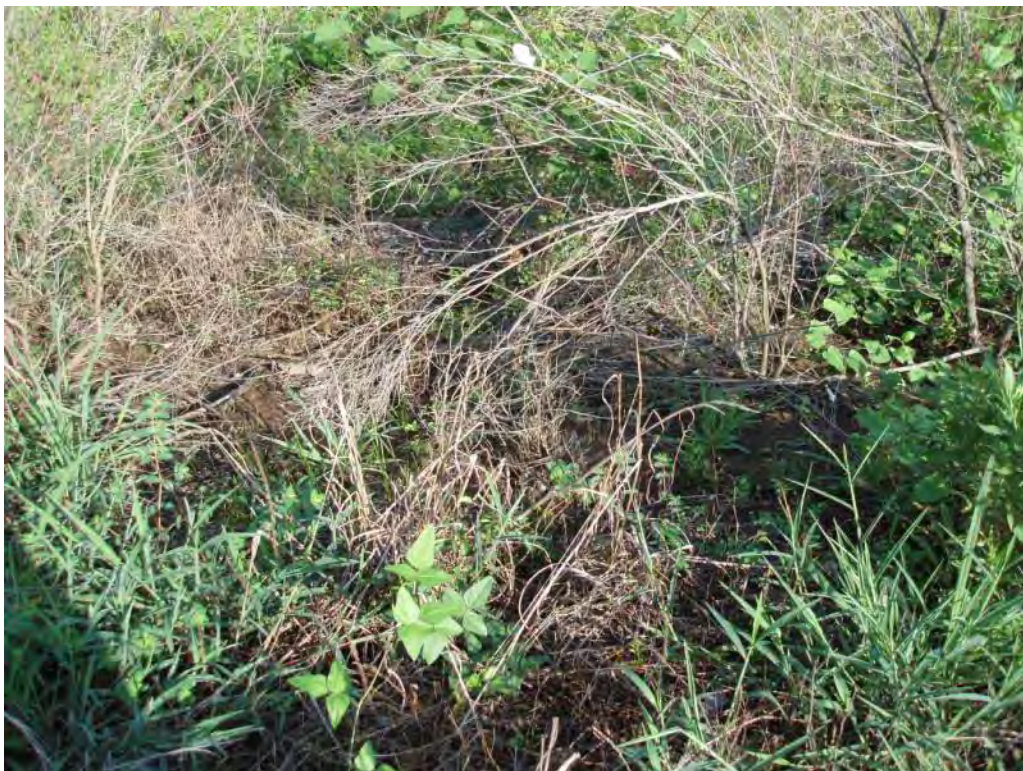
**Photo No. 147: #2/#3 Bottom Ash Pond – West embankment exterior slope, looking north.**

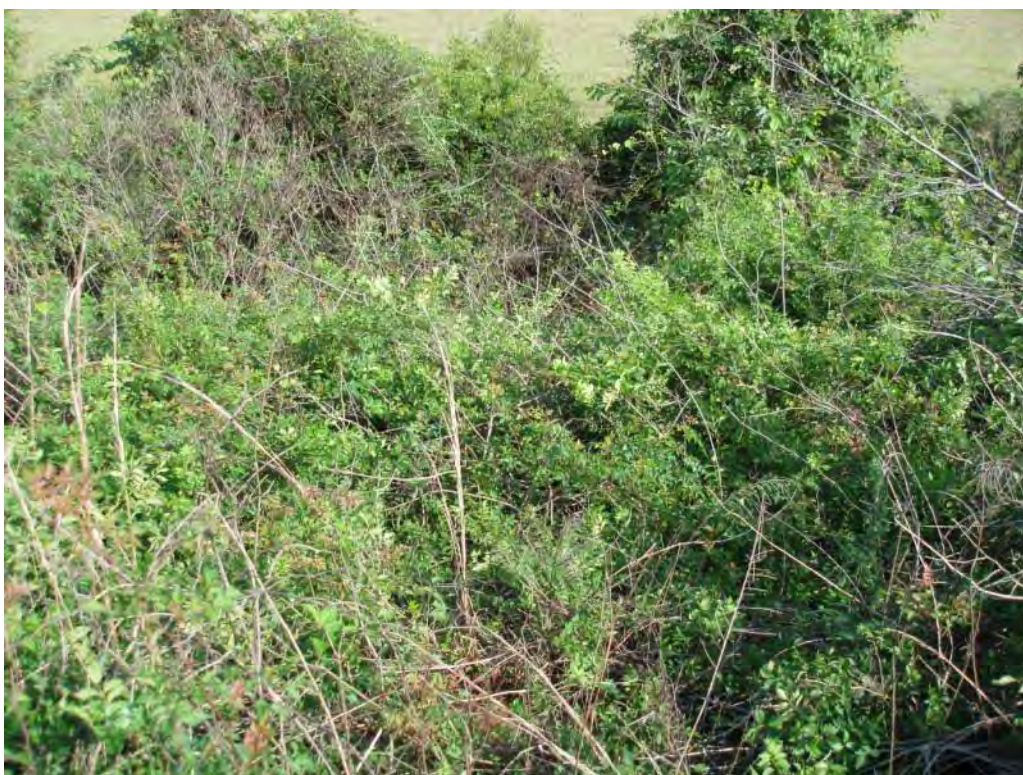
**Photo No. 148: Scrubber Waste Pond – West embankment exterior slope, looking west.  
Looking at typical vegetation on slope.**

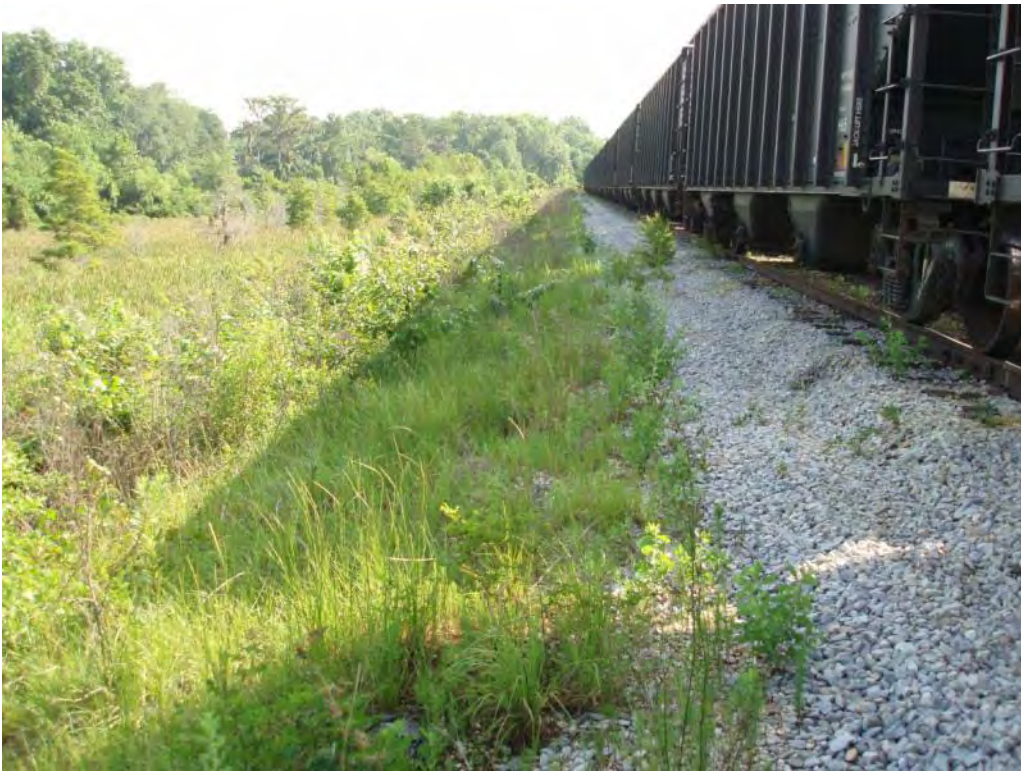
**Photo No. 151: Scrubber Waste Pond – West embankment exterior slope and crest, looking north.**

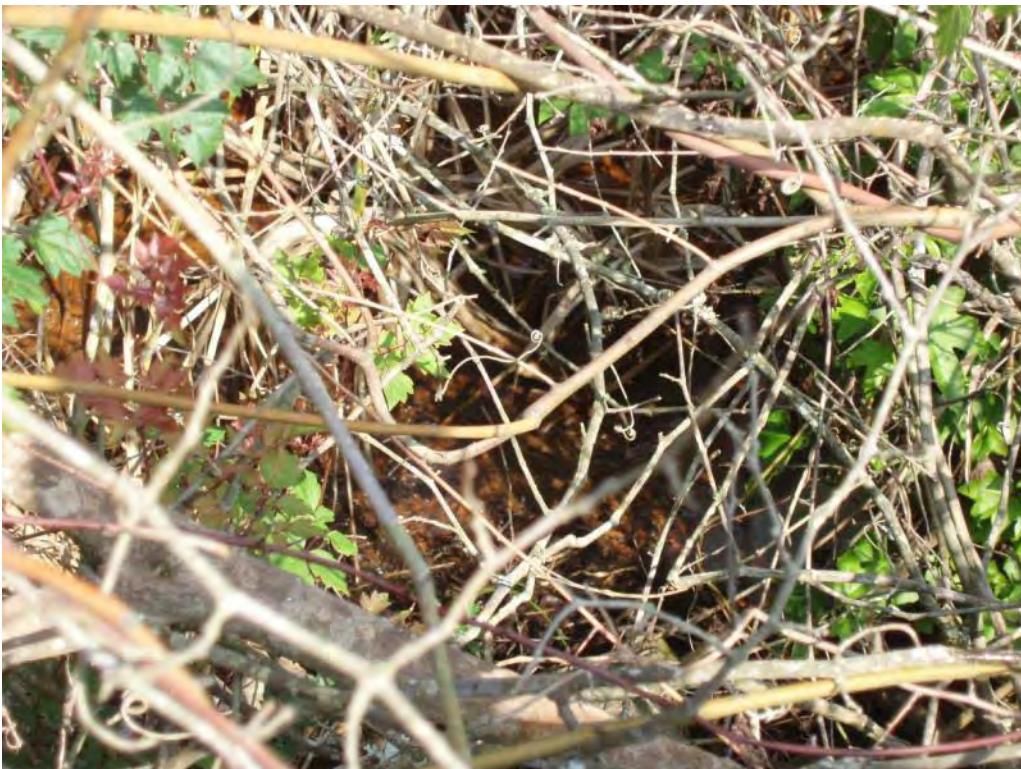
**Photo No. 152: Scrubber Waste Pond – West embankment exterior slope. Looking at possible seepage/standing water near toe.**
