# **Assessment of Dam Safety of Coal Combustion Surface Impoundments**

**PowerSouth Energy Cooperative**

**Charles R. Lowman Power Plant**

**March 30, 2011**

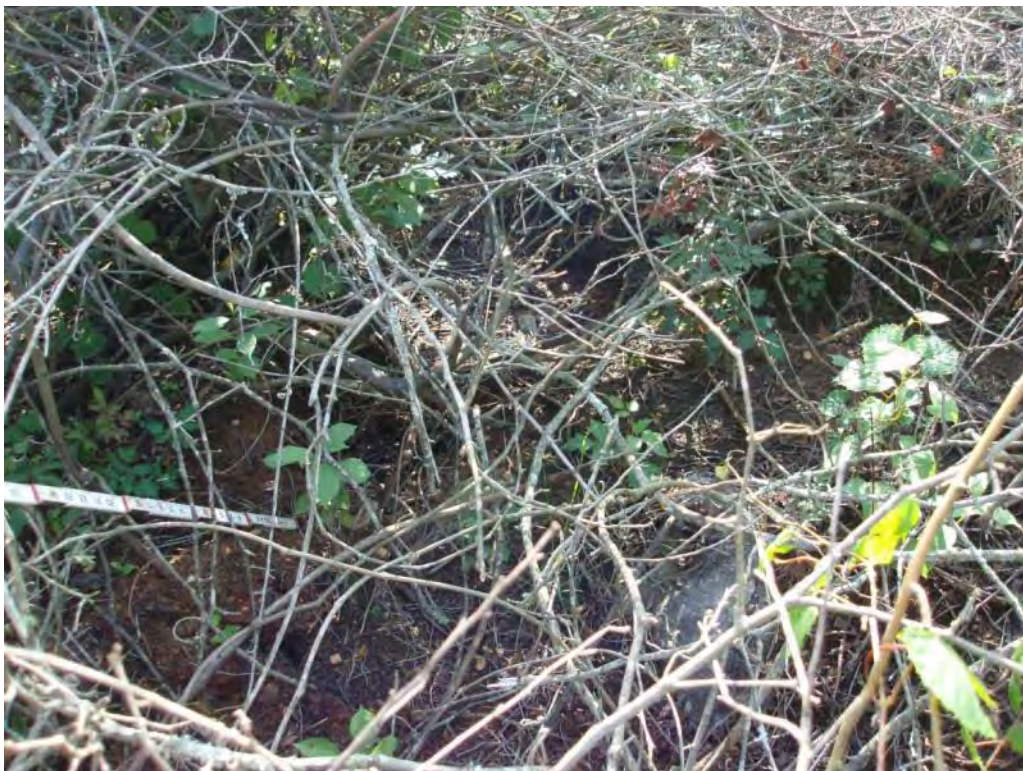
Minor surface erosion, sloughing, and scarps, as well as several animal burrow holes, were observed on the exterior slope of the west embankment within the dense vegetation (Photographs 153, 149, and 150).

**Photo No. 153: Scrubber Waste Pond – West embankment exterior slope. Looking at minor slough.**

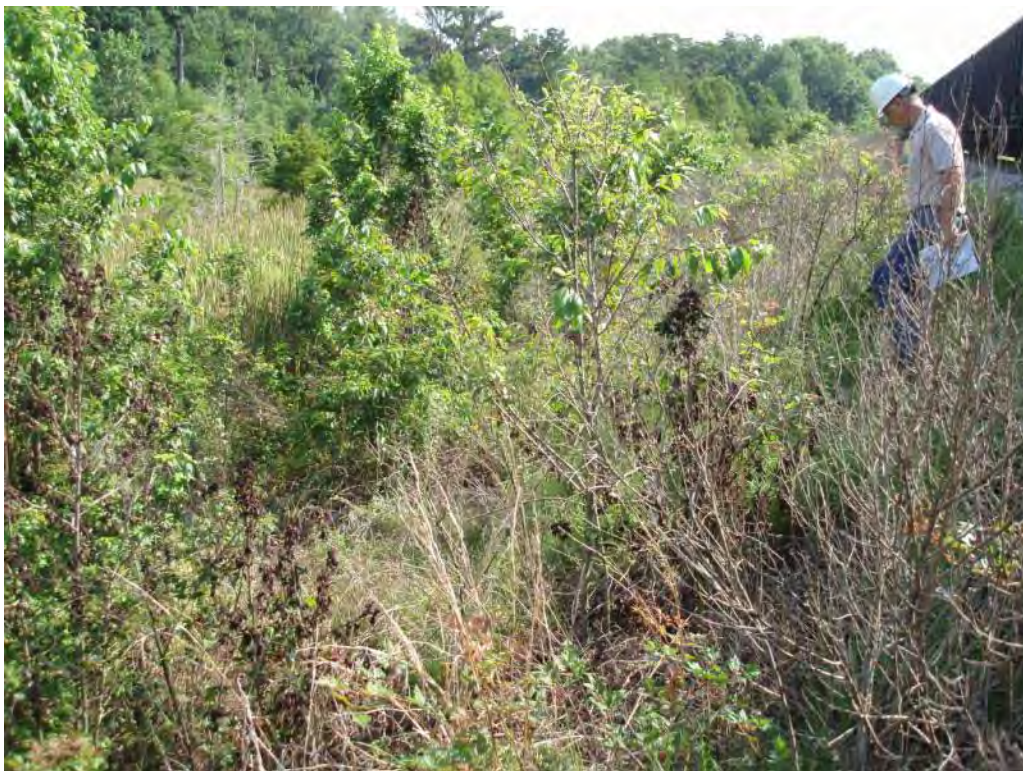
**Photo No. 155: Scrubber Waste Pond – West embankment exterior slope, looking north.**

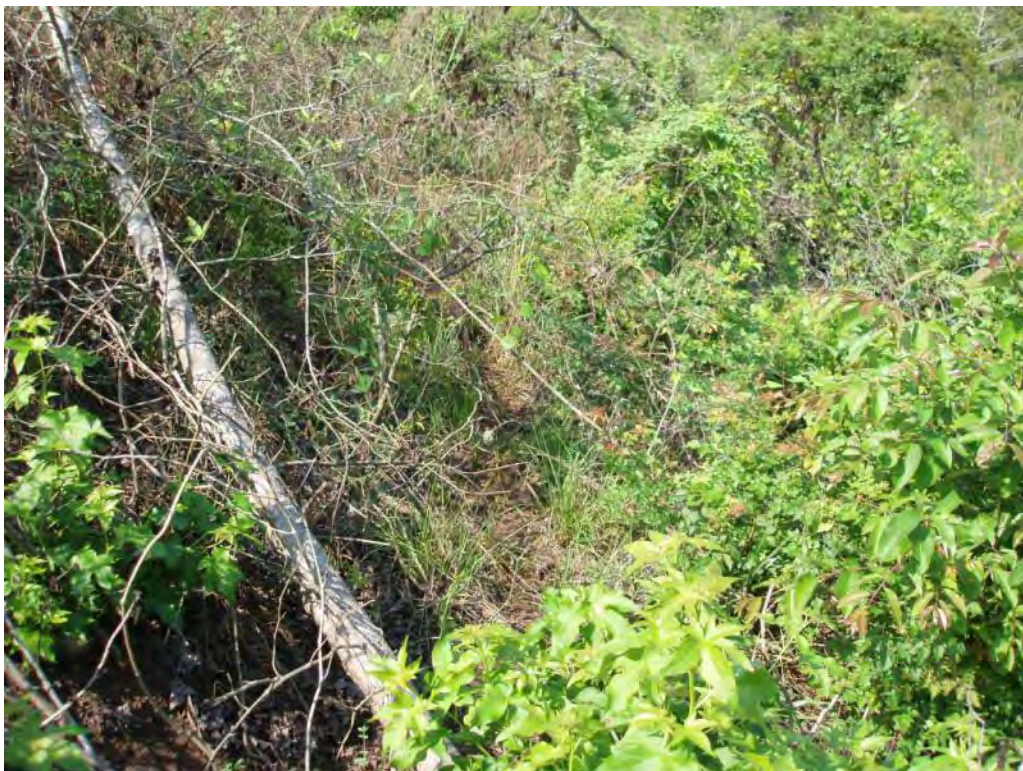
**Photo No. 157: Scrubber Waste Pond – West embankment exterior slope. Looking at surface erosion or possible animal trail.**

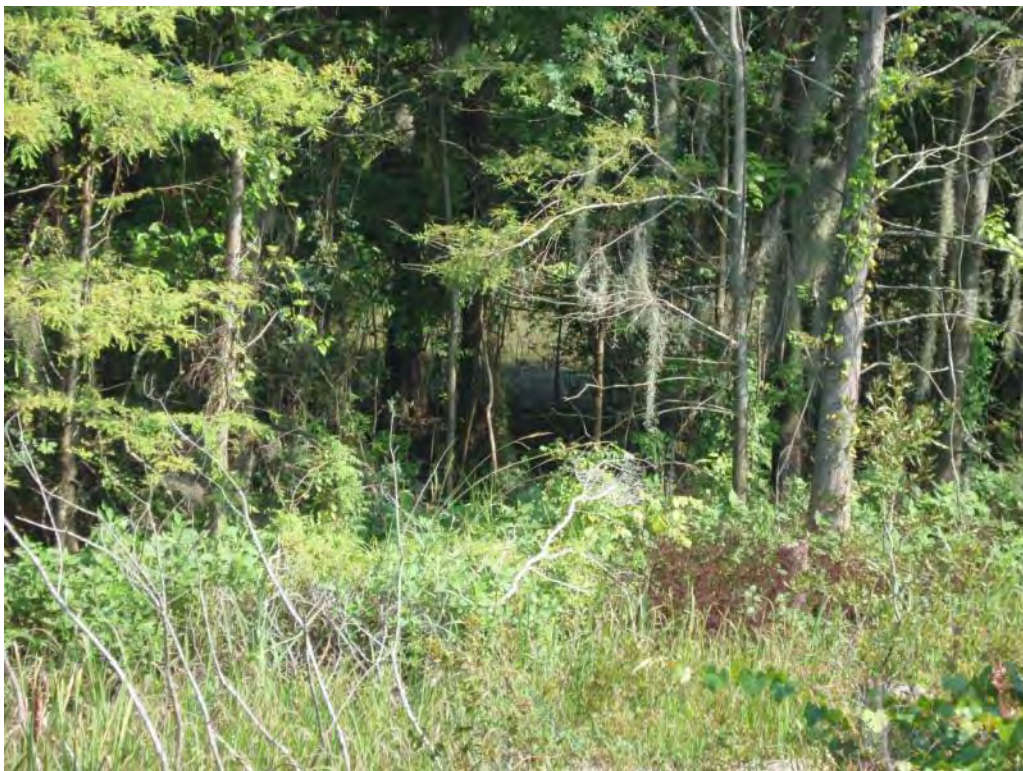
**Photo No. 159: Scrubber Waste Pond – West embankment exterior slope, looking west.  
Looking at standing water outside toe.**

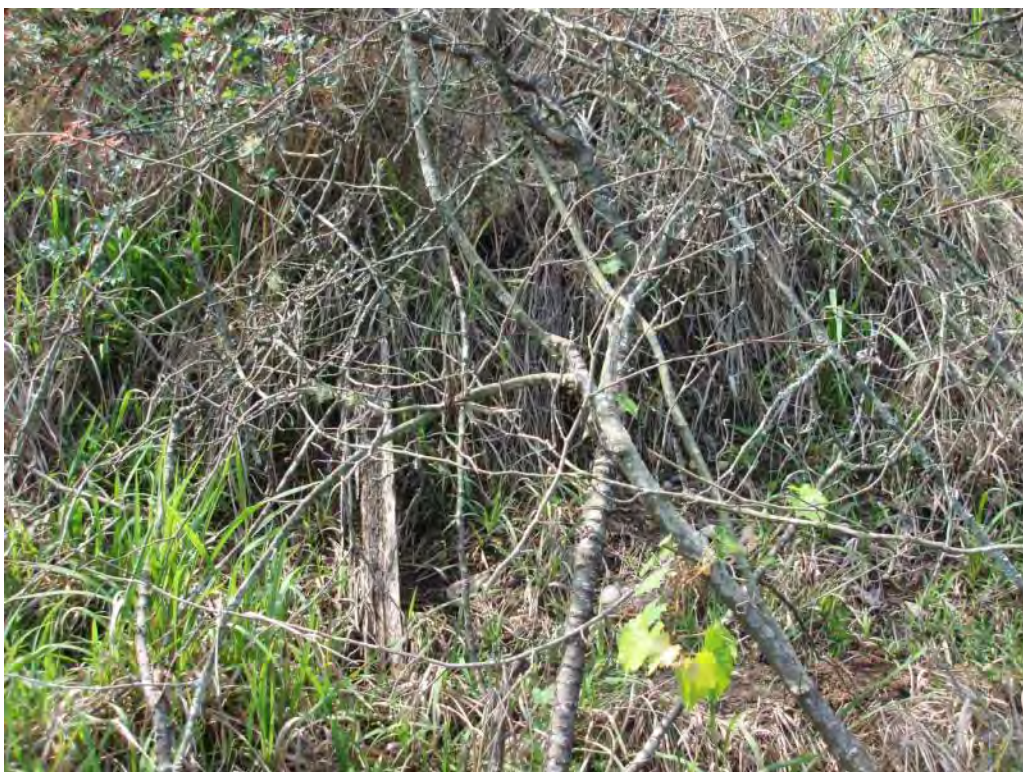
**Photo No. 160: Scrubber Waste Pond – West embankment exterior slope. Looking at minor  
scarp.**

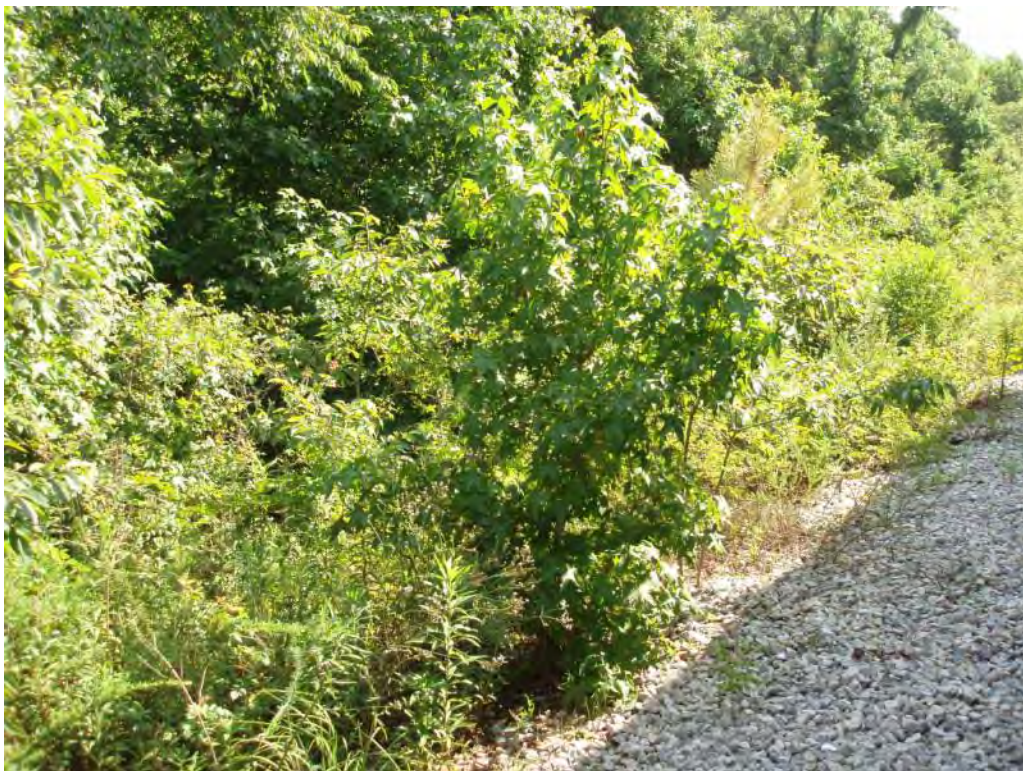
**Photo No. 161: Scrubber Waste Pond - West embankment exterior slope, looking north. Note dense vegetation on slope.**

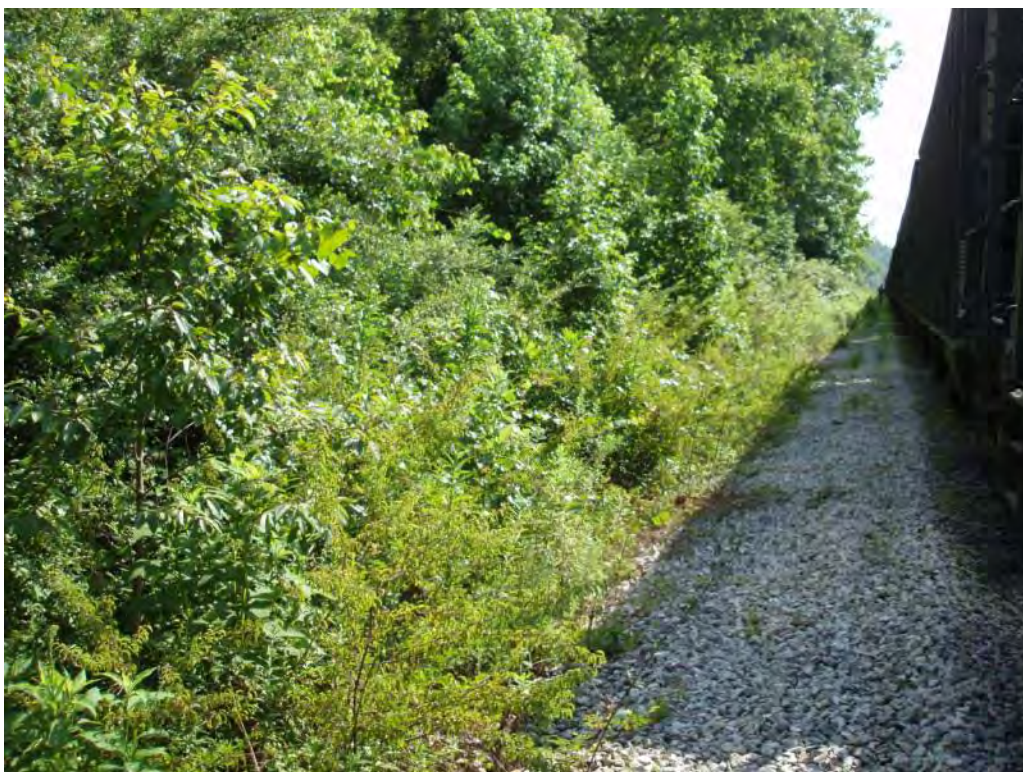
**Photo No. 162: Process Waste Pond - West embankment exterior slope, looking north. Note dense vegetation on slope.**
