# ASSESSMENT OF DAM SAFETY OF COAL COMBUSTION SURFACE IMPOUNDMENTS – DRAFT REPORT

**San Miguel Electric  
Cooperative, Inc.  
San Miguel Electric Plant  
Christine, Texas**

Prepared for  
*U.S. Environmental  
Protection Agency  
Washington, D.C.*

November 2012  
Revision 2, December 2013

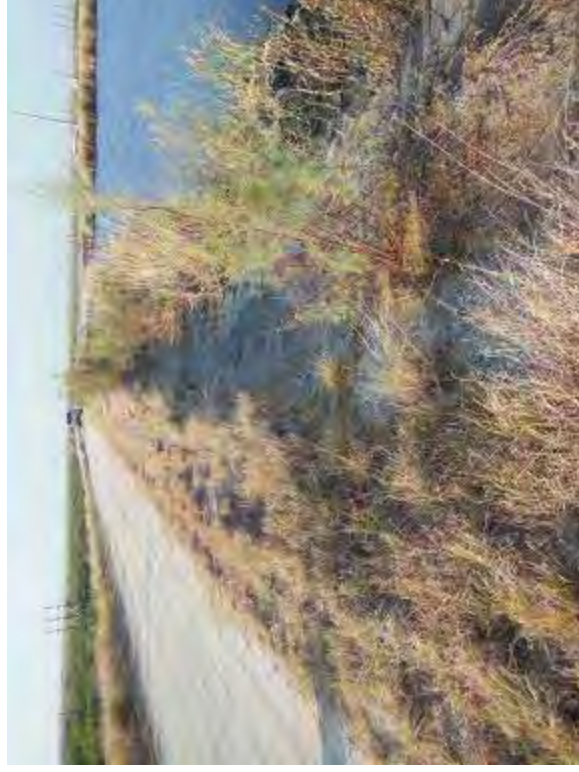
Due to the water level in the Ash Pond during the assessment, only the upper 0.5 to 1 foot of the interior slopes was visible (Photographs 2, 22, 51, 66, and 86). Based on drawings, the interior slopes are 2.5H:1V. An area of erosion into the interior slope approximately 5 feet wide was observed on the east embankment (Photograph 15). Reportedly, this erosion was a result of leakage from a water well pipe traversing the Ash Pond embankment. The water well pipe had been repaired at the time of the site assessment. Minor slope erosion was observed on the east embankment interior slope (Photograph 3). Minor erosion rills were observed on the south embankment interior slopes (Photographs 23 through 26). Grass, approximately 18 inches in height, covered some portions of the interior slopes that were visible (Photographs 2, 33, 63, and 84). Visible portions of interior slopes did not include riprap or other armoring.

Photo 2: East embankment interior slope, looking south.

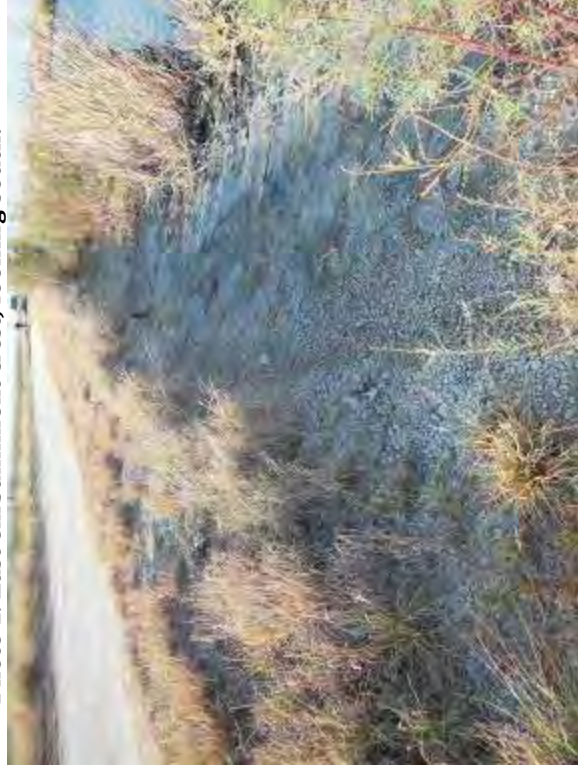
Photo 3: East embankment exterior slope, looking south. Note slope erosion.

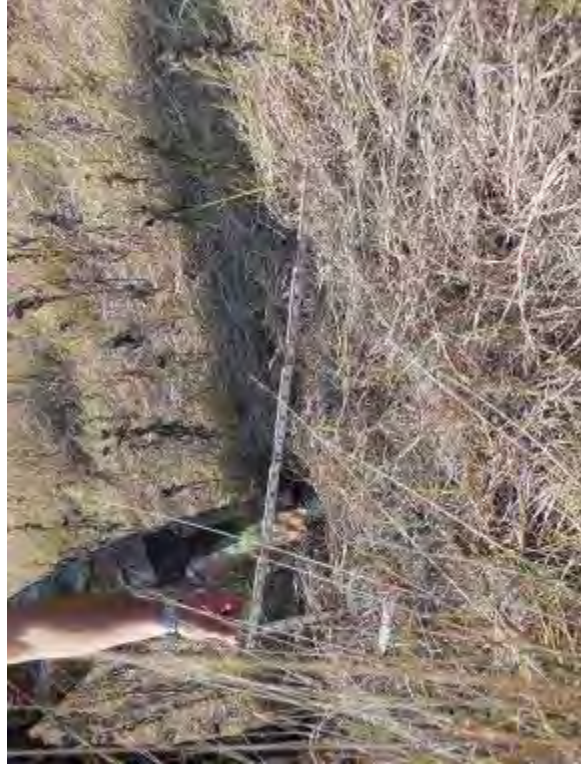
Photo 6: East embankment exterior slope approximately 2.5H:1V.

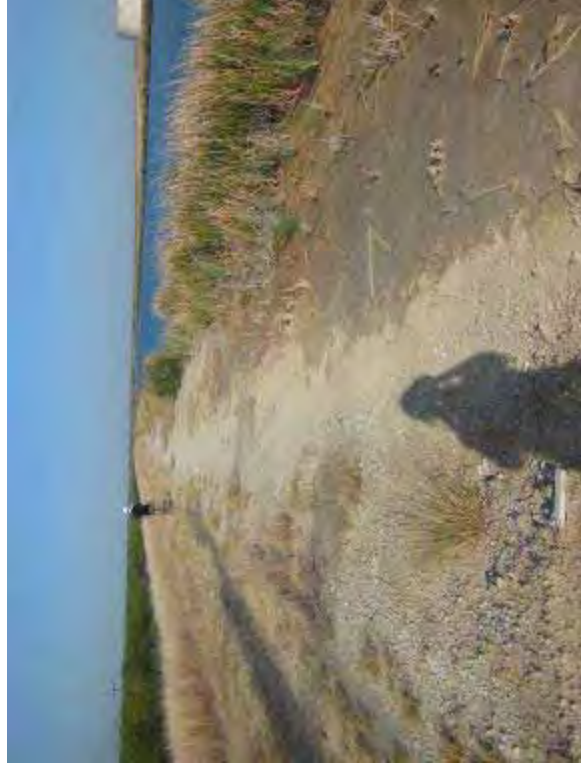
Photo 30: South embankment interior slope, looking west.

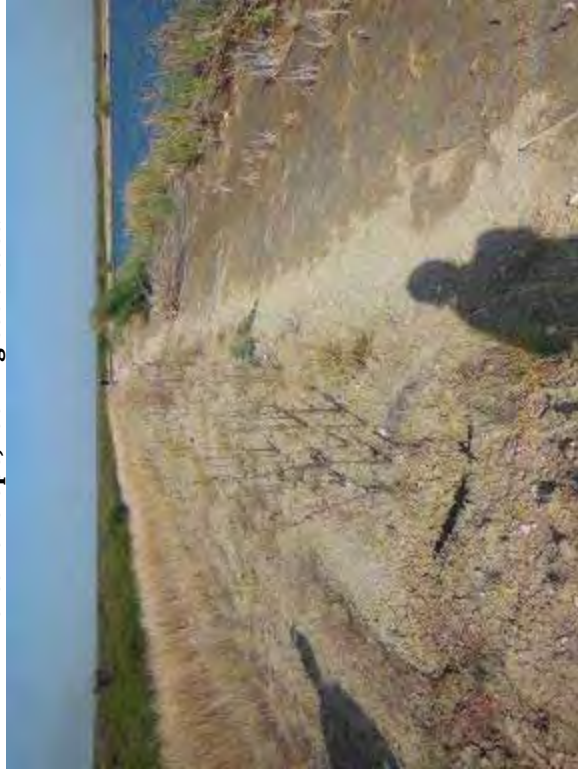
Photo 39: South embankment interior slope, looking west.

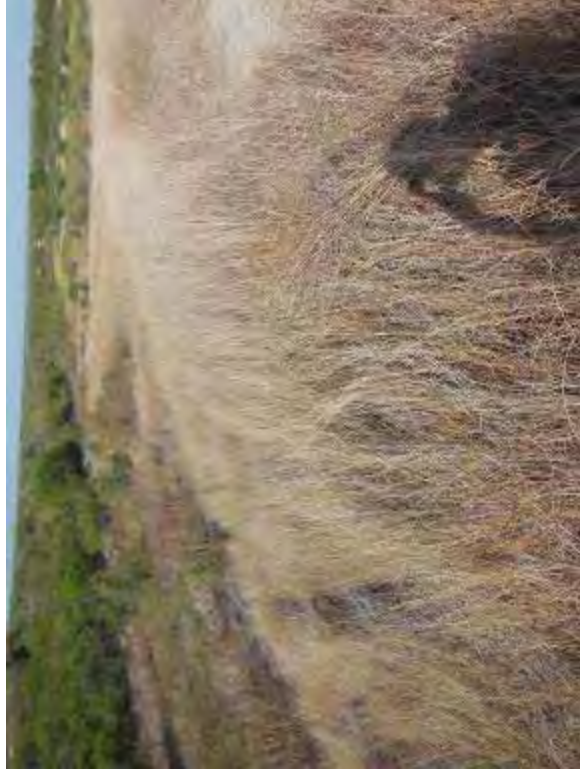
Photo 43: Southwest corner exterior slope, looking west.

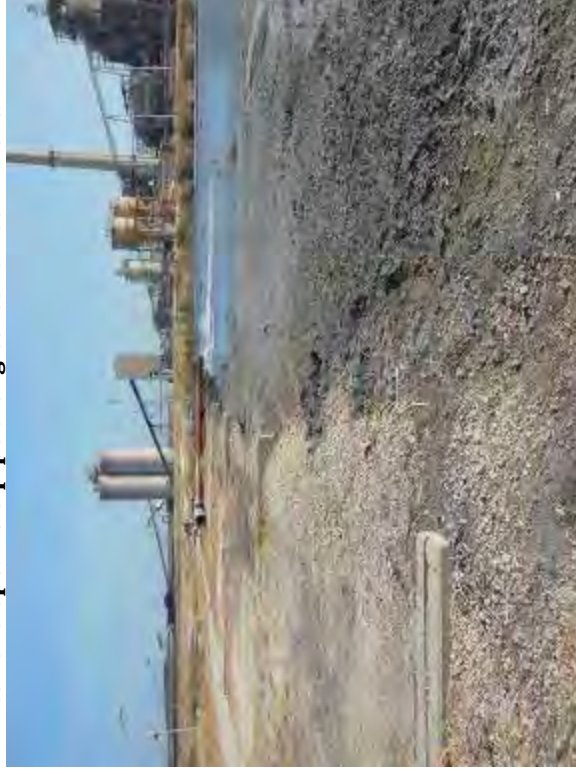
Photo 51: West embankment interior slope, looking north. Note inlet pipes in distance.

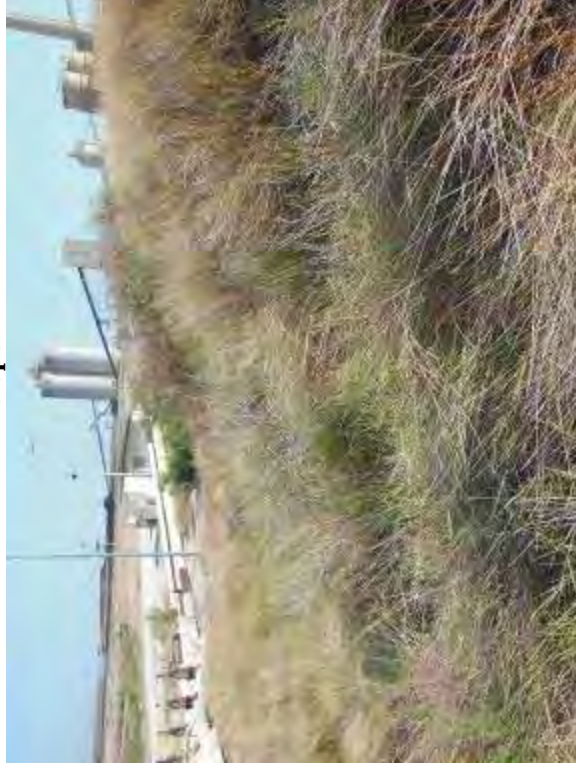
(Photograph 16) and on the west embankment near the potential seepage area (Photograph 58). The exterior slopes are approximately 2.5H:1V and covered in grassy vegetation approximately 2 feet tall (Photographs 5, 19, and 52). The coal pile runoff pond is approximately 100 feet west of the west embankment exterior toe (Photograph 48).

Photo 52: West embankment exterior slope, looking north.

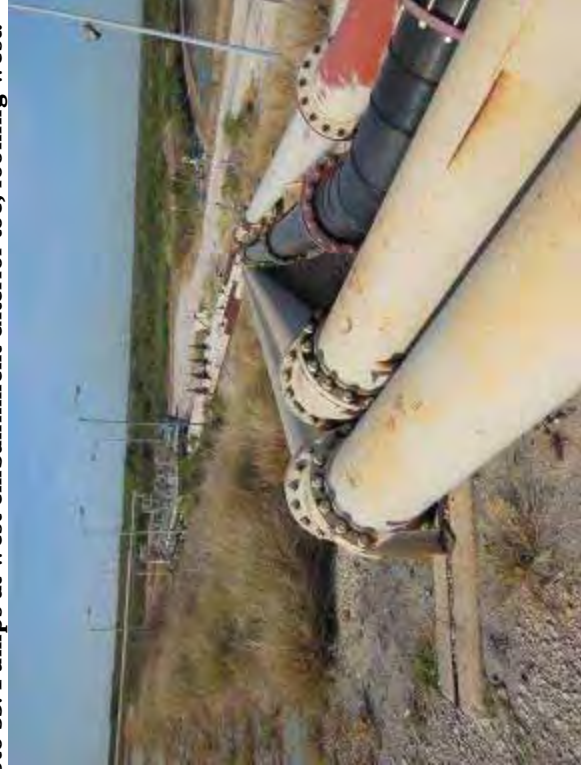
Photo 55: Piping from Plant to pumps at west embankment exterior slope, looking southwest.

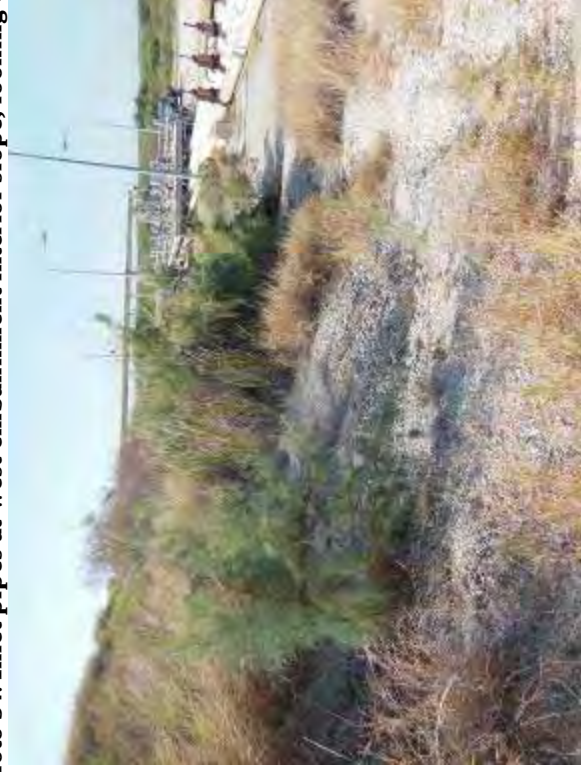
Photo 56: West embankment exterior slope, looking south. Note cattails and other vegetation growing near toe.

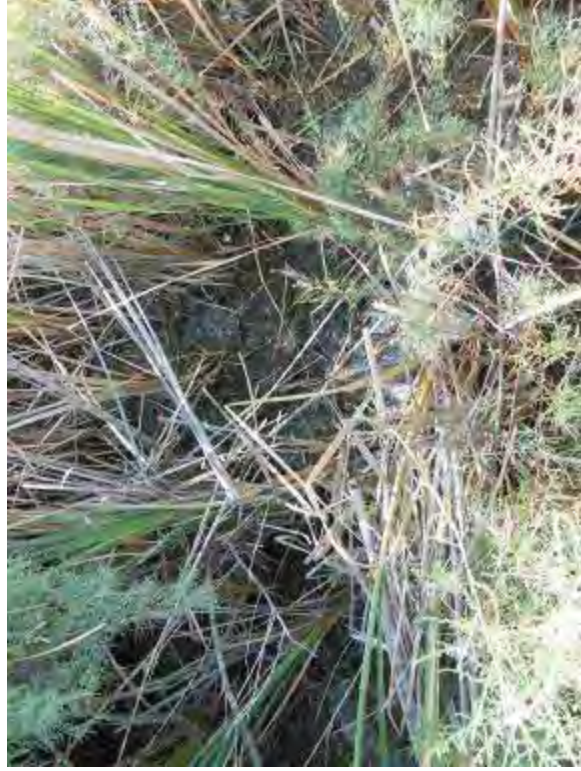
Photo 57: Wet area at west embankment exterior slope.

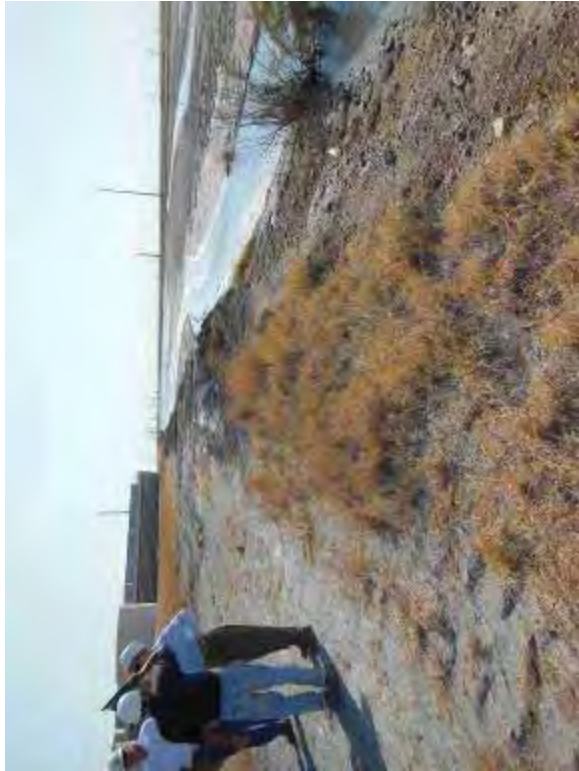
Photo 66: North embankment interior slope, looking east.

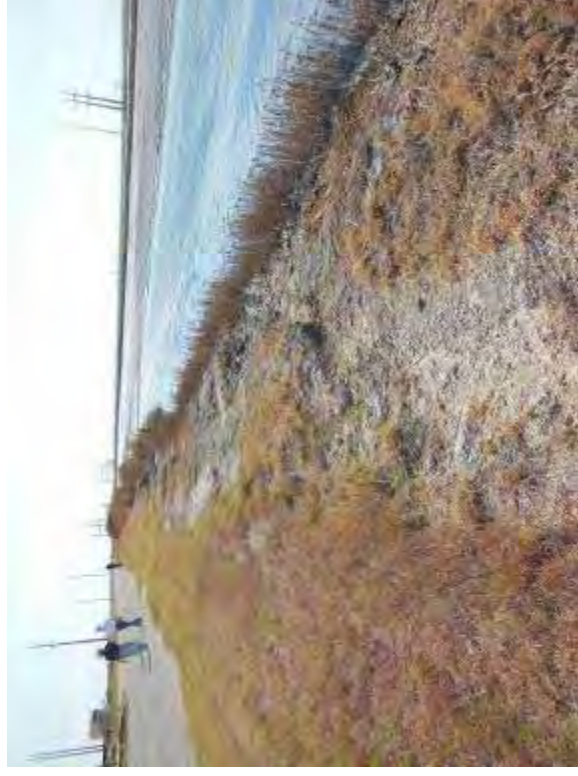
Photo 70: North embankment interior slope, looking east.

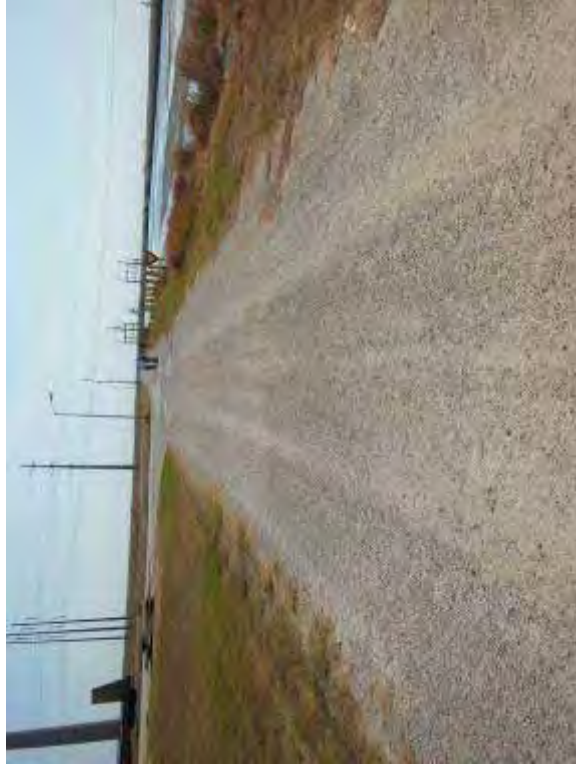
Photo 72: North embankment crest, looking east.

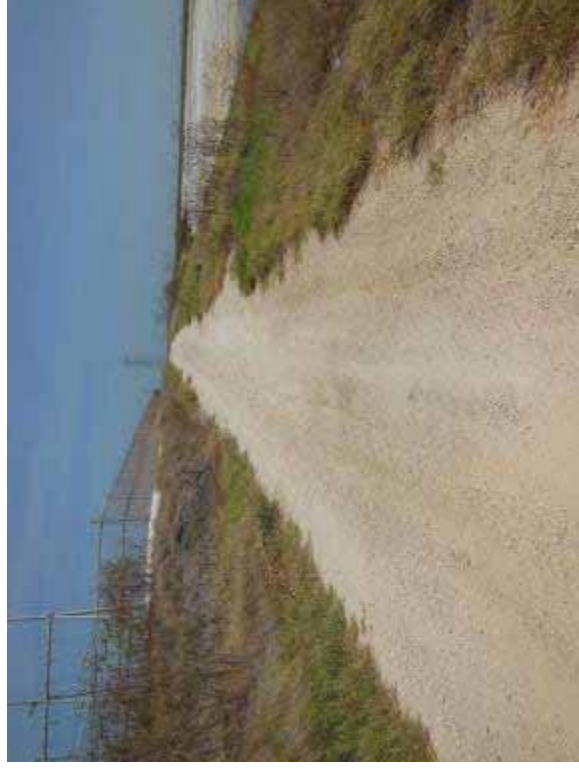
The embankment crest of the Sludge Basin appeared to be in satisfactory condition (Photographs 94, 106, 121, 137 and 145). The crest ranged from 15 to 20 feet wide. The crest of the embankment consists of a compacted gravel drive and grass. The surface is exposed to minimal vehicle traffic. No depressions or evidence of settlement were observed on the crest.

Photo 94: West embankment crest, looking north.

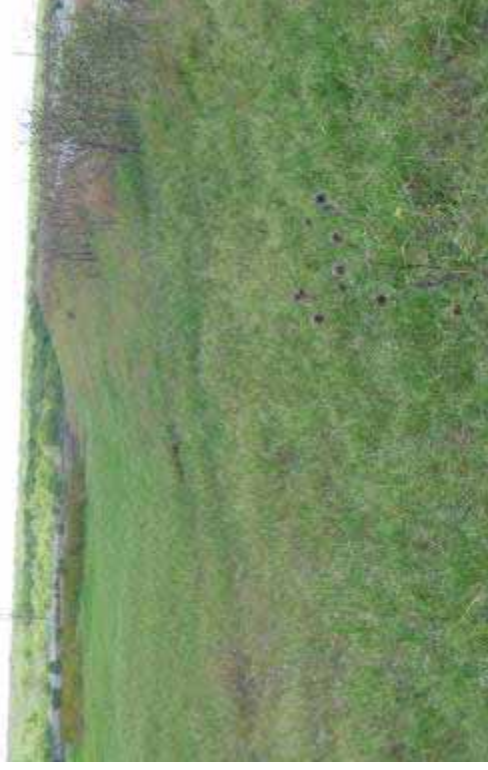
The exterior slopes appear to be in good condition and are covered with grassy vegetation approximately 2 feet high (Photographs 107, 122, 133, and 146). An animal burrow was observed on the south embankment exterior slope (Photograph 143). Based on construction drawings, the exterior slopes are 3H:1V for all embankments, though slopes measured in the field ranged from 3H:1V to 3.5H:1V. The water well storage pond is located at the west embankment exterior slope (Photographs

Photo 122: North embankment exterior slope, looking east.

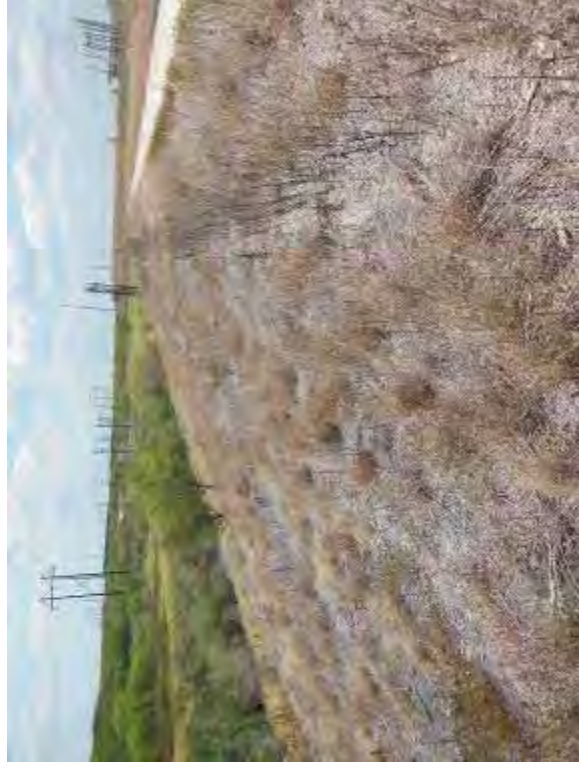
Photo 146: South embankment exterior slope, looking west.

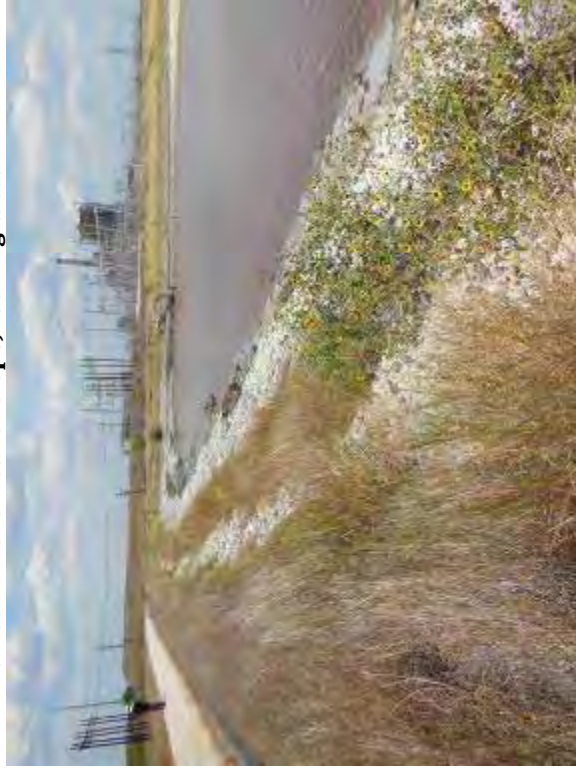
Interior slopes appeared to be in fair condition (Photographs 97, 128, 138, and 147). Erosion rills were observed on the west embankment interior slope (Photographs 99 and 100). An area of either erosion or settling of fill material was observed below the headwall for the stormwater inlet on the west embankment interior slope (Photograph 102). An area of erosion was observed near the outlet structure on the west embankment interior slope (Photograph 151). Based on construction drawings, the interior slopes are 3H:1V for all embankments, though slopes measured in the field ranged from 2H:1V to 3H:1V. Grassy vegetation and small trees up to 3 inches in diameter were observed on the upper portion of the west, north, and east interior slopes (Photographs 103, 108, 117, and 138). Riprap in good condition, but with vegetation growing within was observed on the upper portion of the south embankment interior slope (Photograph 147).

Photo 147: South embankment interior slope, looking west.

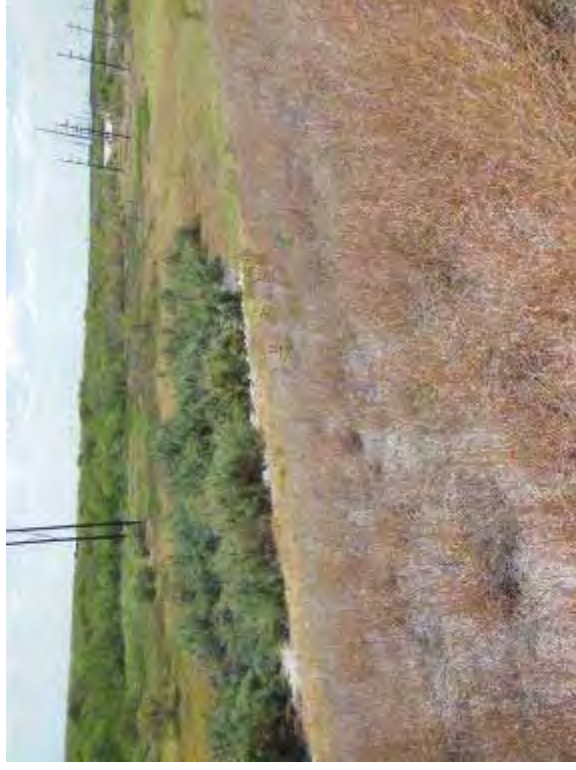
Photo 148: South embankment exterior slope, looking south west.
