**Coal Combustion Residue Impoundment
Round 9 - Dam Assessment Report**

Cross Generating Station

Santee Cooper
Pineville, South Carolina

Dewberry & Davis, LLC
Fairfax, Virginia

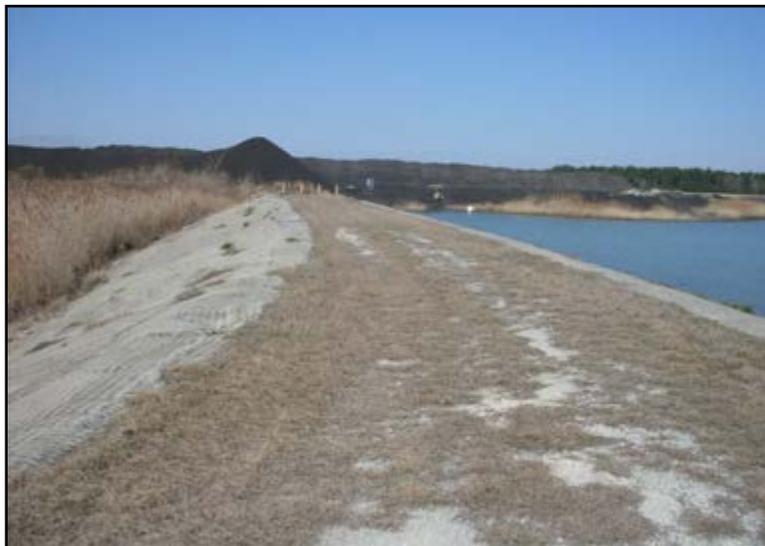
Photograph 5.2. View of crest and inside slope of Bottom Ash Pond 1 northeast dike, looking northwest.

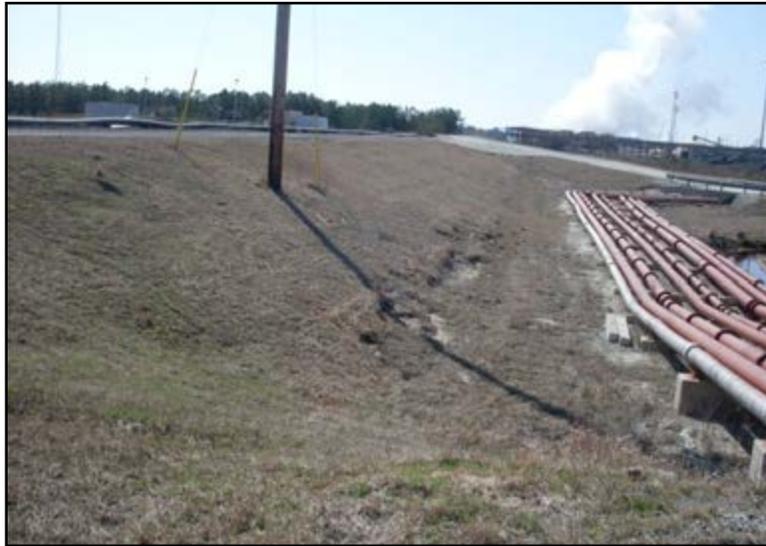
The area along the outside toe of the dike on the southeast side was observed to be covered in woody vegetation (Photograph 5.4). The outside slope of the dike on the northwest side was observed to be covered with mowed grass; however, some erosion was observed along the outside toe of this section of the dike, as shown in Photograph 5.5. There were no indications of seepage.

Photograph 5.5. View of outside slope and toe, northwest side looking southwest.

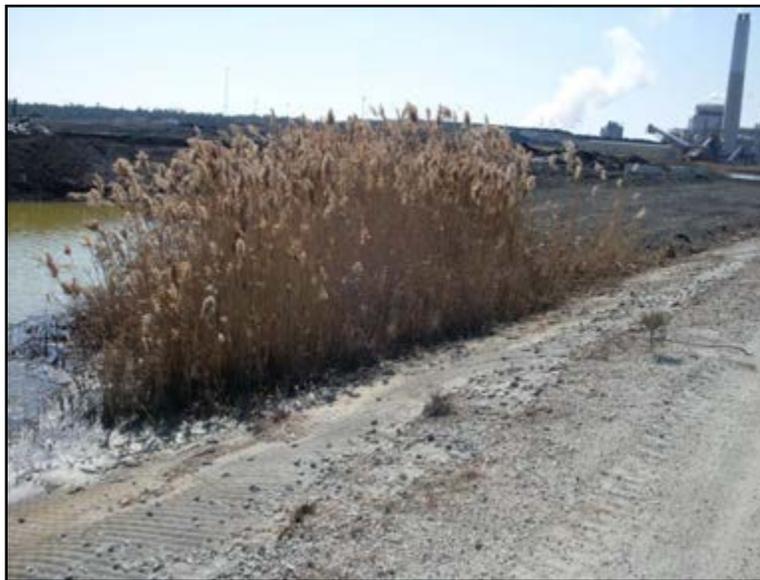
Photograph 5.6c. View of reeds (Phragmites) growing on inside slope, northwest side looking south.

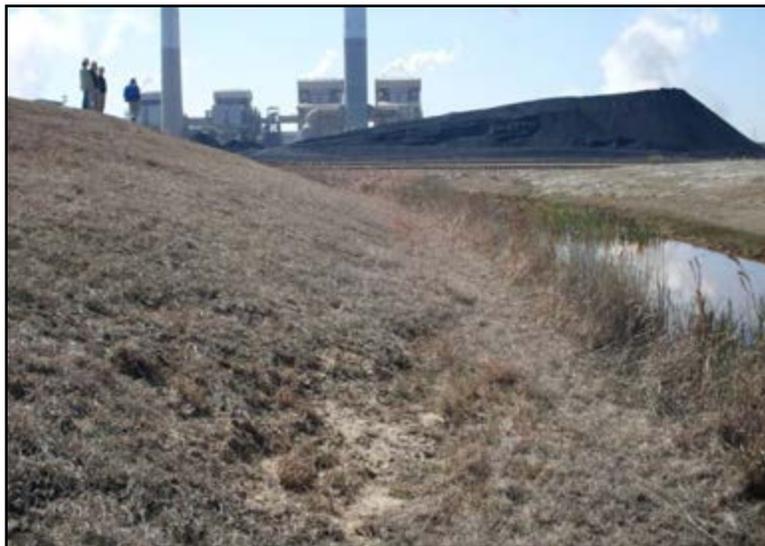
number of locations, typically along the toe, as shown by a typical view in Photograph 5.7b. Santee Cooper personnel indicated that topsoil was not used on the outside slope for vegetation establishment. No areas of major erosion were observed. No obvious signs of slumps, slides, bulges, tension cracks, seepage, or animal holes were observed on the outside slope.

Photograph 5.7b. View of outside slope and toe, northwest side looking southwest.

A water-filled perimeter ditch is located along the outside toe, which restricts access of mowers. Therefore, tall grass was observed to typically occur along the toe (see Photograph 5.7b). There were no obvious signs of seepage from the toe.

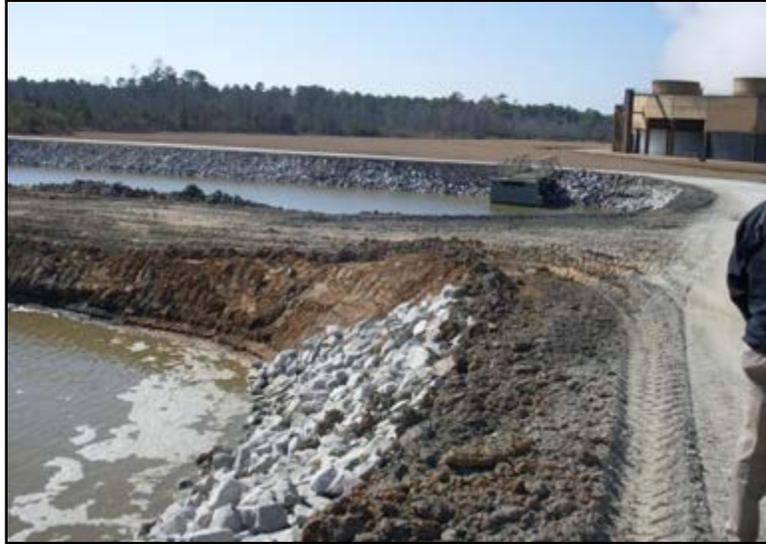
Photograph 5.9a. View of crest, inside slope, finger dike, and emergency overflow structure, northwest side looking southwest.

Typical views of the inside slope of the Gypsum Pond are shown in Photographs 5.9a and 5.9b. Riprap was observed to cover the inside slope of the dike embankment.

The slope of the riprap above the water level appeared steeper than the 3H to 1V design slope of the embankment. The slopes of the finger dike within the pond were observed to be bare earth. No slumps, slides, or other signs of shear failure were observed in the visible parts of the slopes above the water surface.

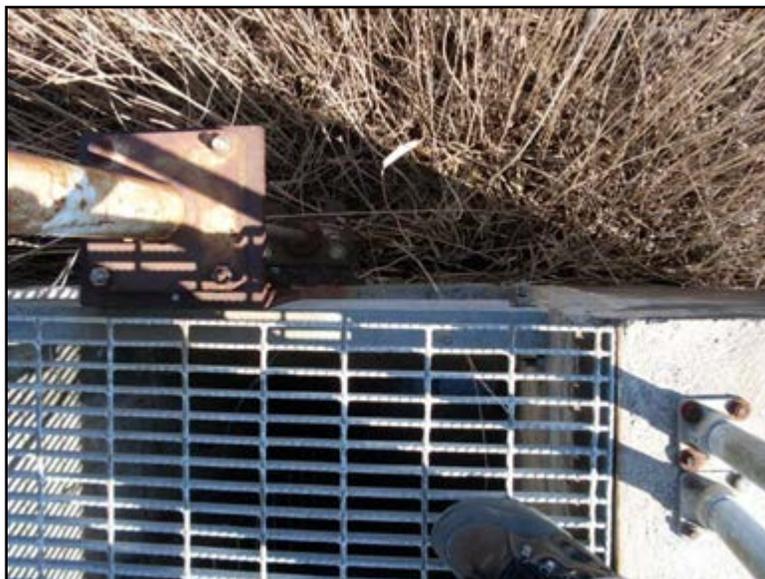
Photograph 5.11b. View (from above) down toward weir in emergency overflow structure.

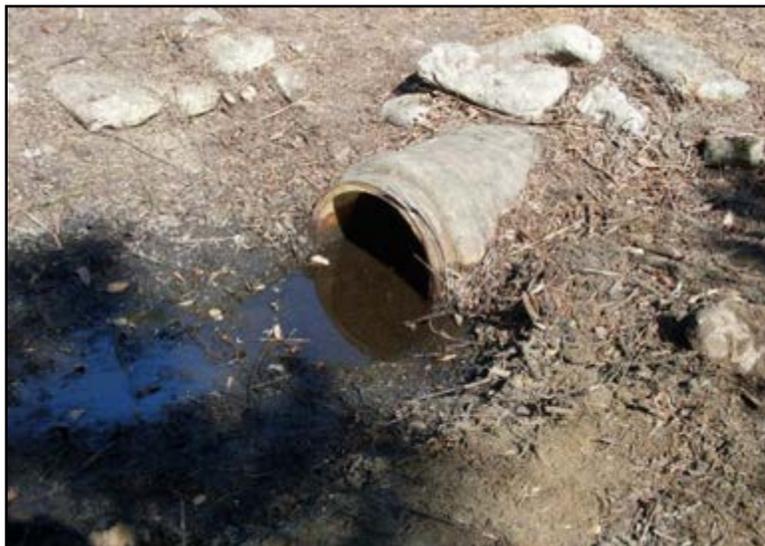
The emergency overflow structure has bottom discharge into an 18-inch diameter conduit through the dike. The discharge end of the emergency outlet conduit, shown in Photograph 5.12, appeared to be prestressed concrete cylinder pipe of the type that consists of a steel cylinder lined with smooth concrete on the inside and wrapped on the outside with prestressing wires and mortar. The visible part of the emergency outlet conduit appeared to be sound. It appeared that discharges from the pipe would flow into a wetland area and ultimately into the Diversion Canal.

Photograph 5.12. Discharge end of emergency outlet conduit.

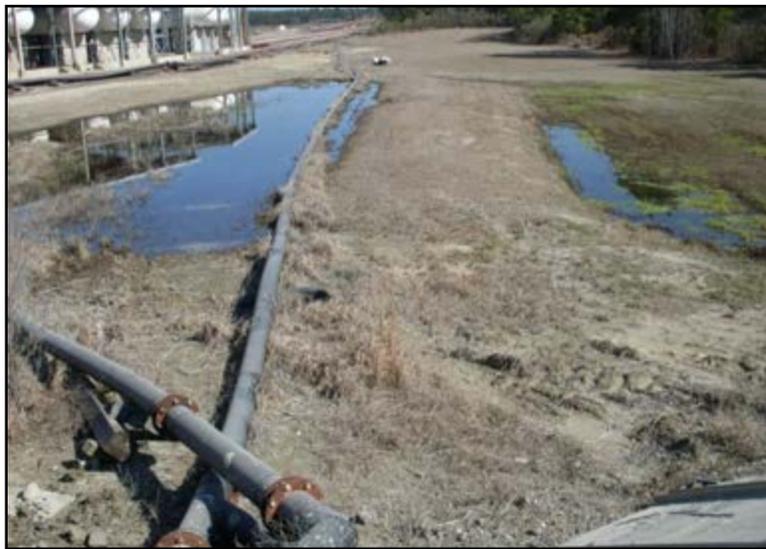
There is a pump structure that conveys water from the Gypsum Pond to Bottom Ash Pond 2. The pump is triggered once the water surface elevation reaches a set elevation. An auxiliary pump is located adjacent to the permanent pump structure. A view of the pump platform is shown in Photograph 5.17. The pump structure and associated equipment appeared to be in satisfactory condition. The pipe outlet conduits from the pump system at the Gypsum Pond are shown in Photograph 5.18. The pipes convey water from the Gypsum Pond to Bottom Ash Pond 2.

Photograph 5.18. View of pipes conveying water from Gypsum Pond to Bottom Ash Pond 2.
