**Coal Combustion Waste Impoundment
Round 5 - Dam Assessment Report**

Jefferies Generating Station (Site #002)

Santee Cooper
Moncks Corner, South Carolina

Dewberry & Davis, LLC
Fairfax, Virginia

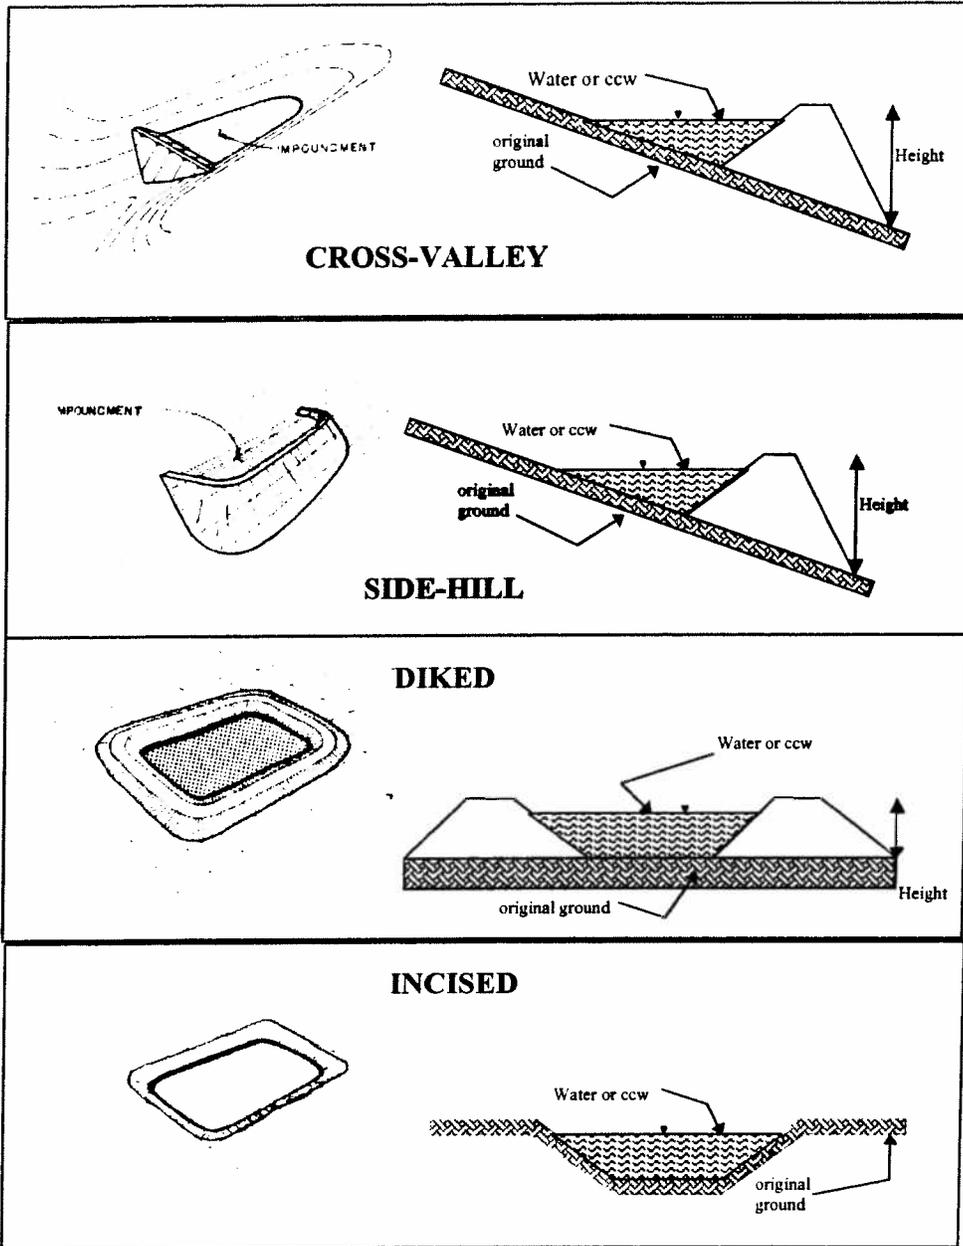
Failure could release CCW into Tailrace
Canal below Pinepolis Dam. No probable loss
of life.

Cross-Valley
 Side-Hill - High ground north & northeast sides. east dke ties into high ground, south side is divider like west side is massive spoil bank from dredging of Tailrace Canal
 Diked
 Incised (form completion optional)
 Combination Incised/Diked
 Embankment Height 4-20 feet Embankment Material EARTH
 Pool Area 127 acres Liner NONE
 Current Freeboard 5.6 feet Liner Permeability -

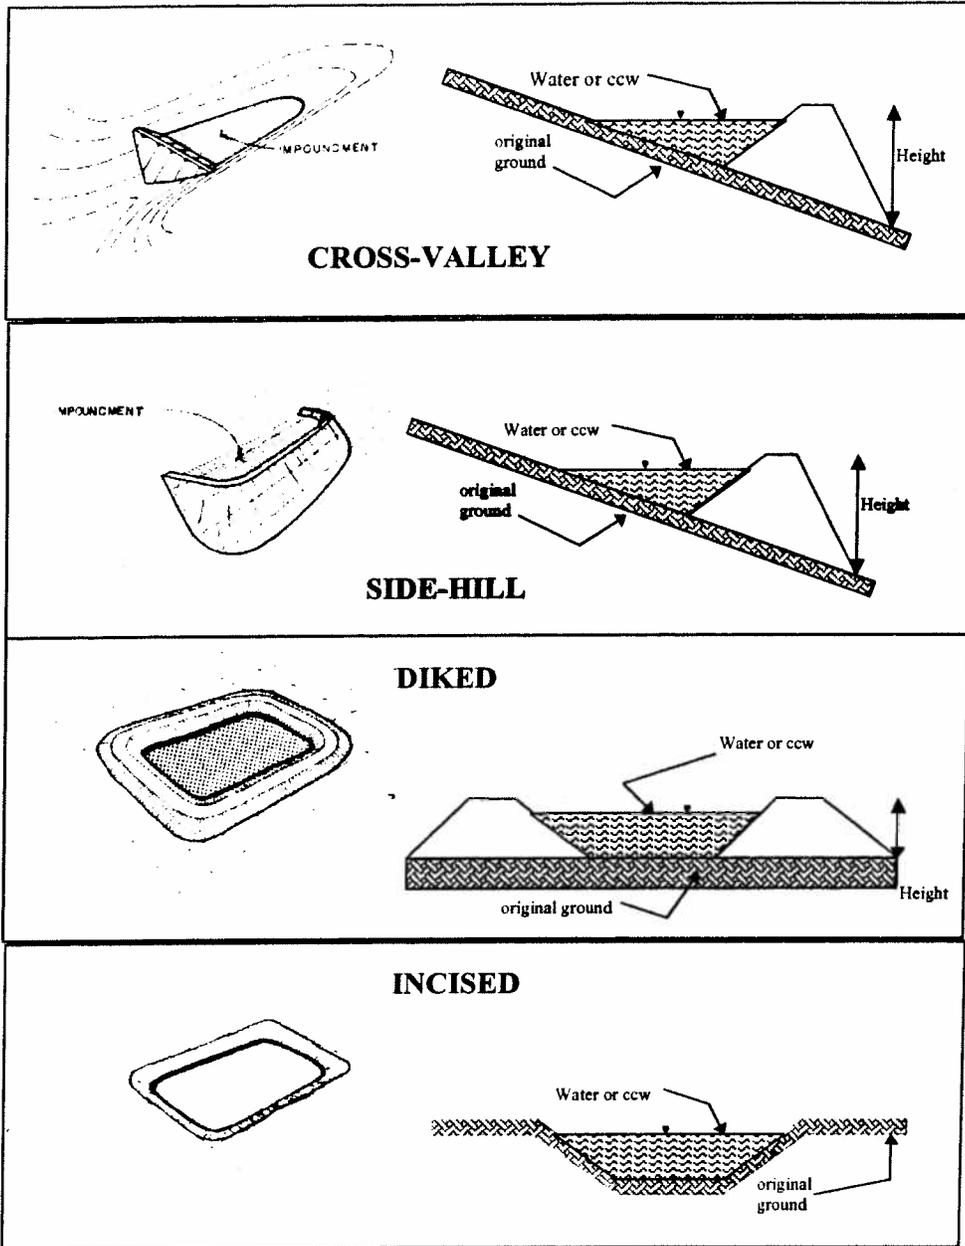
POND B SERVES AS A "POLISHING" POND BEFORE WATER IS DISCHARGED THROUGH PERMITTED OUTLET. NO SIGNIFICANT AMOUNT OF CCW IS STORED IN POND B. THEREFORE, FAILURE WOULD ONLY RELEASE WATER FROM THE SHALLOW (4' NORMAL DEPTH) POND TO THE DOWNSTREAM SWAMP AND INTO THE TAILRACE CANAL BELOW THE PINOPOLIS DAM. NO PROBABLE LOSS OF LIFE.

Embankment Height 10 feet Embankment Material EARTH
 Pool Area 42 acres Liner NONE
 Current Freeboard 6 feet Liner Permeability -
