**Coal Combustion Residue Impoundment  
Round 9 - Dam Assessment Report**

*Canadys Steam Power Station  
Ash Pond Embankments  
South Carolina Electric & Gas  
Canadys, South Carolina*

Dewberry & Davis, LLC  
Fairfax, Virginia

Under Contract Number: EP-09W001727  
**May 2011**

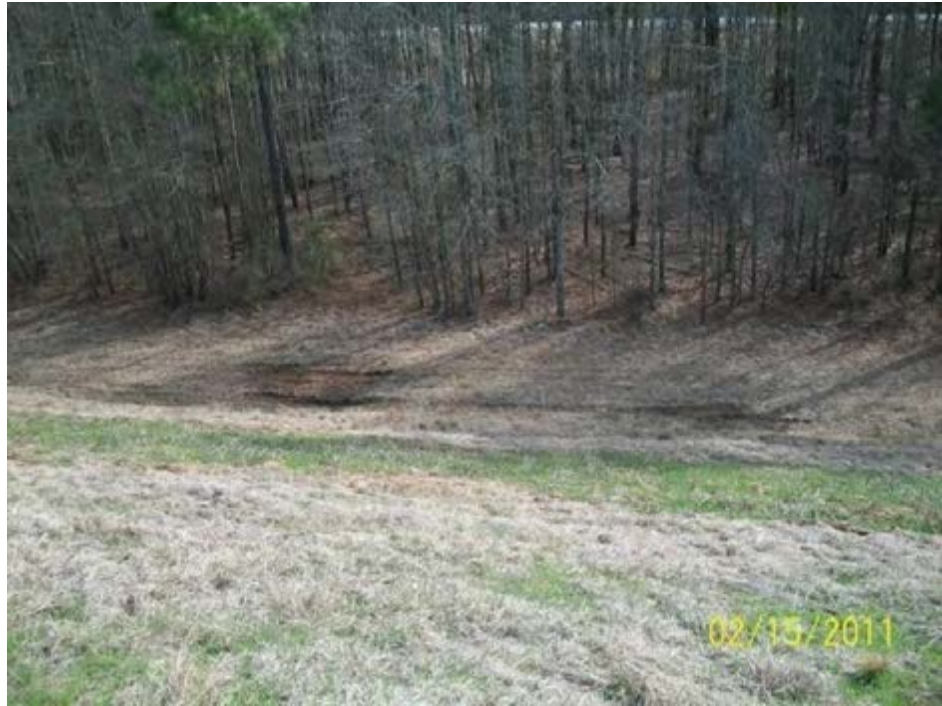
Photo 1. Standing water in vehicular traffic ruts

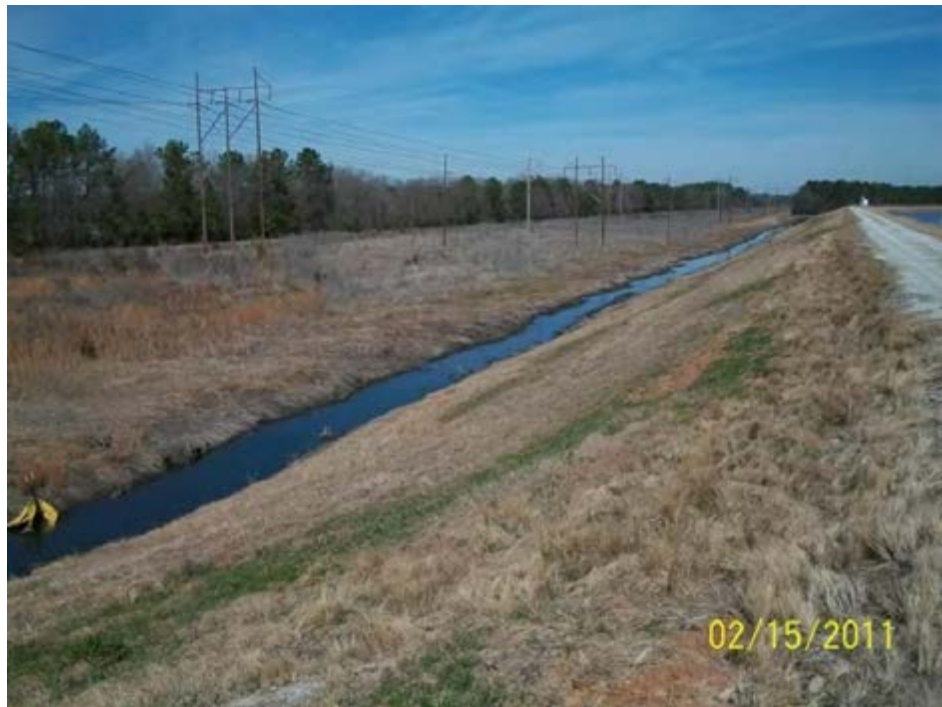
There were signs of surficial sloughing particularly along the downstream slope. Wetlands and a waterway channel are located along the downstream toe of the embankments. (See Photos 1, 2, and 3.)

Photo 2. Channel along the downstream toe

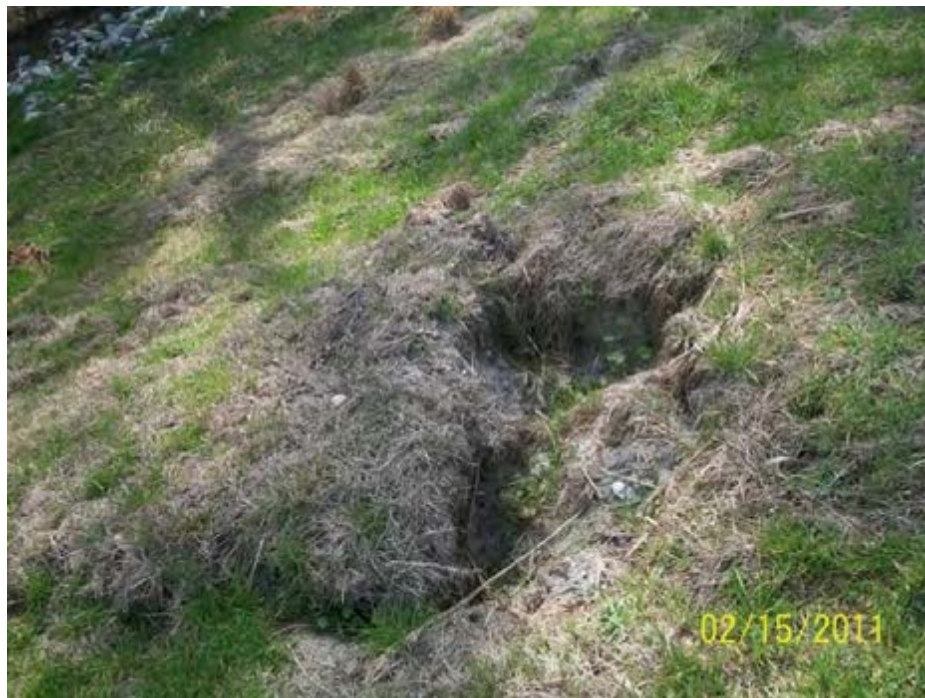
**Photo 3. Surficial sloughing along downstream slope**

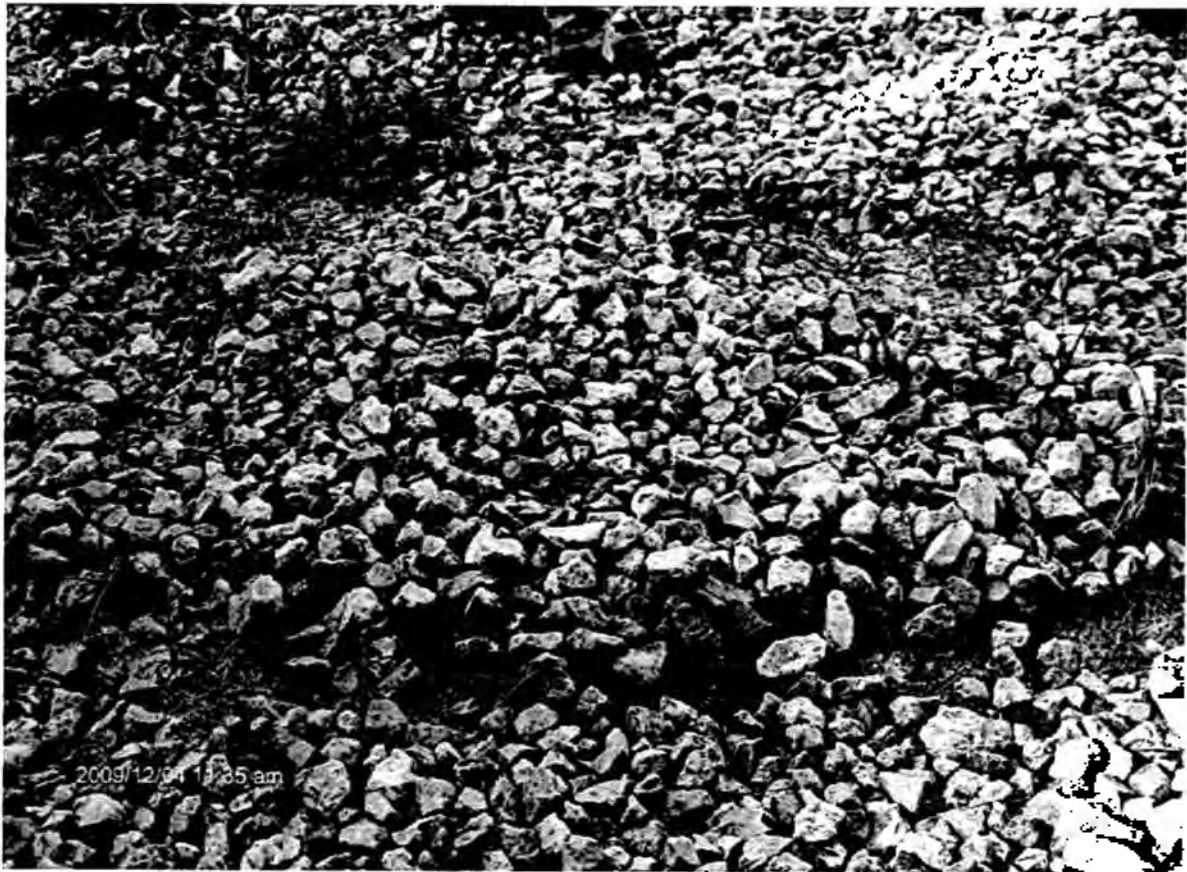
**Figure 3: WA-1 at Time of Annual Inspection**

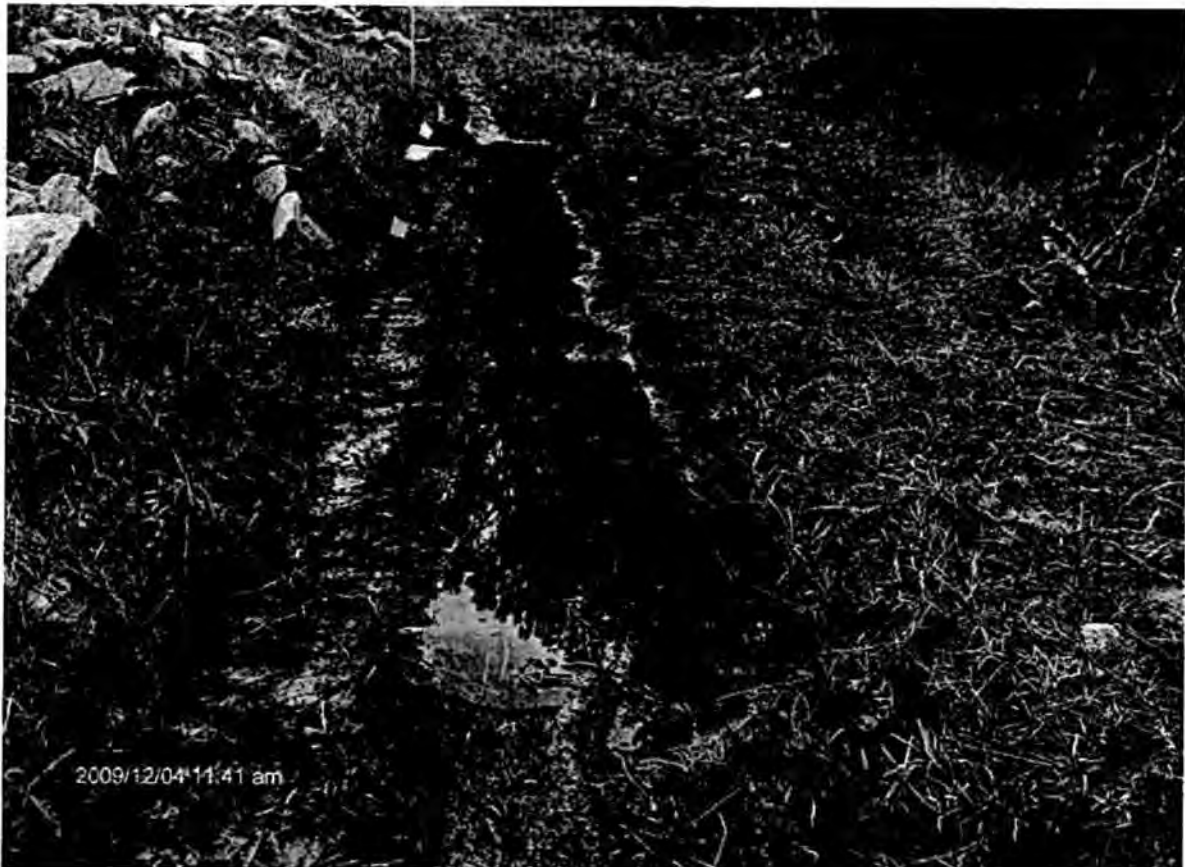
**Figure 4: Standing Water Near Rip Rap Armoring at Southwestern Corner of Active Pond**

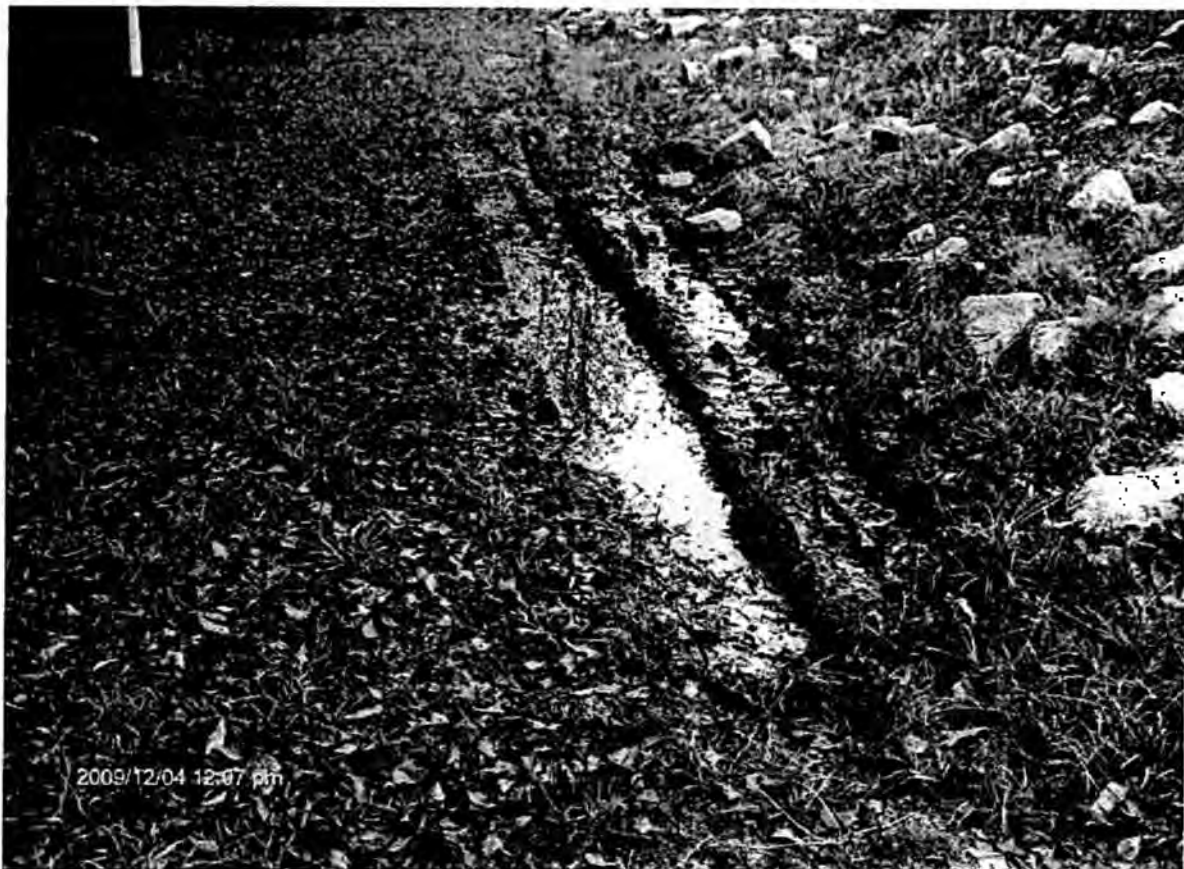
**Figure 8: Example of Area of Standing Water Along Toe of Active Pond West Berm**

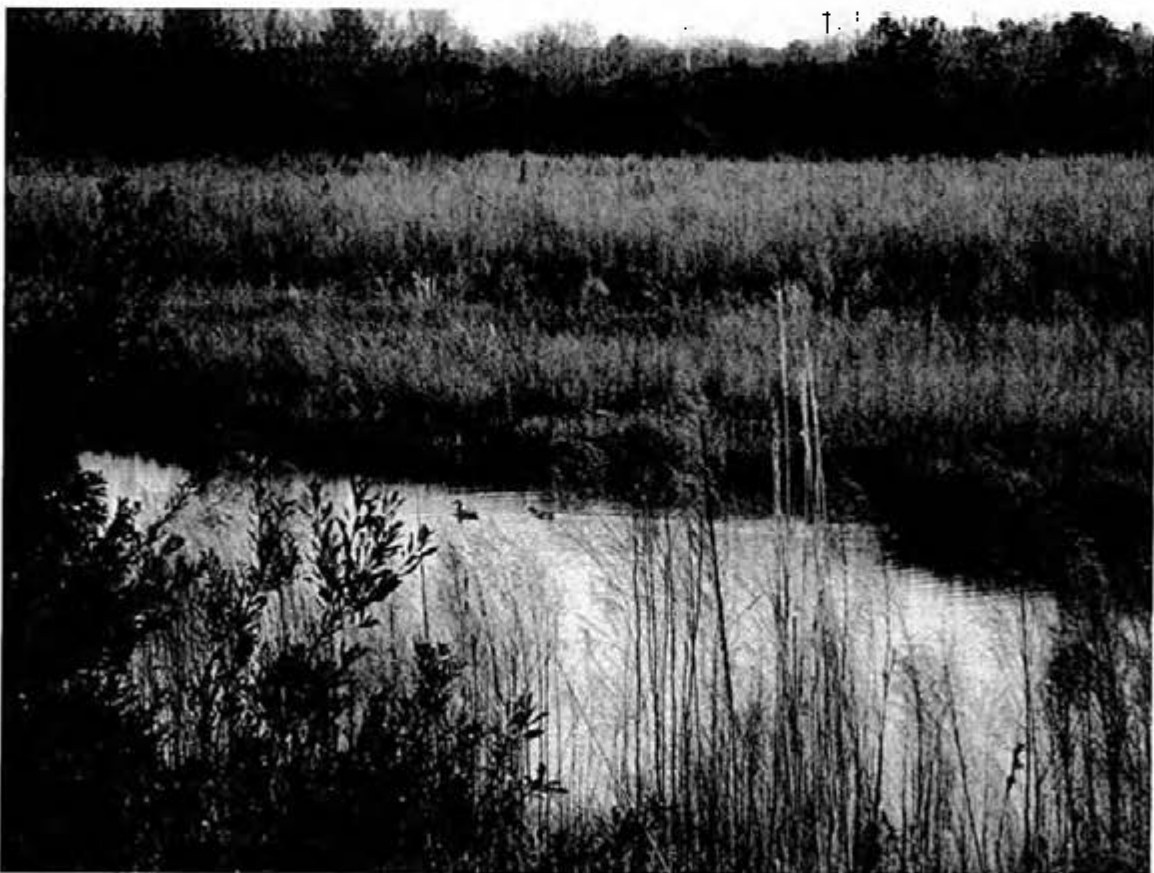
**Figure 16: Ducks Swimming in Impounded Water within Inactive Pond**
