**Coal Combustion Residue Impoundment  
Round 9 - Dam Assessment Report**

***Canadys Steam Power Station  
Ash Pond Embankments  
South Carolina Electric & Gas  
Canadys, South Carolina***

**December 2011**

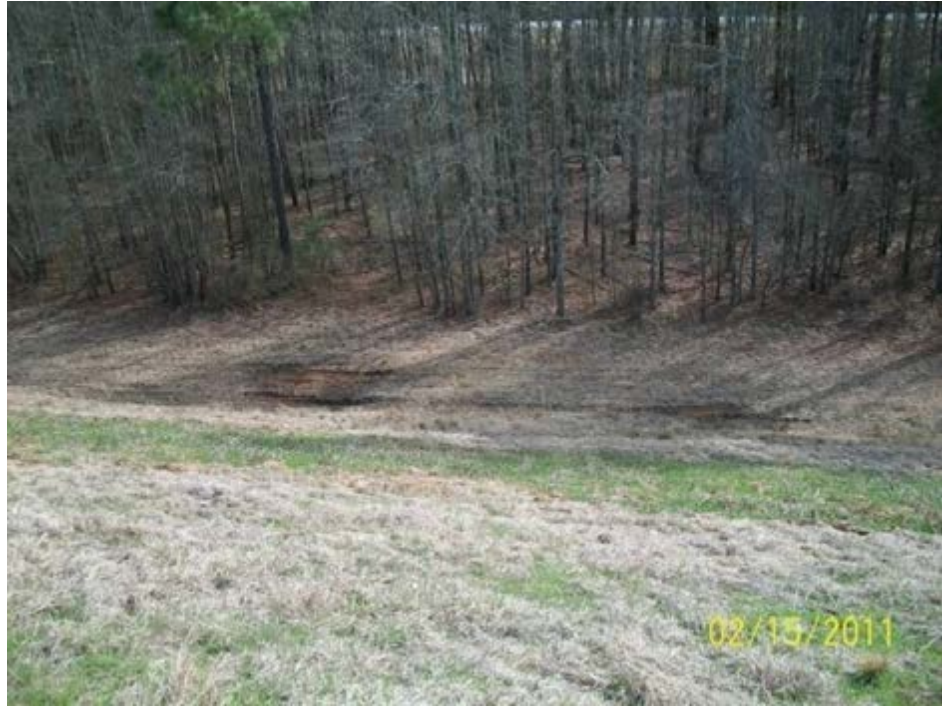
There were signs of surficial sloughing particularly along the downstream slope. Wetlands and a waterway channel are located along the downstream toe of the embankments. (See Photos 1, 2, and 3.)

Photo 1. Standing water in vehicular traffic ruts

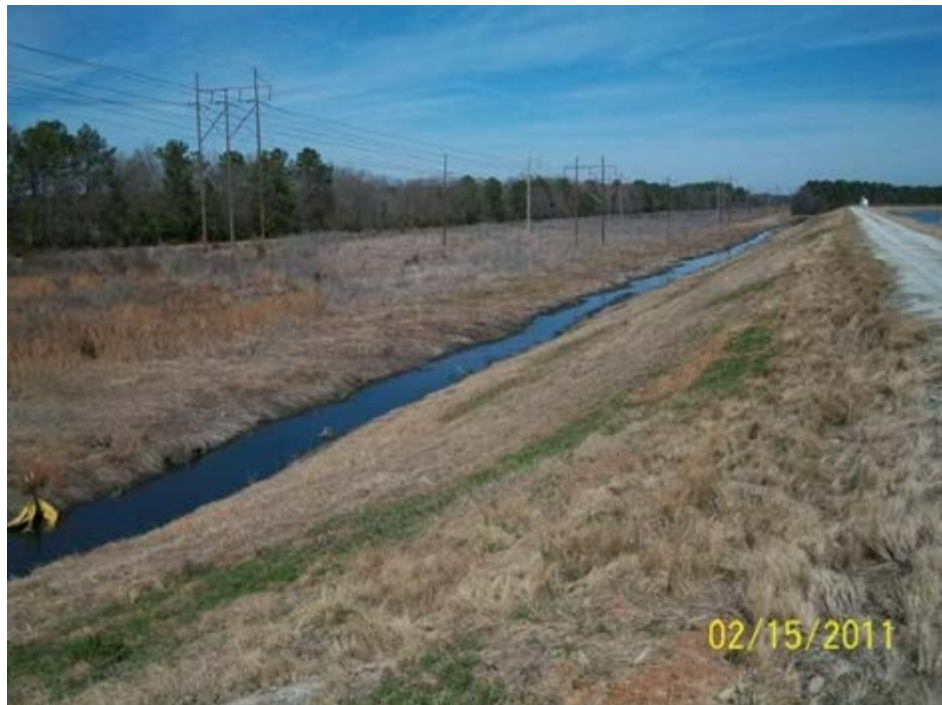
Photo 2. Channel along the downstream toe

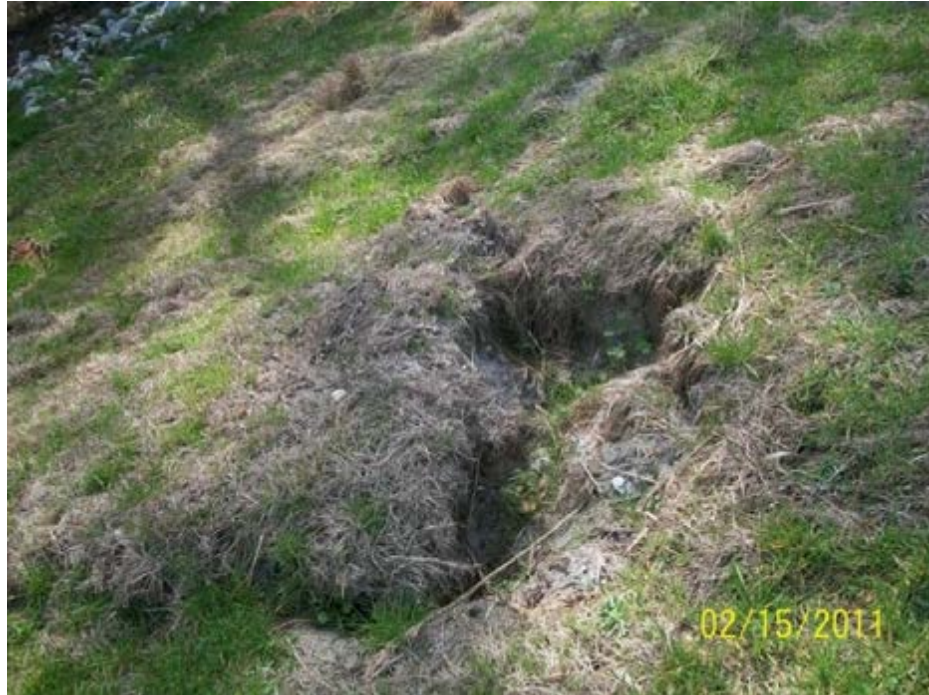
**Photo 3. Surficial sloughing along downstream slope**

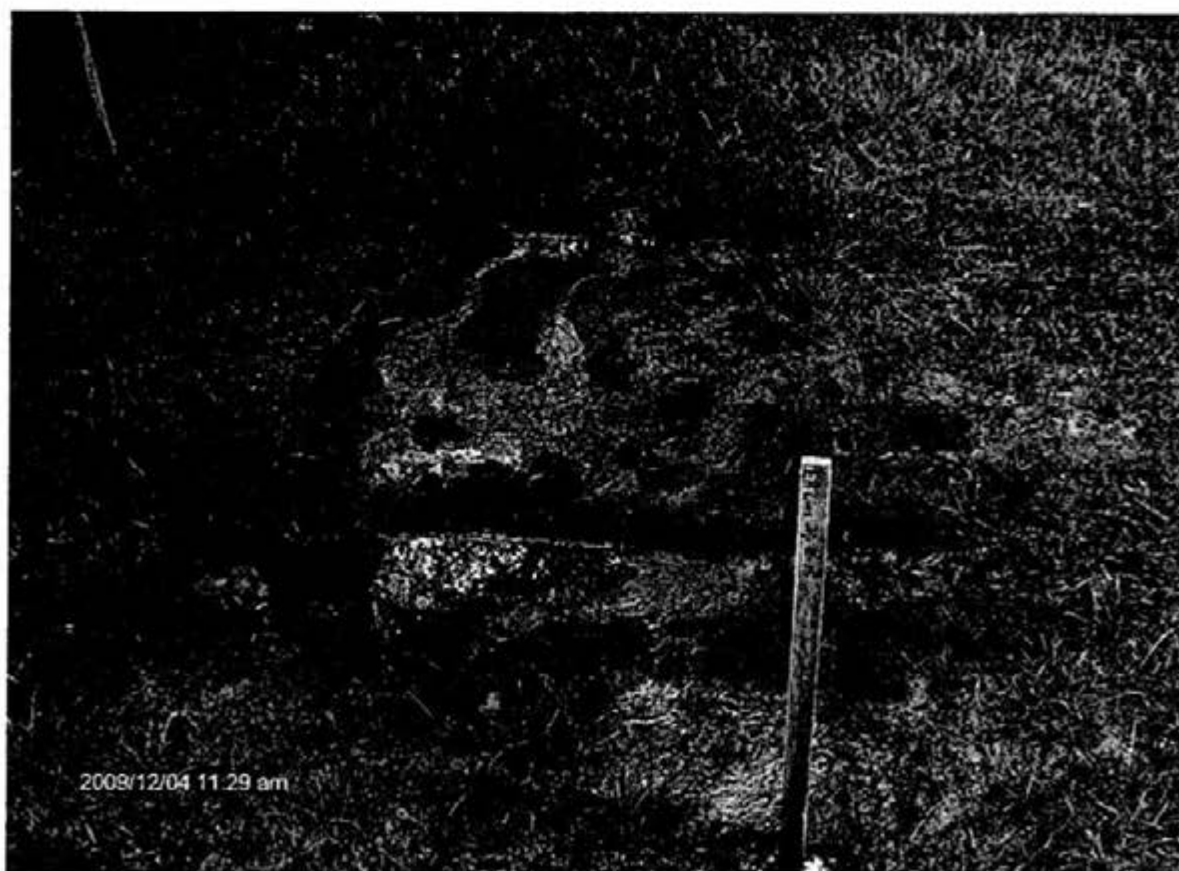
**Figure 2: WA-2 at Time of Annual Inspection**

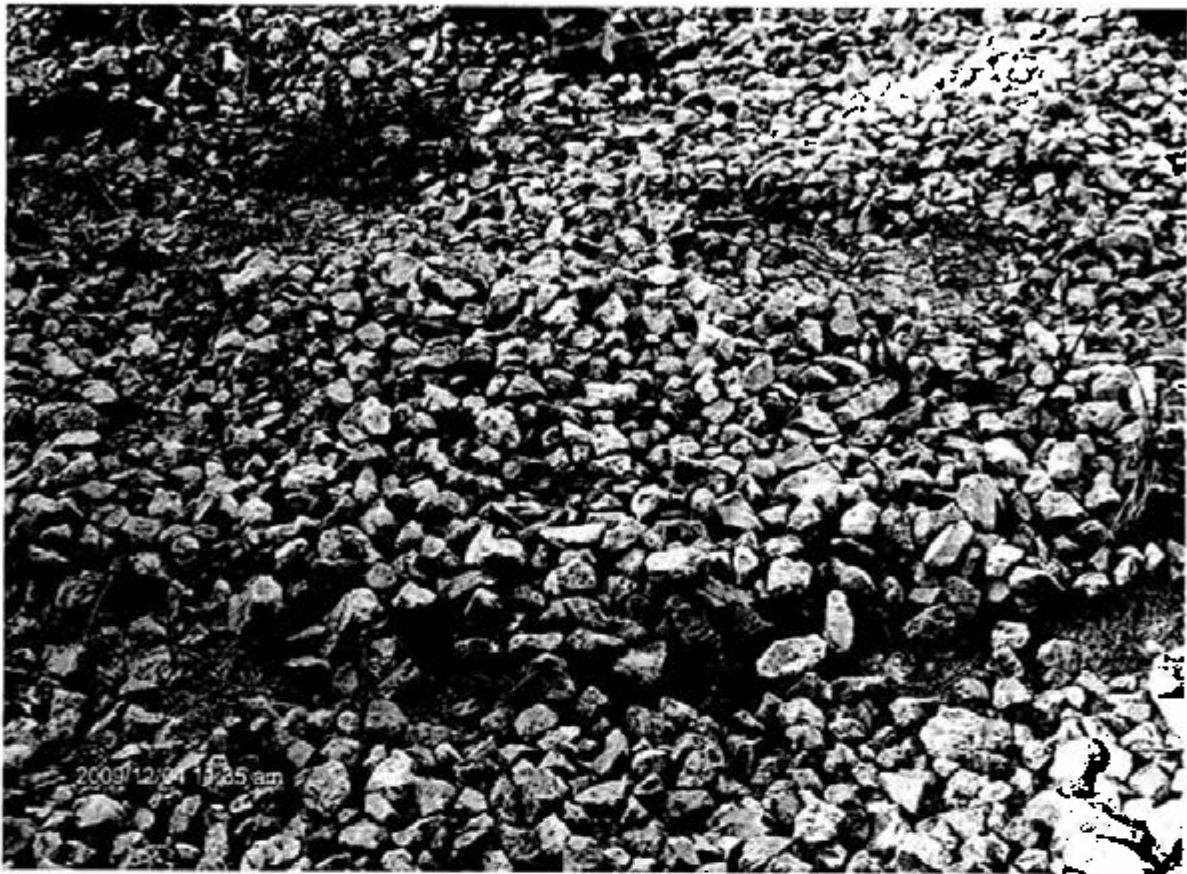
**Figure 3: WA-1 at Time of Annual Inspection**
