Subject: South Carolina Electric & Gas Company  
Urquhart Generating Station  
Coal Combustion Residue Impoundment  
Round 9 – Dam Assessment Report (April 2011)

**Coal Combustion Residue Impoundment  
Round 9 - Dam Assessment Report**

*Urquhart Generating Station*  
*Ash Ponds*  
*South Carolina Electric & Gas*  
*Beech Island, South Carolina*

Dewberry & Davis, LLC  
Fairfax, Virginia

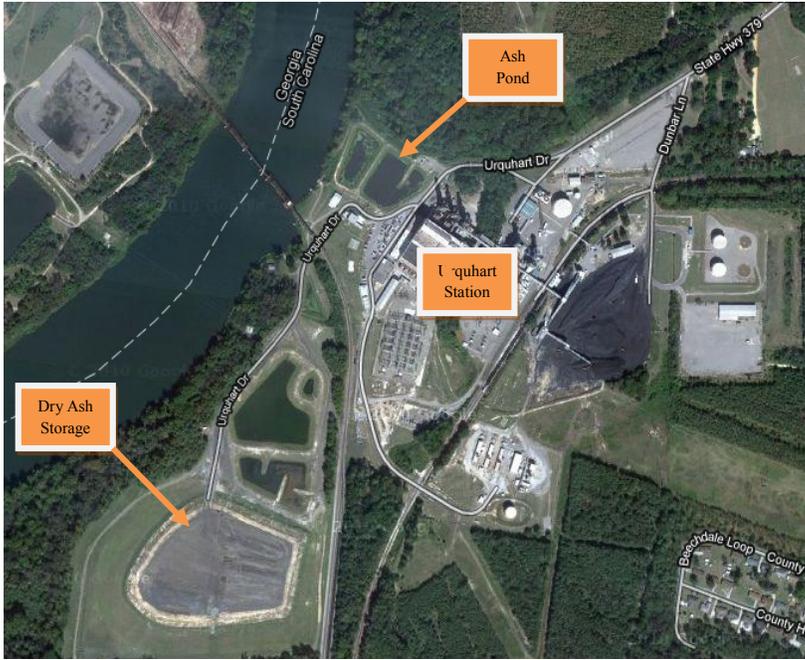
Figure 2.1b: Urquhart Generating Station Aerial View

**Comment [wra1]:** Note – Arrows were pointing to the wrong places. Descriptions and arrows of ash pond, dry ash storage and Urquhart Station are moved to point at the correct item.

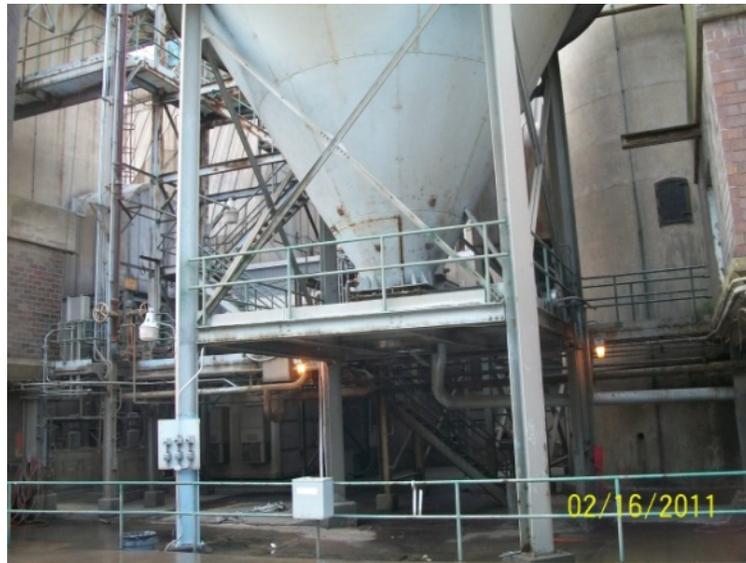
**Comment [wra2]:** Photo below shows a bottom ash dewatering bin, not a fly ash silo

Hopper discharge where trucks can load ash material
