# **Coal Combustion Residue Impoundment Round 9 - Dam Assessment Report**

Ash Ponds
South Carolina Electric & Gas
Beech Island, South Carolina

Dewberry & Davis, LLC Fairfax, Virginia

Under Contract Number: EP-09W001727 **November 2011**

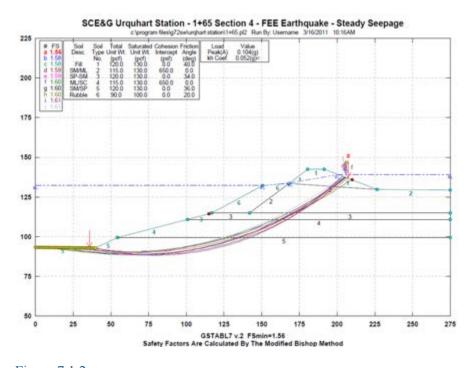
Figure 7.1.2

A report for the ash pond was prepared by F&ME Consultants, Inc. in 2011. The report includes documentation of the shear strength design properties for the ash pond embankments. Five (5) sections of the embankments were analyzed and only one of the most critical sections, which is adjacent to the Savannah River, is shown in this report (See Figure 7.1.2). For the complete documentation see Appendix A - Doc 05: Subsurface Investigation and Structural Stability Report.

It should be noted that no portion of the embankment is built over wet ash, slag, or other unsuitable materials.
