DRAFT REPORT

Dam Safety Assessment of CCW Impoundments

Sikeston Power Station

May 27, 2010

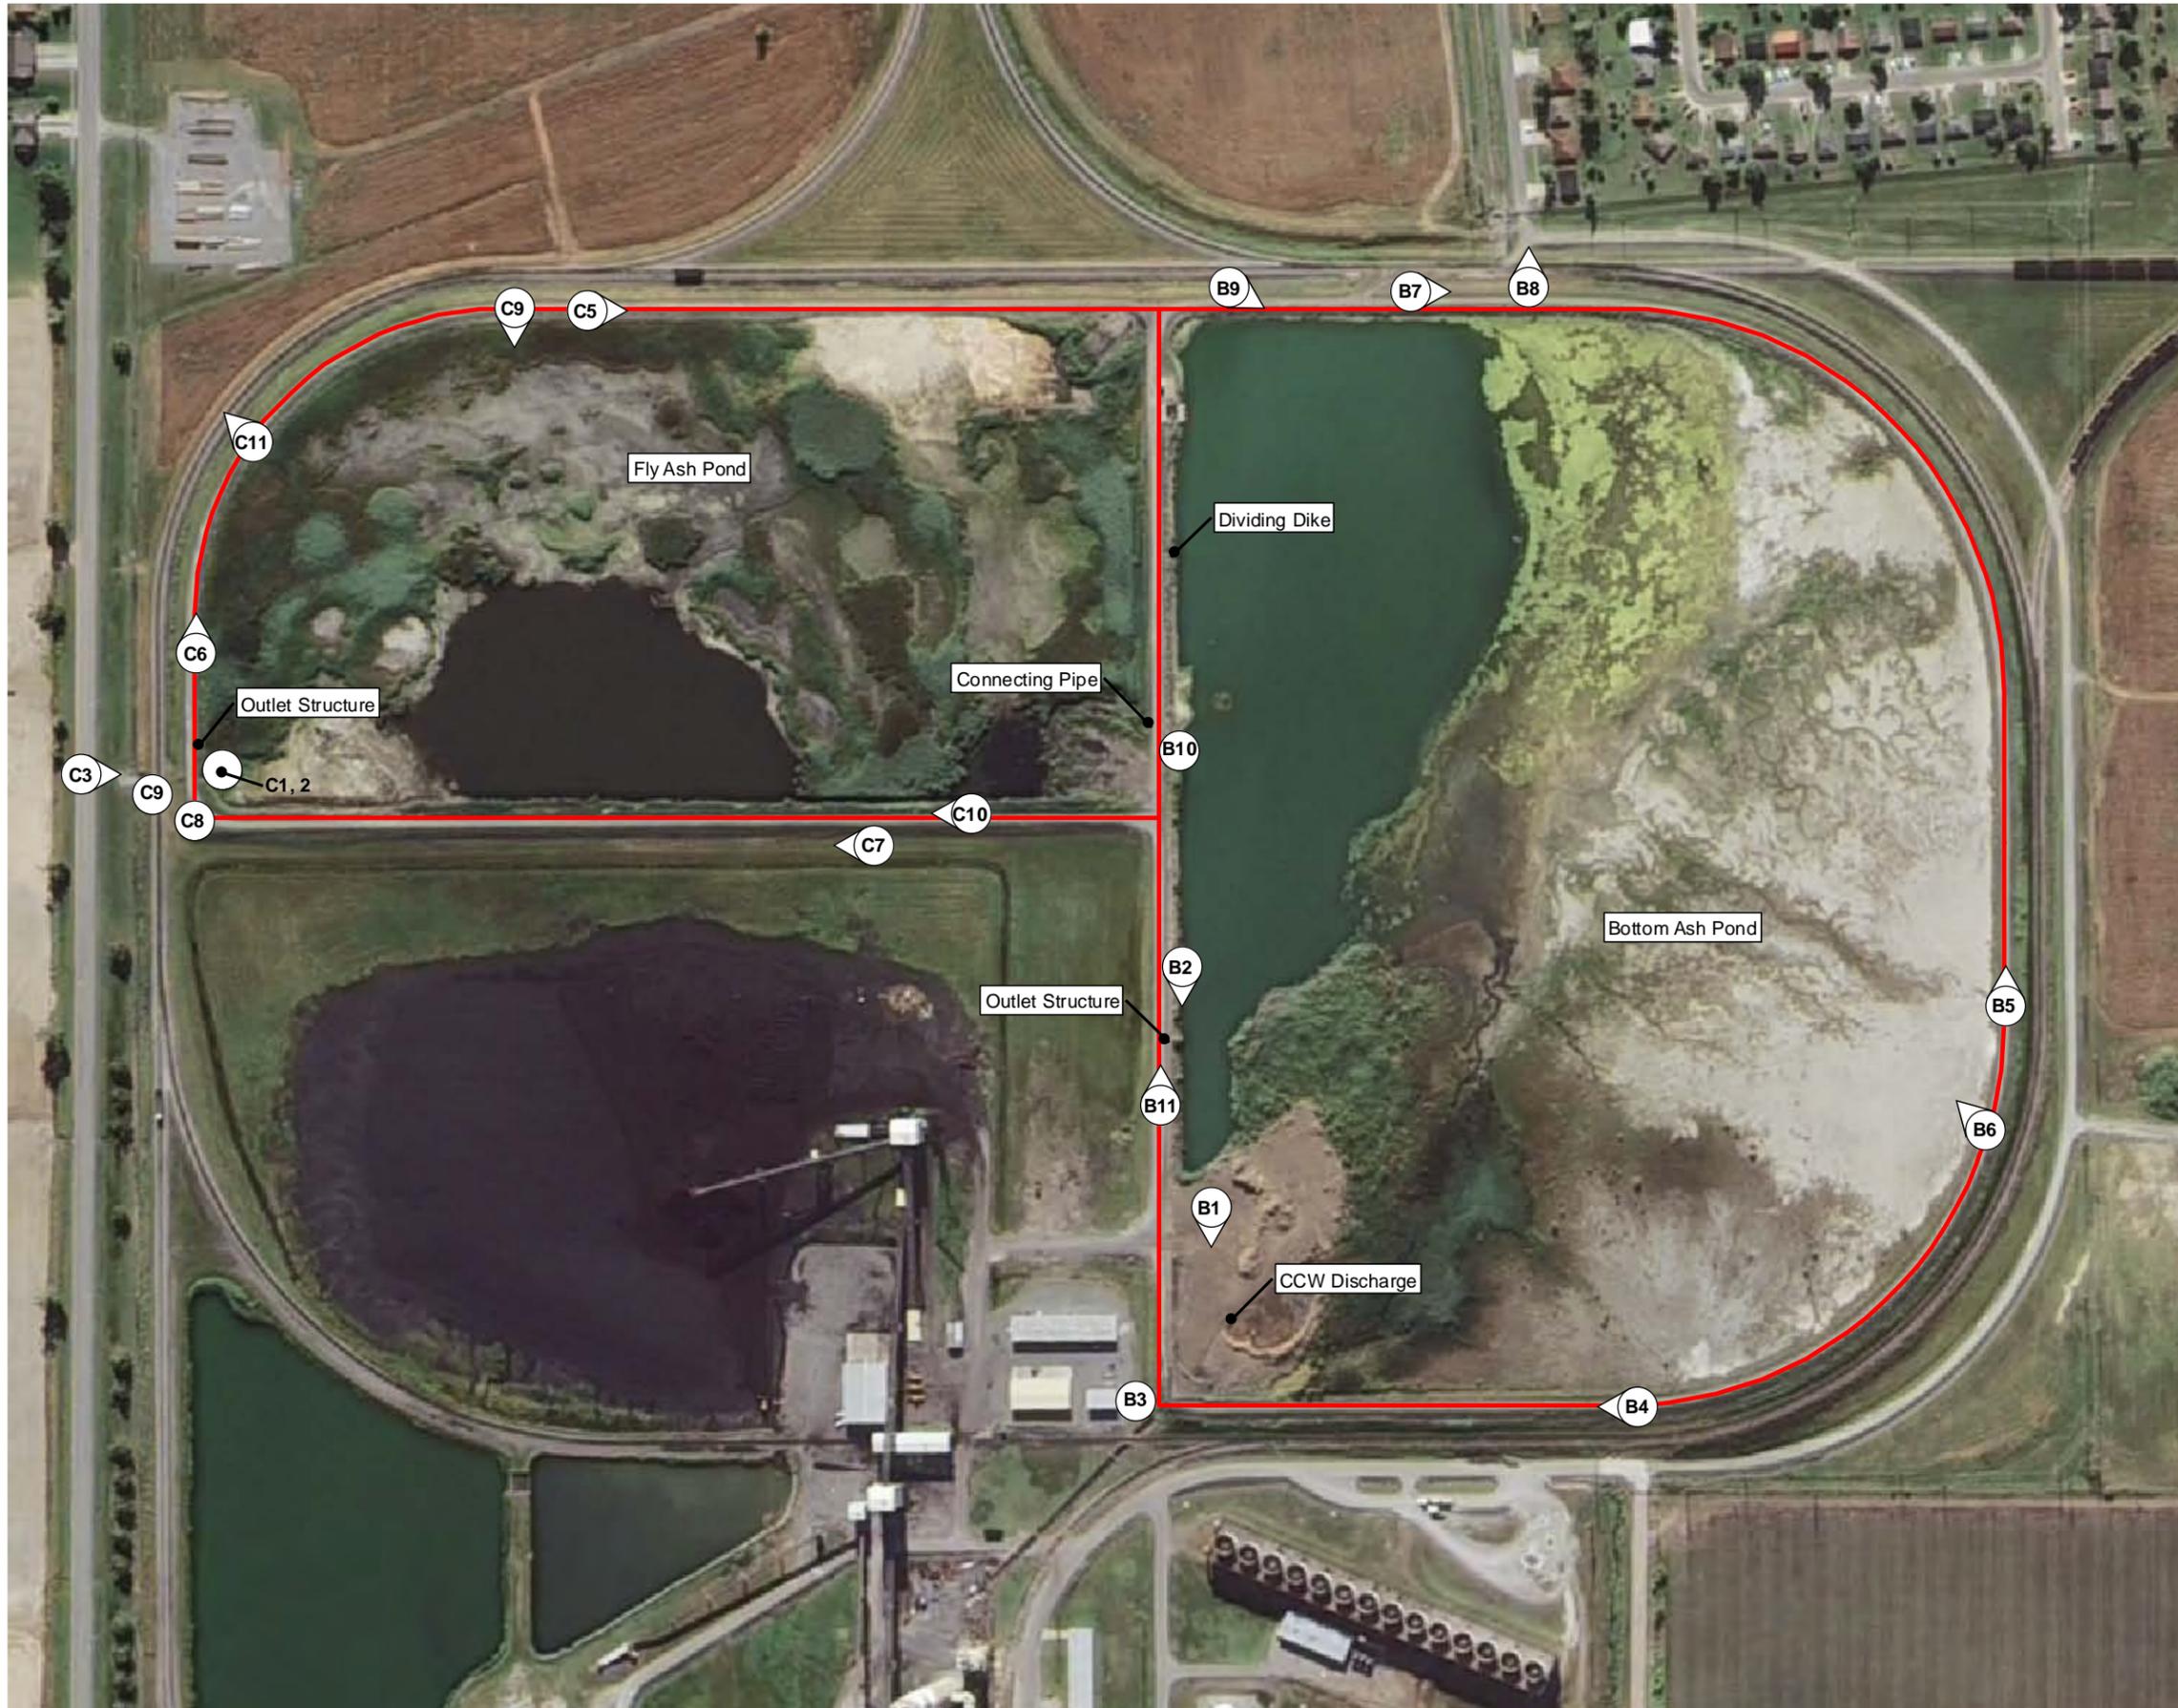
DRAFT FIGURE 3

Figure 3 – Site Plan and Photo Location Identifier - Bottom Ash and Fly Ash Pond

Photos of relevant features and conditions observed during the inspection were taken by O'Brien & Gere and are provided in Appendix B and C for the Bottom Ash Pond and the Fly Ash Pond, respectively. A Site Plan of the Bottom Ash Pond and the Fly Ash Pond is presented as Figure 3, which also provides photograph locations and directions.
