Draft Report

Tanner's Creek Bottom Ash Complex Assessment Report

Lockheed Martin

June 2009

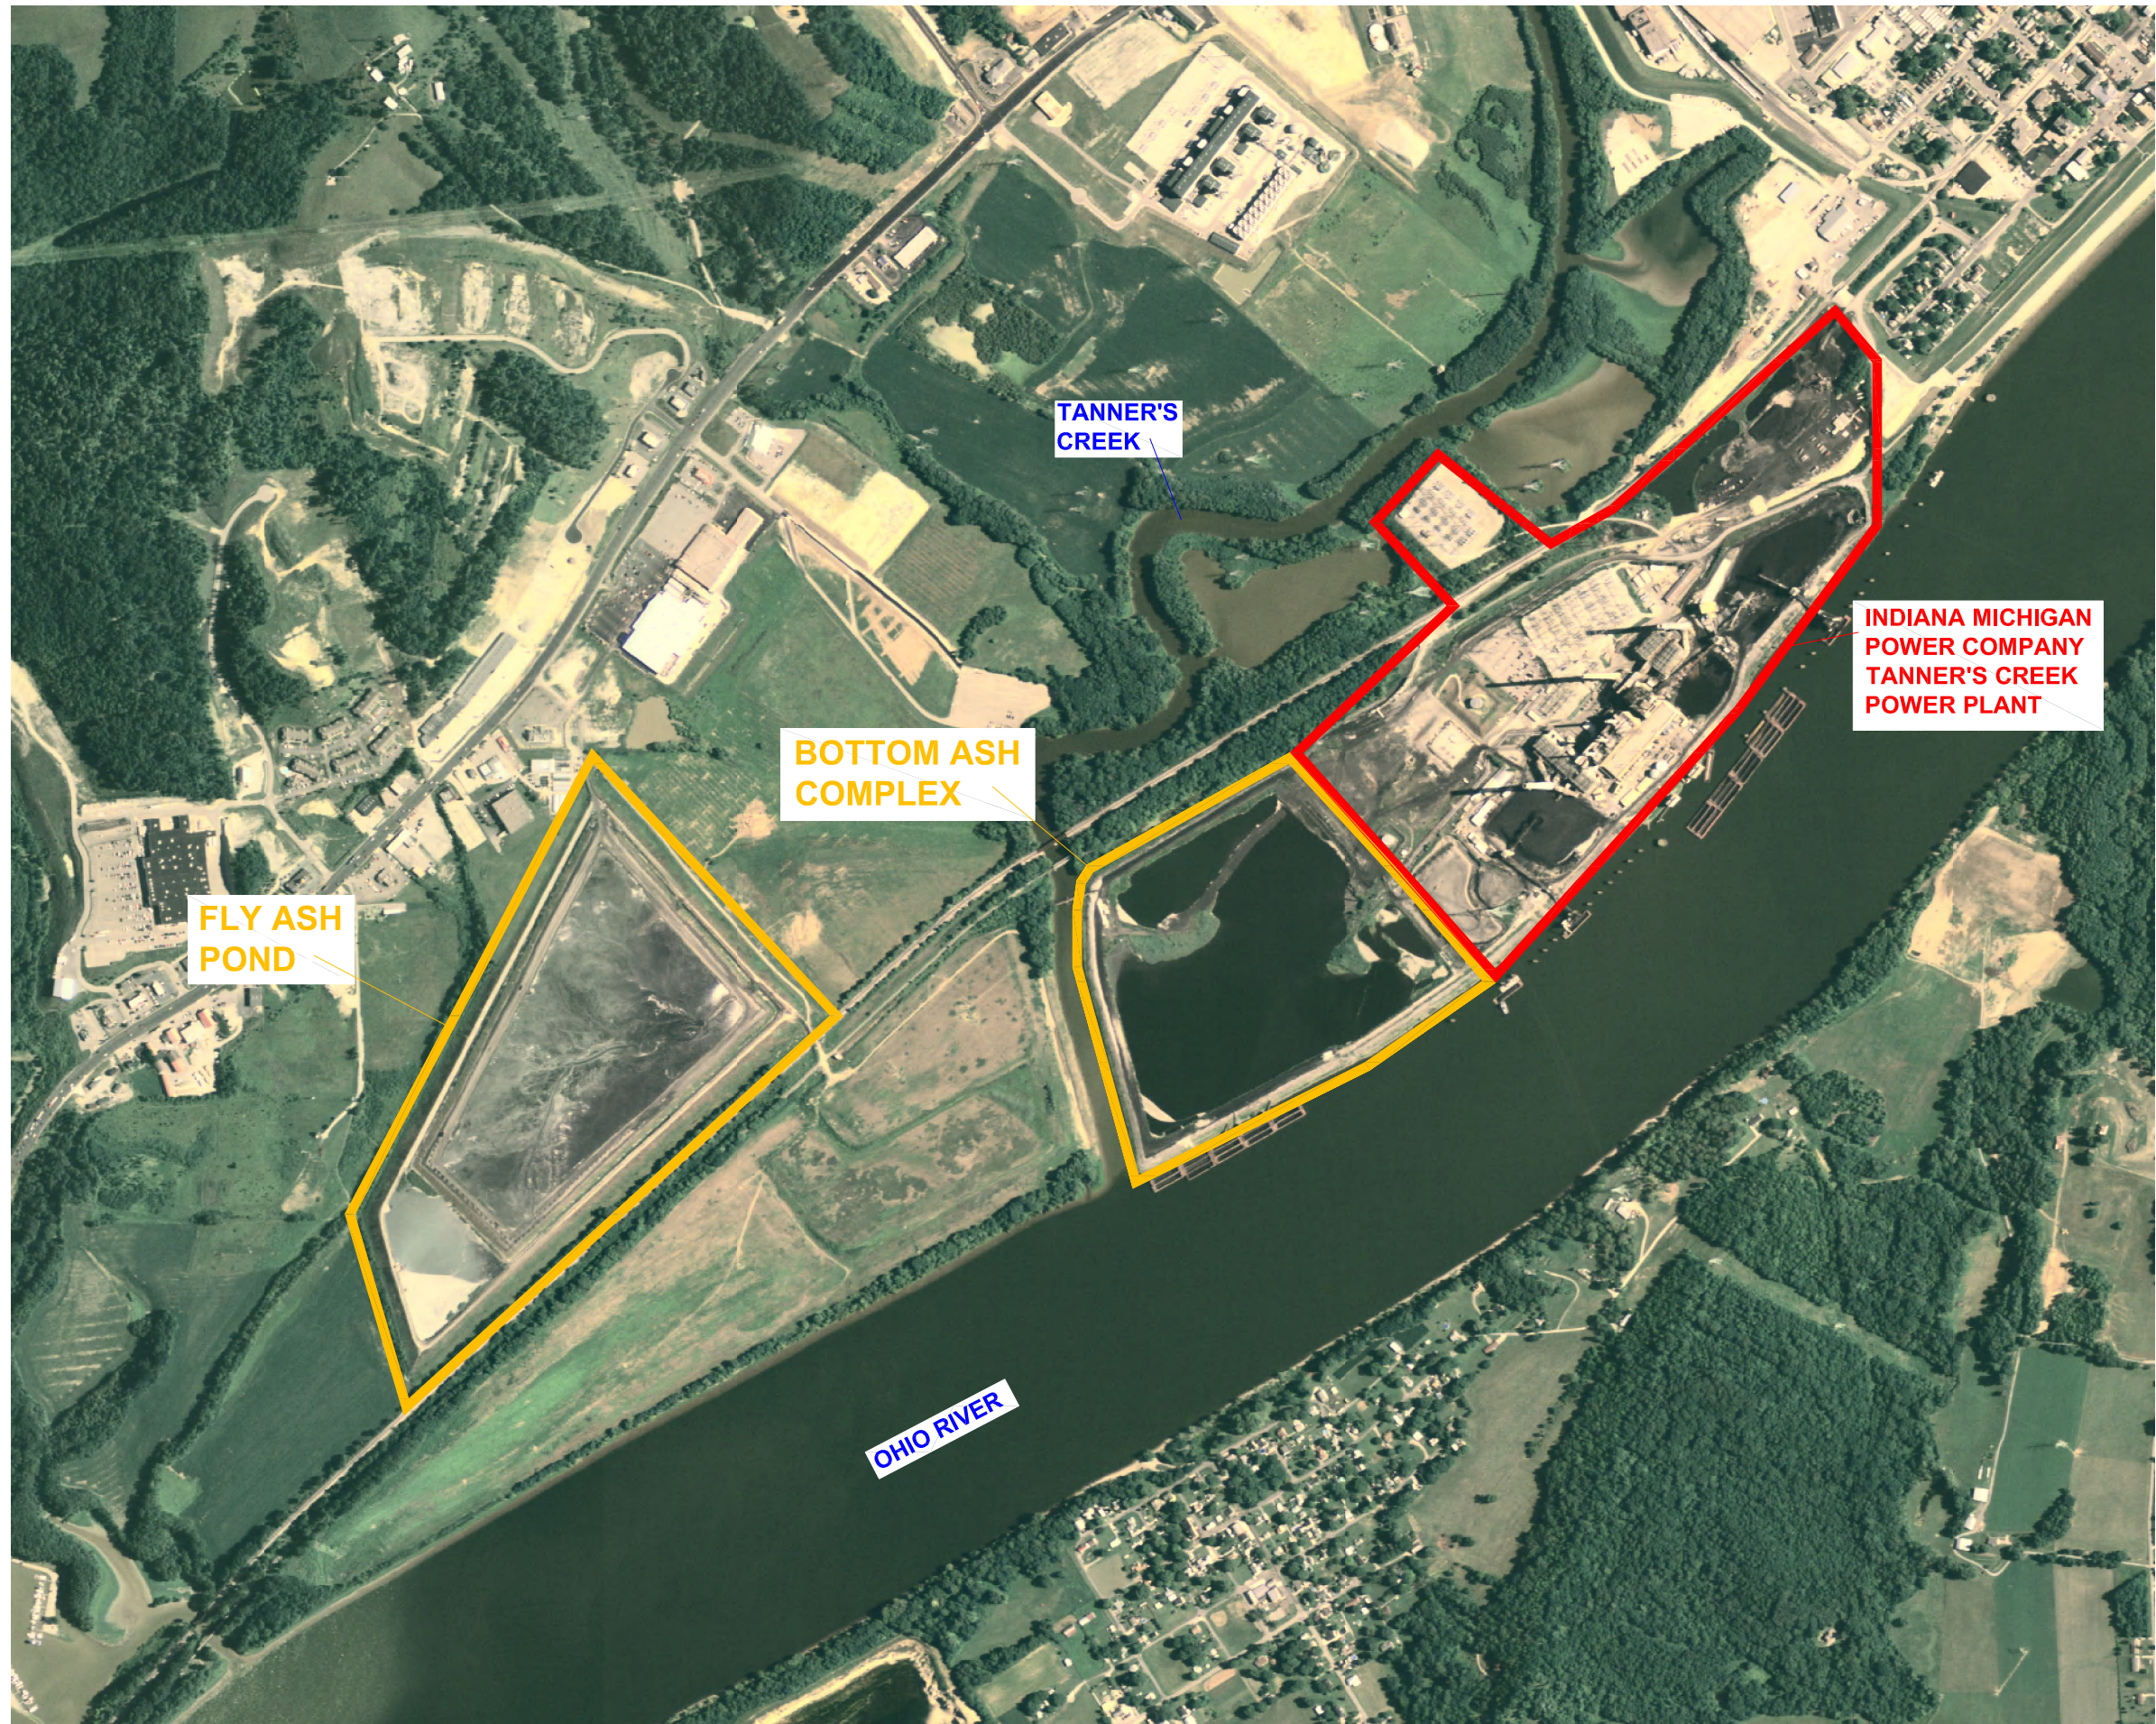
FIGURE 2

- OBSERVATION NOTES (ALSO SEE SECTION 4.2 OF TEXT):
1. SEEPAGE OBSERVED AT MIDSLOPE AND TOE ALONG MAJORITY OF EMBANKMENT
 2. VARIABLE/IRREGULAR SLOPE OBSERVED ALONG MAJORITY OF EMBANKMENT
 3. HEAVY VEGETATIVE GROWTH REMNANTS OBSERVED
 4. BOTTOM ASH MATERIALS OBSERVED ON SURFACE OF SLOPE AT VARIOUS LOCATIONS
 5. ANIMAL BURROWS OF VARIOUS SIZE OBSERVED AT NUMEROUS LOCATIONS ALONG EMBANKMENT
 6. ANIMAL BURROW
 7. WATER FROM SOUTH EMBANKMENT SEEPAGE COLLECTION OBSERVED DISCHARGING FROM OUTLET
 8. MINOR SCARPS OBSERVED
 9. SHRUB TYPE WOODY VEGETATION OBSERVED
 10. ISOLATED SEEP AT ORIGINAL LOCATION OF SEEPAGE COLLECTION SYSTEM DISCHARGE
 11. ISOLATED SEEP AT ABANDONED OUTFALL
 12. EROSION ALONG ROADWAY AT CREST

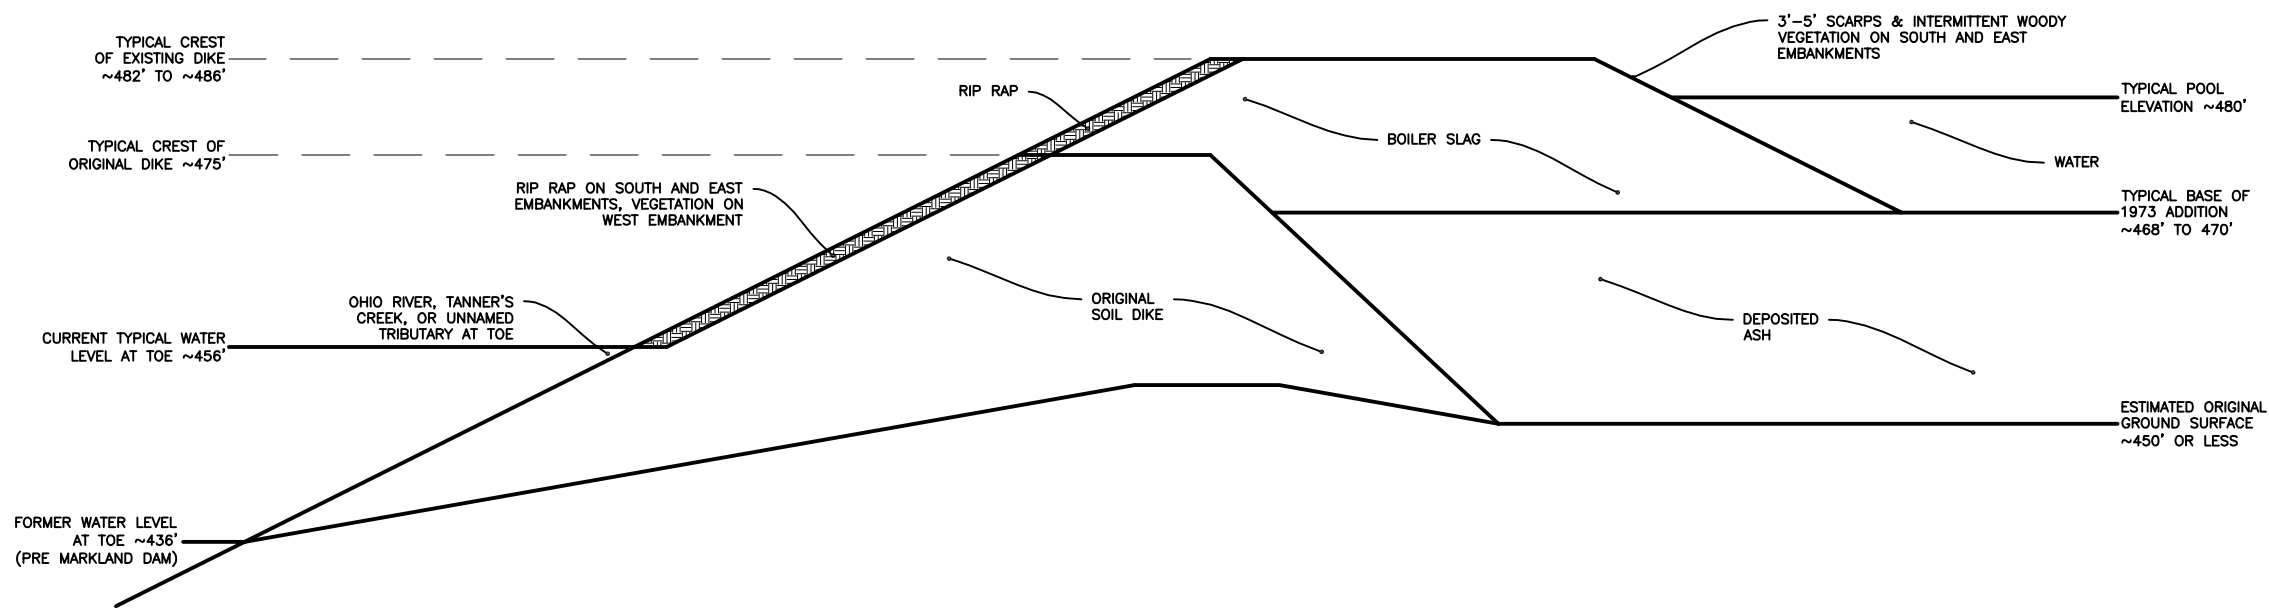
FIGURE 4

A typical embankment cross section is provided as Figure 4 and views of the embankment slopes can be seen in Photos 1 through 4 of Appendix B.

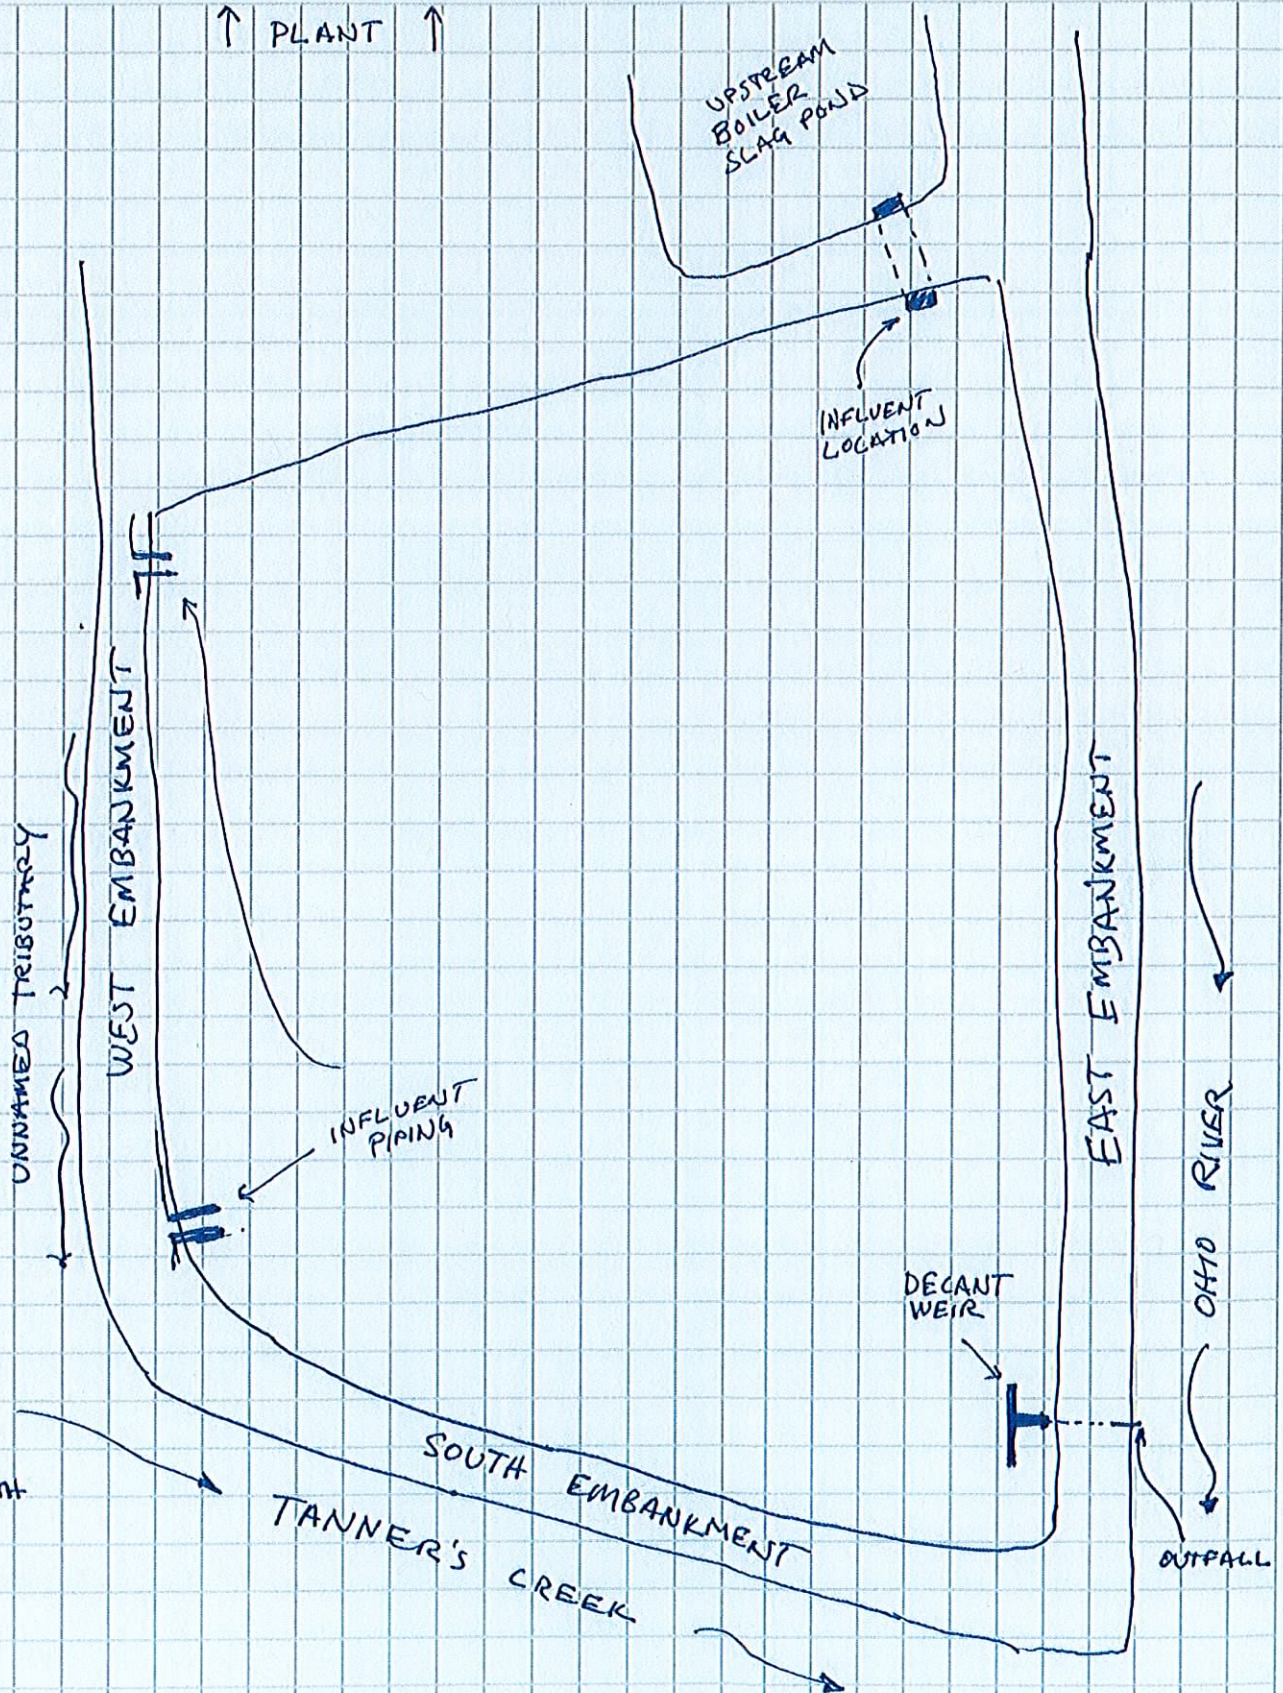
SUBJECT	SHEET	BY	DATE	JOB NO.
BOTTOM ASH COMPLEX - PLAN SKETCH	1/2	JPH	6/3/09	44642

19	A non-uniform surface was observed along entire length of the 'west' embankment. Seepage was observed at the mid-slope and toe along the majority of the length of 'west' embankment. Heavy vegetative growth was recently "brush hogged" on 'west' embankment. Bottom ash materials were observed on the slope at several locations along the 'west embankment' which may have traveled down slope during embankment addition of 1970's.
21	Underdrain is installed in 'south' berm (along Tanner's creek) and seepage was observed from discharge pipe of system.
21	Isolated seepage was observed at two locations along the 'east' embankment (Ohio River side). One location is located where the discharge piping from the 'south' embankment underdrain was formerly located prior to moving to existing location. Another location was observed at location of a former spillway/decant discharge which has been filled in.
21	Widespread seepage was observed nearly continuously at the midslope of the 'west' embankment. The plant reports that a new french drain system is slated for installation along the length of the 'west' embankment later this year.
