**Tanner's Creek Bottom Ash Complex
Assessment Report**

Lockheed Martin

September 2009

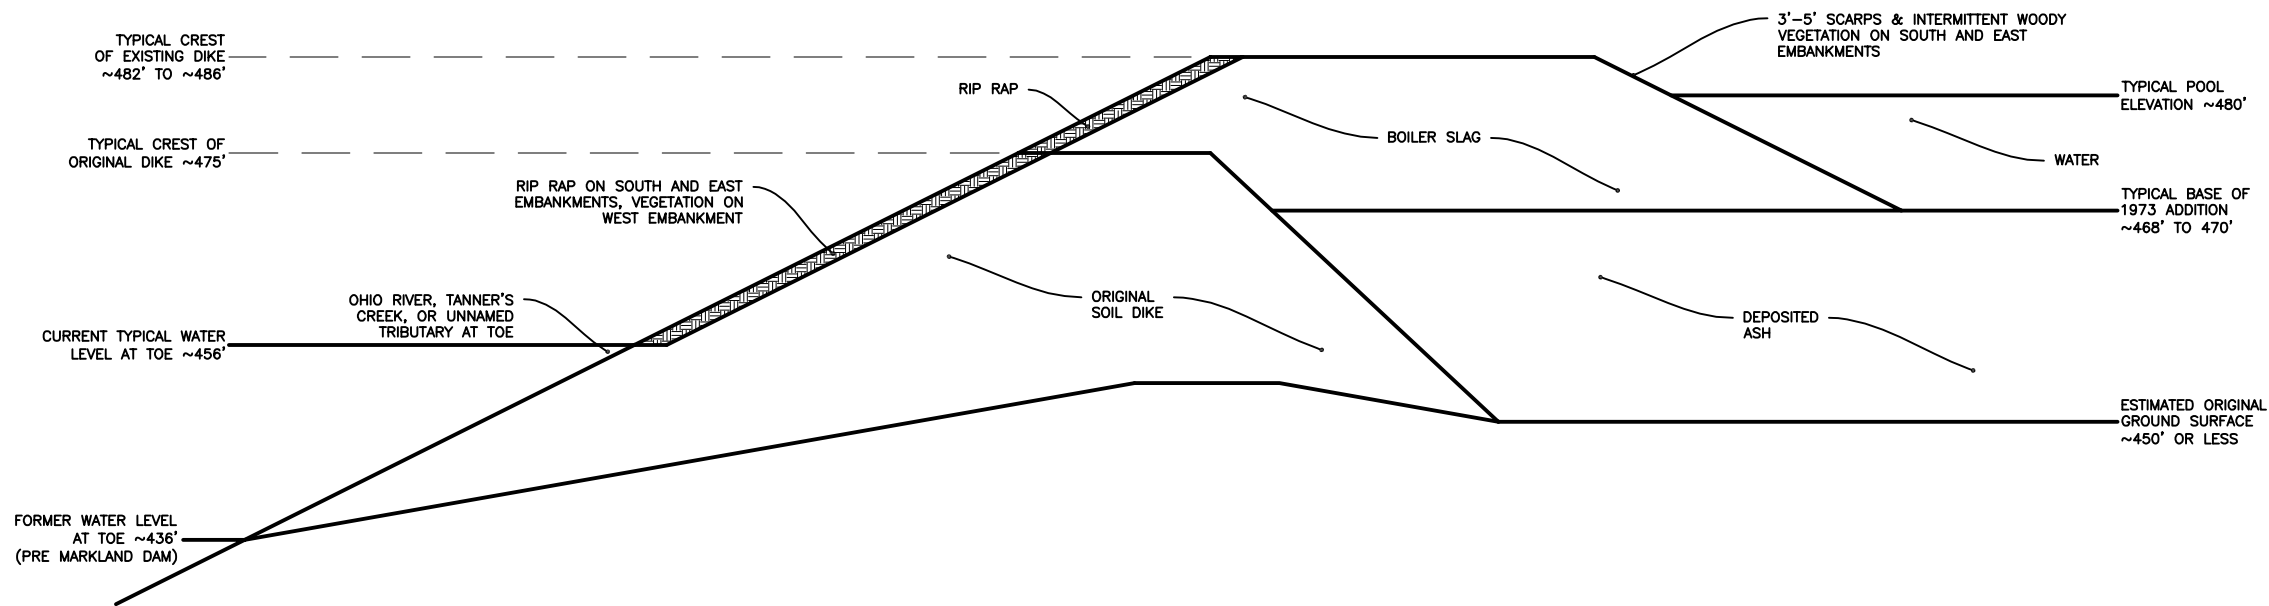
FIGURE 4

- OBSERVATION NOTES (ALSO SEE SECTION 4.2 OF TEXT):
1. SEEPAGE OBSERVED AT MIDSLOPE AND TOE ALONG MAJORITY OF EMBANKMENT
 2. VARIABLE/IRREGULAR SLOPE OBSERVED ALONG MAJORITY OF EMBANKMENT
 3. HEAVY VEGETATIVE GROWTH REMNANTS OBSERVED
 4. BOTTOM ASH MATERIALS OBSERVED ON SURFACE OF SLOPE AT VARIOUS LOCATIONS
 5. ANIMAL BURROWS OF VARIOUS SIZE OBSERVED AT NUMEROUS LOCATIONS ALONG EMBANKMENT
 6. ANIMAL BURROW
 7. WATER FROM SOUTH EMBANKMENT SEEPAGE COLLECTION OBSERVED DISCHARGING FROM OUTLET
 8. MINOR SCARPS OBSERVED
 9. SHRUB TYPE WOODY VEGETATION OBSERVED
 10. ISOLATED SEEP AT ORIGINAL LOCATION OF SEEPAGE COLLECTION SYSTEM DISCHARGE
 11. ISOLATED SEEP AT ABANDONED OUTFALL
 12. EROSION ALONG ROADWAY AT CREST
