**Tanner's Creek Fly Ash Pond
Assessment Report**

**Lockheed Martin
Contractor for the USEPA**

September 2009

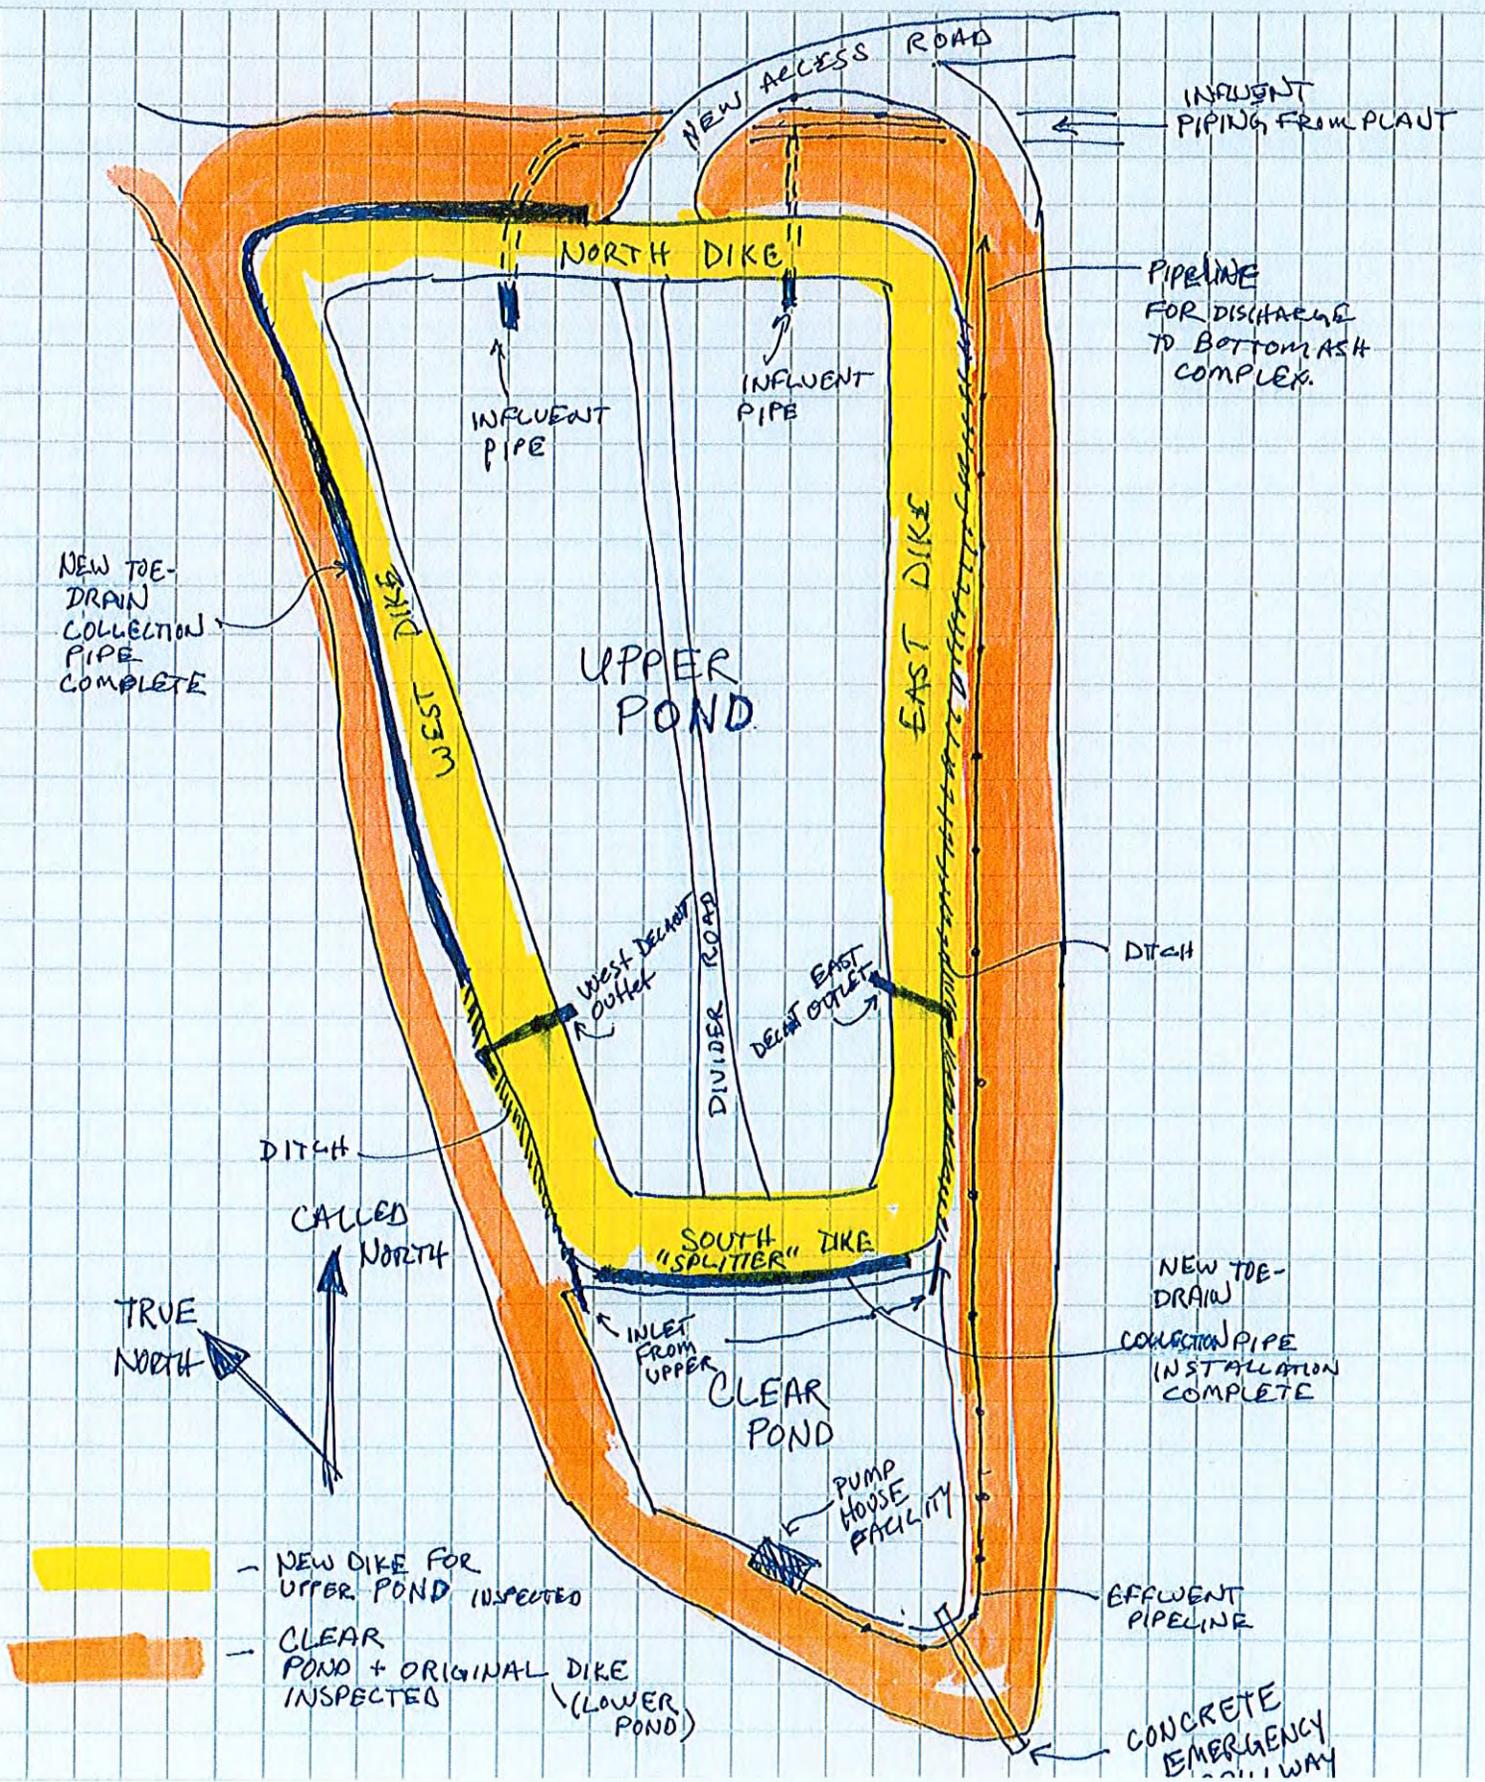
SUBJECT PLAN SKETCH - FLY ASH POND	SHEET 1	BY JPH	DATE 6/3/09	JOB NO. 44642
---------------------------------------	------------	-----------	----------------	------------------

17	Numerous minor scarps were observed along the top of the upstream side of the 'east' and 'south' embankment slopes. Scarps are typically 3' in height and are made more prominent by the addition of roadway aggregate on the embankment crest.
20	Fly Ash Pond not in operation at time of inspection
21	The base of the dike is constructed with a porous gravel toe drain that is designed to collect embankment seepage. A slotted drainpipe is currently being installed at downstream toe around perimeter of dike to replace the existing ditch which conveys the embankment seepage to the outlet.
23	During inspection, the upper pond was filled to capacity with fly ash and fully drained of free surface water. However, when receiving new fly ash, or in an extreme precipitation event, the level of the clear pond (lower pool) may be elevated and this water may rest against the toe of the 'south' (splitter) dike.

- NEW DIKE FOR UPPER POND INSPECTED
- CLEAR POND + ORIGINAL DIKE INSPECTED (LOWER POND)
