**Coal Combustion Residue Impoundment  
Round 11 - Dam Assessment Report**

*Allen Fossil Plant*

*Tennessee Valley Authority*  
**Memphis, Tennessee**

**August 2012**

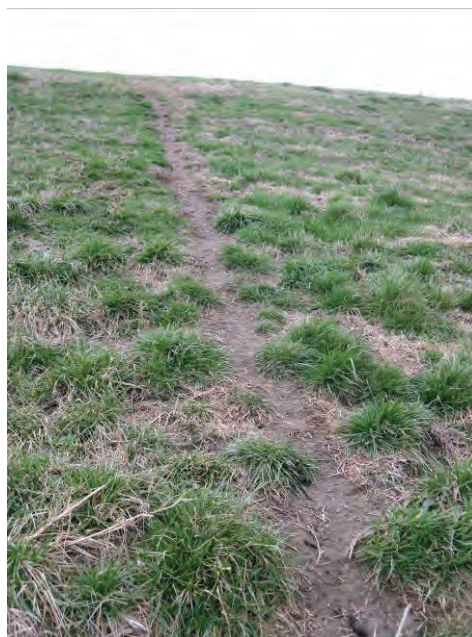
Drawing Mark EASP-3

Access ramp to crest on southeast corner of pond. Note the erosion on the ramp.
