**Coal Combustion Residue Impoundment
Round 11 - Dam Assessment Report**

Allen Fossil Plant

Tennessee Valley Authority
Memphis, Tennessee

Dewberry Consultants LLC
Fairfax, Virginia

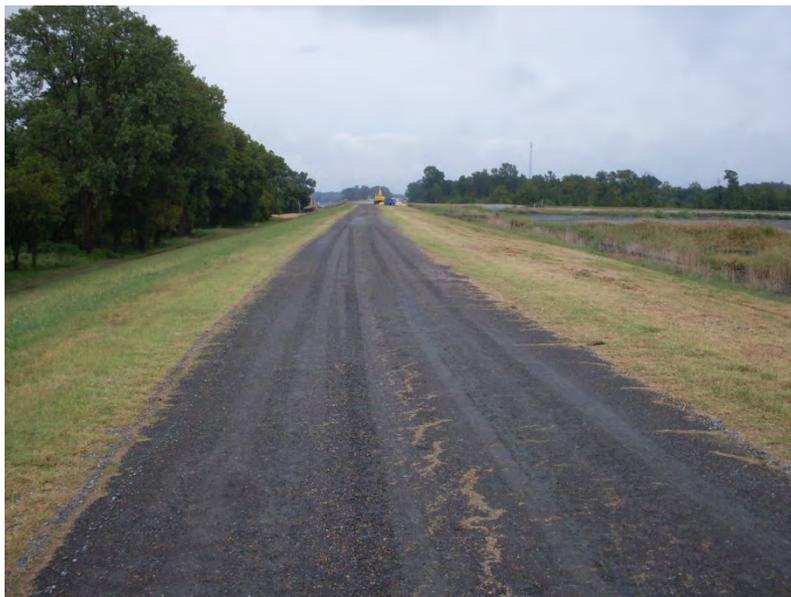
The crest of the East Ash Pond (EAP) perimeter dike is accessible by automobile. The crest of the perimeter dike south side was observed to be extra wide, accommodating the ash/gravel-surfaced crest road as well as railroad siding, as shown in Photo 5.1. The embankment at the railroad siding is minimum, See Photo 5.1. TVA reported that the tracks are rarely used. The majority of the coal is barged in. This photo also shows water ponded in a wide shallow depression. The shallow depression appeared to be due to wear of the surface caused by haul trucks turning into the dredge cell. A more typical view of the crest condition is shown by Photo 5.2, which is a view of the crest on the perimeter dike north side. Overall, the perimeter dike crest was observed to be in good condition. No major depressions (caused by settlement), sags, tension cracks, or other signs of significant settlement or mass soil movement were observed.

Photo 5.2: EAP Perimeter dike crest north side, looking east.

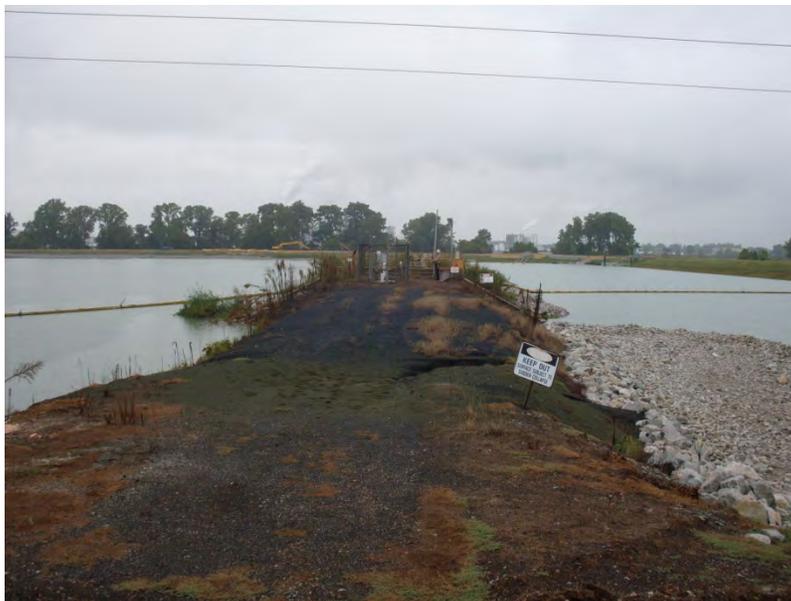
The crest of the divider dike between the perimeter dike south side and the spillway was observed to be eroded at the south end, as shown in Photo 5.3. The crest of the divider dike between the spillway and the perimeter dike north side appeared to be in satisfactory condition.

Photo 5.3: EAP Divider dike crest south end, looking north. Note gully erosion in the bottom ash embankment.

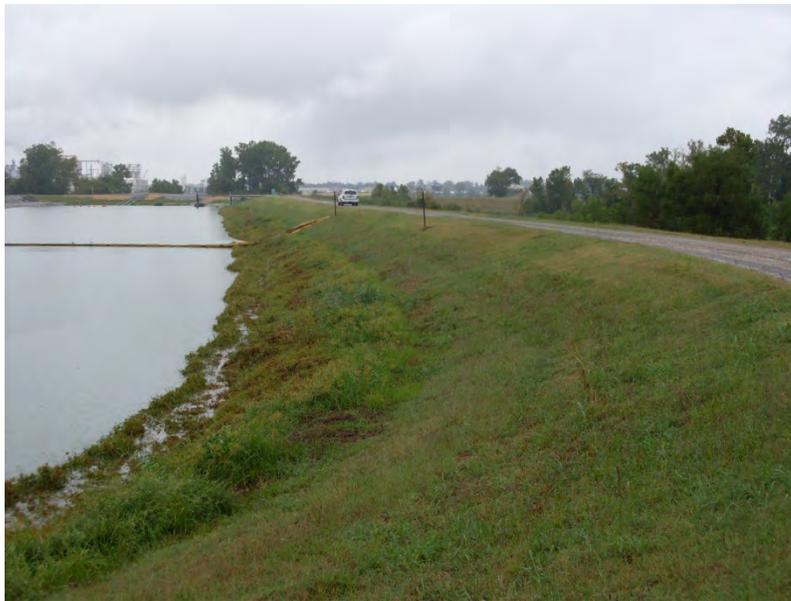
Photo 5.5: EAP Perimeter dike inside slope east side (stilling pond), looking north.

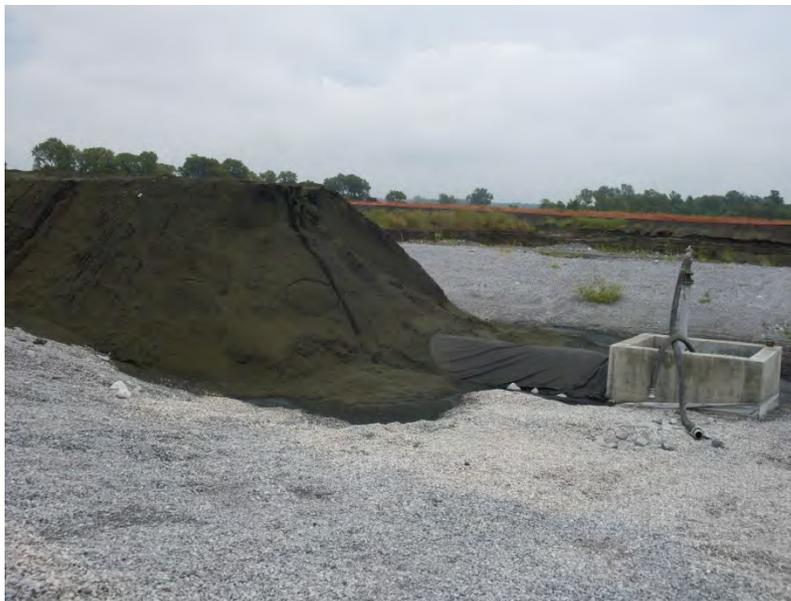
Investigation of a depression that had developed in the ash surface in the dredge cell of the East Ash Pond in early December 2010 led to the discovery of damage to the active 30-inch diameter ductile iron pipe (DIP) sanitary sewer line that passes under the cell. Plans to construct a temporary bypass with a 30-inch HDPE line were developed by Stantec, as shown by selected drawings in Appendix A Doc 12. Construction of the bypass had been essentially completed by the time of Dewberry's site visit. The new 30-inch runs south to north across the majority of the East Ash Pond. A protective dike is over the line with a minimum cover of 2 feet. The bottom of the pipe is above the normal pool elevation.

Photo 5.9: EAP South end of temporary bypass construction for active sanitary sewer under dredge cell.

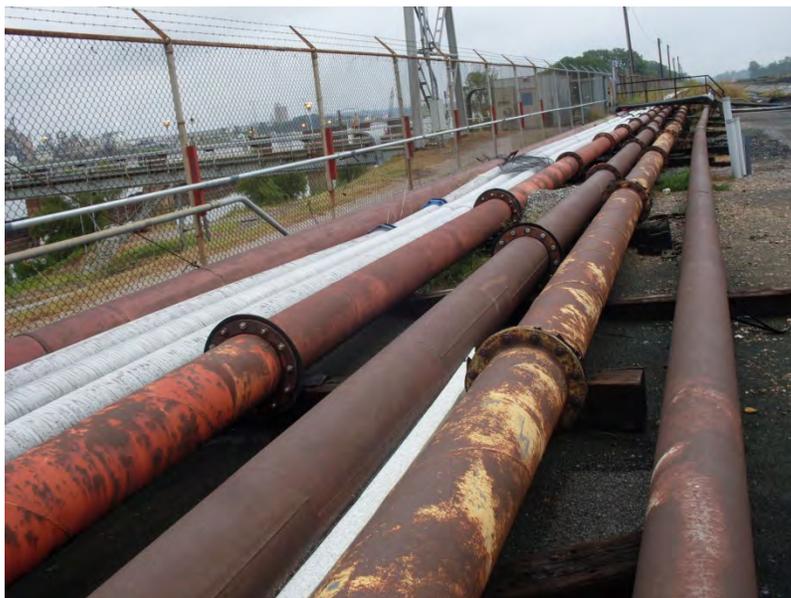
Photo 5.10: EAP View of ash sluice lines and plant process water line (leftmost) extending from the plant to the active pond, looking east. Rightmost line is abandoned.

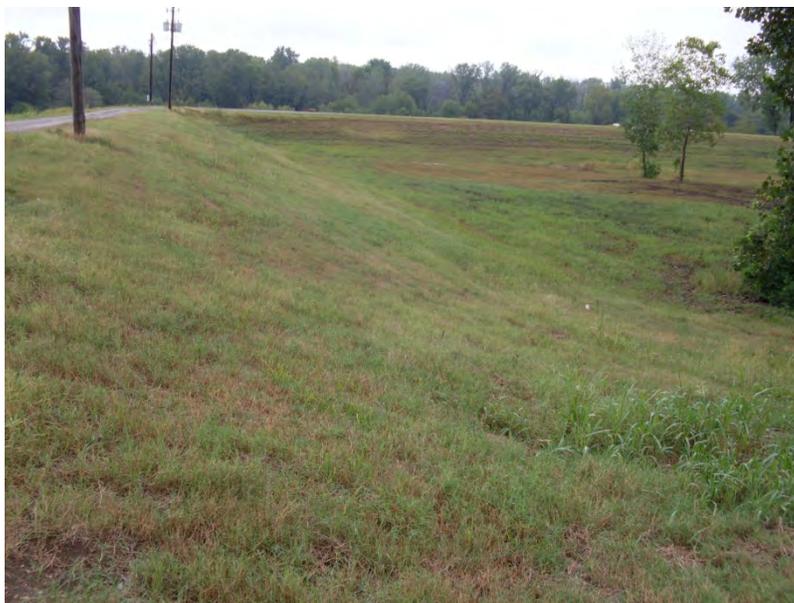
Photo 5.11: WAP Typical view perimeter inside slope west side, viewed north.

At the West Ash Pond (WAP) the inside slopes were observed to have a well-maintained cover of grass, as shown by the typical view in Photo 5.11. The inside slopes were in satisfactory condition. The interior of the inactive pond was observed to have some scattered trees, but the area was clear of brush and undergrowth and covered with a well-maintained grass cover, as shown in Photo 5.12. It was observed that the eastern part had been filled in with what appeared to be dry ash, as shown in Photo 5.13. The piles of stones on the barren surface had been placed to discourage nesting of the Least Tern in close proximity to the plant.

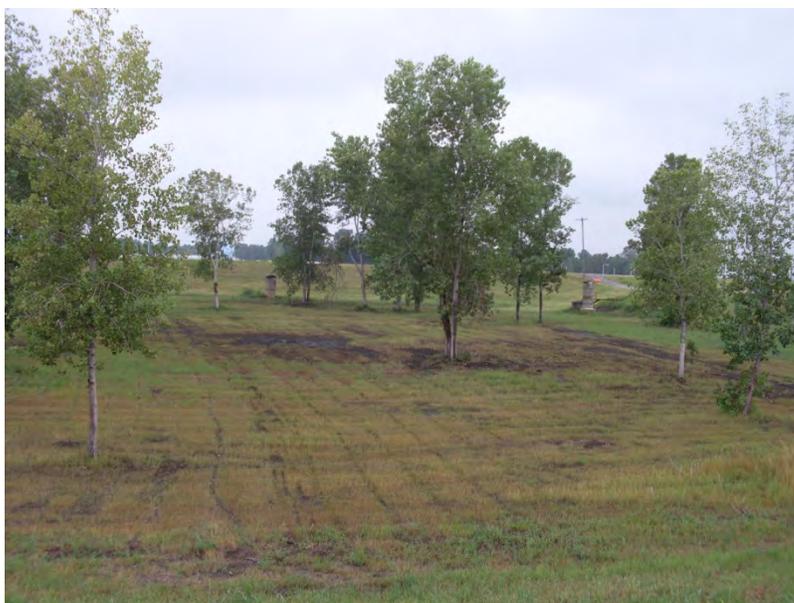
Photo 5.12: WAP Typical view of inactive pond area, viewed south.

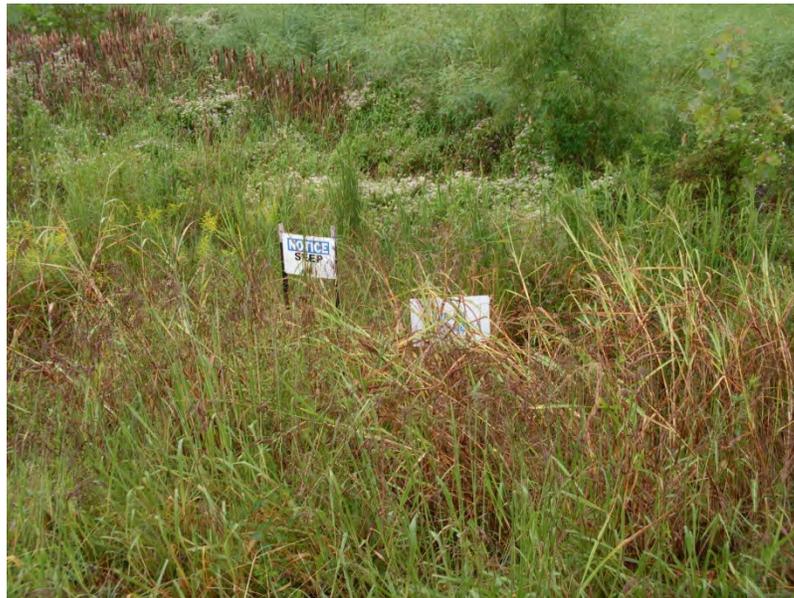
The outside slopes of the East Ash Pond perimeter dike were observed to be in satisfactory condition with no areas of major erosion and no obvious signs of slumps, slides, bulges, tension cracks, significant seepage, or animal holes. No woody vegetation was observed on the outside slopes. A view of the outside slope of the perimeter dike east side is shown in Photo 5.14 and is typical of the outside slopes. The area of a previously observed seep, posted with a sign, at the toe of the perimeter dike east side is shown in Photo 5.15. At the time of the site visit there appeared to be no seep or wet soil in this area, although tall grass and weeds in the area

Photo 5.15: EAP Perimeter dike outside toe east side, identified seep area.

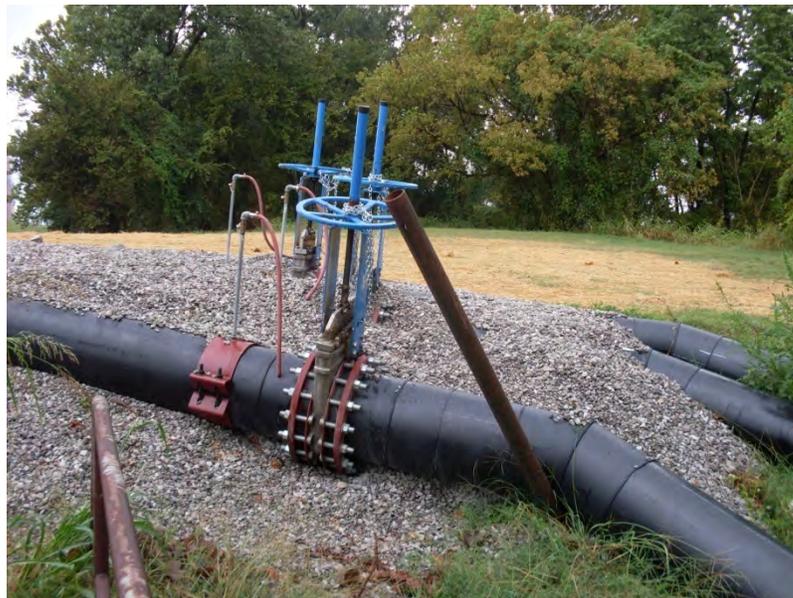
improvements at the stilling pond and will remain in place. The siphons and associated gate valves are shown in Photos 5.25 and 5.26 (see also outlet ends of siphons in Photo 5.23). The siphons and associated gates and hardware were observed to be in satisfactory condition.

Photo 5.26: EAP Gate valves in siphons, looking west.

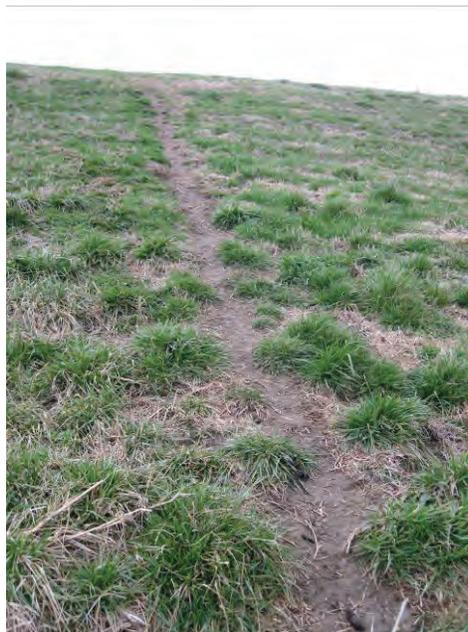
Drawing Mark EASP-3

Access ramp to crest on southeast corner of pond. Note the erosion on the ramp.

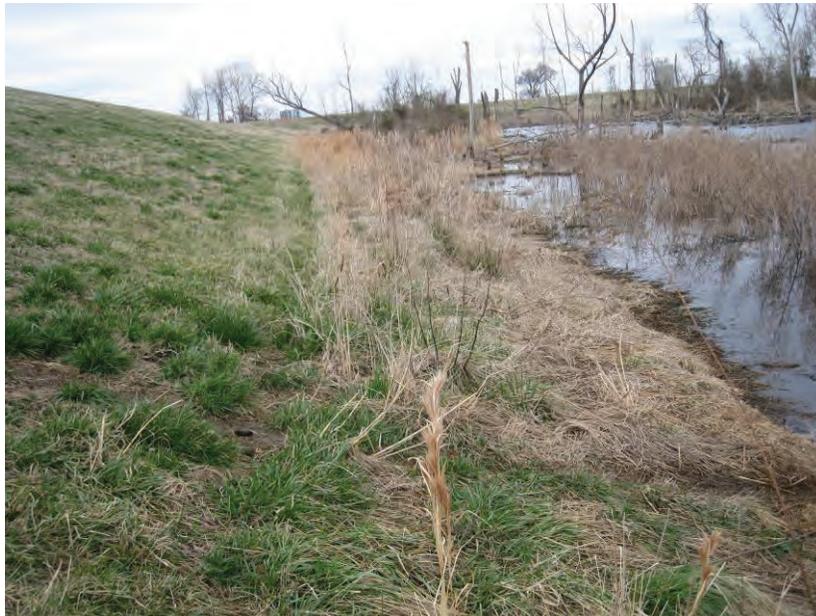
Drawing Mark EASP-4

Eastern embankment has animal paths extending from toe of exterior slope to water surface of interior slope.

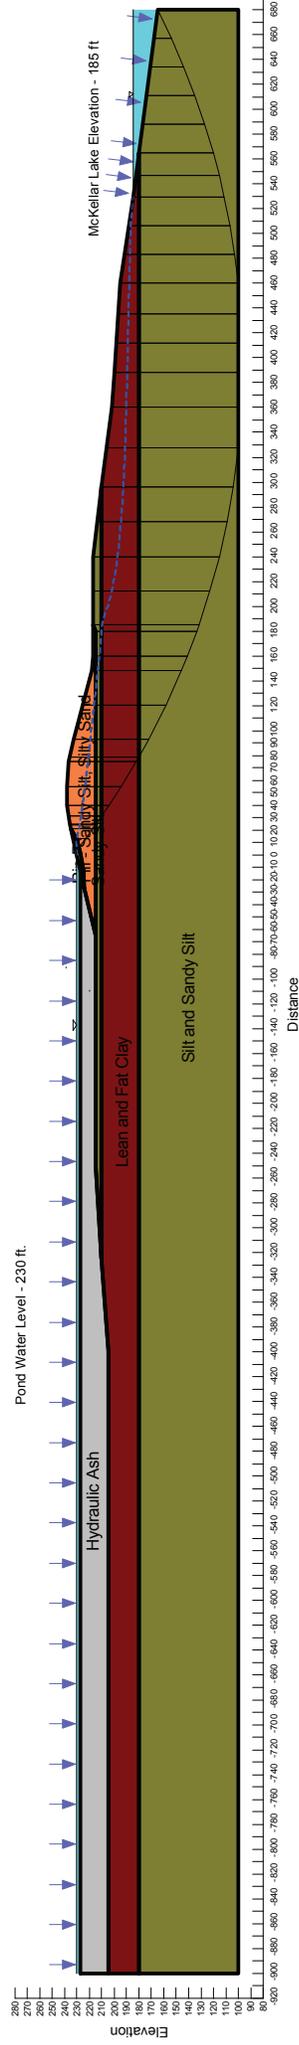
**Pseudostatic Slope Stability Analysis
CCP Storage Facilities - Existing Conditions
Tennessee Valley Authority Fossil Plants**

Factor of Safety: 0.73

Horizontal Seismic Coefficient $K_h = 0.127 g$
500-year Return Period Event

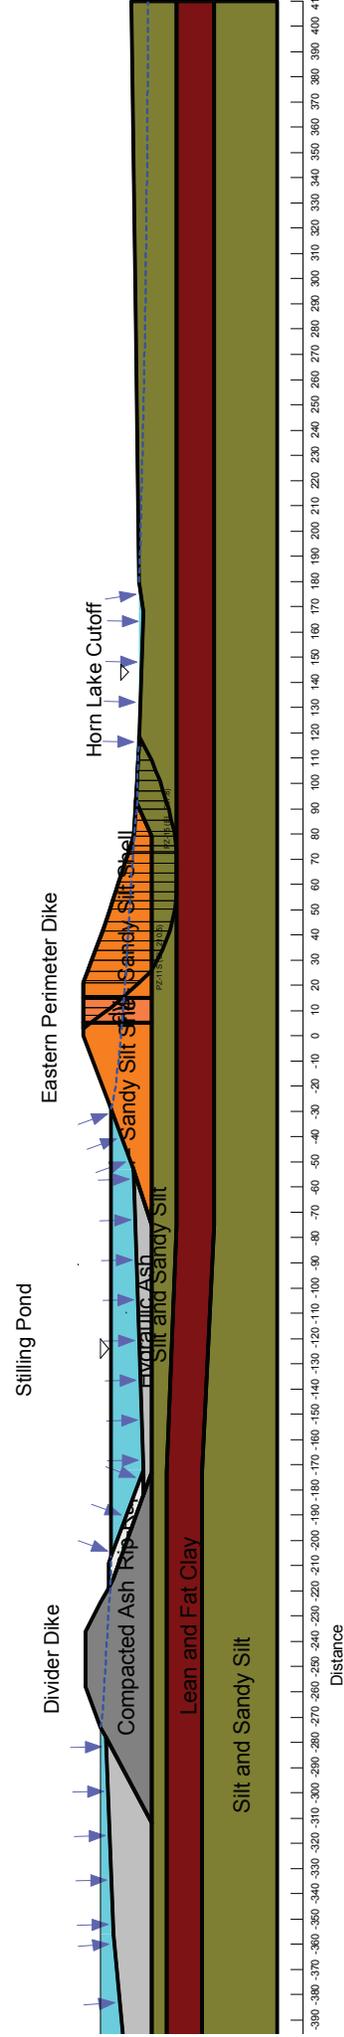
**Pseudostatic Slope Stability Analysis
CCP Storage Facilities - Existing Conditions
Tennessee Valley Authority Fossil Plants**

Deep Failure Circle

Factor of Safety: 0.90
Horizontal Seismic Coefficient $K_h = 0.127 g$
500-year Return Period Event

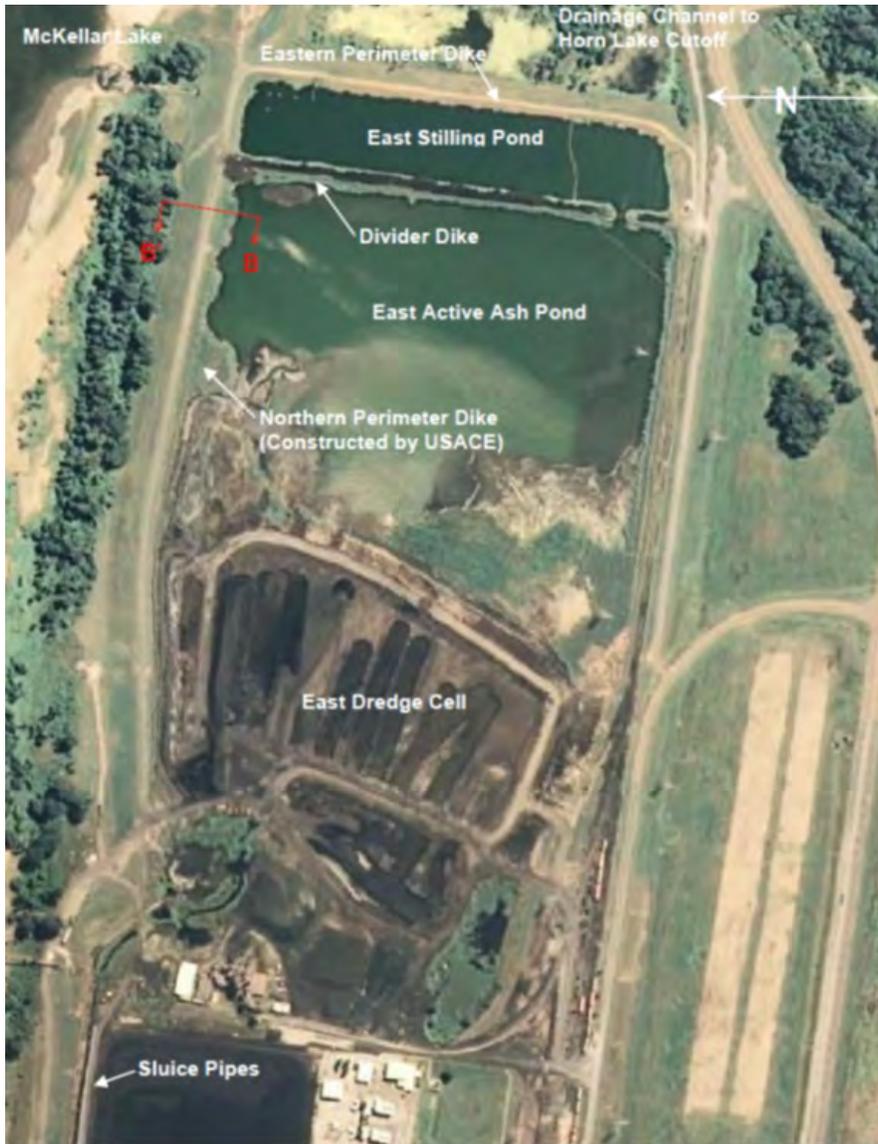
Figure 1: Site Layout for Allen Fossil Plant

Consistent with previously submitted seismic analysis, cross section B-B' along the northern perimeter dike system of the east active ash disposal area was analyzed. Please refer to Figure 1 for an aerial image of the east active ash disposal area facility layout as well as the location of cross section B-B'.

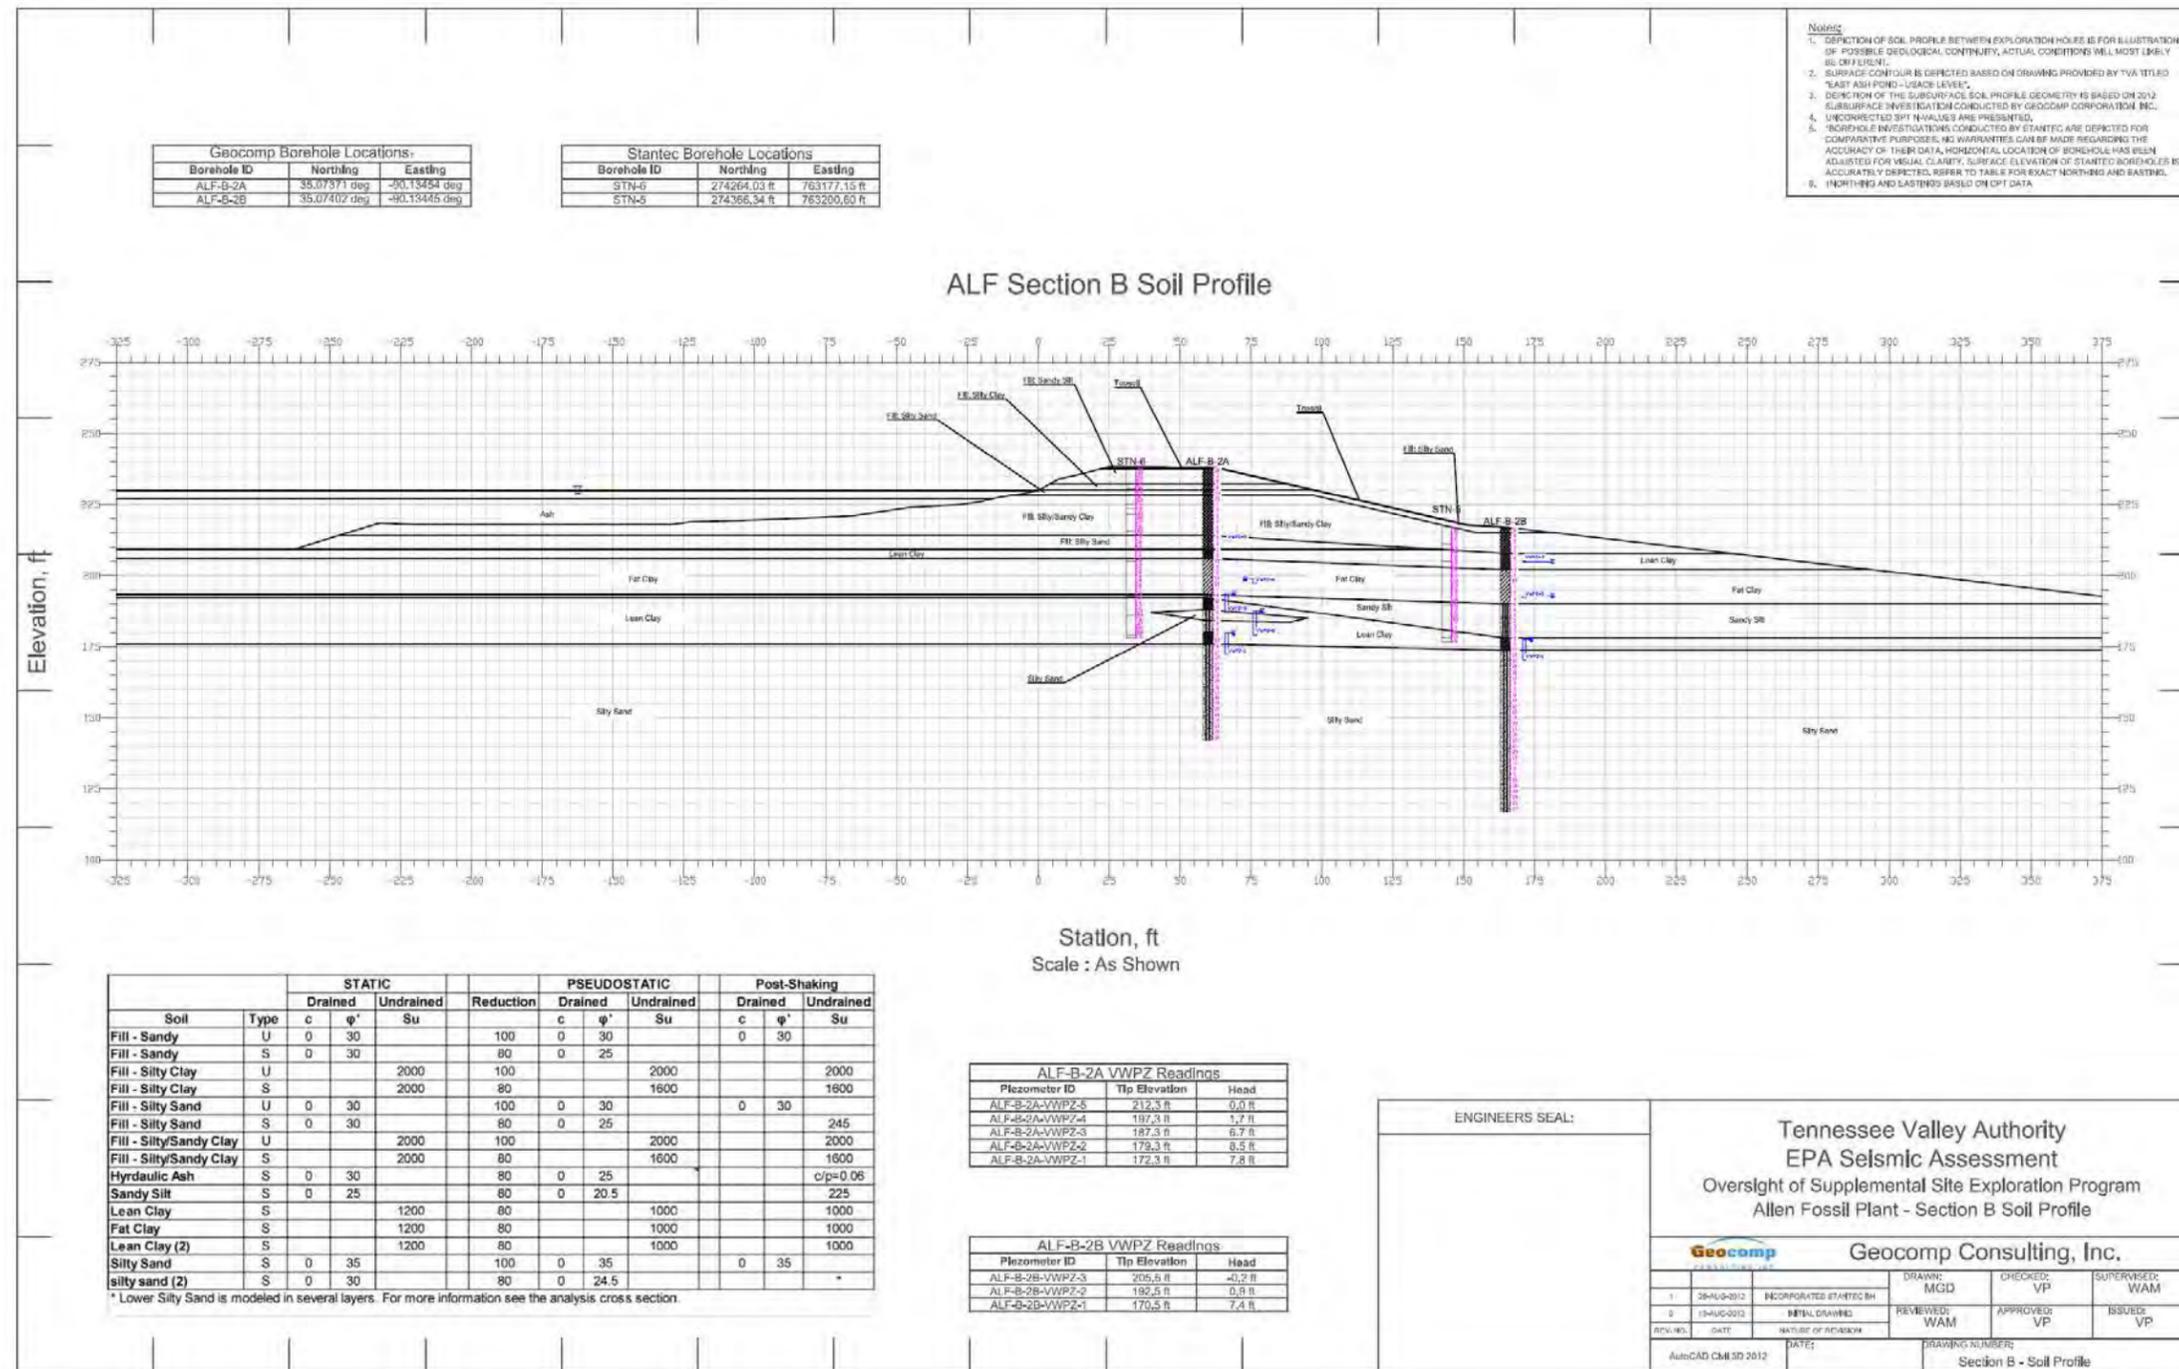
Figure 2: Representative Cross Section for ALF East Ash Disposal Area

Figure 2 provides the cross section details developed from the existing information and the additional information obtained during the supplemental site investigation program. A significant result from the field investigation was the determination that pore pressures are significantly less than hydrostatic throughout the cross section. This means that effective stresses are higher and correspondingly soil strengths are higher than what is obtained if pore pressures are assumed to be hydrostatic below the top phreatic surface.

Figure 2 also includes a table that summarizes the soil strength parameters. A major effort was devoted to determining soil strength parameters with current state-of-practice methods. SPT testing was done under the observation of a geotechnical engineer or geologist to help ensure that all test conditions met the requirements of ASTM D1586. Cone penetration testing with shear wave velocity measurements was done to help define the layering and strength characteristics of the various soil layers. Field vane tests were run to measure in situ shear strength. Laboratory tests were run to determine undrained shear strength of cohesive strengths. Results of a laboratory test program on fly

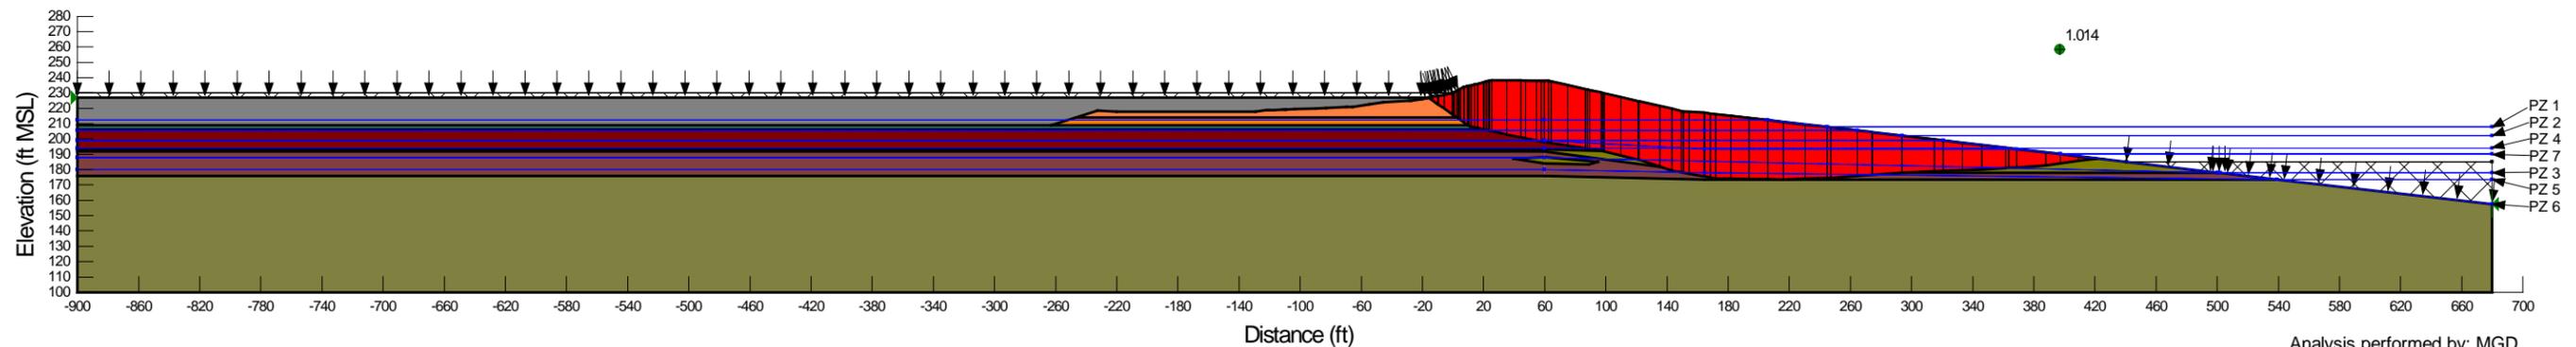
Factor of Safety: 1.014
Horizontal Seismic Coefficient: 0.185

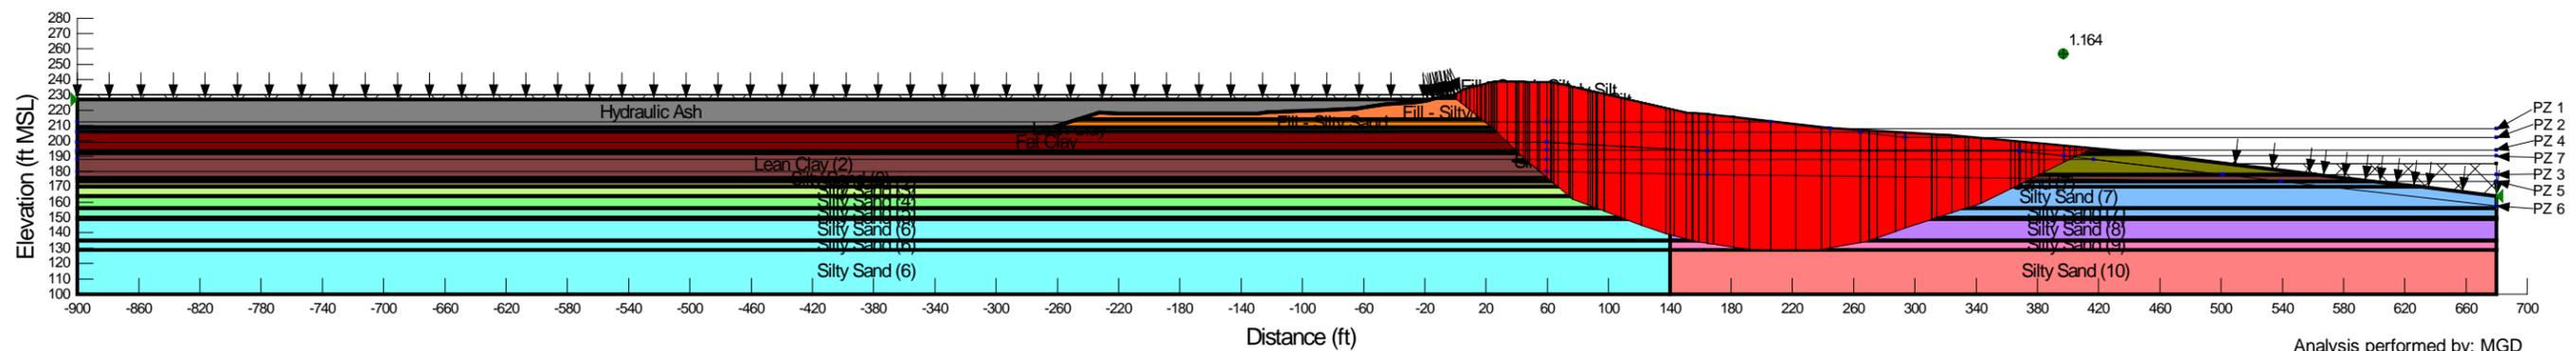
Factor of Safety: 1.164

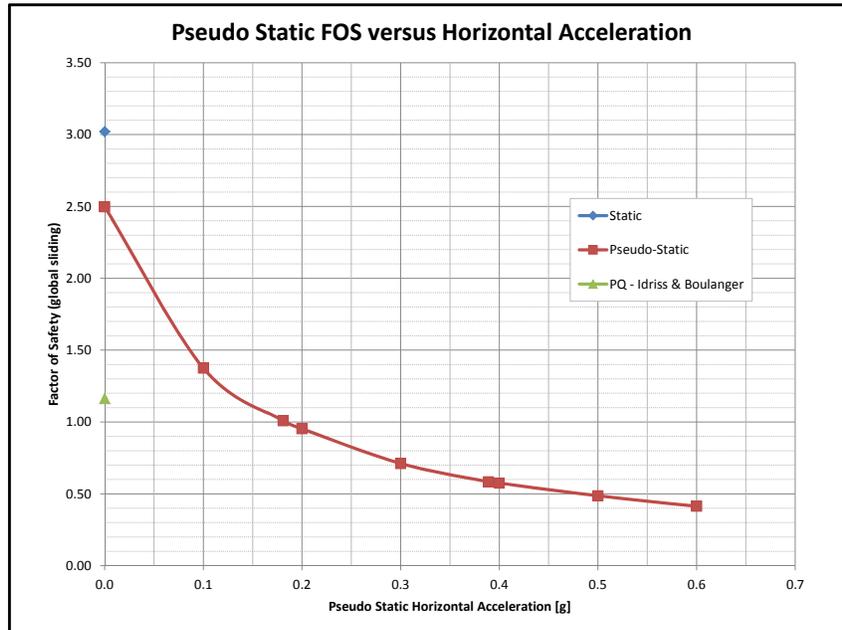
Global Stability Analysis Results

Horizontal Acceleration, K [g]		0.0	0.1	0.181	0.2	0.3	0.389	0.4	0.5	0.6
Static	Factor Of Safety	3.02	---	---	---	---	---	---	---	---
Pseudo-Static	Factor Of Safety	2.50	1.38	1.01	0.95	0.71	0.58	0.58	0.49	0.41
PQ - Idriss & Boulanger	Factor Of Safety	1.16	---	---	---	---	---	---	---	---
