## **Coal Combustion Residue Impoundment Round 11 - Dam Assessment Report**

Bull Run Fossil Plant (#002) CCR Impoundment Areas 1, 2, 2A Tennessee Valley Authority Clinton, Tennessee

United States Environmental Protection Agency Office of Resource Conservation and Recovery

Dewberry & Davis, LLC Fairfax, Virginia

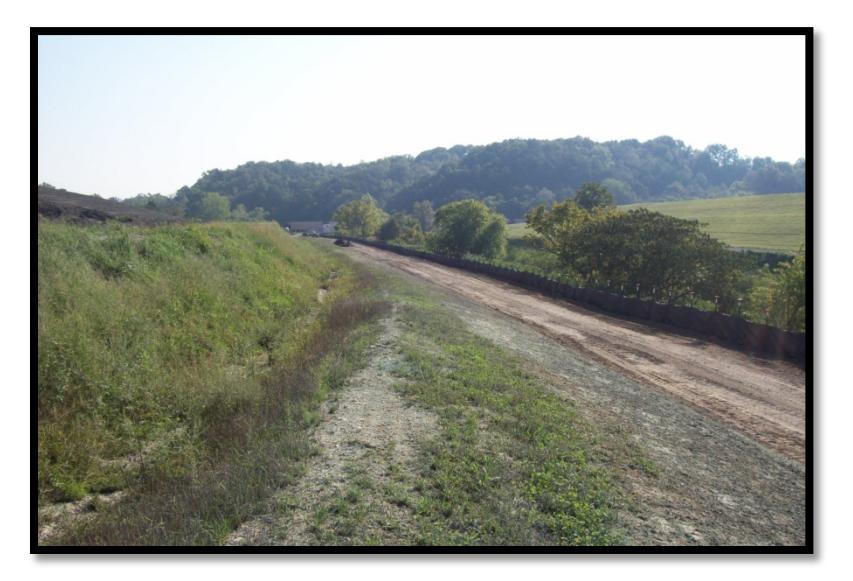
The crest of the embankment had no signs of significant depressions, tension cracks or other indications of settlement or shear failure. Figure 5.2.1-1 and Figure 5.2.1-2 shows the typical crest conditions along the embankment.

**Figure 5.2.1-1:** Crest of Area 1 Lower South Dike (original dike), East. Drainage channel (WOUS) to the right.

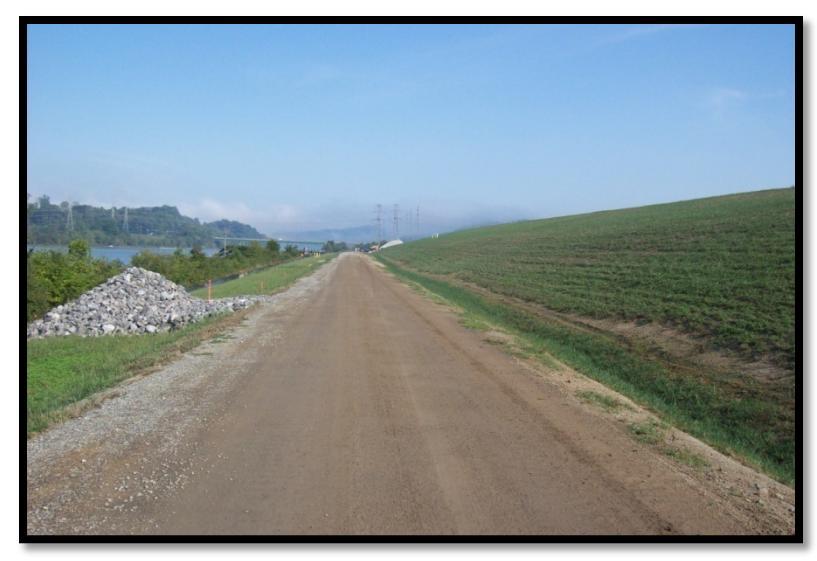
**Figure 5.2.1-2:** Crest of Area 1 Lower West Dike (original dike), Northwest. Clinch River to left.

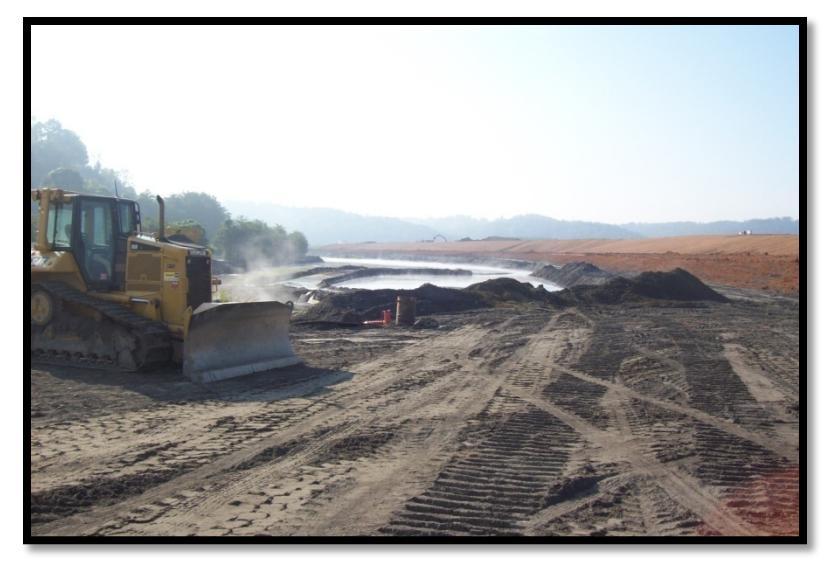
Area 1 is primarily composed of bottom ash stack. The Area 1 stack is adjacent to a portion of the sluice ditch that receives and transports sluiced ash to Area 2. The interior slopes of the sluice ditch (where it extends parallel to the Area 1 stack) as well as the Area 1 stack interior slopes appear stable and maintained, despite the lack of vegetative cover or riprap lining. The stack is covered with what appeared to be a lining of topsoil. The operating pool elevation for the sluiced ditch is 806.5 ft, consequently only 7-8 ft of the inside slope was visible during the site visit. There were no observed scarps, sloughs, bulging, cracks, depressions or other indications of slope instability. Figures 5.2.2-1 and 5.2.2-2 show a section of the Area 1 stack and sluice ditch inside slope.

**Figure 5.2.2-1:** Upstream slope of Area 1 Stack/Sluice Ditch, South.

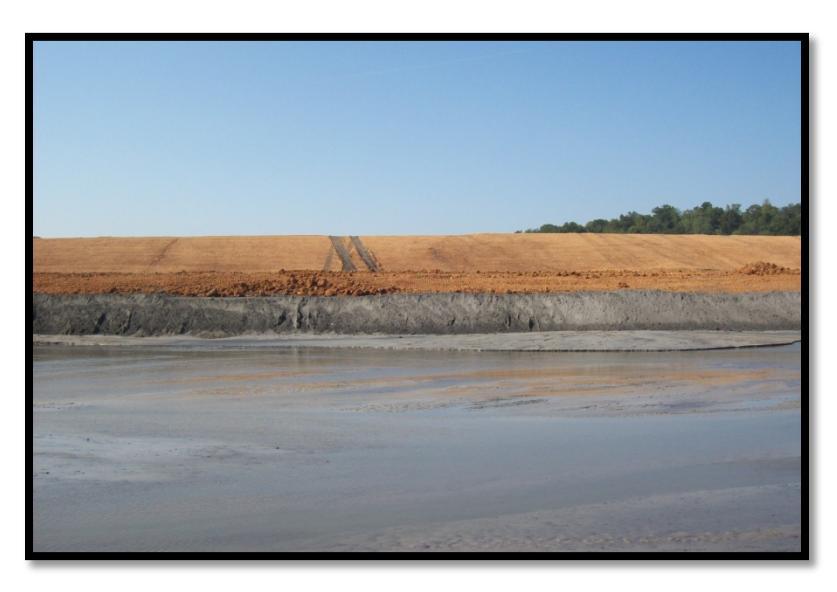
**Figure 5.2.2-2:** Upstream slope of Area 1 Stack/Sluice Ditch, West.

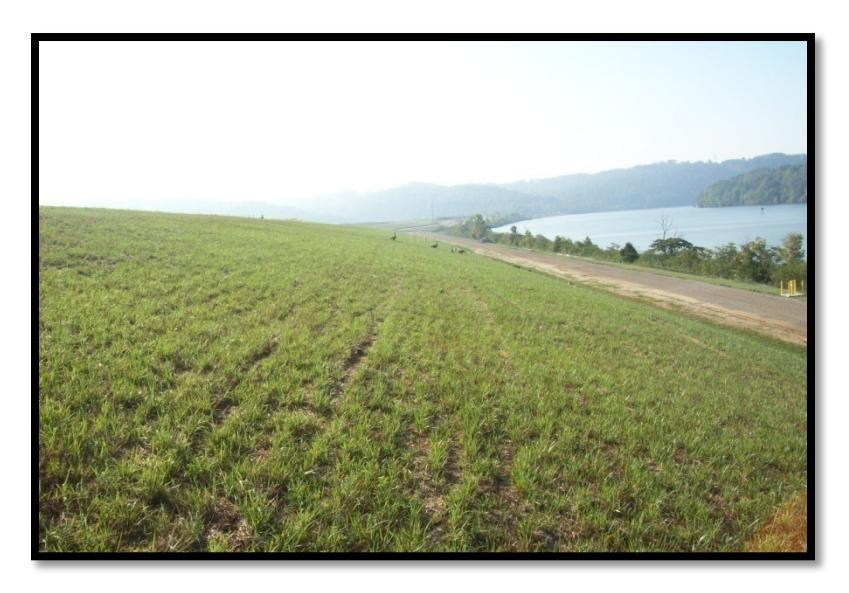
The outside slope of the embankment appeared to have a fairly well maintained cover of grasses/weeds. The lower portion of the outside slope is covered with a riprap blanket. Trees and shrubs are growing on these lower portions of the outside slope, along both the west and south slopes. Maintenance work to remove trees and replenish riprap blanket was under way at the time of the site visit. A gravel access road wraps around the middle outside slope, inside stack slope and crest of the embankment. No scarps, sloughs, bulging, cracks,

depressions or other indications of slope instability were observed along the slope. Figures 5.2.3-1 through 5.2.3-3 show representative sections of the embankment.

**Figure 5.2.3-1:** Downstream slope of Area 1 showing gravel perimeter access road, Southwest. Note trees and shrubs along lower portions of the slope.

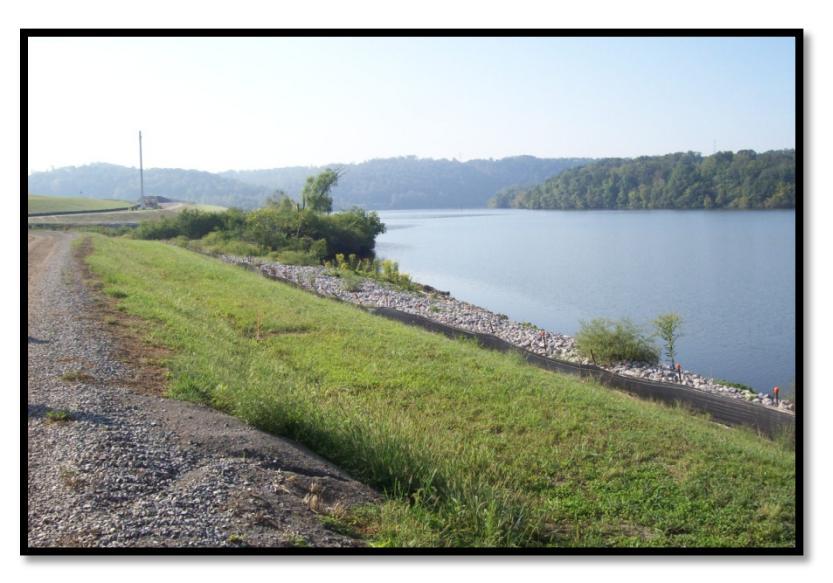
**Figure 5.2.3-2:** Lower portion of Area 1 downstream slope, Southwest. Note riprap blanket along slope.

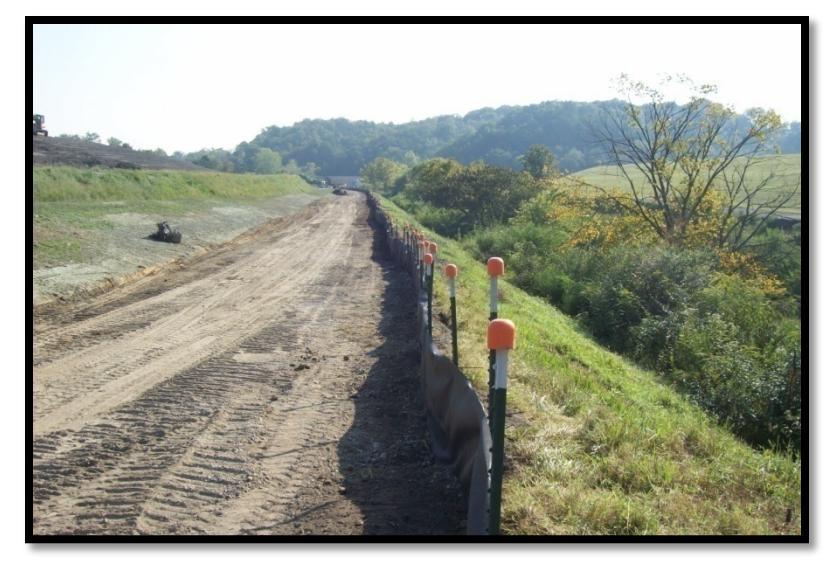
**Figure 5.2.3-3:** Downstream slope of Area 1 West Dike, East. Drainage channel (WOUS) to right. Note trees and shrubs along lower portions of the slope.

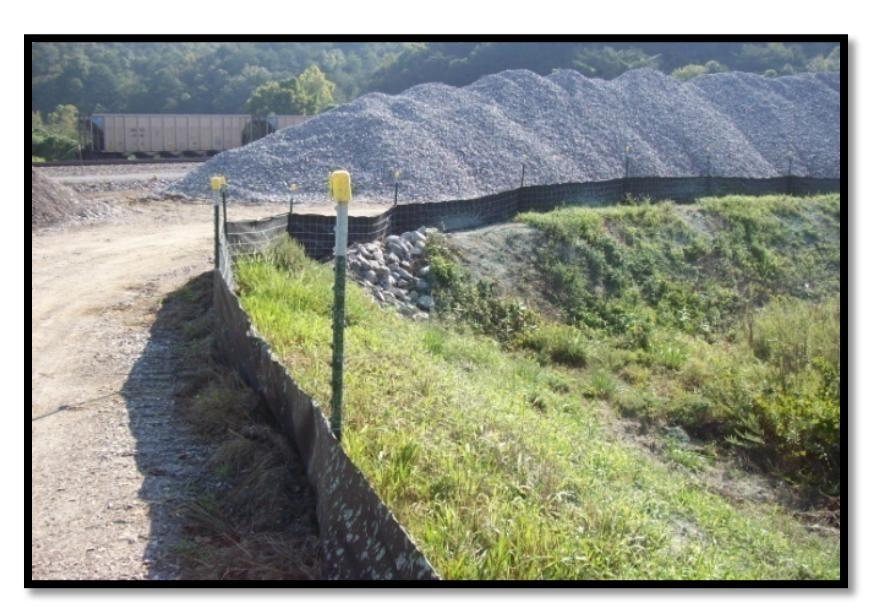
All groins and abutments were well maintained. There were no observed scarps, sloughs, bulging, cracks, depressions or other indications of slope instability. Figure 5.2.4-1 shows an outside groin for Area 1.

Figure 5.2.4-1: Outside groin for Area 1 South Dike, East.

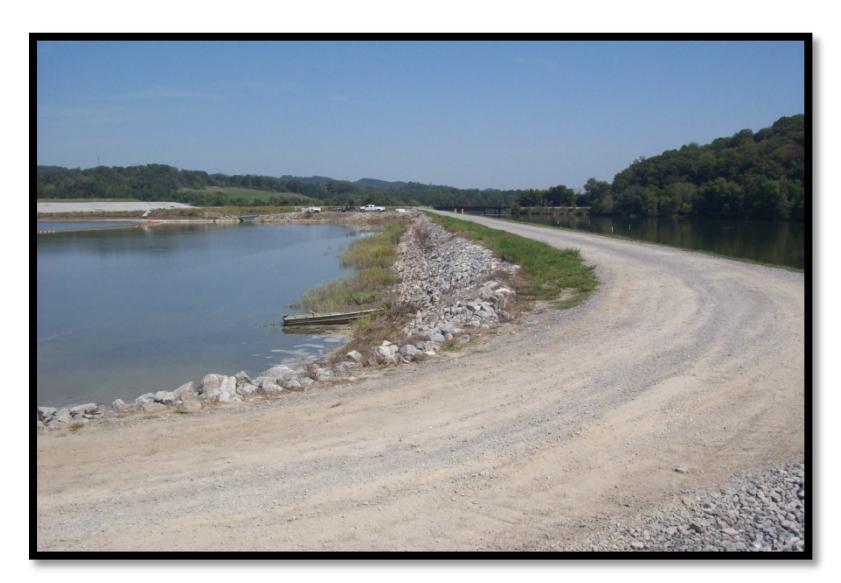
A gravel access road wraps around the embankment perimeter dike. No depressions, tension cracks or other indications of settlement or shear failure were observed on the crest of the middle or lower dike. Figure 5.3.1-1 shows typical crest conditions along the embankment.

Figure 5.3.1-1: Crest of Area 2, East.

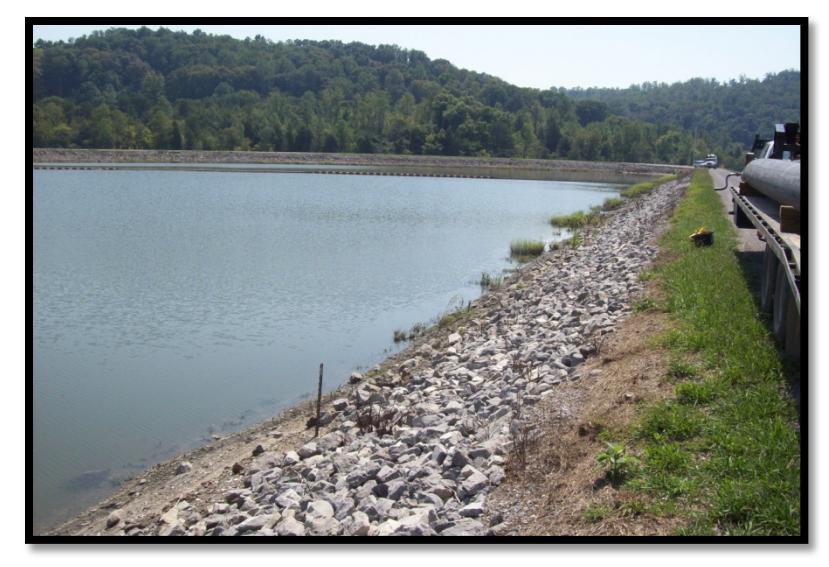
The interior slopes of Area 2 are partly riprap lined and partly covered with a good stand of grass/weeds. The slopes appear stable and well maintained. The operating pool elevation was 801.00 ft, consequently only 9 ft of the inside was visible during the site visit. There were no observed scarps, sloughs, bulging, cracks, depressions or other indications of slope instability. Figures 5.3.2-1 shows a section of the Area 2 inside slope.

Figure 5.3.2-1: Inside slope of Area 2, South.

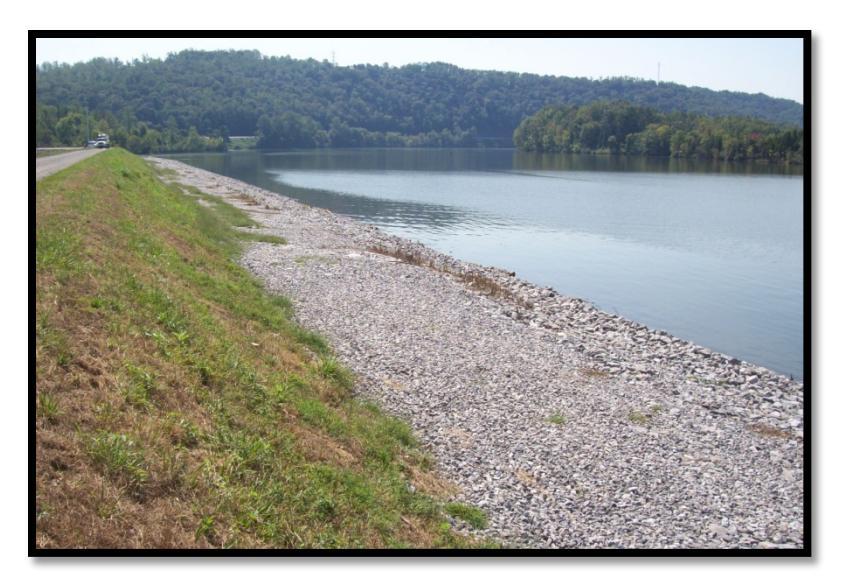
The outside slope of the embankment was covered with a good stand of grass/weeds. The lower portion of the outside slope is covered with a riprap blanket to protect against wave action. No scarps, sloughs, bulging, cracks, depressions or other indications of slope instability were observed along the slope. Figures 5.3.3-1 and 5.3.3-2 shows representative sections of the outside slopes and toe.

Figure 5.3.3-1: Area 2 downstream slope, South. Clinch River to right.

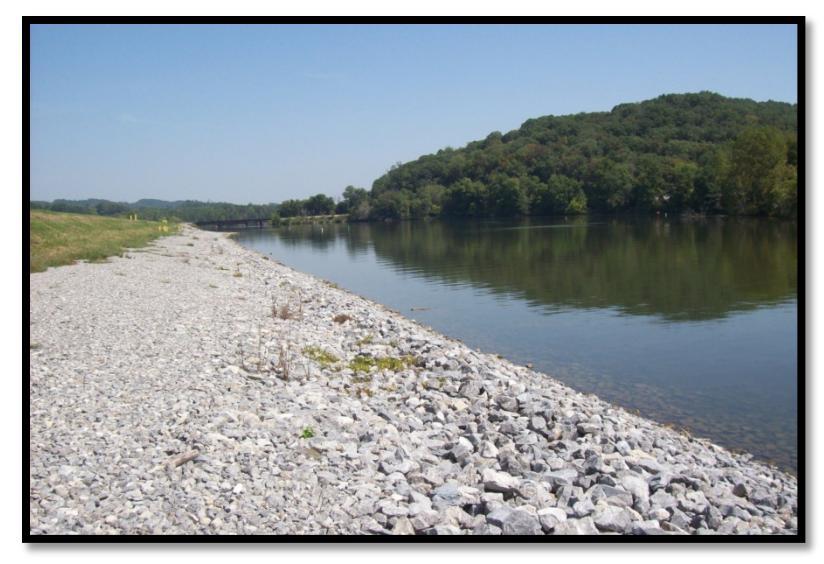
**Figure 5.3.3-2:** Area 2 downstream toe of slope, East. Bull Run Creek to right.

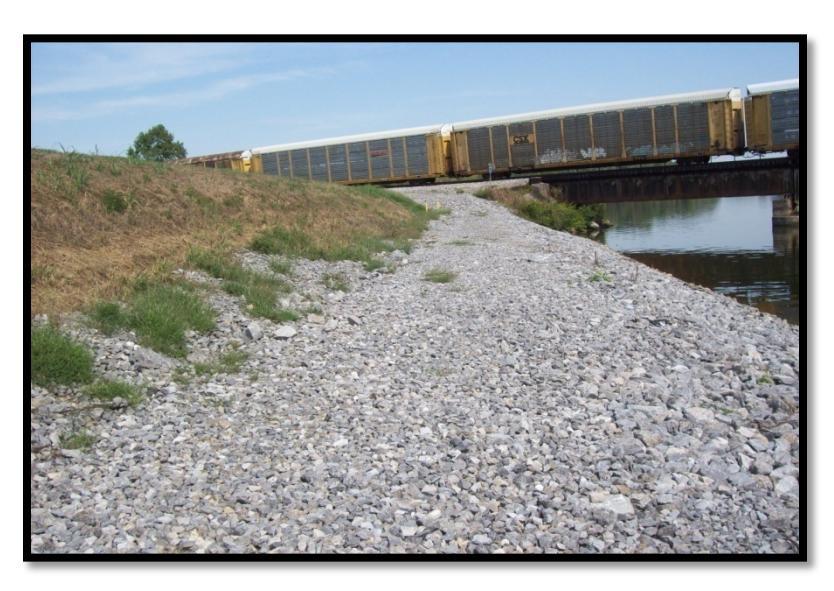
There were no observed scarps, sloughs, bulging, cracks, depressions or other indications of slope instability at dike abutments and groin areas of Area 2; see Figures 5.3.4-1 and 5.3.4-2.

Figure 5.3.4-1: Area 2 outside groin area, East.

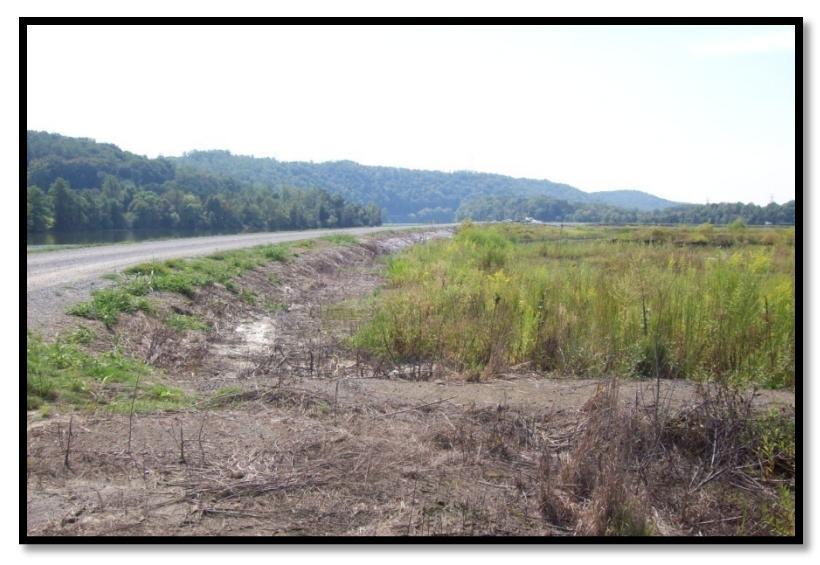
Figure 5.3.4-2: Area 2 inside groin area, West.

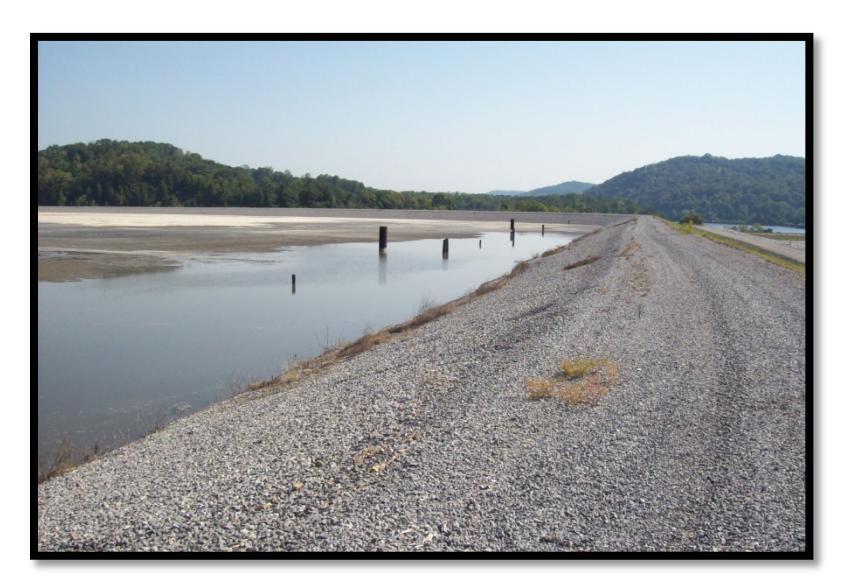
The crest of the Area 2A embankment had no signs of significant depressions, tension cracks or other indications of settlement or shear failure. The entire crest is gravel covered. Figure 5.4.1-1 shows the typical crest conditions along the embankment.

Figure 5.4.1: Crest of Area 1 South Dike, East.

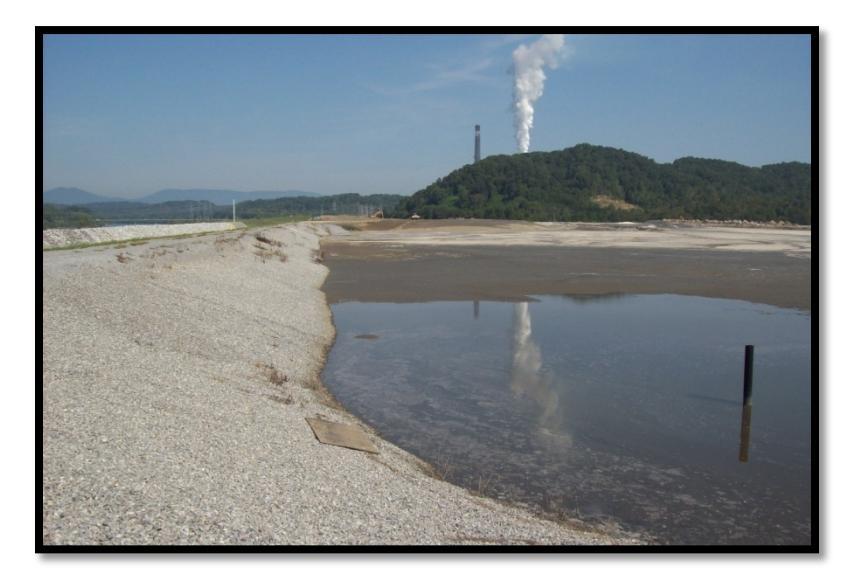
Area 2A is primarily composed of the gypsum disposal stack, however it impounds water directly along its south dike. The interior slopes of Area 2A are riprap lined and appear stable and maintained. There were no observed scarps, sloughs, bulging, cracks, depressions or other indications of slope instability. Figures 5.4.2 shows a section of the Area 2A inside slope.

Figure 5.4.2: Upstream slope of Area 2A, North.

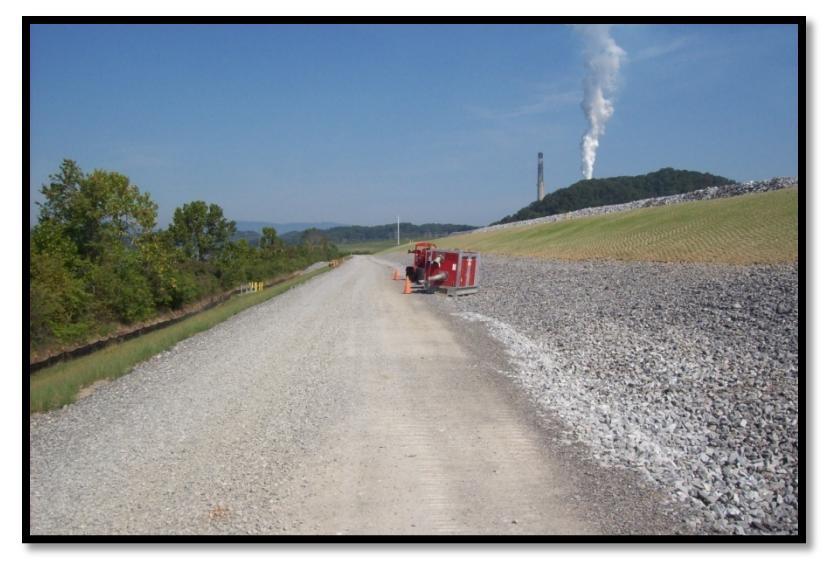
The outside slope of the Area 2A embankment appeared to have a satisfactorily maintained cover of grasses/weeds. Portions of the outside slope are covered with a riprap blanket. Trees and shrubs are growing on these lower portions of the outside slope along the west and north slopes. Maintenance work to remove trees and replenish riprap blanket was under way at the time of the site visit. A gravel access road wraps around the middle outside slope and crest of the embankment. No scarps, sloughs, bulging, cracks, depressions or other indications of slope instability were observed along the slope. Figure 5.4.3-1 and Figure 5.4.3-2 show representative sections of the embankment.

**Figure 5.4.3-1:** Downstream slope of Area 2A showing gravel perimeter access road, North. Note trees and shrubs along lower portions of the west slope.

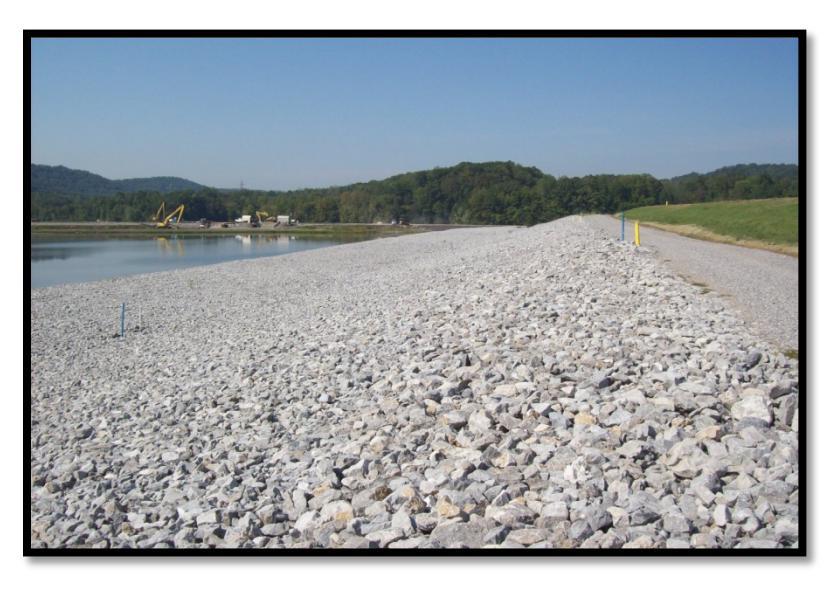
**Figure 5.4.3-2:** Lower portion of Area 2A downstream slope, West. Note riprap blanket along toe of south slope.

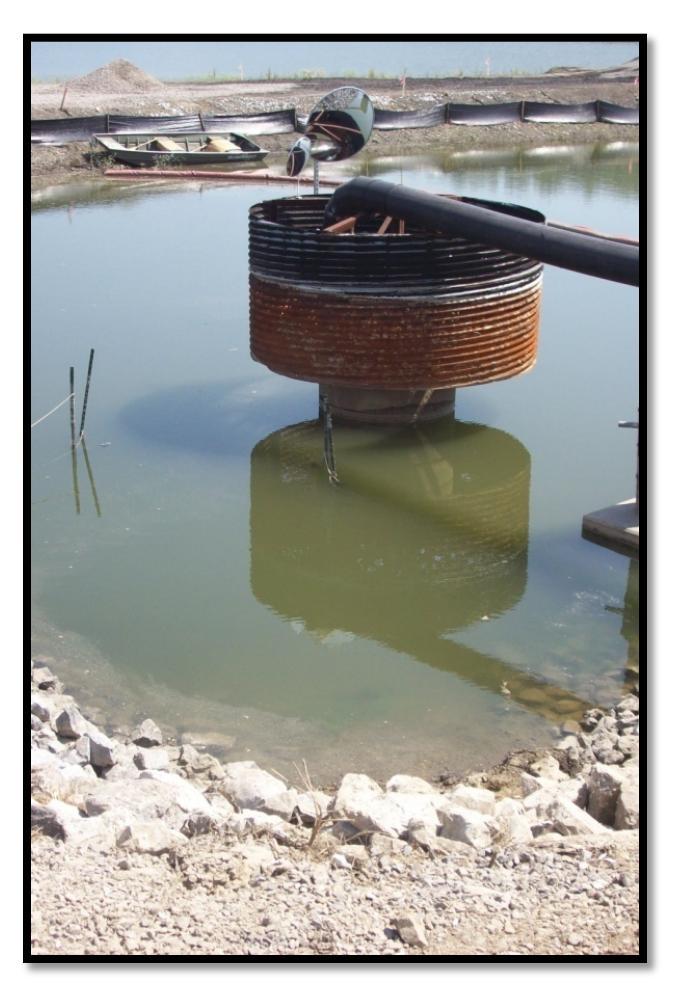
All three disposal areas share the same primary overflow structures located in the south western corner of the Area 2 stilling pond, see Figure 5.4.1. The overflow structure consists of three 52-inch diameter steel circular weirs mounted on 48-inch diameter reinforced concrete riser pipes. The structures appeared to be in satisfactory conditions and there were no signs of a clogged outlet. Water could not be observed entering the structure; during the site visit flow was being pumped to the outlet. Area 1 and Area 2A each outfall into Area 2. Area 1 outfalls into Area 2 via a sluice ditch that extends along Area 1 and Area 2A, while Area 2A outfalls via open culvert pipes located through its south dike.

**Figure 5.4.1:** One of three primary overflow structures in the Area 2 stilling pond.

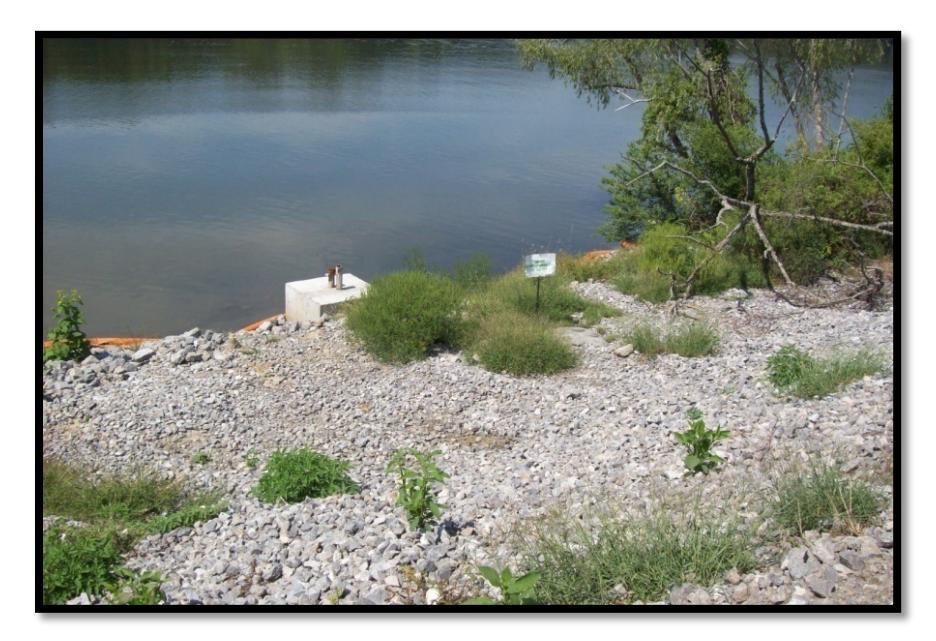
The primary outlet conduits for all disposal areas consists of three 36-inch reinforced concrete pipes leading from the separate overflow structures located in the Area 2 stilling pond. Each concrete pipe outfalls through the west dike of Area 2 into the Clinch River. The final outlet of each pipe was not visible as each was completely submerged in the Clinch River, see Figure 5.5.2-1 and Figure 5.5.2-2. As previously mentioned, the outlet for Area 2A consists of two 24-inch HDPE pipes located near the south western corner. The location of the inlet of each conduit was unknown as each was completely submerged. However, each outfall was clearly identified and visible along the south dike downstream slope. Water exiting each conduit appeared to be flowing clear, see Figure 5.5.2-3.

Figure 5.5.2-1: Outlet conduit location along Clinch River, West. NPDES Permitted Outlet.

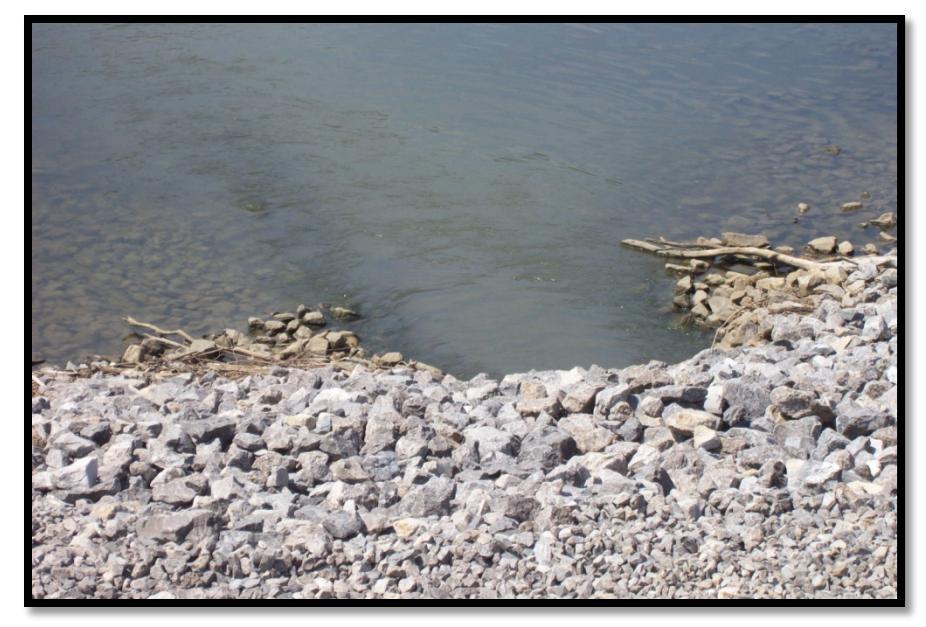
Figure 5.5.2-2: Principal spillway outlet conduit in Area 2.

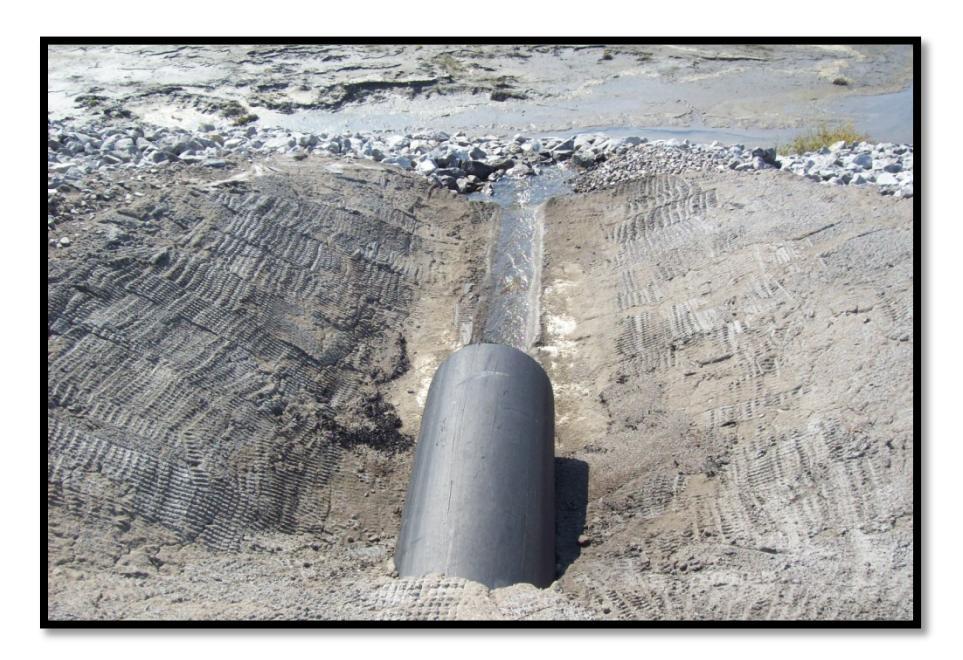
Figure 5.5.2-3: Outlet conduit for Area 2A.

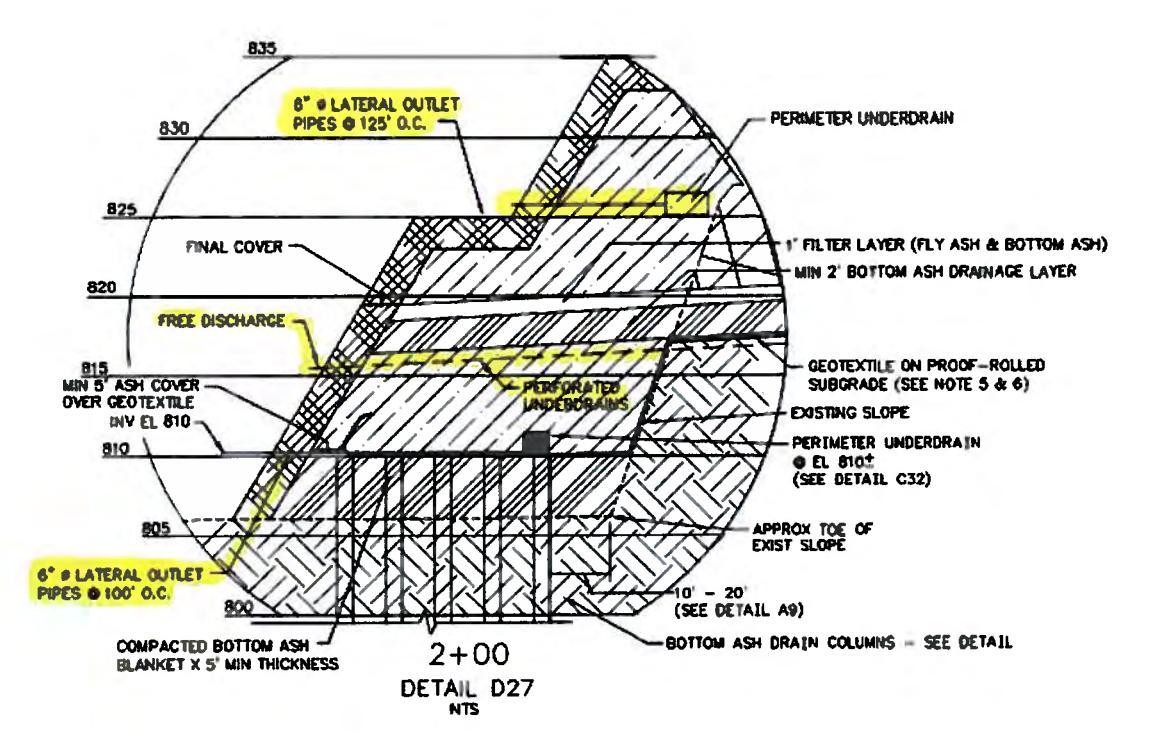
Figure 4. Detail D27 South Slope Toe Area Design (Drawing 10W297-27)

In addition, the toe area design included a perimeter under-drain (6 inch perforated pipe wrapped in crushed stone and filter fabric traversing parallel to the slope contours) at elevation 810 feet. The perimeter under-drain was to include lateral outlet pipes (6 inch non-perforated pipe) at 100 feet intervals, as indicated on Detail D27 of Drawing 10W297-27 reproduced below.

Detail D27 and Section B27 of Drawing 10W297-27 also show a series of 4 inch perforated under-drain pipes traversing across the entire bottom of the disposal area in a north-south direction, with the pipes installed at 50-foot intervals and discharging near elevation 815 feet. The design also called for another perimeter under-drain at elevation 825 feet with 6-inch lateral outlet pipes installed at 125-foot intervals. Drawing 10W297-26 also shows perimeter drains at elevation 815 feet running parallel to the east and west sides of Area 2A, with lateral outlet pipes installed at 250 feet spacing intervals.

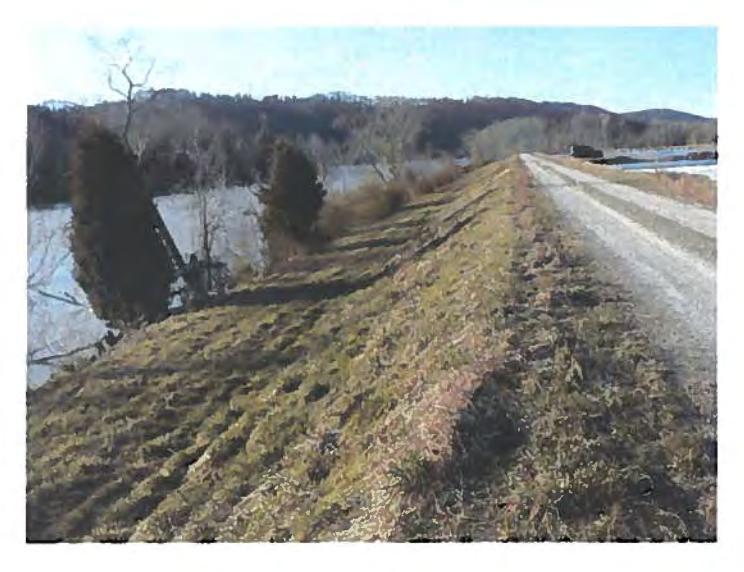
Photo 1 Ash Pond Dike Slope

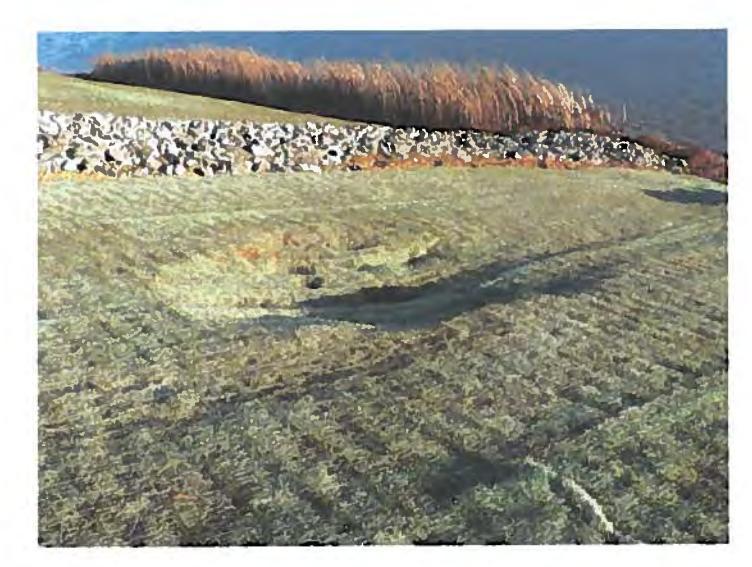
Photo 2 Depression along south slope of Gypsum Stack

The subsurface conditions of these depressed areas should be explored using a backhoe or excavator and treated accordingly based on the results of the exploration. The exploratory and treatment work should be performed under the monitoring of a geotechnical engineer, who should formulate the treatment measures to be used based on his observations. Depending on the subsurface material encountered, the treatment may require the use of geotextile fabric, fine (1" maximum dimension) and medium (2") coarse stone, clayey soil, topsoil and erosion control blanket. Proper equipment to

compact the fill material will be required in addition to the backhoe and excavator. This work can be implemented as soon as TVA's resources are available, preferably within the next two to three weeks.

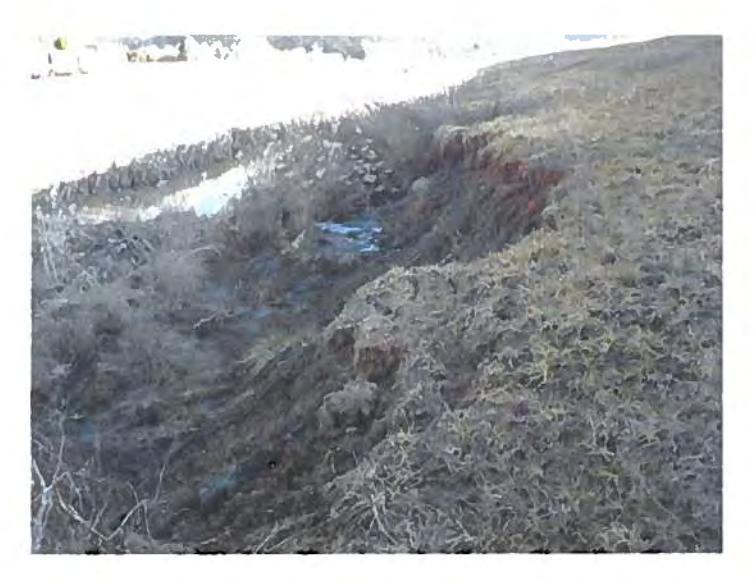
The east side of the gypsum stack exterior slope toes out along the bank of an ash sluice ditch traversing from north to south. The ditch bank height is less than 10 feet but relatively steep or practically vertical in some intervals. The existing grading of several ditch intervals does not appear to allow positive drainage as indicated by standing or pooled water observed in several areas along the ditch (see Photo 3). It is possible current ditch bank conditions have not changed significantly in recent years but have occasionally become more unstable due to uncontrolled flow or standing water along the ash sluice ditch. One bank area exhibiting slumping and erosion has been stabilized using riprap since the initial visit to the site by Stantec personnel in early January.

Photo 3 Ash sluice ditch eroded bank along toe of gypsum stack east slope

The dike slope is 3:1 or flatter and includes an intermediate bench. Therefore, the unstable ash ditch bank areas will probably not cause a sudden failure of the gypsum stack dike unless slumping and erosion of the bank is left uncontrolled. The bank slope should be stabilized by either (1) grading it back and lining it with a clay cover and erosion control blanket, or (2) by lining it with a layer of filter blanket and riprap as recently performed. Once current topographic mapping of the site is provided by TVA and current ash sluice ditch/ash pond operations are reviewed, Stantec will prepare a work plan to establish long term stability as well as positive drainage conditions.

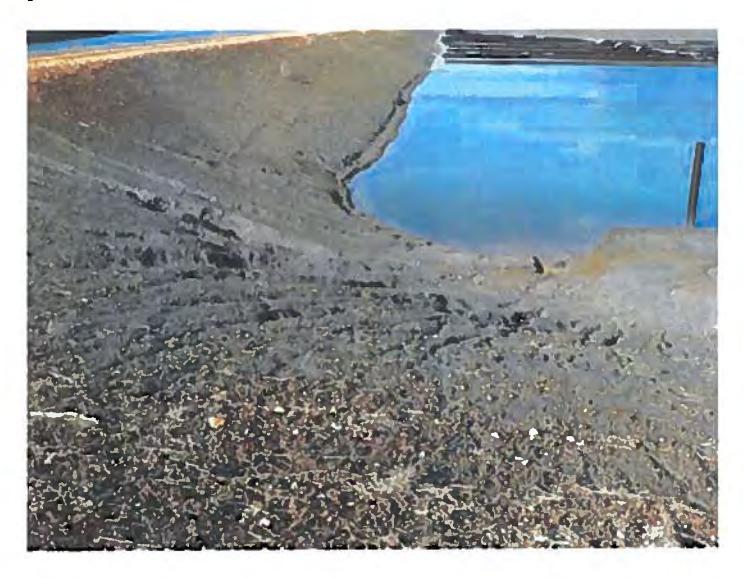
Certain interior slopes of the gypsum stack have been severely eroded or rutted by surface runoff (see Photo 4). This is occurring because gypsum erodes readily when exposed to rainfall runoff for an extended period of time. In this case, the pool elevation is several feet below the top of the dike, which leaves the gypsum on the interior slopes exposed and subject to erosion.

Photo 4 Interior slope of gypsum stack eroded by surface runoff

Interior slope areas of the gypsum stack showing severe rutting should be re-graded periodically to prevent ruts from creating slumps or slope failures.

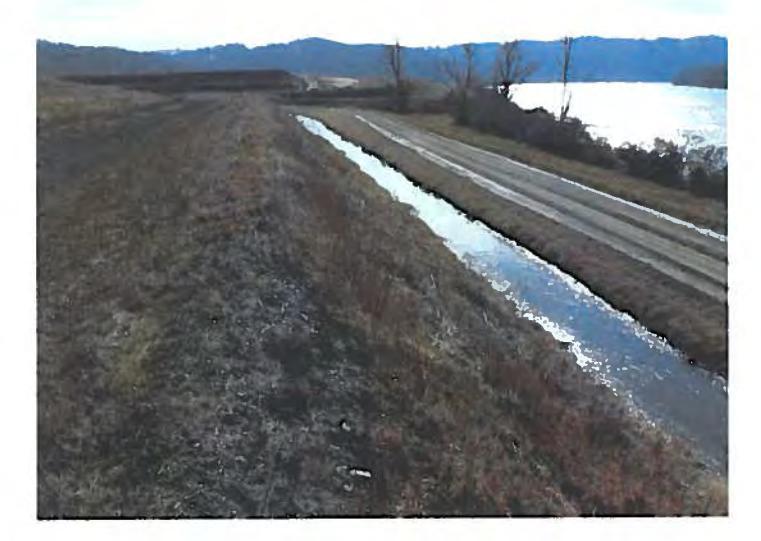
• Standing water was observed in surface ditches traversing (1) the toe of the Bottom Ash Storage Area - Pond 1 (see Photo 5) and Gypsum Stack west slopes; and (2) the roadside ditch of the access road traversing along the south side of Pond 1.

Photo 5 Standing water in ditch traversing along west slope of Bottom Ash Storage Area – Pond 1

These ditch areas need to be re-graded to provide positive drainage (eliminate standing water) to allow proper inspection of the slopes. At this time it is not known if the source of the standing water is rainfall runoff, seepage through the dike slopes, or both. Stantec will obtain current topographic information during the next phase of the facility assessments and prepare re-grade plans to provide positive drainage along these ditch areas. A monitoring program will be prepared and implemented after these ditch areas are repaired to allow proper assessment of the dike surface conditions.

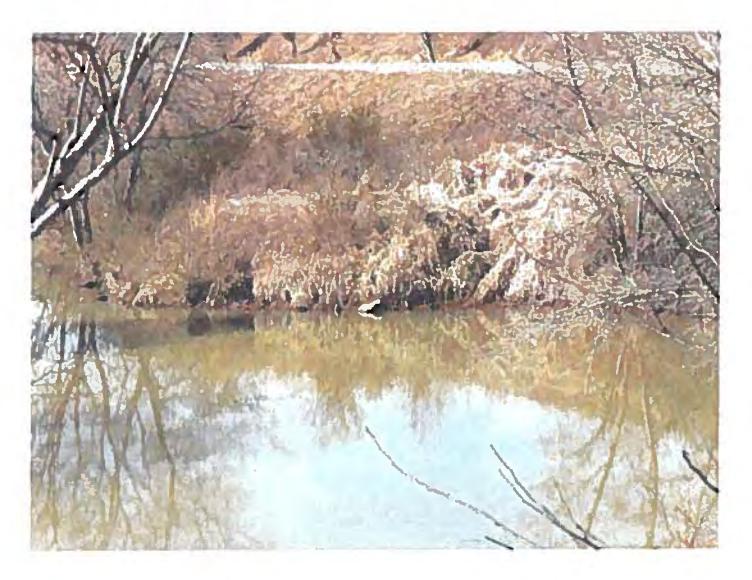
• Red water seeps were observed surfacing along the toe of the south slope of Pond 1, near the southeast corner of the pond (see Photo 6). In this area, the slope between the access road and the bottom ditch (separating Pond 1 from the gypsum stack) has apparently failed in the past as indicated by the slumped configuration of the slope. The bottom ditch, which separates Pond 1 and the Gypsum Stack, detains water for undetermined reasons.

Photo 6 Red water seeps surfacing along toe of failed bank below south side of Bottom Ash Storage Area – Pond 1

The purpose of detaining water along the bottom ditch described above should be reviewed. If practical, this water detention should be eliminated. Once the detained water is drained, the slumped slope area and red water seeps can be evaluated to determine what corrective actions may be appropriate. Since this appears to be a localized failure, the corrective measures may consist of placing fill material along the toe of the slope to provide additional support. Further movement of the slumped area may require more substantial corrective measures.

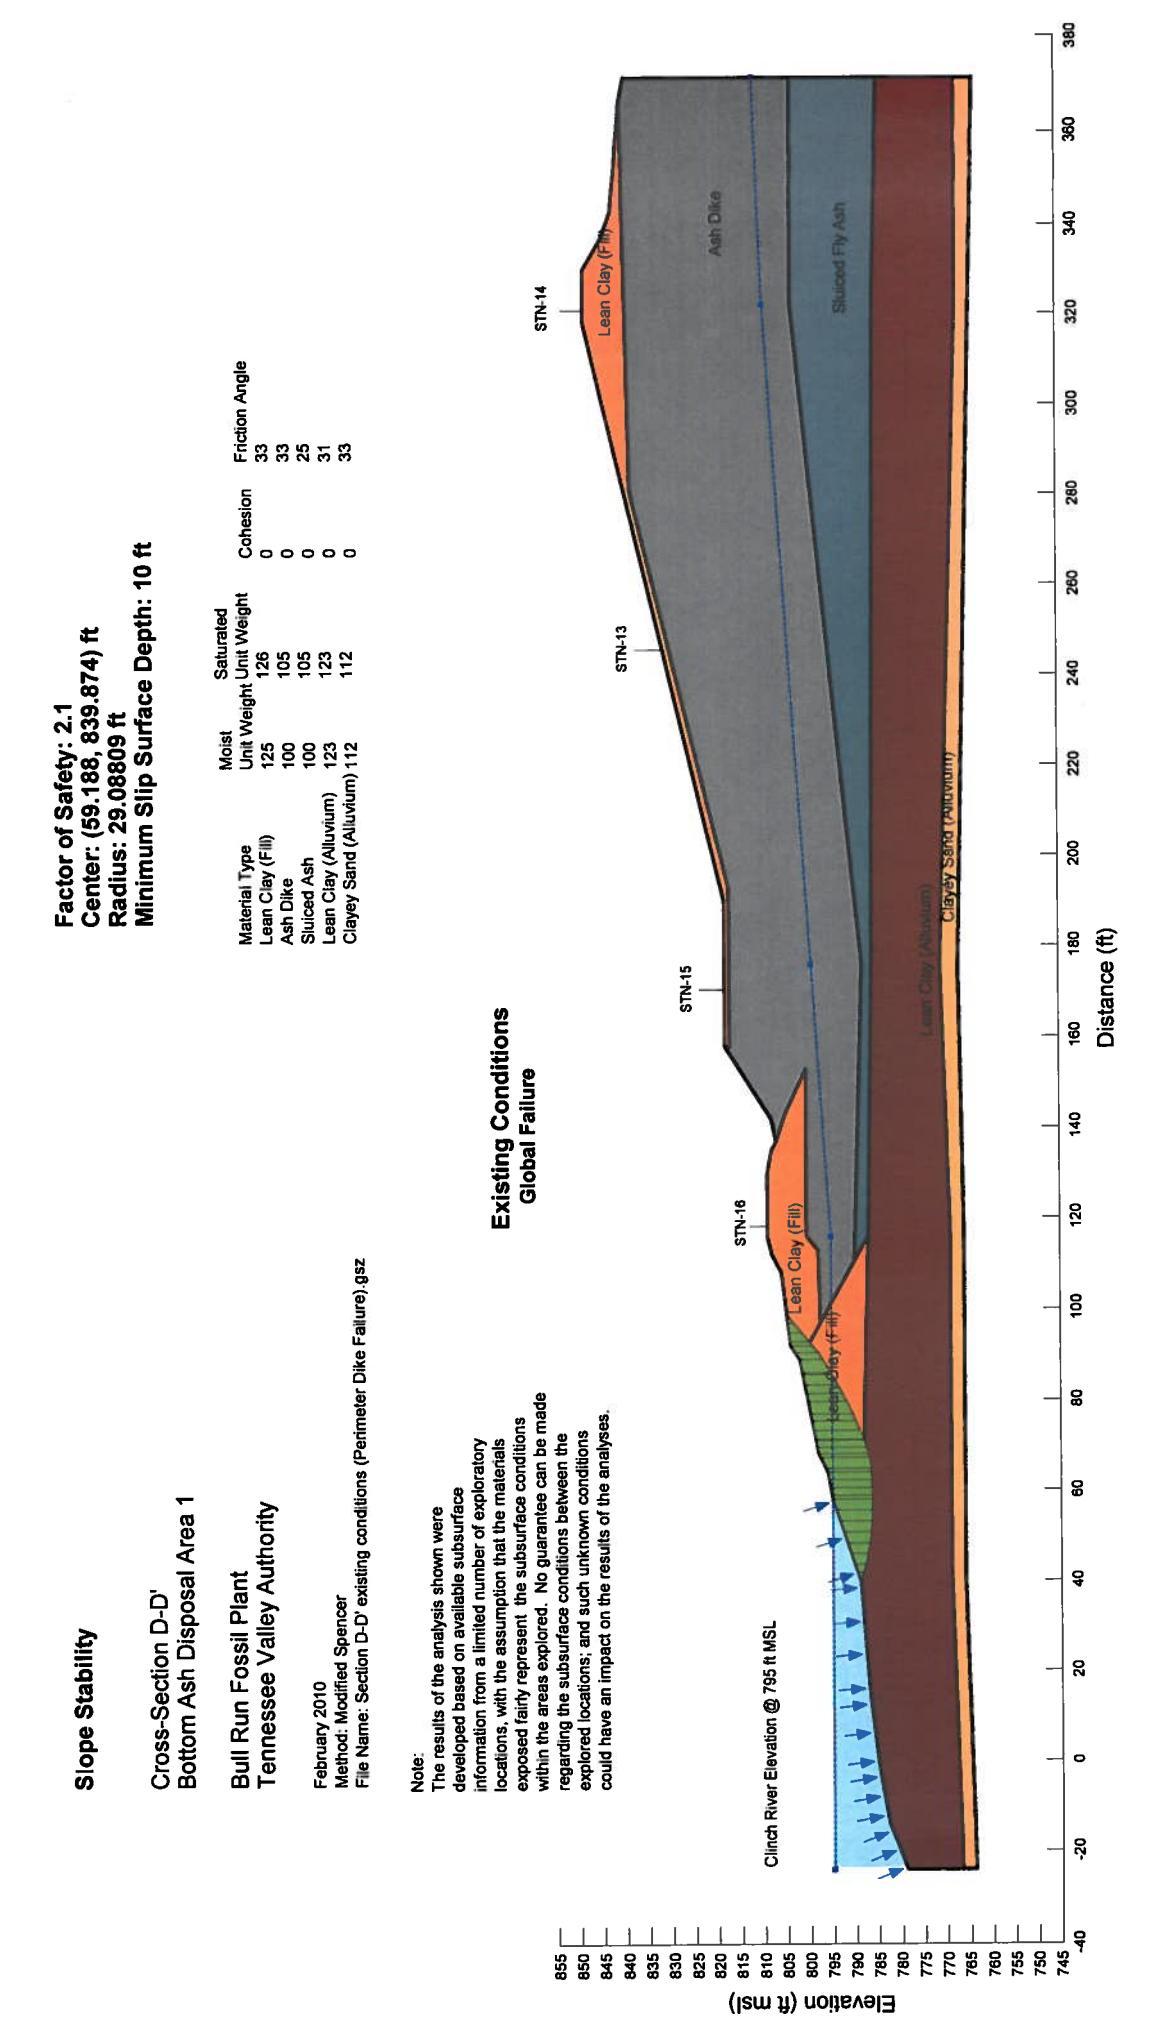
V:\1714\active\1714\66118\environmenta\Bull Run - 172679015\ReportEngineering Analysis\Sect D-D'Section D-D' existing conditions (Perimeter Dike Failure), gsz

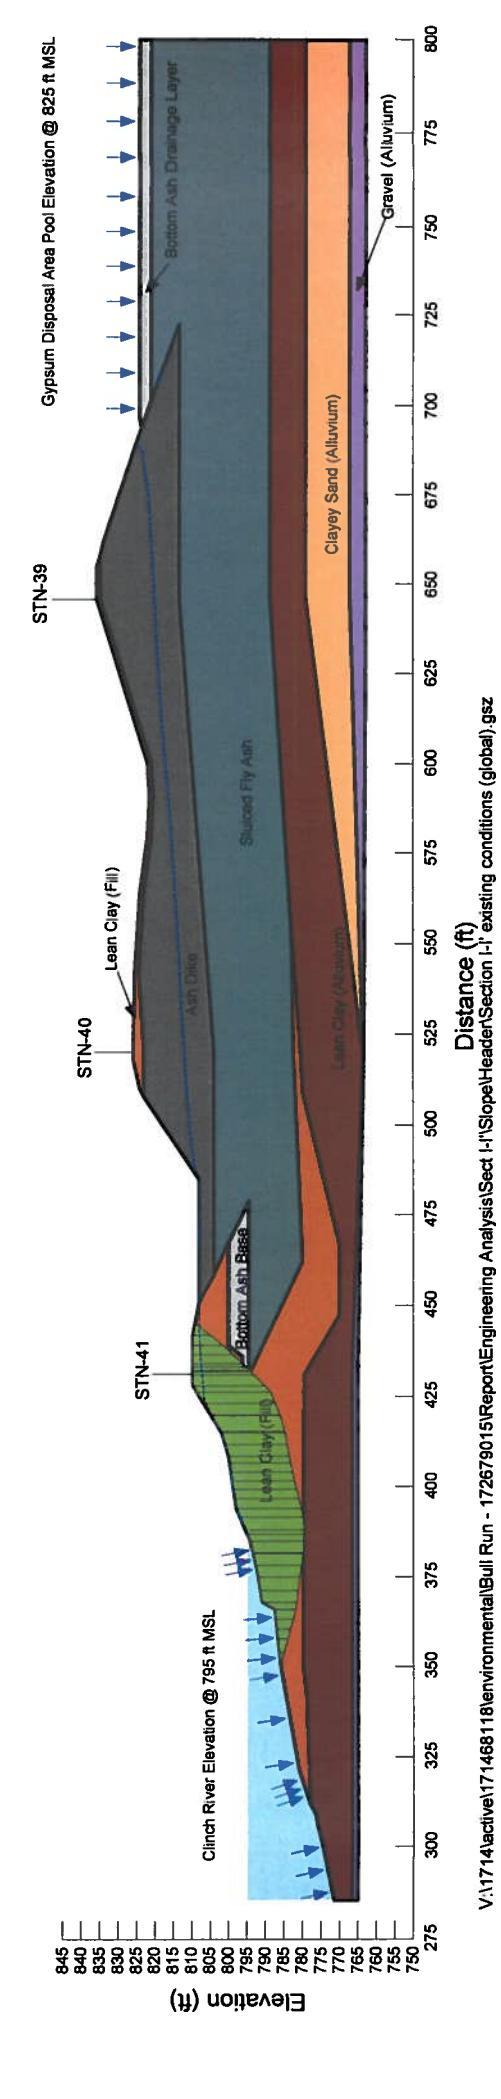
Existing Conditions Global Failure
