## **Coal Combustion Residue Impoundment Round 11 - Dam Assessment Report**

Bull Run Fossil Plant (#002) CCR Impoundment Areas 1, 2, 2A Tennessee Valley Authority Clinton, Tennessee

United States Environmental Protection Agency Office of Resource Conservation and Recovery

Dewberry & Davis, LLC Fairfax, Virginia

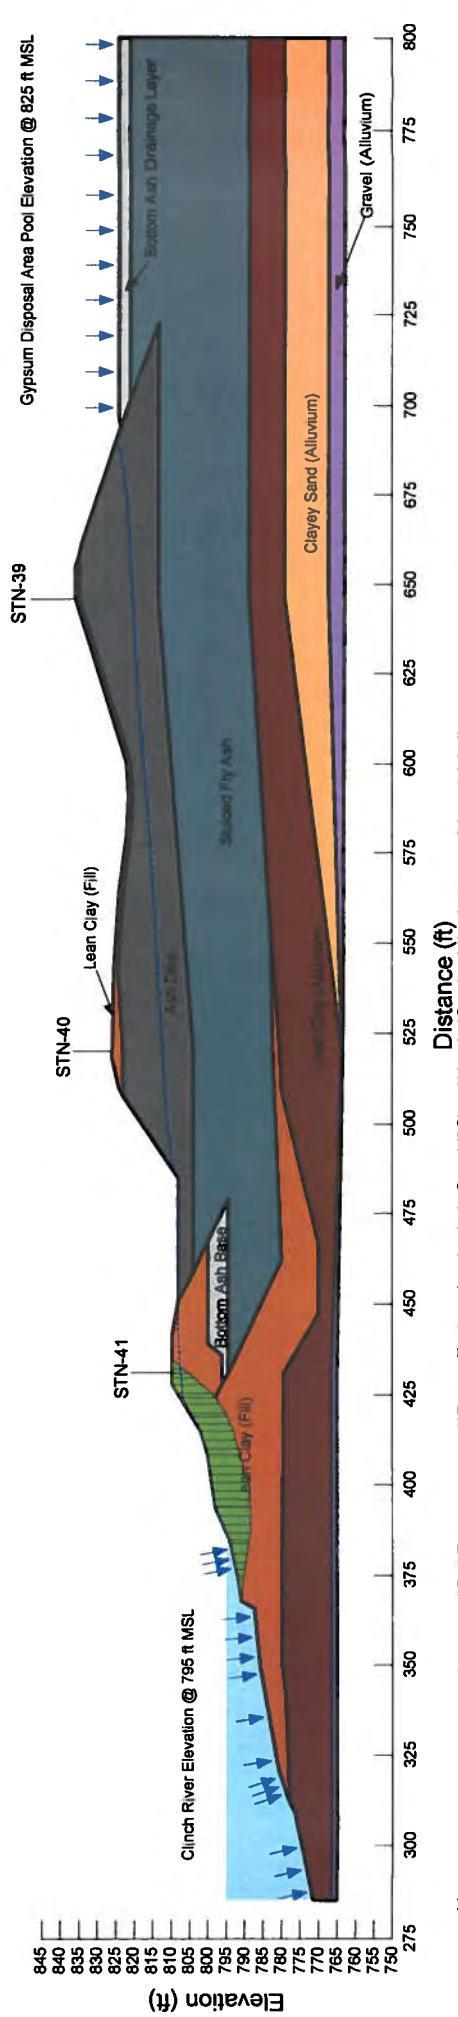
Non-Global Failure (Perimeter Dike) **Existing Conditions**

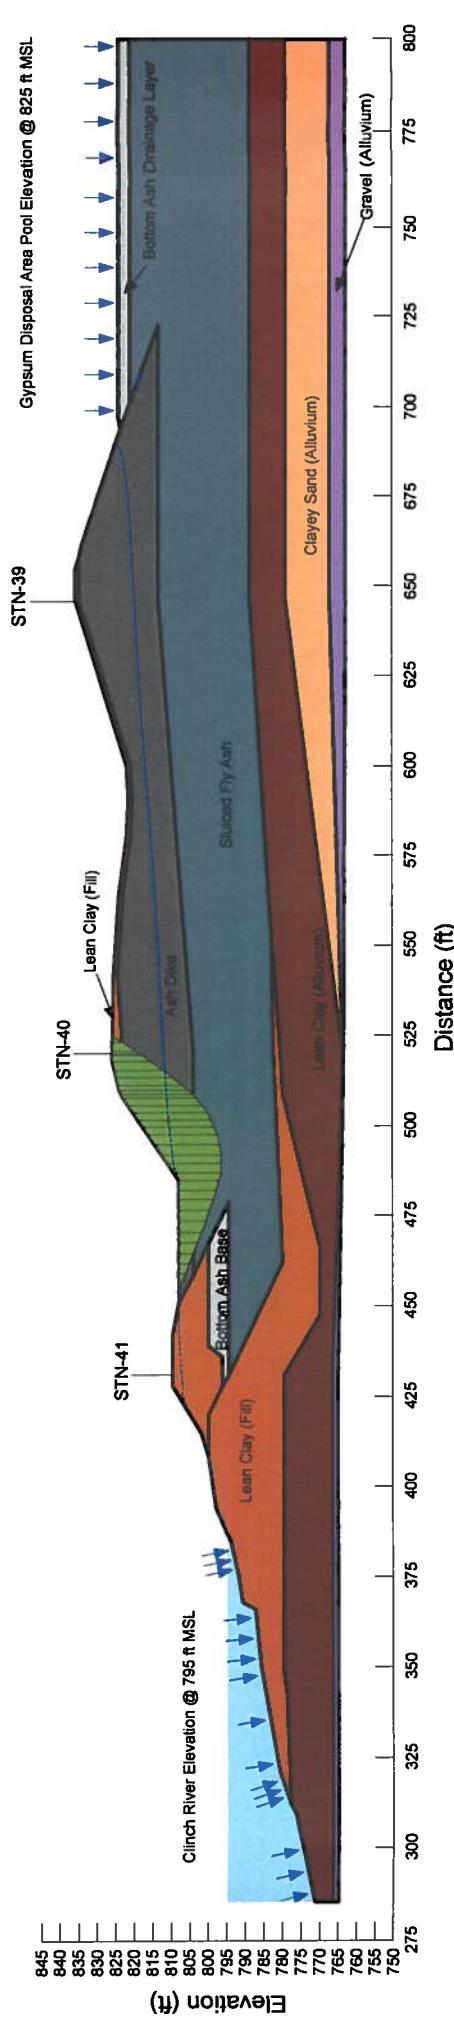
Existing Conditions Non-Global Failure (Ash Embankment)

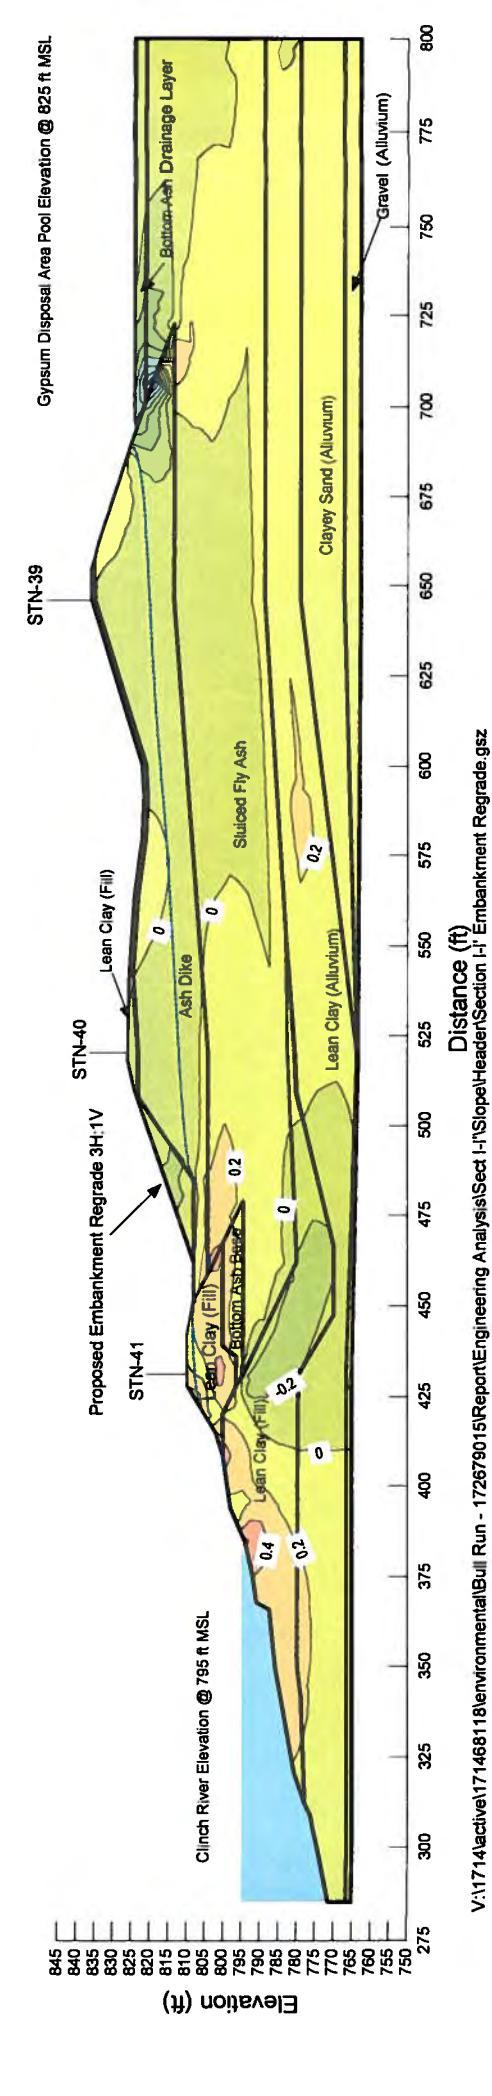
Maximum Exit Gradient occurs at (385,794) Total Head = 795 ft At (385.90,789.93) Total Head = 797.77 ft dH = 2.77 ft dI = 5.07 ft i = 0.546 i(criticial) = 1.0 FSpiping = 1.8

Maximum Exit Gradient occurs at (385,794) Total Head = 795 ft At (385.90,789.93) Total Head = 797.77 ft dH = 2.77 ft dl = 5.07 ft i = 0.546 i(criticial) = 1.0 FSpiping = 1.8

## Proposed Embankment Regrade 3H:1V

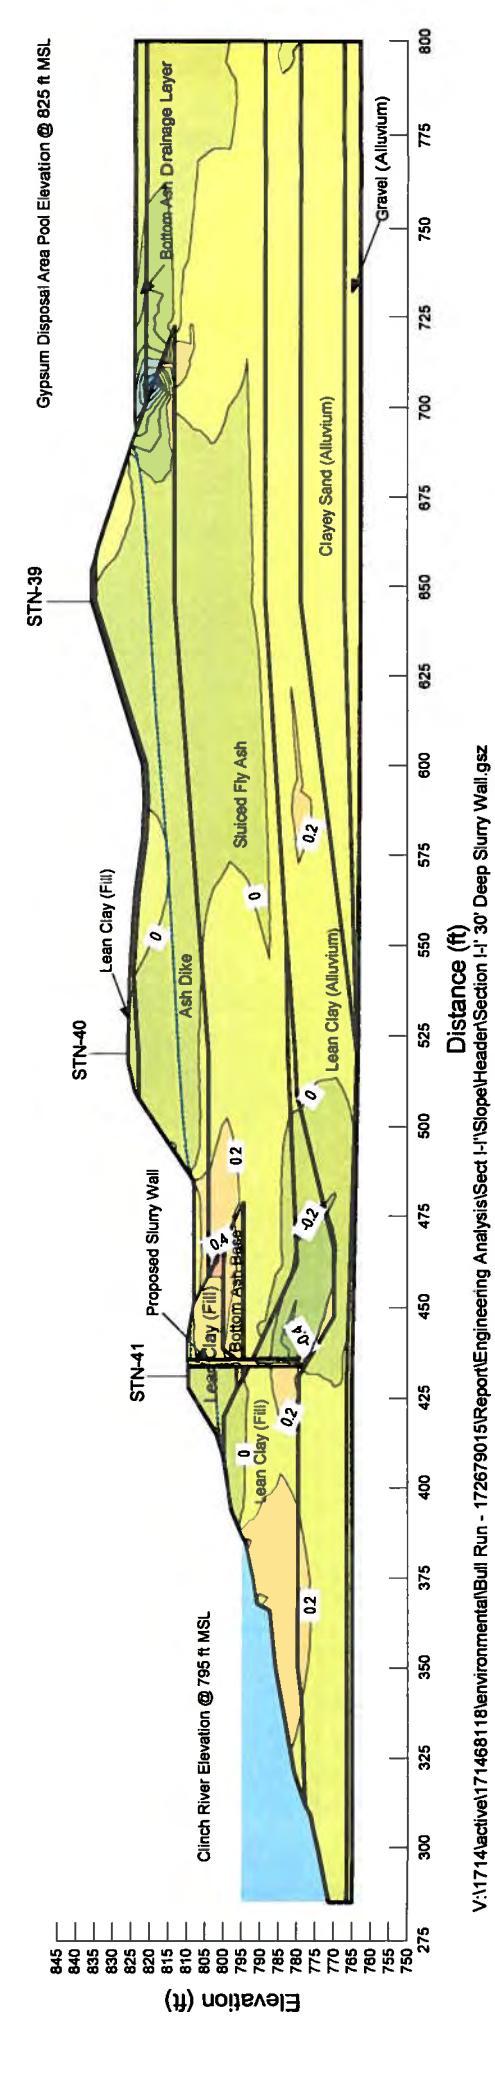
Piping Potential Maximum Exit Gradient occurs at (385,794) Total Head = 795 ft At (385.90,789.93) Total Head = 796.91 ft dH = 1.91 ft dl = 5.07 ft i = 0.377 i(critical) = 1.0 FSpiping = 2.7

## Proposed 30 Ft Deep Slurry Wall to Elevation 780'

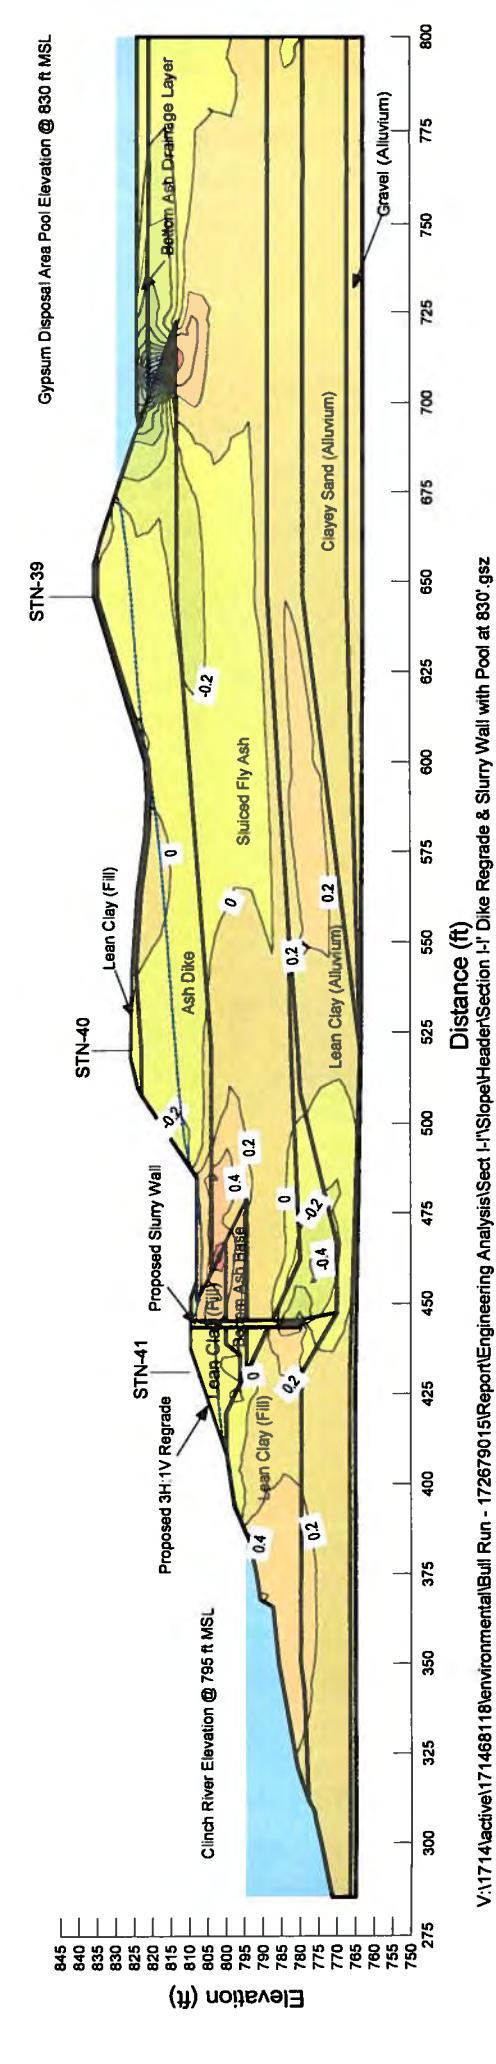
Vertical Gradient Contours

Proposed 3H:1V Upper Dike Regrade and 30' Slurry Wall with Pool at Elevation 830'

Maximum Exit Gradient occurs at (385,794) dH = 1.89 ft dI = 5.07 fti = 0.373 i(criticial) = 1.0 Total Head = 796.89 ft Total Head = 795 ft At (385.90,789.93) FSpiping = 2.7 **Piping Potential**

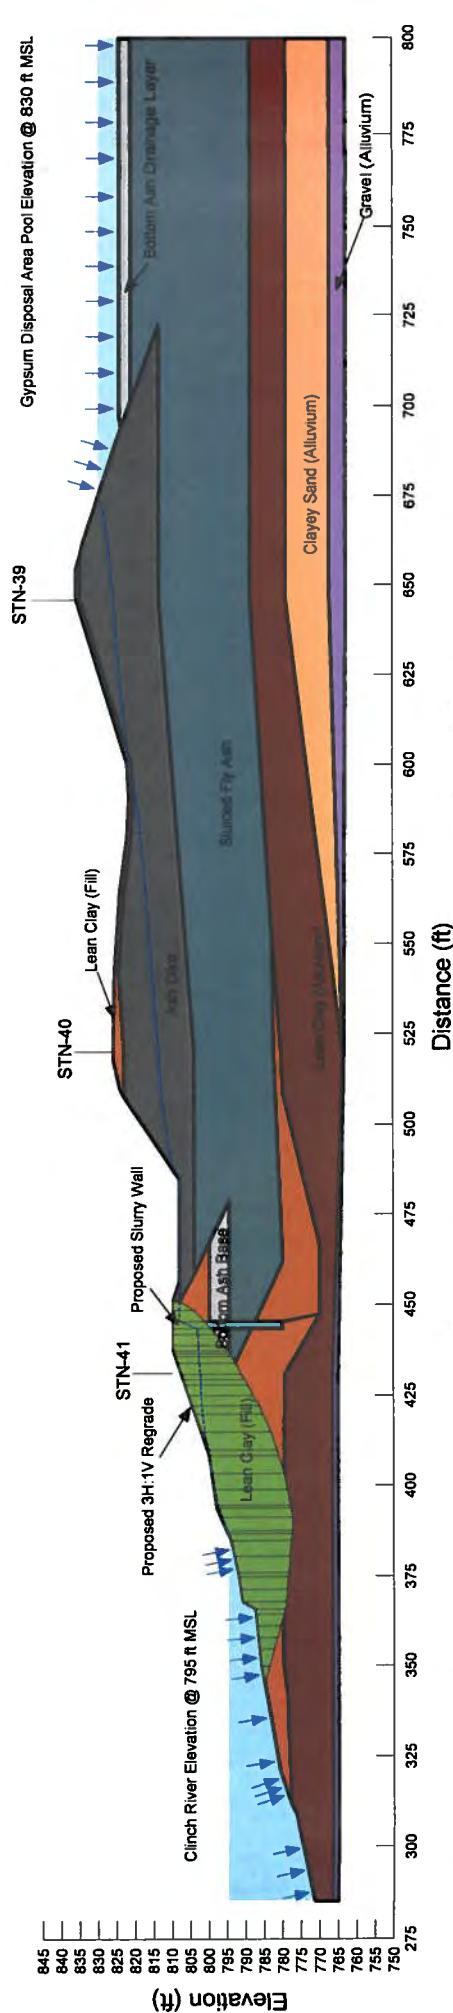
Global Failure

Proposed 3H:1V Upper Dike Regrade and 30' Slurry Wall with Pool at Elevation 830'

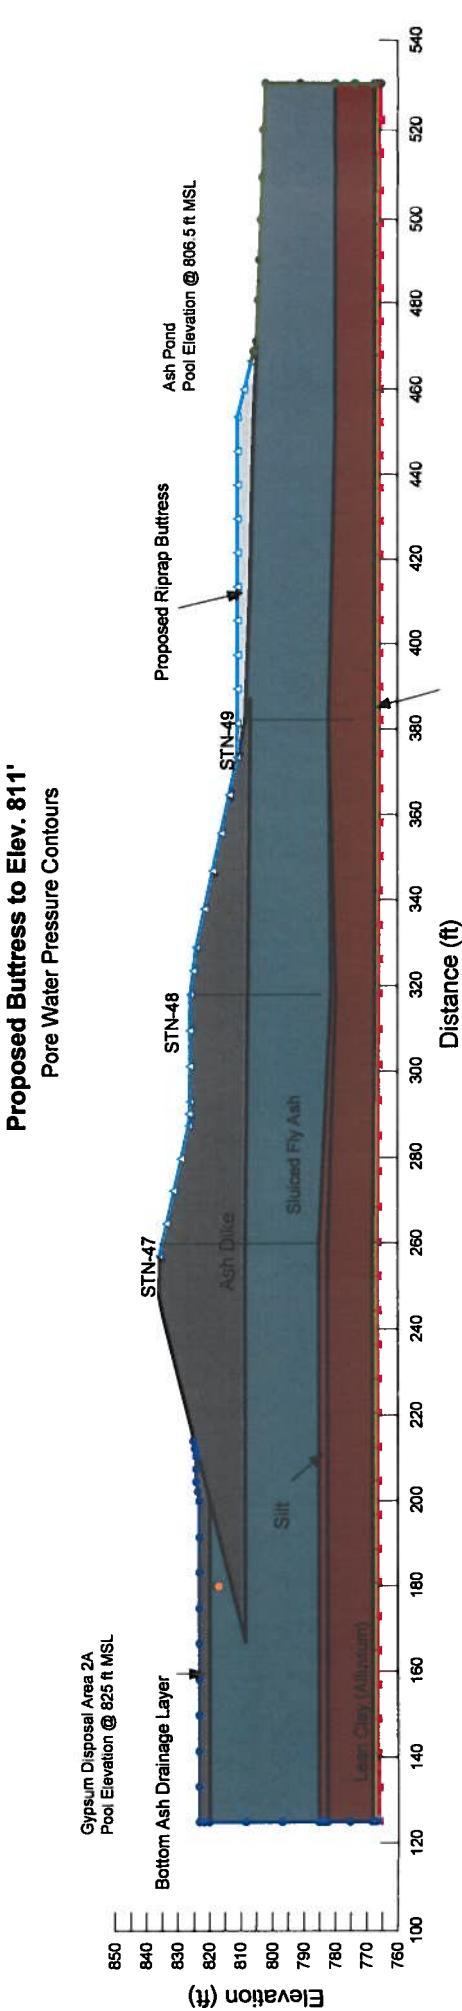
Piping Potential Maximum Exit Gradient occurs at (373.45,811) Total Head = 808.91 ft At (372.15,807.12) Total Head = 810.92 ft dH = 2.01 ft dl = 3.88 ft i = 0.518 i(criticial) = 0.708 FSpiping = 1.37

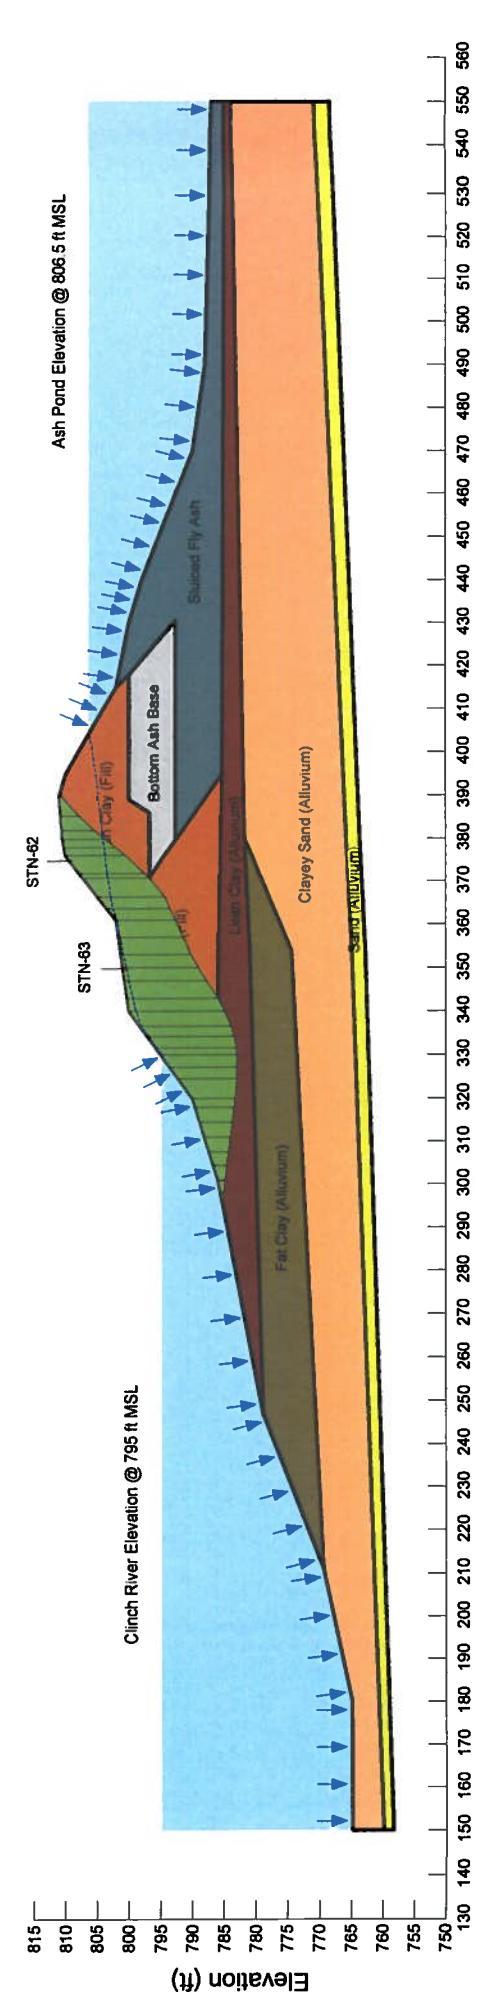
Factor of Safety: 1.1 Center: (321.667, 823.667) ft Radius: 23.87803 ft Minimum Slip Surface Depth: 10 ft

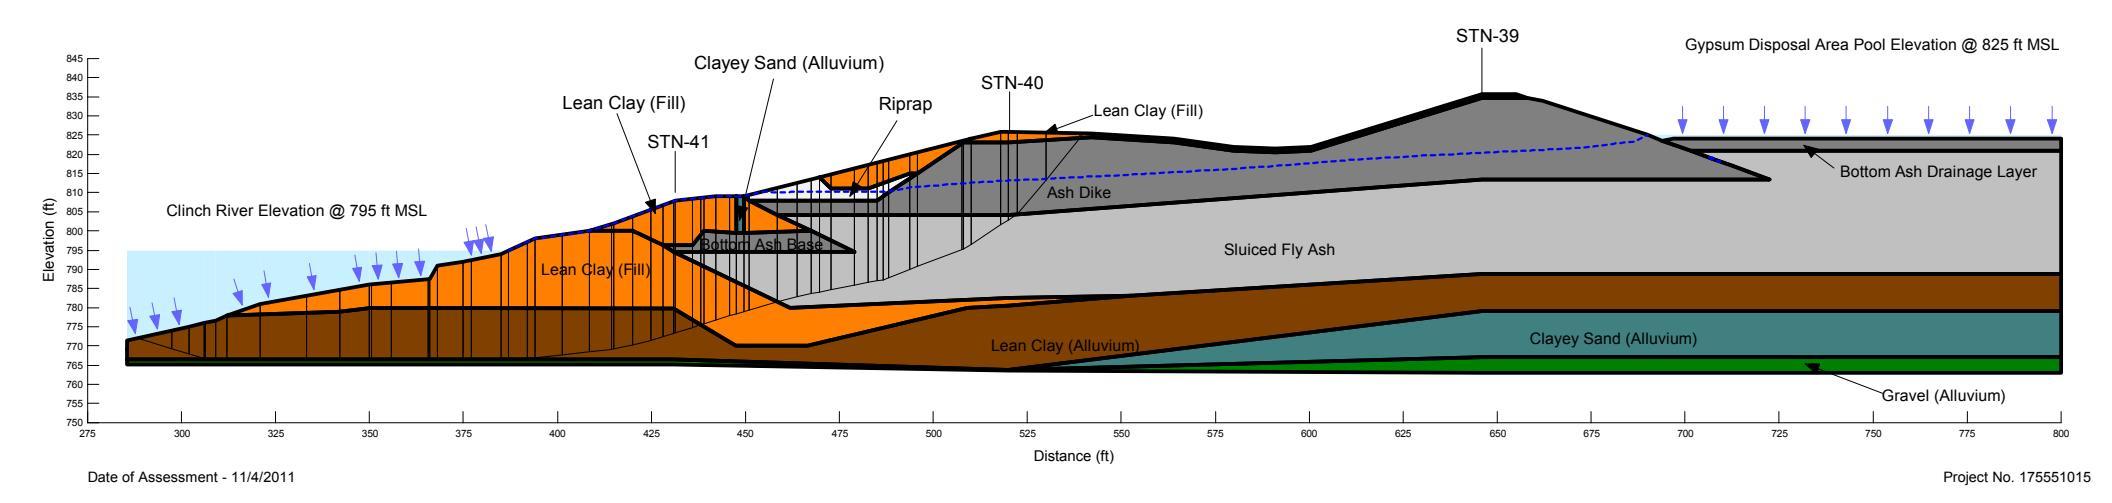
### Factor of Safety: 1.0

Horizontal Seismic Coefficient Kh = 0.131 g 2500 year Return Period Event

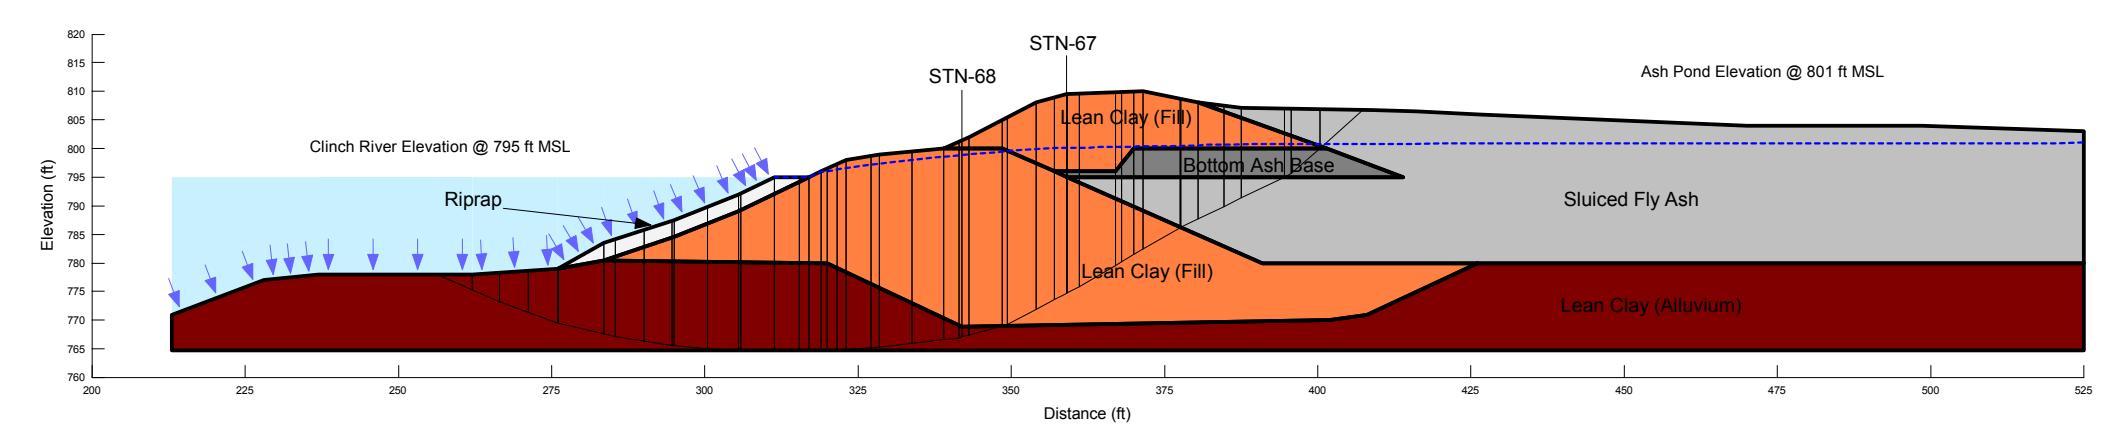
Factor of Safety: 1.4

Horizontal Seismic Coefficient Kh = Value: 0.131 g 2500-year Return Period Event

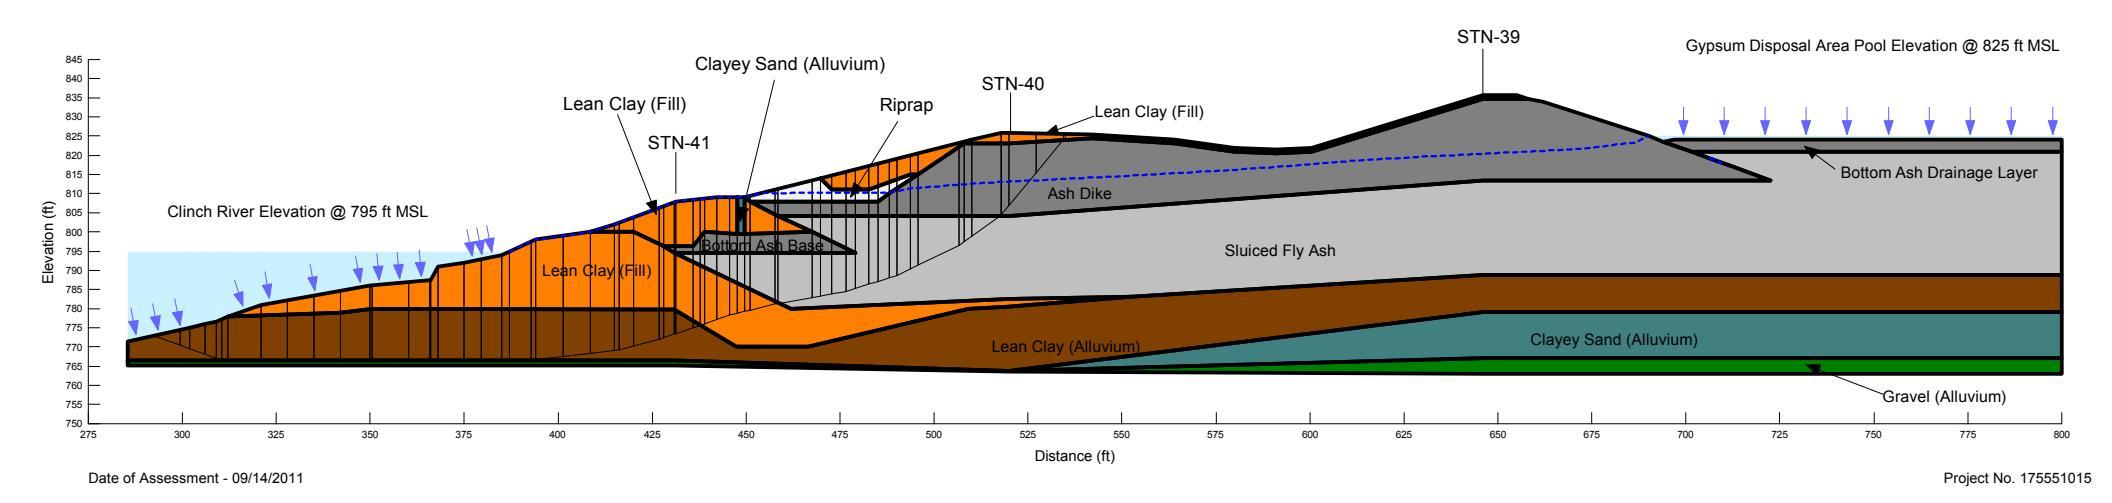
#### Factor of Safety: 1.39

Horizontal Seismic Coefficient Kh = 0.043 g 500 year Return Period Event

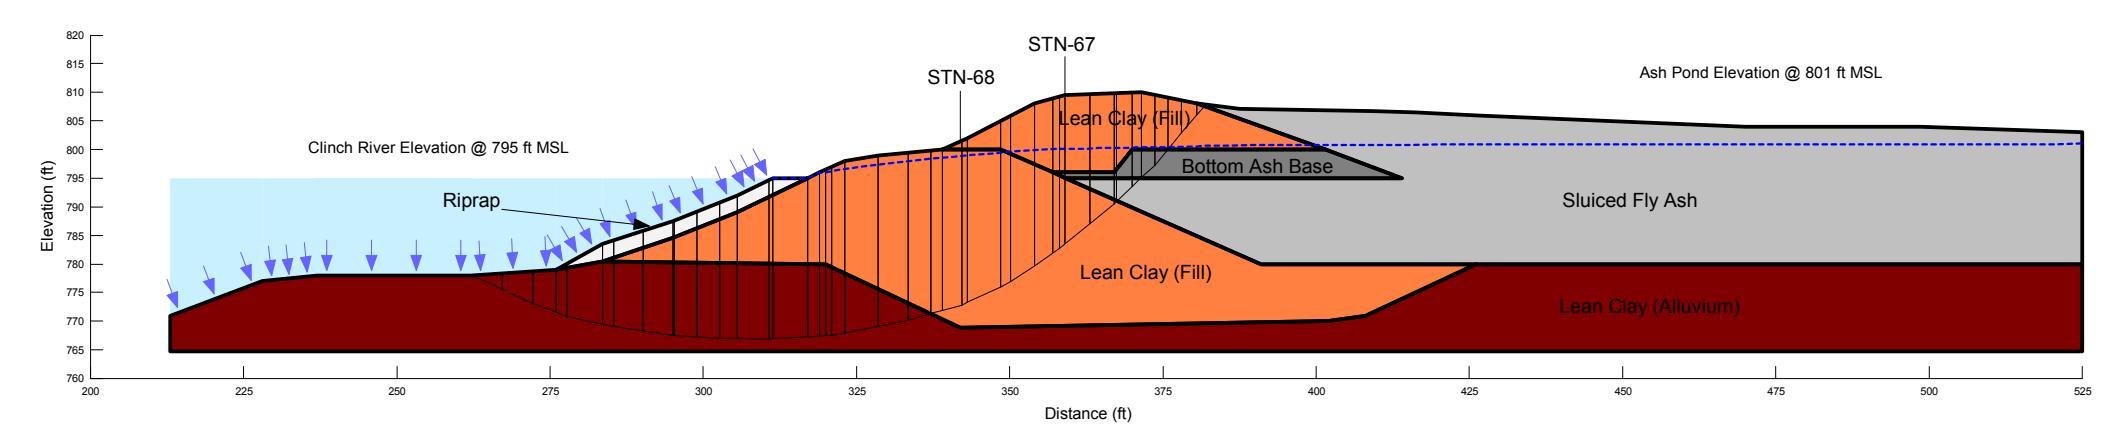
Factor of Safety: 1.85

Horizontal Seismic Coefficient Kh = Value: 0.043 g 500-year Return Period Event

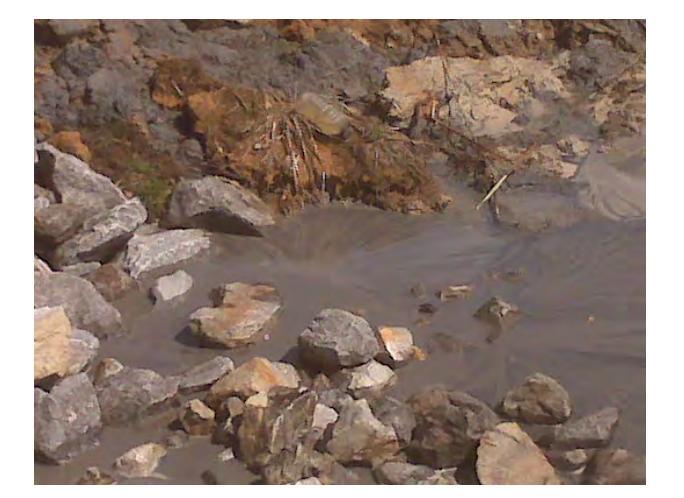
#### Area of Concern 1

3/27/2010 Seep carrying ash fines to surface noted in a drainage ditch at the toe of the ash embankment.

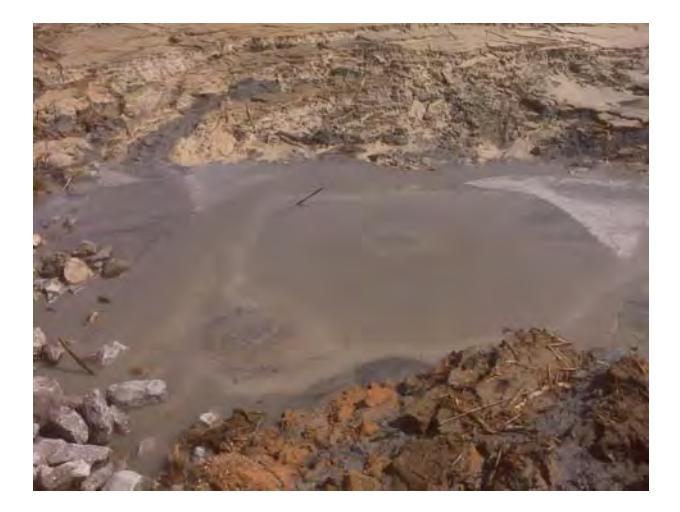
#### Area of Concern 2

3/28/2010 Boils noted at the toe of the south slope directly below the spillway outlets.

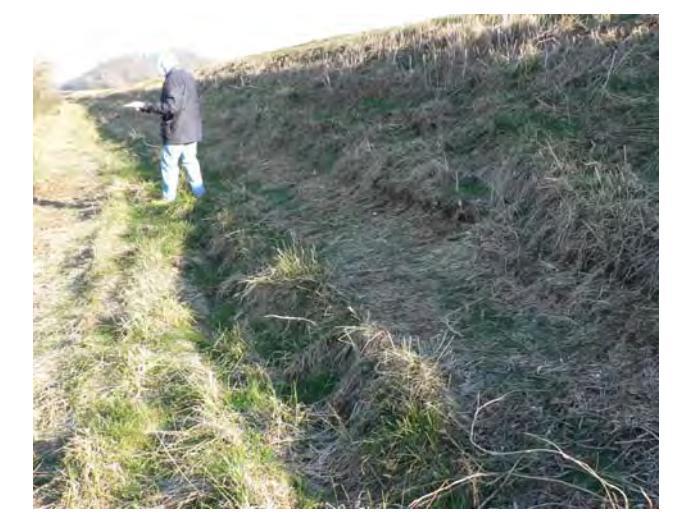
#### Area of Concern 3

1/14/2009 Wet areas along exterior slopes noted during Phase 1 Inspections.

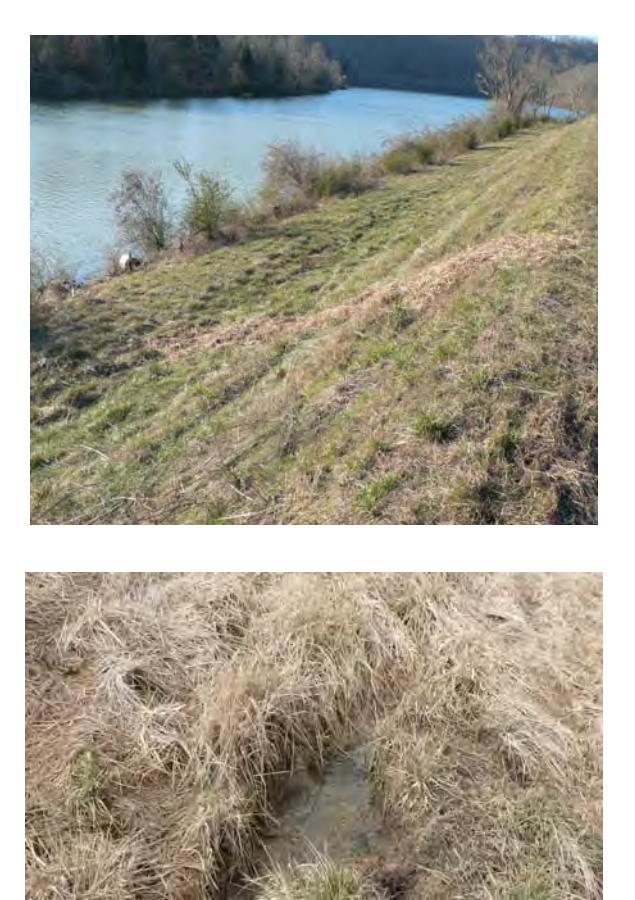
#### Area of Concern 4

1/14/2009 Wet areas along exterior slopes noted during Phase 1 Inspections.

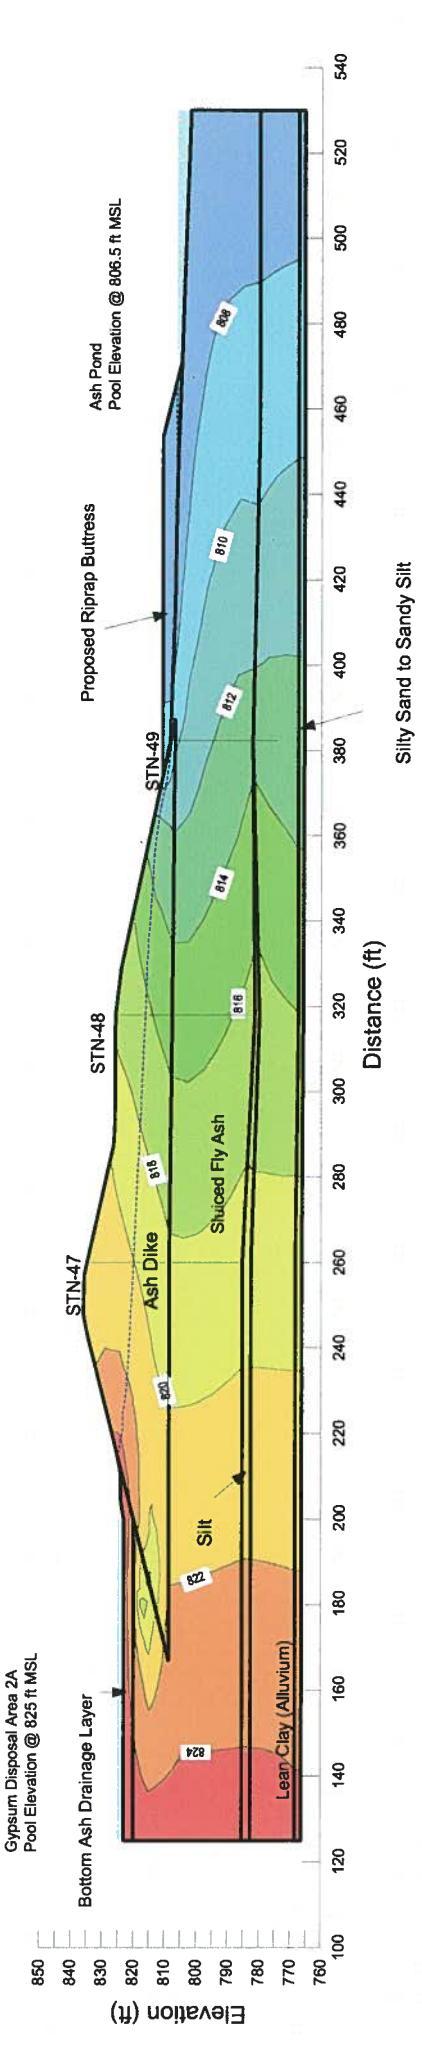
**Slope Stability**

Cross-Section K-K' Gypsum Disposal Area 2A Bull Run Fossil Plant Tennessee Valley Authority February 2010 Method: Modified Spencer File Name: 18.gsz (See workplan for file name convention) Note: The results of the analysis shown were developed based on available subsurface information from a limited number of exploratory locations, with the assumption that the materials exposed fairly represent the subsurface conditions within the areas explored. No guarantee can be made regarding the subsurface conditions between the explored locations; and such unknown conditions could have an impact on the results of the analyses.

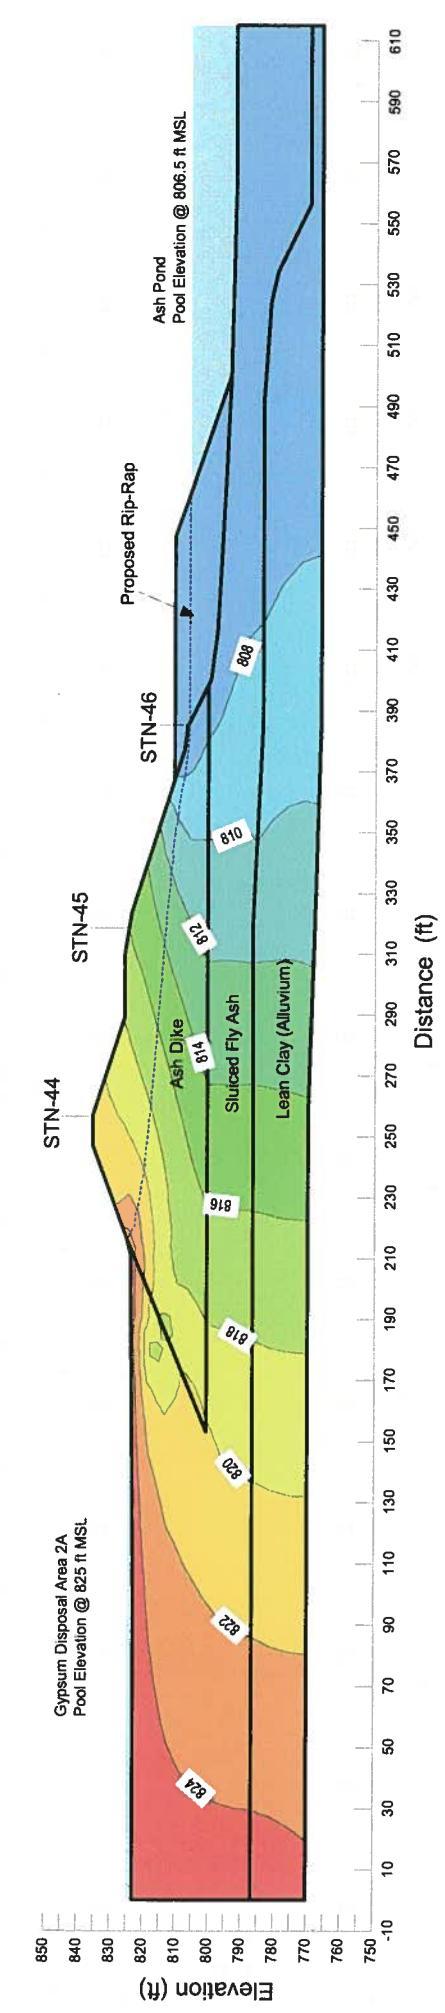
Proposed Buttress to Elev. 811'

Slope Stability (Slope Failure)

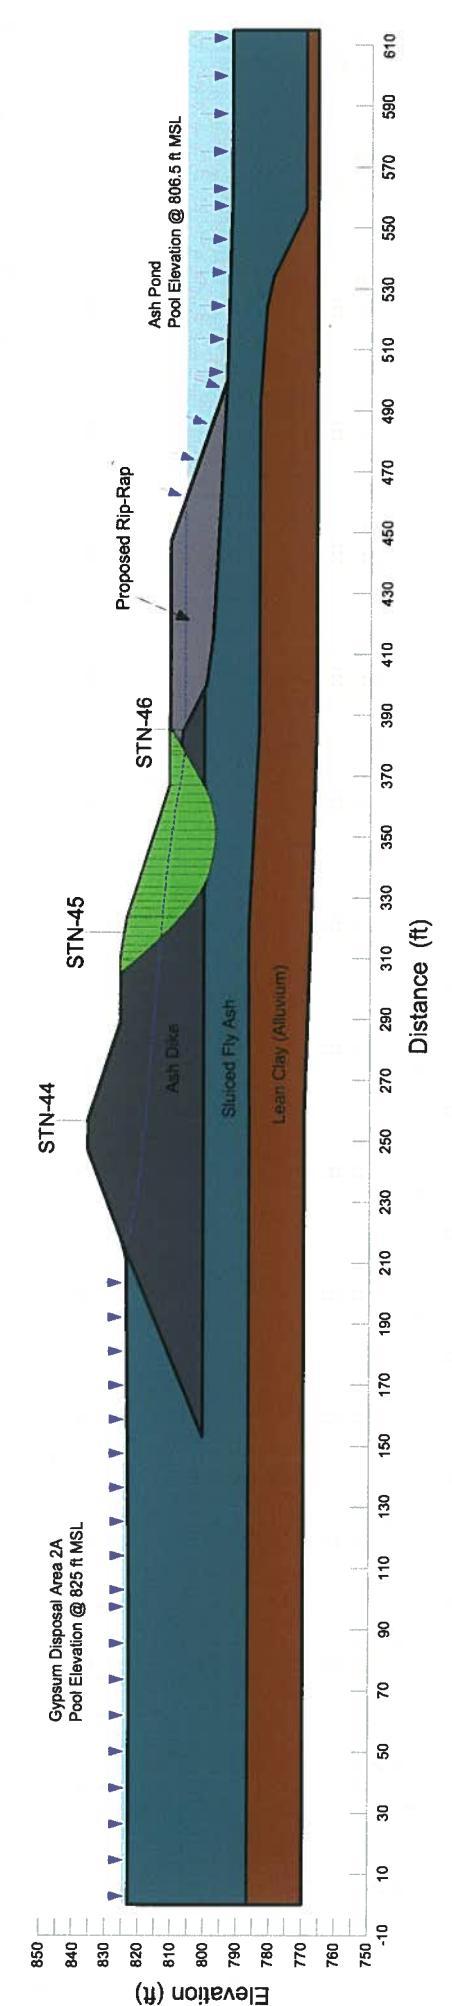
Proposed Buttress to Elev. 811'

Piping Potential Maximum Exit Gradient occurs at (505,793.88) Total Head = 806.50 ft At (504.07,788.16) Total Head = 806.79 ft dH = 0.29 ft dl = 5.72 ft i = 0.05 i(criticial) = 0.708 FSpiping = 14.2

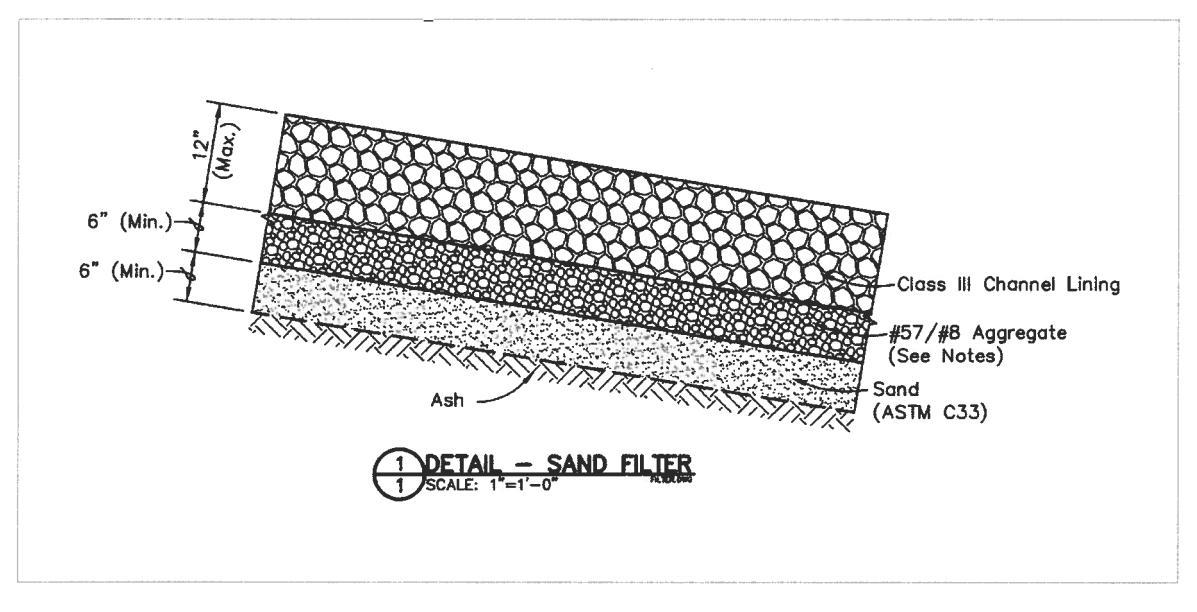
Figure 1: Proposed Sand Filter Detail

The calculations presented here are for the sand filter detail shown in Figure 1. Specifically, this letter addresses the filter design calculations for **Ash Dike Material versus Sand**. The proposed sand filter will be utilized for armoring the south slope of the Gypsum Stack Area 2A.

For more information regarding the proposed slope armoring repairs please refer to the following work plans issued by Stantec.

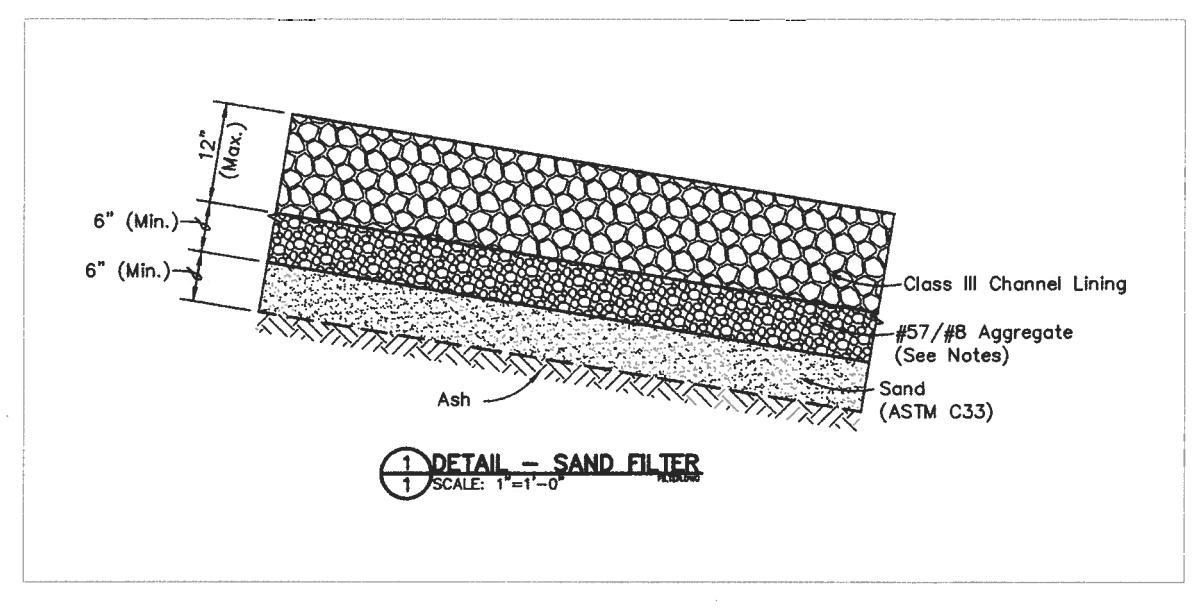
Figure 1: Proposed Sand Filter Detail

The calculations presented here are for the sand filter detail shown in Figure 1. Specifically, this letter addresses the filter design calculations for **Fly Ash versus Sand**. The proposed sand filter will be utilized for armoring the south slope of the Gypsum Stack Area 2A.

For more information regarding the proposed slope armoring repairs please refer to the following work plans issued by Stantec.

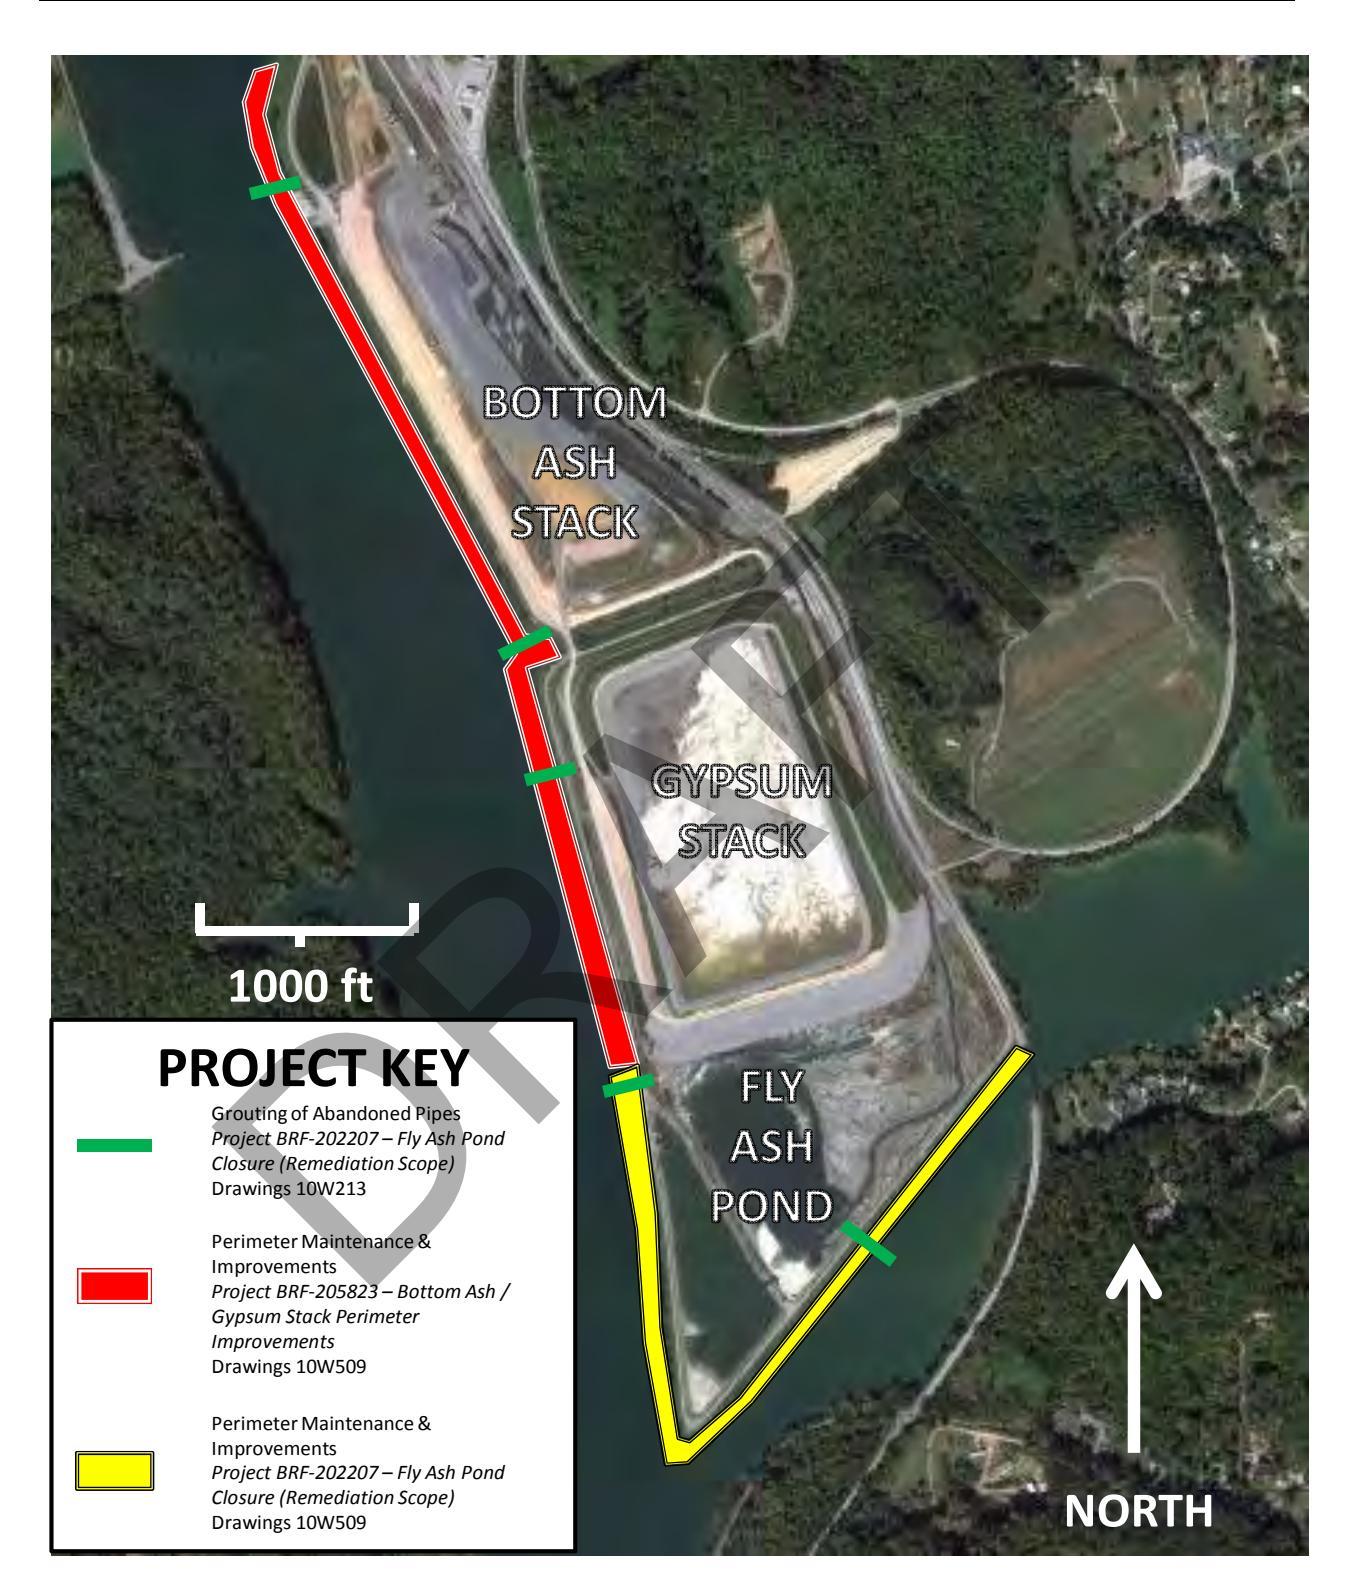
Figure 1 – Plan view of projects BRF-202207 and BRF-205823

It should be noted that only the portions of TVA Project ID BRF-202207 – Fly Ash Pond Closure covered by Drawings 10W213 and 10W509 have been designed and completed to date. The completed portions refer to the Remediation Scope, or work required to increase the slope stability FoS to at least 1.5 during normal pond operations. The remaining portions of the project, pertaining to final closure of the fly ash pond, will be designed and constructed at a later date.

- Clearing and grubbing of woody vegetation along the perimeter dikes of the CCP disposal areas (Projects BRF-202207 [Remediation Scope] and BRF-205823, Drawing Set 10W509);
- Placement of rip-rap as erosion protection and thin buttressing in two zones (1 and 2) (Project BRF-202207 [Remediation Scope], Drawing Set 10W509);
- Placement of rip-rap as erosion protection in eleven zones (3 through 13) (Project BRF-205823, Drawing Set 10W509); and
- Cleaning and grouting of five abandoned spillway pipes (Project BRF-202207, Drawing Set 10W213).
