**Coal Combustion Residue Impoundment  
Round 11 - Dam Assessment Report**

*John Sevier Fossil Plant*

*Ash Basin Dikes*

*Tennessee Valley Authority  
Rogersville, Tennessee*

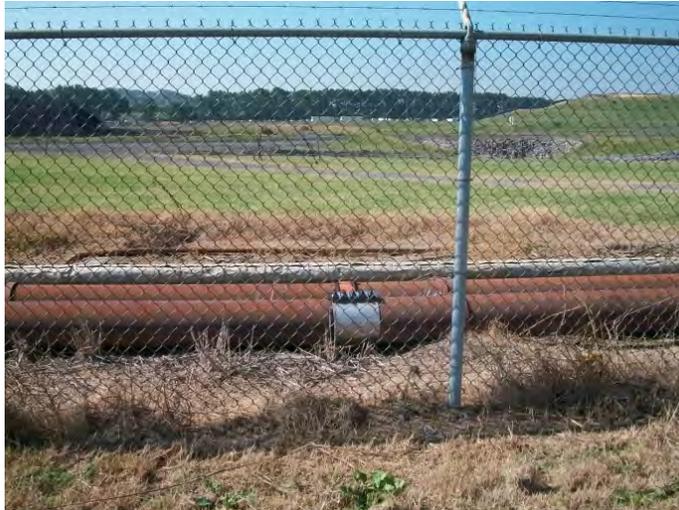
**Photograph 2.2.2a: Bottom ash sluice pipes outside plant**

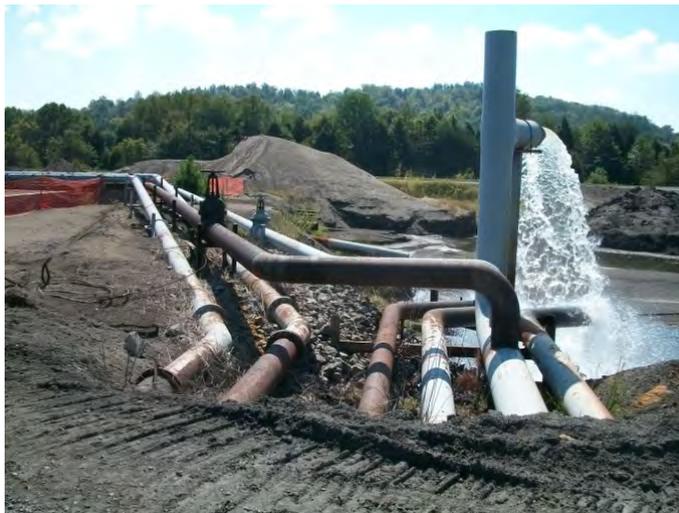
**Photograph 2.2.2b: Bottom ash sluice pipes at Bottom Ash Disposal Area 2**

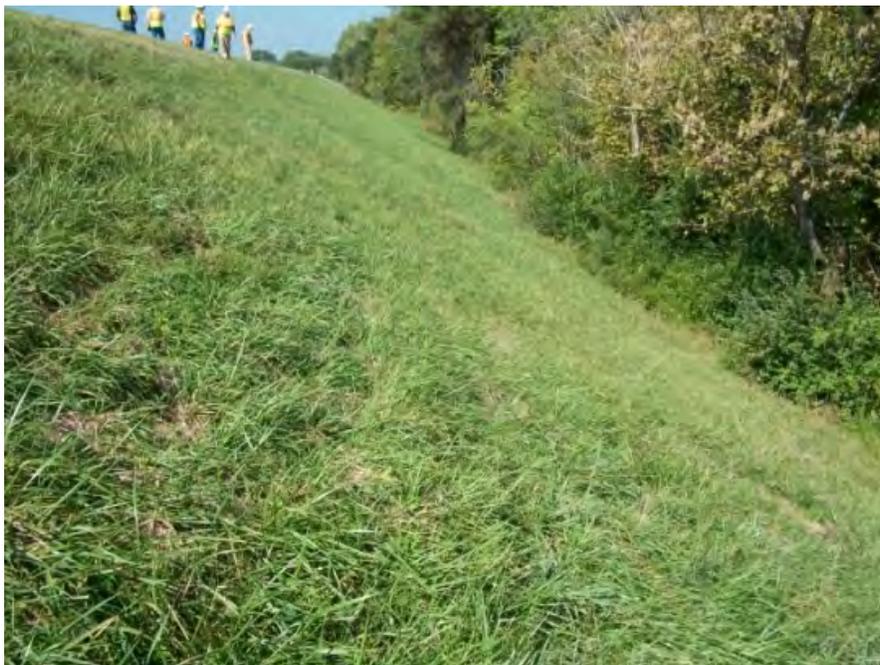
Several seeps were clearly marked for monitoring. Several feet below the crest a horizontal discontinuity in the slope was observed; however it was not deemed an indicator of slope instability. No scarps, sloughs, depressions, bulging or other indications of slope instability or signs of erosion were observed (see Figure 5.2.3-1).

Figure 5.2.3-1 Outside Slope

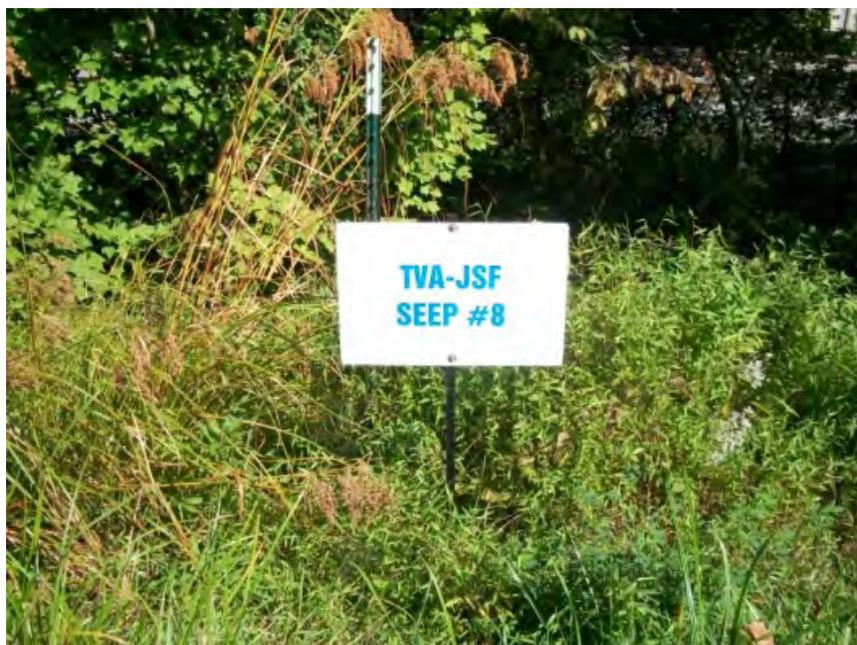
Note: Stantec prepared a Seepage Action Plan dated June 25, 2010 (Figure 5.2.3-2 shows a seep area).

Figure 5.2.3-2 Typical Seep Area, Downgradient Slope, Bottom Ash Disposal Area 2

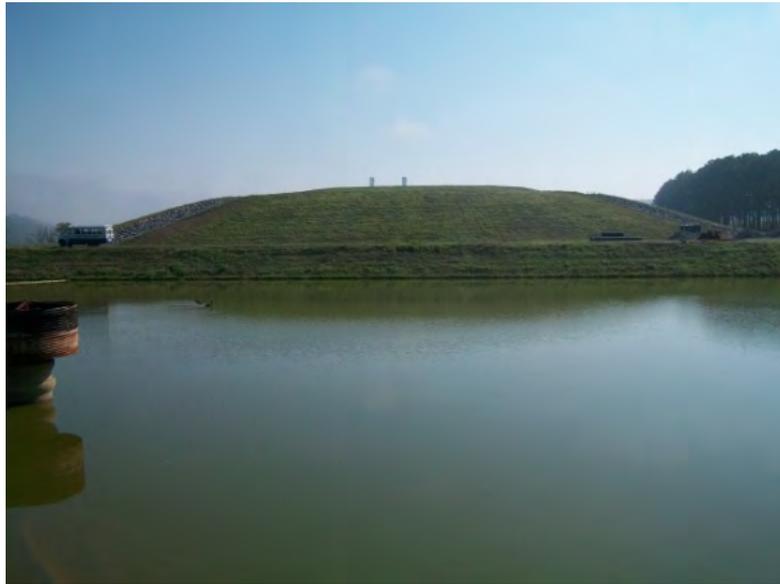
The interior slopes of the West Sediment Pond are vegetated with sparse grass and low weeds (See Figure 5.3.2-1)

**Figure 5.3.2-1 Dry Fly Ash Stack West Sediment Pond Embankment Inside Slope)**

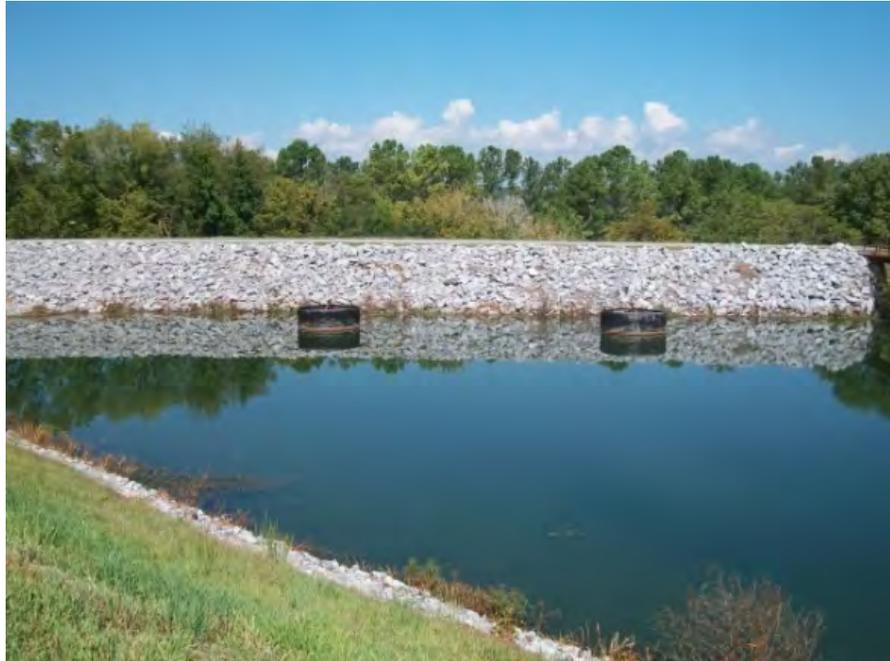
The Bottom Ash Disposal Area 2 contains two 48-inch diameter reinforced concrete risers that serve as an outlet structure (see Figure 5.4.1-1).

**Figure 5.4.1-1 Overflow Risers, Bottom Ash Disposal Area 2**

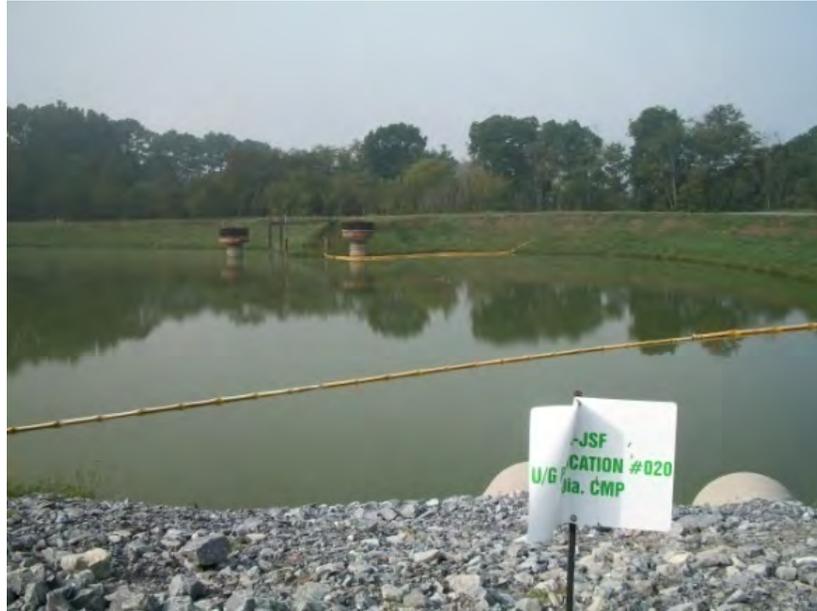
Stormwater runoff from the western portion of the Dry Fly Ash Stack is directed towards the West Sediment Pond, formerly Area G of the impoundment. The West Sediment Pond overflow structure consists of two 48-inch diameter reinforced concrete risers. (see Figure 5.4.1-2).

**Figure 5.4.1-2 Dry Fly Ash Stack West Sediment Pond Risers**

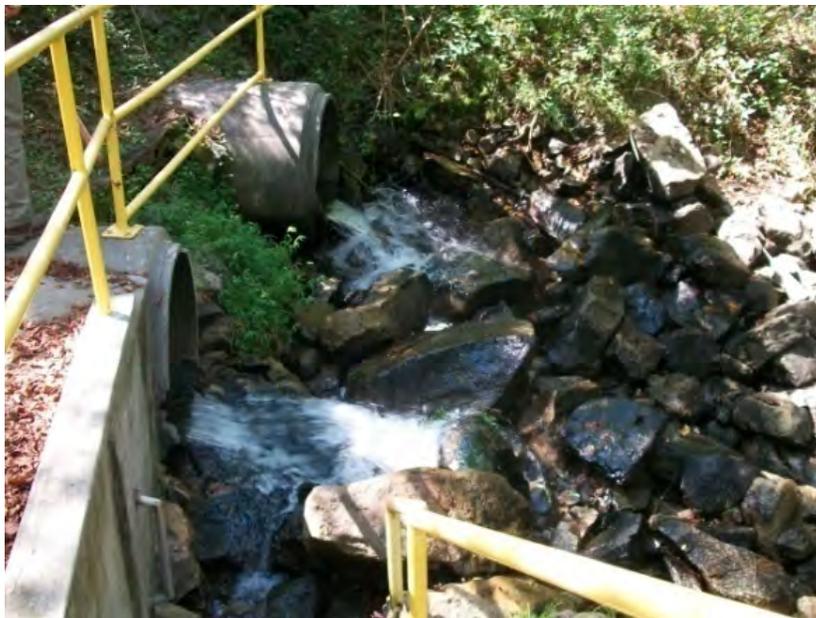
The Bottom Ash Disposal Area 2 outlet conduit consists of two 36-inch diameter reinforced concrete pipes that discharge to a rip-rap lined ditch that flows to a diffuser structure and into the Holston River (see Figure 5.4.2-1).

**Figure 5.4.2-1 Bottom Ash Disposal Area 2 Outfall**

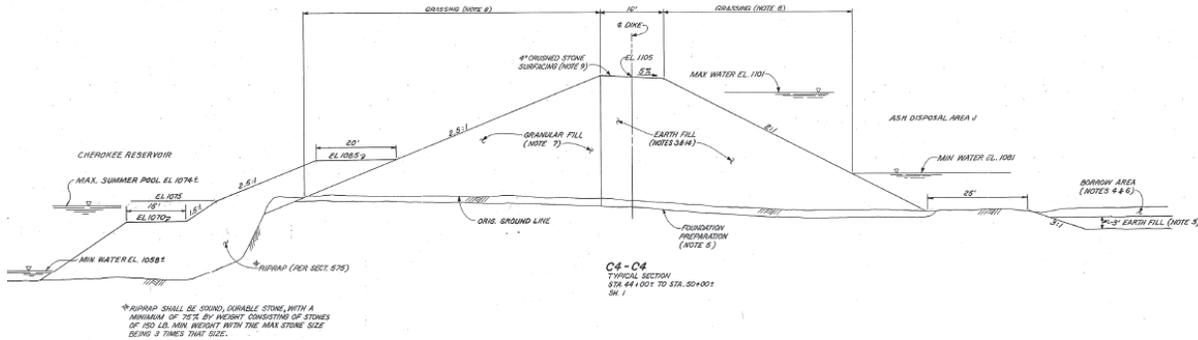
Sheet 4 of the drawings illustrates some repair work performed toward the west end of the north dike slope to stabilize the river bank. A relatively narrow tree area located between the toe of the dike and a steep (near vertical) river bank apparently slumped into the river compromising the toe of the dike. Similar pre-slump conditions currently exist east of this

area of the north dike slope. A typical dike cross section from a Reference No. 5 drawing is shown in Figure 8. This section also shows the measures taken to stabilize the river bank area discussed above.

**Figure 8. Ash Disposal Area "J" – Typical Section 1984**

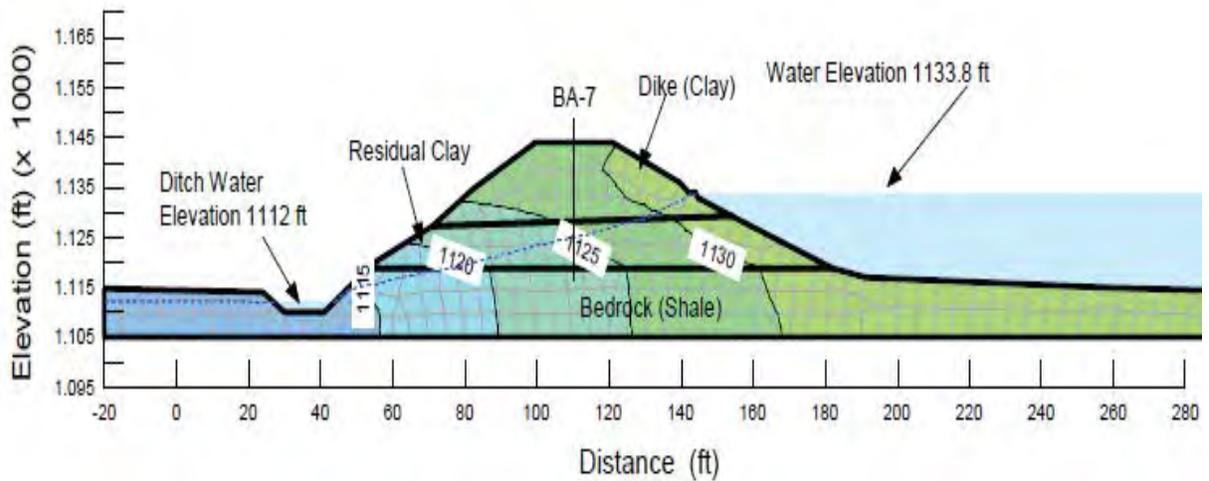
The total head distribution for cross section I-I' is presented in Figure 10. Table 17 presents a comparison of the SEEP/W results (total head) with the average measurements taken from piezometer BA-8.

**Figure 10. Cross Section I-I' (Total Head Contours in Feet)**

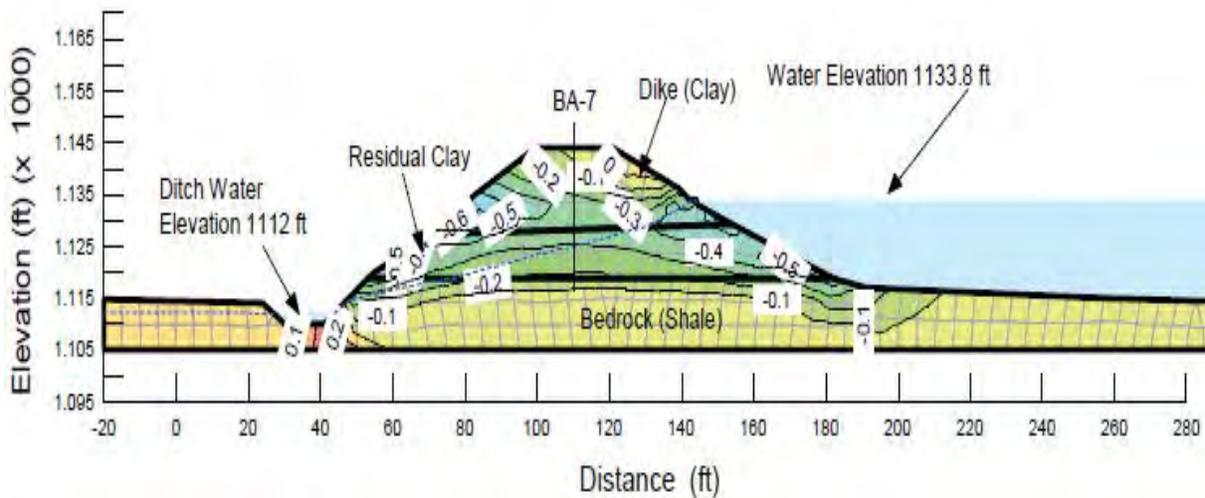
The United States Army Corps of Engineers (USACE) design criteria (EM 1110-2-1901) indicates factors of safety against piping should be at least 3.0. The vertical gradient contours for cross section I-I' are presented below in Figure 11.

**Figure 11. Cross Section I-I' (Vertical Gradient Contours)**

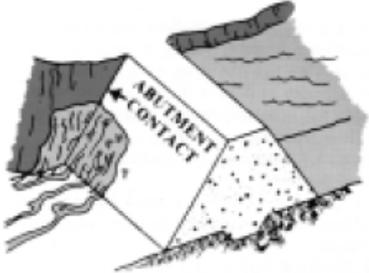
Seepage Problem	Recommendations
<p data-bbox="256 373 683 432">Seepage Water Exiting at Abutment Contact</p>

<p data-bbox="751 436 1406 646">Study leakage area to determine quantity of flow and extent of saturation. Stake out the saturated area and monitor for growth or shrinkage. Inspect frequently for slides. Water level in the impoundment may be lowered to increase embankment safety. A QUALIFIED ENGINEER should inspect the conditions and recommend further actions to be taken.</p>
<p data-bbox="240 806 695 865">Seepage Water Exiting as a Boil in the Foundation</p>

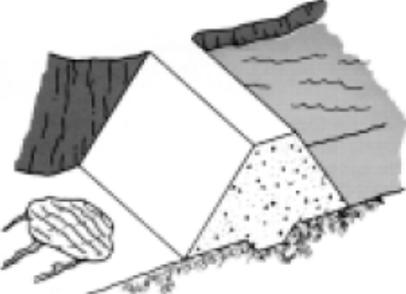
<p data-bbox="272 1299 662 1329">Spongy Condition at Toe of Dam</p>

<p data-bbox="751 1381 1401 1499">Carefully inspect the area for outflow quantity and any transported material. A QUALIFIED ENGINEER should inspect the condition and recommend further actions to be taken.</p>

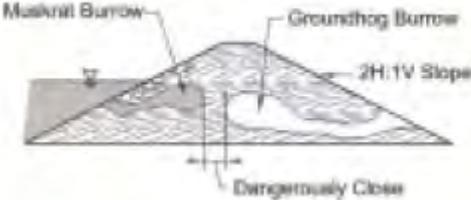
Seepage Problem	Recommendations
<p data-bbox="375 373 558 403">Rodent Activity</p>

<p data-bbox="751 457 1370 546">Control rodents to prevent more damage. Determine exact location of digging and extent of tunneling. Remove rodents and backfill existing holes.</p>
<p data-bbox="256 722 680 781">Seepage Water Exiting from a Point Adjacent to the Outlet</p>

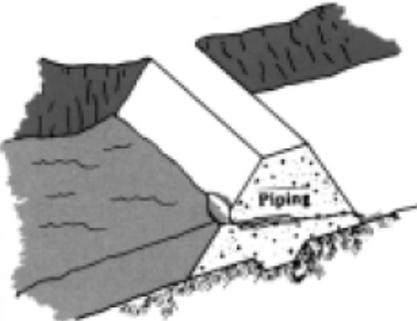
<p data-bbox="751 795 1403 1035">Investigate the area by probing and/or carefully shoveling to see if the cause can be determined. Determine if leakage water is carrying soil particles evidenced by discoloration. Determine quantity of flow. If flow increases, or is carrying embankment materials, reservoir level should be lowered until leakage stops. A QUALIFIED ENGINEER should inspect the condition and recommend further actions to be taken.</p>
<p data-bbox="415 1203 518 1232">Sinkhole</p>

<p data-bbox="751 1310 1390 1459">Inspect other parts of the dam for seepage or more sinkholes. Identify exact cause of sinkholes. Check seepage and leakage outflows for dirty water. A QUALIFIED ENGINEER should inspect the conditions and recommend further actions to be taken.</p>

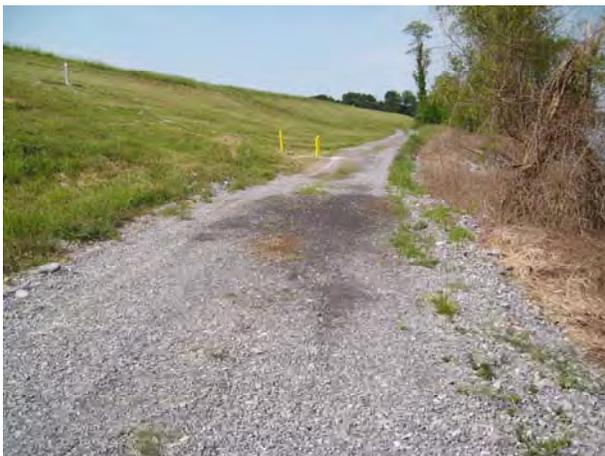
5/29/2010

Seep Initially observed by TVA in 2006. Located near toe of exterior slope of the dry fly ash stack near the lower perimeter road. SAP Level 1.

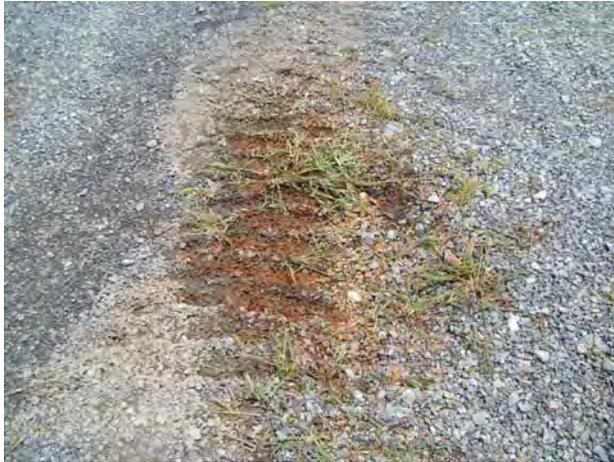
**Area of Concern 3**

Seep initially observed by TVA in 2009. Located near toe of exterior slope of the dry fly ash stack in the lower perimeter road. SAP Level 1.

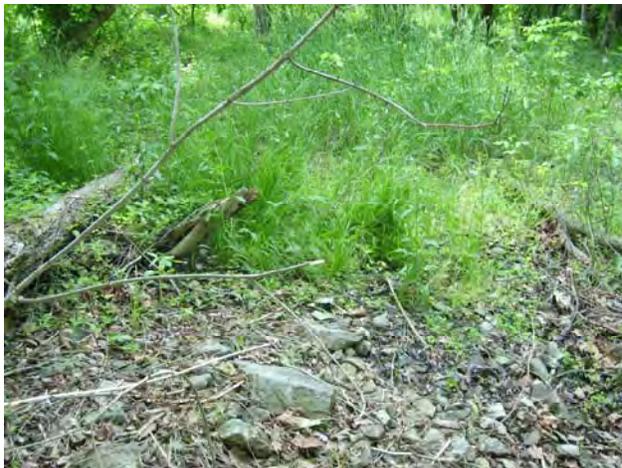
**Area of Concern 3**

Seep initially observed by TVA in 2009. Located near toe of exterior slope of the dry fly ash stack in the lower perimeter road. SAP Level 1.

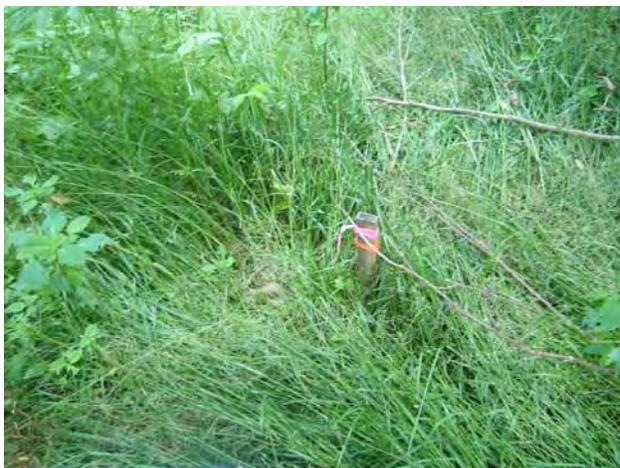
**Area of Concern 4**

Seep initially observed by TVA in 2008. Located approximately 50 feet away from the toe of the exterior west slope of the dry fly ash stack and 10 feet east of Polly Creek. SAP Level 1.

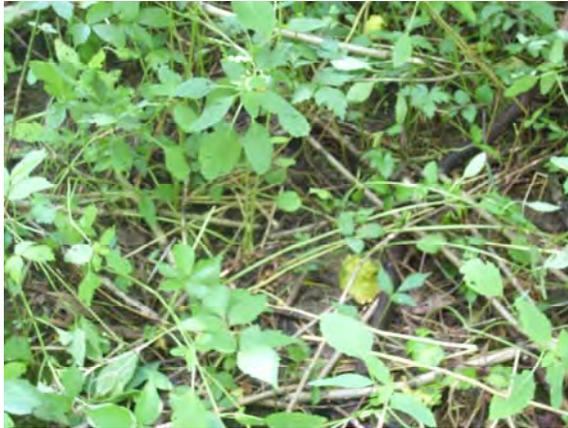
**Area of Concern 4**

Seep initially observed by TVA in 2008. Located approximately 50 feet away from the toe of the exterior west slope of the dry fly ash stack and 10 feet east of Polly Creek. SAP Level 1.

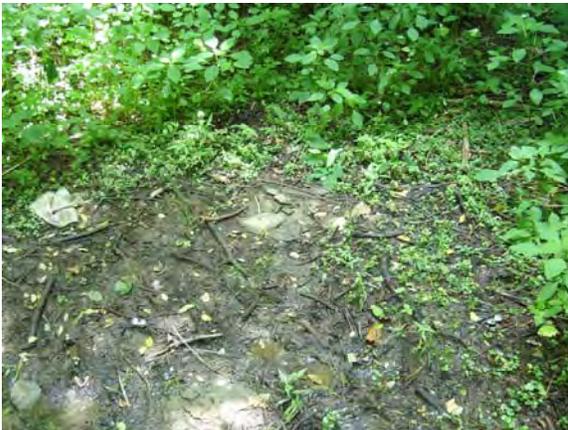
**Area of Concern 5**

Potential seep initially observed by TVA in 2002. Located near toe of west exterior slope of the dry fly ash stack. Was not observed to be wet during 2010 Annual Inspection on 6/16/2010. SAP Level 1.

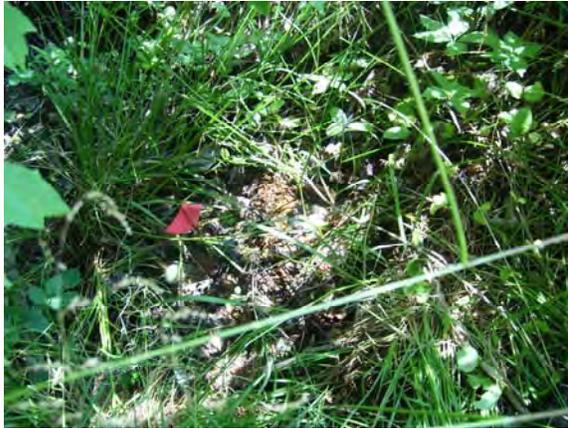
Potential red water seep initially observed by TVA in 2009. Located near toe of north exterior slope of the bottom ash dredge cell. Seep location was not apparent during Annual inspection on 6/16/2010. SAP Level 1.

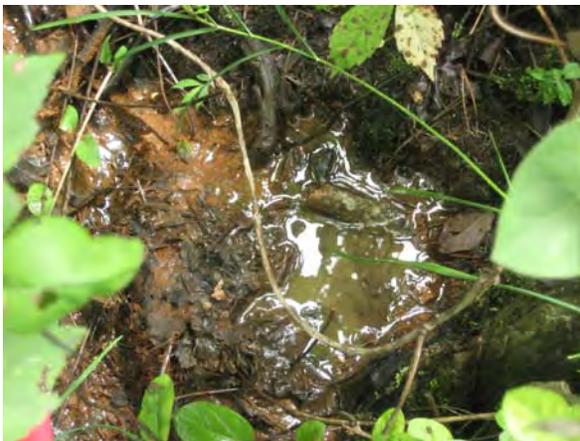
**Area of Concern 8**

Red water seep initially observed by Stantec/TVA in 7/2009 during maintenance and tree removal. Located at the toe of the north exterior slope of the main ash pond. Seep Level 1.

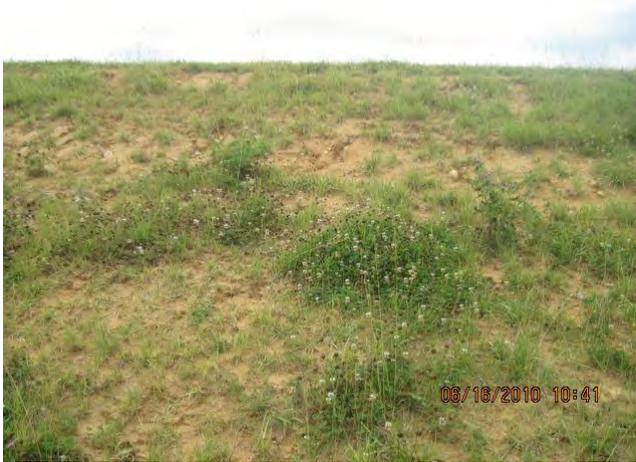
**Photo 3 (TVA Item No. 34)**

**Erosion:** Erosion was observed on the upper exterior slope on the west end of the area (see Photo 3, TVA Item No. 34), on the interior of the area (see Photo 16, TVA Item No. 31), and on the bench on the east side of the area (see Photo 27, TVA Item No. 2).

Erosion and multiple rills located on the west end of the upper exterior slope of the area.

- It is recommended that the areas of erosion observed on the exterior slopes (see Photo 3, TVA Item No. 34; Photo 16, TVA Item No. 31; and Photo 27, TVA Item No. 2) be repaired. It is expected that rip-rap may be needed to protect the embankment. (Priority 4)

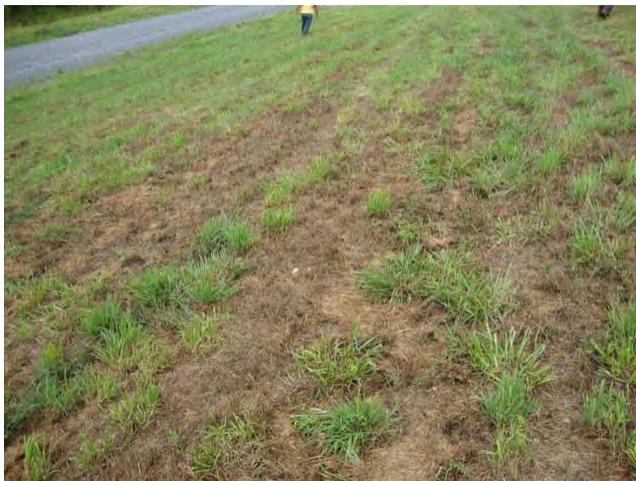
**Photo 4 (TVA Item No. 35)**

Sparse vegetation located on the upper exterior slope on the northwest corner of the area.

- It is recommended that the areas of sparse vegetation observed on the exterior slopes (see Photo 4, TVA Item No. 35; Photo 5, TVA Item No. 64; Photo 7, TVA Item No. 62; Photo 8, TVA Item No. 60; Photo 9, TVA Item No. 59; Photo 18, TVA Item No. 37; Photo 20, TVA Item No. 9; Photo 21, TVA Item No. 8; Photo 22, TVA Item No. 7; and Photo 25, TVA Item No. 4) be reworked and/or reseeded to support vegetation growth consistent with the remainder of the slopes. (Priority 4)

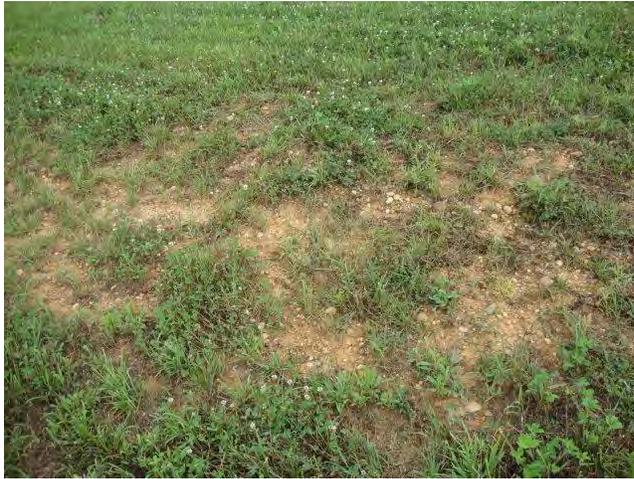
**Photo 6 (TVA Item No. 63)**

Tire rutting was observed on the upper exterior slope on the south side of the area (see Photo 6, TVA Item No. 63).

Tire rutting observed on the upper exterior slope on the south side of the area.

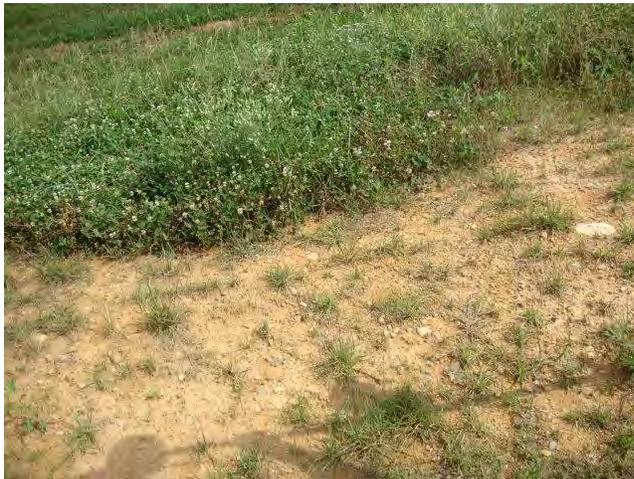
**Photo 7 (TVA Item No. 62)**

Sparse vegetation located on the upper exterior slope on the south side of the area.

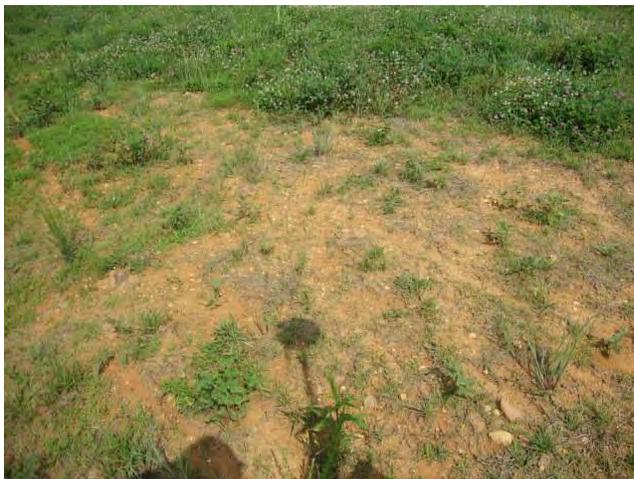
**Photo 8 (TVA Item No. 60)**

Sparse vegetation located on the upper exterior slope on the south side of the area.

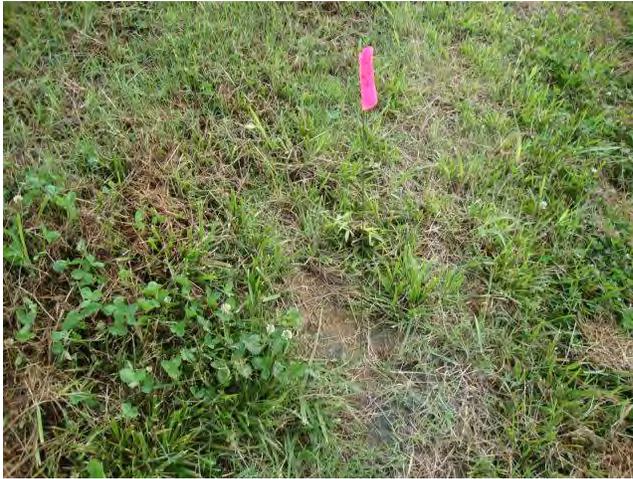
**Photo 12 (TVA Item No. 57)**

Exposed ash was observed on the lower exterior slope on the south side of the area (see Photo 12, TVA Item No. 57; Photo 13, TVA Item No. 56; Photo 14, TVA Item No. 55; and Photo 15, TVA Item No. 54), on the upper exterior slope on the north side of the area (see Photo 19, TVA Item No. 67), and in the upper slope on the interior of the area (see Photo 17, TVA Item No. 30).

Exposed ash observed on the lower exterior slope on the south side of the area.

- It is recommended that the areas of exposed ash observed on the exterior slopes (see Photo 12, TVA Item No. 57; Photo 13, TVA Item No. 56; Photo 14, TVA Item No. 55; Photo 15, TVA Item No. 54; Photo 17, TVA Item No. 30; and Photo 19, TVA Item No. 67) be reworked and/or reseeded to support vegetation growth consistent with the remainder of the slopes. (Priority 4)

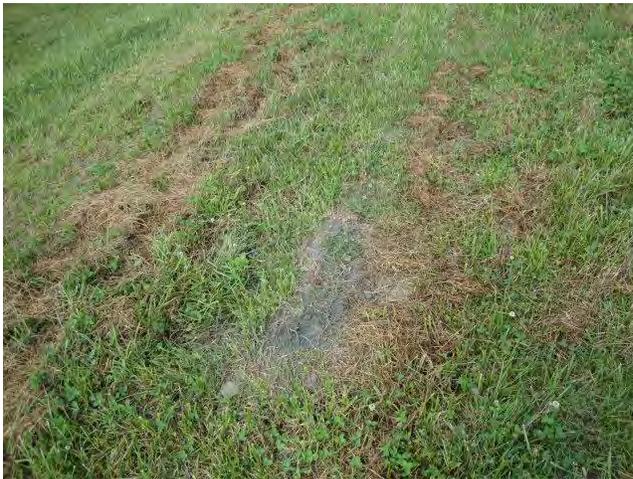
**Photo 13 (TVA Item No. 56)**

Exposed ash observed on the lower exterior slope on the south side of the area.

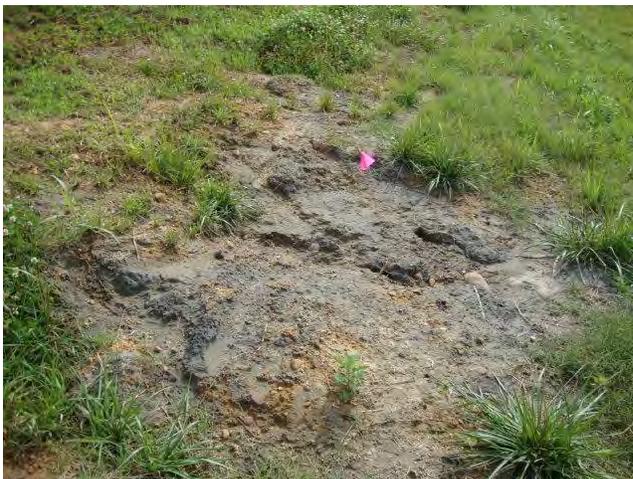
**Photo 14 (TVA Item No. 55)**

Exposed ash observed on the lower exterior slope on the south side of the area.

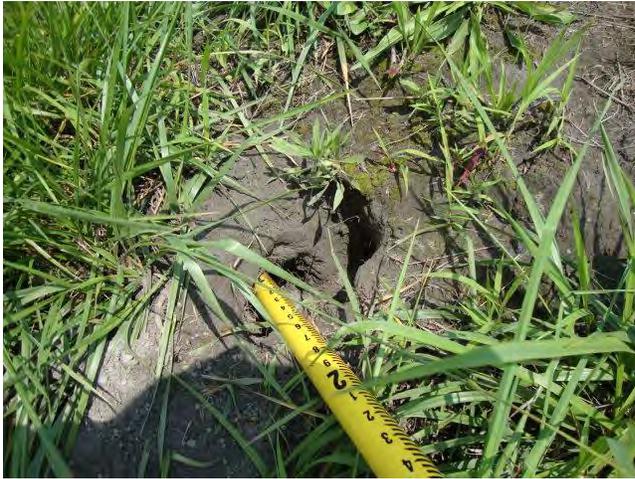
**Photo 18 (TVA Item No. 37)**

Sparse vegetation observed on the upper exterior slope on the north side of the area.

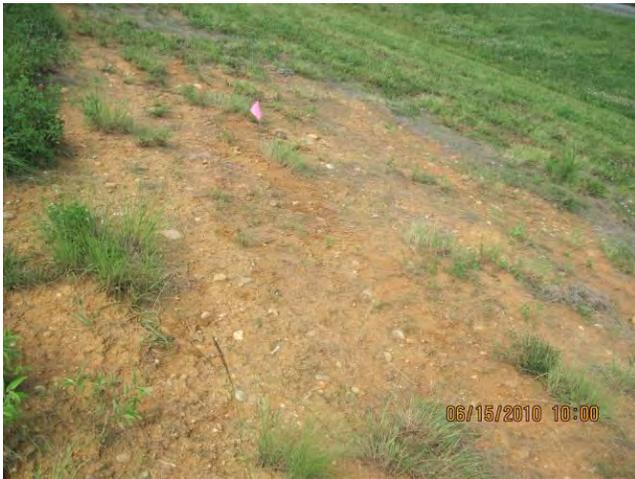
**Photo 19 (TVA Item No. 67)**

Exposed ash observed on the upper exterior slope on the north side of the area.

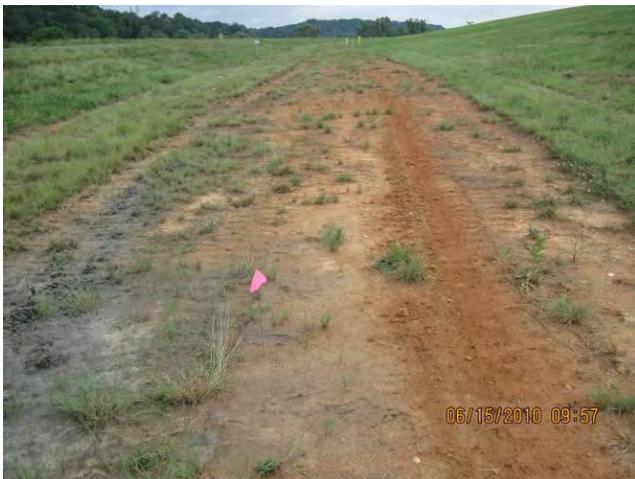
**Photo 20 (TVA Item No. 9)**

Sparse vegetation observed on the lower exterior slope on the north side of the area.

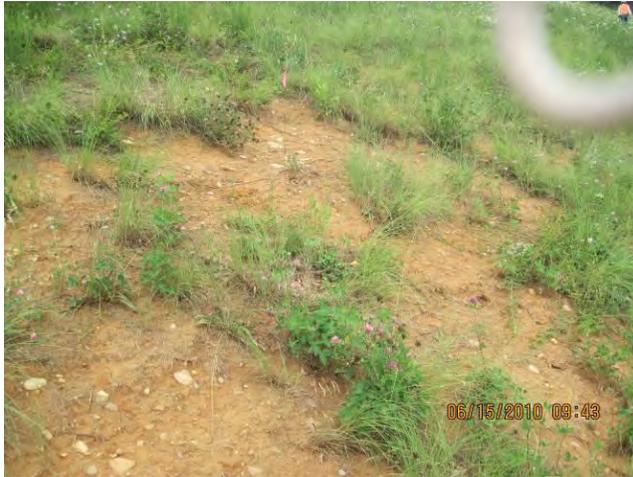
**Photo 21 (TVA Item No. 8)**

Sparse vegetation observed on the upper exterior slope in ditch line on the north side of the area.

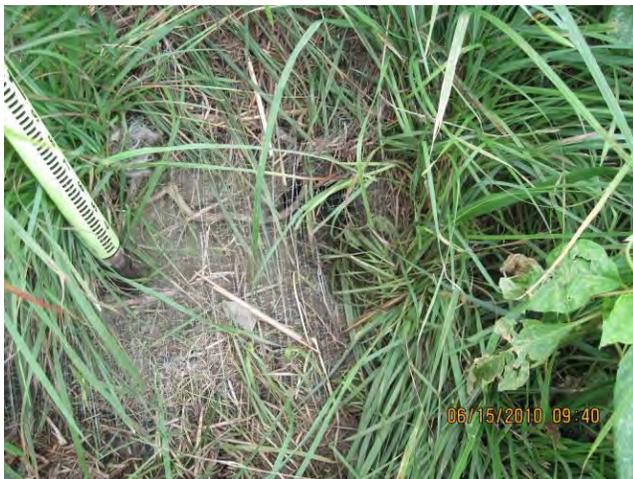
**Photo 22 (TVA Item No. 7)**

Sparse vegetation observed on the lower exterior slope on the east side of the area.

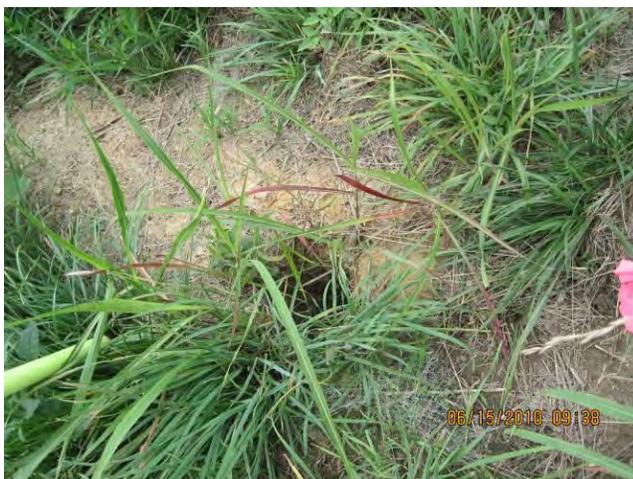
**Photo 23 (TVA Item No. 6)**

Animal burrows were observed on the upper exterior slope on the north side (see Photo 10, TVA Item No. 36) and on the lower exterior slope on the east side of the area (see Photo 23, TVA Item No. 6 and Photo 24, TVA Item No. 5).

Animal burrow observed on the lower exterior slope on the east side of the area.

- The low areas observed along the bench (see Photo 26, TVA Item No. 3 and Photo 28, TVA Item No. 1) should be graded to drain. (Priority 4)
- The animal burrows observed during the inspection on the exterior slope (see Photo 10, TVA Item No. 36; Photo 23, TVA Item No. 6; and Photo 24, TVA Item No. 5) should be repaired in accordance with the guidelines given in Enclosure J. (Priority 4)

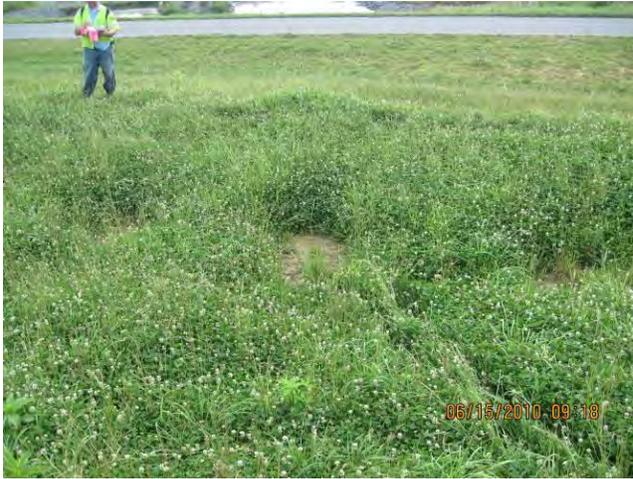
**Photo 27 (TVA Item No. 2)**

Erosion observed near the bench on the east side of the area.

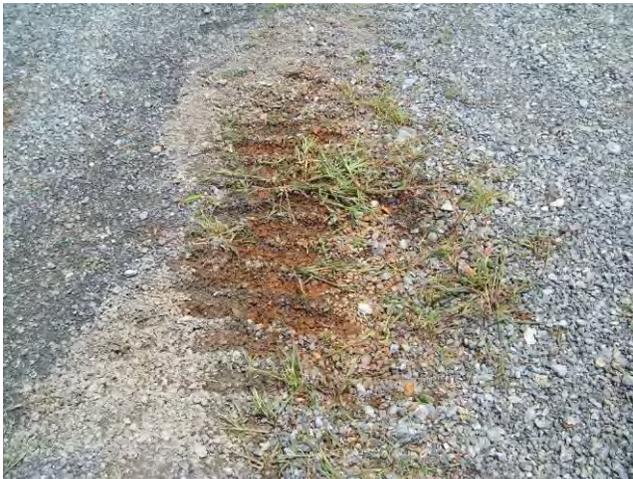
**Photo 28 (TVA Item No. 1)**

Low areas were observed on the bench on the east side of the area (see Photo 26, TVA Item No. 3 and Photo 28, TVA Item No. 1).

Low spot observed on the bench on the east side of the area.

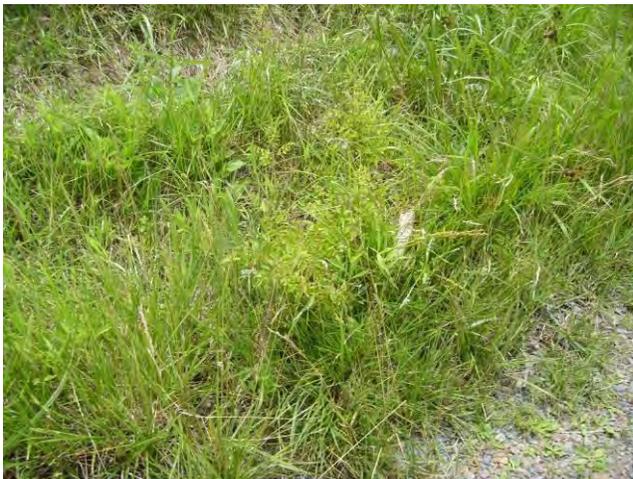
**Photo 29**

Three locations of seepage have been noted in past inspections. ND-E1 was near the toe of the exterior embankment on the north side of the area (not seen during this inspection), ND-2 was located on the access road near the toe of the exterior slope on the north side of the area (see Photo 30), and ND-3 was also located on the access road near the toe of the exterior slope on the north side of the area (see Photo 29).

Location of Seep ND-3 on the lower perimeter road on the south side of the area.

slope during past inspections (see Photo 29 and Photo 30) continue to be monitored as indicated in the Seepage Action Plan dated June 25, 2010. It is anticipated that these seeps will be remediated upon construction of Work Plan 4 (JSF-100518-WP-4)R1.

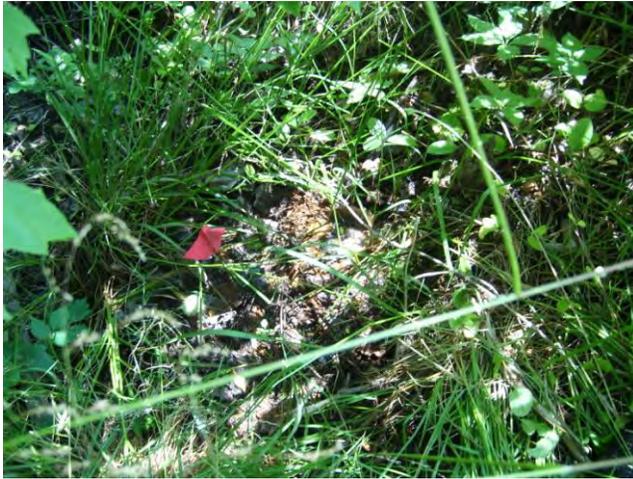
**Photo 1 (TVA Item No. 69)**

Seepage area located on the north side of the pond; documented seep "BAP-N2".

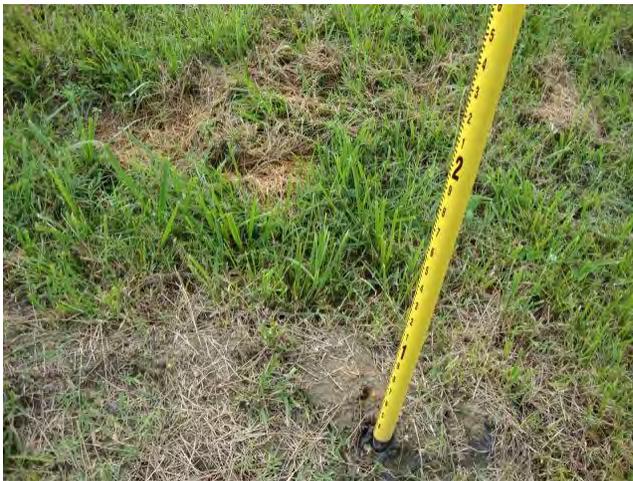
**Photo 2 (TVA Item No. 68)**

Animal burrow located on the interior slope on the north side of the pond.

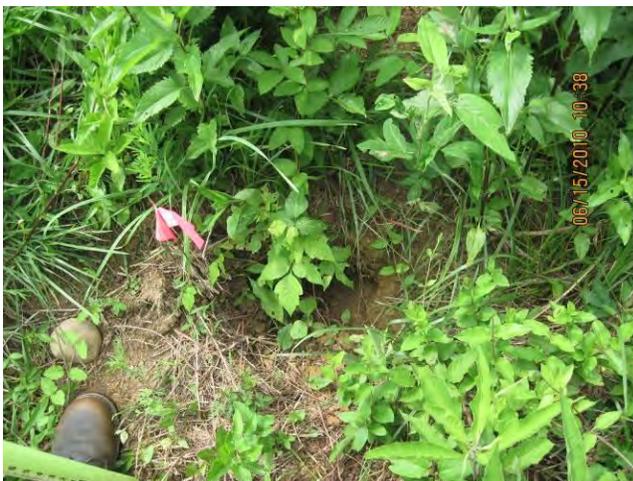
**Photo 3 (TVA Item No. 10)**

Animal burrow located on the exterior slope on the north side of the pond.

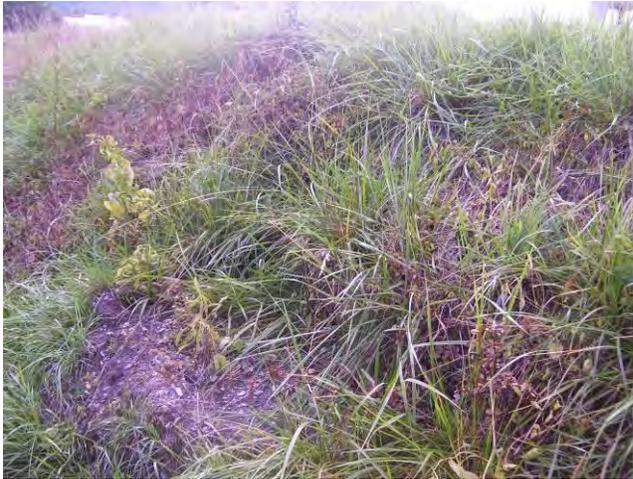
**Photo 4 (TVA Item No. 11)**

Erosion observed on the exterior slope on the north side of the pond.

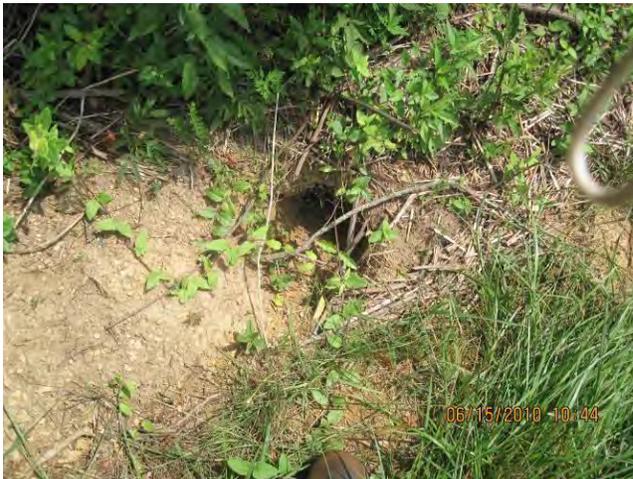
**Photo 5 (TVA Item No. 12)**

Location of three animal burrows near the toe on the north exterior slope of the pond.

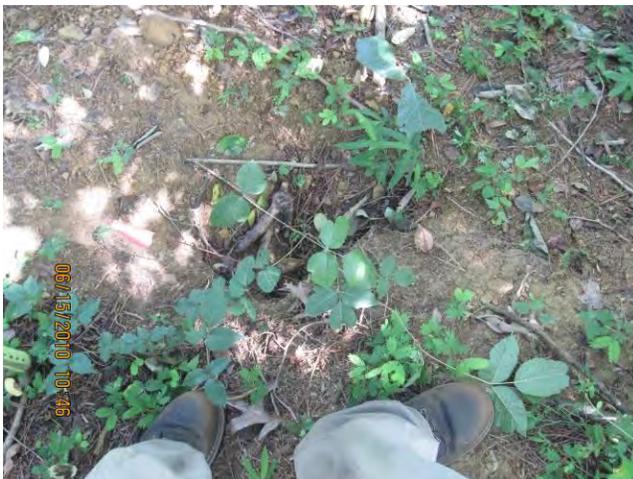
**Photo 6 (TVA Item No. 13)**

Animal burrow located near the toe on the exterior slope on the north side of the pond.

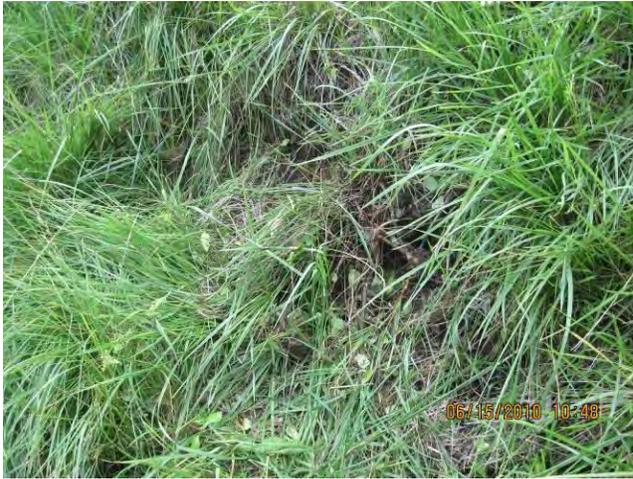
**Photo 7 (TVA Item No. 14)**

Slough/erosion observed on the exterior slope north of the pond.

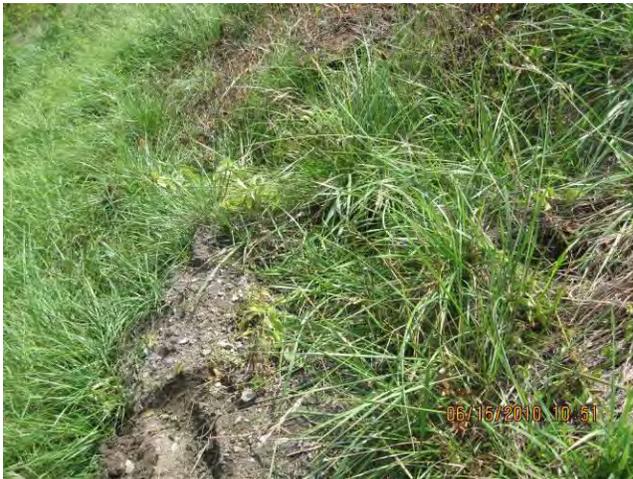
**Photo 8 (TVA Item No. 15)**

Slough/erosion observed on the exterior slope north of the pond. A large piece of iron is also present, 6 feet long and 2 feet wide.

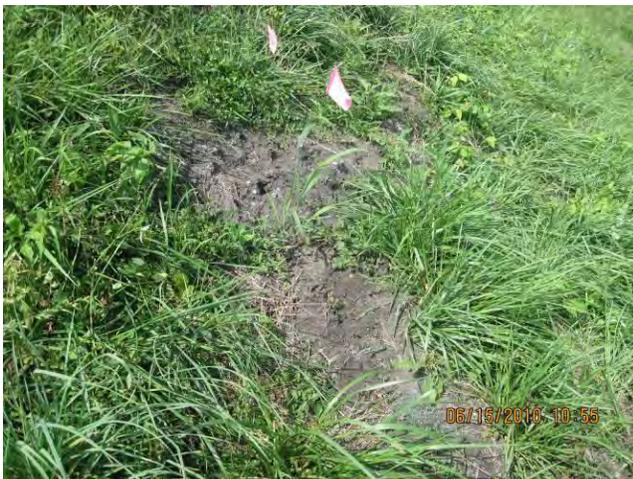
**Photo 9 (TVA Item No. 16)**

Exposed ash observed on the exterior slope on the north side of the pond.

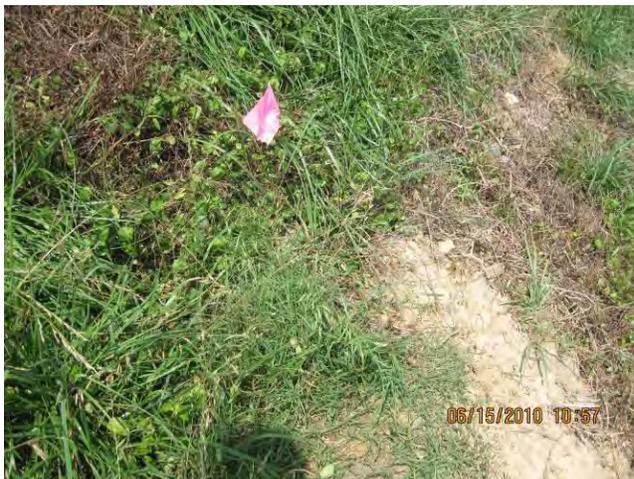
**Photo 12 (TVA Item No. 17)**

**Instabilities:** Minor sloughing was observed at the northeast corner of the pond (see Photo 12, TVA Item No. 17).

Slough observed on the exterior slope on the northeast interior corner of the pond.

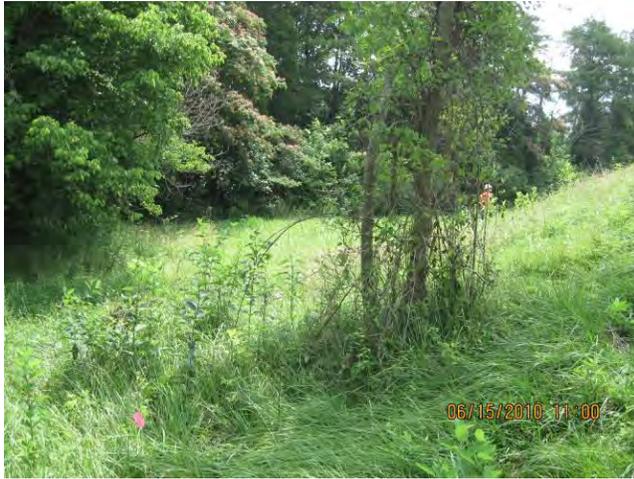
**Photo 13 (TVA Item No. 20)**

Tree and stump observed near the toe on the exterior slope on the northeast side of the pond.

Photo 13, TVA Item No. 20) and the tree stumps observed on the south slope (see Photo 19, TVA Item No. 27) of the exterior of the pond be removed in accordance with the guidelines shown in Enclosure I. (Priority 4)

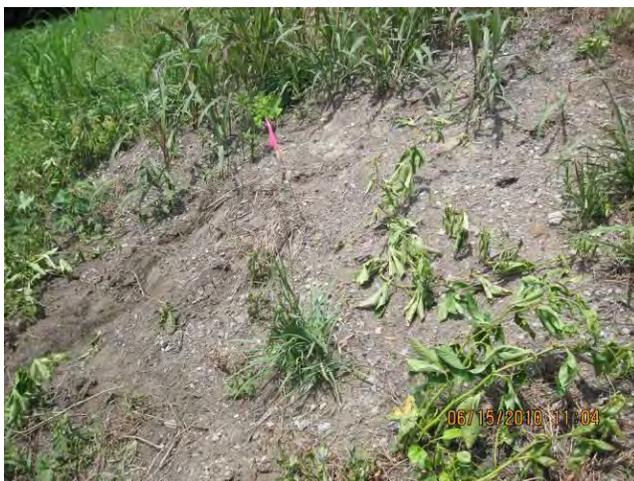
**Photo 14 (TVA Item No. 21)**

Animal burrow located on the exterior slope on the southeast side of the pond.

- The animal burrows observed during the inspection on the interior slope (see Photo 2, TVA Item No. 68) and on the exterior slope of the pond (see Photo 3, TVA Item No. 10; Photo 5, TVA Item No. 12; Photo 6, TVA Item No. 13; Photo 14, TVA Item No. 21; Photo 16, TVA Item No. 24; Photo 17, TVA Item No. 25; Photo 18, TVA Item No. 26; Photo 20, TVA Item No. 28; Photo 30, TVA Item No. 46; Photo 31, TVA Item No. 47; Photo 33, TVA Item No. 49; Photo 34, TVA Item No. 50; Photo 35, TVA Item No. 51; Photo 36, TVA Item No. 52; Photo 37, TVA Item No. 53; and Photo 38, TVA Item No. 70) be repaired in accordance with the guidelines given in Enclosure J. (Priority 4)

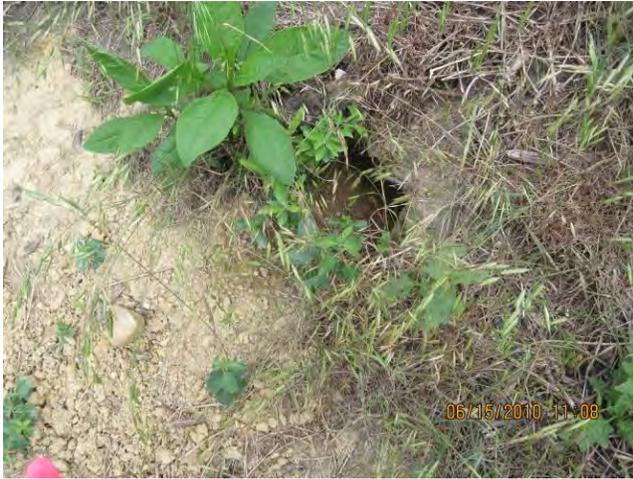
**Photo 15 (TVA Item No. 23)**

**Vegetation:** Most slopes are heavily vegetated with grass. Exposed ash was observed on the north side of the pond (see Photo 9, TVA Item No. 16) and on the south side of the pond (see Photo 15, TVA Item No. 23 and Photo 21, TVA Item No. 29).

Area of sparse vegetation on exterior slope on the south side of the pond.

- It is recommended that the areas of exposed ash observed on the interior slopes (see Photo 27, TVA Item No. 43, Photo 28, TVA Item No. 44; and Photo 29, TVA Item No. 45) and on the exterior slopes (see Photo 9, TVA Item No. 16; Photo 15, TVA Item No. 23; and Photo 21, TVA Item No. 29) be reworked and/or reseeded to support vegetation growth. (Priority 4).

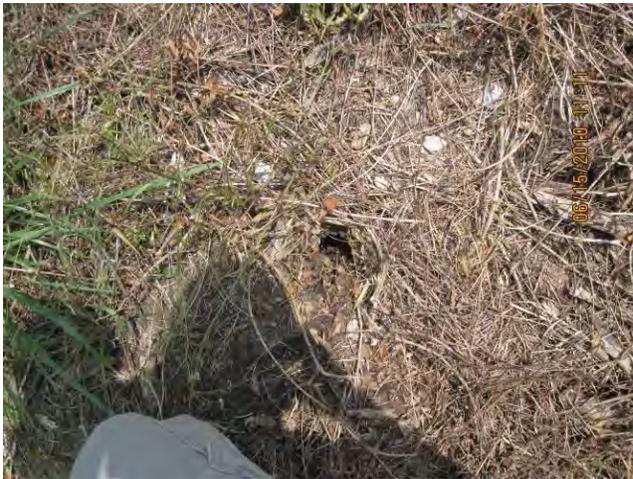
**Photo 16 (TVA Item No. 24)**

Location of two animal burrows on the exterior slope on the south side of the pond.

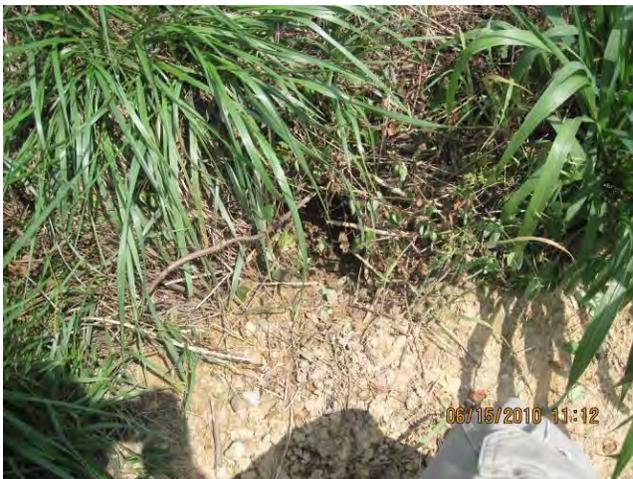
**Photo 17 (TVA Item No. 25)**

Animal burrow located on the exterior slope on the south side of the pond.

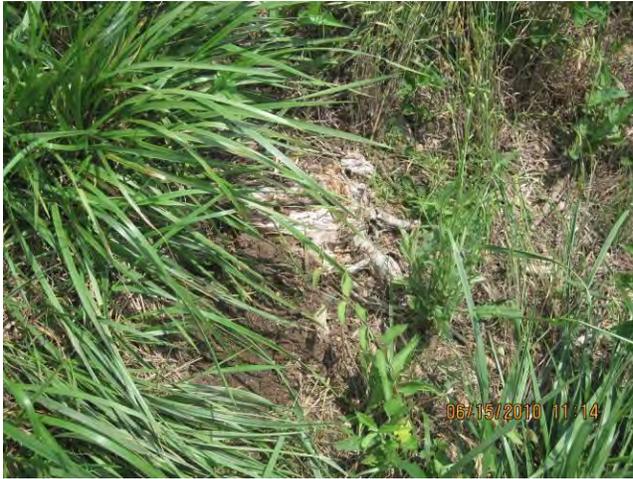
**Photo 18 (TVA Item No. 26)**

Animal burrow located on the exterior slope on the south side of the pond.

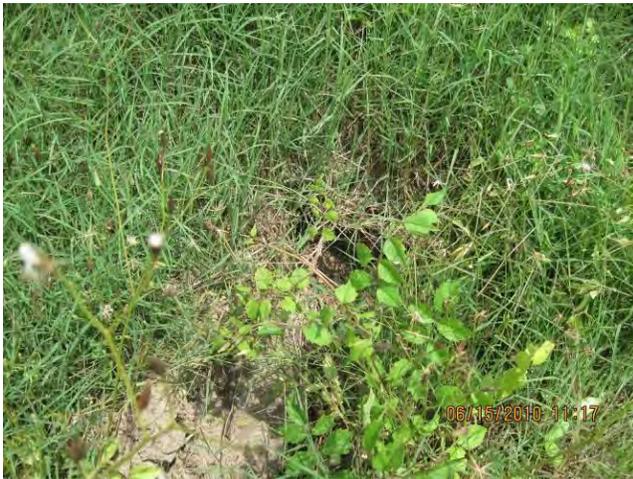
**Photo 19 (TVA Item No. 27)**

**Trees:** A small cluster of trees was observed near the toe on the exterior slope on the northeast side of the pond (see Photo 13, TVA Item No. 20). Stumps from previous tree growth were observed on the south side of the pond (see Photo 19, TVA Item No. 27).

Tree stump observed on the exterior slope on the south side of the pond.
