**Coal Combustion Residue Impoundment  
Round 11 - Dam Assessment Report**

*John Sevier Fossil Plant*

*Ash Basin Dikes*

*Tennessee Valley Authority  
Rogersville, Tennessee*

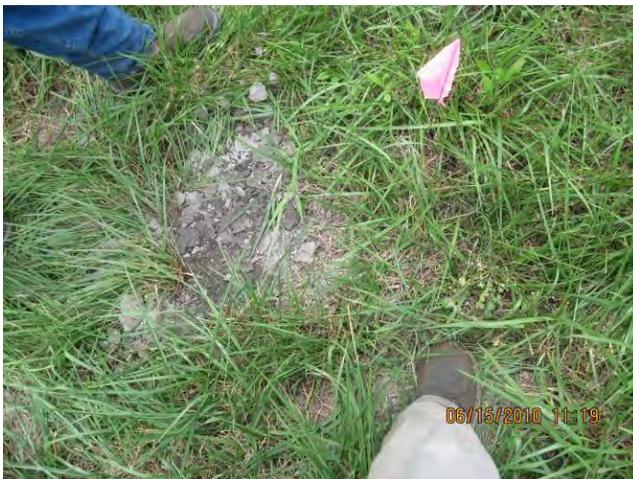
**Photo 20 (TVA Item No. 28)**

Animal burrow located on the exterior slope on the south side of the pond.

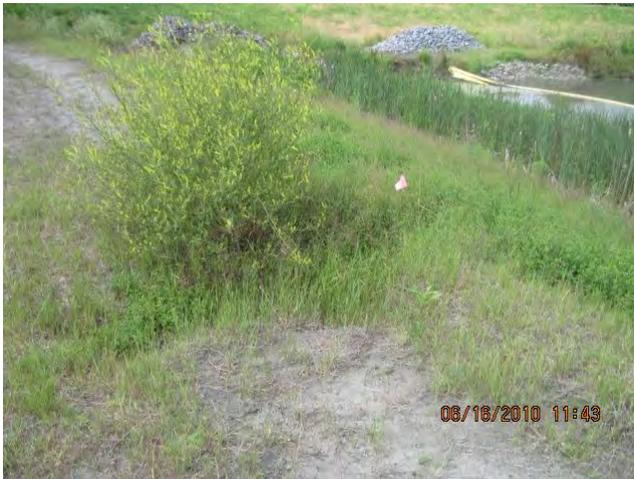
**Photo 25 (TVA Item No. 41)**

**Erosion:** The internal ash dike that separates the inactive dredge area and the ash pond has numerous erosion gullies (see Photo 22, TVA Item No. 38; Photo 23, TVA Item No. 39; Photo 24, TVA Item No. 40; Photo 25, TVA Item No. 41; and Photo 26, TVA Item No. 42).

Erosion observed on the slope of the interior embankment (divider dike) of the pond.

- It is recommended that the areas of erosion observed on the interior slopes (see Photo 22, TVA Item No. 28; Photo 23, TVA Item No. 39; Photo 24, TVA Item No. 40; Photo 25, TVA Item No. 41; Photo 26, TVA Item No. 42; and Photo 32, TVA Item No. 48) and on the exterior slopes (see Photo 4, TVA Item No. 11; Photo 7, TVA Item No. 14; and Photo 8, TVA Item No. 15) be repaired. It is expected that rip-rap will be needed on interior slopes to protect the embankment (Priority 4).

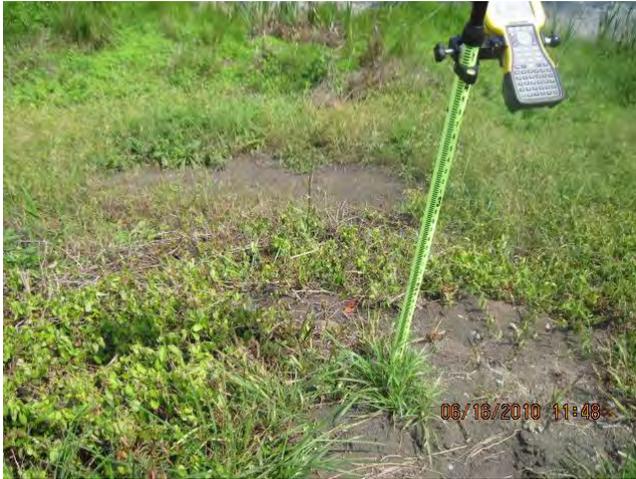
**Photo 27 (TVA Item No. 43)**

**Vegetation:** Most of the slopes are heavily vegetated with grass and brush. Exposed ash was observed on the south side of the pond (see Photo 27, TVA Item No. 43; Photo 28, TVA Item No. 44; and Photo 29, TVA Item No. 45).

Exposed ash on the interior slope of the south side of the pond.

- It is recommended that the areas of exposed ash observed on the interior slopes (see Photo 27, TVA Item No. 43, Photo 28, TVA Item No. 44; and Photo 29, TVA Item No. 45) and on the exterior slopes (see Photo 9, TVA Item No. 16; Photo 15, TVA Item No. 23; and Photo 21, TVA Item No. 29) be reworked and/or reseeded to support vegetation growth. (Priority 4).

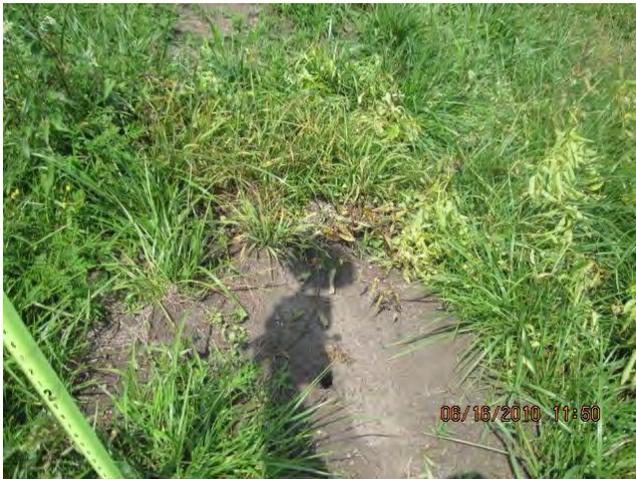
**Photo 28 (TVA Item No. 44)**

Exposed ash on the interior slope of the south side of the pond.

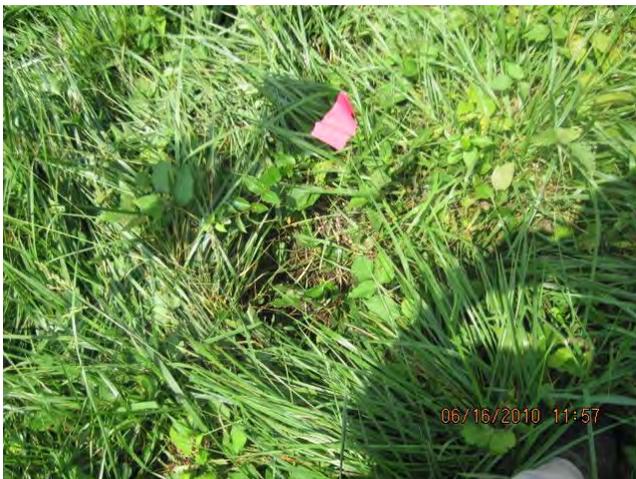
**Photo 29 (TVA Item No. 45)**

Exposed ash on the interior slope of the south side of the pond.

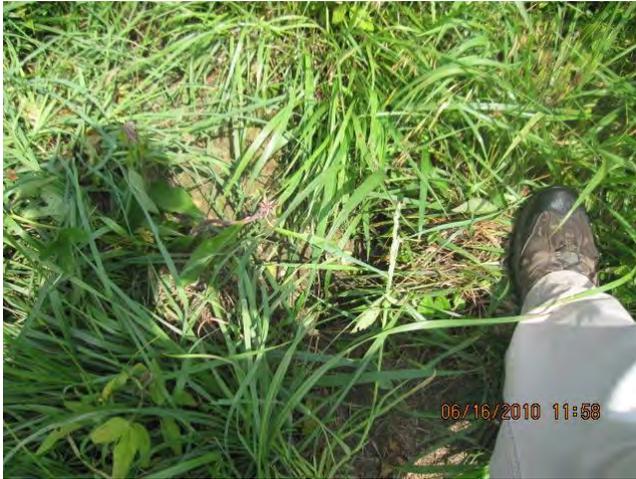
**Photo 30 (TVA Item No. 46)**

Animal burrow located on the exterior slope of the south side of the pond.

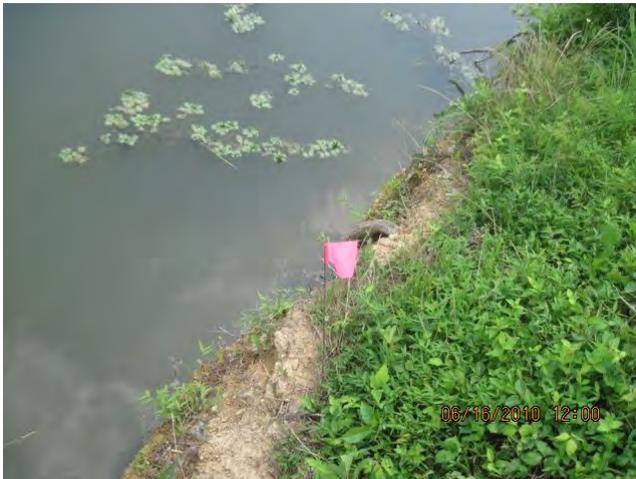
**Photo 31 (TVA Item No. 47)**

Animal burrow located on the exterior slope of the south side of the pond.

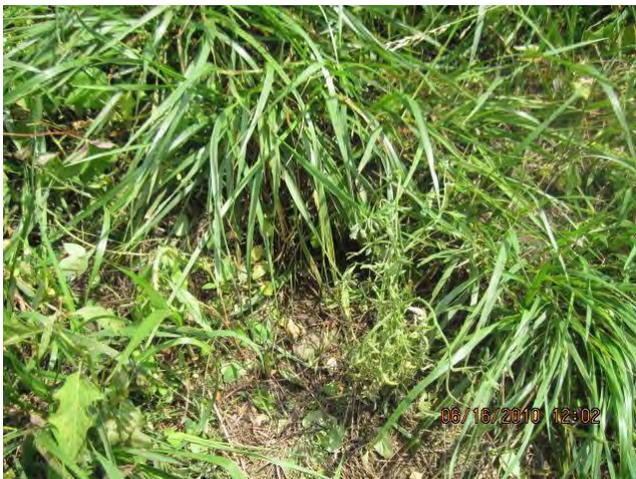
**Photo 32 (TVA Item No. 48)**

Erosion due to wave action was observed on the south side of the pond (see Photo 32, TVA Item No. 48).

Wave erosion located on the embankment of the interior slope on the south side of the pond.

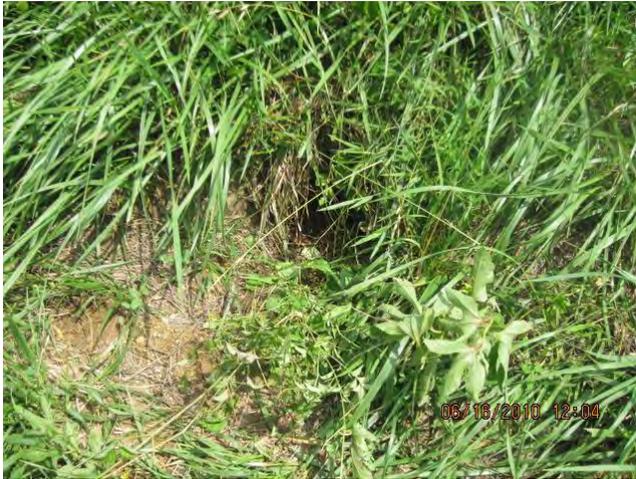
**Photo 33 (TVA Item No. 49)**

Animal burrow located on the exterior slope of the south side of the pond.

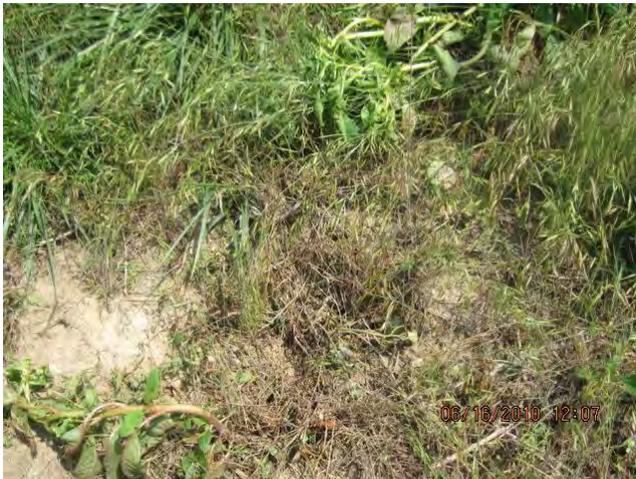
**Photo 34 (TVA Item No. 50)**

Animal burrow located on the exterior slope of the south side of the pond.

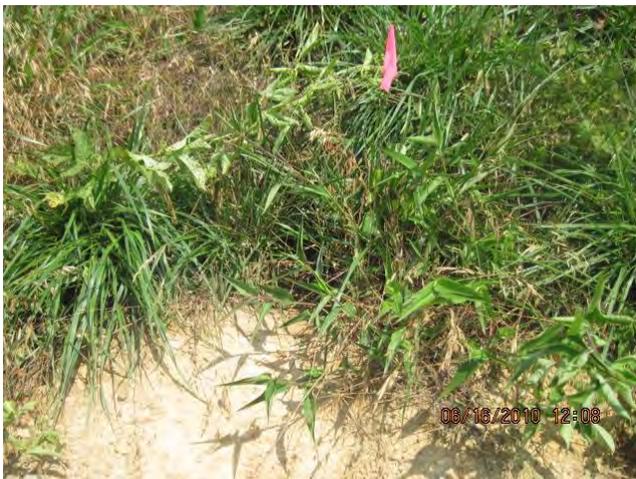
**Photo 35 (TVA Item No. 51)**

Animal burrow located on the exterior slope of the south side of the pond.

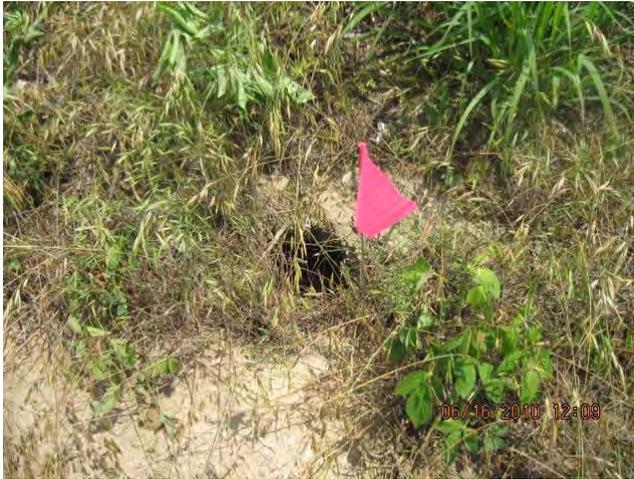
**Photo 36 (TVA Item No. 52)**

Animal burrow located on the exterior slope of the south side of the pond.

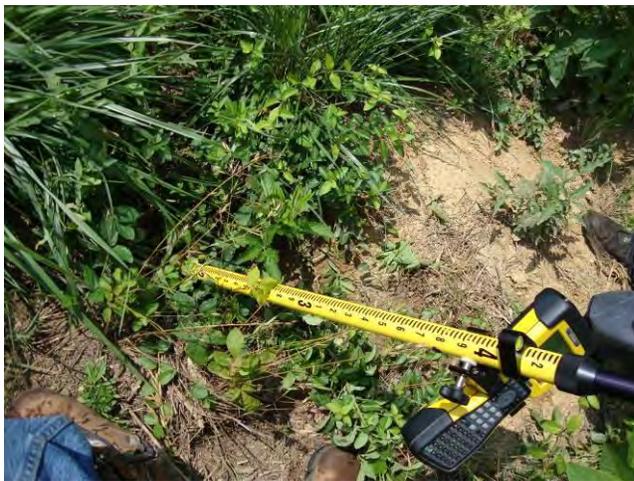
**Photo 37 (TVA Item No. 53)**

Animal burrow located on the exterior slope of the south side of the pond.

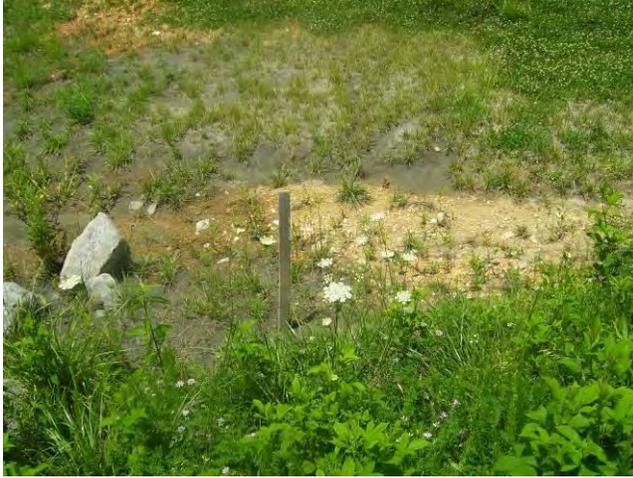
**Photo 4**

Erosion and sedimentation in drainage ditch at the north corner of the pond.

- It is recommended that the areas of sparse vegetation on the north and west slopes (see Photo 3) and at the southeast corner of the pond (see Photo 2) be reseeded to be consistent with the rest of the slopes. (Priority 4)
- It is recommended that the erosion observed at the north end of the pond be repaired (see Photo 4). It is expected that rip-rap may be needed to line a portion of the ditch. (Priority 4)
- It is recommended that sediment accumulated at the north end of the pond be removed. (Priority 4)

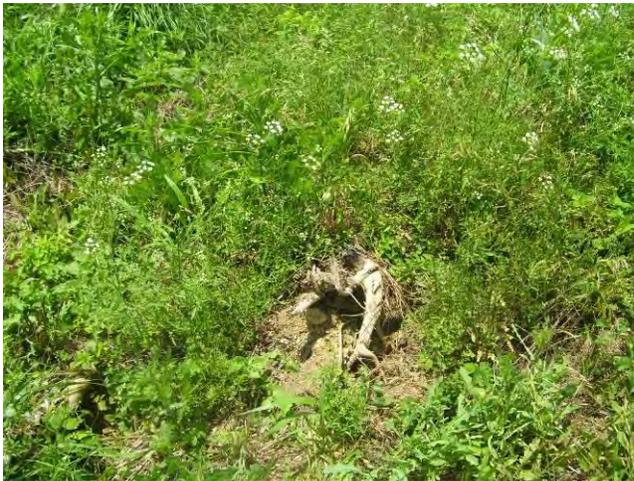
**Photo 2**

Tree stump observed on the east interior slope of the pond.

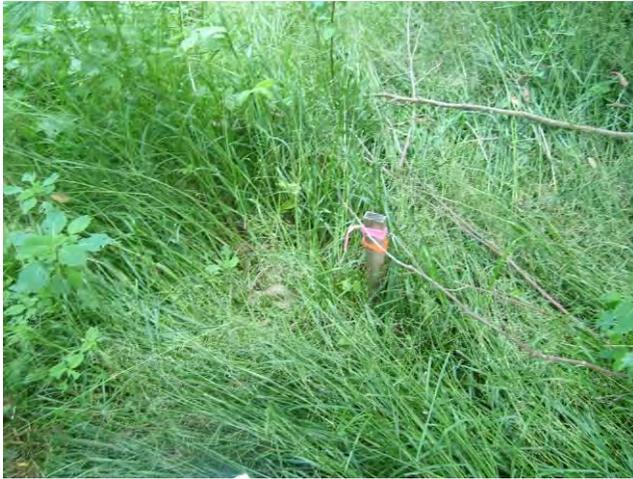
**Photo 7**

Location of Seep WD-1 on the west side of the pond near Polly Creek.

the west slope (see Photo 7 for Seep WD-1, Photo 8 for Seep WD-2, and Photo 9 for Seep WD-3) continue to be monitored as indicated in the Seepage Action Plan dated June 25, 2010.

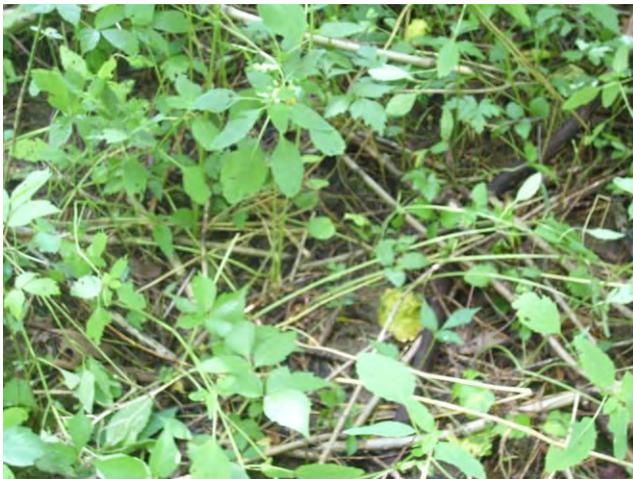
**Photo 8**

Location of Seep WD-2 on the west side of the pond near the toe of the embankment.

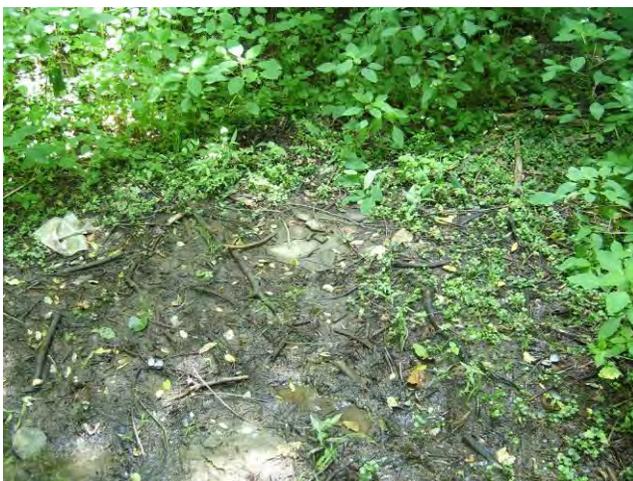
**Photo 9**

Location of Seep WD-3 on the west side of the pond near Polly Creek.

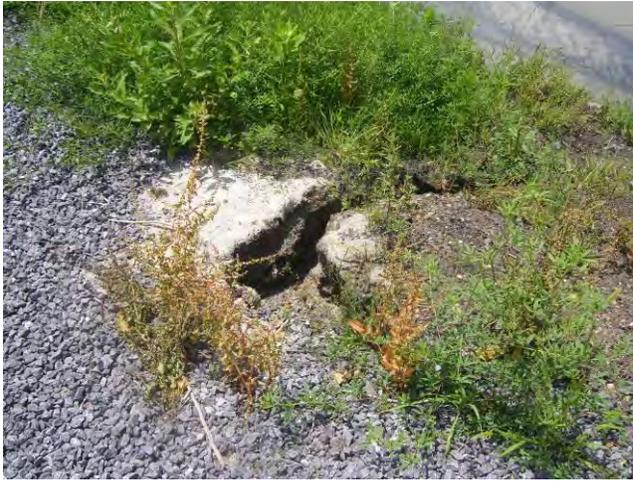
**Photo 1**

Erosion observed at the east end of the interior dike access road that crosses the pond.

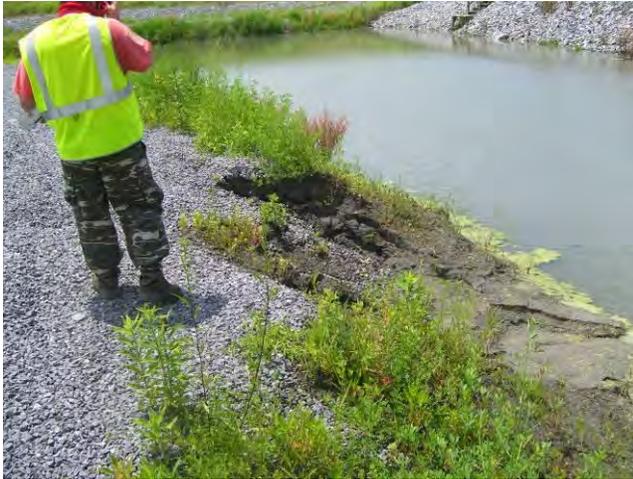
**Photo 4**

Erosion observed along the interior dike access road that crosses the pond.

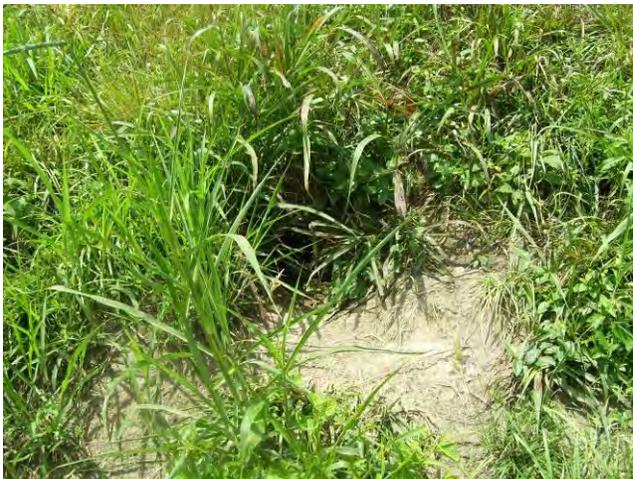
**Photo 6**

Animal burrow observed on the north slope of the pond.

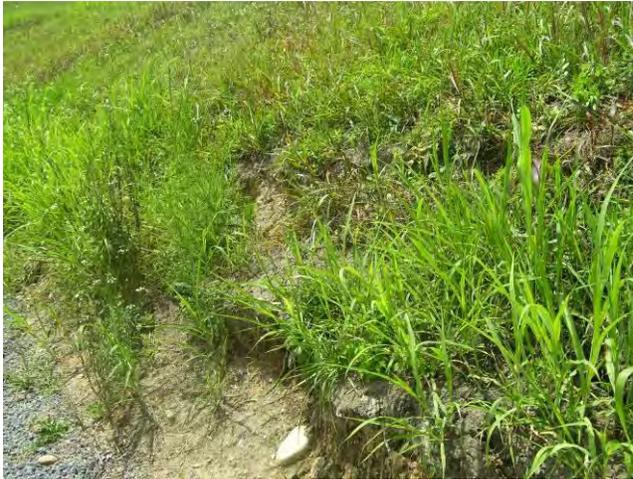
**Photo 7**

Slough observed on the north slope of the pond due to excavation of the toe.

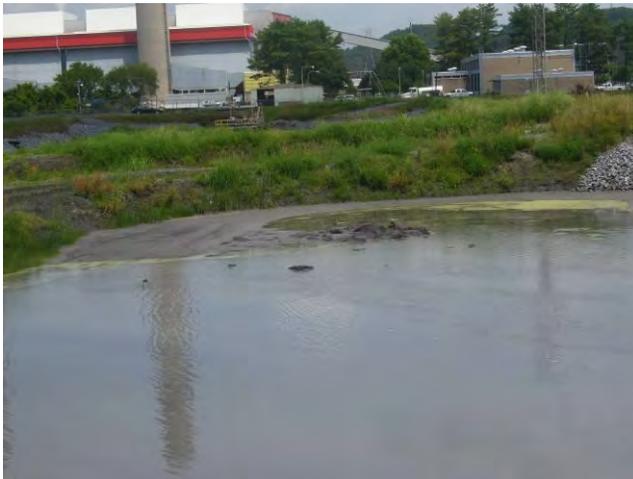
**Photo 8**

Sedimentation build-up at the base of the pond was observed at the west end.

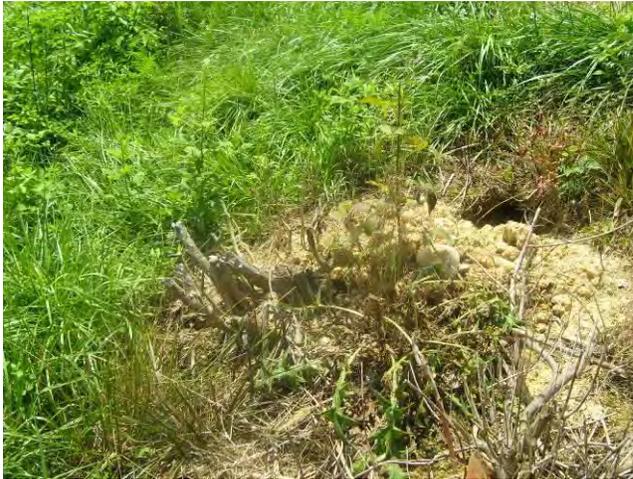
**Photo 1**

Tree stump observed on the west interior slope of the pond.

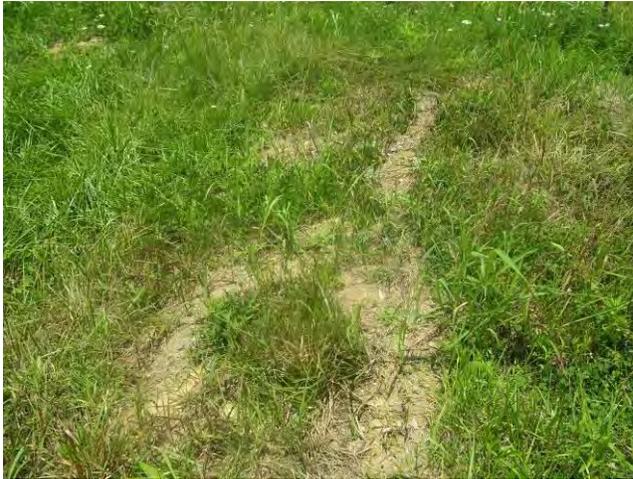
**Photo 4**

Sparse vegetation observed at the northeast corner of the pond.

- It is recommended that the sparse area observed at the northeast corner of the pond (see Photo 4) be reseeded in order for the vegetation growth to be consistent with the rest of the slope. (Priority 4)
- It is recommended that the tree growth observed in the rip-rap protection at the southeast corner of the pond (see Photo 3) and the tree stump observed on the west interior slope of the pond (see Photo 1) be removed in accordance with the guidelines shown in Enclosure I. (Priority 4)
- It is recommended that the animal burrow observed at the midslope on the west side of the pond be repaired in accordance with the guidelines given in Enclosure J. (Priority 4)

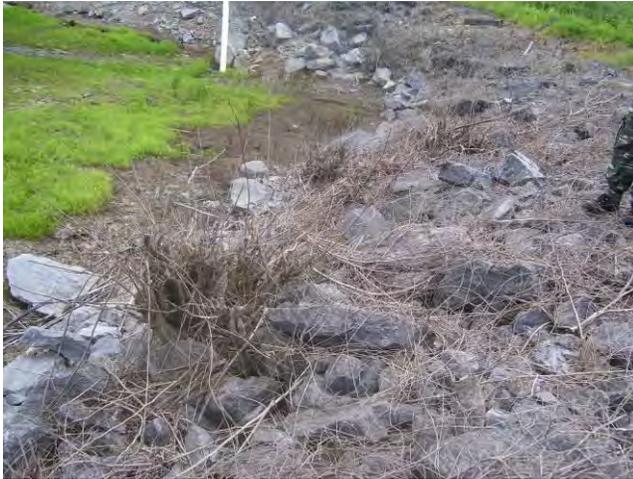
**Photo 1**

Tree growth observed on the south interior slope of the pond.

- It is recommended that the tree growth observed on the south interior slope (see Photo 1) be removed in accordance with the guidelines shown in Enclosure I. (Priority 4)
- It is recommended that the toe erosion observed at the interior southeast corner of the pond (see Photo 2) be repaired. It is expected that rip-rap will be needed to protect the embankment (Priority 4).
- It is recommended that the minor sloughing observed in the northeast corner of the pond be repaired (see Photo 5). (Priority 4)
- It is recommended that the two animal burrows observed at the northeast corner of the pond (see Photo 3 and Photo 4) be repaired in accordance with the guidelines given in Enclosure J. (Priority 4)
- It is recommended that maintenance mowing of heavily vegetated grass be performed more frequently to allow proper inspection of surfaces. (Priority 4)

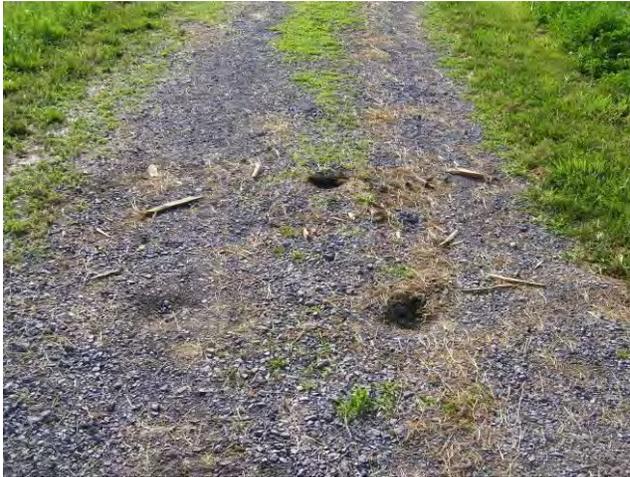
**Photo 1**

- Other:** Circular depressions (see Photo 1) and settled boring holes (see Photo 6) were observed at various locations along the access road on the bench near the crest of the area.

Circular holes observed in the top of the access road near the crest on the northeast corner of the area.

- It is recommended that the circular depressions (see Photo 1) and the boring holes that have settled (see Photo 6) along the access road on the bench near the crest be repaired. The path is used as a recreation trail for the public and these holes could be a trip hazard. (Priority 4)

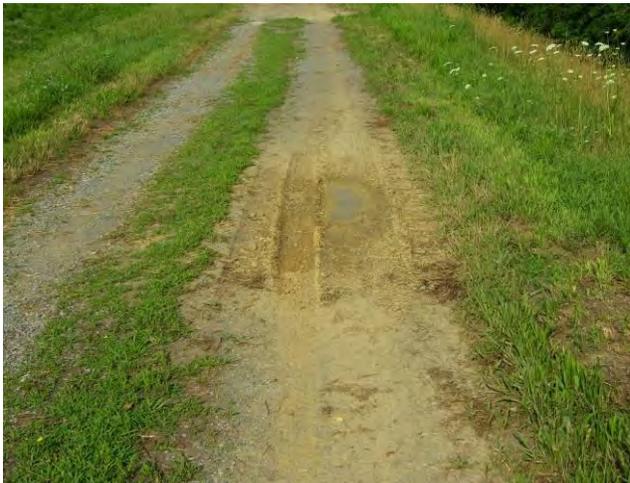
**Photo 2**

- Along the access road on the bench near the crest on the northeast (see Photo 2), north (see Photo 6), west (see Photo 11), and south (see Photo 17) sides of the area;
- On the crest on the north (see Photo 5 and Photo 7) and south (see Photo 14) sides of the area.

Rutting observed in the top of the access road near the crest on the northeast corner of the area.

- It is recommended that the rutting observed on the bench near the crest (see Photo 2, Photo 11, and Photo 17), the rutting observed on the interior of the pond near the crest (see Photo 5, Photo 7, and Photo 14), and the rutting observed in the drainage ditches along the perimeter of the area be repaired and vegetation reestablished in these location when applicable. (Priority 5) It is recommended that mowing operations be conducted at times that will not cause rutting of the surface.

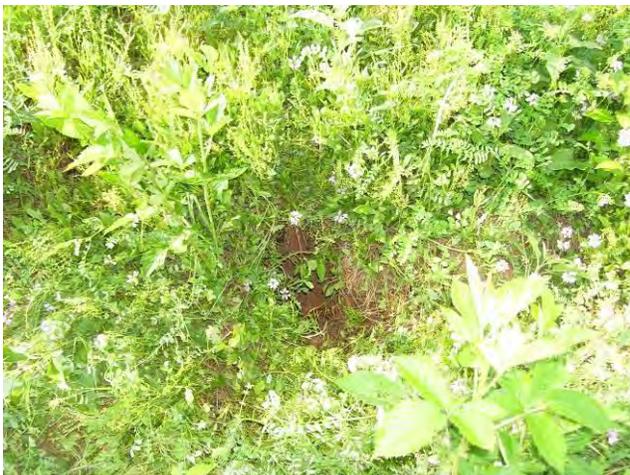
**Photo 3**

- Three were located on the north slope near the crest (see Photo 3, Photo 4, and Photo 9);
- The fourth was located on the south slope near the crest (see Photo 16).

Animal burrow observed on the exterior north slope above the access road near the crest, on the east end of the area.

- It is recommended that the three animal burrows observed on the exterior north slope (see Photo 3, Photo 4, and Photo 9) and the animal burrow observed on the exterior south slope (see Photo 16) be repaired in accordance with the guidelines given in Enclosure J. (Priority 4)

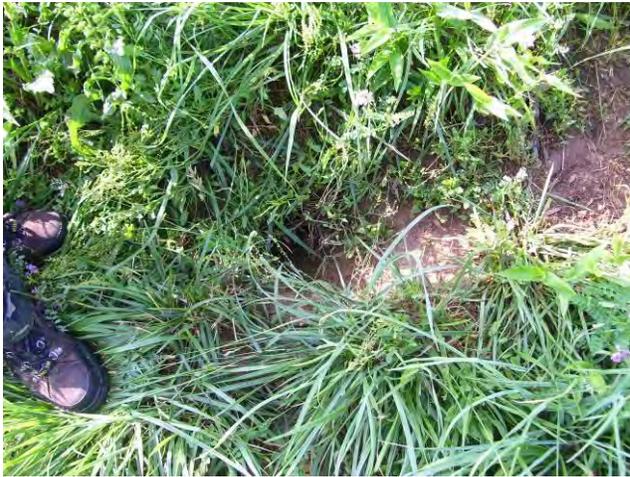
**Photo 4**

Animal burrow observed on the exterior north slope above the access road near the crest, on the east end of the area.

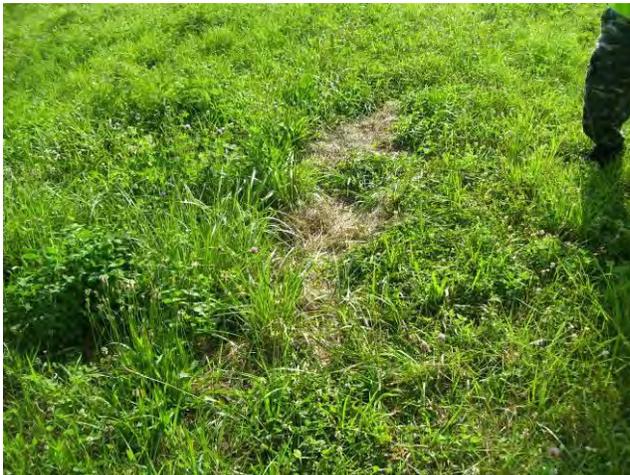
**Photo 5**

Rutting observed in the top of the exterior slope above the access road near the crest on the north side of the area.

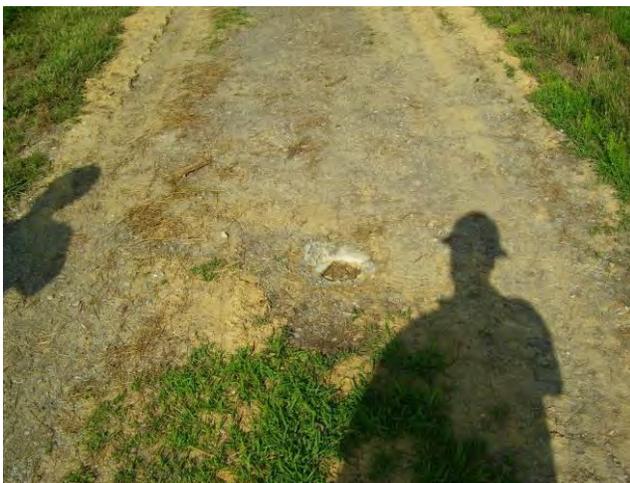
**Photo 6**

Settlement of boreholes observed on the access road near the crest on the north side of the area.

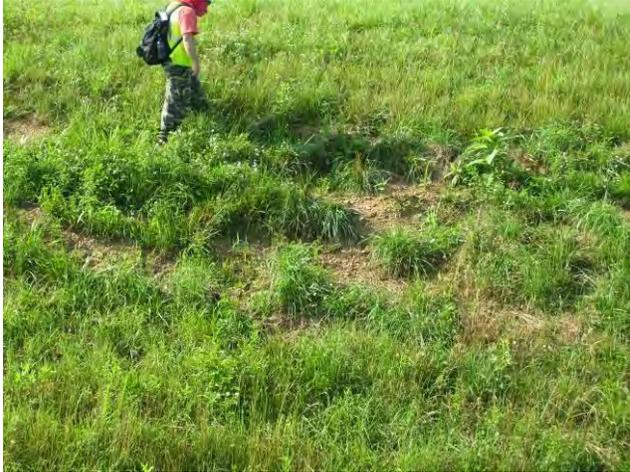
**Photo 7**

Rutting/sparse area observed on the exterior north slope above the access road near the crest of the area.

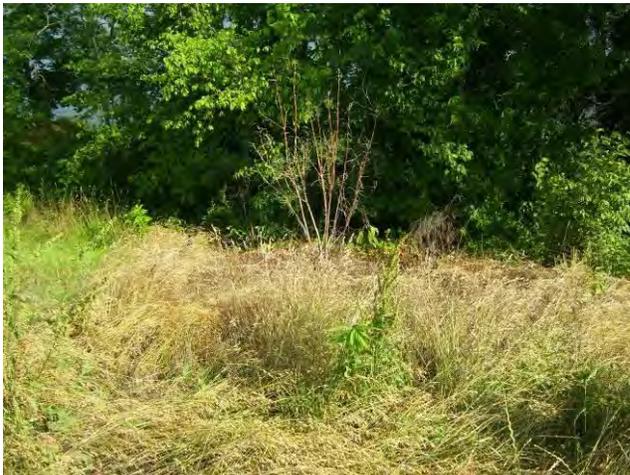
**Photo 8**

- Vegetation:** The slopes are heavily vegetated with grass and some brush.
- Trees:** One tree was observed at the midslope of the north slope (see Photo 8). Multiple small trees were observed growing in the rip-rap channels on the south side of the area (see Photo 12).

Tree observed on the north exterior slope of the area.

- It is recommended that the tree observed on the exterior north slope (see Photo 8), the trees observed in the rip-rap on the exterior south slope (see Photo 12), and the tree stumps observed on the exterior north slope (see Photo 19) be removed in accordance with the guidelines shown in Enclosure I. (Priority 4)

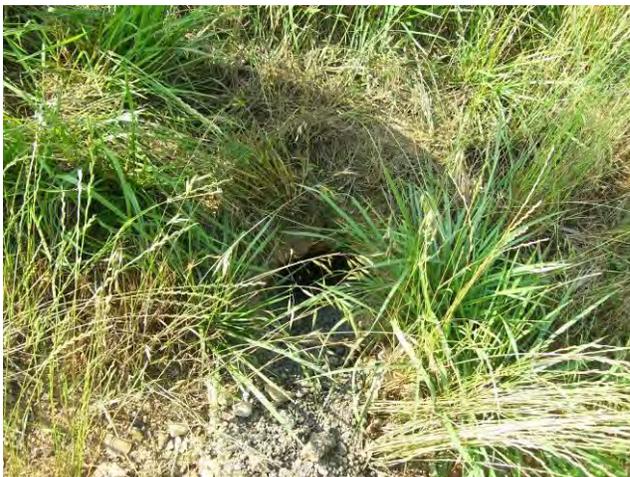
**Photo 9**

Animal burrow observed on the exterior north slope above the access road near the crest of the area.

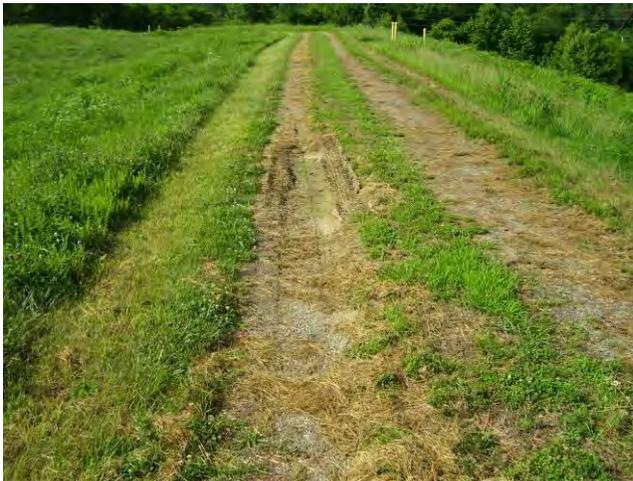
**Photo 11**

Rutting observed on the access road near the crest on the west end of the area.

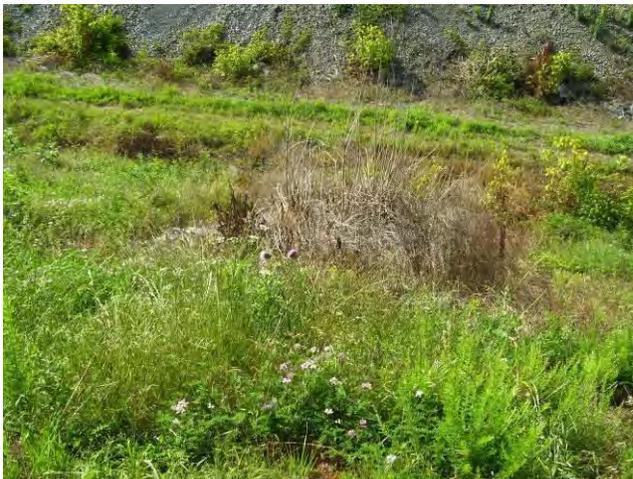
**Photo 12**

Trees observed in rip-rap on the south exterior slope of the area.

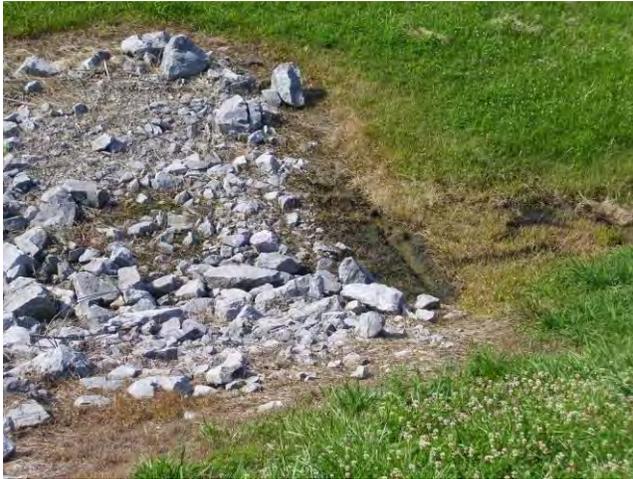
**Photo 13**

Damp area and rutting observed near drainage outlet at the toe of the exterior slope on the south side of the area.

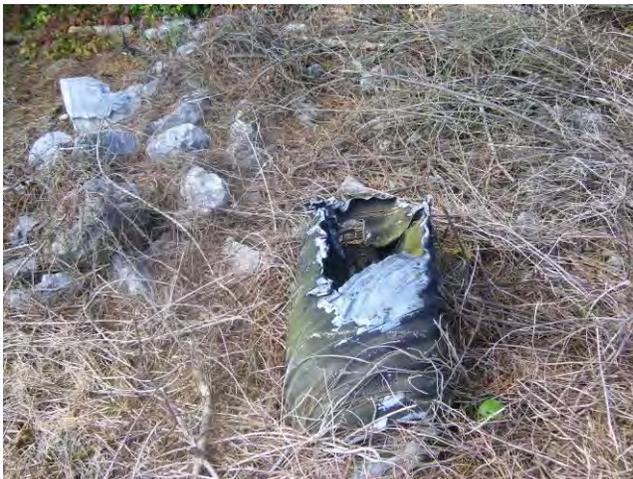
**Photo 15**

Damaged Corrugated Metal Pipe (CMP) on the exterior slope on the south side of the area.

- It is recommended that the inlets and outlets of the pipe structures within the area be monitored and repaired as conditions warrant. Damage to the pipes was observed on the south side of the area (see Photo 15) and beneath an access road to the crest of the area on the southeast end of the area (see Photo 18).

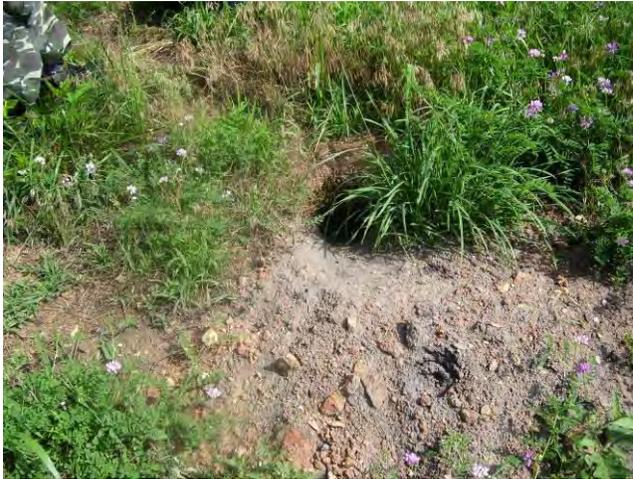
**Photo 16**

Animal burrow observed on the exterior south slope near the crest of the area.

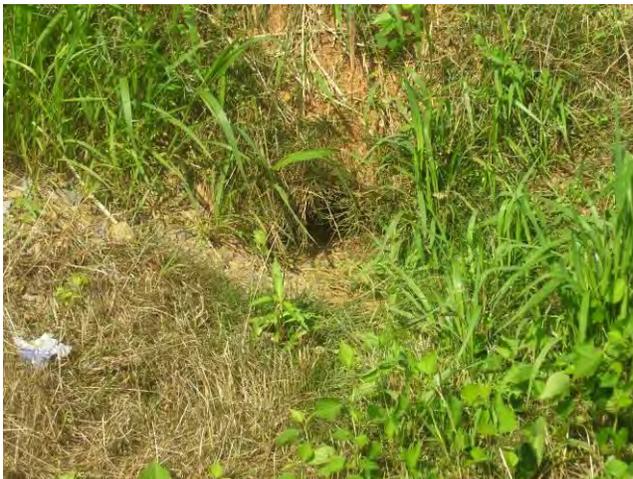
**Photo 18**

<b>Vegetation:</b>	Downed tree limbs and vegetation (see Photo 21) were observed in the drainage ditch on the south side of the area.
<b>Rip-Rap Channel Lining:</b>	Rip-rap was observed below the outlet of selected drainage pipes (see Photo 13) on the north and south sides of the area.
<b>Erosion:</b>	None observed.
<b>Sedimentation in Ditches:</b>	None observed.
<b>Standing Water in Ditches or on Benches:</b>	Standing water was observed at the toe of the embankment (see Photo 20) in the drainage ditch on the south side of the area.
<b>Silted/Impeded Drainage Pipes:</b>	One pipe was damaged at its outlet (see Photo 15).
<b>Other:</b>	Tire rutting was observed in a drainage ditch near a rip-rap channel (see Photo 13) on the south side of the area.  Damage to a drainage pipe underlying an access road on the east end of the pond was observed (see Photo 18).

Bent pipe observed near the drainage ditch on the east side of an access road on the east end of the area.

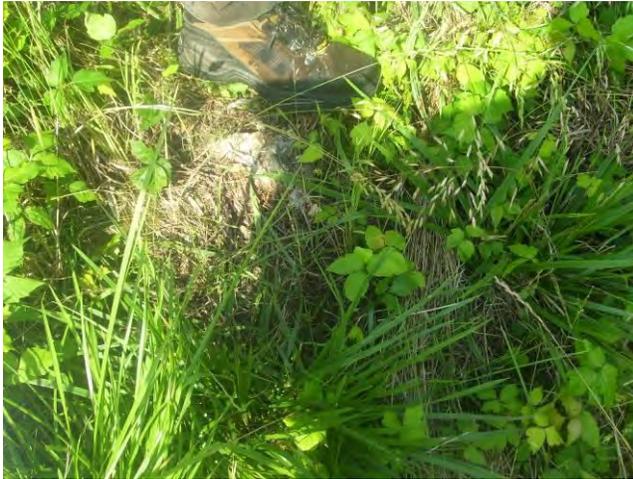
**Photo 19**

Stumps from previously removed trees (see Photo 19) were observed on the north side of the area.
- Erosion:** None observed.
- Instabilities:** None observed.

Tree stump observed on the north exterior slope of the area.

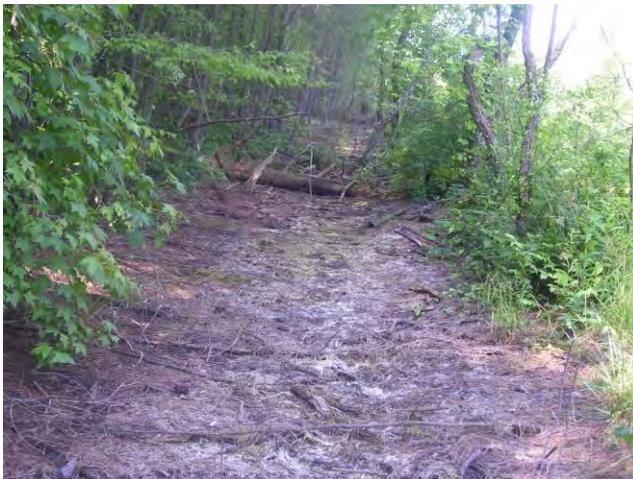
**Photo 21**

Downed trees and sediment observed in the drainage ditch on the south side of the area.

- It is recommended that the drainage ditches on the perimeter of the area be cleaned of downed tree limbs (see Photo 21) to allow proper drainage in the ditches during a rain event. (Priority 4)
