**Coal Combustion Residue Impoundment
Round 11 - Dam Assessment Report**

John Sevier Fossil Plant

Ash Basin Dikes

*Tennessee Valley Authority
Rogersville, Tennessee*

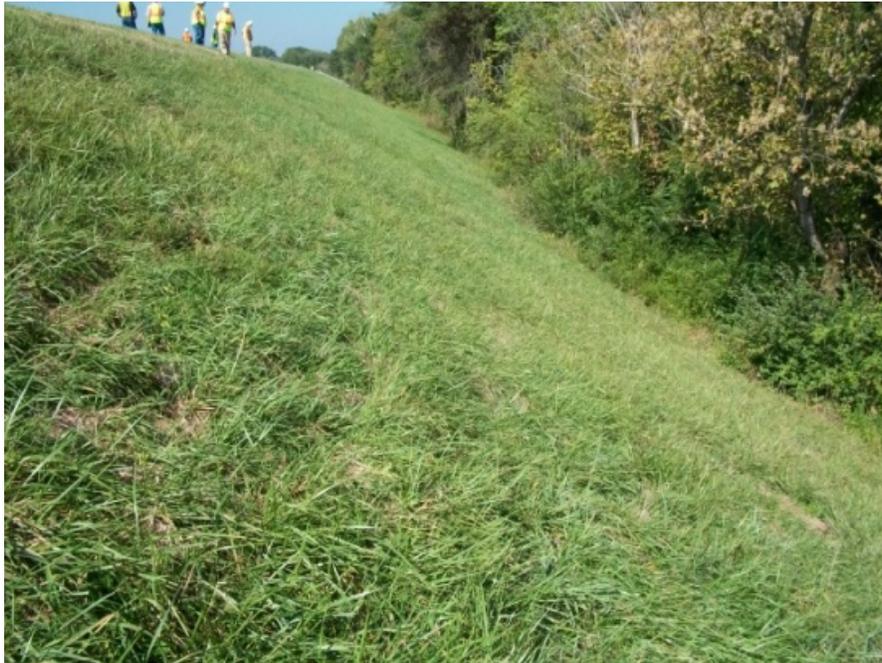
Figure 5.2.3-1 Outside Slope

Several seeps were clearly marked for monitoring. Several feet below the crest a horizontal discontinuity in the slope was observed; however it was not deemed an indicator of slope instability. No scarps, sloughs, depressions, bulging or other indications of slope instability or signs of erosion were observed (see Figure 5.2.3-1).

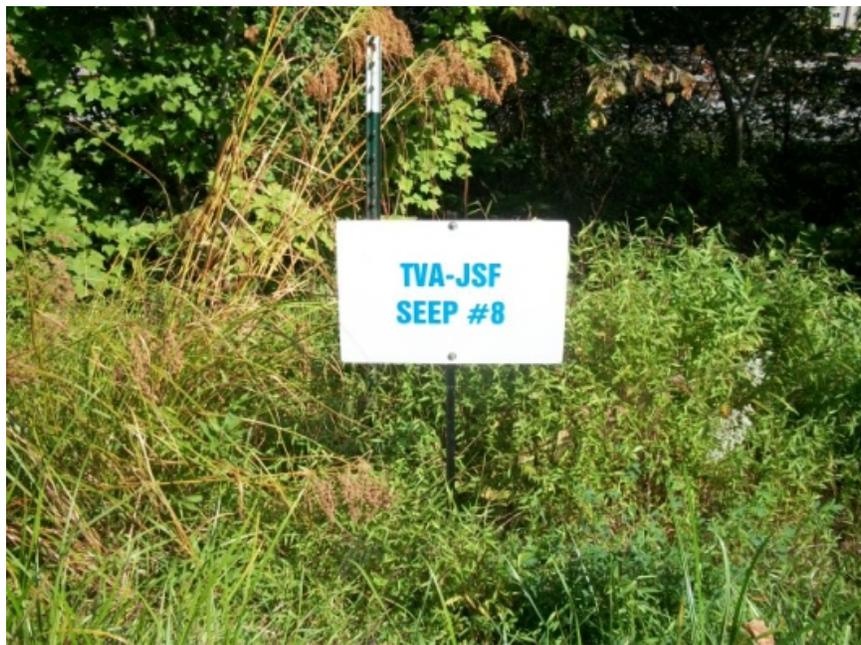
Note: Stantec prepared a Seepage Action Plan dated June 25, 2010 (Figure 5.2.3-2 shows a seep area).

Figure 5.2.3-2 Typical Seep Area, Downgradient Slope, Bottom Ash Disposal Area 2

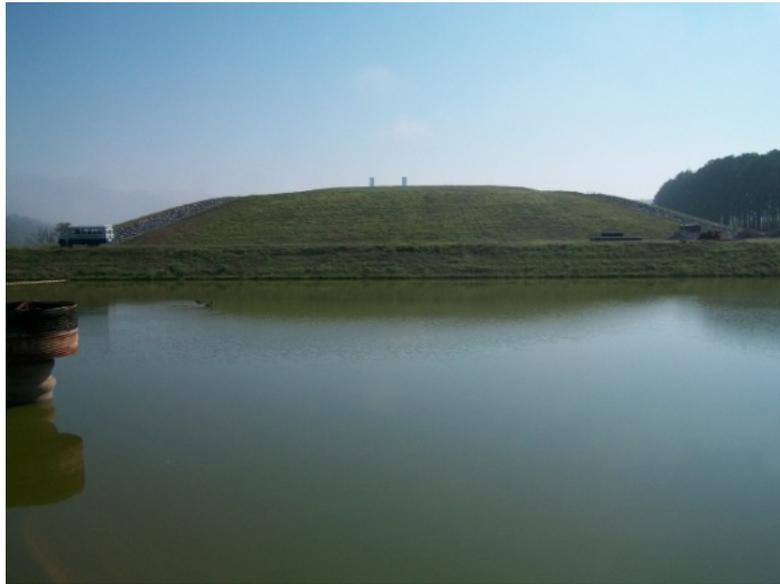
The interior slopes of the West Sediment Pond are vegetated with sparse grass and low weeds (See Figure 5.3.2-1)

Figure 5.3.2-1 Dry Fly Ash Stack West Sediment Pond Embankment Inside Slope)

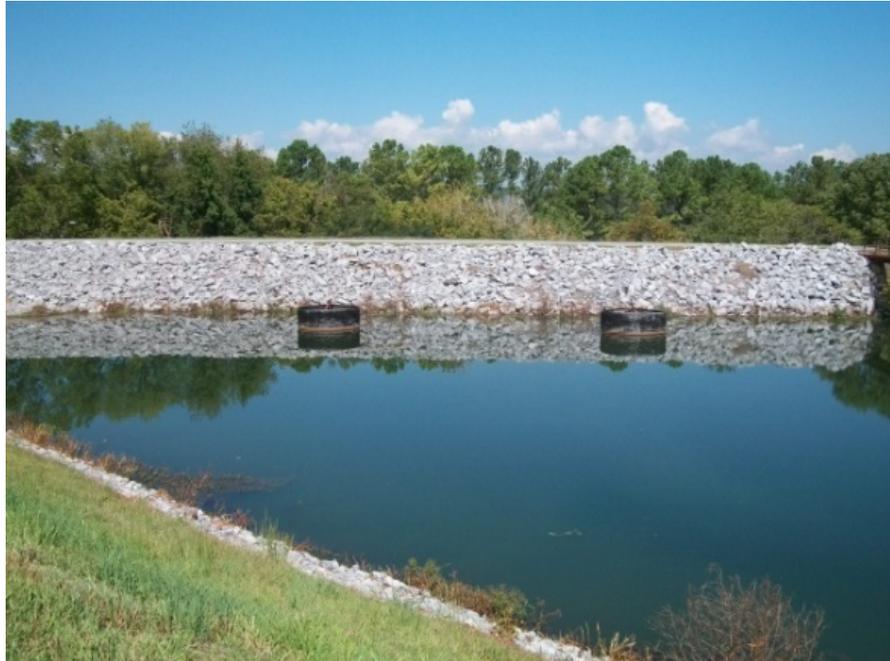
The Bottom Ash Disposal Area 2 contains two 48-inch diameter reinforced concrete risers that serve as an outlet structure (see Figure 5.4.1-1).

Figure 5.4.1-1 Overflow Risers, Bottom Ash Disposal Area 2

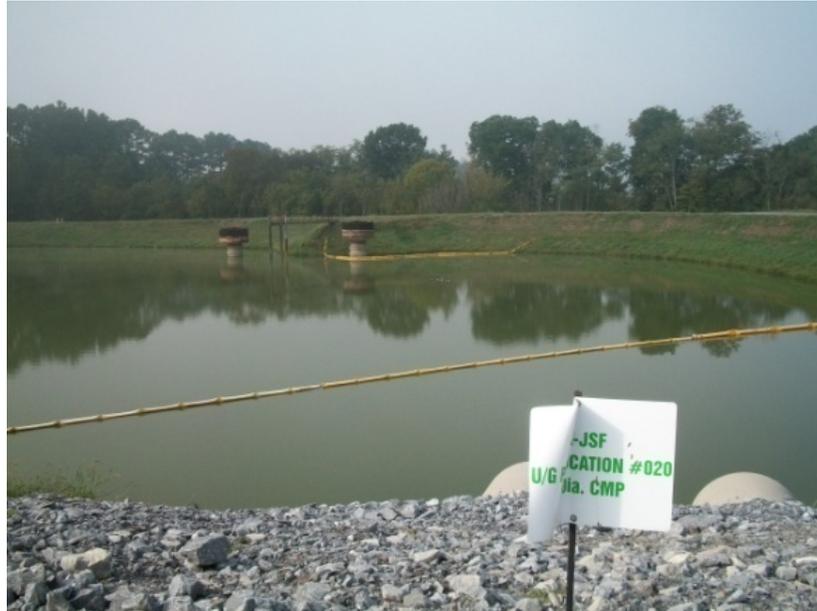
Stormwater runoff from the western portion of the Dry Fly Ash Stack is directed towards the West Sediment Pond, formerly Area G of the impoundment. The West Sediment Pond overflow structure consists of two 48-inch diameter reinforced concrete risers. (see Figure 5.4.1-2).

Figure 5.4.1-2 Dry Fly Ash Stack West Sediment Pond Risers

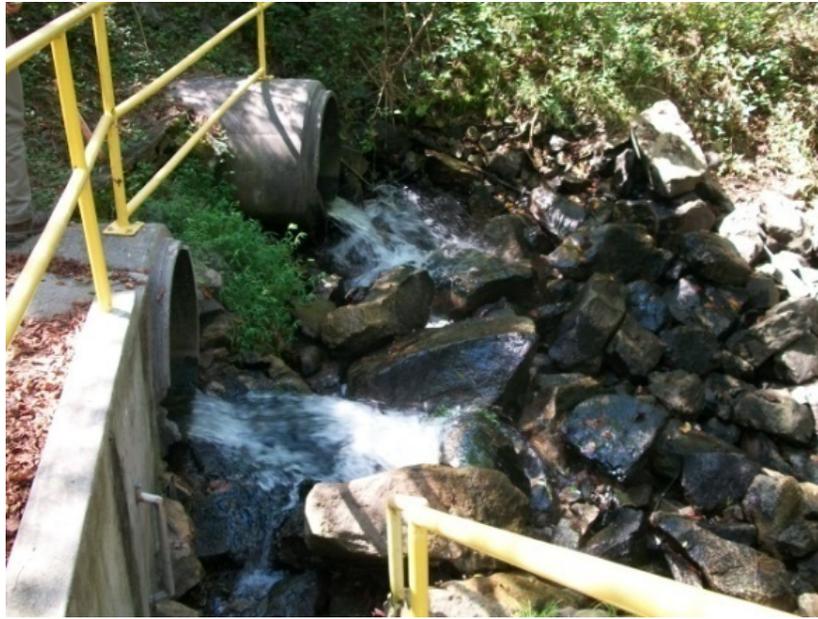
The Bottom Ash Disposal Area 2 outlet conduit consists of two 36-inch diameter reinforced concrete pipes that discharge to a rip-rap lined ditch that flows to a diffuser structure and into the Holston River (see Figure 5.4.2-1).

Figure 5.4.2-1 Bottom Ash Disposal Area 2 Outfall

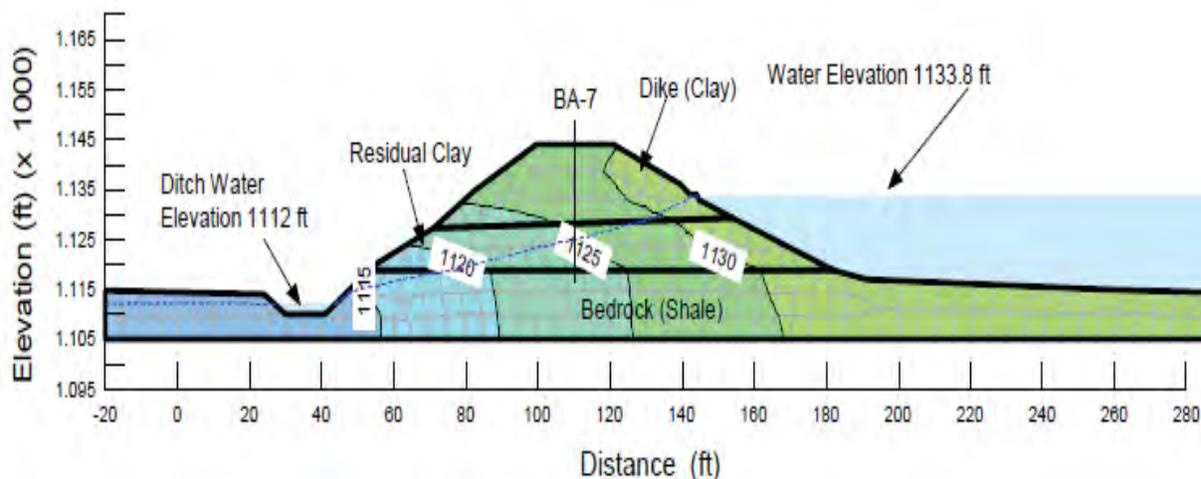
Figure 10. Cross Section I-I' (Total Head Contours in Feet)

The total head distribution for cross section I-I' is presented in Figure 10. Table 17 presents a comparison of the SEEP/W results (total head) with the average measurements taken from piezometer BA-8.

Cross-Section	Piezometer	Tip Elevation (feet)	Pond Pool Elevation (feet)	Drainage Ditch Pool Elevation (feet)	SEEP/W Phreatic Elevation (feet)	Average Field Measurement Phreatic Elevation (feet)
I-I'	BA-8	1110.7	1133.8	1112.0	1125.5	1126.0

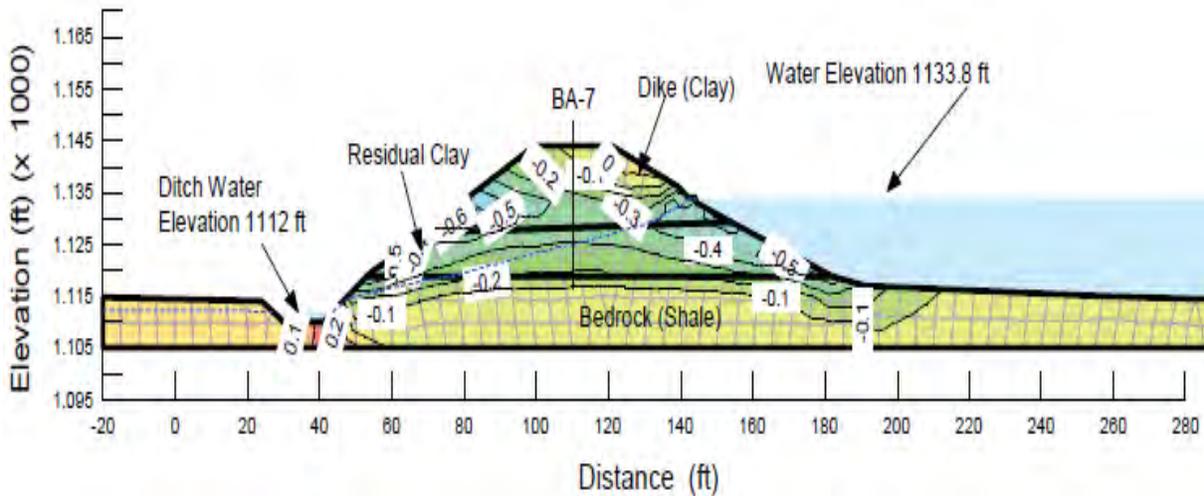
Vertical Gradient (i_v) at Critical Exit Point*	Critical Gradient (i_{crit})	Location of Maximum Vertical Gradient	FS_{piping}
0.2	1.28	Shale	6.4

The United States Army Corps of Engineers (USACE) design criteria (EM 1110-2-1901) indicates factors of safety against piping should be at least 3.0. The vertical gradient contours for cross section I-I' are presented below in Figure 11.

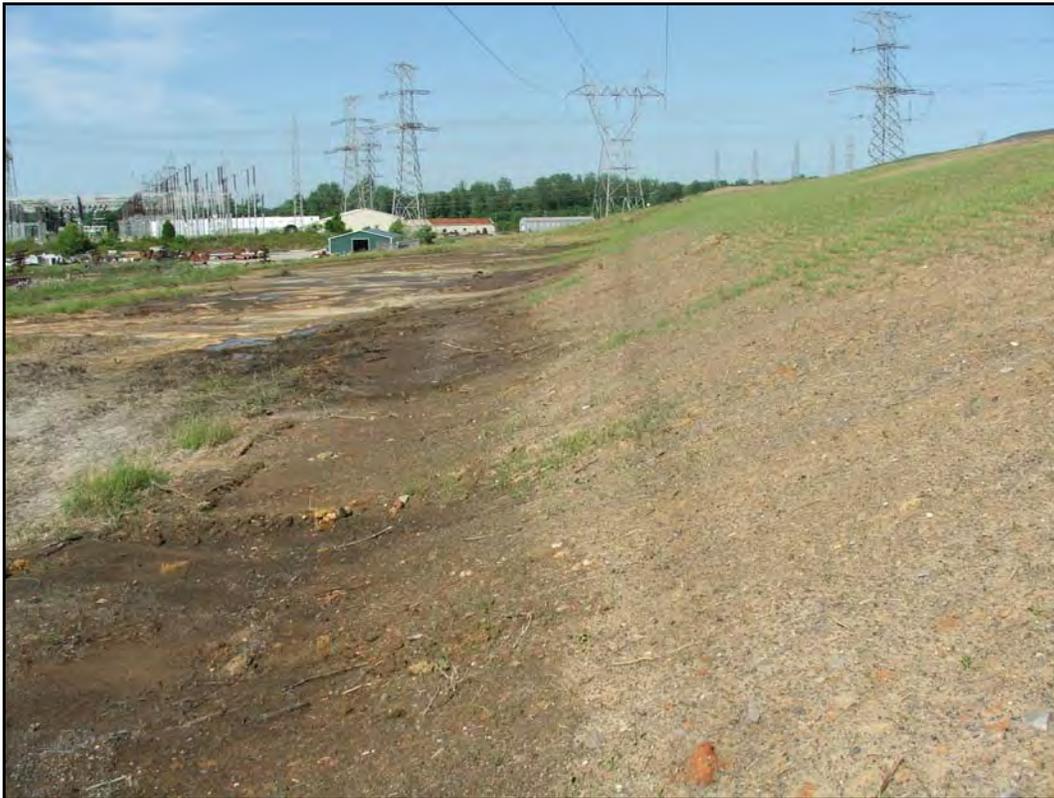
Figure 2. Example of Action Level 1 – Non-Flowing – Wet Area

Seepage occurs in all earthen dams and dikes. The key is to properly collect and control seepage in a manner that does not cause damage to the embankment. Seepage that is not flowing but is evident by damp areas or ponded water does not generally represent an imminent threat to the embankment in terms of erosion (see Figure 2). However, if left unattended this seepage can lead to slope instabilities. Therefore, this should be noted so that it can be observed for changing conditions both at the downstream observation point and immediately upstream along the interior slopes.

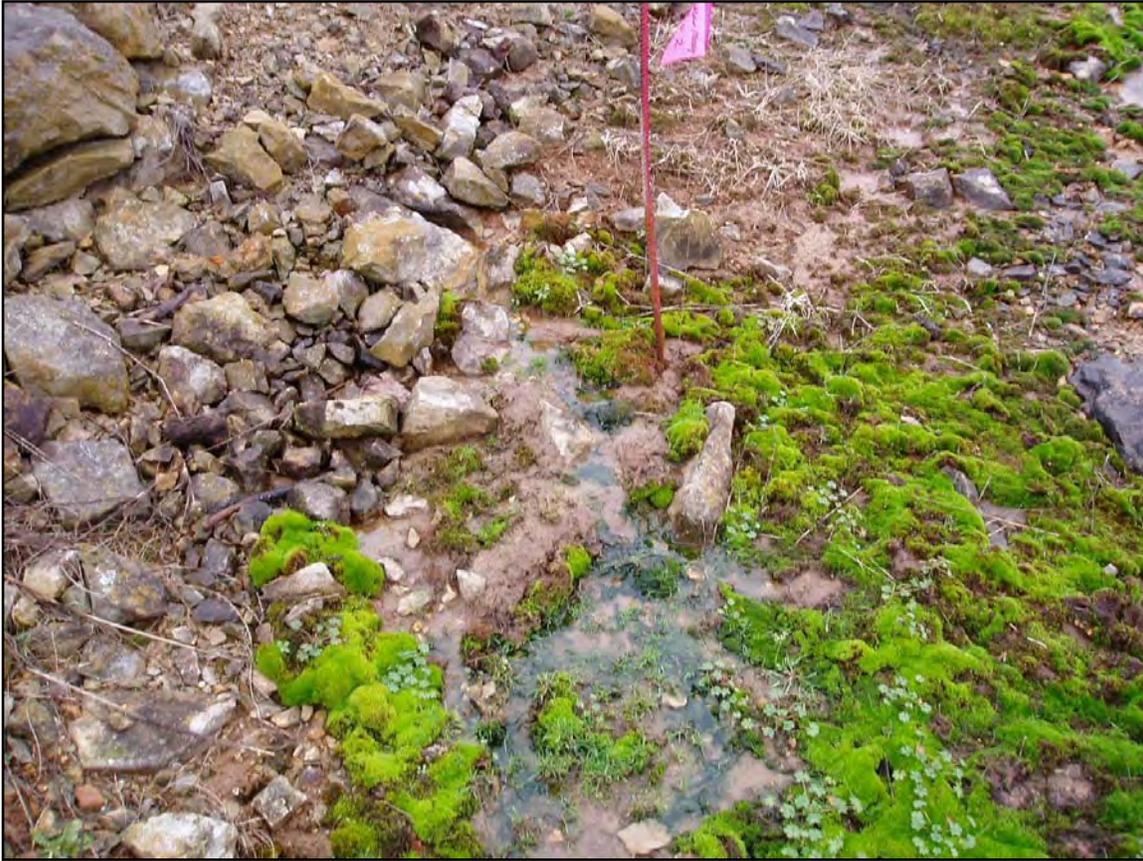
Figure 3. Example of Action Level 2 – Clear Flowing – Seepage Boil

Action Level 2 involves observations of flowing seepage, but evidence of erosion is not noted. Evidence of erosion can be in the form of turbid (muddy water) flow, sediment deposition, obvious hole or soil “pipe”. Evidence of erosion can be subtle and as a result, any flowing seepage should be carefully reviewed and monitored at least monthly. A picture

of flowing seepage water showing no evidence of erosion is depicted in Figure 3. Note that a seep does not need to be continuously turbid for a piping situation to be forming.

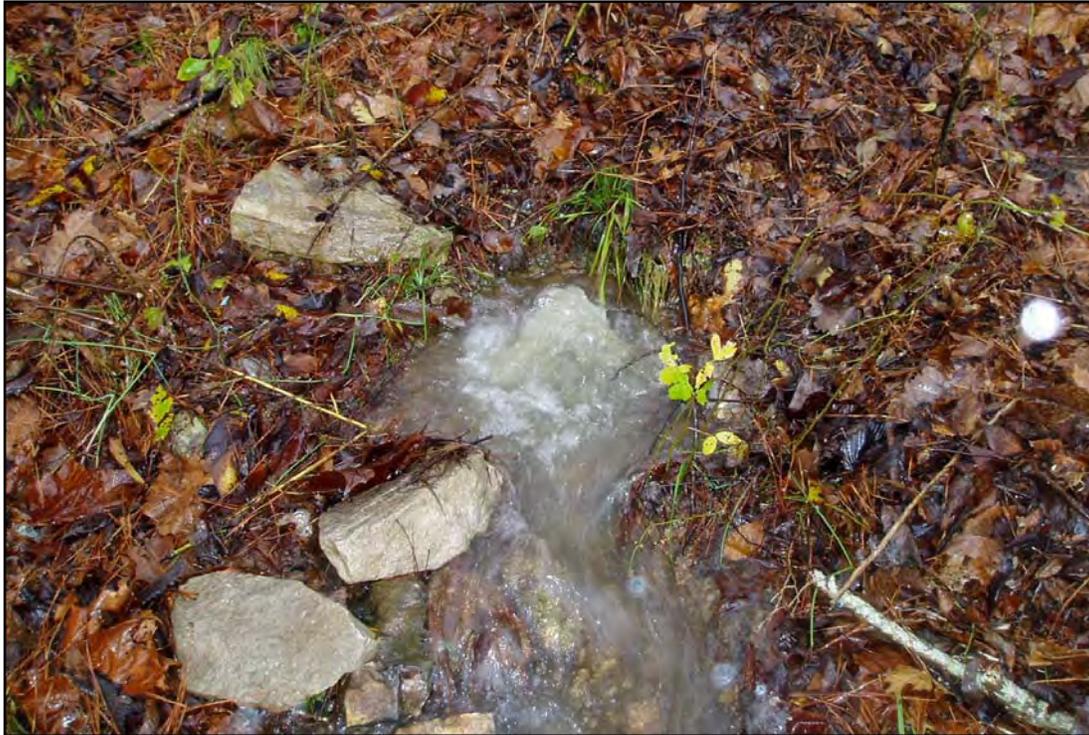
Figure 4. Example of Action Level 3 – Turbid Flowing – Seepage Boil

Left unmitigated seepage demonstrating active erosion can lead to progressive failure of the embankment and catastrophic loss of the impoundment. Evidence of erosion can be in the form of turbid flow, sediment deposition, boil, obvious hole or soil “pipe”. Evidence of erosion can be subtle and as a result, any flowing seepage should be carefully reviewed and monitored frequently. Careful attention should be given to seepage below water such as a stilling pond, creek or river (see Figure 6). This type of seepage is difficult to observe and determine if soil erosion is occurring. In moving water, evidence of seepage boils conveying embankment soil/ash materials will likely be (partially) washed away. Examples of active erosion are shown in Figures 4 thru 5.

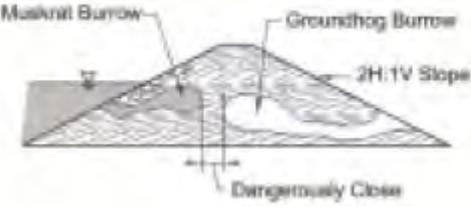
Seepage Problem	Recommendations
<p>Rodent Activity</p>

<p>Control rodents to prevent more damage. Determine exact location of digging and extent of tunneling. Remove rodents and backfill existing holes.</p>
<p>Seepage Water Exiting from a Point Adjacent to the Outlet</p>

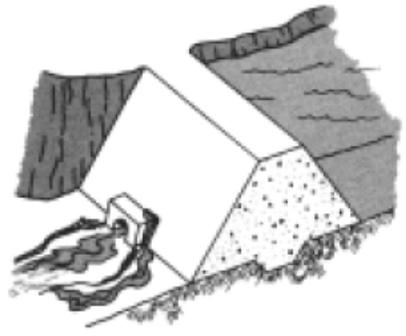
<p>Investigate the area by probing and/or carefully shoveling to see if the cause can be determined. Determine if leakage water is carrying soil particles evidenced by discoloration. Determine quantity of flow. If flow increases, or is carrying embankment materials, reservoir level should be lowered until leakage stops. A QUALIFIED ENGINEER should inspect the condition and recommend further actions to be taken.</p>
<p>Sinkhole</p>

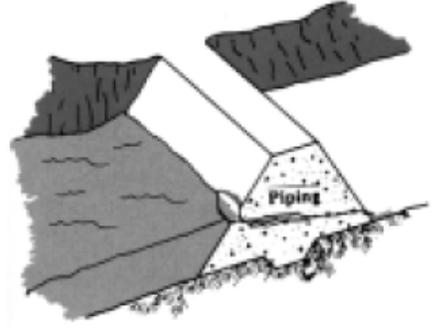
<p>Inspect other parts of the dam for seepage or more sinkholes. Identify exact cause of sinkholes. Check seepage and leakage outflows for dirty water. A QUALIFIED ENGINEER should inspect the conditions and recommend further actions to be taken.</p>

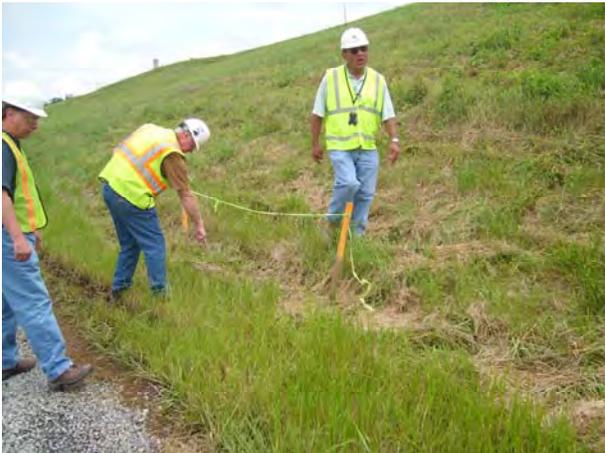
Area of Concern 2

Seep Initially observed by TVA in 2006. Located near toe of exterior slope of the dry fly ash stack near the lower perimeter road. SAP Level 1.

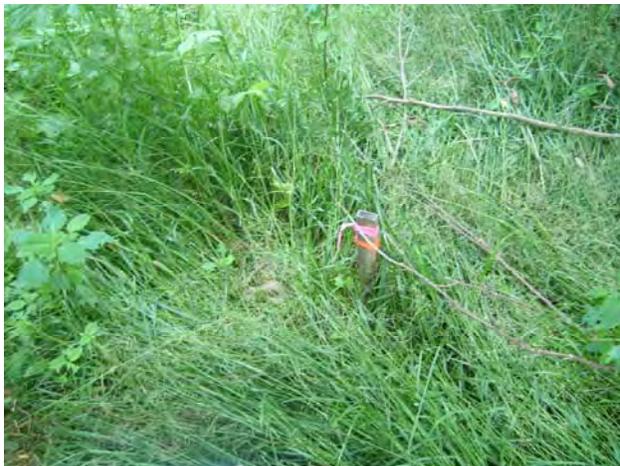
Area of Concern 4

Seep initially observed by TVA in 2008.
Located approximately 50 feet away from
the toe of the exterior west slope of the dry
fly ash stack and 10 feet east of Polly Creek.
SAP Level 1.

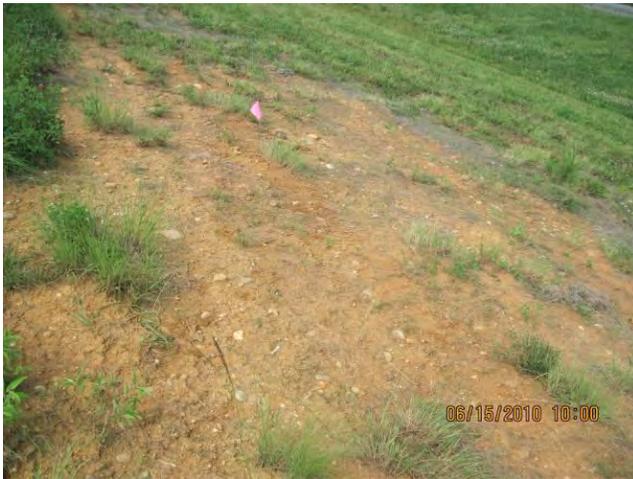
Photo 20 (TVA Item No. 9)

Sparse vegetation observed on the lower exterior slope on the north side of the area.

- It is recommended that the areas of sparse vegetation observed on the exterior slopes (see Photo 4, TVA Item No. 35; Photo 5, TVA Item No. 64; Photo 7, TVA Item No. 62; Photo 8, TVA Item No. 60; Photo 9, TVA Item No. 59; Photo 18, TVA Item No. 37; Photo 20, TVA Item No. 9; Photo 21, TVA Item No. 8; Photo 22, TVA Item No. 7; and Photo 25, TVA Item No. 4) be reworked and/or reseeded to support vegetation growth consistent with the remainder of the slopes. (Priority 4)

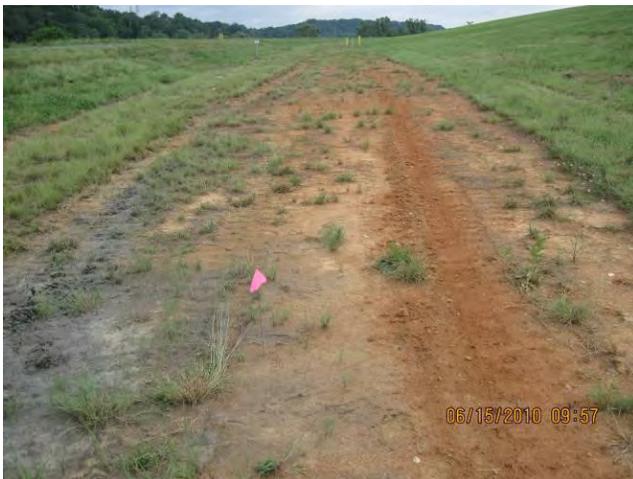
Photo 21 (TVA Item No. 8)

Sparse vegetation observed on the upper exterior slope in ditch line on the north side of the area.

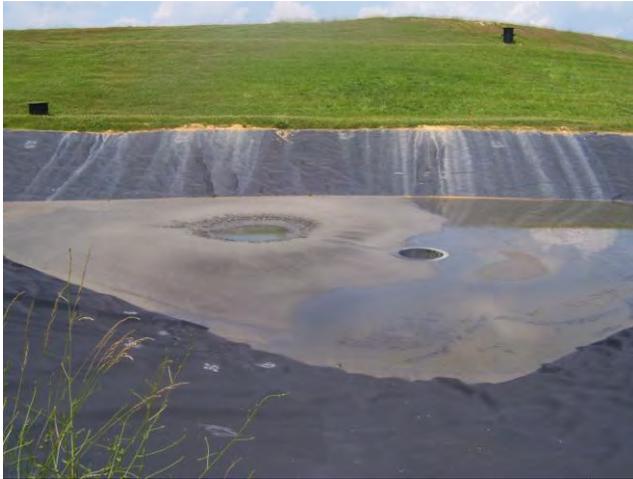
Photo 31

- A new lined pond has been constructed southeast of the Dry Fly Ash Stack, north of Chemical Treatment Pond Copper (see Photo 31). Leachate from the lined Phase 1 and Phase 2 areas of the Dry Fly Ash Stack (where ash is actively being placed) is collected and directed to this lined pond. From the lined pond the leachate is directed to the Coal Yard Runoff Ponds.

New lined pond constructed on the southeast side of the Dry Fly Ash Stack, north of the Chemical Treatment Pond – Copper.

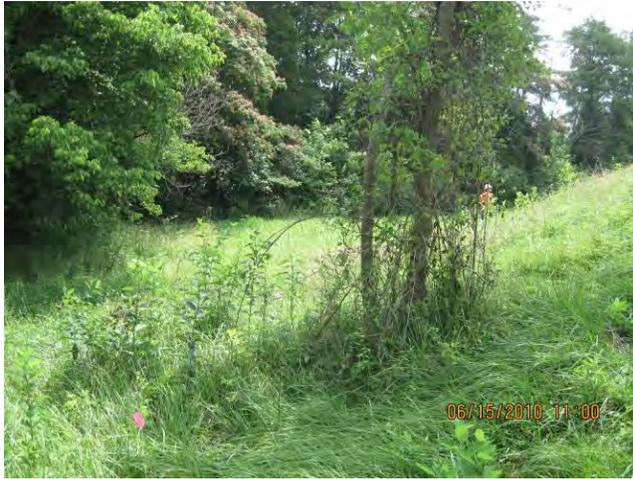
Photo 12 (TVA Item No. 17)

Instabilities: Minor sloughing was observed at the northeast corner of the pond (see Photo 12, TVA Item No. 17).

Slough observed on the exterior slope on the northeast interior corner of the pond.

- It is recommended that the areas of minor sloughing observed on the interior slope (see Photo 12, TVA Item No. 48) and on the exterior slope of the pond (see Photo 7, TVA Item No. 14 and Photo 8, TVA Item No. 15) be repaired to maintain a uniform appearance along the embankment. (Priority 4)

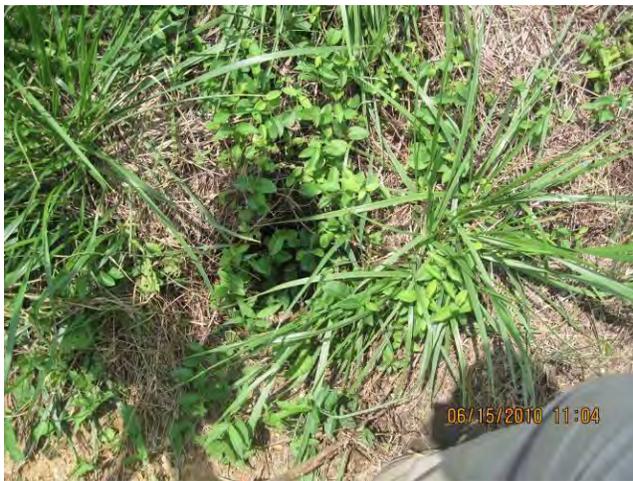
Photo 13 (TVA Item No. 20)

Trees: A small cluster of trees was observed near the toe on the exterior slope on the northeast side of the pond (see Photo 13, TVA Item No. 20). Stumps from previous tree growth were observed on the south side of the pond (see Photo 19, TVA Item No. 27).

Tree and stump observed near the toe on the exterior slope on the northeast side of the pond.

Photo 13, TVA Item No. 20) and the tree stumps observed on the south slope (see Photo 19, TVA Item No. 27) of the exterior of the pond be removed in accordance with the guidelines shown in Enclosure I. (Priority 4)

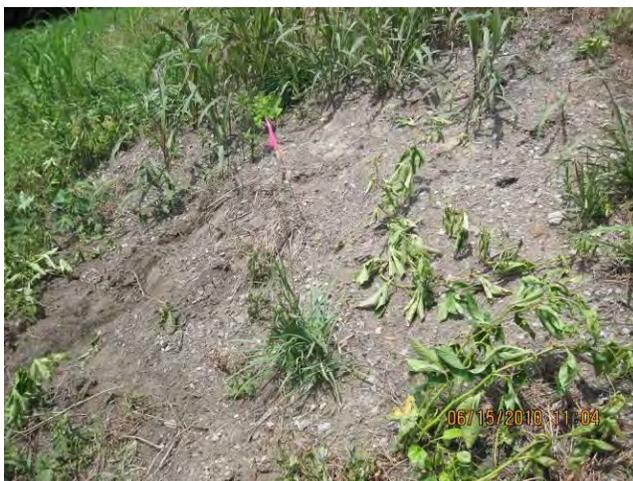
Photo 14 (TVA Item No. 21)

Animal burrow located on the exterior slope on the southeast side of the pond.

- The animal burrows observed during the inspection on the interior slope (see Photo 2, TVA Item No. 68) and on the exterior slope of the pond (see Photo 3, TVA Item No. 10; Photo 5, TVA Item No. 12; Photo 6, TVA Item No. 13; Photo 14, TVA Item No. 21; Photo 16, TVA Item No. 24; Photo 17, TVA Item No. 25; Photo 18, TVA Item No. 26; Photo 20, TVA Item No. 28; Photo 30, TVA Item No. 46; Photo 31, TVA Item No. 47; Photo 33, TVA Item No. 49; Photo 34, TVA Item No. 50; Photo 35, TVA Item No. 51; Photo 36, TVA Item No. 52; Photo 37, TVA Item No. 53; and Photo 38, TVA Item No. 70) be repaired in accordance with the guidelines given in Enclosure J. (Priority 4)

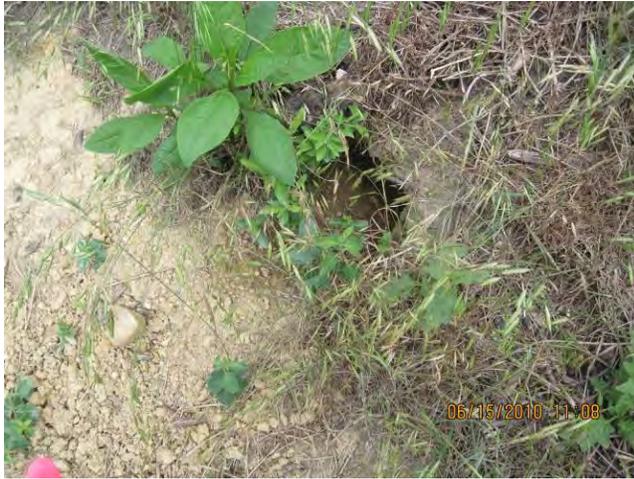
Photo 15 (TVA Item No. 23)

Vegetation: Most slopes are heavily vegetated with grass. Exposed ash was observed on the north side of the pond (see Photo 9, TVA Item No. 16) and on the south side of the pond (see Photo 15, TVA Item No. 23 and Photo 21, TVA Item No. 29).

Area of sparse vegetation on exterior slope on the south side of the pond.

- It is recommended that the areas of exposed ash observed on the interior slopes (see Photo 27, TVA Item No. 43, Photo 28, TVA Item No. 44; and Photo 29, TVA Item No. 45) and on the exterior slopes (see Photo 9, TVA Item No. 16; Photo 15, TVA Item No. 23; and Photo 21, TVA Item No. 29) be reworked and/or reseeded to support vegetation growth. (Priority 4).

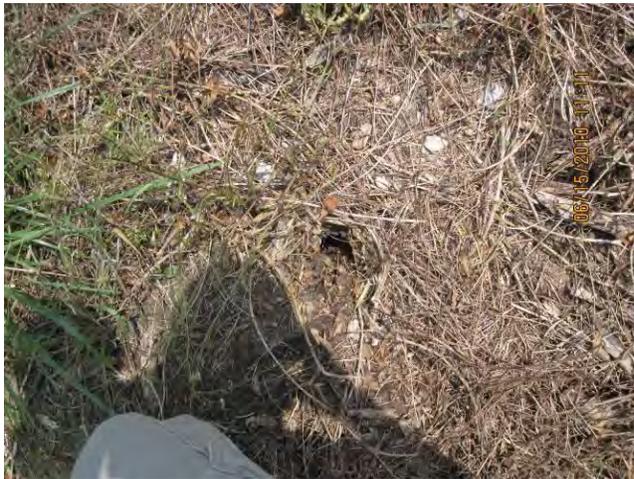
Photo 16 (TVA Item No. 24)

Location of two animal burrows on the exterior slope on the south side of the pond.

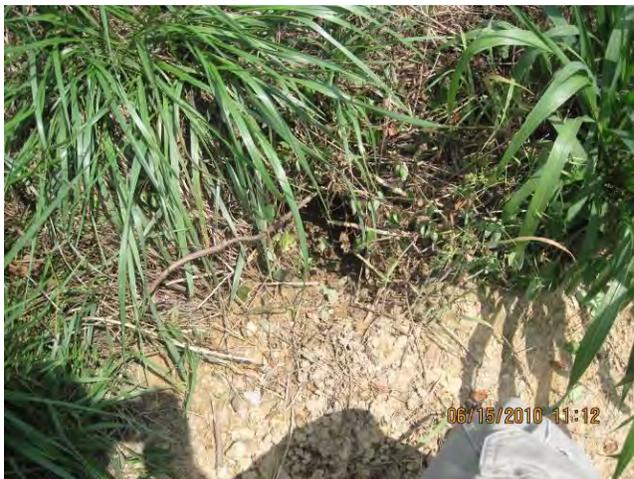
Photo 17 (TVA Item No. 25)

Animal burrow located on the exterior slope on the south side of the pond.

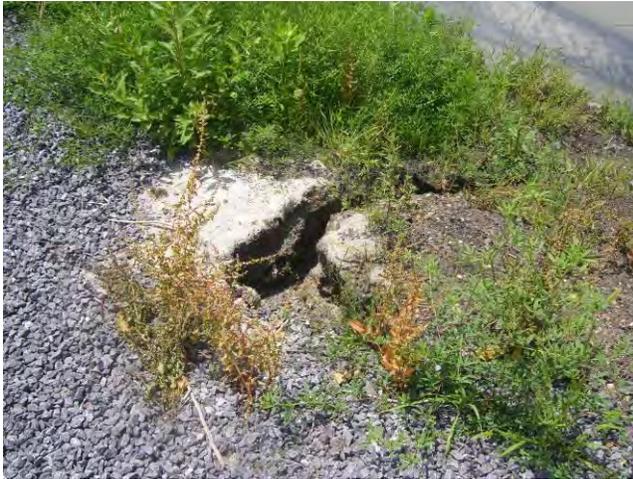
Photo 1

Erosion observed at the east end of the interior dike access road that crosses the pond.

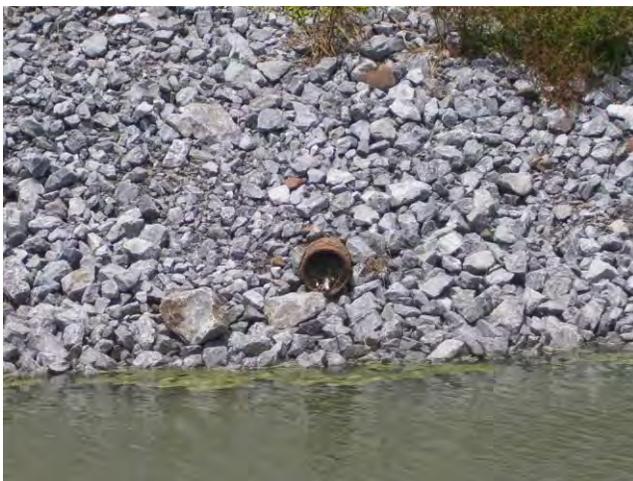
Photo 3

Silted pipe inlet was observed on the north slope of the pond.

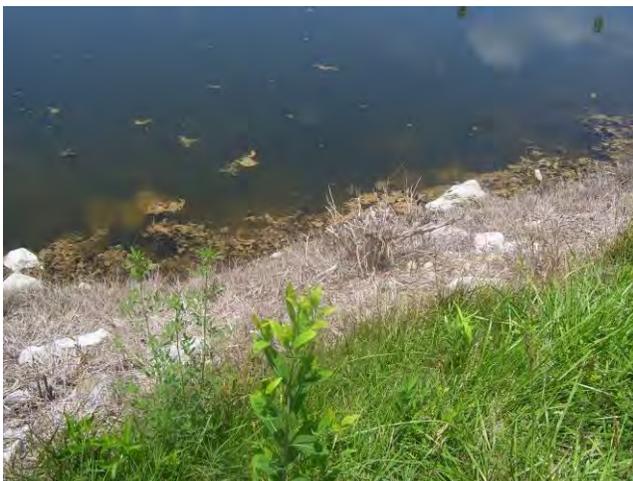
Photo 3

Tree growth observed in rip-rap protection at the southeast corner of the pond.

- It is recommended that the sparse area observed at the northeast corner of the pond (see Photo 4) be reseeded in order for the vegetation growth to be consistent with the rest of the slope. (Priority 4)
- It is recommended that the tree growth observed in the rip-rap protection at the southeast corner of the pond (see Photo 3) and the tree stump observed on the west interior slope of the pond (see Photo 1) be removed in accordance with the guidelines shown in Enclosure I. (Priority 4)
- It is recommended that the animal burrow observed at the midslope on the west side of the pond be repaired in accordance with the guidelines given in Enclosure J. (Priority 4)

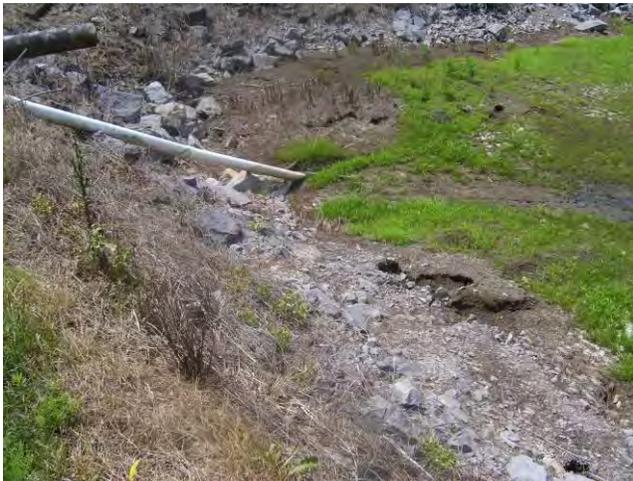
Photo 2

Toe erosion observed at the southeast corner of the pond.

- It is recommended that the tree growth observed on the south interior slope (see Photo 1) be removed in accordance with the guidelines shown in Enclosure I. (Priority 4)
- It is recommended that the toe erosion observed at the interior southeast corner of the pond (see Photo 2) be repaired. It is expected that rip-rap will be needed to protect the embankment (Priority 4).
- It is recommended that the minor sloughing observed in the northeast corner of the pond be repaired (see Photo 5). (Priority 4)
- It is recommended that the two animal burrows observed at the northeast corner of the pond (see Photo 3 and Photo 4) be repaired in accordance with the guidelines given in Enclosure J. (Priority 4)
- It is recommended that maintenance mowing of heavily vegetated grass be performed more frequently to allow proper inspection of surfaces. (Priority 4)

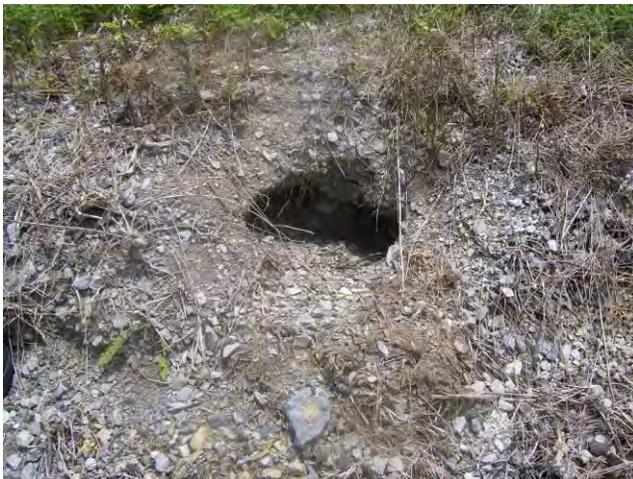
Photo 3

Animal burrow observed at the northeast corner of the pond.

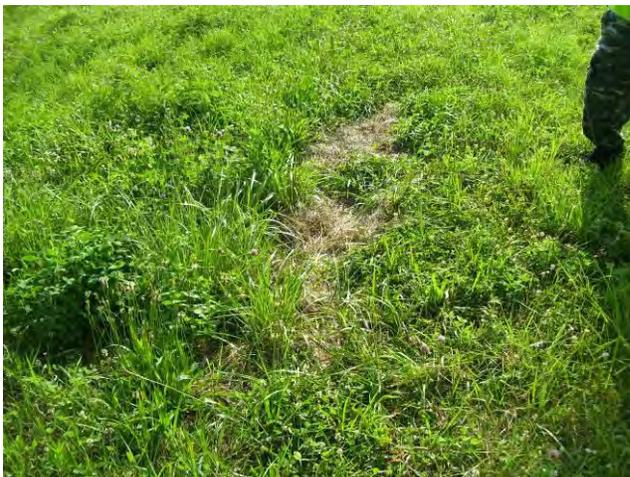
- Along the access road on the bench near the crest on the northeast (see Photo 2), north (see Photo 6), west (see Photo 11), and south (see Photo 17) sides of the area;
- On the crest on the north (see Photo 5 and Photo 7) and south (see Photo 14) sides of the area.

Rutting observed in the top of the exterior slope above the access road near the crest on the north side of the area.

- It is recommended that the rutting observed on the bench near the crest (see Photo 2, Photo 11, and Photo 17), the rutting observed on the interior of the pond near the crest (see Photo 5, Photo 7, and Photo 14), and the rutting observed in the drainage ditches along the perimeter of the area be repaired and vegetation reestablished in these location when applicable. (Priority 5) It is recommended that mowing operations be conducted at times that will not cause rutting of the surface.

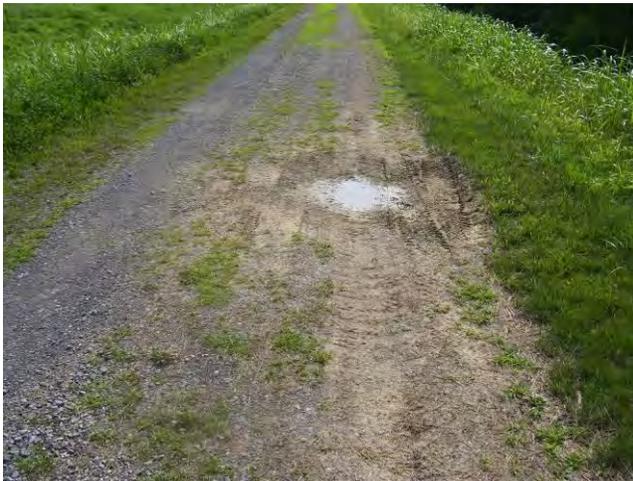
Photo 17

Rutting observed on the access road near the crest on the south side of the area.
