**FINAL REPORT  
ROUND 10 DAM ASSESSMENT  
UGI DEVELOPMENT COMPANY  
HUNLOCK CREEK POWER STATION  
ASH BASIN 003 (EAST BASIN) & ASH BASIN 005 (WEST BASIN)  
HUNLOCK CREEK, PENNSYLVANIA**

**AUGUST 17, 2012**

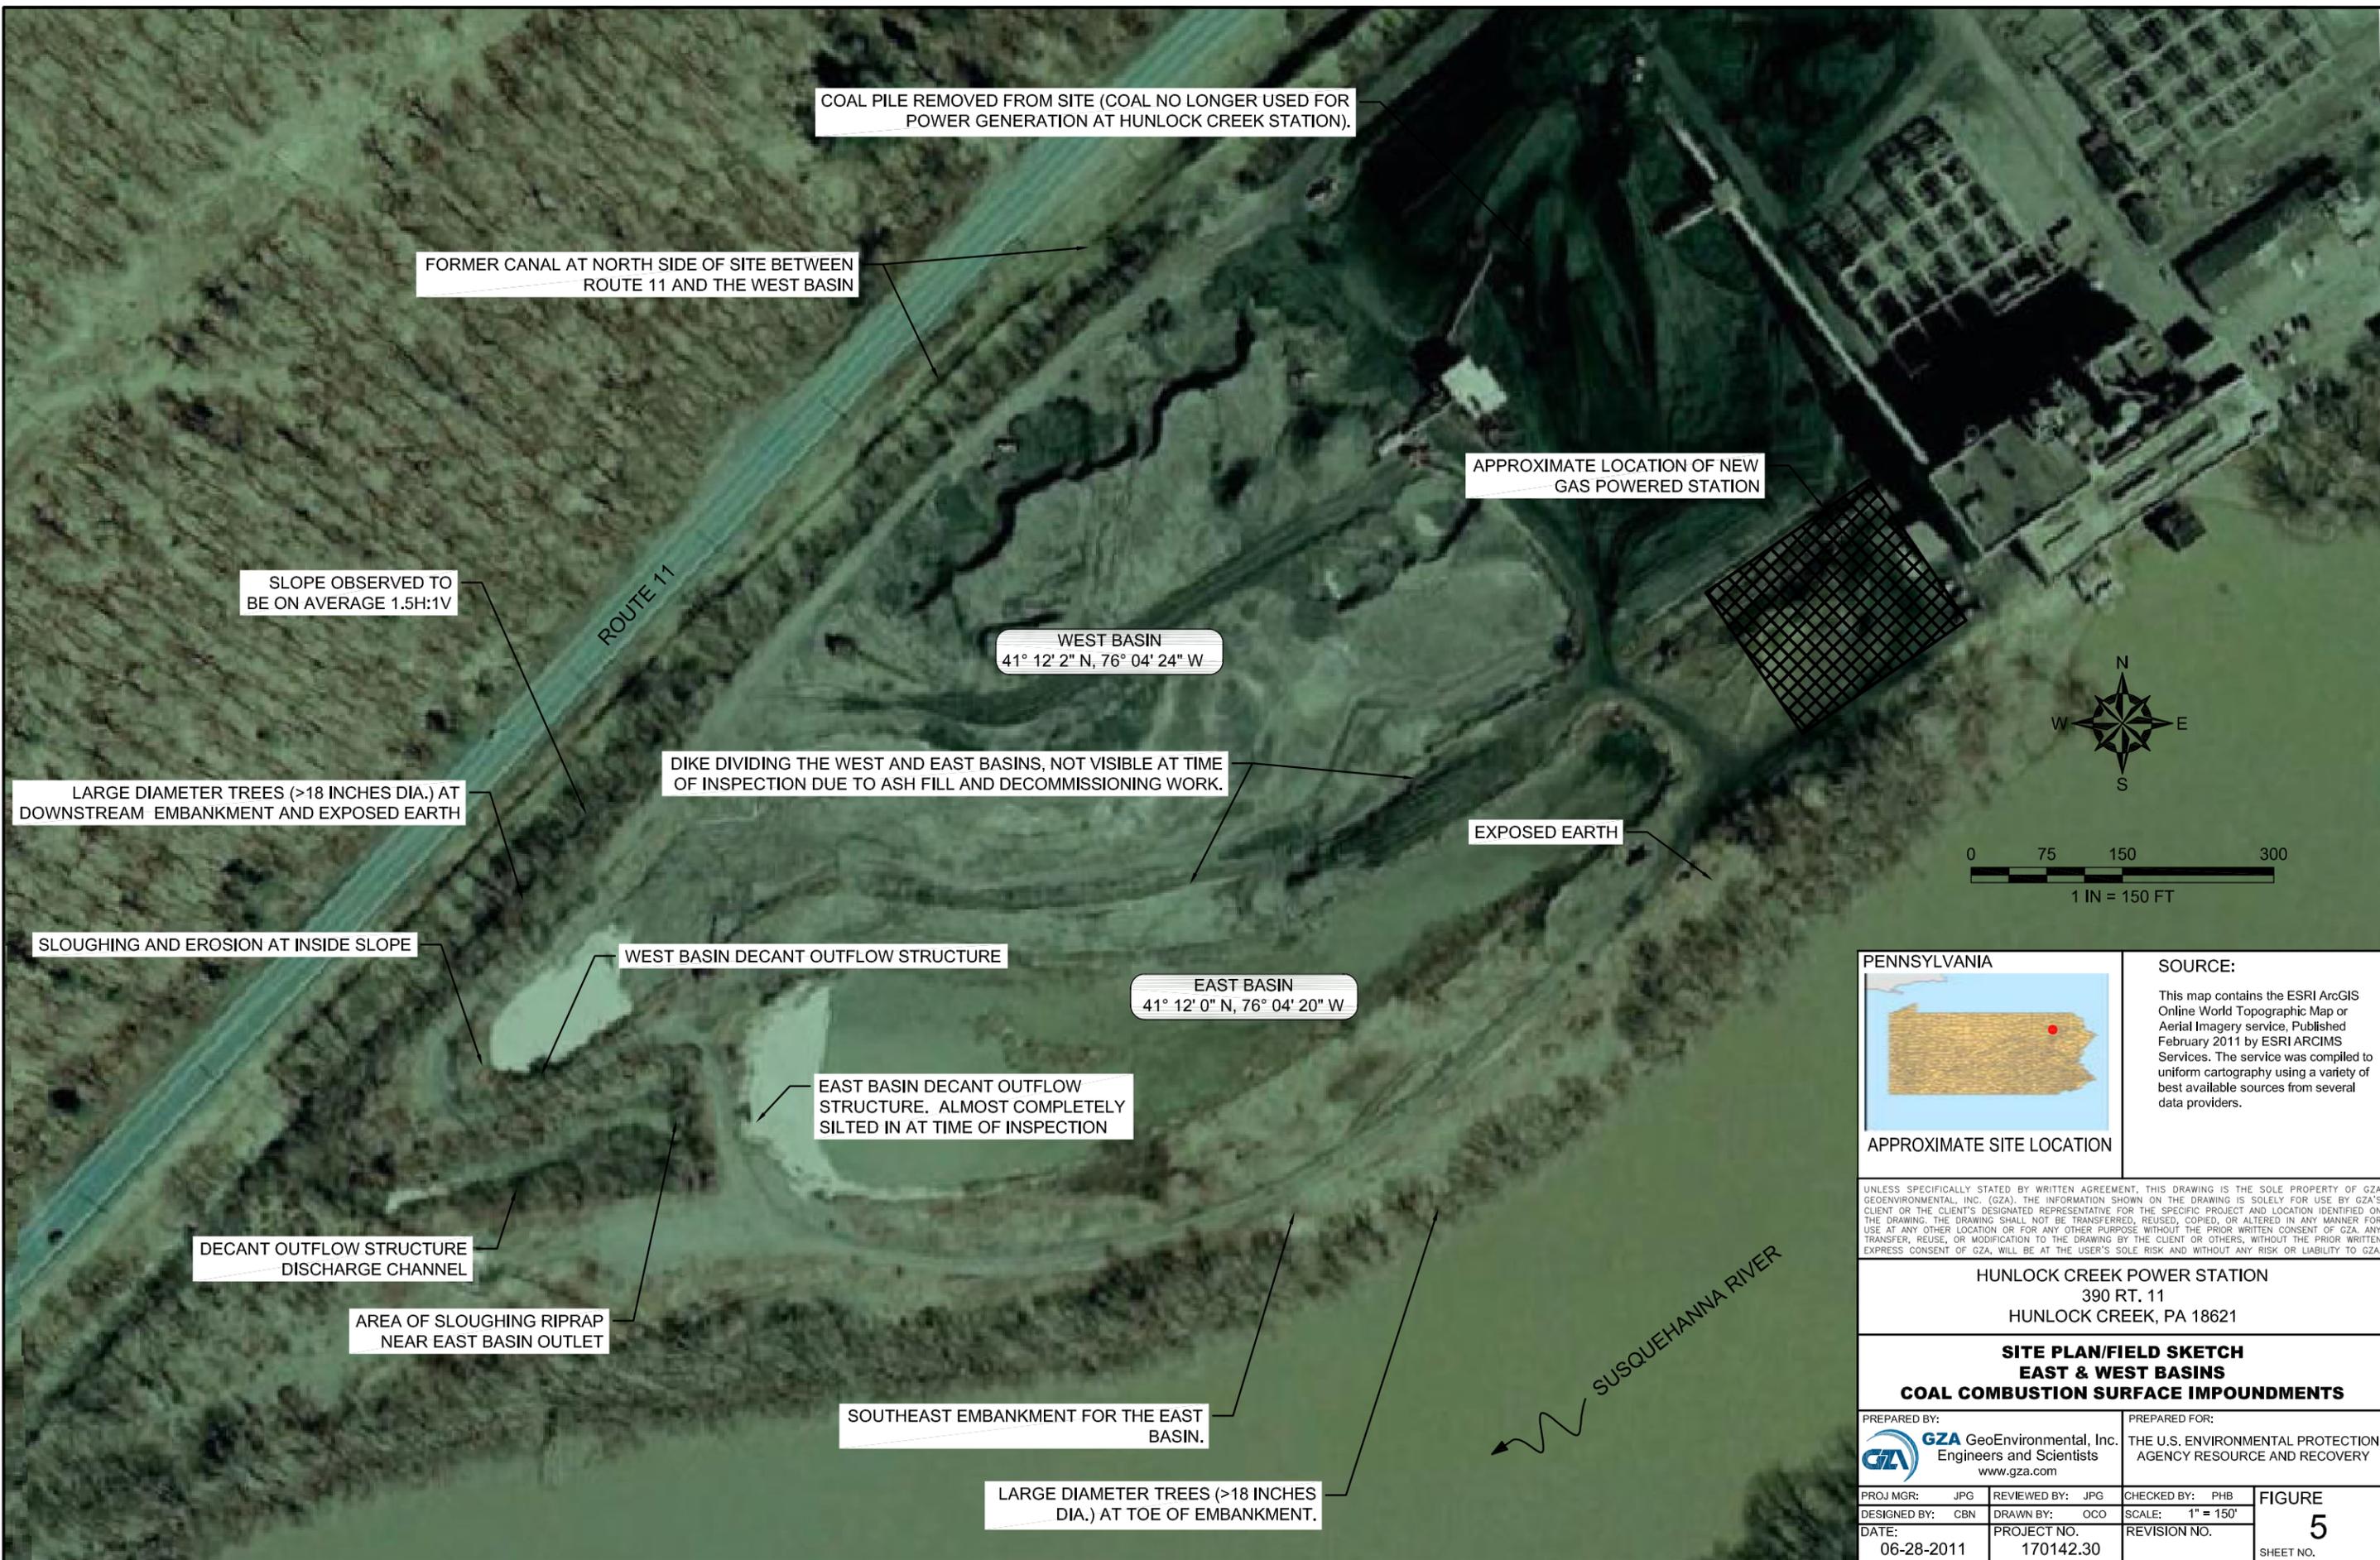
In general, the East Basin was found to be in FAIR condition. However, based on EPA's assessment criteria, the impoundment has been given a **POOR** condition rating, because no geotechnical computations were made available to GZA to review. Thus the stability of the embankments could not be independently verified even though, in GZA's professional opinion, the embankments in their current state at the time of the visual assessment appeared to be suitably stable and no immediate remedial action appears necessary. An overall site plan showing the impoundment is provided as **Figure 5**. The location and orientation of photographs provided as **Figure 6**.

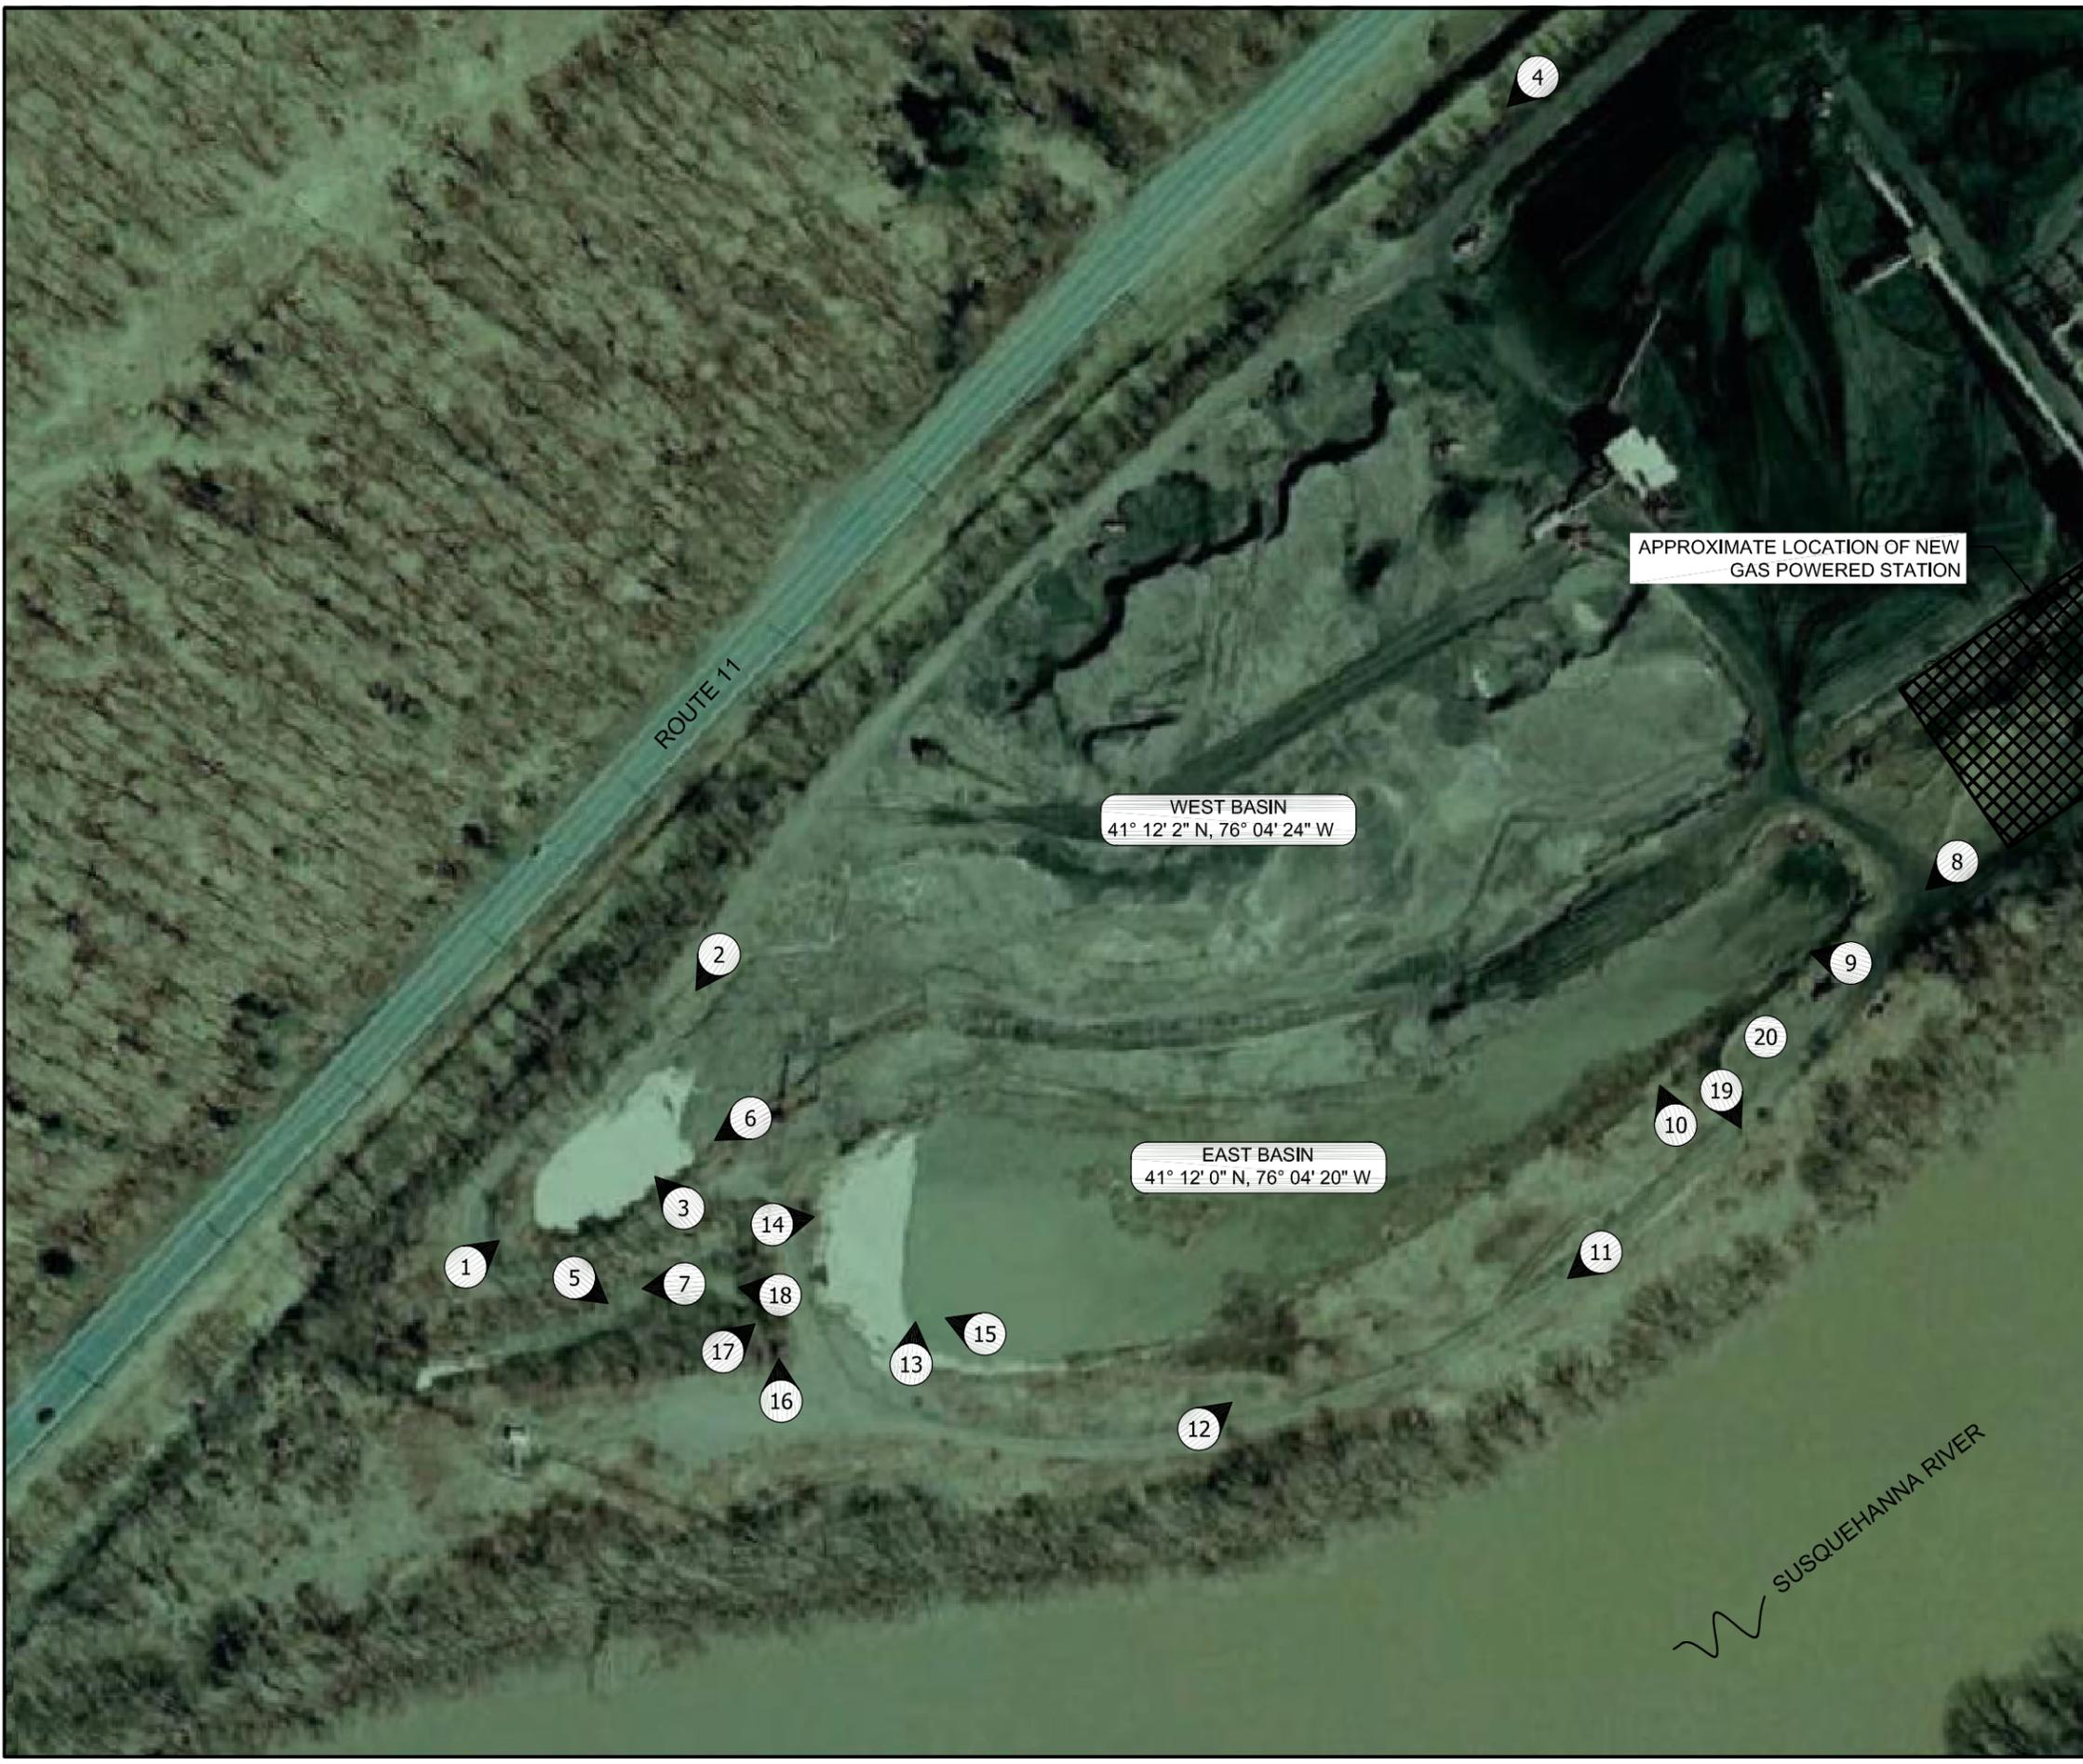
In general, the West Basin was found to be in **POOR** condition based on the results of our visual assessment alone, notwithstanding the fact that no geotechnical computations were made available to GZA for review. An overall site plan showing the impoundment is provided as **Figure 5**. The location and orientation of photographs provided as **Figure 6**.
