**Coal Combustion Waste Impoundment
Round 7- Dike Assessment Report**

Lawrence Energy Center

Ash Impoundment Dike

Westar Energy

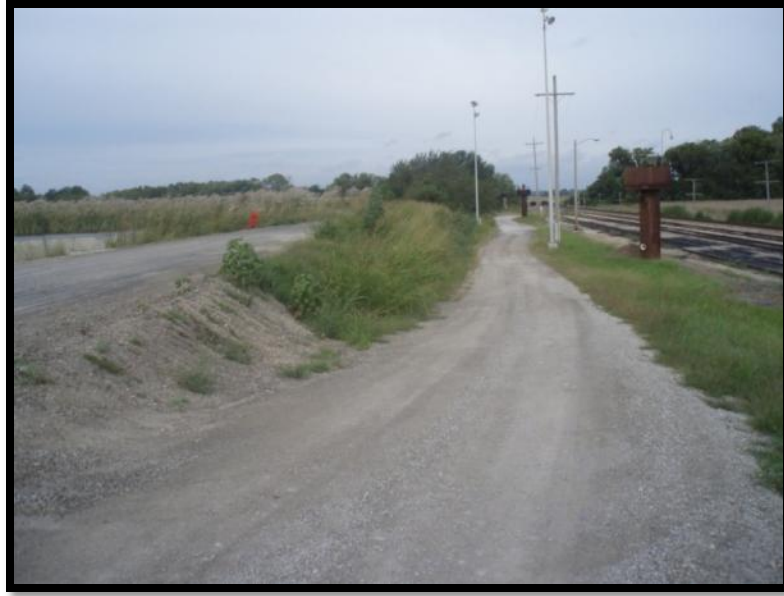
The outside slope of the northeastern portion of the perimeter dike embankment is bordered by a small ditch that drains to Baldwin Creek and runs along the railroad embankment, see Figure 5.2.3-1. The outside slope is covered with various species of tall grass and other vegetation. The steepness of the slope makes access difficult. Dewberry inspectors were not able to access parts of the toe of the embankment.

Figure 5.2.3-1: Outside Slope of Northeastern Portion of Perimeter Dike (Area 1).

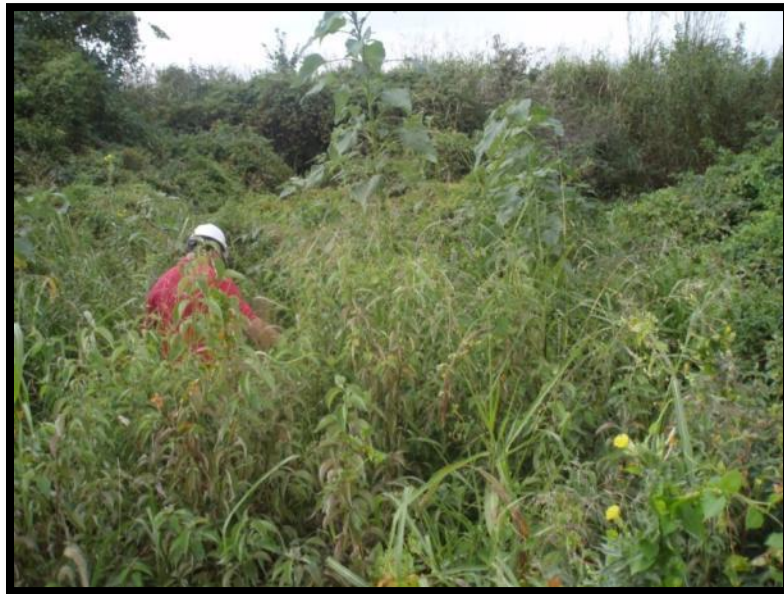
The emergency overflow outlet discharges at the base of the northeastern slope of the perimeter dike. The heavy vegetation made access to this area impossible, see Figure 5.2.3-2.

Figure 5.2.3-2: Vegetative Growth in the Area of the Overflow Outlet.

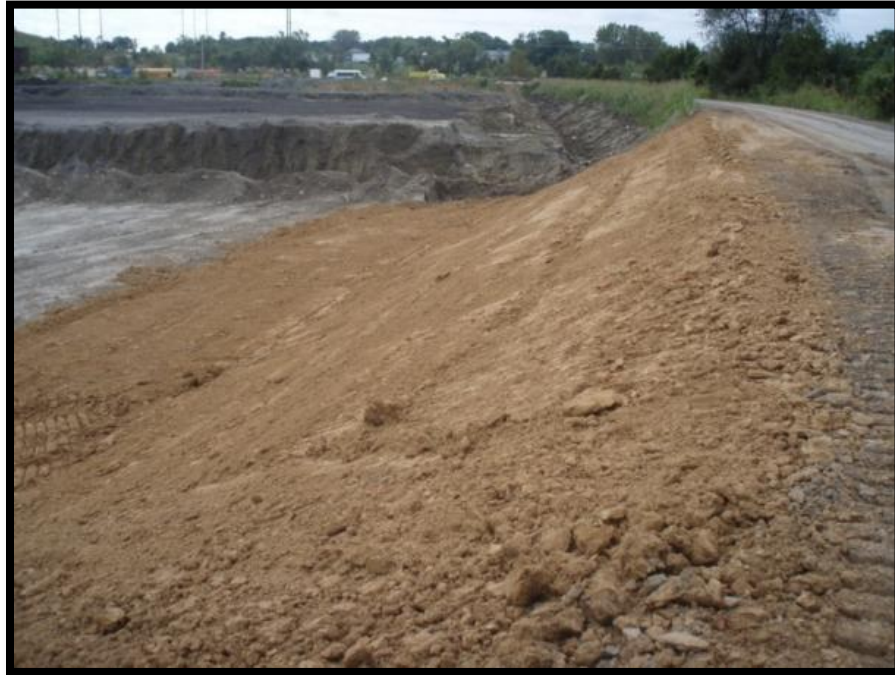
At the time of the site visit, Area 3 was drained and the ash was being removed. A clay liner was being installed and the slope was being restored to 3:1, see Figure 5.3.2-2.

Figure 5.3.2-2: Inside Slope of Western Portion of Perimeter Dike (Area 3).

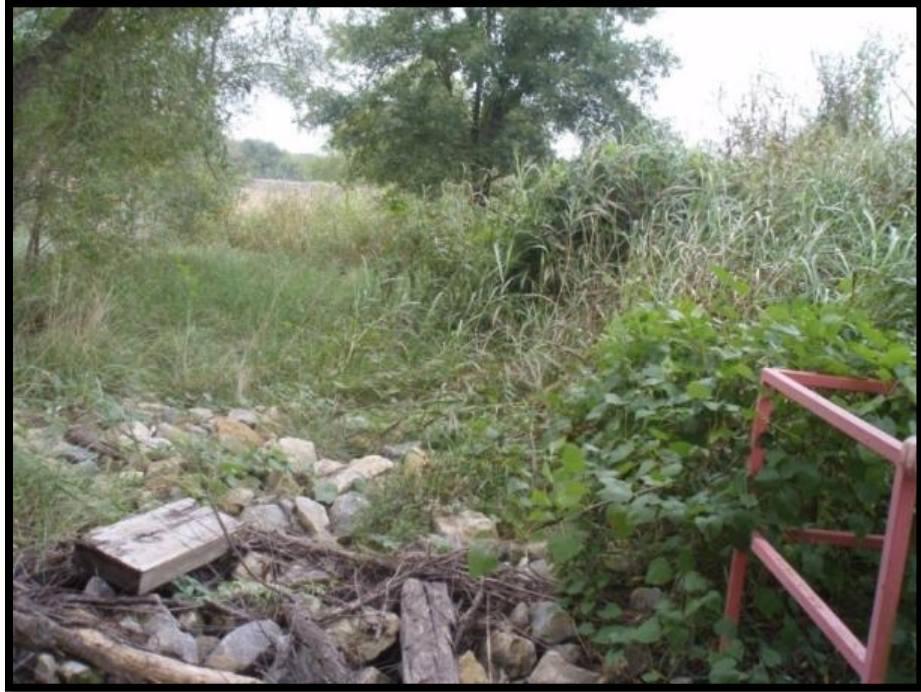
The south side of Area 3 is bordered by a storm water pond, which is contained within the perimeter dike, see Figure 5.4.3-1.

Figure 5.4.3-1: Outside of the Stormwater Pond Embankment on South Side.

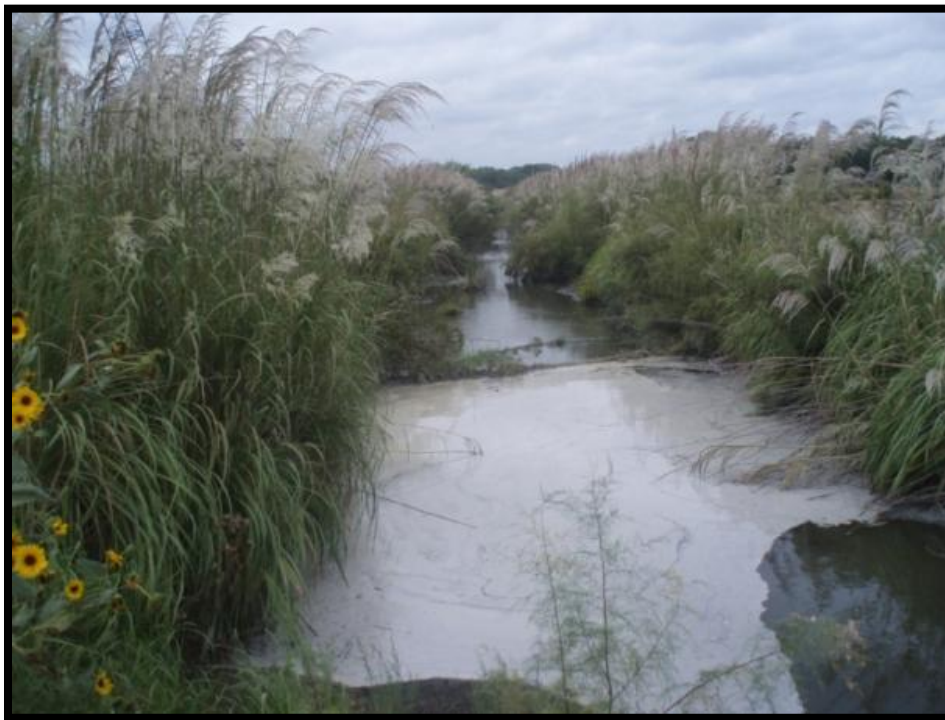
A shallow ditch connecting Areas 2 and 3 is immediately adjacent to the southern portion of Area 2 of the ash pond area, see Figure 5.4.3-2. The banks of the ditch are at natural grade.

Figure 5.4.3-2: Ditch Connecting Areas 2 and 3.

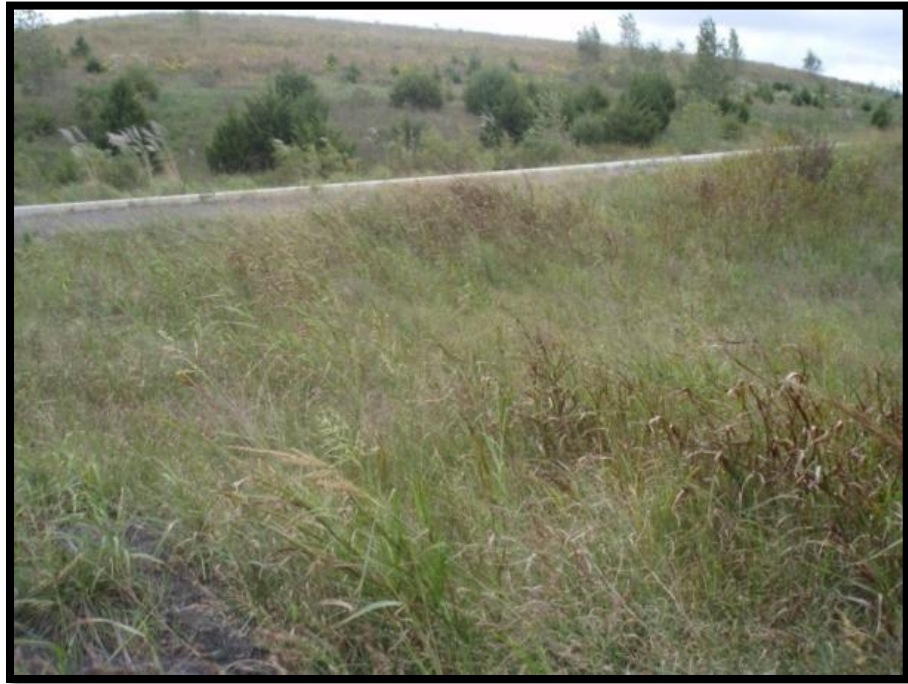
The east end of the southern portion of the perimeter dike, along the south edge of the storm water pond, ties into a road embankment, see Figure 5.4.4-1.

Figure 5.4.4-1: Tie-in of southern portion of perimeter dike to road embankment.

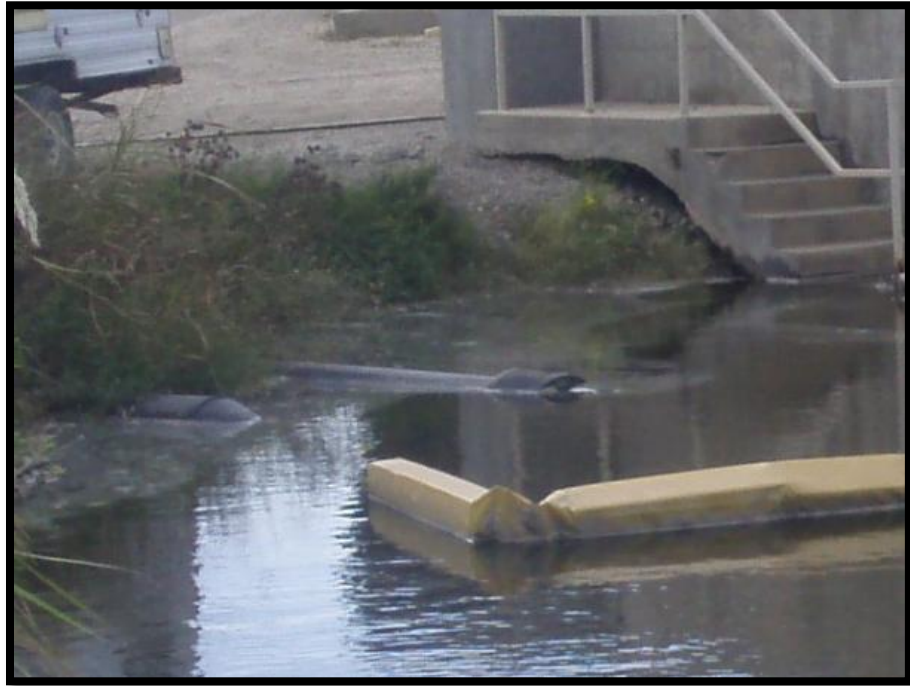
Water from Area 1 is discharged via a pipe in the northeast corner of Area 1 to the Kansas River (Figure 5.5.2-1).

Figure 5.5.2-1: Inlet end of the Area 1 Outlet Structure that leads to the Kansas River.

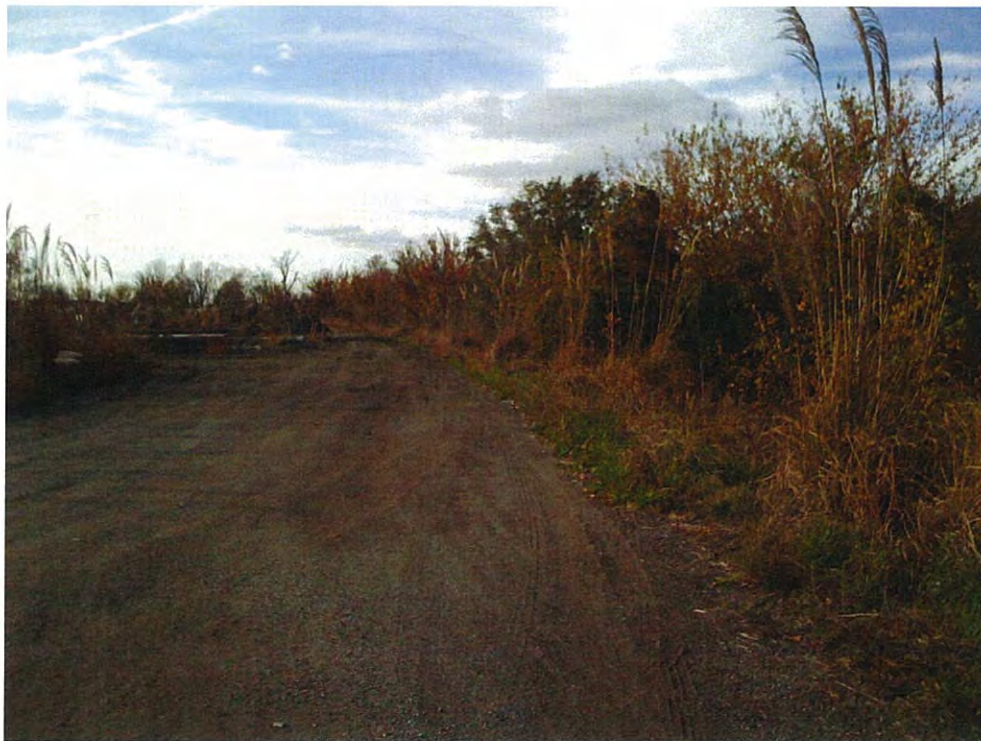
Photograph 4 – Berm crest near Borehole LEC-1 (looking northwest)

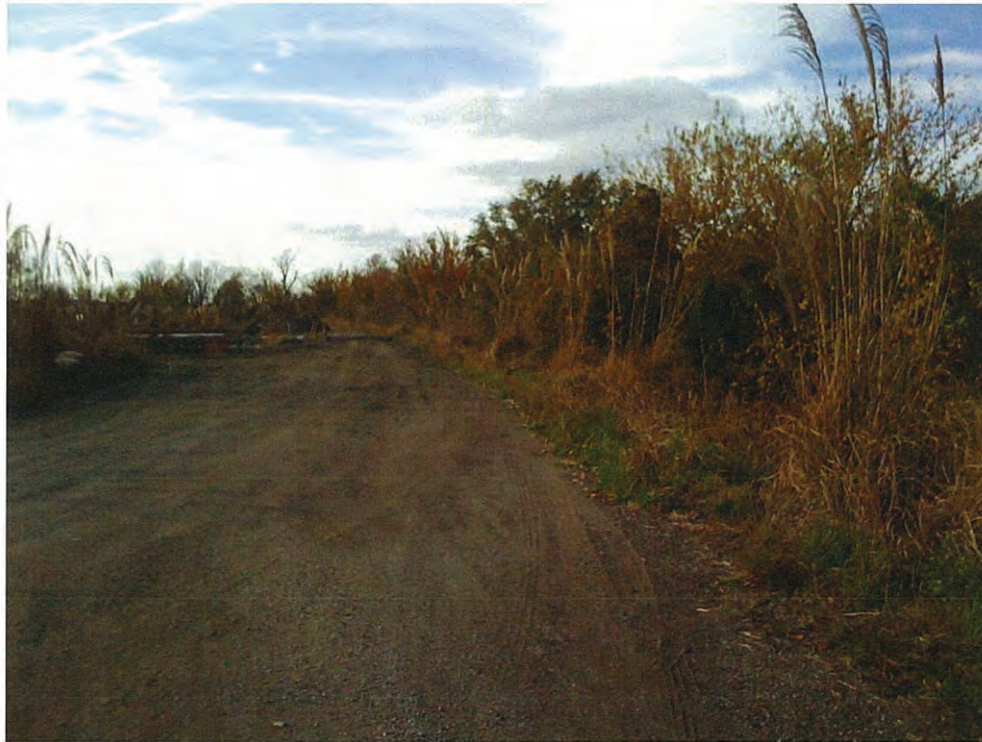
Photograph 5 – Berm crest (looking northwest)

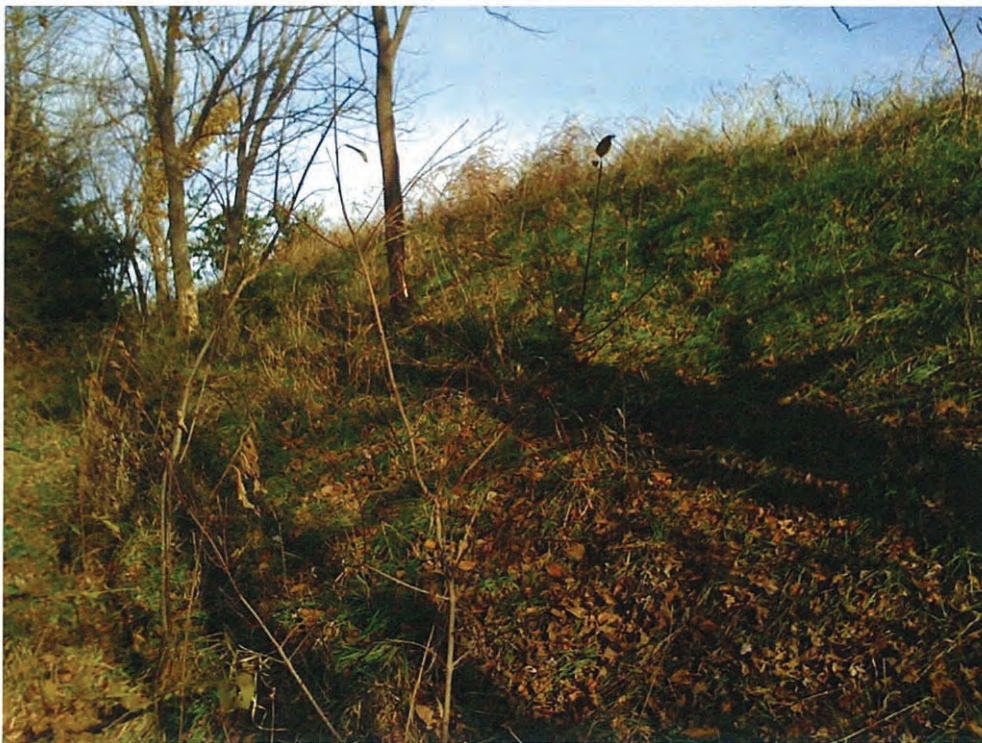
Photograph 6 – Downstream berm slope northwest of CCP storage facilities (looking east)

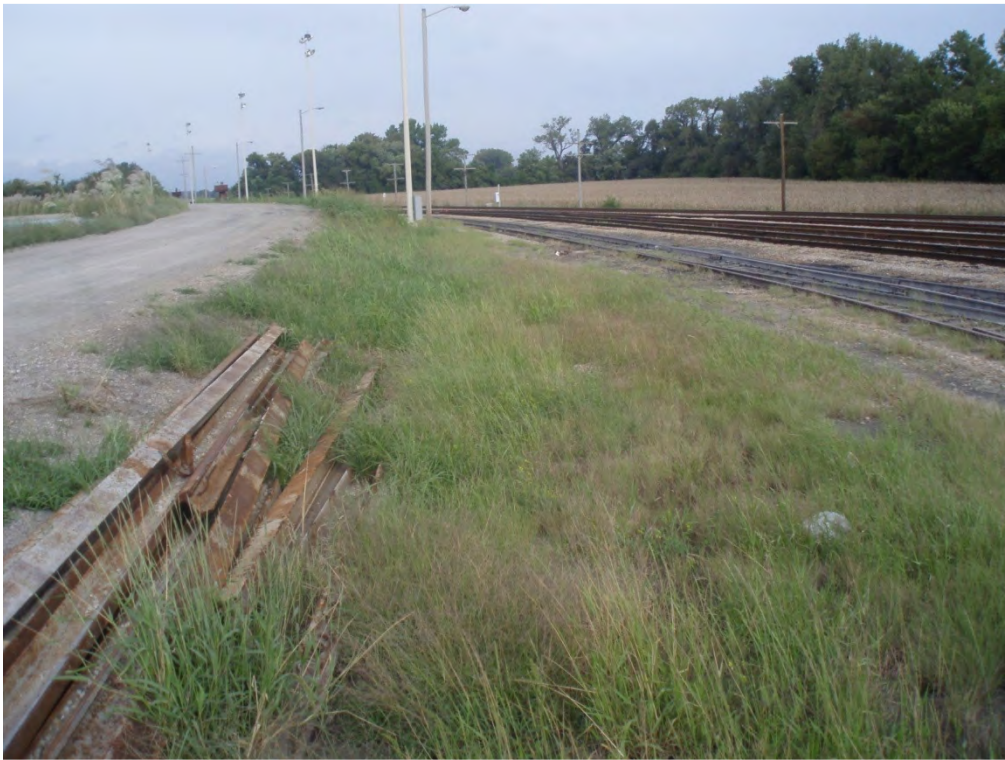
1. EXTERIOR OF NORTHEASTERN PORTION OF PERMETER DIKE – TAKEN FROM EAST END OF AREA 1, LOOKING WEST

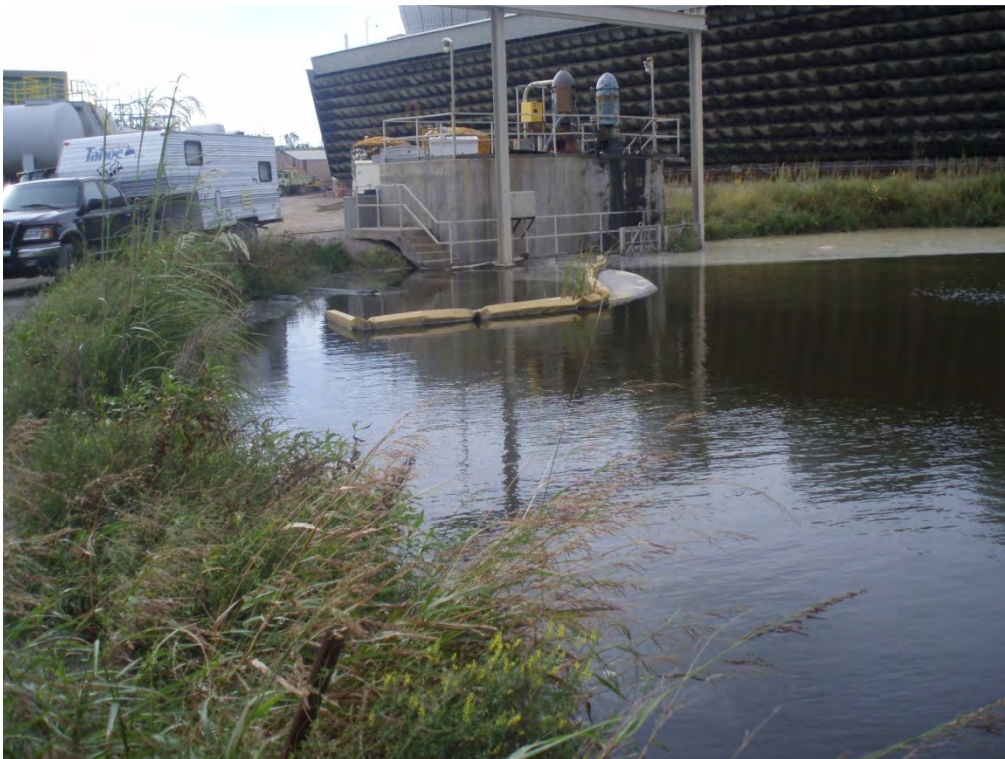
2. DISCHARGE PIPE AT EAST END OF AREA 1

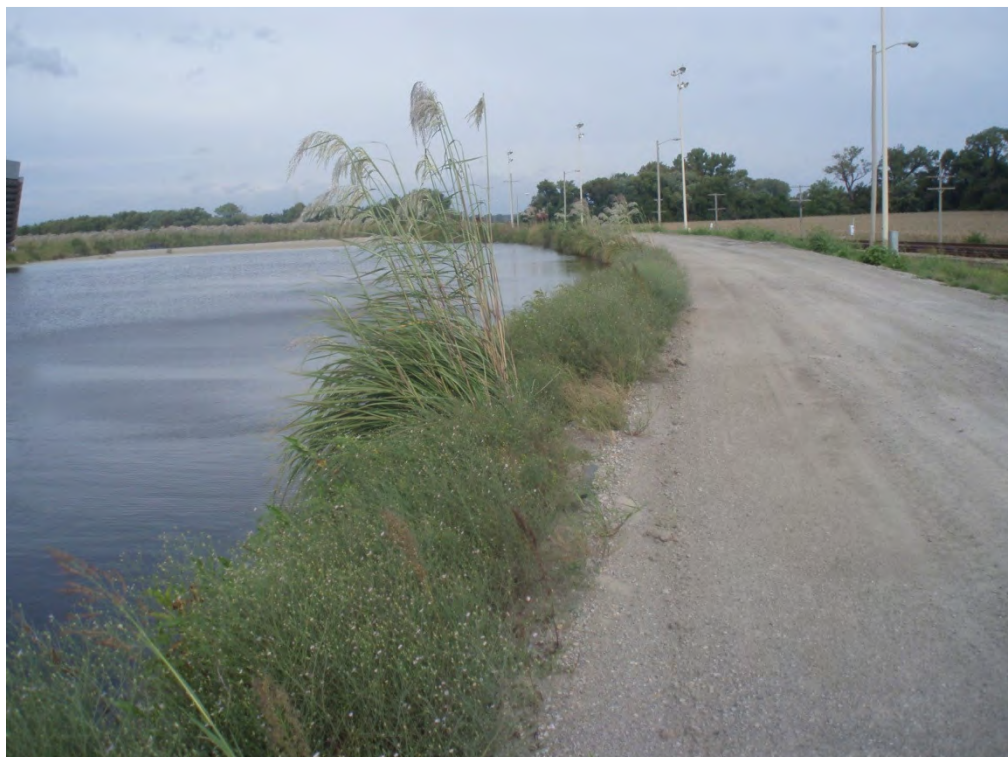
3. INTERIOR OF NORTHEASTERN PORTION OF PERMETER DIKE – TAKEN FROM EAST END OF AREA 1, LOOKING WEST

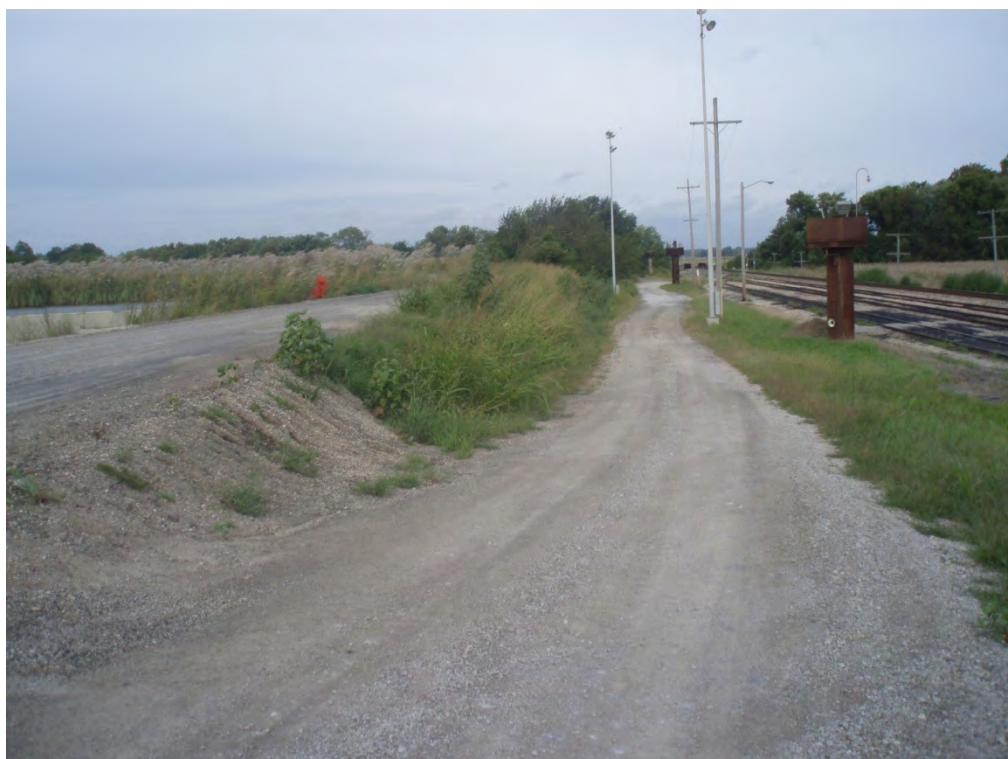
4. EXTERIOR OF NORTHEASTERN PORTION OF PERMETER DIKE – TAKEN FROM EAST END OF AREA 1, LOOKING WEST

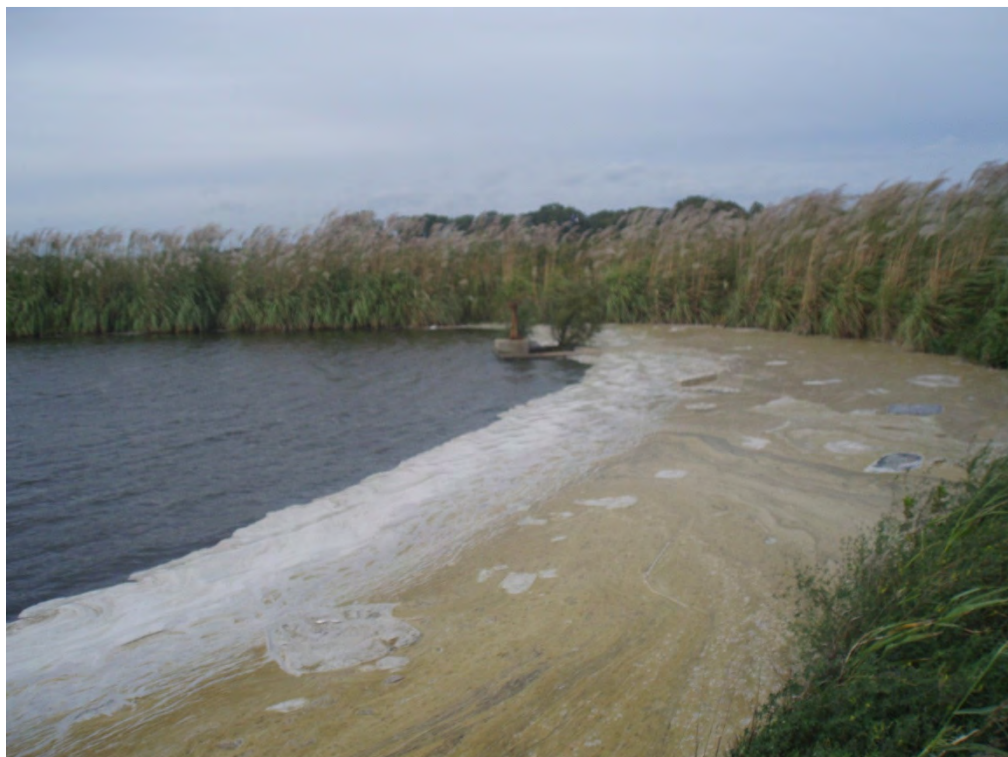
5. EMERGENCY OVERFLOW STRUCTURE – WEST END OF AREA 1

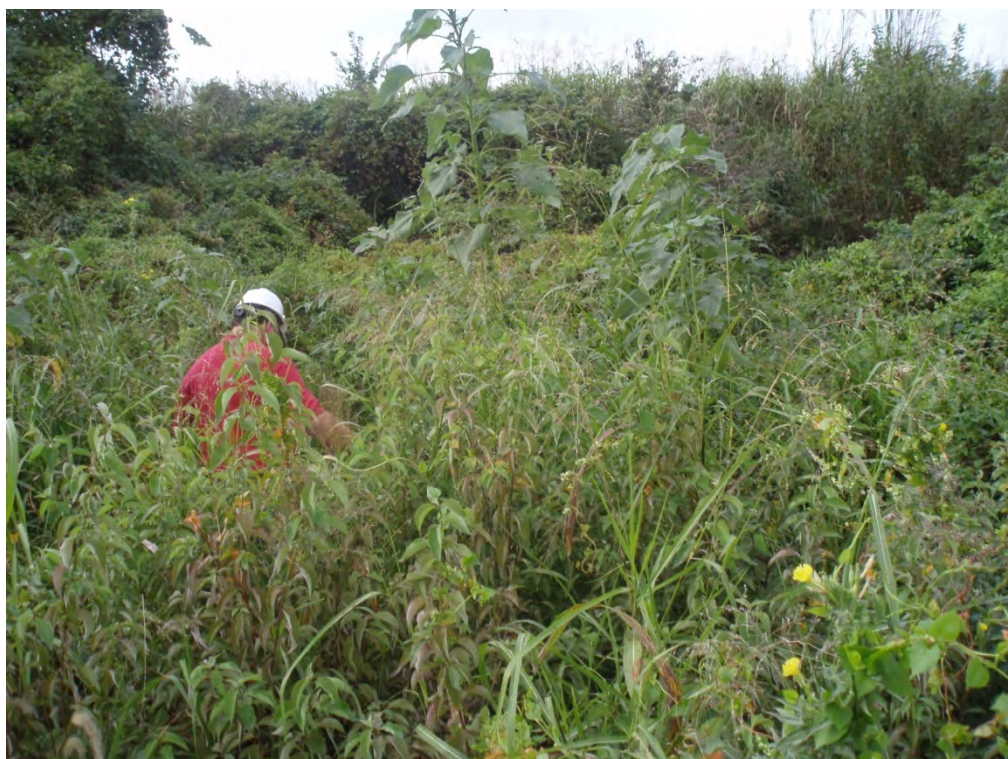
6. OUTFALL OF EMERGENCY OVERFLOW STRUCTURE – EXTERIOR OF NORTH SIDE OF AREA 1 DIKE. HEAVY VEGETATION MAKES ACCESS TO THE OUTFALL IMPRACTICAL.

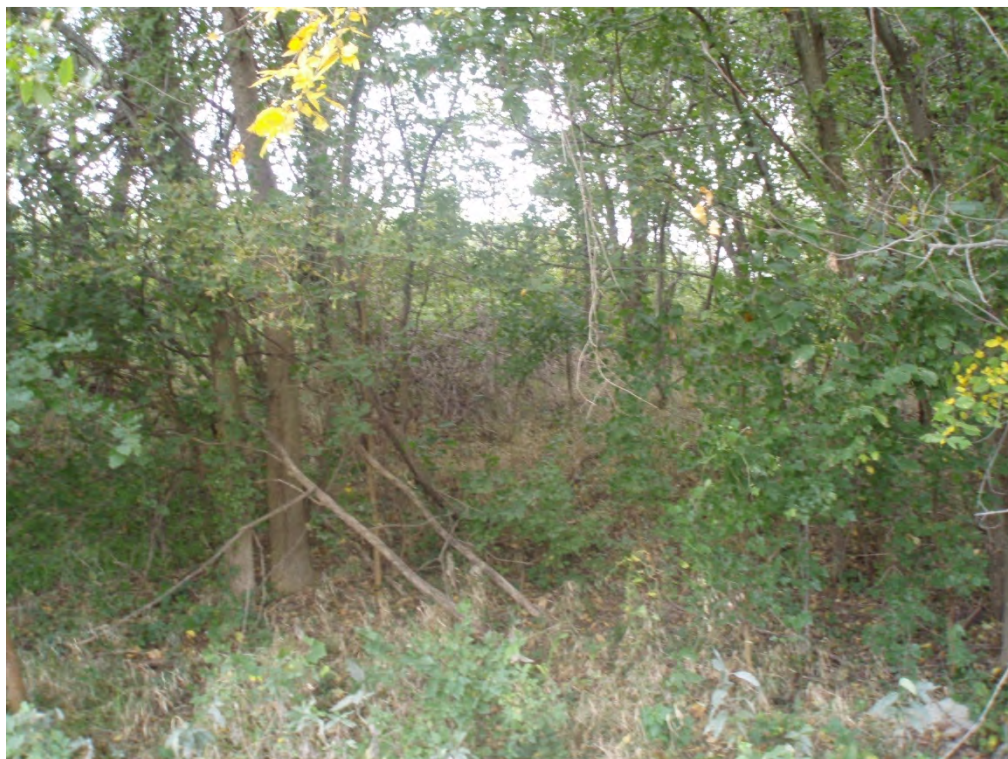
7. EXTERIOR OF PERIMETER DIKE - TAKEN FROM NORTH SIDE OF AREA 4 LOOKING SOUTH, UP SIDE OF DIKE.

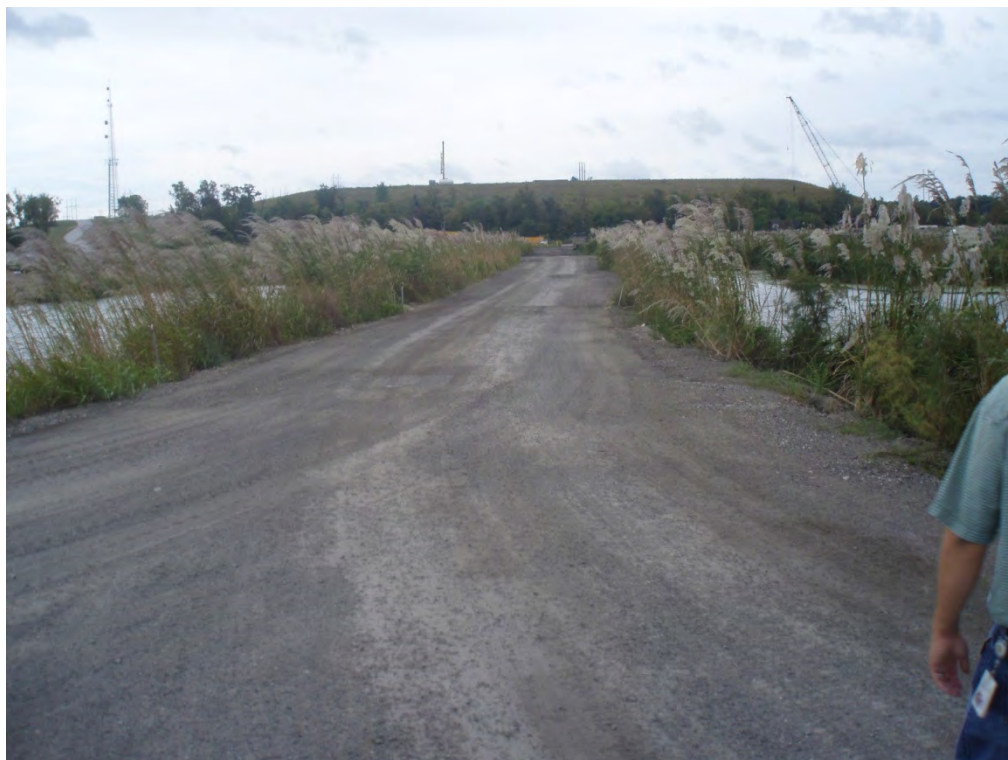
8. INTERIOR SEPARATION DIKE, SEPARATING AREA 1 FROM AREA 4 - TAKEN FROM NORTH END, LOOKING SOUTH.

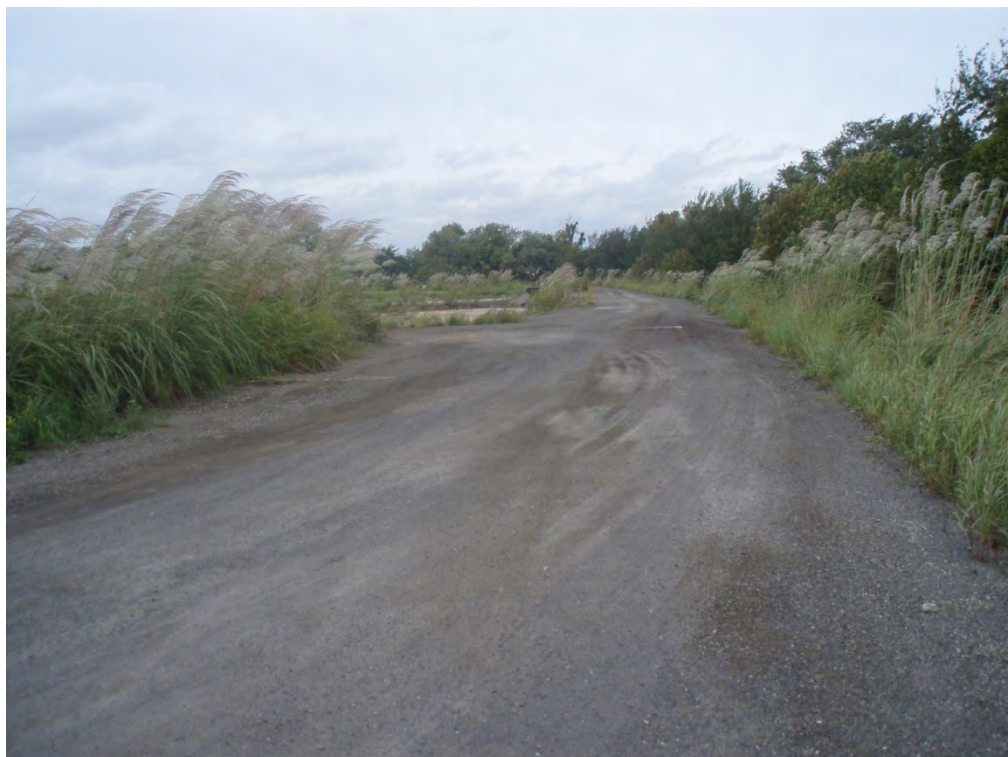
9. TOP OFNORTHEASTERNPORTIONOFPERMETERDIKE – TAKENFROM MIDPOINT BETWEEN AREA 1 AND 4 LOOKINGWEST

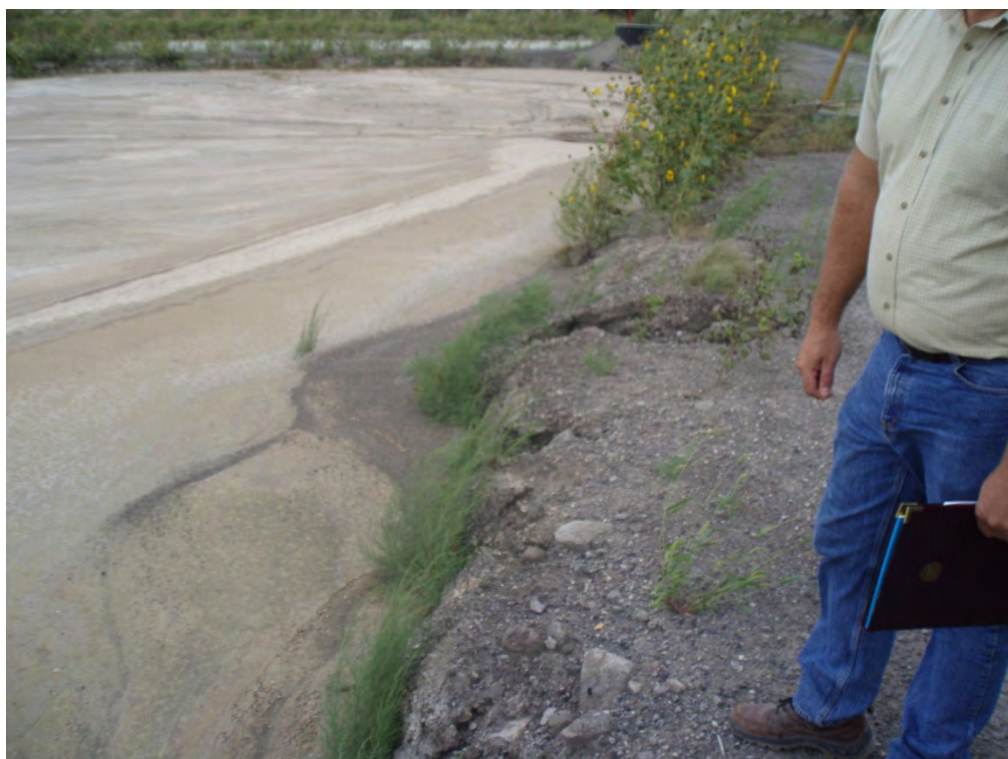
10. INTERIOROFNORTHEASTERNPORTIONOFPERMETERDIKE IN AREA 4 – SOME MINORWASHOUT/EROSIONOBSERVED.

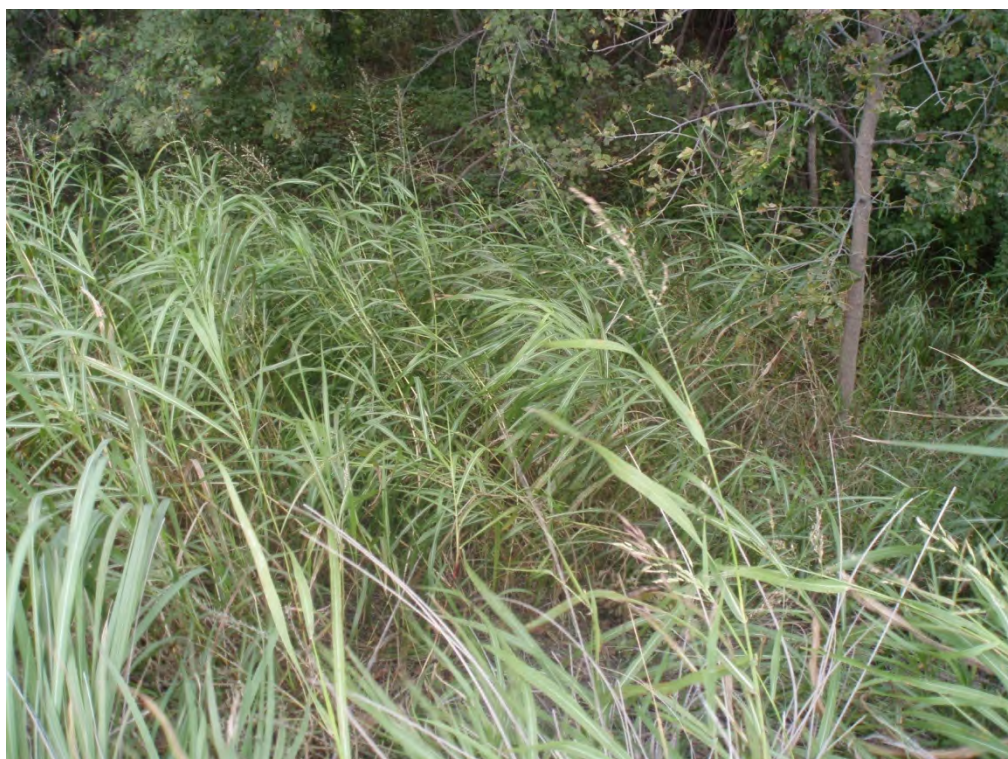
12. EXTERIOROFNORTHEASTERNPORTIONOFPERMETERDIKE (AREA 4) – HEAVYVEGETATIONOBSERVED.

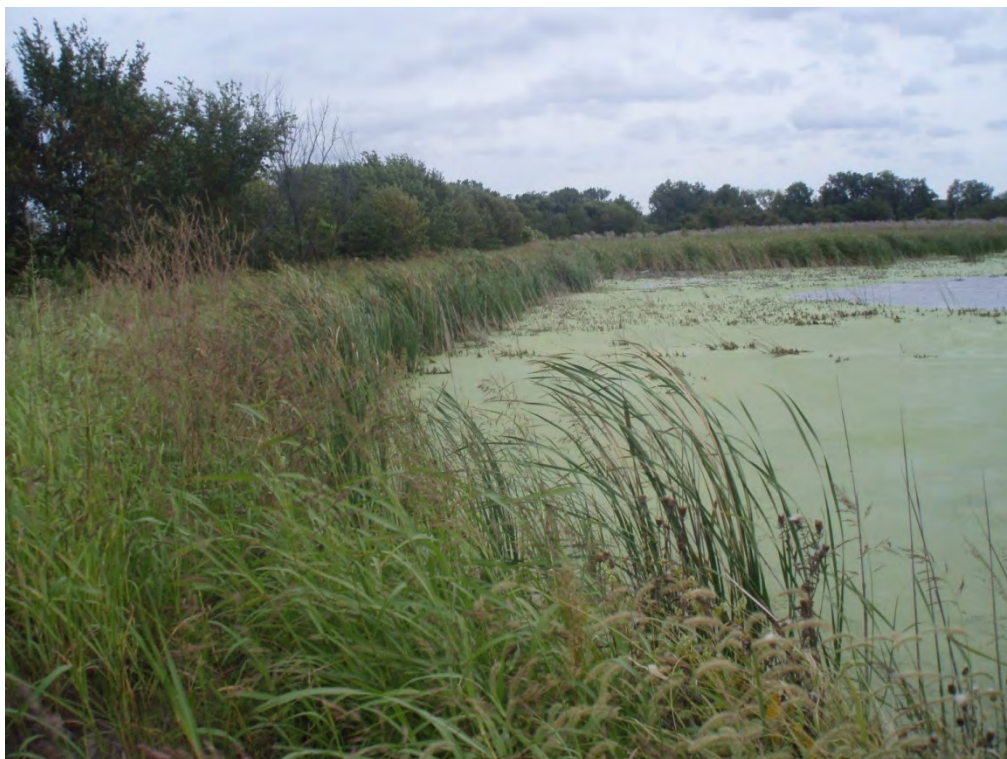
19. INTERIOR OF NORTHWESTERN PORTION OF PERIMETER DIKE – TAKEN FROM MIDPOINT (BETWEEN AREA 3 AND 4) LOOKING NORTH

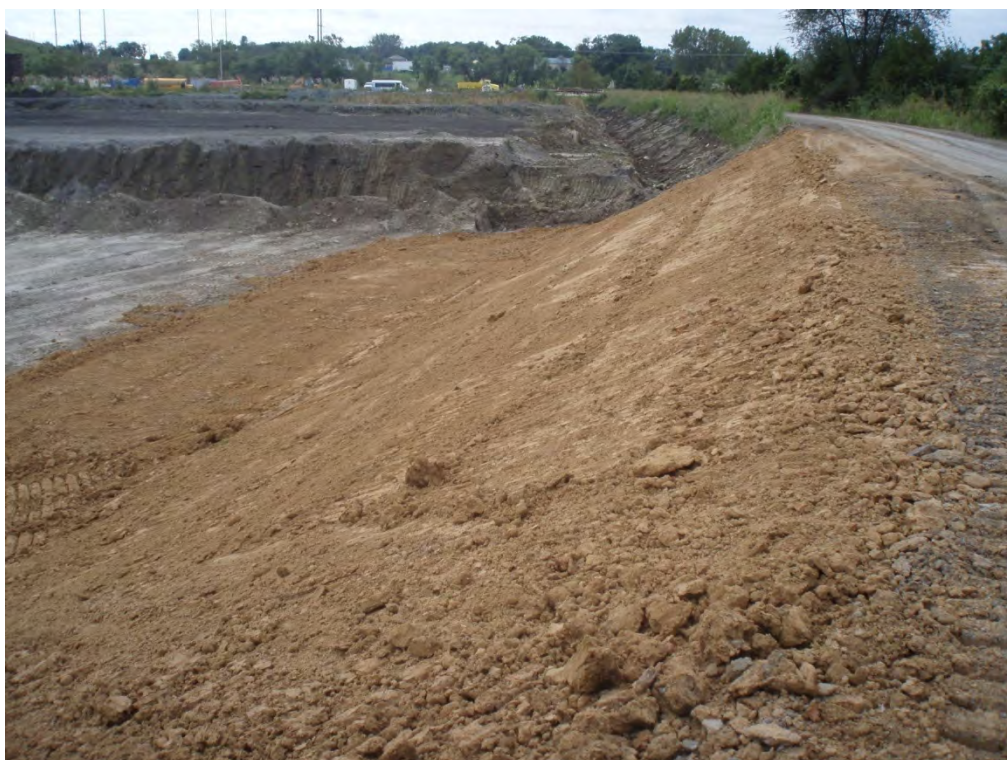
20. INTERIOR OF WESTERN PORTION OF PERIMETER DIKE (AREA 3) – TAKEN FROM WESTERN DIKE LOOKING SOUTH ALONG INTERIOR OF DIKE. CLAY LINER BEING INSTALLED

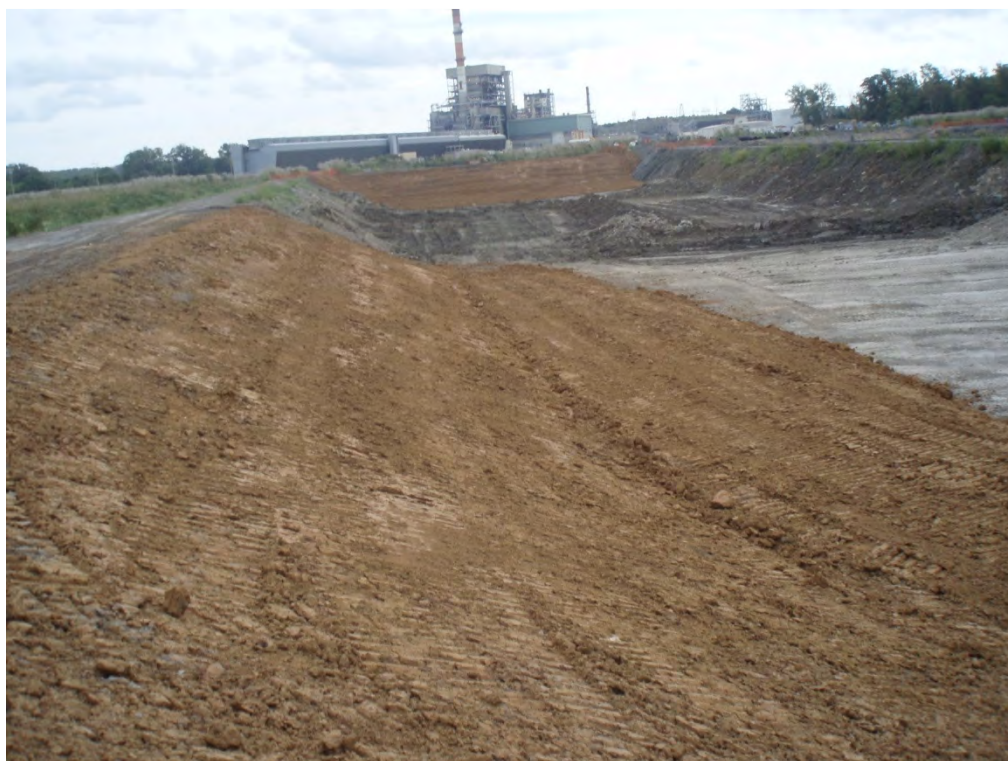
21. INTERIOR SEPARATION DIKE (AREA 3) - TAKEN FROM WESTERN PORTION OF PERMETER DIKE LOOKING EAST ALONG INTERIOR SEPARATION DIKE. CLAY LINER BEING INSTALLED

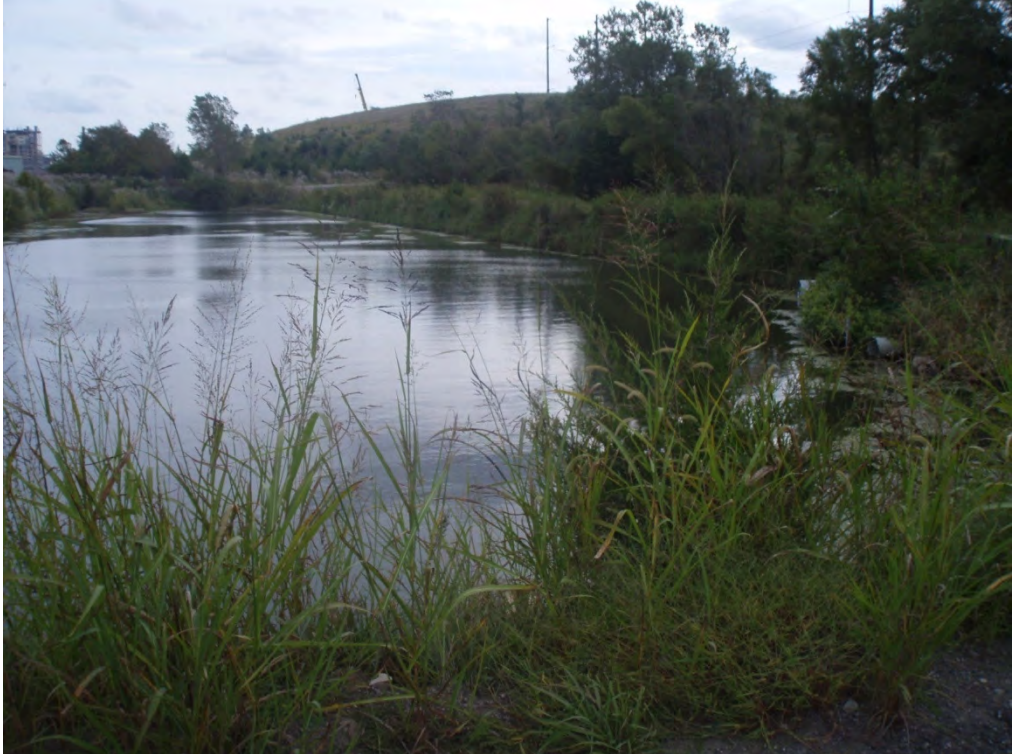
23. STORM WATERPOND AT SOUTH END OF ASH POND AREA/AREA 3 – TAKEN FROM WESTERN PORTION OF PERIMETER DITCH LOOKING EAST.

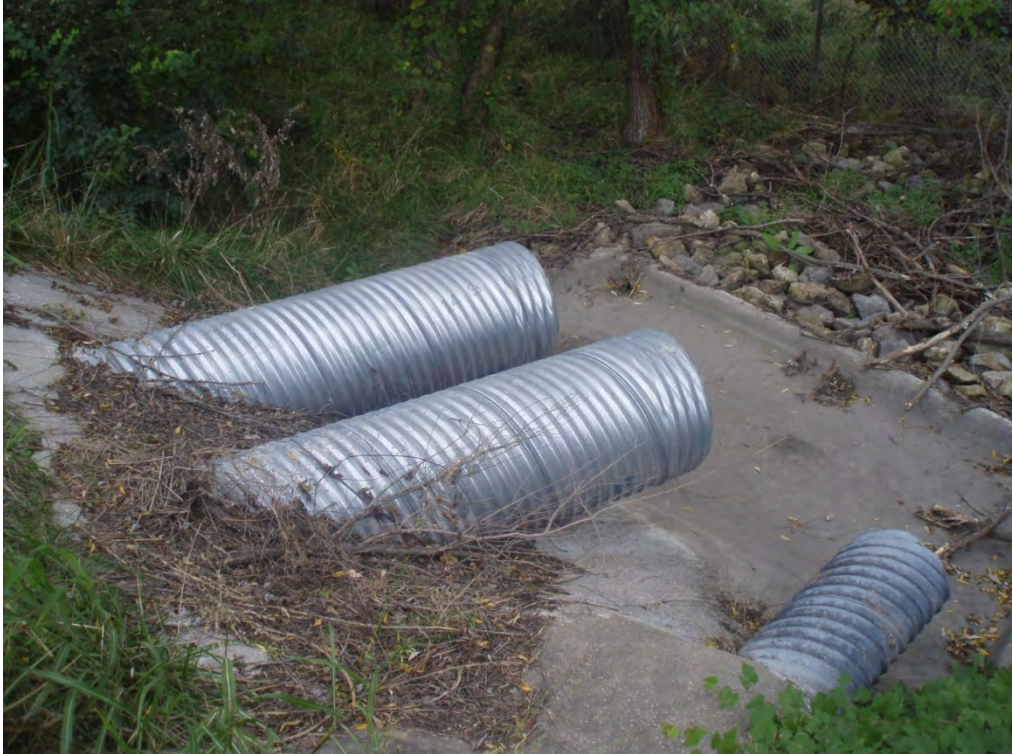
25. STORM WATERPOND OUTFALL PIPES ON EXTERIOR OF SOUTH SIDE OF AREA 3.

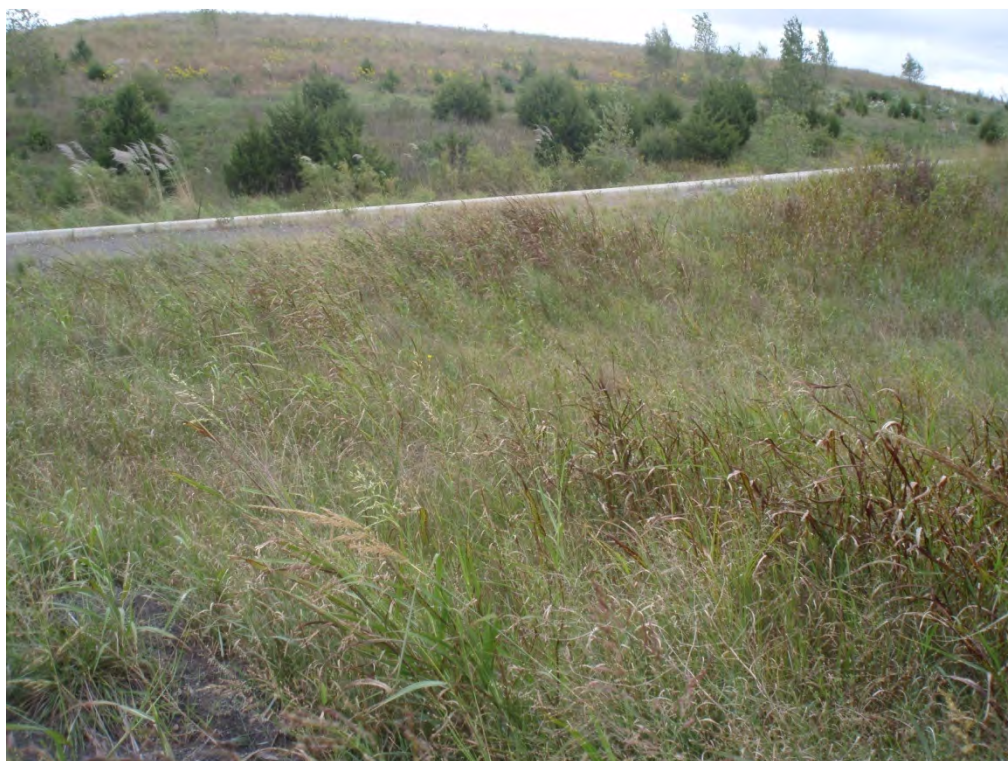
27. EXTERIOR VIEW OF PERIMETER DIKE TO EXISTING GRADE/ROAD EMBANKMENT ALONG SOUTH SIDE OF AREA 3.

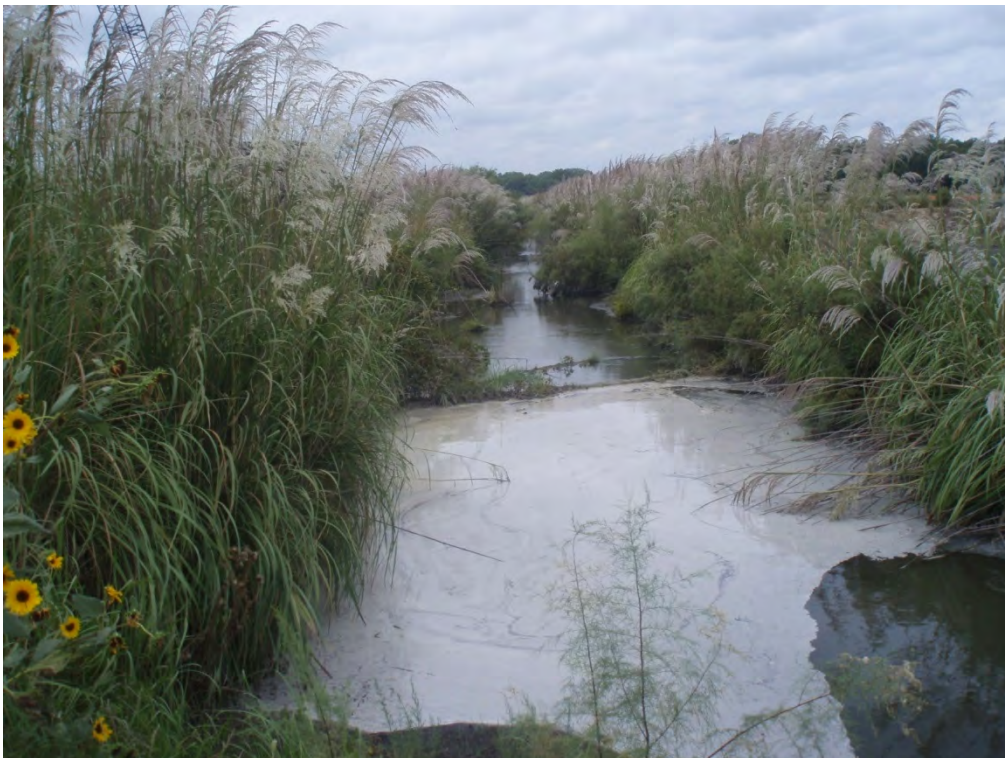
30. CHANNEL CONNECTING AREA 2 AND AREA 3 - TAKEN FROM EAST END LOOKING WEST.
