# **WILLIAMSON COUNTY AERATED BIOREACTOR LANDFILL: OPERATIONS AND PERFORMANCE**

**Presented by  
Civil & Environmental Consultants  
for the  
U.S. Environmental Protection Agency  
Workshop On Bioreactor Landfills  
February 27-28, 2003**

# WILLIAMSON COUNTY LANDFILL

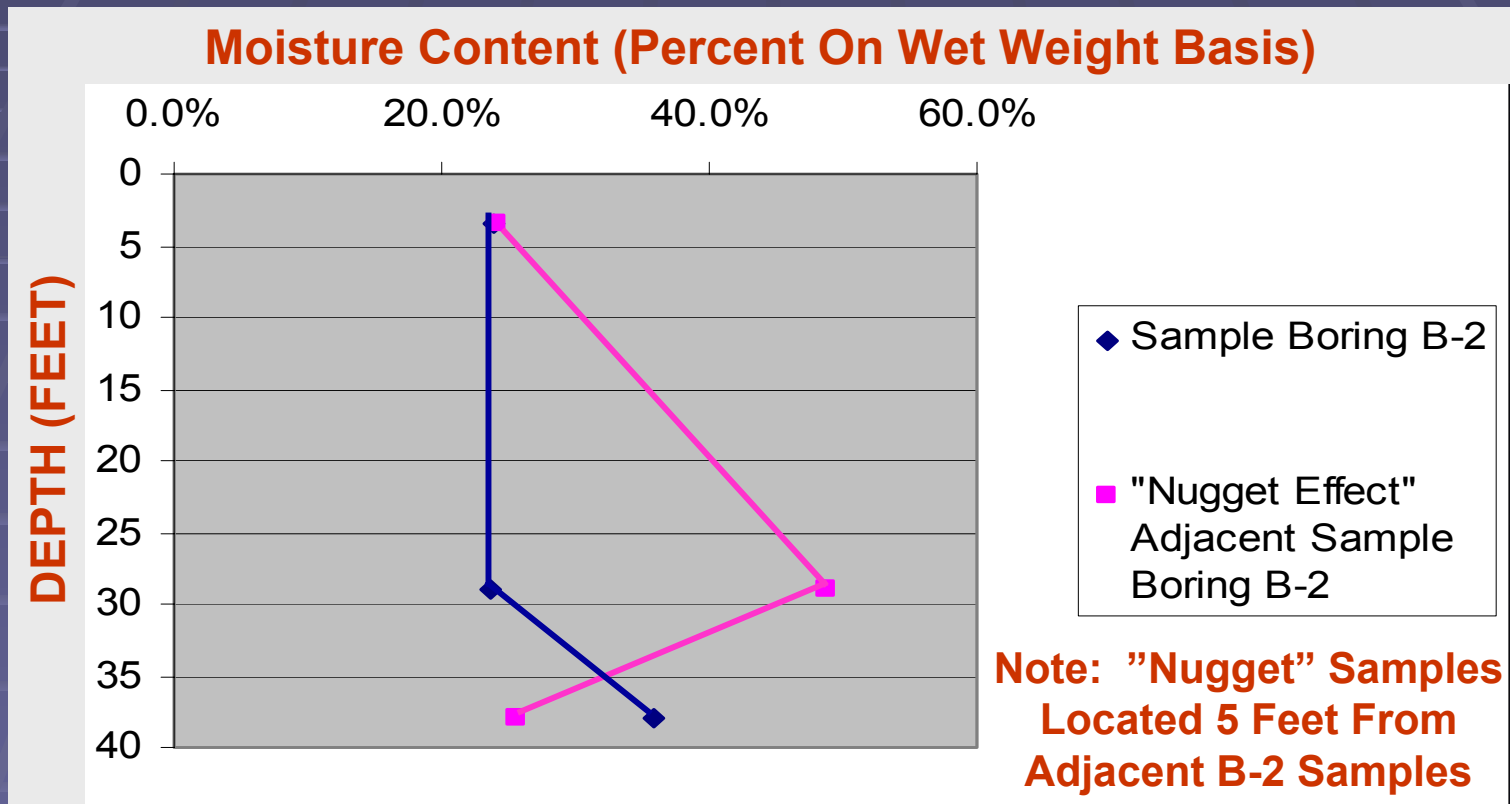
# MOISTURE CONTENT DATA FROM OCTOBER 2002 SAMPLING EVENT

- **The effectiveness of moisture distribution directly affects:**
  - **Air distribution**
  - **Water Availability for microorganisms**
- **Evidence of heterogeneous distribution of moisture, including saturated pockets and relatively dry areas**
- **For aerated systems, a tighter operating range of moisture content is needed**

- ***In-situ* moisture content measurements are necessary for effective operation relative to concerns over maintaining FAS**
- **For Retrofits - Improved methods and materials of construction in well and header system construction**
  - **auguring or sonic drilling for wells**
  - **greater well diameter**
  - **angular granular materials used in annular space backfill**
  - **HDPE pipe and fittings for header system**

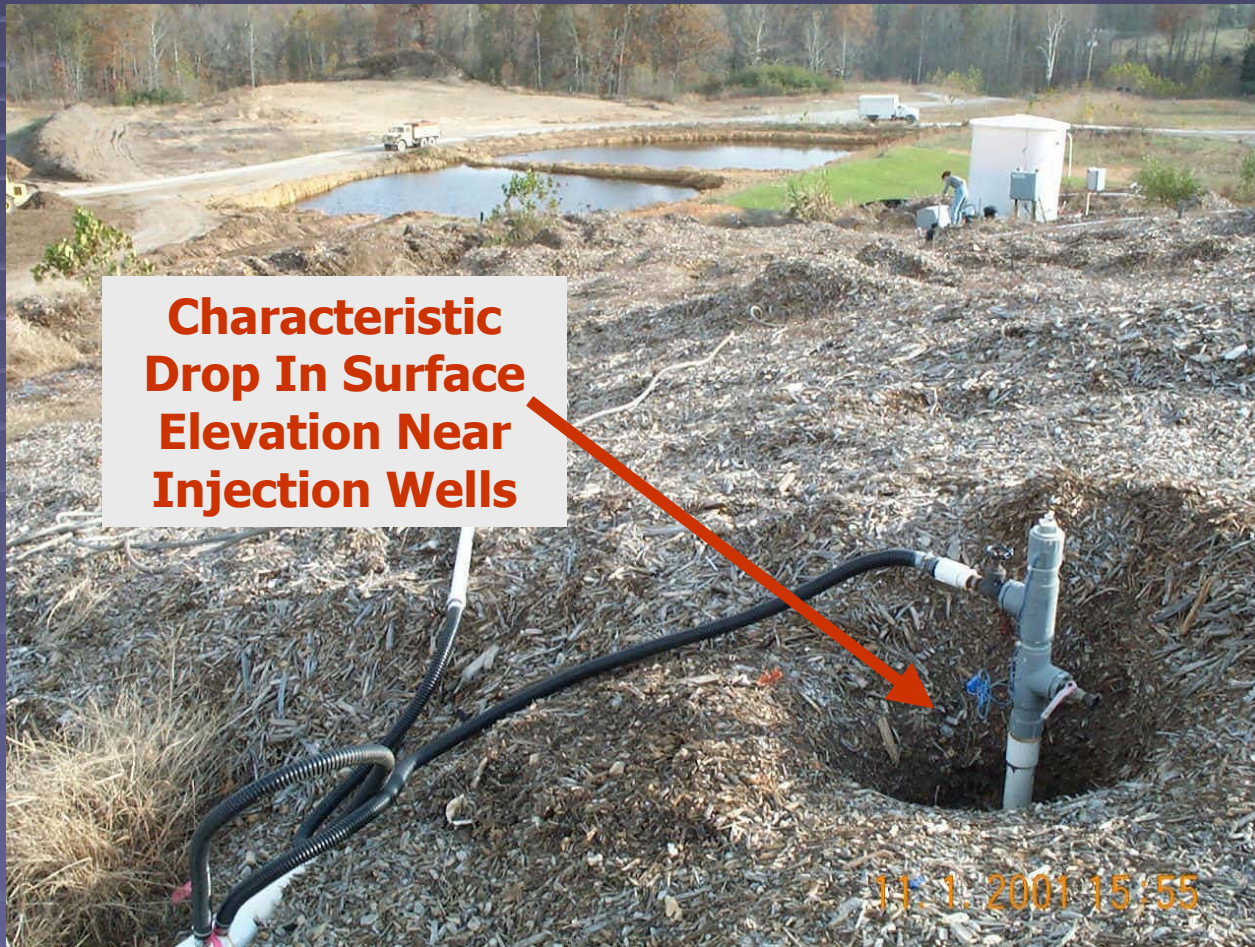
# SETTLEMENT

➤ **Average Settlement Across Site = 22 inches or 4.9% of original avg. depth**
