Facility Name & Location:
ALLENCO ENERGY LOS ANGELES CA

**Dates Photographs
Were Taken:**
11/6/2013

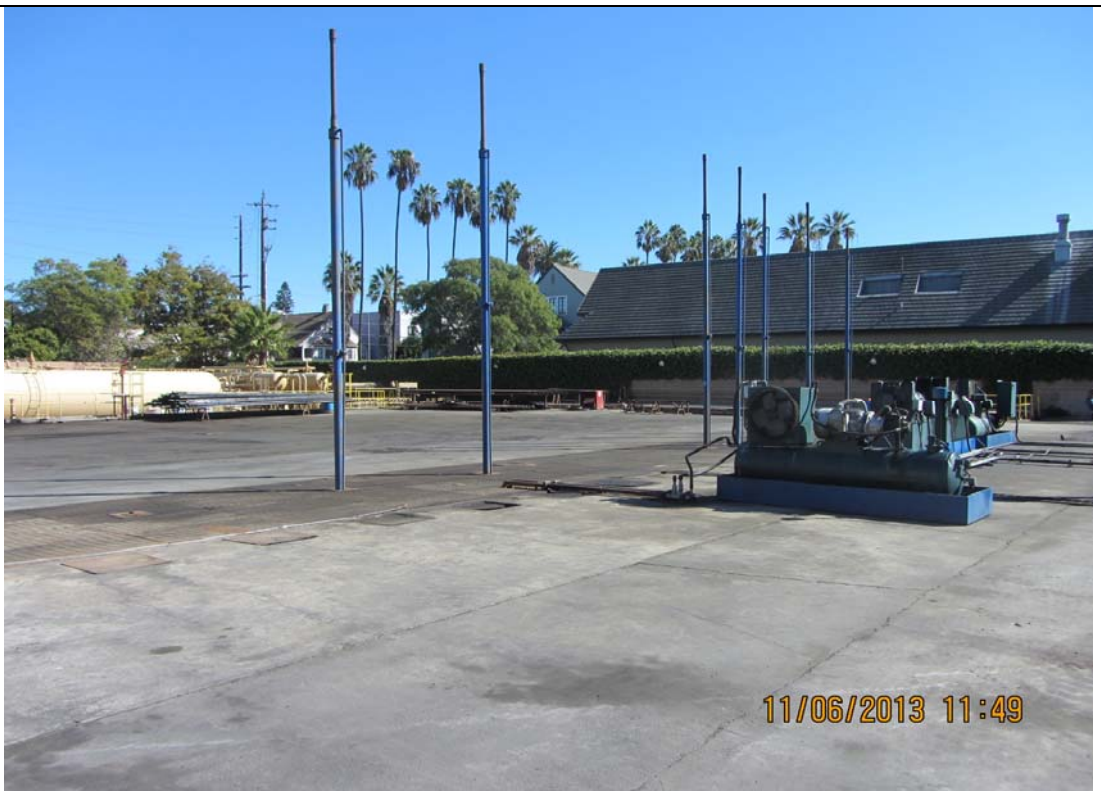
Photo No. 4	Time: 1049
-----------------------	----------------------

Photo Description:
VIEW ABOVE WELL GALLERY

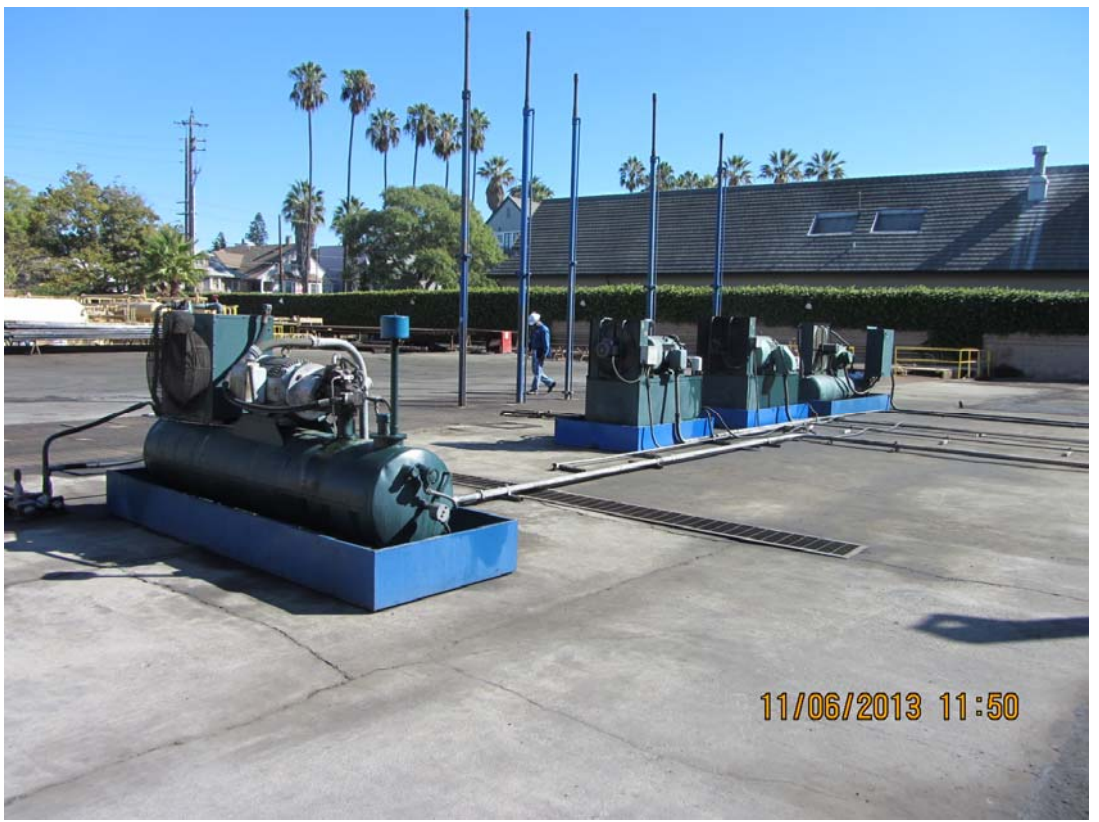
Photographer: WITUL	
Photo No. 5	Time: 1050
Direction Photo Taken: E	
Photo Description: AREA ABOVE WELL GALLERY

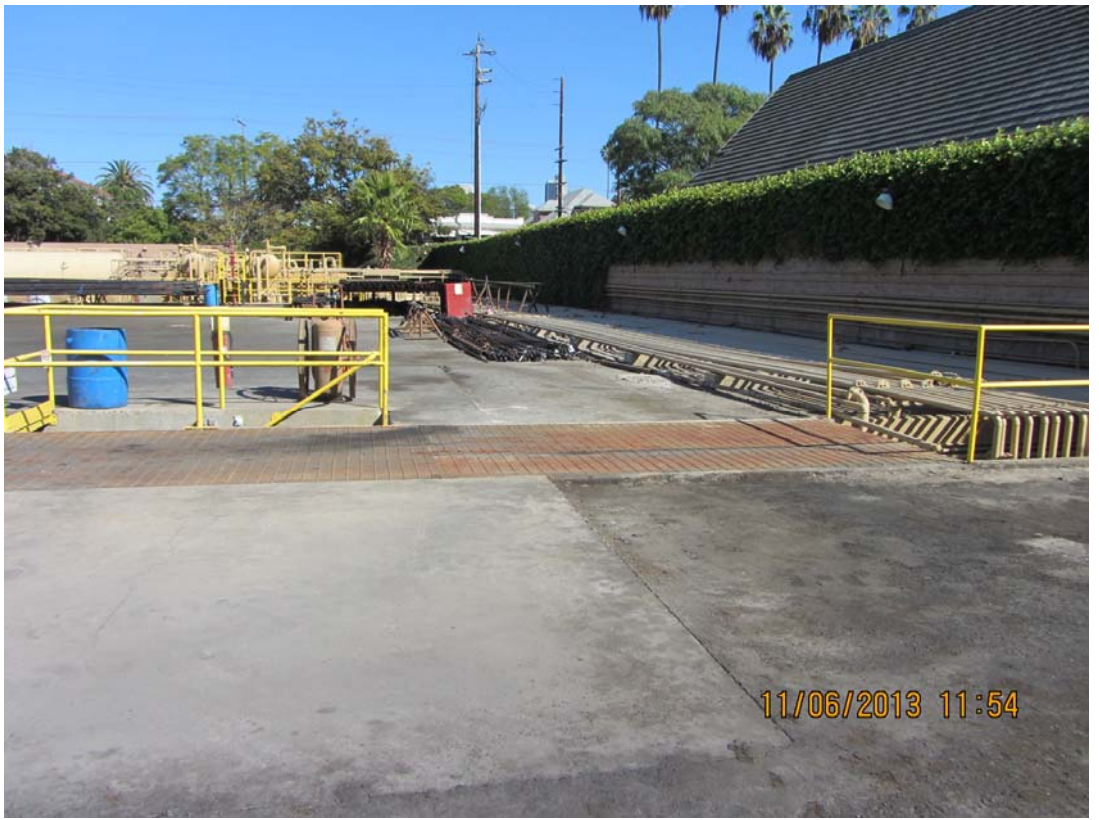
Photo No. 9	Time: 1054
-----------------------	----------------------

WELL GALLERY EAST ENTRANCE AND TRANSFER PIPES AT RIGHT.

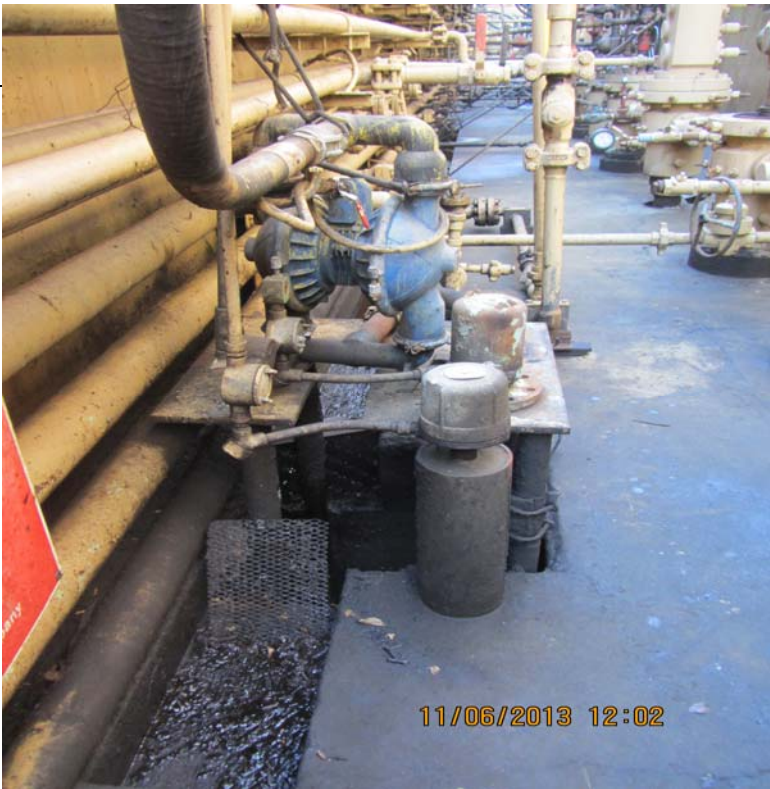
Photo No. 12	Time: 1102

Direction Photo Taken: W		
Photo Description: TRENCH PUMP IN WELL GALLERY TRENCH

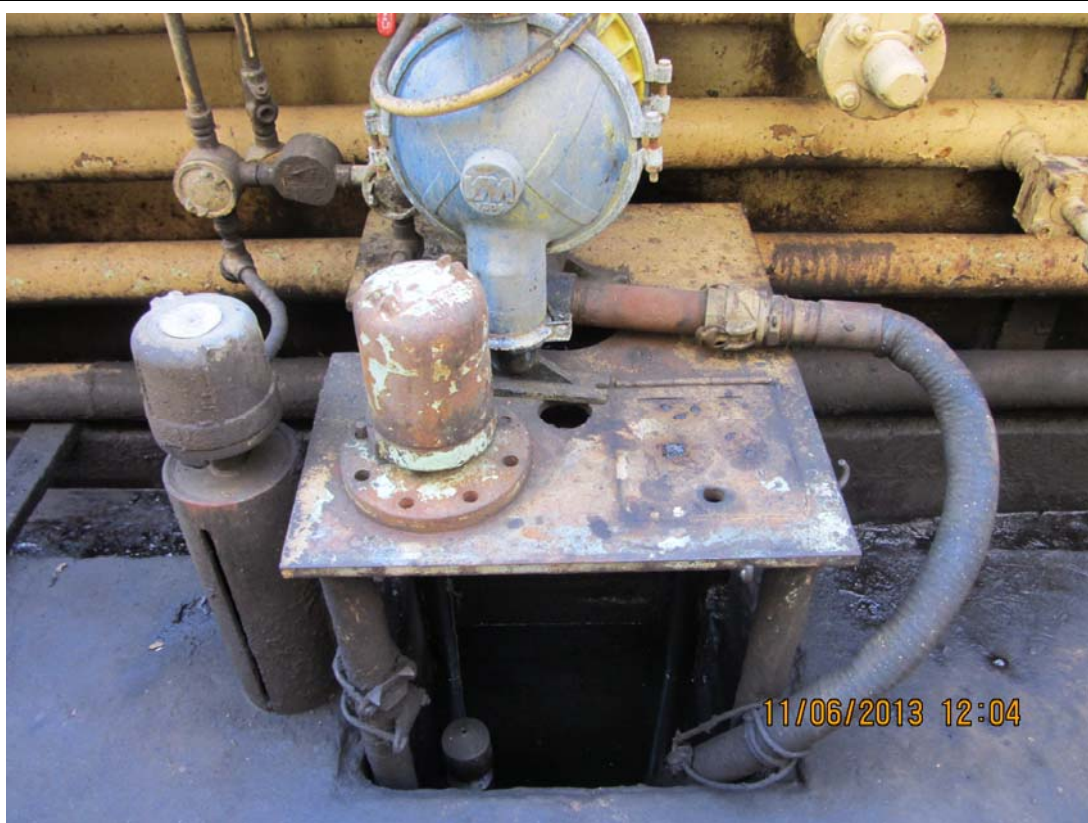
Photo No. 13	Time: 1104
------------------------	----------------------

TRENCH PUMP IN WELL
GALLERY TRENCH

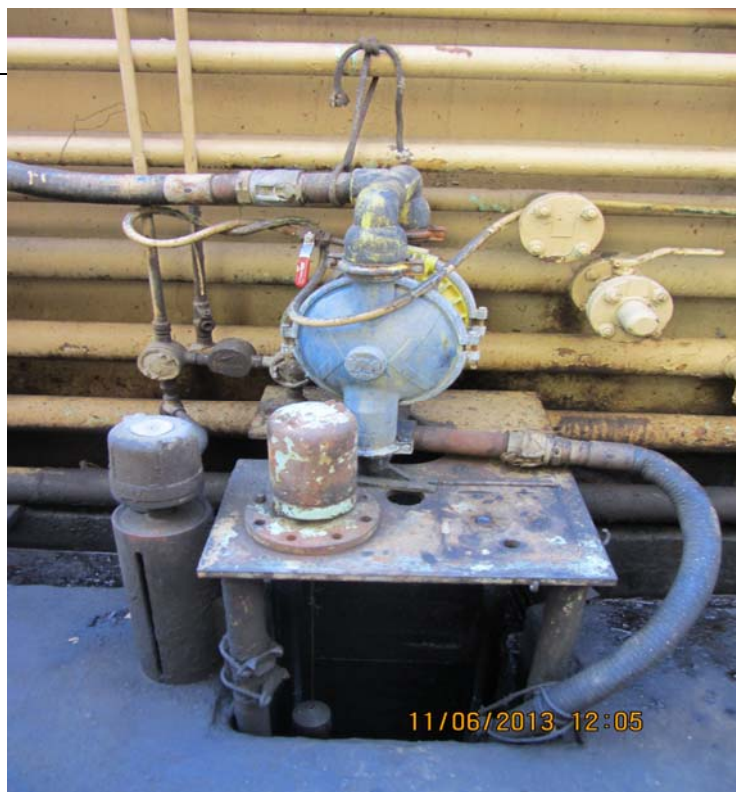
Photo No. 14	Time: 1105
------------------------	----------------------

TRENCH PUMP IN WELL
GALLERY TRENCH

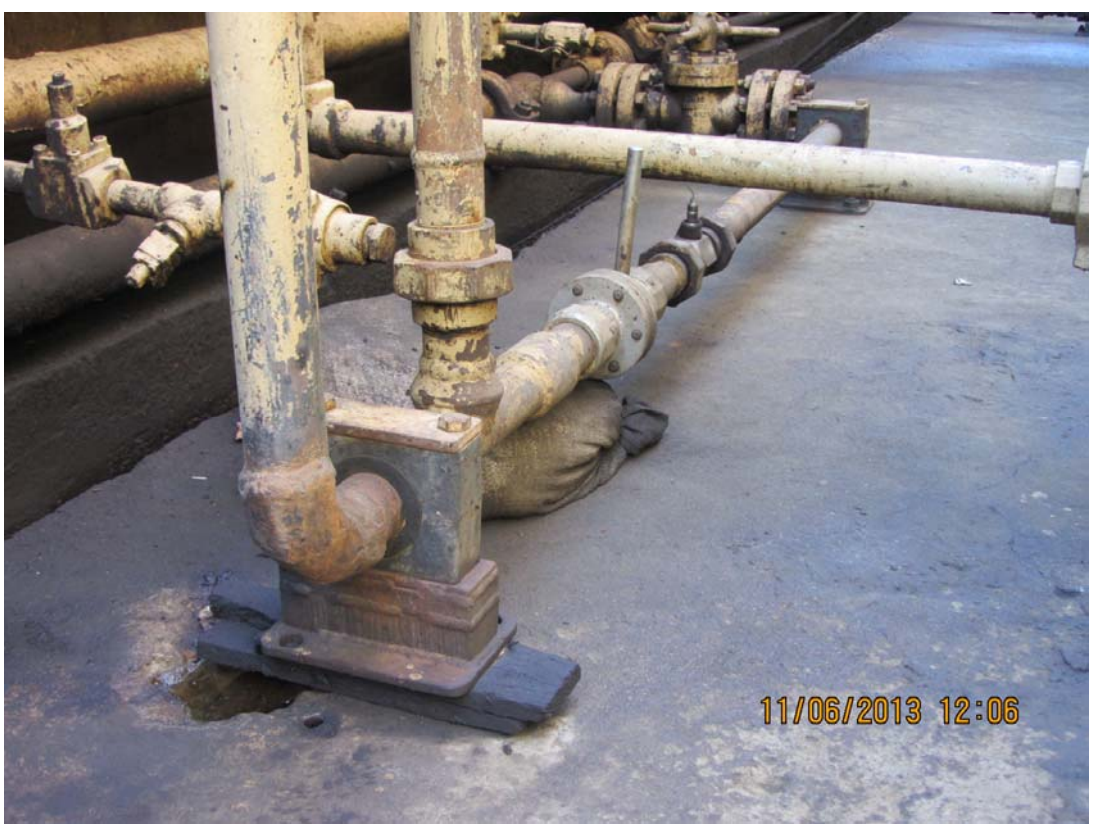
Photographer: WITUL	
Photo No. 15	Time: 1106
Direction Photo Taken: W	
Photo Description: PIPING SUPPORTS IN WELL GALLERY

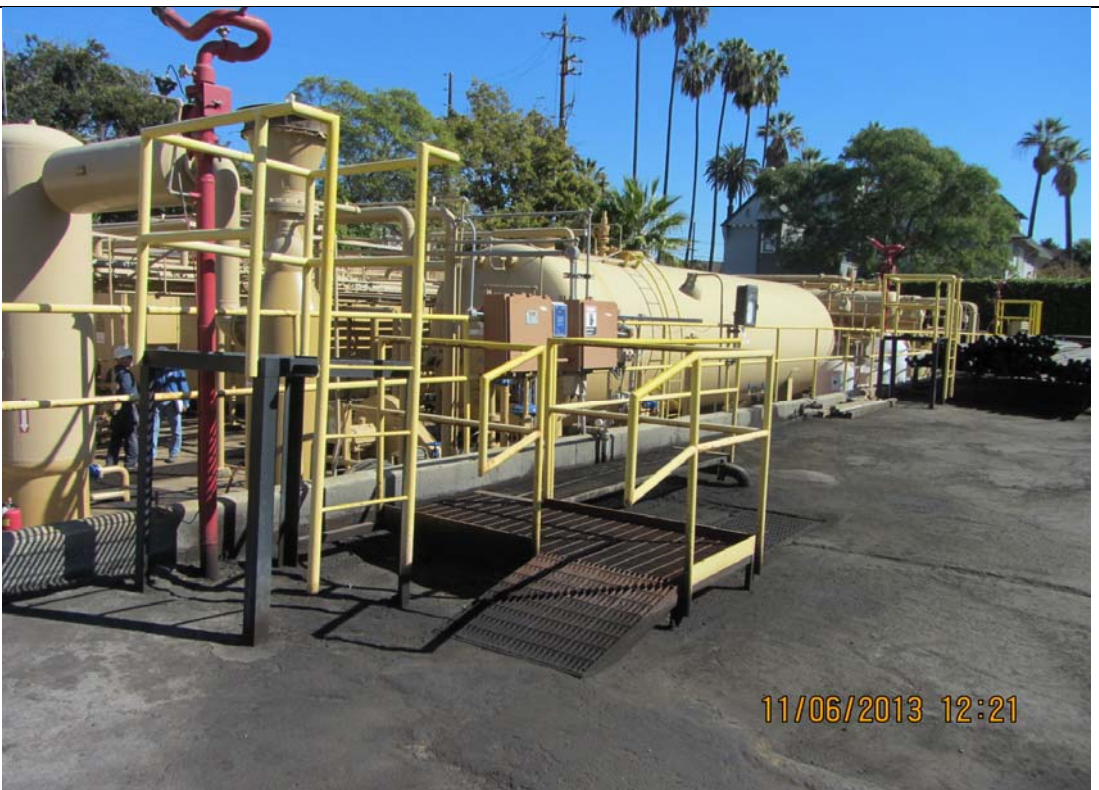
Photo No. 20	Time: 1121
------------------------	----------------------

TANK FARM CONTAINMENT AREA, SCRUBBER AT LEFT (IN PIT).

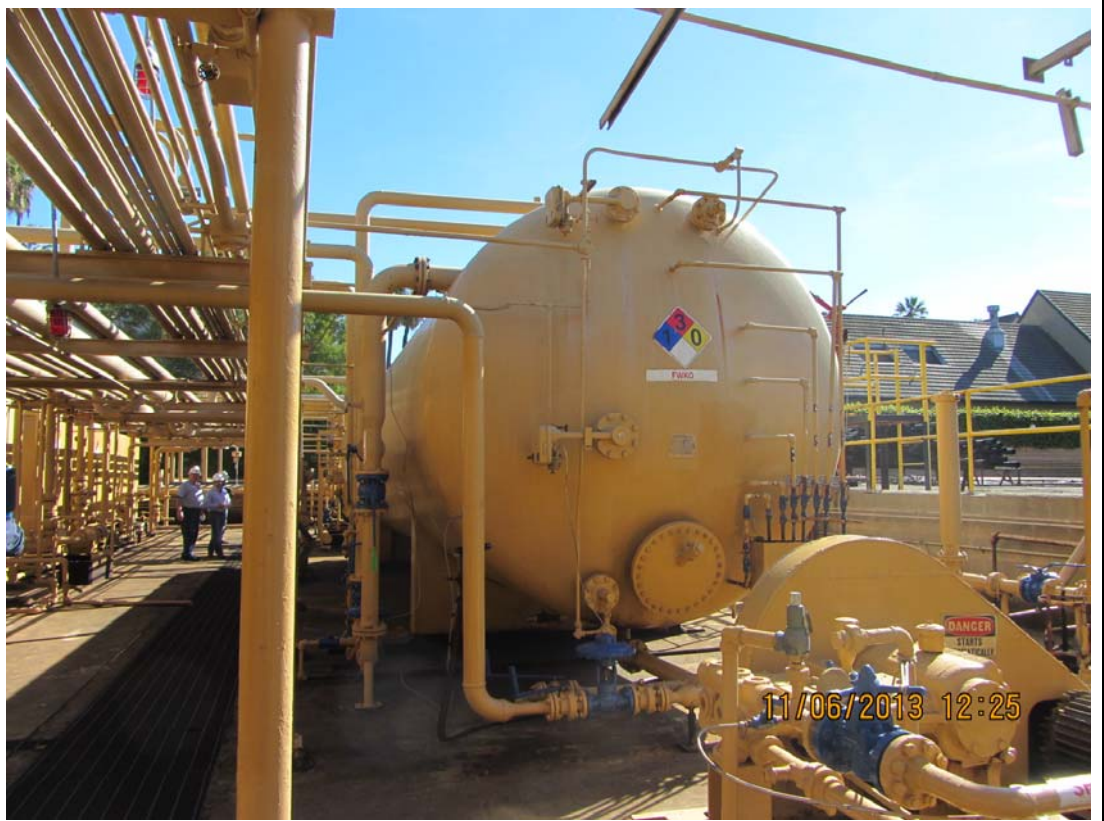
Photo No. 21	Time: 1125
------------------------	----------------------

FREE WATER KNOCK OUT TANK – CAPACITY 500 BBLS (21,000 GAL) PER SPCC PLAN.

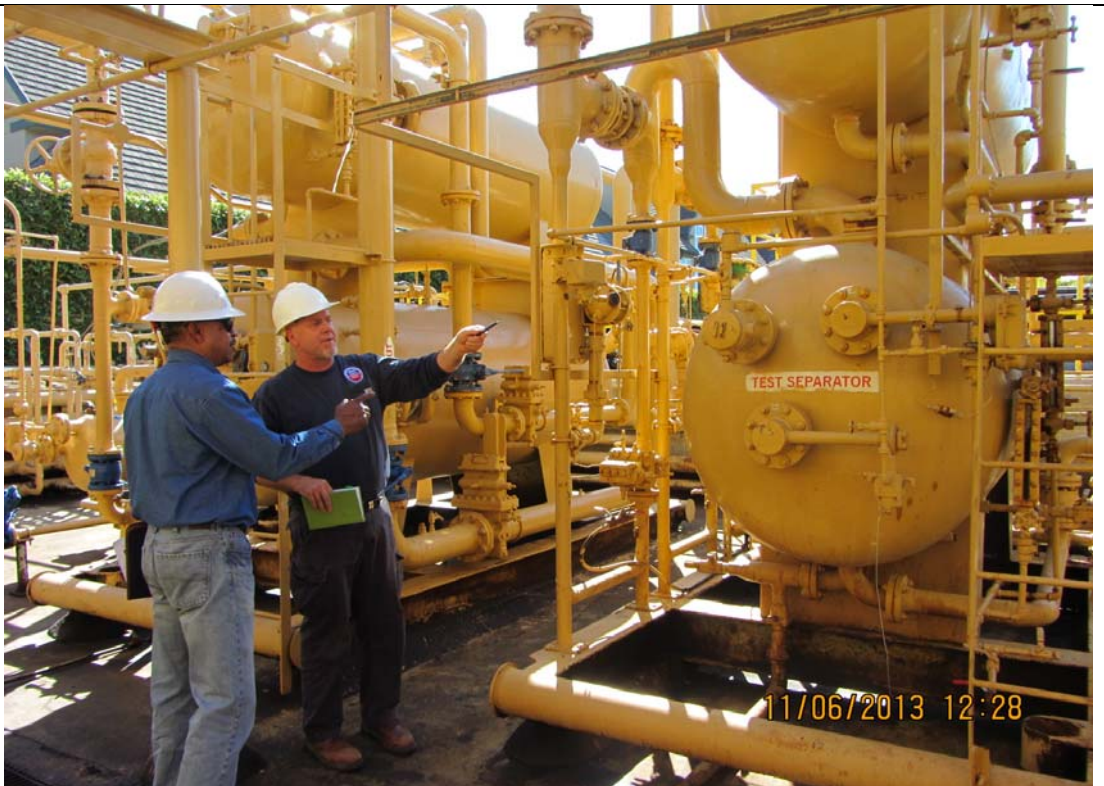
Photo No. 22	Time: 1128
------------------------	----------------------

TRAVIS CAIN, JEREMY JOHNSTONE AND SEPARATOR TANKS

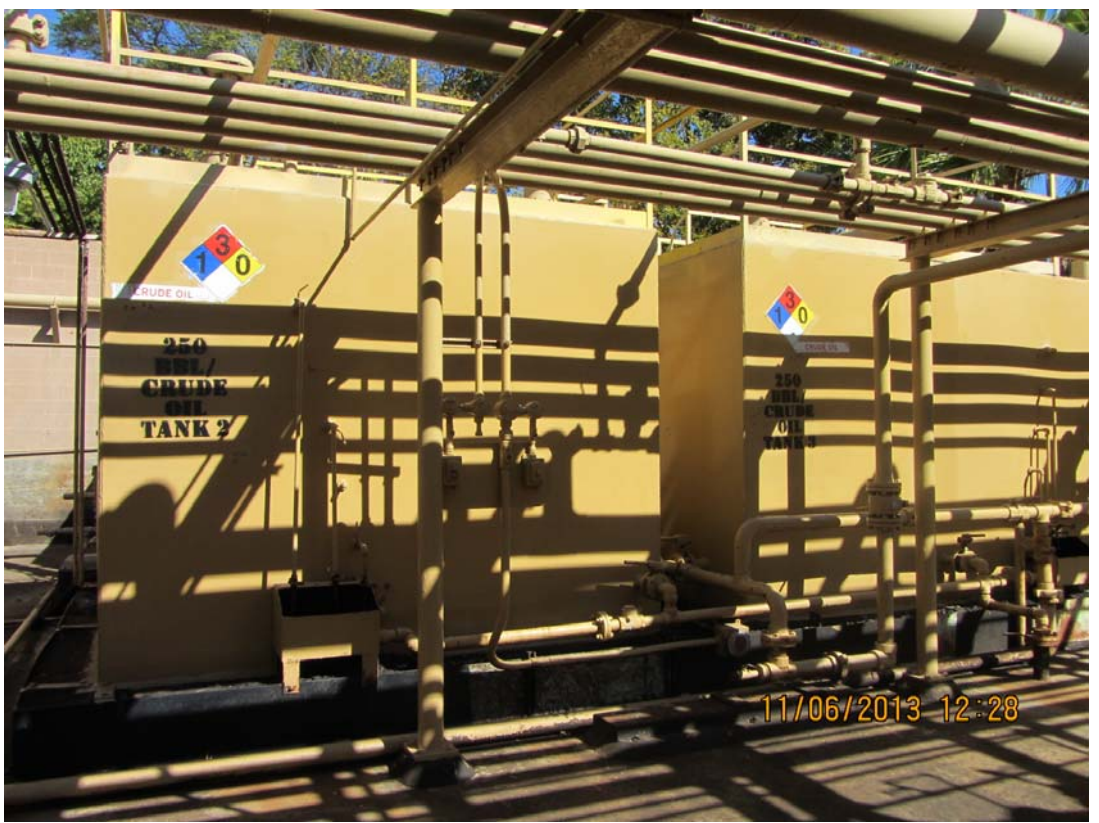
Photo No. 23	Time: 1128
------------------------	----------------------

CRUDE OIL TANK 2 AND TANK 3, MARKED 250 BBLS EACH (10,500 GAL)

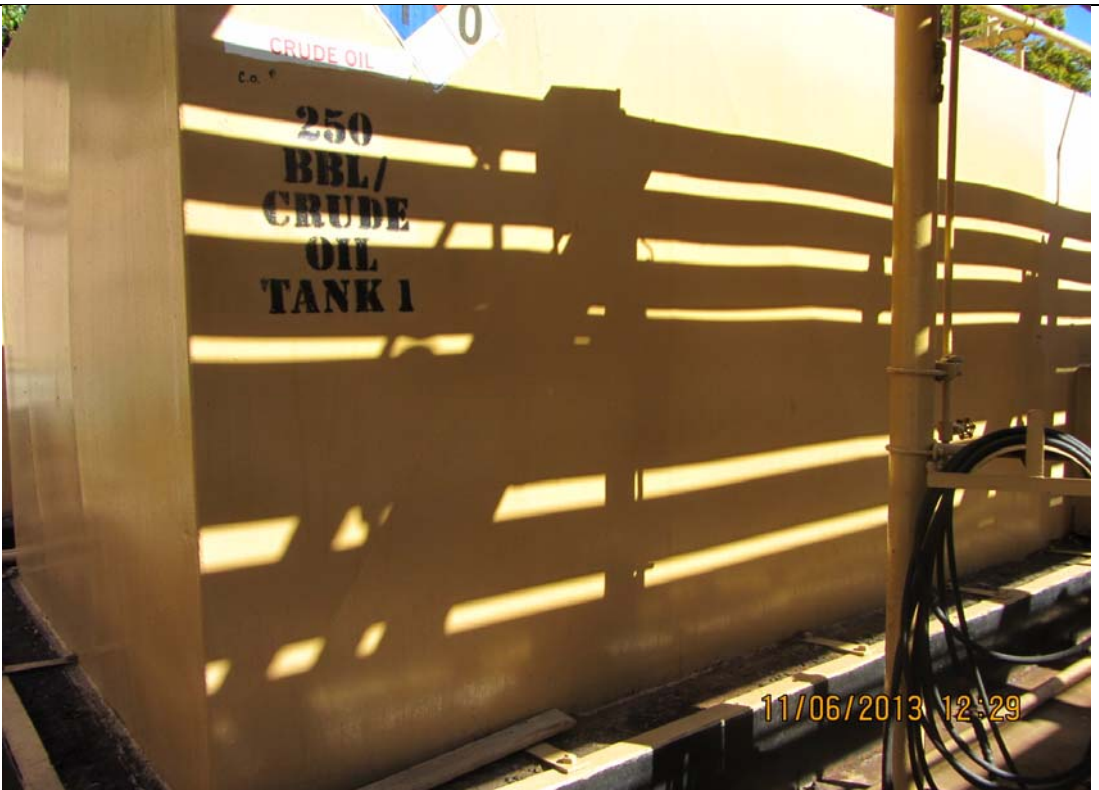
Photo No. 24	Time: 1129
------------------------	----------------------

CRUDE OIL TANK 1, MARKED 250 BBLS (10,500 GAL)

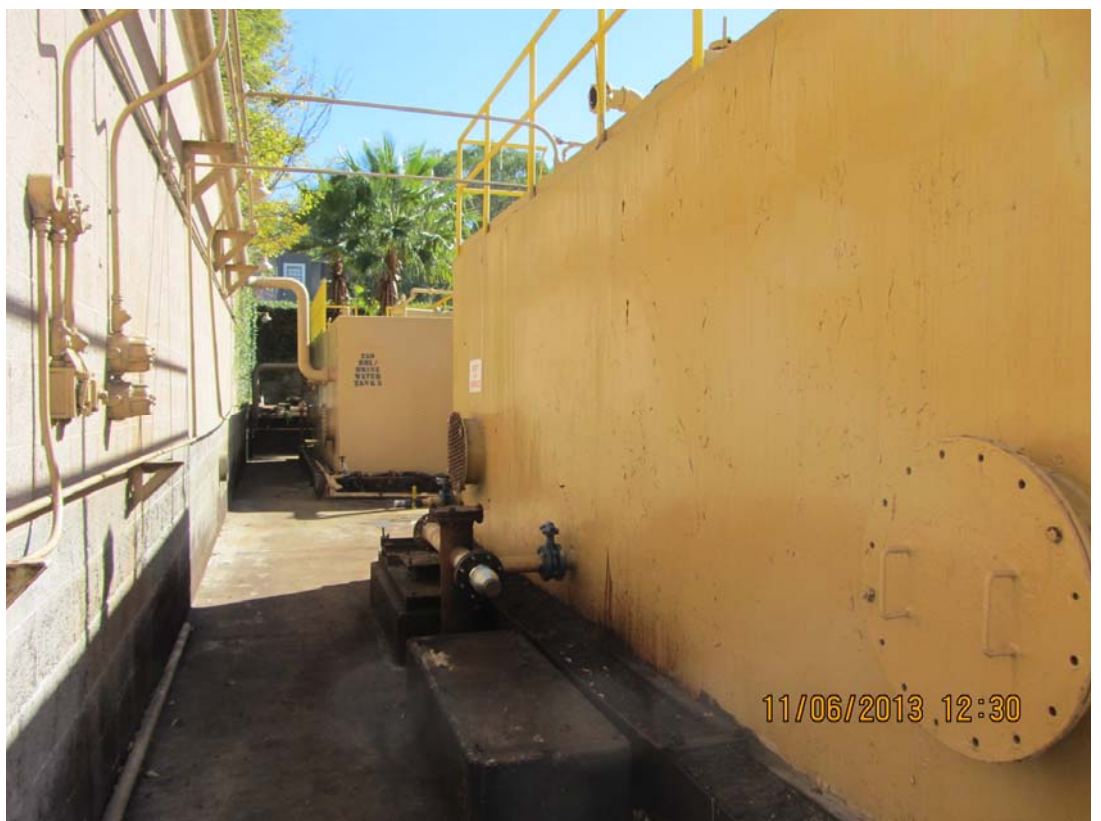
Photographer: WITUL	
Photo No. 25	Time: 1130
Direction Photo Taken: E	
Photo Description: BRINE WATER TANK #3 AT REAR, BRINE WATER TANK #2 AT RIGHT, EACH MARKED 250 BBLs

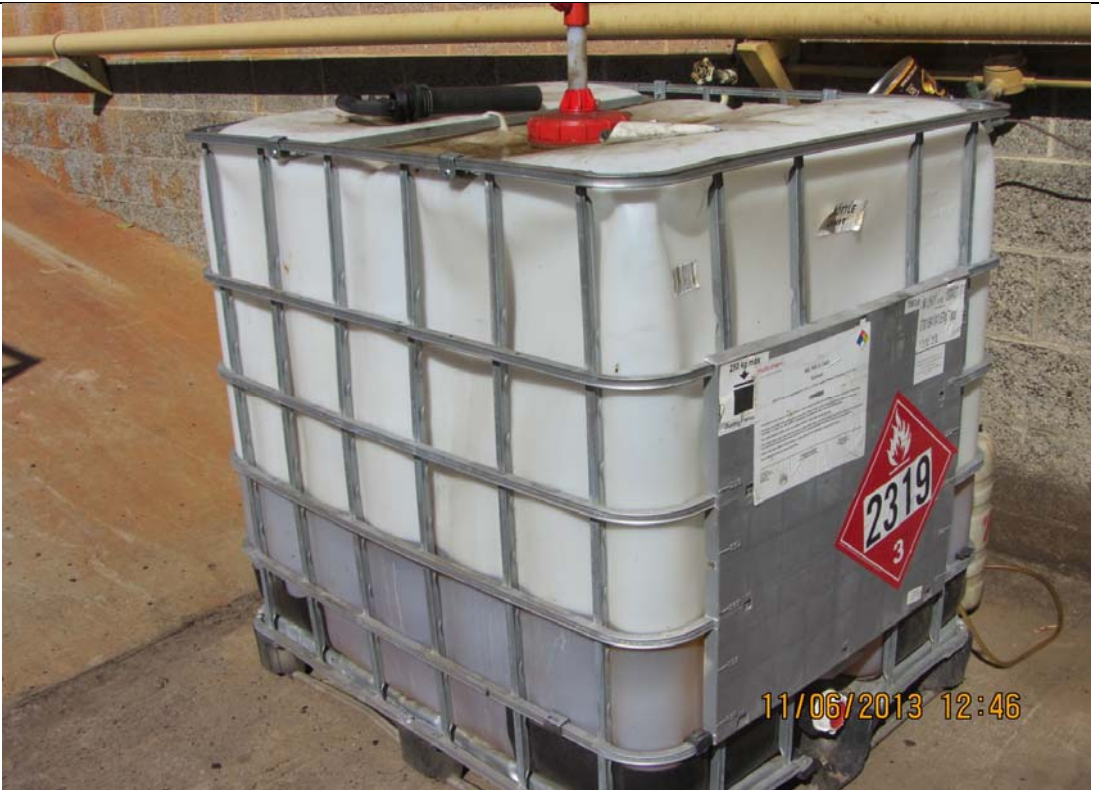
Photo No. 30	Time: 1146
------------------------	----------------------

ORANGE-SCENTED
SOLVENT TOTE IN
TANK FARM
CONTAINMENT AREA

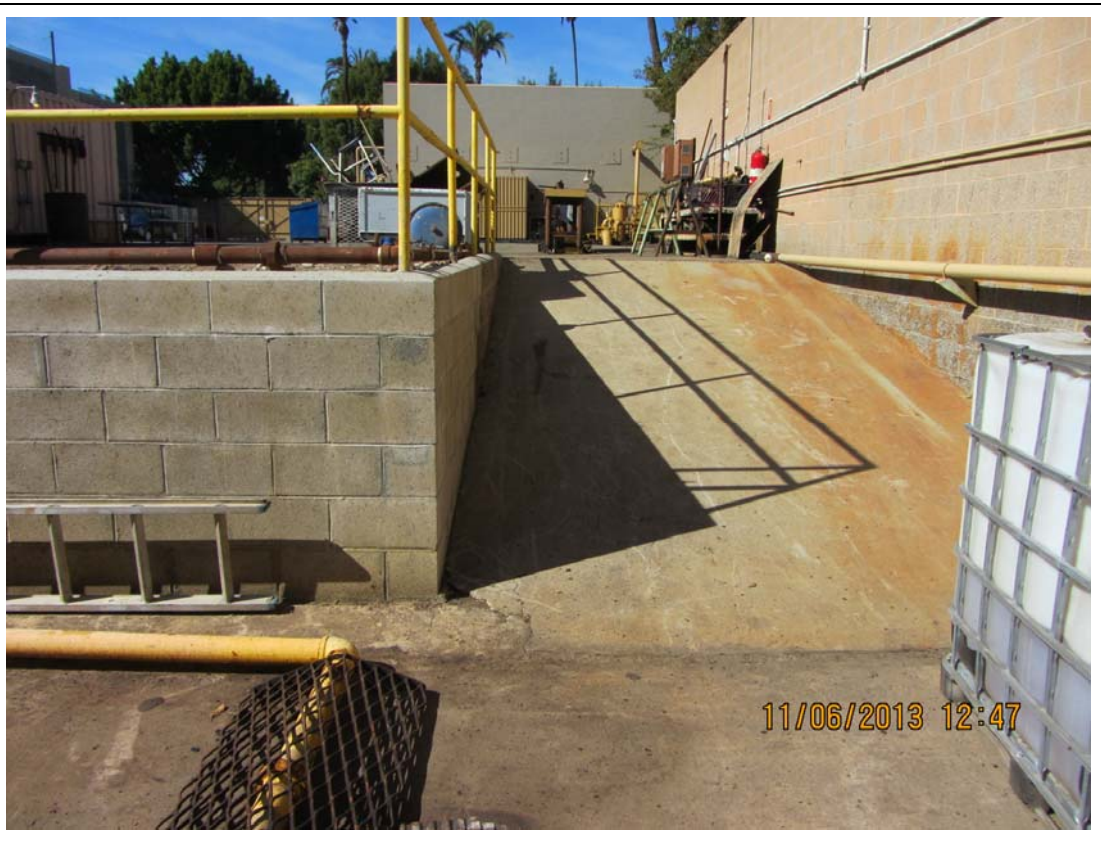
Photographer: WITUL	
Photo No. 31	Time: 1147
Direction Photo Taken: NW	
Photo Description: RAMP AT TANK FARM CONTAINMENT AREA; PIPING PROTECTED FROM VEHICLES BY METAL GUARDS

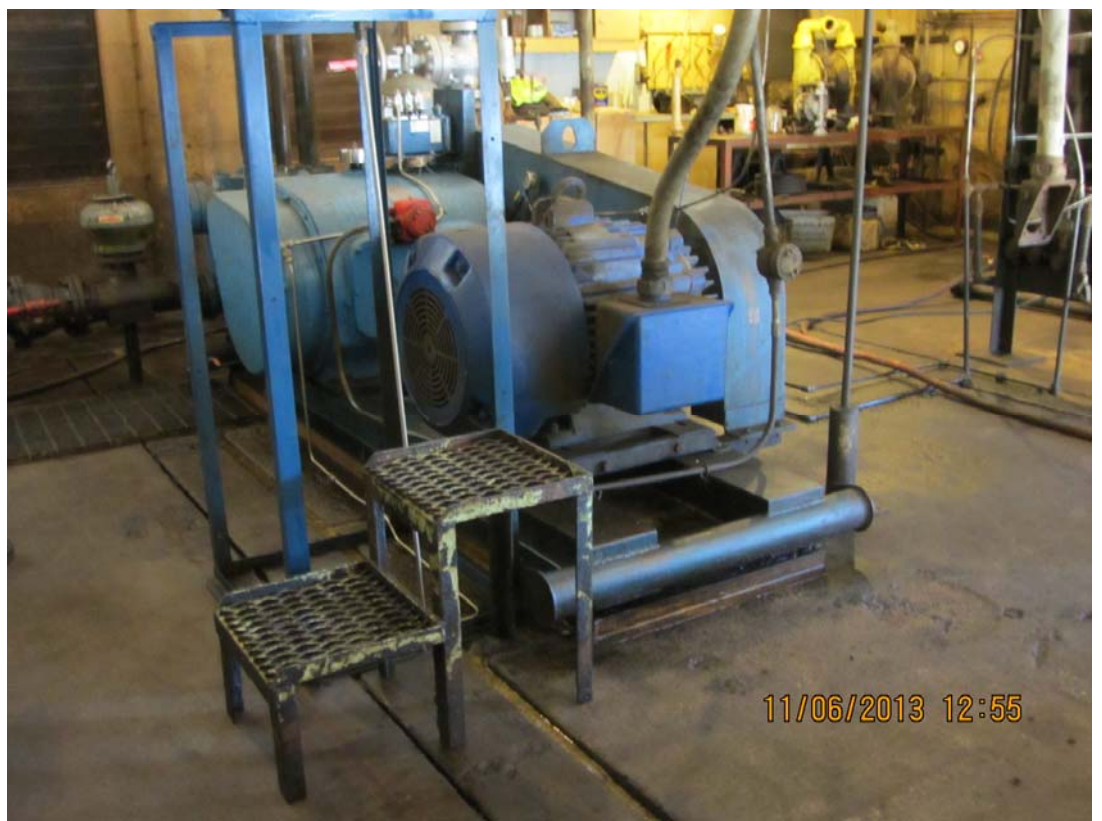
Photo No. 33	Time: 1155
------------------------	----------------------

PUMP IN WATER INJECTION PUMP HOUSE.

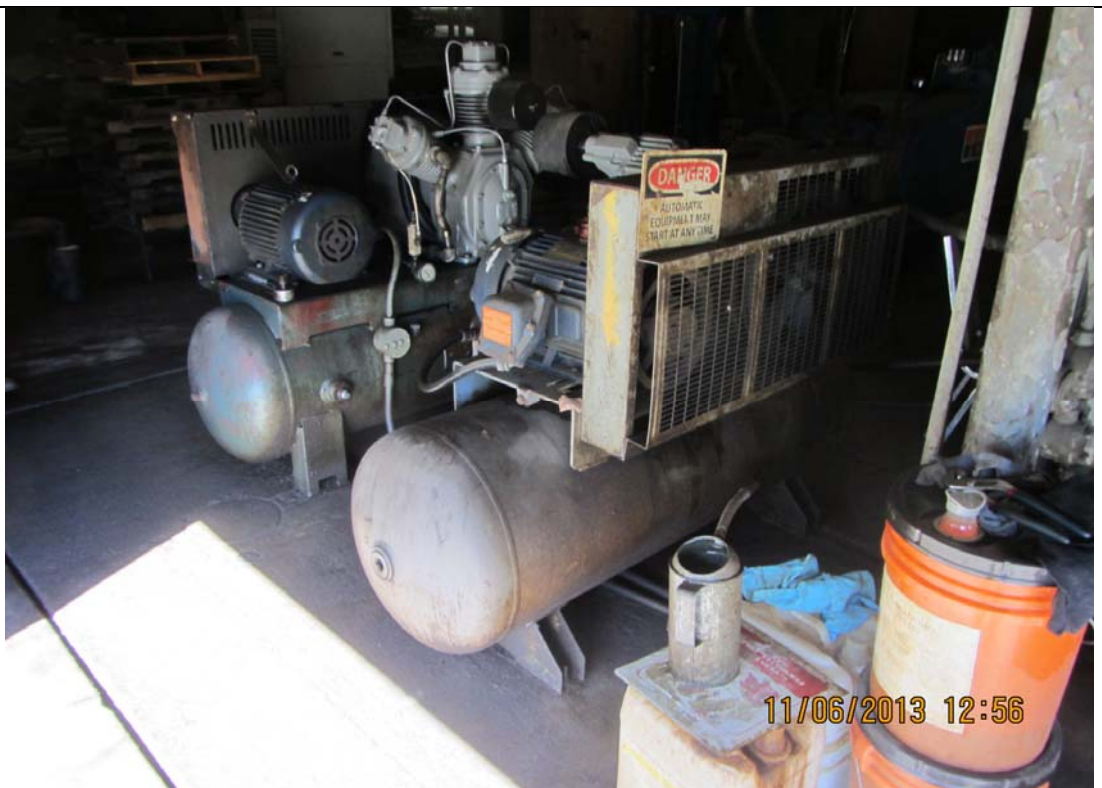
Photo No. 34	Time: 1156
------------------------	----------------------

COMPRESSOR VESSELS IN WATER INJECTION PUMP HOUSE.

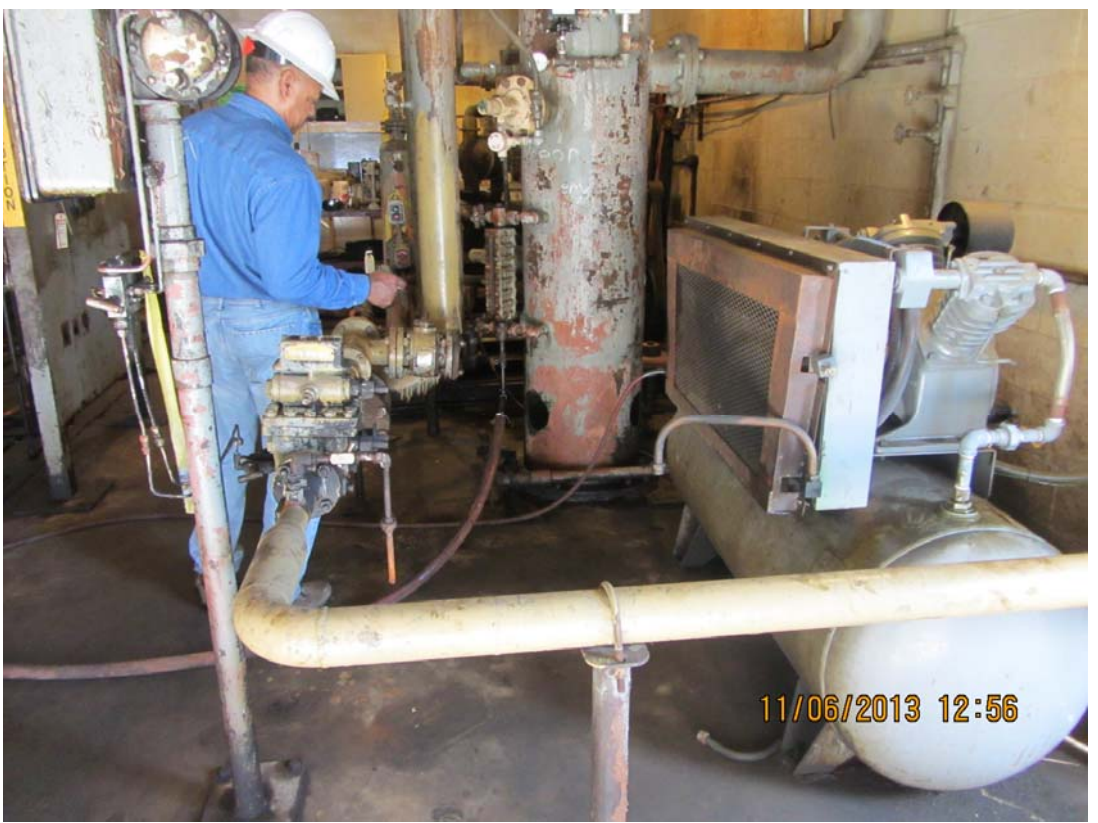
Photographer: WITUL	
Photo No. 35	Time: 1156
Direction Photo Taken: NE	
Photo Description: VAPOR RECOVERY UNIT AT REAR, COMPRESSOR AT RIGHT, AND PIPING - IN WATER INJECTION PUMP HOUSE.

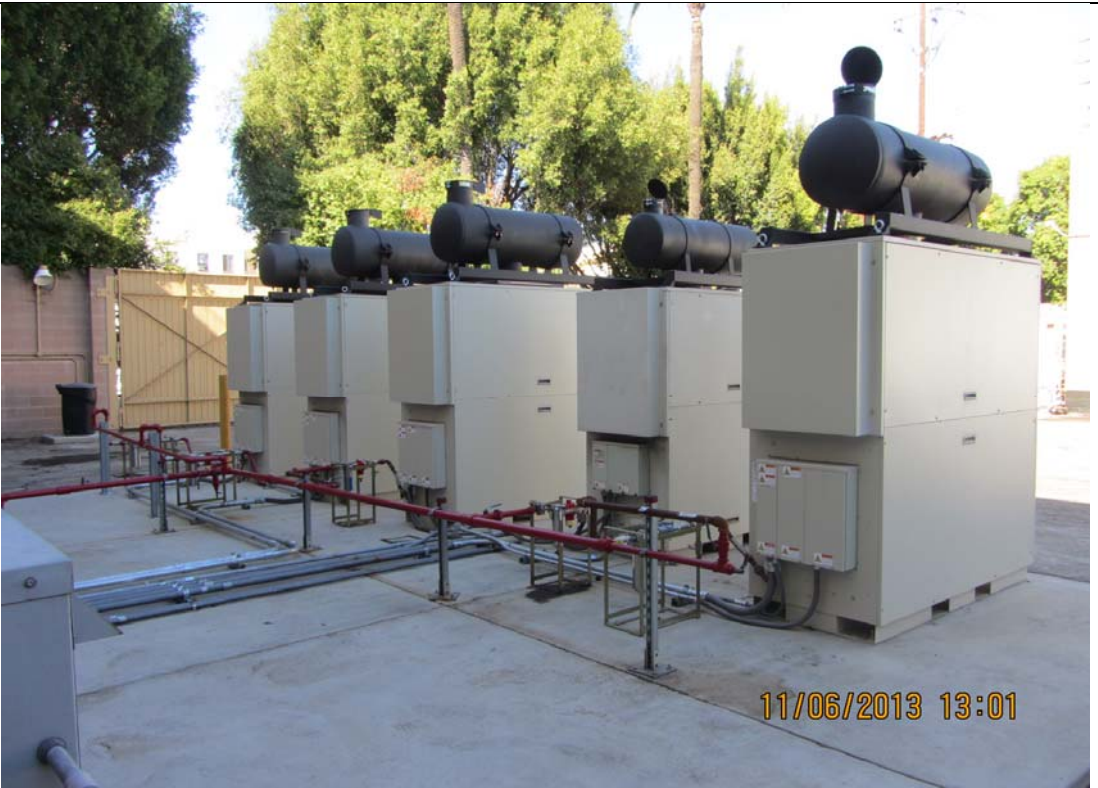
Photo No. 36	Time: 1201
Direction Photo Taken: N	
Photo Description: MICROTURBINES FOR GAS EXTRACTED AT FACILITY.

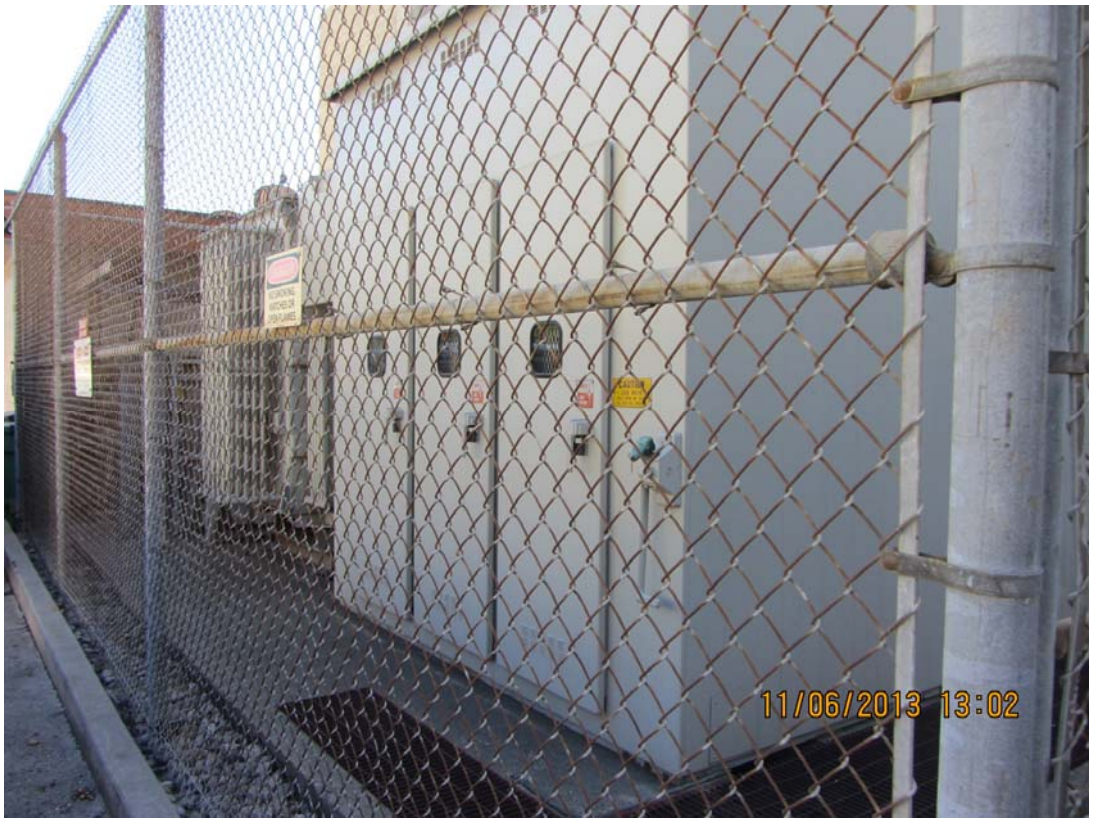
Photographer: WITUL	
Photo No. 37	Time: 1202
Direction Photo Taken: S	
Photo Description: UTILITY OWNED/OPERATED EQUIPMENT – INDUSTRIAL STATION IS-1332
