Purpose: RCRA Compliance Evaluation Inspection

Facility: Clean Harbors Buttonwillow, LLC.

Dates of Investigation: October 18 through 22, 2010

June 2, 2011

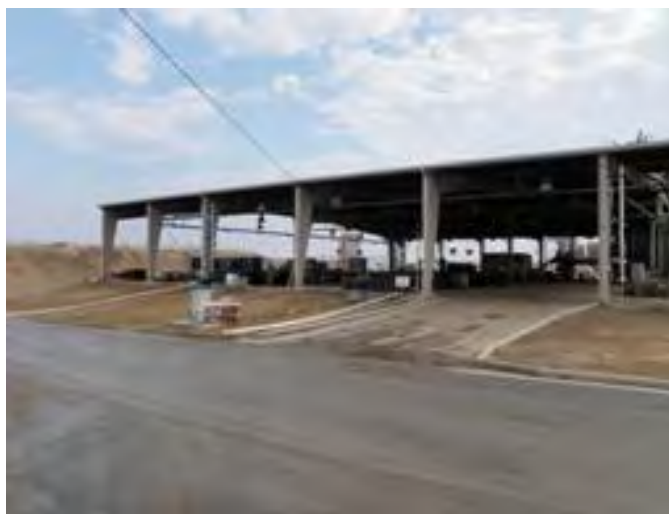
Olympus Stylus 8000, Photo #2; View of the drum storage area in the Stabilization/Treatment Unit (STU) area, facing northeast.

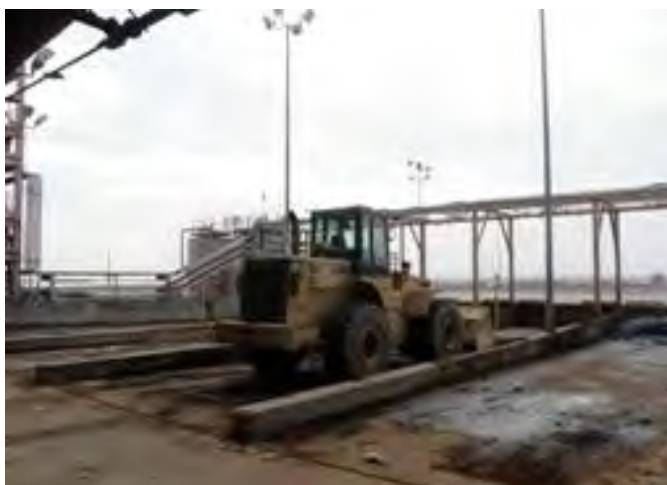
Olympus Stylus 8000, Photo #5; View of the bulk unloading bays at the STU, facing southeast.

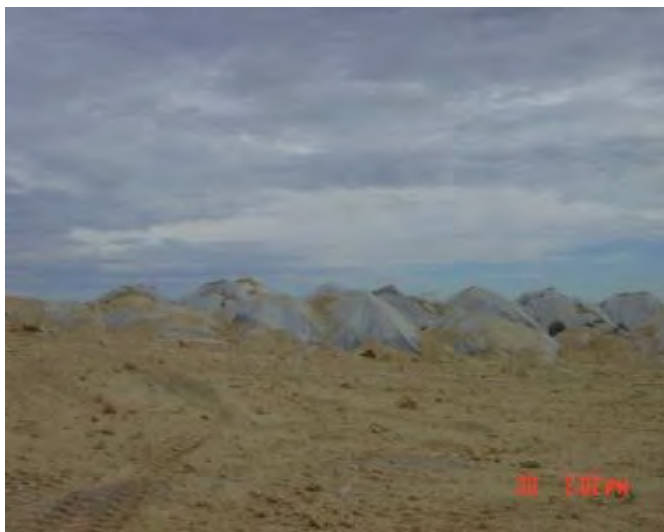
Sony Digital DSC-S75, Photo #13; View of the treated waste staging piles atop WMU 34 (under plastic tarping). View is from the southwest corner of WMU 34, facing east.

Sony Digital DSC-S75, Photo #13; View of the treated waste staging piles atop WMU 34 (under plastic tarping). View is from the southwest corner of WMU 34 facing east.

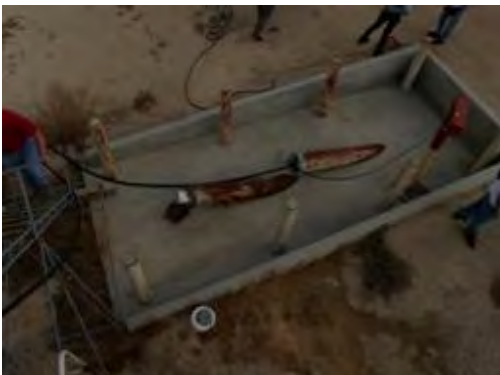
Olympus Stylus 8000, Photo #76; View of the leachate collection system at WMU 28 from the top of the leachate collection frac tank (Frac Tank 3)

Olympus Stylus 8000, Photo #76; View of the leachate collection system at WMU 28 from the top of the leachate collection frac tank (Frac Tank 3).

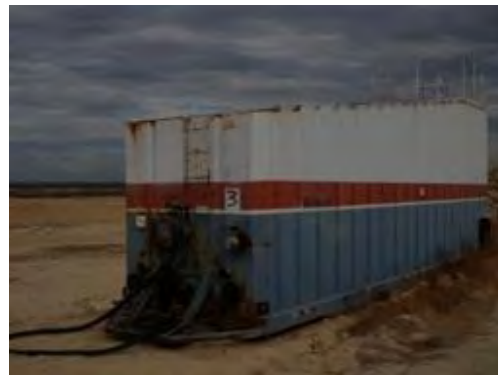
Olympus Stylus 8000, Photo #73; View of the leachate collection frac tank (Frac Tank 3) at WMU 28.

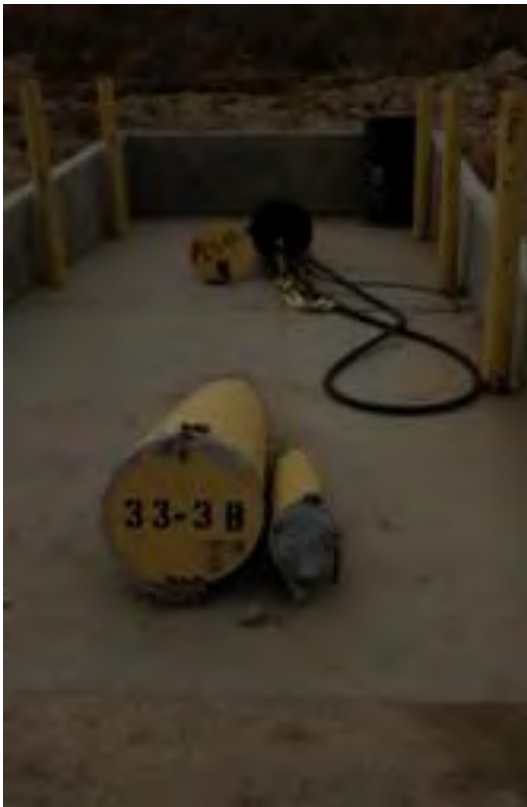
Olympus Stylus 8000, Photo #81; View of the leachate collection system at WMU 33 Cell #3B.

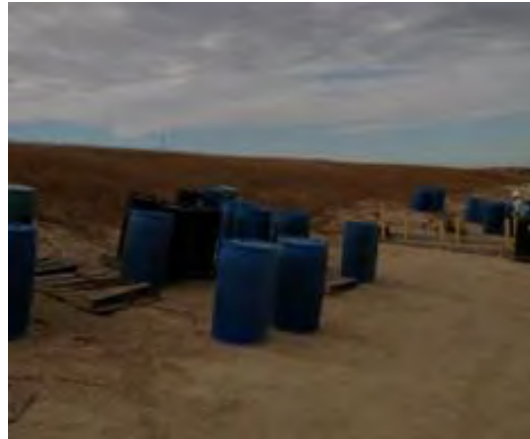
Olympus Stylus 8000, Photo #82; View of the leachate collection system and less-than-90-day storage area at WMU 33 Cell #3B.

The inspectors observed 13, full, 55-gallon containers of F039 leachate in the storage area associated with WMU 33, Cell #3, shown below in Olympus Stylus 8000, Photo #82.

Olympus Stylus 8000, Photo #82; View of the leachate collection system and the less-than-90-day storage area at WMU 33, Cell #3.

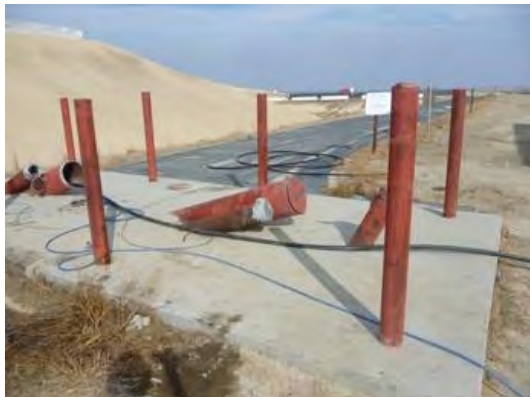
Panasonic Lumix DMC-TZ5, Photo #17; WMU 34 leachate collection ports, facing northeast.

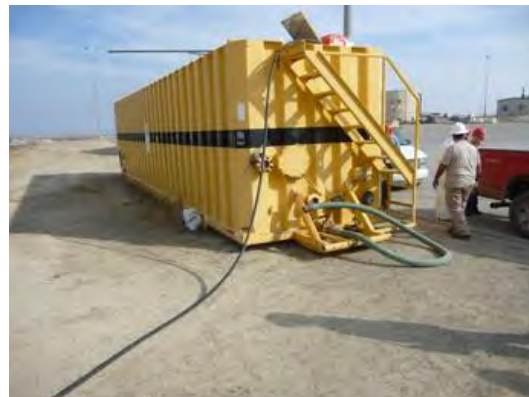
Panasonic Lumix DMC-TZ5, Photo #30; WMU 34 leachate collection frac tank, facing southeast.

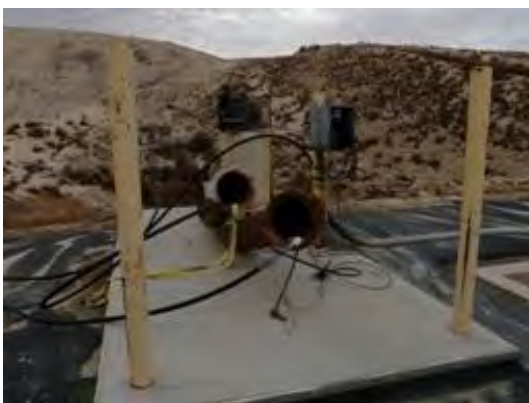
Olympus Stylus 8000, Photo #95; leachate collection system at WMU 35 Cell #1

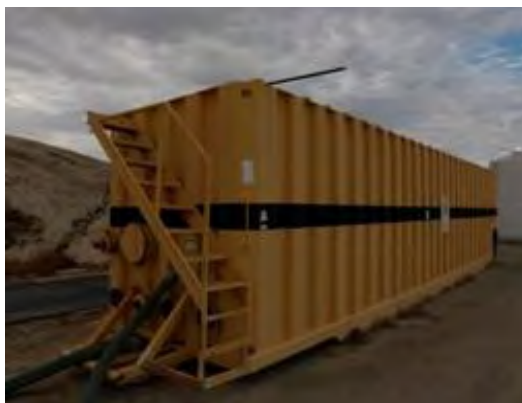
Olympus stylus 8000, Photo #96; leachate collection frac tank (Tank 80) at WMU 35 Cell #1.

Olympus Stylus 8000, Photo #96; View of the leachate collection frac tank (Tank 80) at WMU 35, Cell #1.

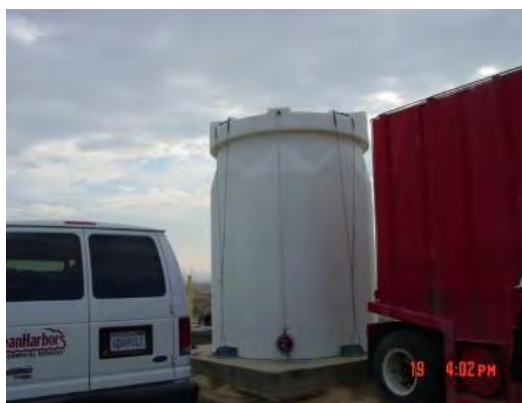
Sony DSC-S75, Photo #11; View of a 5,000-gallon, white plastic, leachate collection tank at WMU 35 Cell #3, facing west.

Sony DSC-S75, Photo #11; View of a 5,000-gallon, plastic, leachate collection tank at WMU 35, Cell #3, facing west.

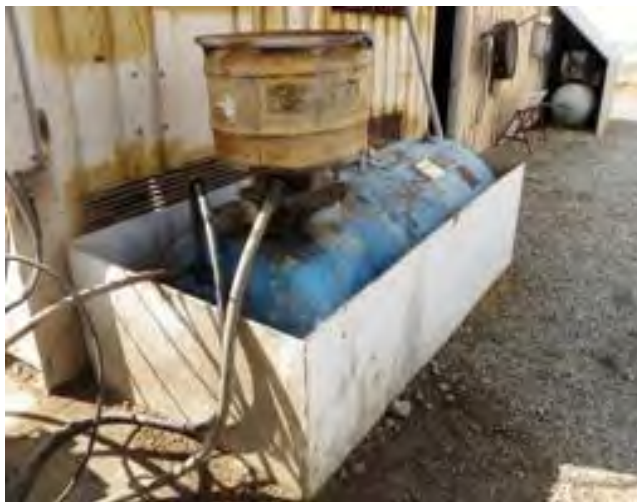
Olympus Stylus 8000, Photo # 50; View of the used oil storage tank at the maintenance building.

The Used Oil Storage Tank Area is located west of the Heavy Equipment Storage Area and the Maintenance Area. The used oil AST is located within secondary containment, the base of which was covered in liquid (refer to Olympus Stylus 8000, Photo #50 below). At the time of the CEI, the accumulation start date noted on the used oil storage tank label indicated that the 90 day accumulation date would be reached on July 22, 2010 (refer to Olympus Stylus 8000, Photo #51 below). Staining was identified in the area surrounding the used oil storage tank.

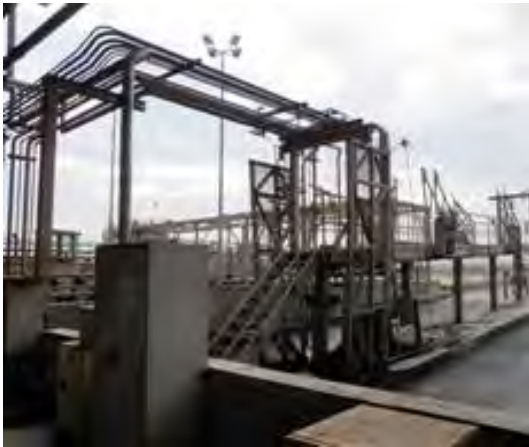
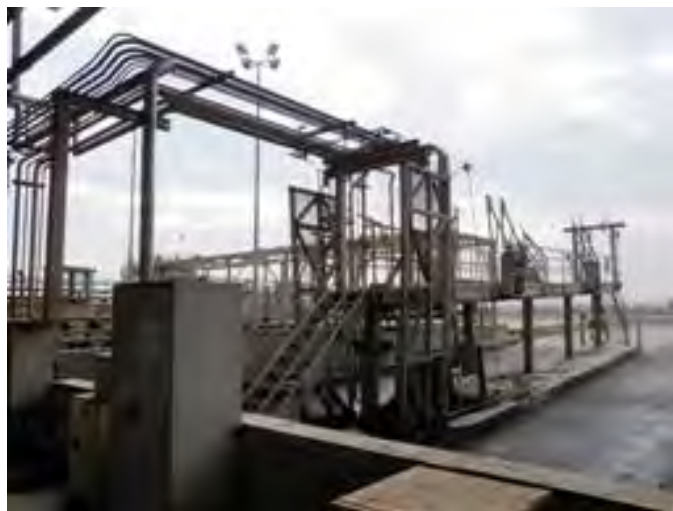
Olympus Stylus 8000, Photo #4; View of the truck wash area at the STU.

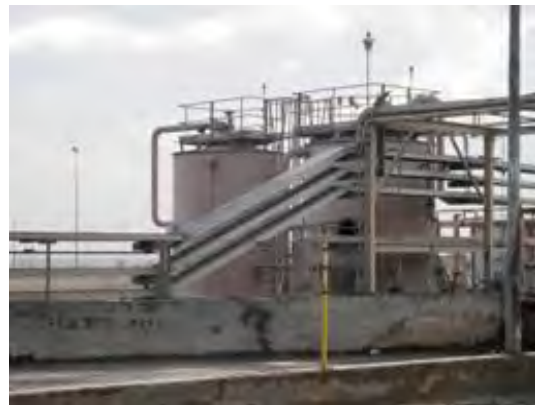
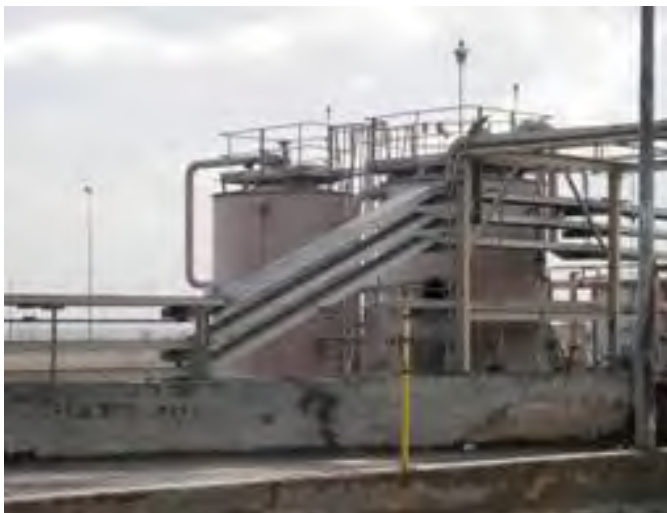
Olympus Stylus 8000, Photo #6; View of the RCRA-permitted water (left) and dirty water (right) storage tanks, facing southeast

Olympus Stylus 8000, Photo #6; View of the RCRA-permitted water (left) and dirty water (right) storage tanks, facing southeast.

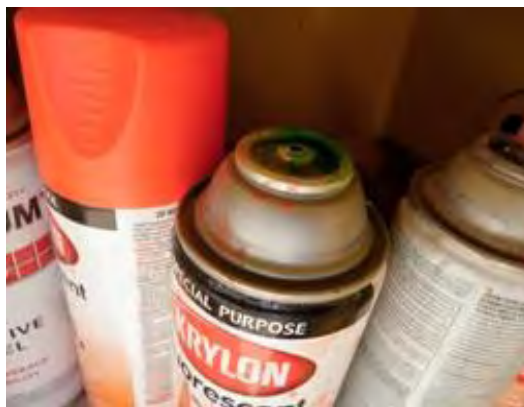
The Drum Unloading Area is located directly north of and adjacent to the Drum Unloading Bay. The Drum Unloading Area is constructed of concrete, and an overhead roof is present. During the CEI, inspectors identified a flammable materials storage cabinet with various aerosol canisters. Inspectors further noted that a nozzle on one of the aerosol cans was broken.

Olympus Stylus 8000, Photo #48; View of a flammable storage cabinet at the STU, holding aerosol products.

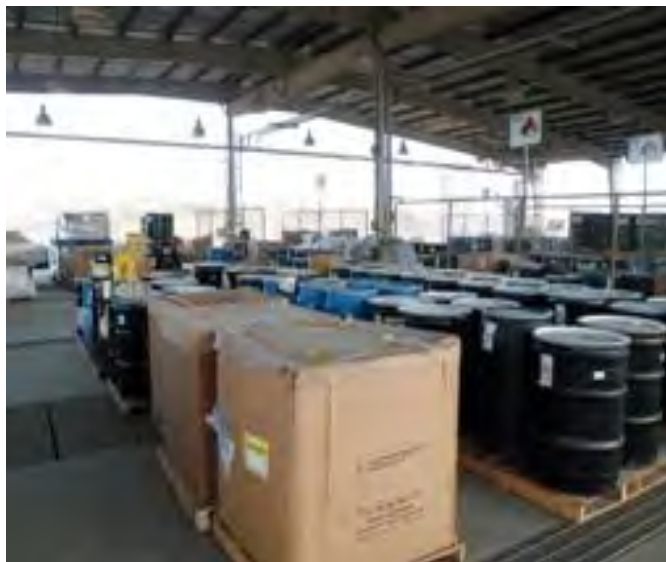
Olympus Stylus 8000, Photo #9; View of the drum storage area at the STU area, facing southwest.

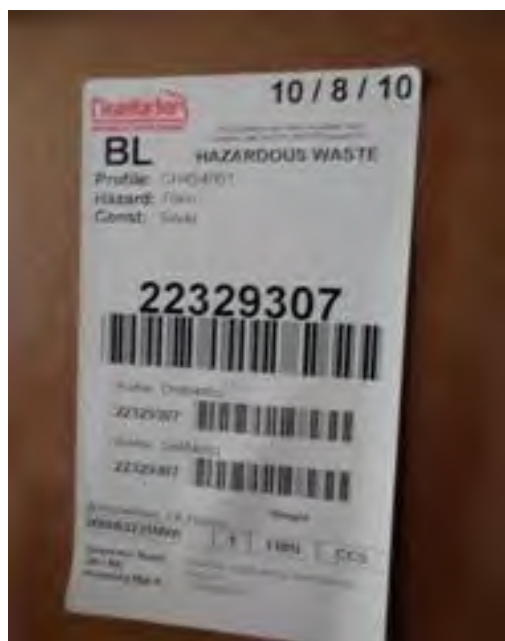
Olympus Stylus 8000, Photo # 14; Close-up view of a label with profile CH454001 (D011 toxic silver waste) on a container at the DSHA 1.

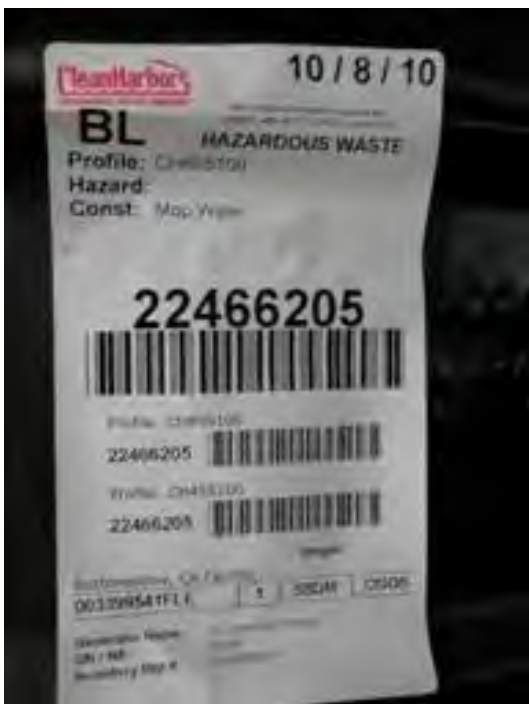
Olympus Stylus 8000, Photo # 12; Close-up view of a label with profile CH455100 (mop water) on a 55-gallon container in the drum storage area at DSHA Area 1. This waste is regulated as a California hazardous waste.

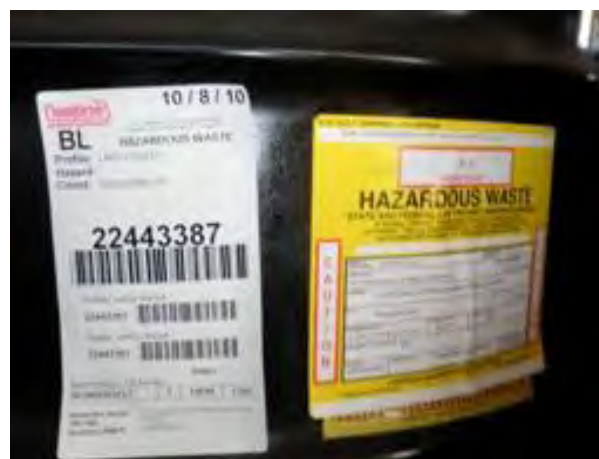
Olympus Stylus 8000, Photo # 13; Close-up view of a label with profile LAP01-9001A (debris with oil) on a 55-gallon container in the drum storage area at DSHA Area 1. This waste is regulated as a California hazardous waste.

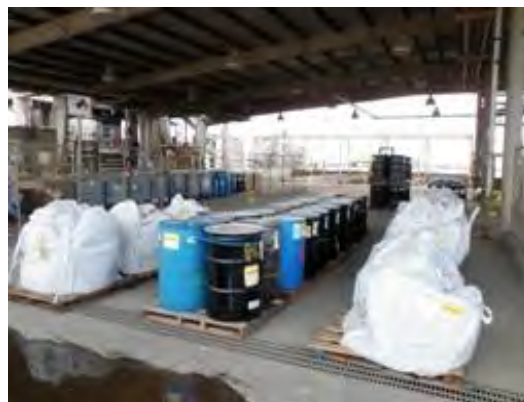
Olympus Stylus 8000, Photo # 21; Drum storage area at DSHA Area 6, facing southeast.

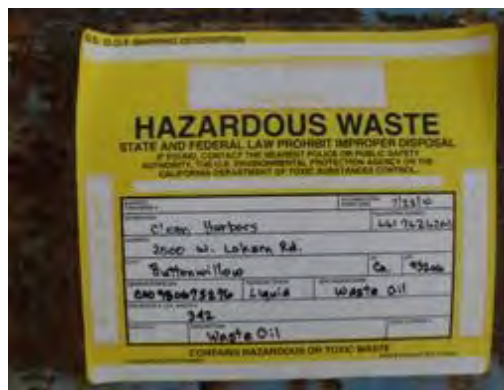
Olympus Stylus 8000, Photo #51; View of the label on the waste oil storage tank at the maintenance building. Accumulation start date is 7/22/10.

Clean Harbors shipped the used oil offsite on October 22, 2010. A copy of the manifest for the used oil shipment is included as Attachment #4.

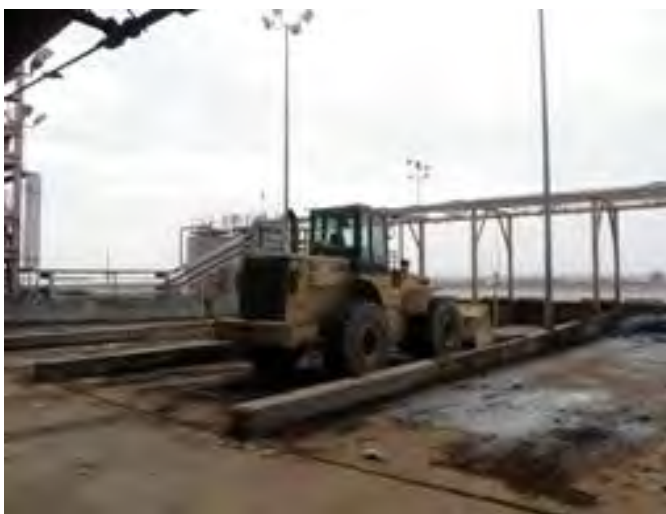
Olympus Stylus 8000, Photo #5; View of the bulk unloading bays at the STU, facing southeast.

At the time of the inspection the westernmost bay contained approximately two (2) cubic yards (yds³) of gray soil, the bay directly to the east was empty, the next bay to the east contained a small amount of brownish/gray soil, and the easternmost bay nearest the Main STU Structure was empty.

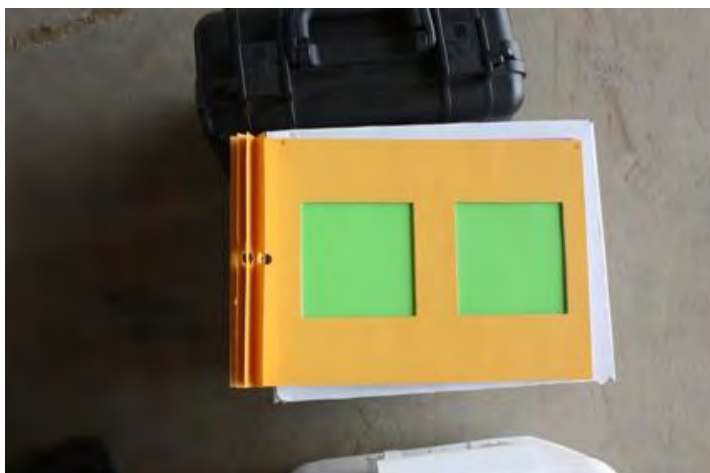
Canon EOS Rebel XSi, Photo #6; View of the PCB wipe templates (two, 10cm x 10cm squares cut in each template).

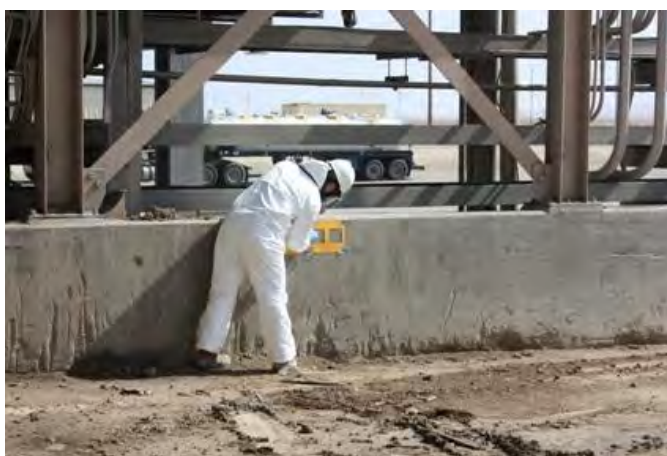
Figure 1 Canon EOS Rebel XSi, Photo #20; PCB wipe sampling at location CH-1935-WP-04, facing east-southeast

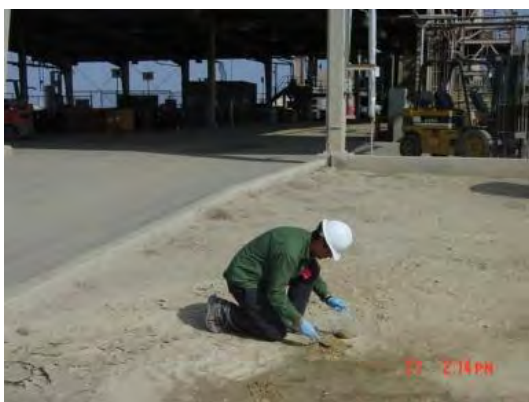
Sony DSC-S75, Photo #22; PCB soil sampling adjacent to the STU access ramp, facing east.

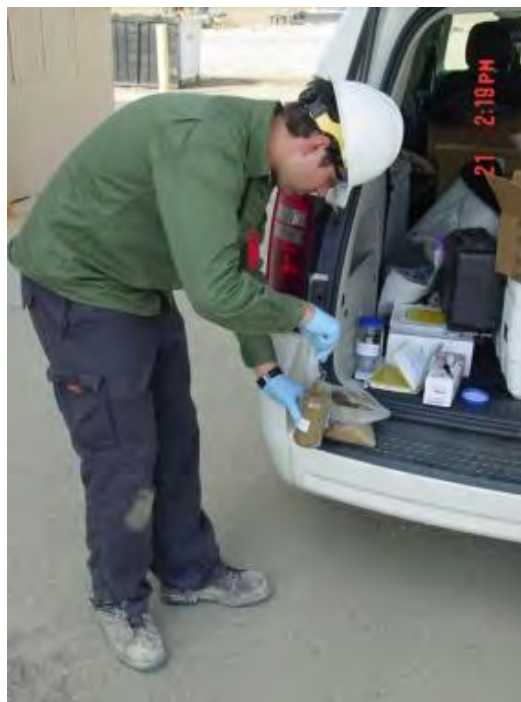
Sony DSC-S75, Photo #24; PCB soil sampling. Homogenization of soil and filling the sample container, facing north.

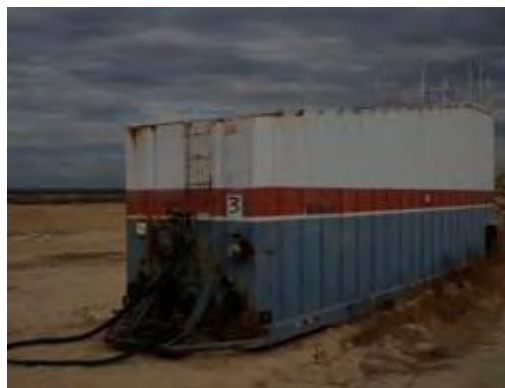
At the time of the CEI, the frac tank was structurally sound, labeled as hazardous waste and dated 9/14/2010. The inspectors observed that the ports on top of the frac tank were not closed. Photos of these open ports can be viewed below.

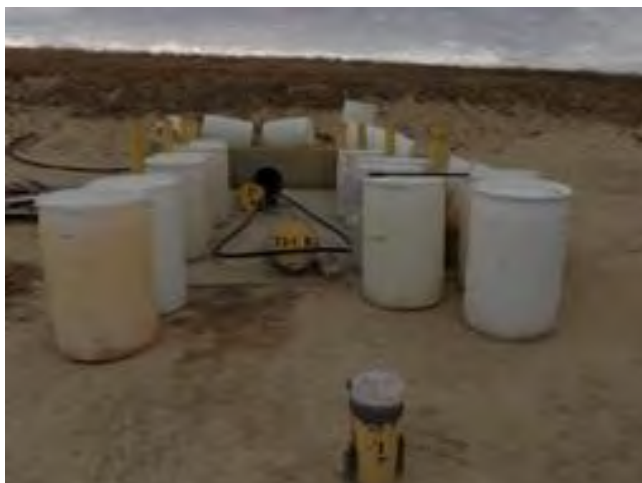
Olympus Stylus 8000, Photo #91; View of the leachate collection system at WMU 33 Cell #1. There are four full and one partially-full 55-gallon containers of F039 leachate in the less-than-90-day storage area.

The inspectors observed five, 55-gallon containers (four full, one partially filled) of F039 leachate in the storage area associated with WMU 33, Cell #1, shown to the right. The hazardous waste containers were labeled as hazardous waste, closed, and dated (dates ranging from 10/8/2010 through 10/18/2010).

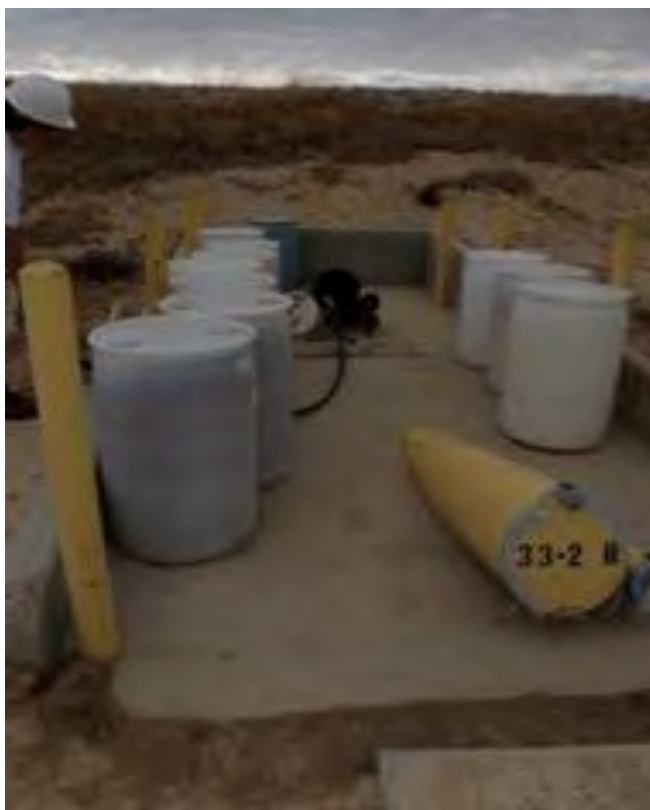
At WMU 33, Cell #2, the inspectors observed several empty containers and one, full, 55-gallon container of F039 hazardous waste leachate, as shown to the right. The container was labeled as hazardous waste, closed, and dated 10/13/2010.

Olympus Stylus 8000, Photo #90; View of the leachate collection system at WMU 33, Cell #2. One, full 55-gallon container of F039 leachate, dated 10/13/10 to the left.

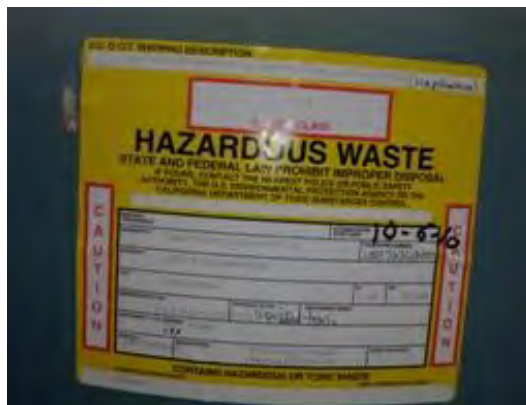
Olympus Stylus 8000, Photo #83; View of the label on a 55-gallon container of F039 leachate (naphthalene) from WMU 33, Cell #3, stored in the less-than-90-day storage area.

The hazardous waste storage containers were labeled as hazardous waste, closed, and dated (dates ranging from 9/22/2010 through 10/19/2010). Two of the hazardous waste labels indicated the leachate management method as incineration (for naphthalene contamination); an example of the hazardous waste label is presented in Olympus Stylus 8000, Photo #83 above.

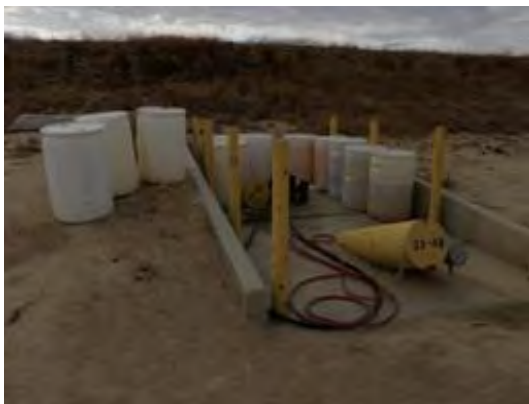
At WMU 33, Cell #4, the inspectors observed several empty containers and three, full, 55-gallon hazardous waste containers holding F039 leachate, shown in Olympus Stylus 8000, Photo #87.

Olympus Stylus 8000, Photo #87; View of the leachate collection system and less-than-90-day storage area at WMU 33, Cell #4.

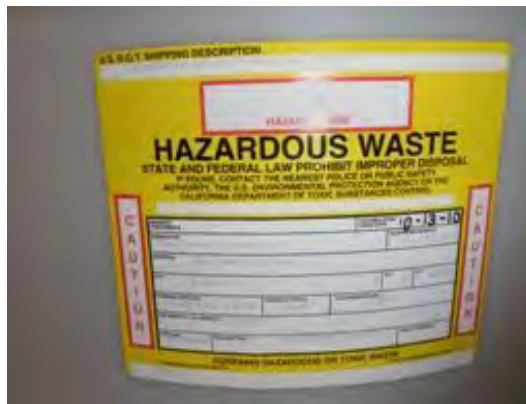
Olympus Stylus 8000, Photo #86; View of the label on a 55-gallon container of F039 leachate from WMU 33, Cell #4, stored in the adjacent less-than-90-day storage area.

The hazardous waste storage containers were labeled as hazardous waste, closed, and dated (dates ranging from 10/8/2010 through 10/19/2010); an example label is shown above in Olympus Photo #86.

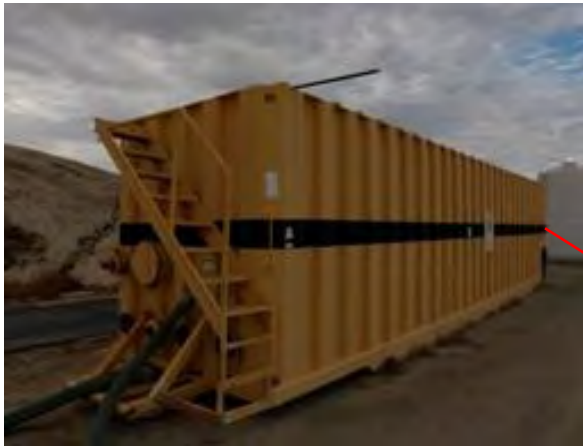
At WMU 35, Cell #1, the inspectors observed that the primary and secondary LCRSs discharge to a 20,000-gallon frac tank (known as Tank 80). The frac tank was structurally sound, labeled as hazardous waste, and dated 9/14/2010. However, the inspectors observed that the ports on top of the frac tank were open, as well as the pumping port on the side of the tank, as shown in the following four photos.

22 CCR §66260.10 [40 CFR §260.10] defines treatment as any method or process that changes the physical or chemical character of a hazardous waste to make it less hazardous, safer to manage, reduced in volume, etc. The open ports on the WMU frac

tank would allow rainwater to enter the container and dilute the F039 hazardous waste. The open ports would also allow evaporation of the F039 hazardous waste (reduction in volume). Clean Harbors' RCRA permit does not authorize evaporation or dilution as hazardous waste treatment methods.

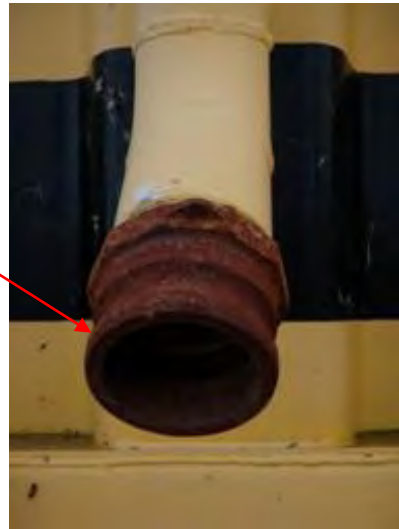
Olympus Stylus 8000, Photo #99; View of the open pumping port at the rear of the leachate collection frac tank (Tank 80) at WMU 35, Cell #1.

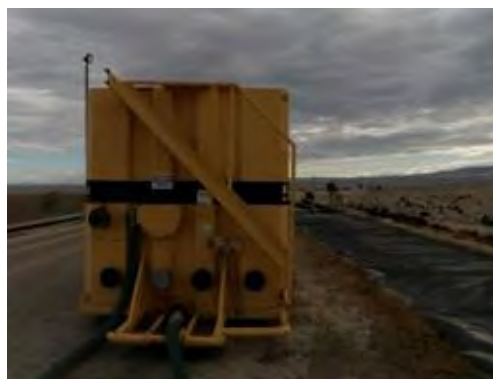
At WMU 35, Cell #2, the inspectors observed that the primary and secondary LCRSs discharge to a 20,000-gallon frac tank (known as Tank 70), shown in the photo to the right.

The frac tank was structurally sound, labeled as hazardous waste, and dated 9/14/2010. As with the frac tank at Cell #1, the leachate frac tank at WMU 35, Cell #2 is not closed (no photo taken during the CEI).

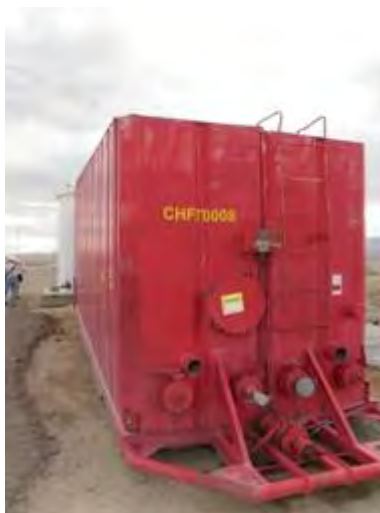
Olympus Stylus 8000, Photo #105; View of the red, leachate collection frac tank at WMU 35, Cell #3.

The frac tank was structurally sound, labeled as hazardous waste, and dated 9/4/2010. However, the labels were extremely faded and the accumulation start dates were only barely legible; the following two photos show examples of the labels.

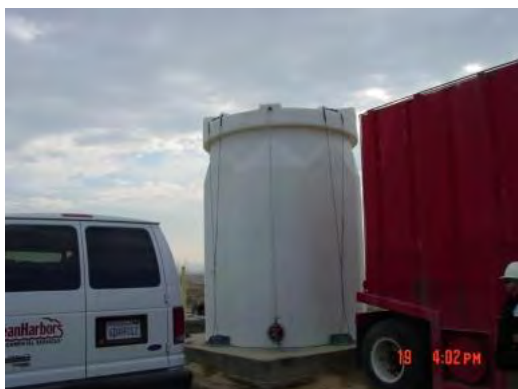
The plastic tank is double-walled, structurally sound, labeled as hazardous waste, and dated 9/1/2010, shown above. However, the tank is not equipped with a leak detection system.

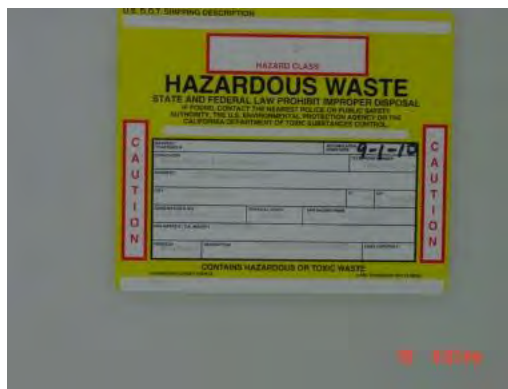
Sony DSC-S75, Photo #9; View of a 5,000-gallon, plastic, leachate collection tank at WMU 35, Cell #3; close-up of the hazardous waste label on the east side of the tank, facing west.

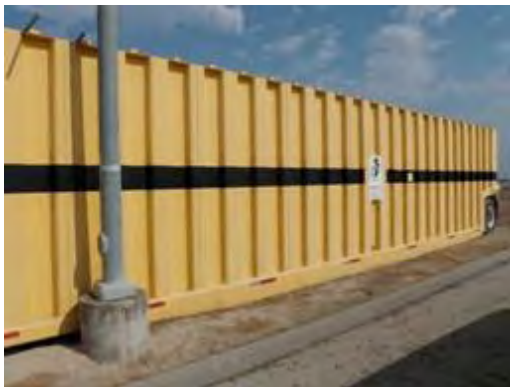
Olympus Stylus 8000, Photo #55; View of the leachate collection frac tank at WMU 34, facing northeast.

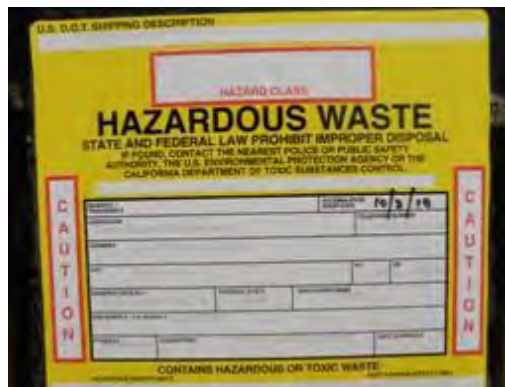
Olympus Stylus 8000, Photo #54; View of the label on the leachate collection frac tank at WMU 34. Accumulation start date is 10/2/10.

At the time of the CEI, the frac tank was structurally sound, labeled as hazardous waste and dated 10/2/2010, as shown in Olympus Stylus 8000 Photo #54.

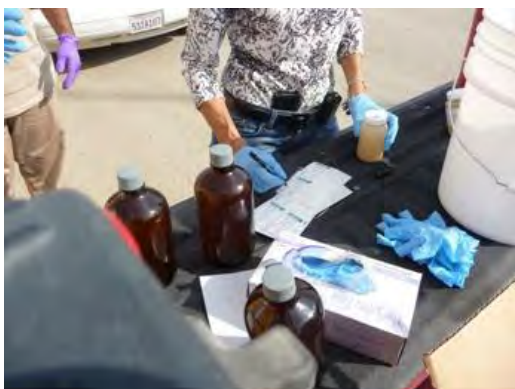
Sample processing (i.e., placement into containers, labeling) occurred on the tailgate of a Clean Harbors truck, shown below. After the samples were collected, the inspectors noted some leachate spillage on the ground beneath the tailgate, shown below.

Panasonic Lumix DMC-TZ5, Photo #35; WMU 34 leachate sampling –transferring samples into containers and labeling.

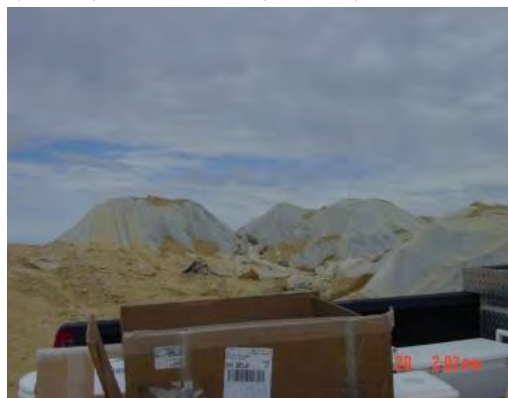
Sony DSC-S75, Photo#14; View of the treated waste staging piles atop Landfill 34 (under plastic tarping). View is from the southwest corner of Landfill 34, facing north.

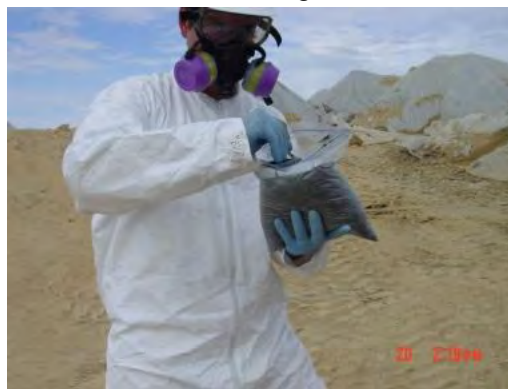
Sony DSC-S75, Photo #15; Treated waste pile sampling at Landfill 34. View of homogenization of sample prior to collection in sample containers, facing north.
