UNITED STATES ENVIRONMENTAL PROTECTION AGENCY

Subject: Transmittal of "Port of Stockton Municipal Separate Storm Sewer Audit Report"

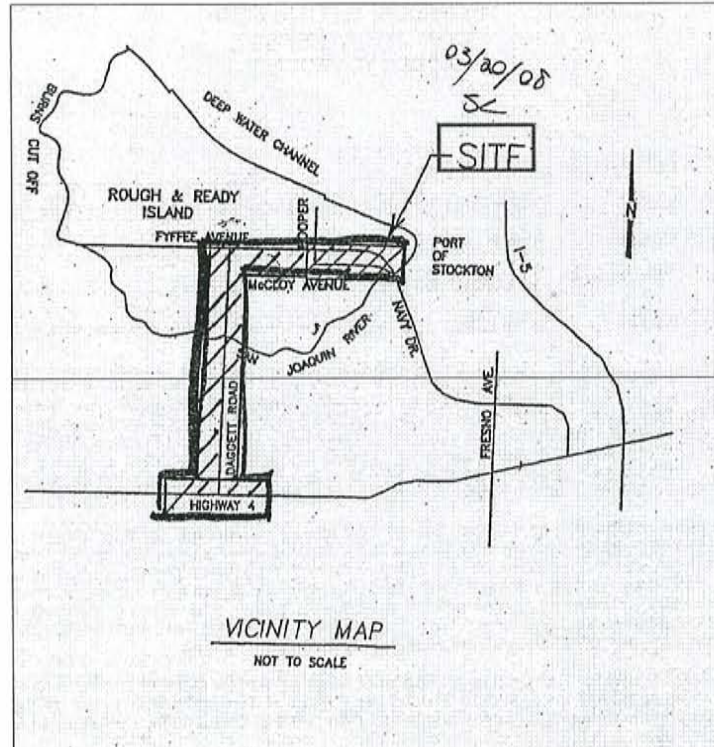
Exhibit 1 – Approximate location of the Daggett Road Project Packages A, B, C, D, and E (adapted from the SWPPP for Navy Drive to McCloy Security Reroute Project Package D, dated April 13, 2007).

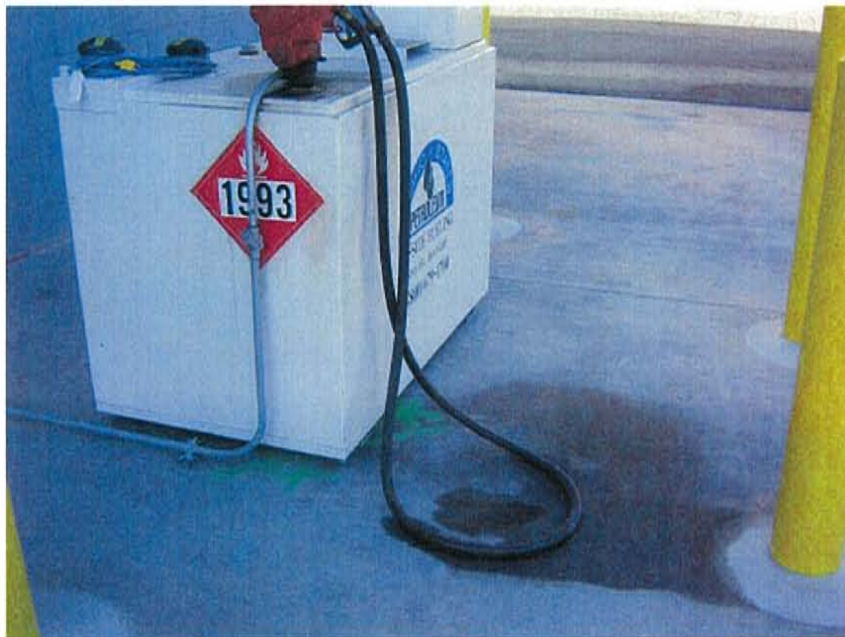
The Lowe’s Distribution Center is a completed commercial project consisting of a warehousing and distribution facility for home improvement goods and building and construction materials. Section C.14.a.v of the Order defines the parking lot category as “parking lots exposed to rainfall that are 5,000 square feet or more, or with 25 or more parking spaces.” The site includes a newly constructed equipment maintenance (Photograph 11) and fueling (Photograph 12) shop and approximately 20 acres of

Photograph 12: View of Lowe's Distribution Center fuel storage tank located adjacent to the maintenance shop.
