UNITED STATES ENVIRONMENTAL PROTECTION AGENCY  
REGION IX  
75 Hawthorne Street  
San Francisco, CA 94105-3901

Enclosed is the U.S. Environmental Protection Agency's (EPA) report of the Nevada Department on the Transportation (NDOT) Storm Water Management Program (Program) Audit. Representatives from EPA Region 9 and the Nevada Department of Environmental Protection (NDEP) conducted the Audit from August 9 – 12, 2011.

**MS4 Audit Report**

## **NDOT MS4 Audit Photo Log – Carson City Maintenance Facility 8.10.2011**

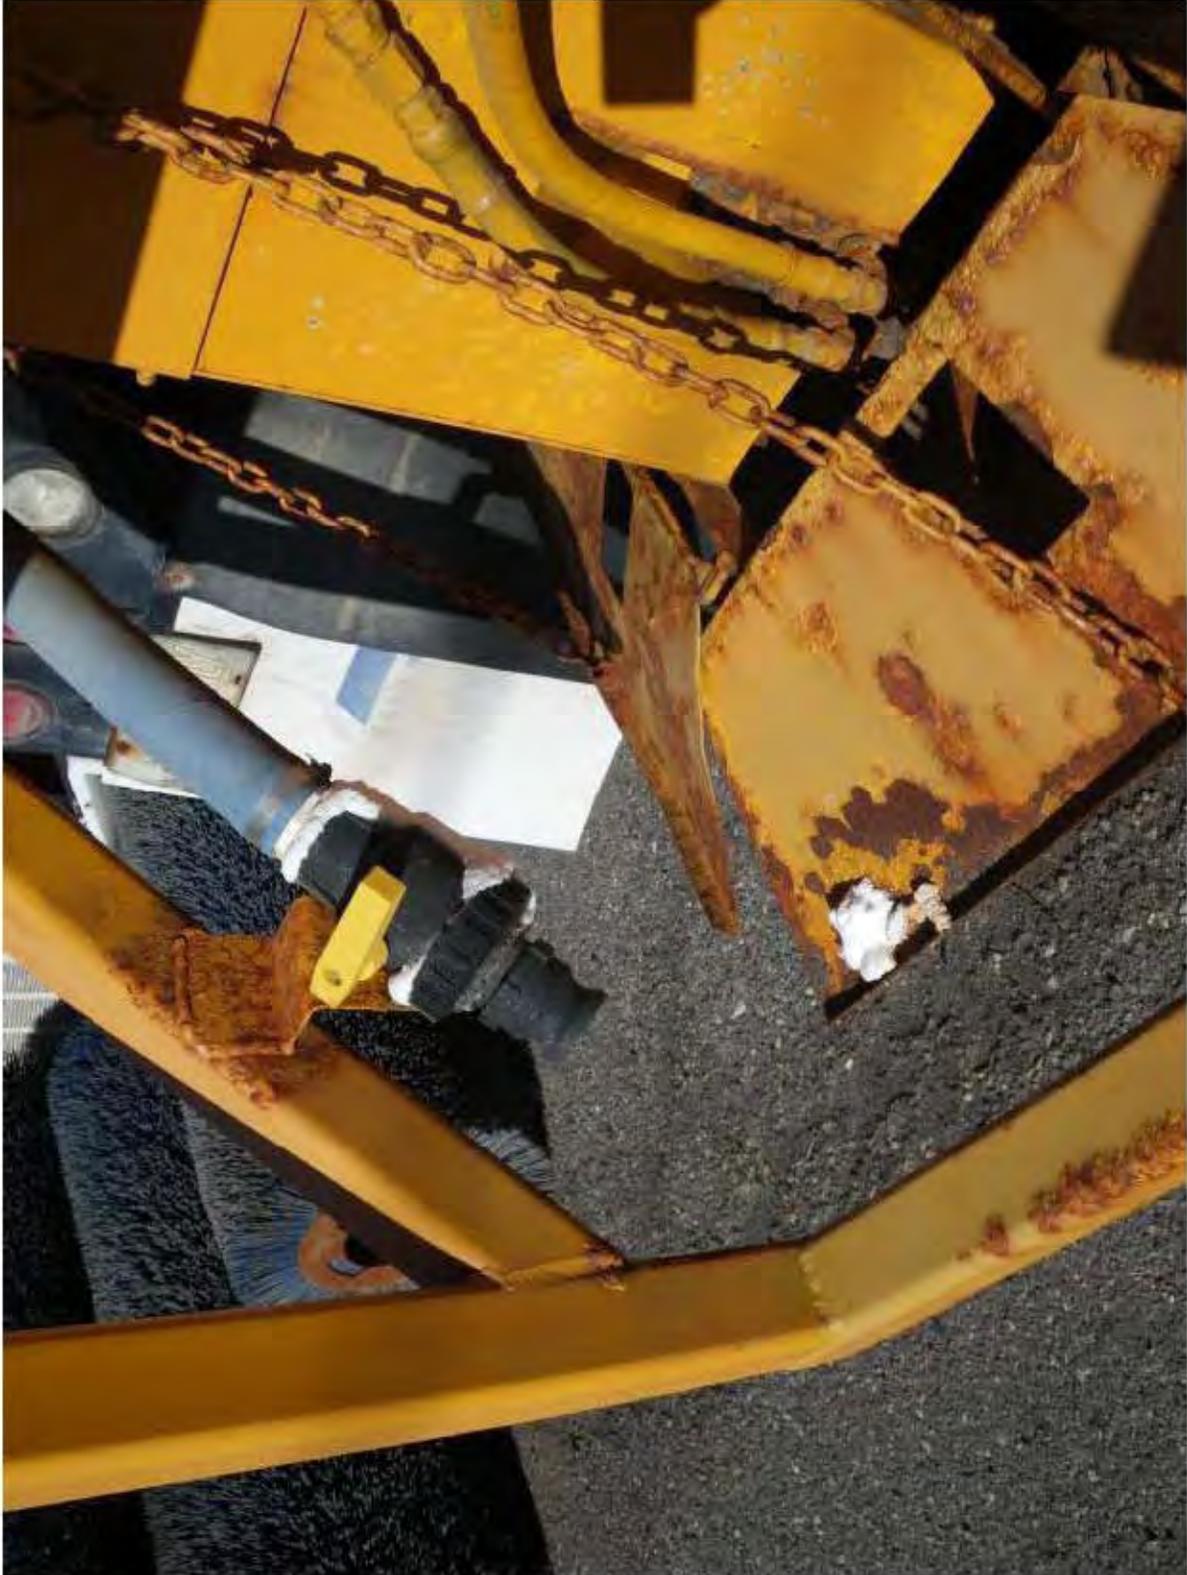
IMGP0579.JPG

**IMGP0579** – Accumulated salt residue at the discharge nozzle for the brine system, blistering paint and rust on the sand spreading chute.

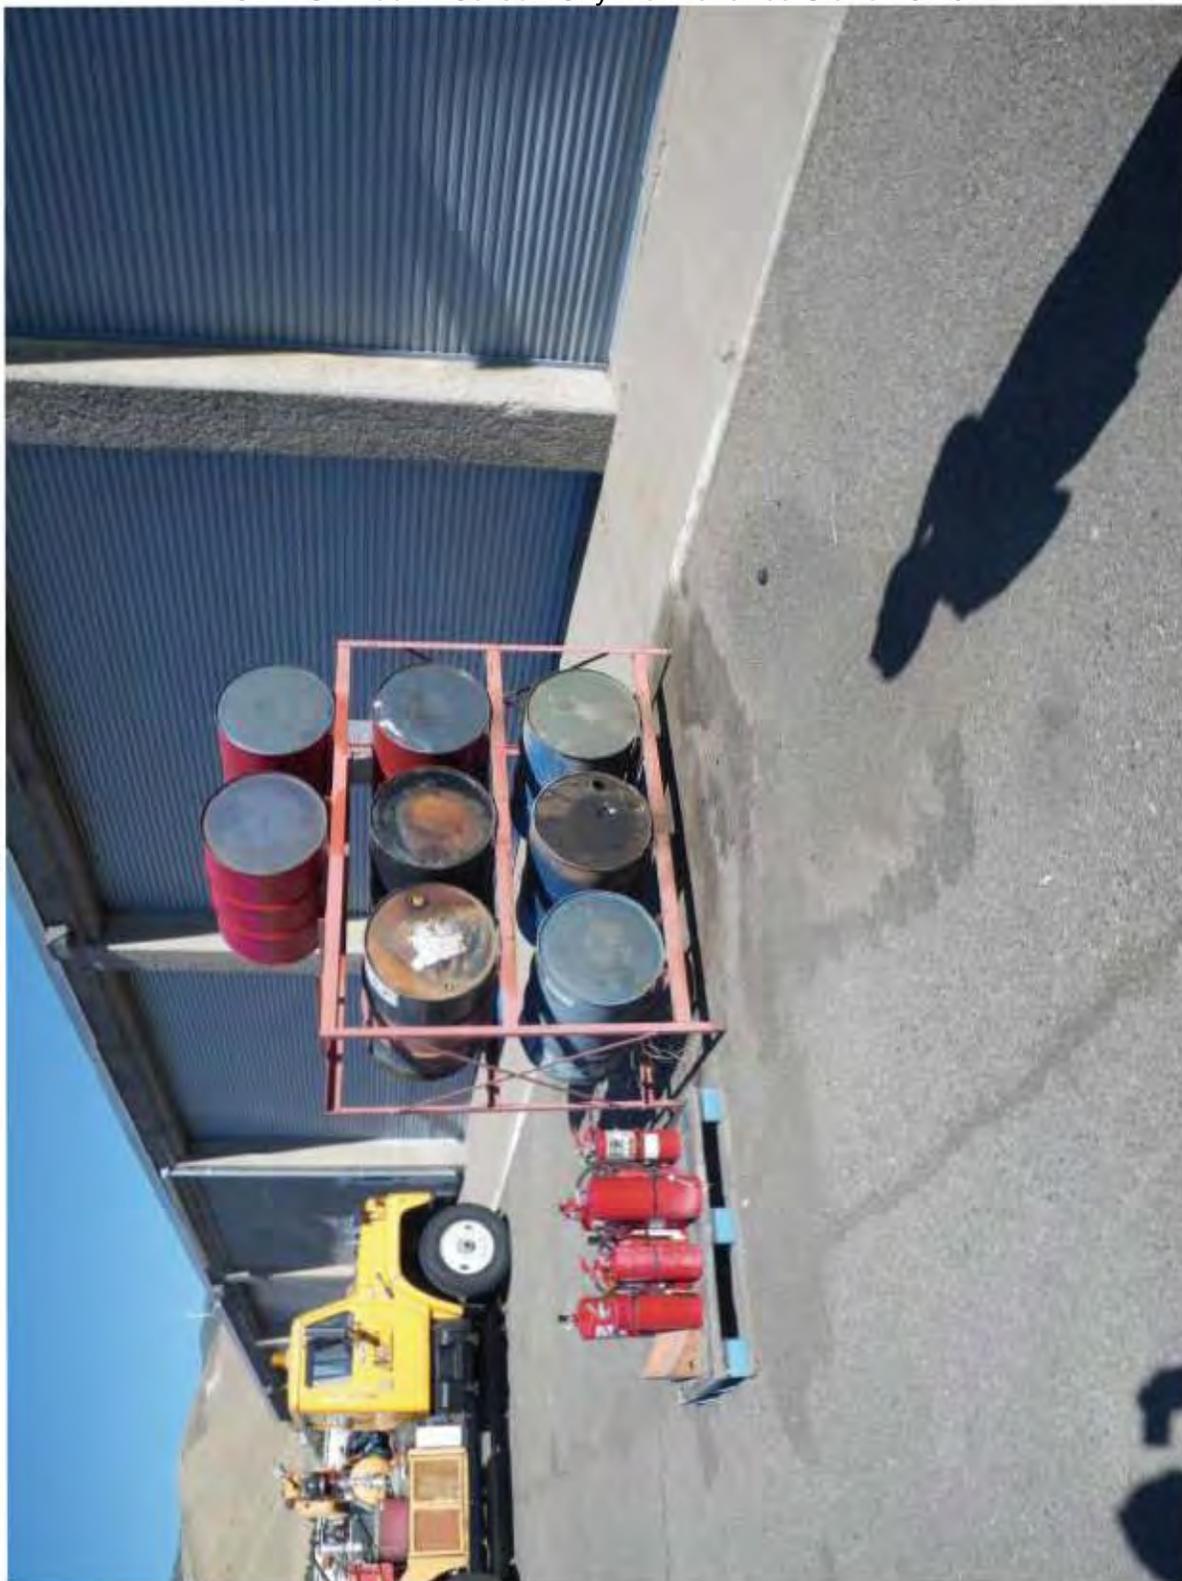
IMGP0587.JPG

**IMGP0587** – Uncovered empty-barrel storage area with staining on the ground.

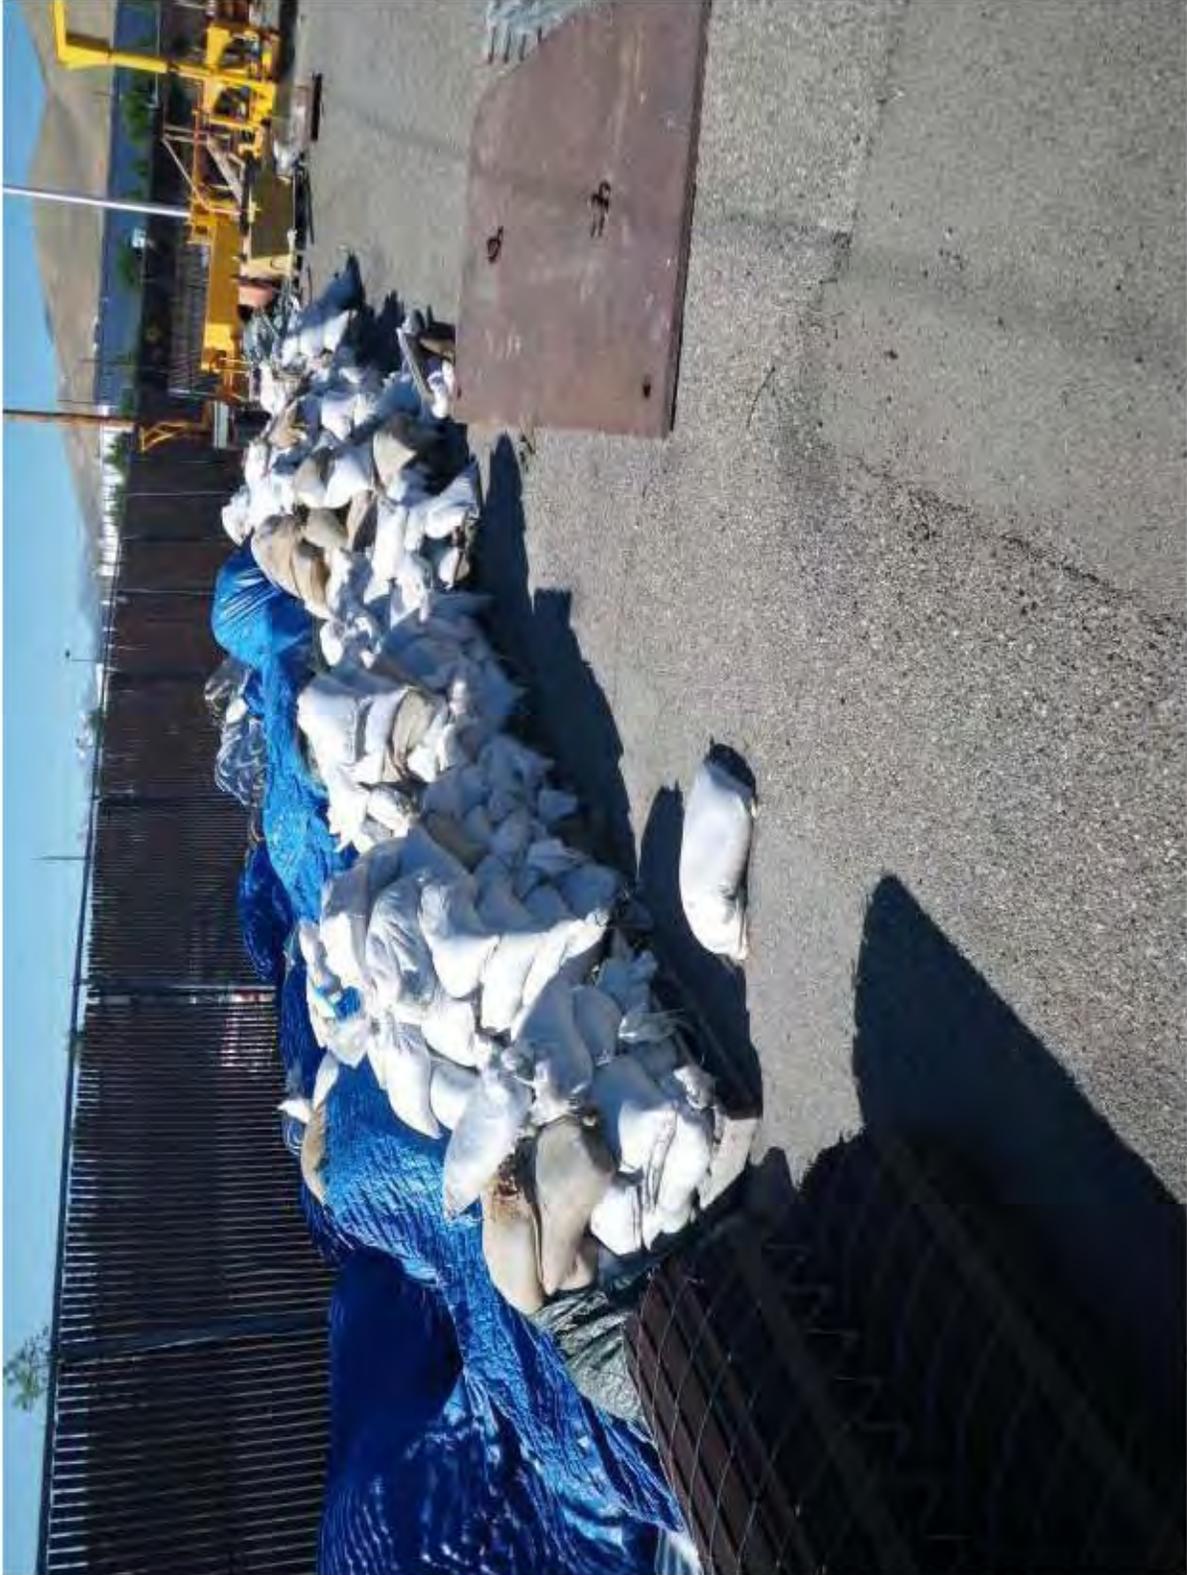
IMGP0596.JPG

**IMGP0596** – Partially covered sand/gravel bags. Plastic bags were partially deteriorated and beginning to leak material. Tarps were also partially deteriorated condition and also partially pulled back.

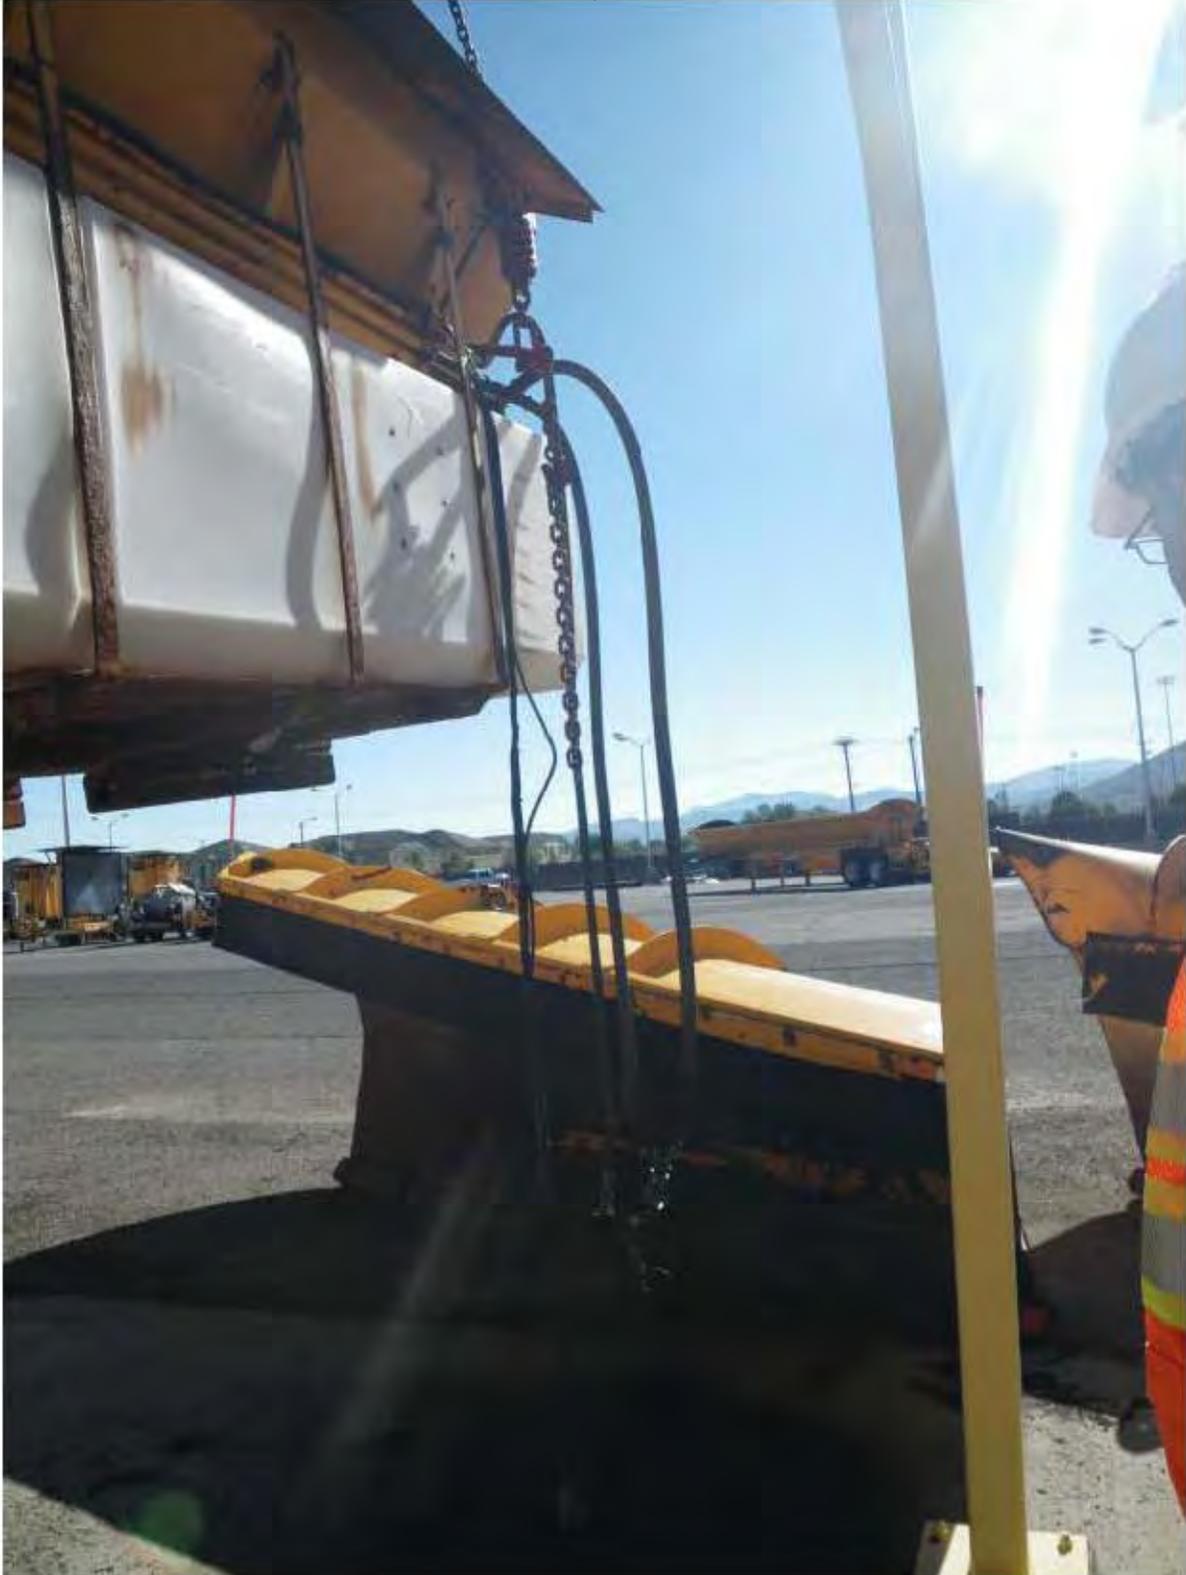
IMGP0601.JPG

**IMGP0601** – Hanging hydraulic lines were contributing to staining on the yard surface.

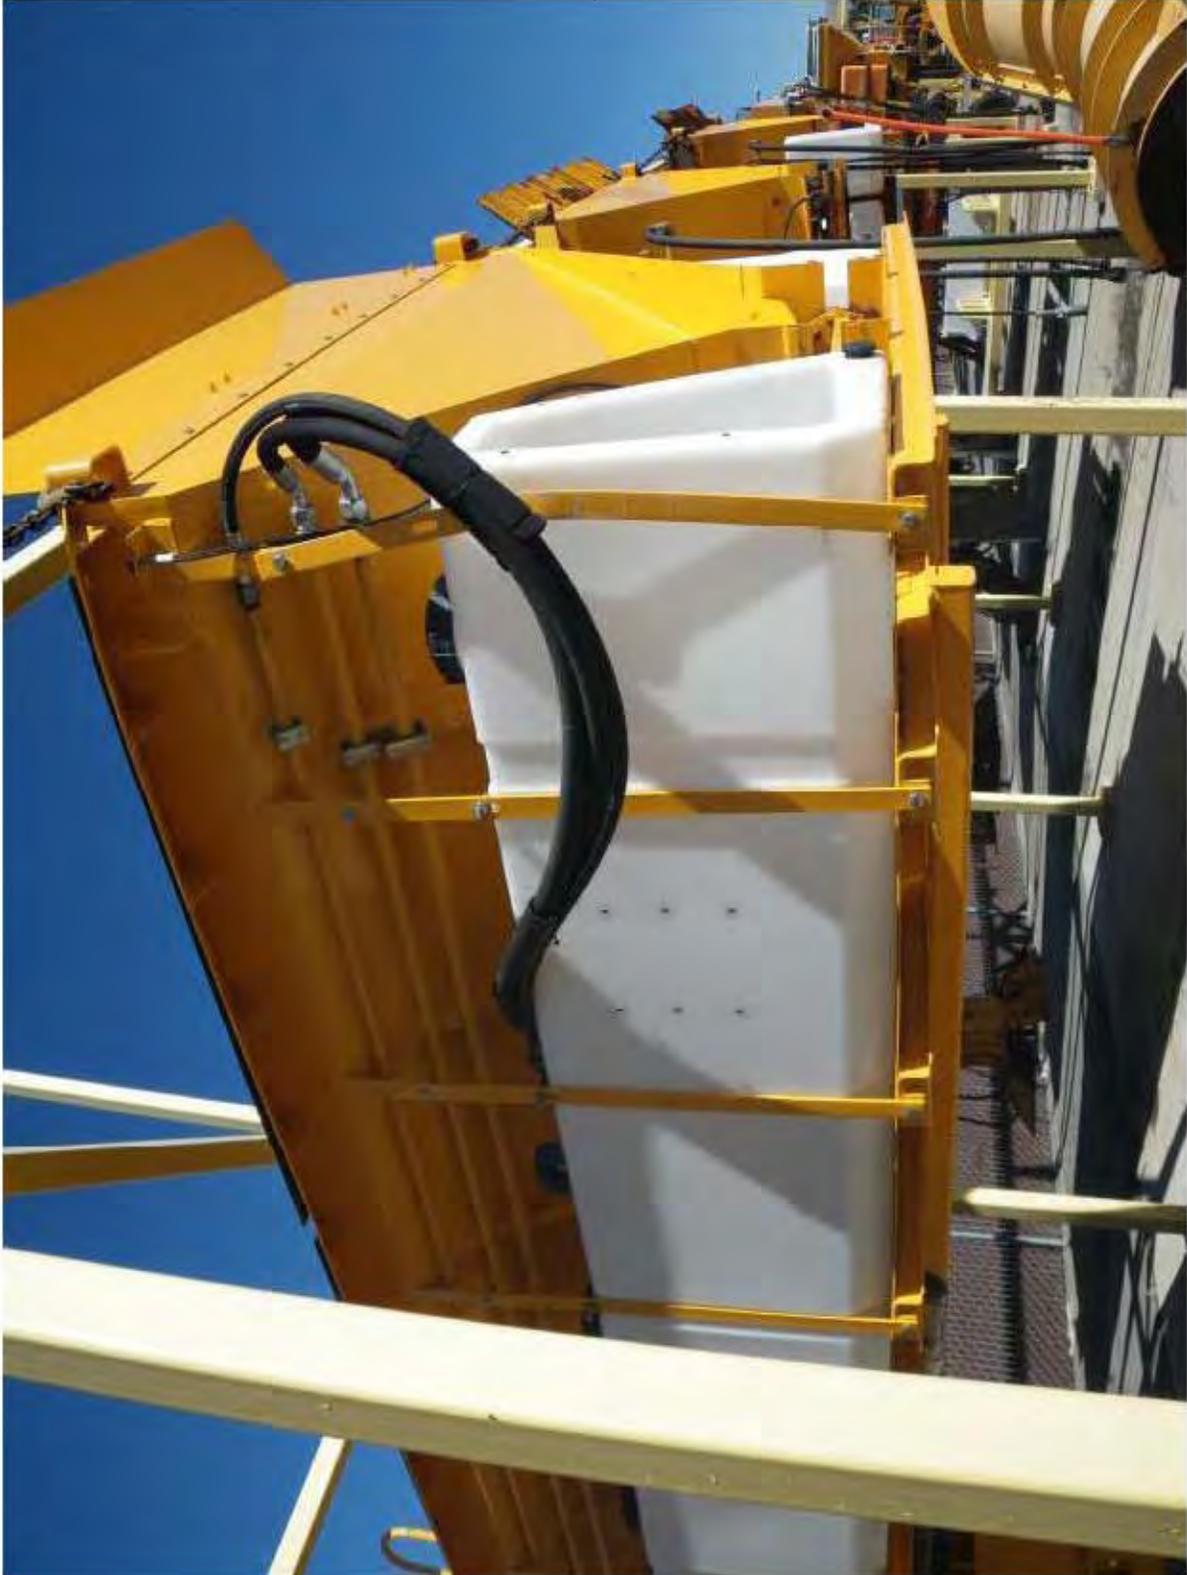
IMGP0602.JPG

**IMGP0602** – The only rig with hydraulic lines tucked away, and the only rig with no oil staining at the front of the rig. The other rigs down the line had hanging hydraulic lines and had oil staining underneath.

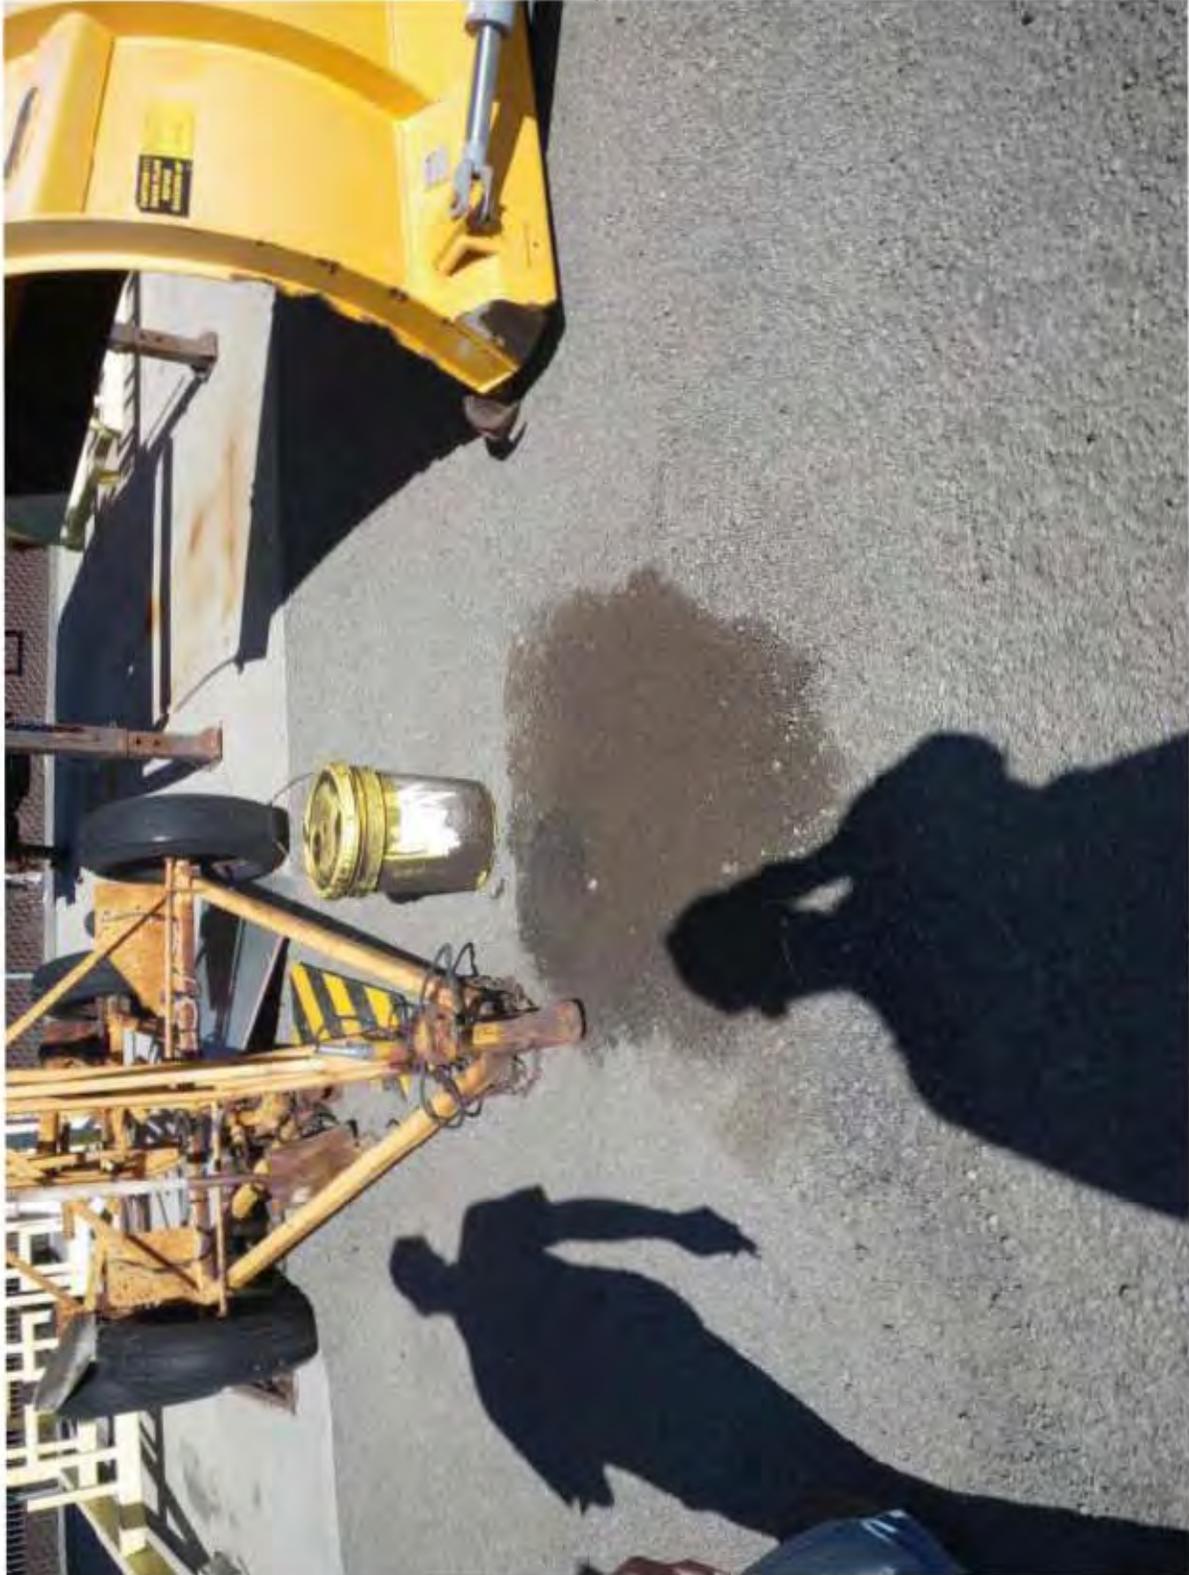
IMGP0603.JPG

**IMGP0603** – Bucket of ‘Tractor Oil’ with oil staining in the foreground. Trailers to the left of the bucket are situated over a drop inlet where flowing water has heard.

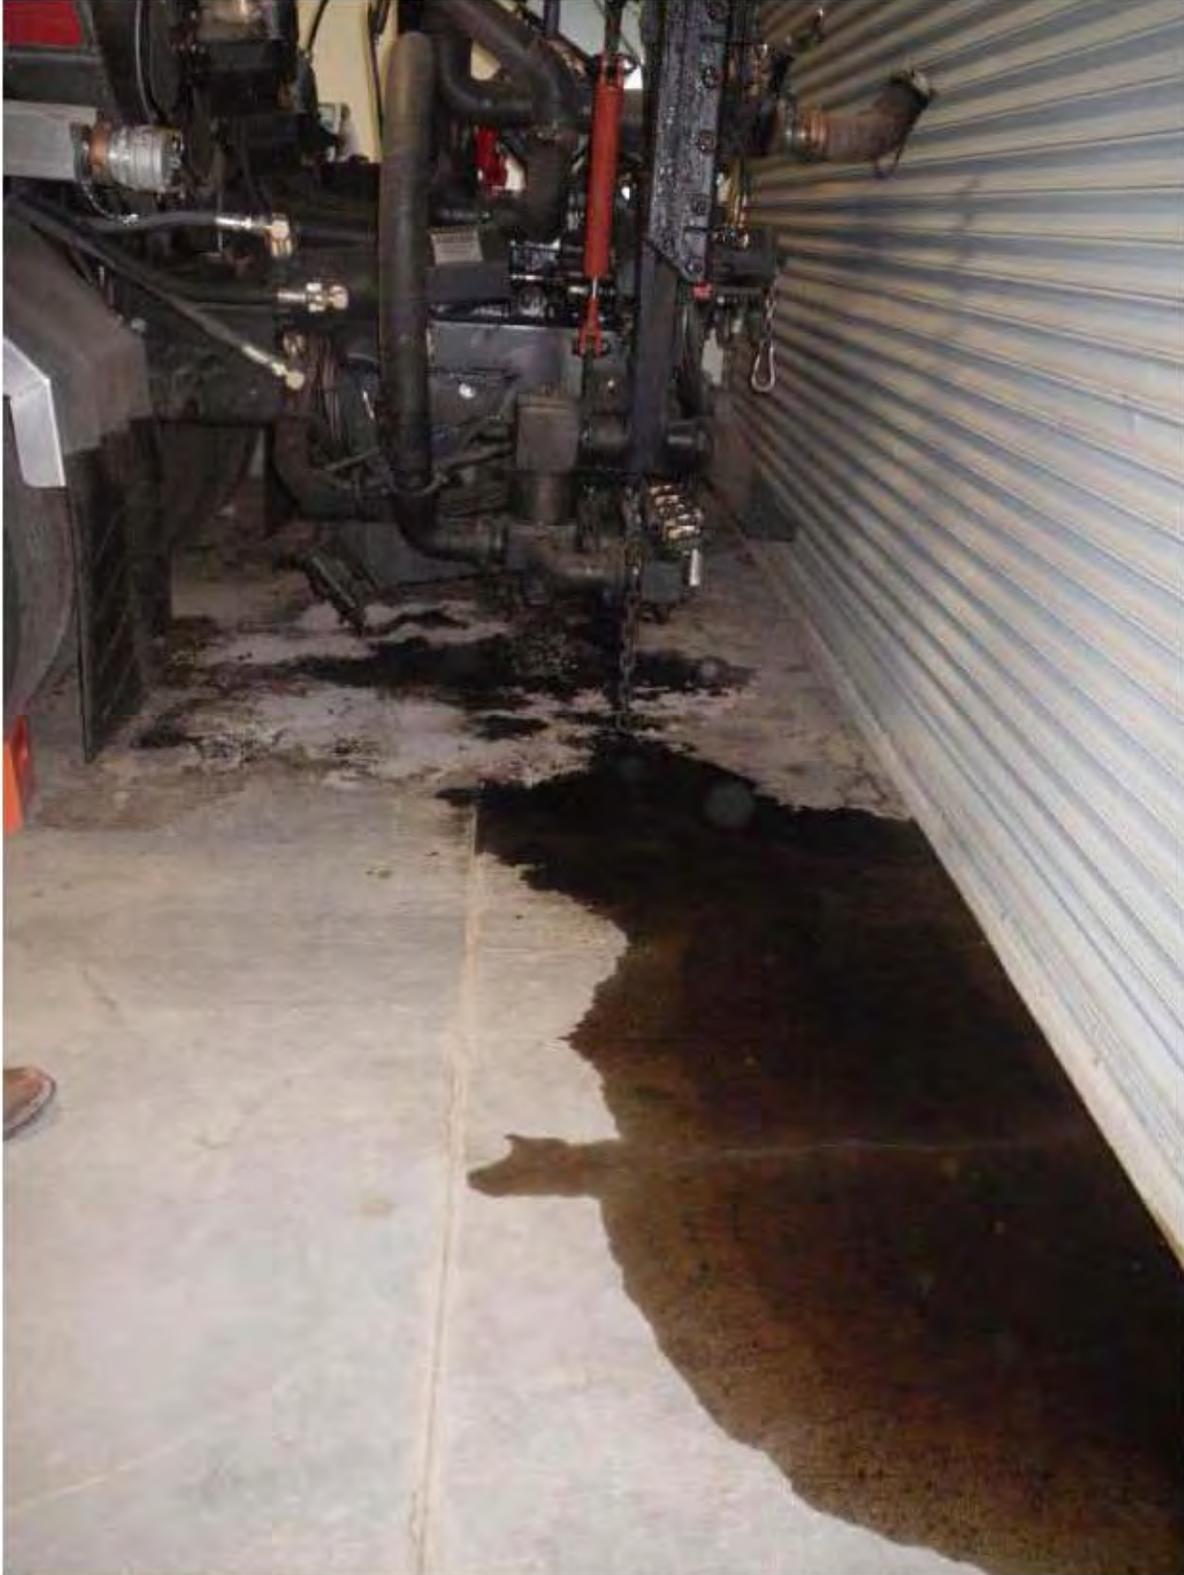
IMGP0611.JPG

**IMGP0611** – Source of fugitive oil identified in IMGP0586. A road oiler continued leaking after it was parked, and absorbent had been previously deployed for related issues.

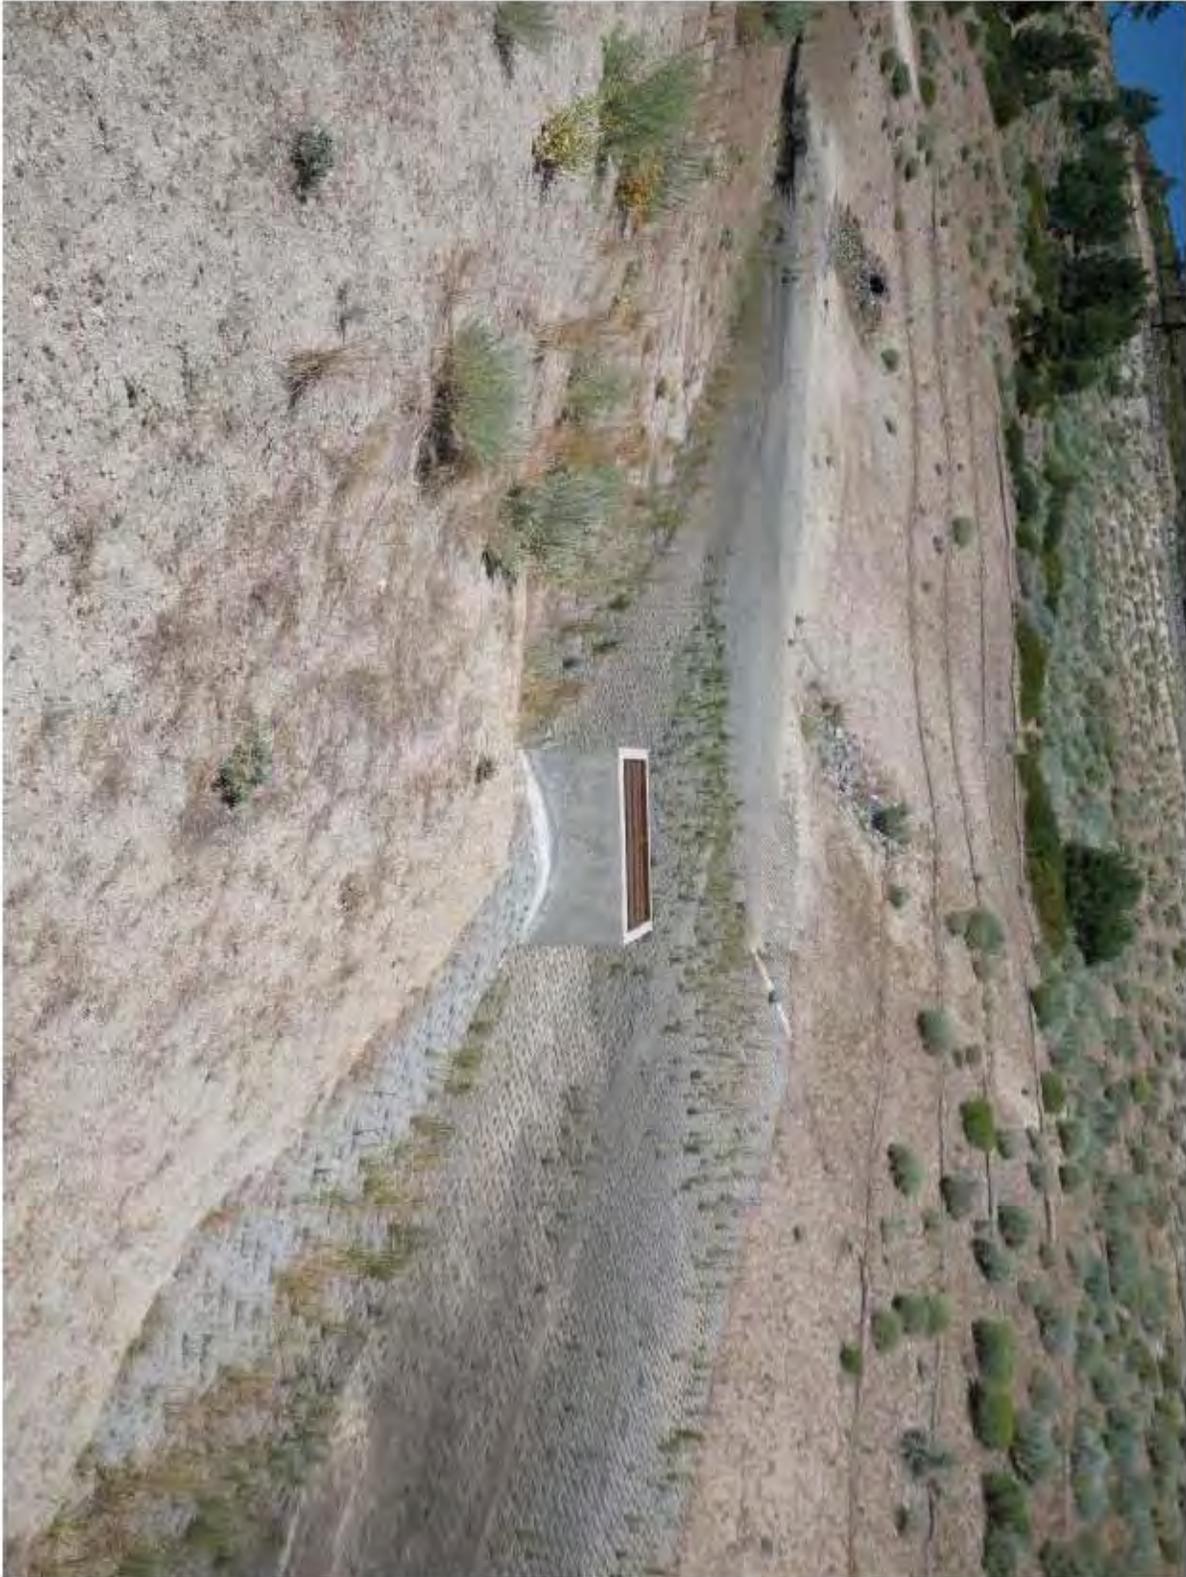
IMGP0634.JPG

**IMGP0634** – (Area 3) Culvert out falls that discharge to the detention basin. Stabilized and revegetated hillside, and articulated blocks that serve as the bottom liner for the basin and promote infiltration of storm water.

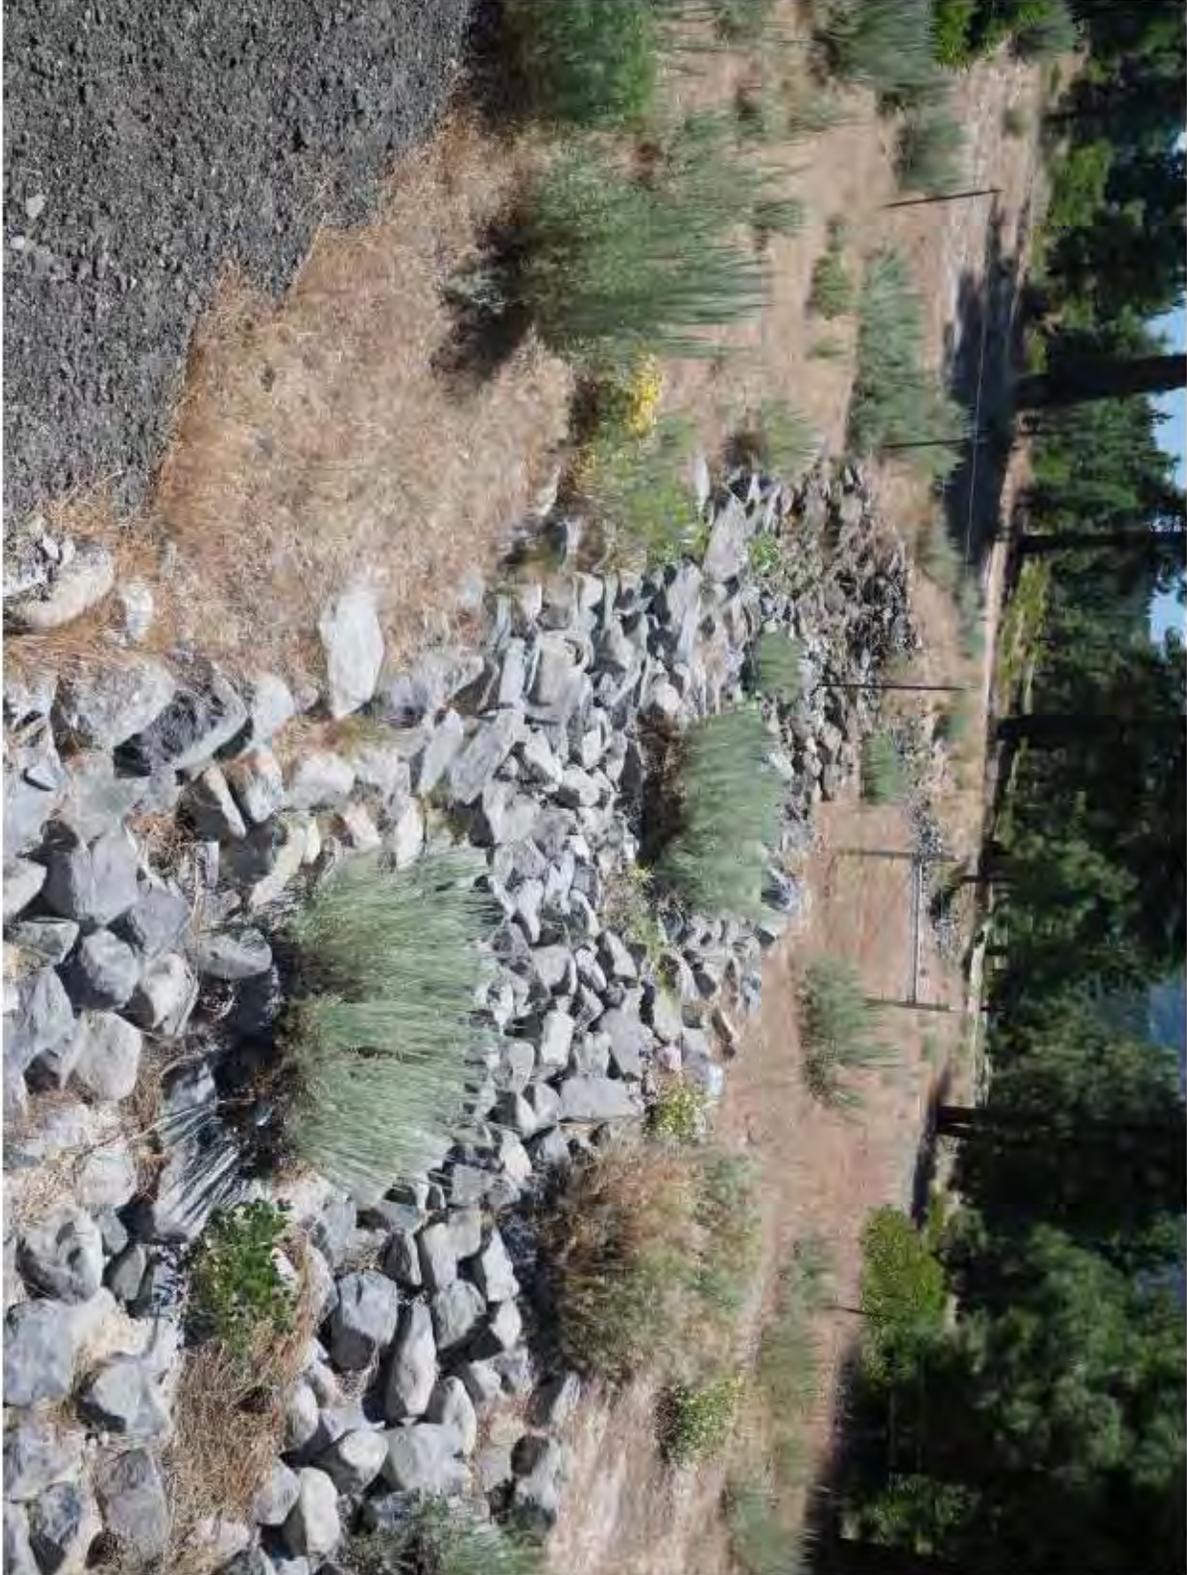
IMGP0636.JPG

**IMGP0636** – (Area 3) Outfall from detention basin.

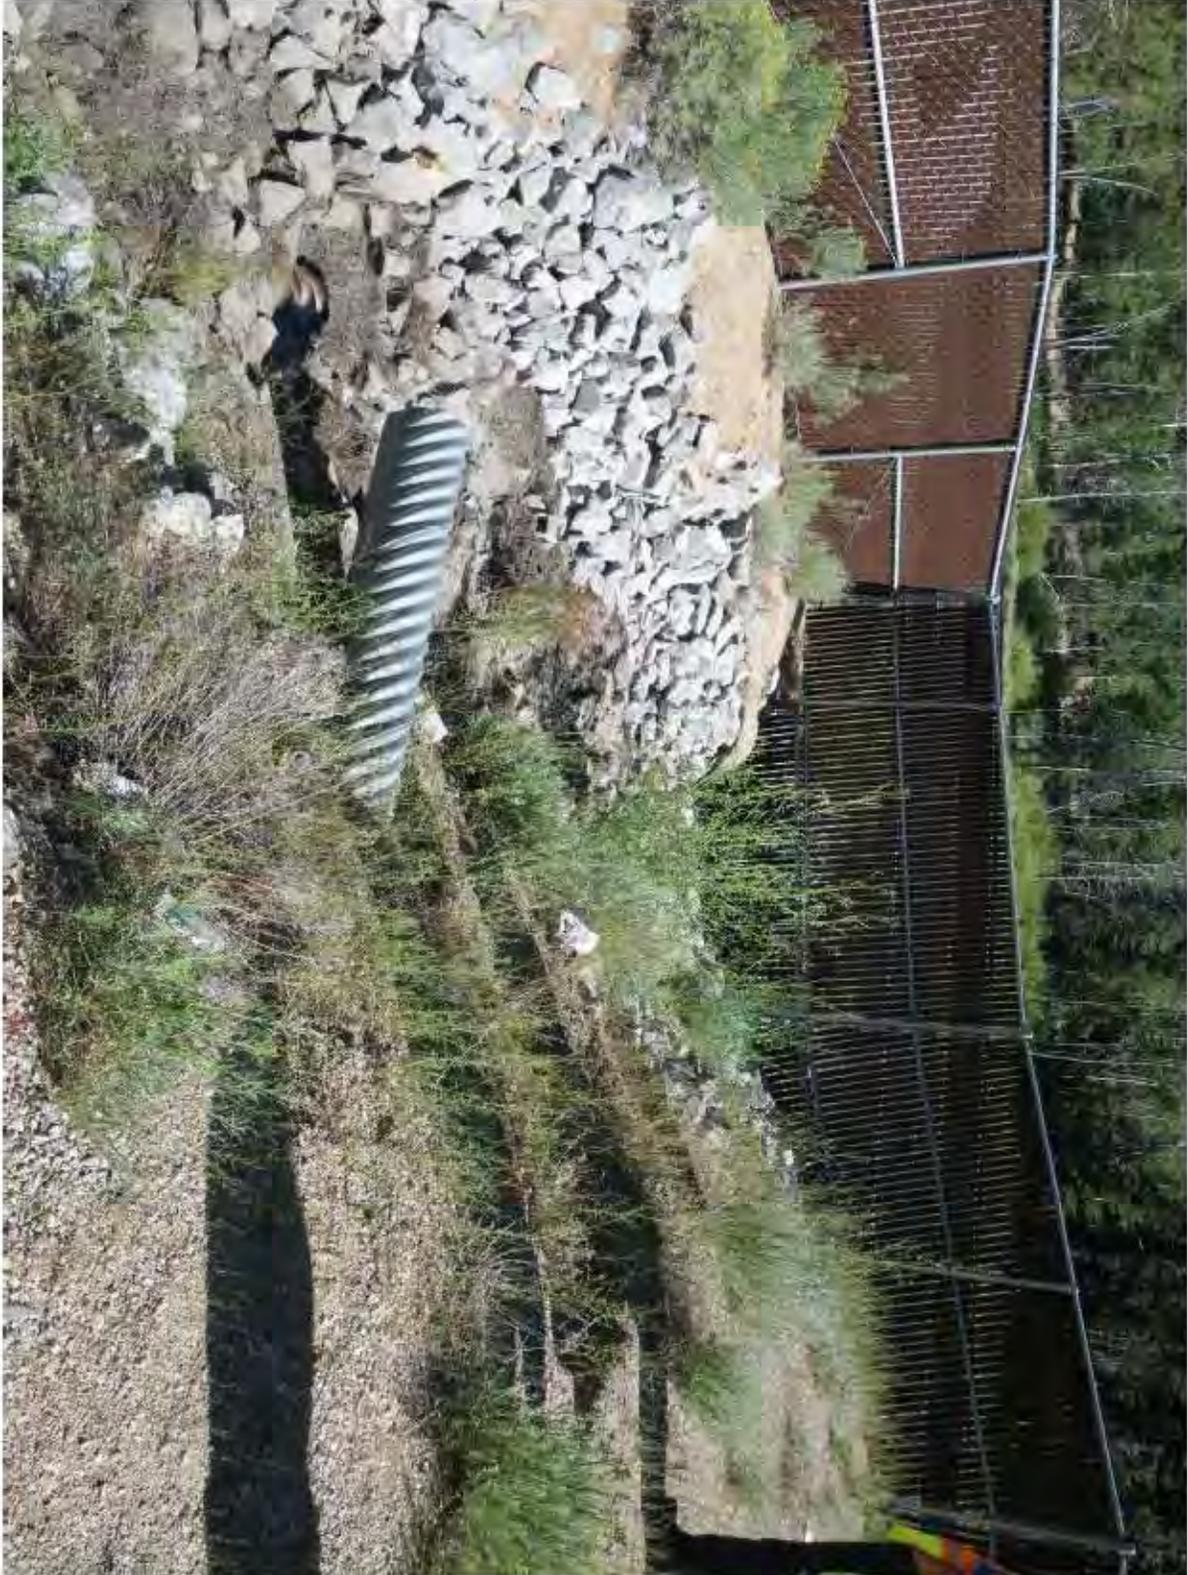
IMGP0643.JPG

**IMGP0643** – The outfall culvert discharges into a rock-lined drainage channel. Accumulated sediment was observed in the channel resulting from opening the outfall gate during heavy runoff that was causing the pond to over-top its berm.

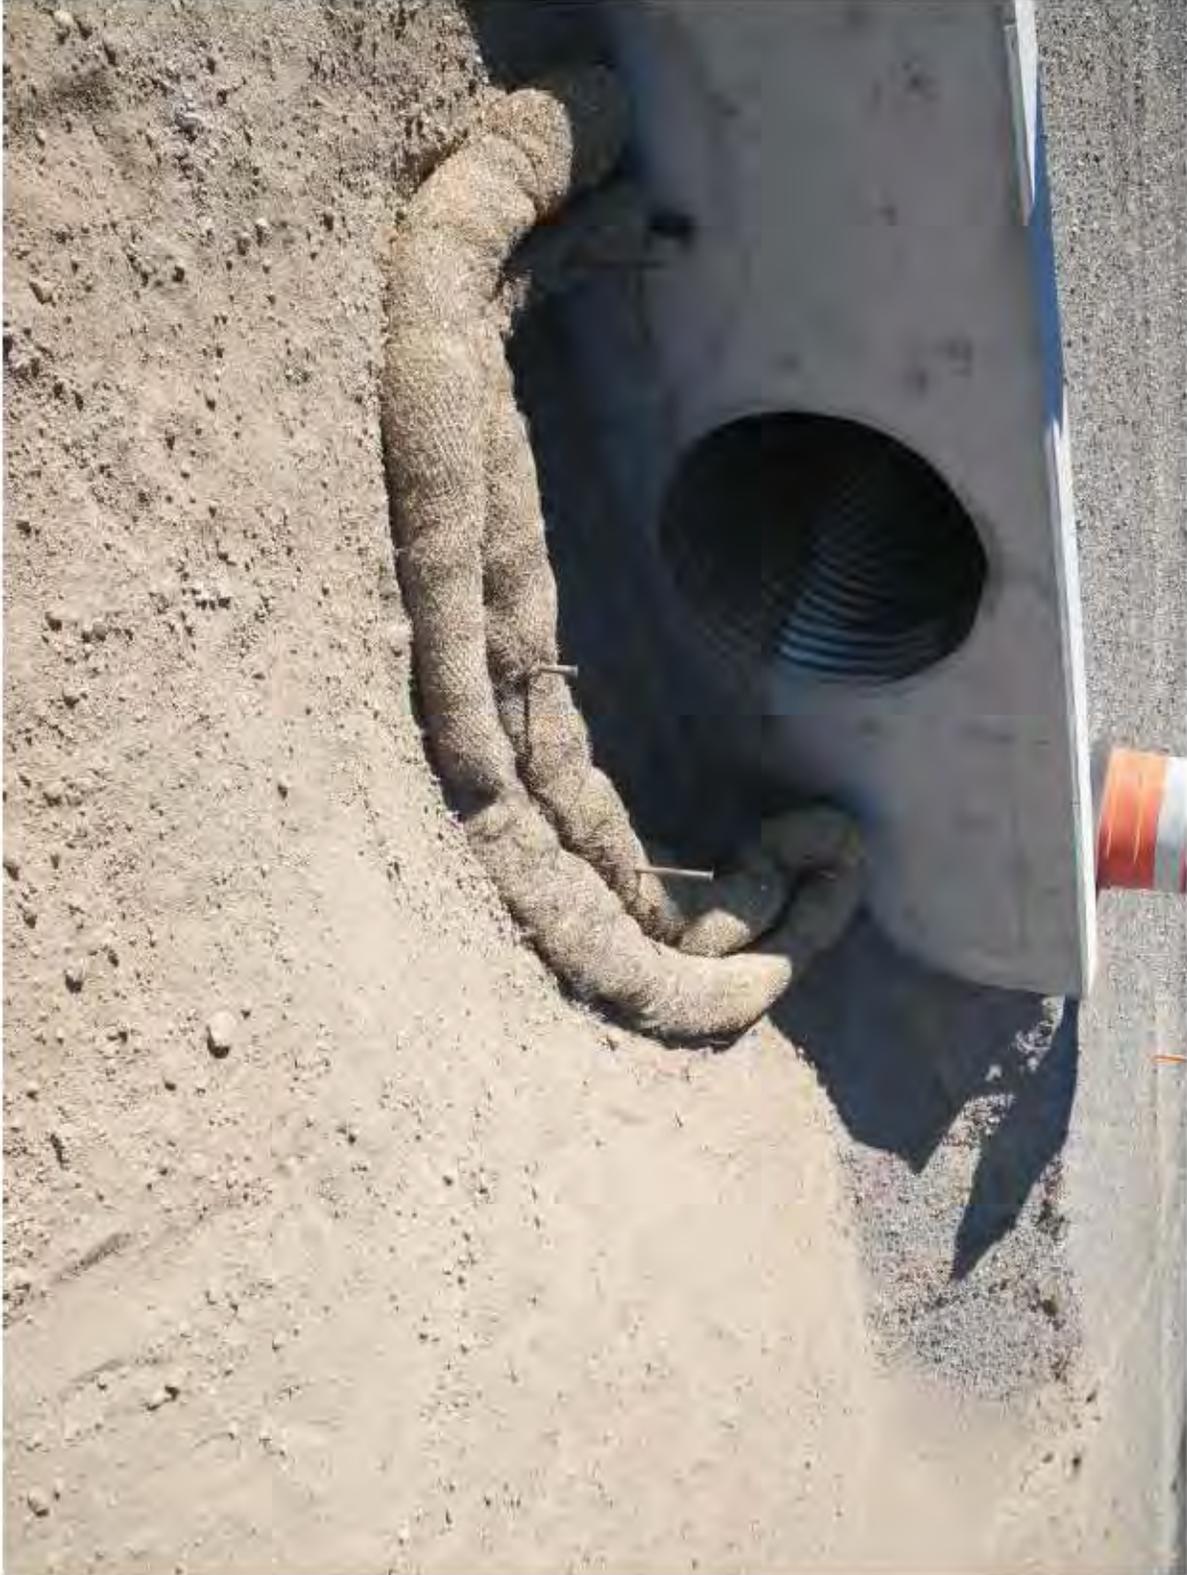
IMGP0645.JPG

**IMGP0645** – Newly constructed culvert inlet that had been cleaned out and maintained after failure during a storm event. Accumulated wind-deposited sediment inundated the inlet basin, and sediment laden storm water caused a failure of the fiber roll. Sediment was cleared from the inlet, and the fiber-roll was re-keyed and staked.

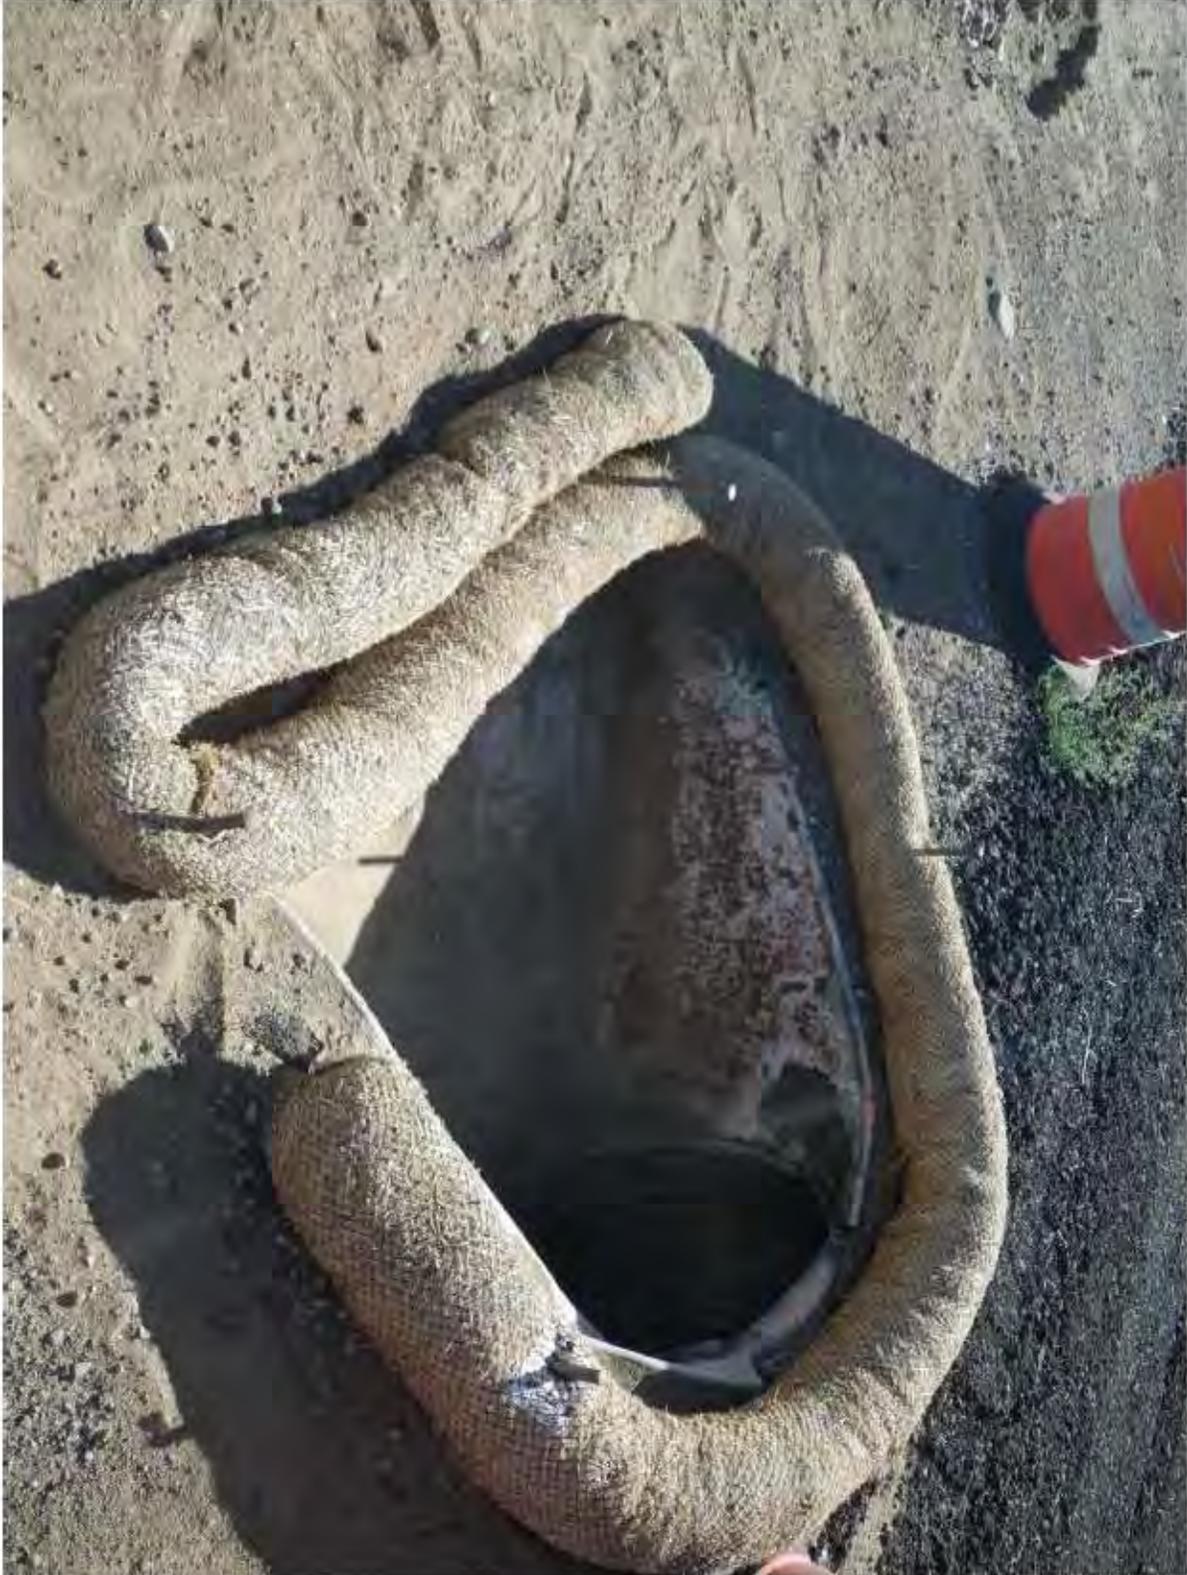
IMGP0648.JPG

**IMGP0648** – Rehabilitated culvert inlet that had been cleaned out and maintained after failure during a storm event. Accumulated wind-deposited sediment inundated the inlet basin, and sediment laden storm water caused a failure of the fiber roll. Sediment was cleared from the inlet, and the fiber-roll was re-keyed and staked.
