UNITED STATES ENVIRONMENTAL PROTECTION AGENCY  
REGION IX  
75 Hawthorne Street  
San Francisco, CA 94105-3901

Enclosed is the U.S. Environmental Protection Agency's (EPA) report of the Nevada Department on the Transportation (NDOT) Storm Water Management Program (Program) Audit. Representatives from EPA Region 9 and the Nevada Department of Environmental Protection (NDEP) conducted the Audit from August 9 – 12, 2011.

**MS4 Audit Report**

## **NDOT MS4 Audit Photo Log – Carson City Maintenance Facility 8.10.2011**

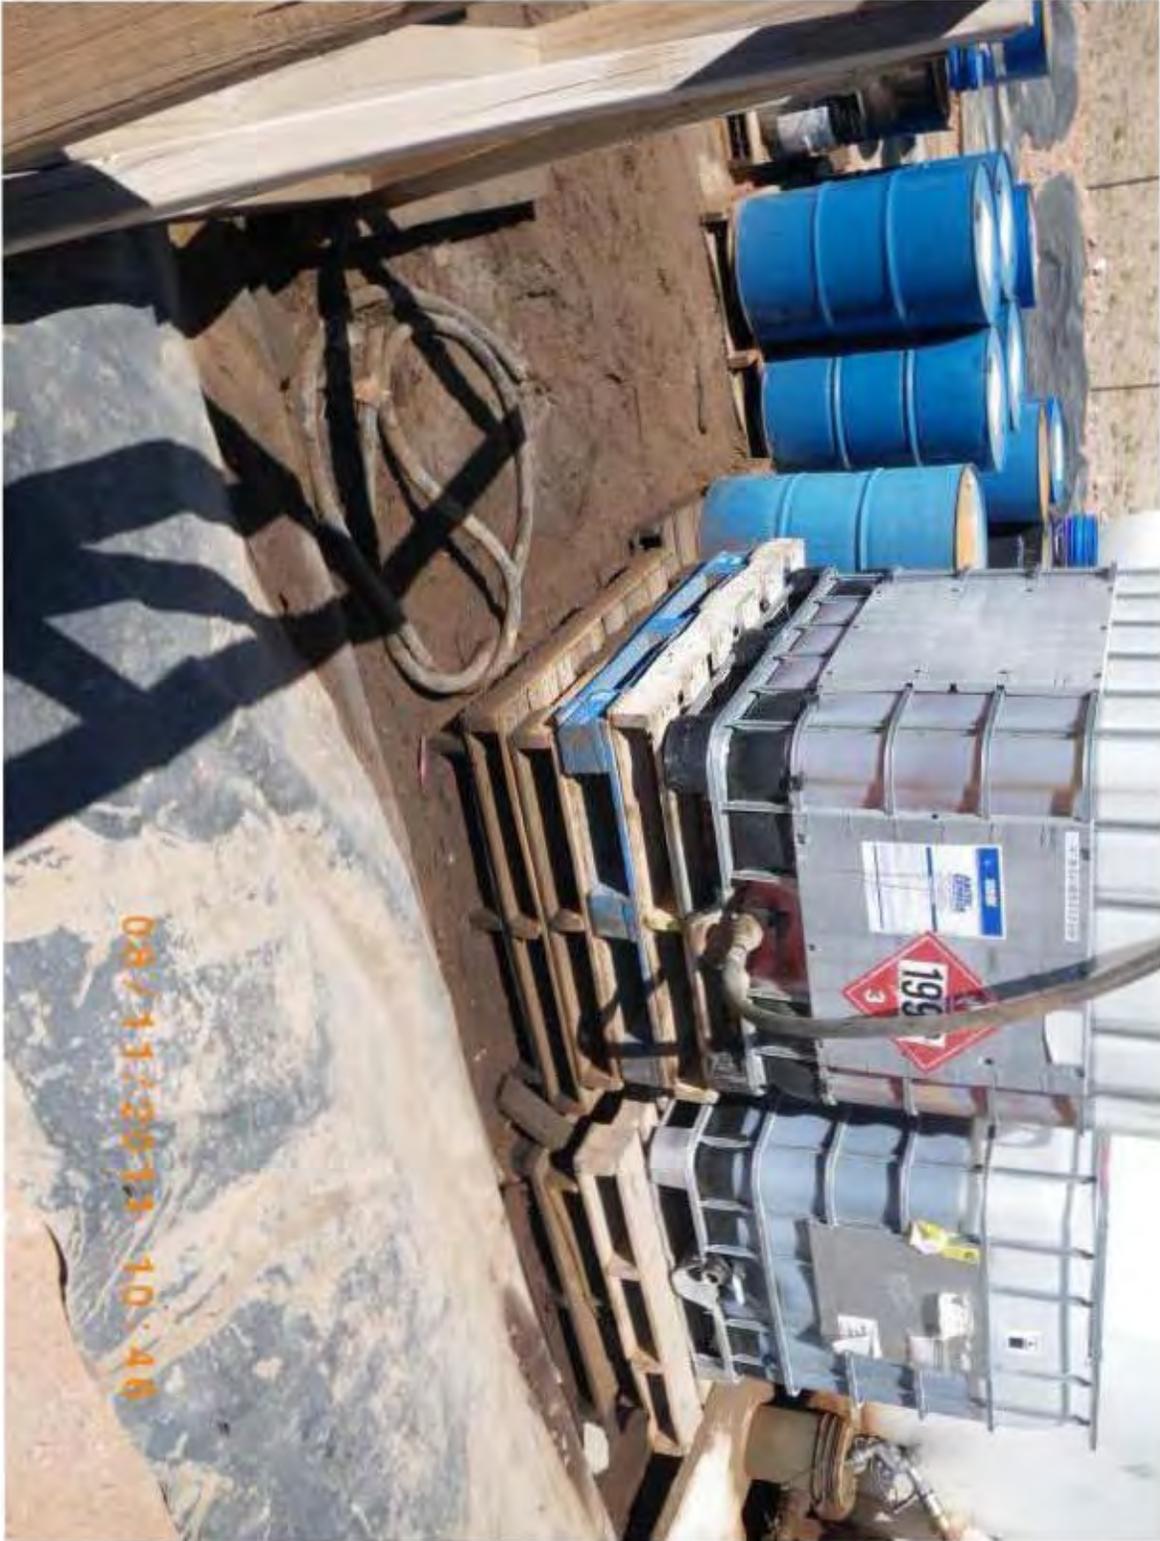
IMGP0177.JPG

**IMGP0177.JPG** –Photo shows secondary containment around diesel fuel and equipment lubrication operation at the contractor staging area. Note stained area within the containment area. This area was also inspected by NDOT Contractor and reported in June 24 inspection report (photo 11) as requiring liquid at the time to be removed. I recommended that the contractor also remove the oil-stained dirt from within the area so the liner could be properly inspected for tears.

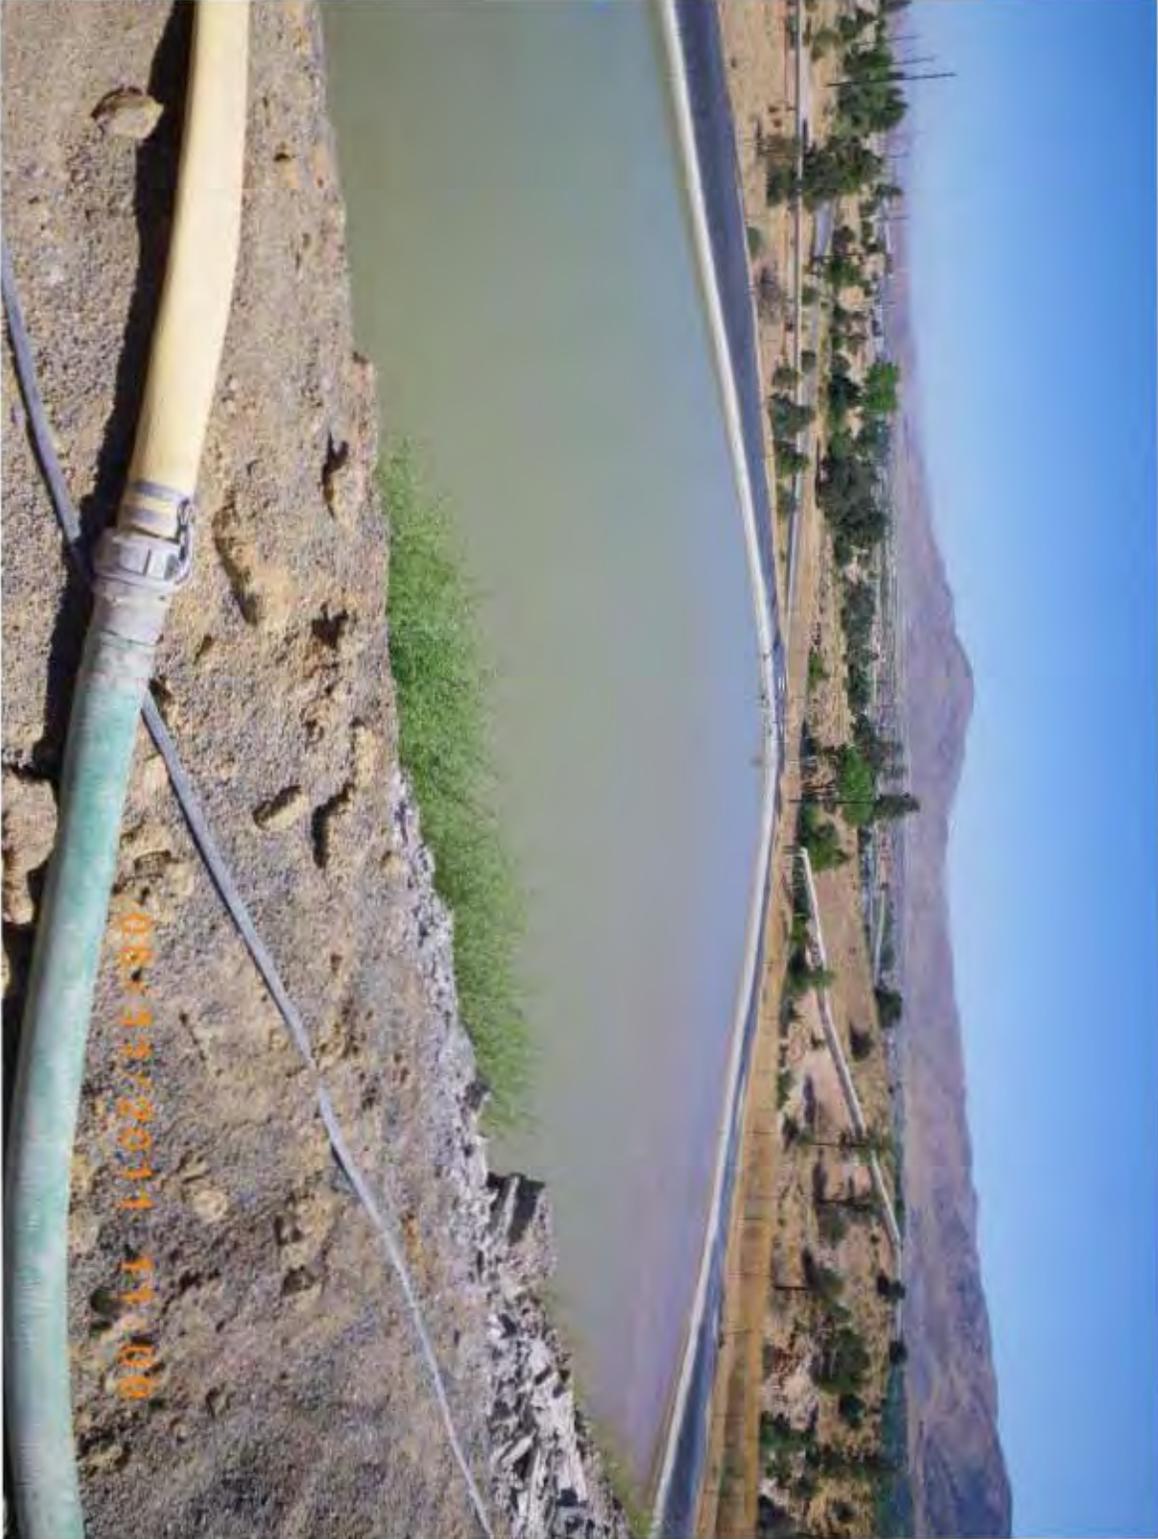
IMGP0180.JPG

**IMGP0180.JPG** – View looking northeast of secondary settling pond at concrete batch plant. Water from this pond is pumped back up hill to the on-site aggregate washing operation. Note the low freeboard in the northeast corner of the pond. Contractor noted that this is less freeboard than they would like but said it's been permitted by the state of NV (Water Resources – Dam Construction).

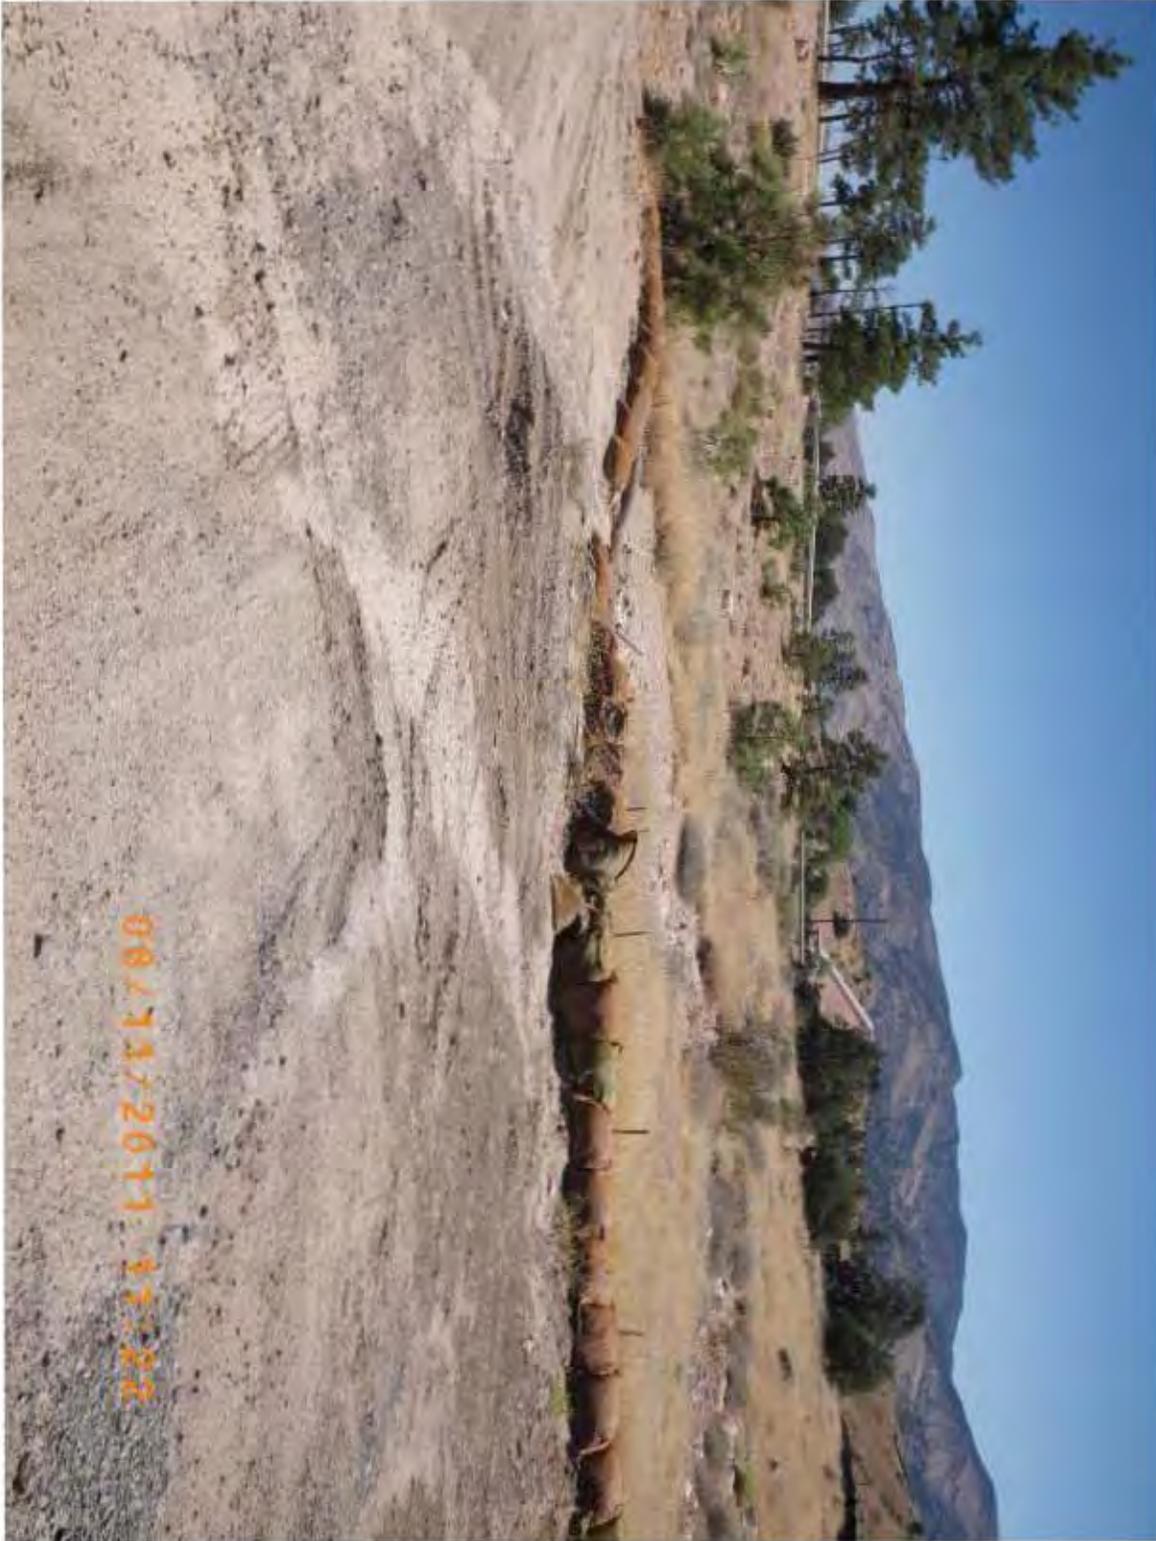
IMGP0181.JPG

- Galena forest drainage (adjacent to the concrete plant) – At this location several dirt roads criss-crossed the area and we noted the BMPs in the area had deteriorated (see photo IMGP0181).

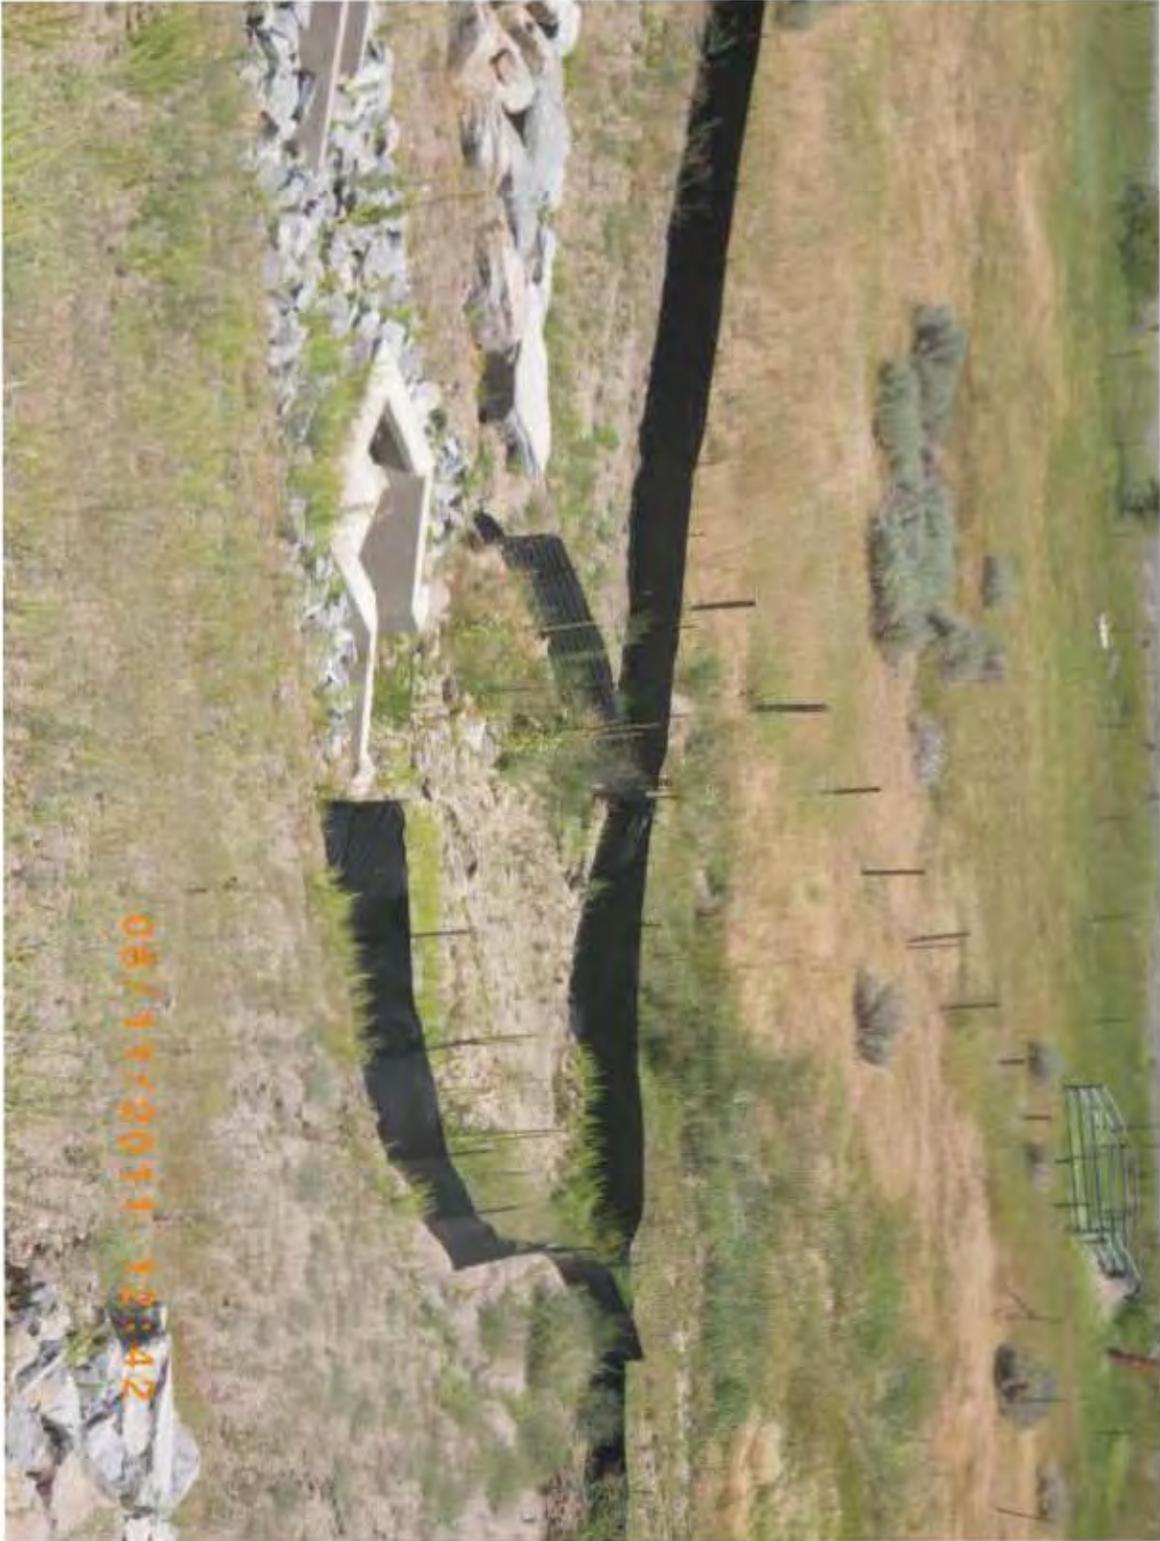
IMGP0184.JPG

**IMGP0184.JPG** – Photo looking east and down the slope from I-580 construction site at Winters Creek. Note silt fences in place to capture onsite and offsite surface water that may have sediment entrained in it.

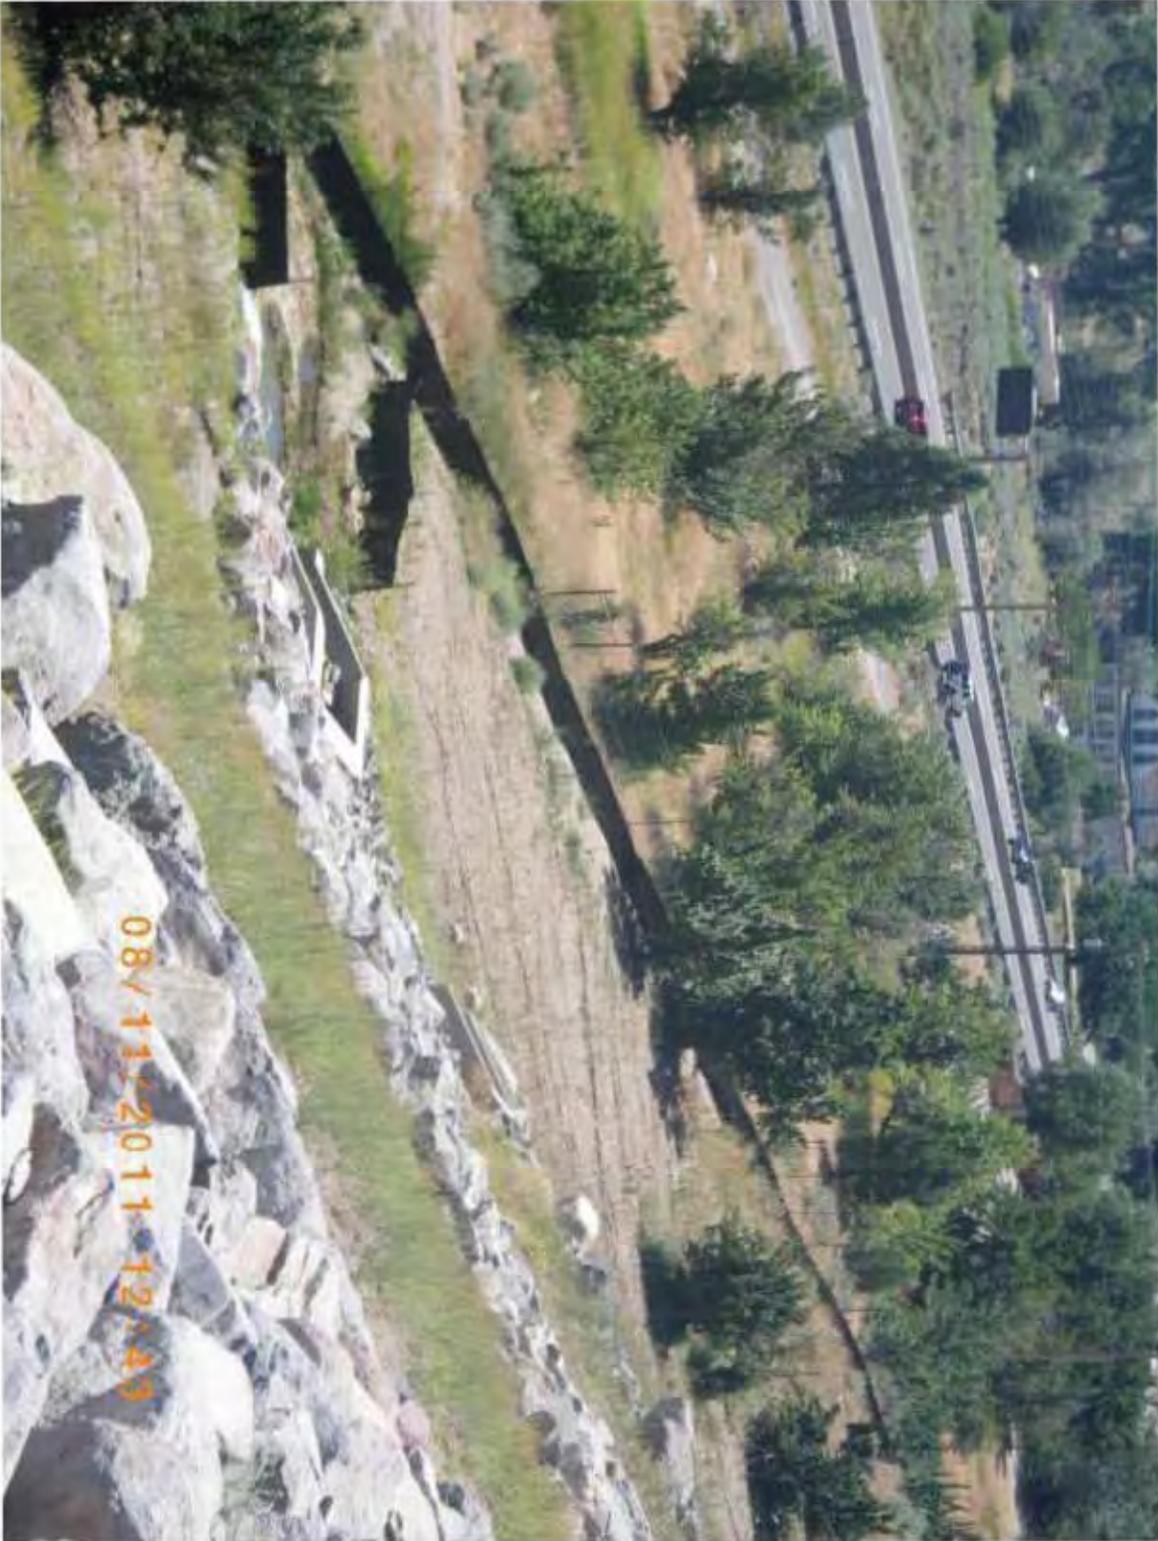
IMGP0185.JPG

**IMGP0185.JPG** – View looking southeast near Winters Creek. Note silt fences at toe of slope and Hwy 395 in the background. Considerable amounts of rock are also used to support the slope of hwy during and after construction.

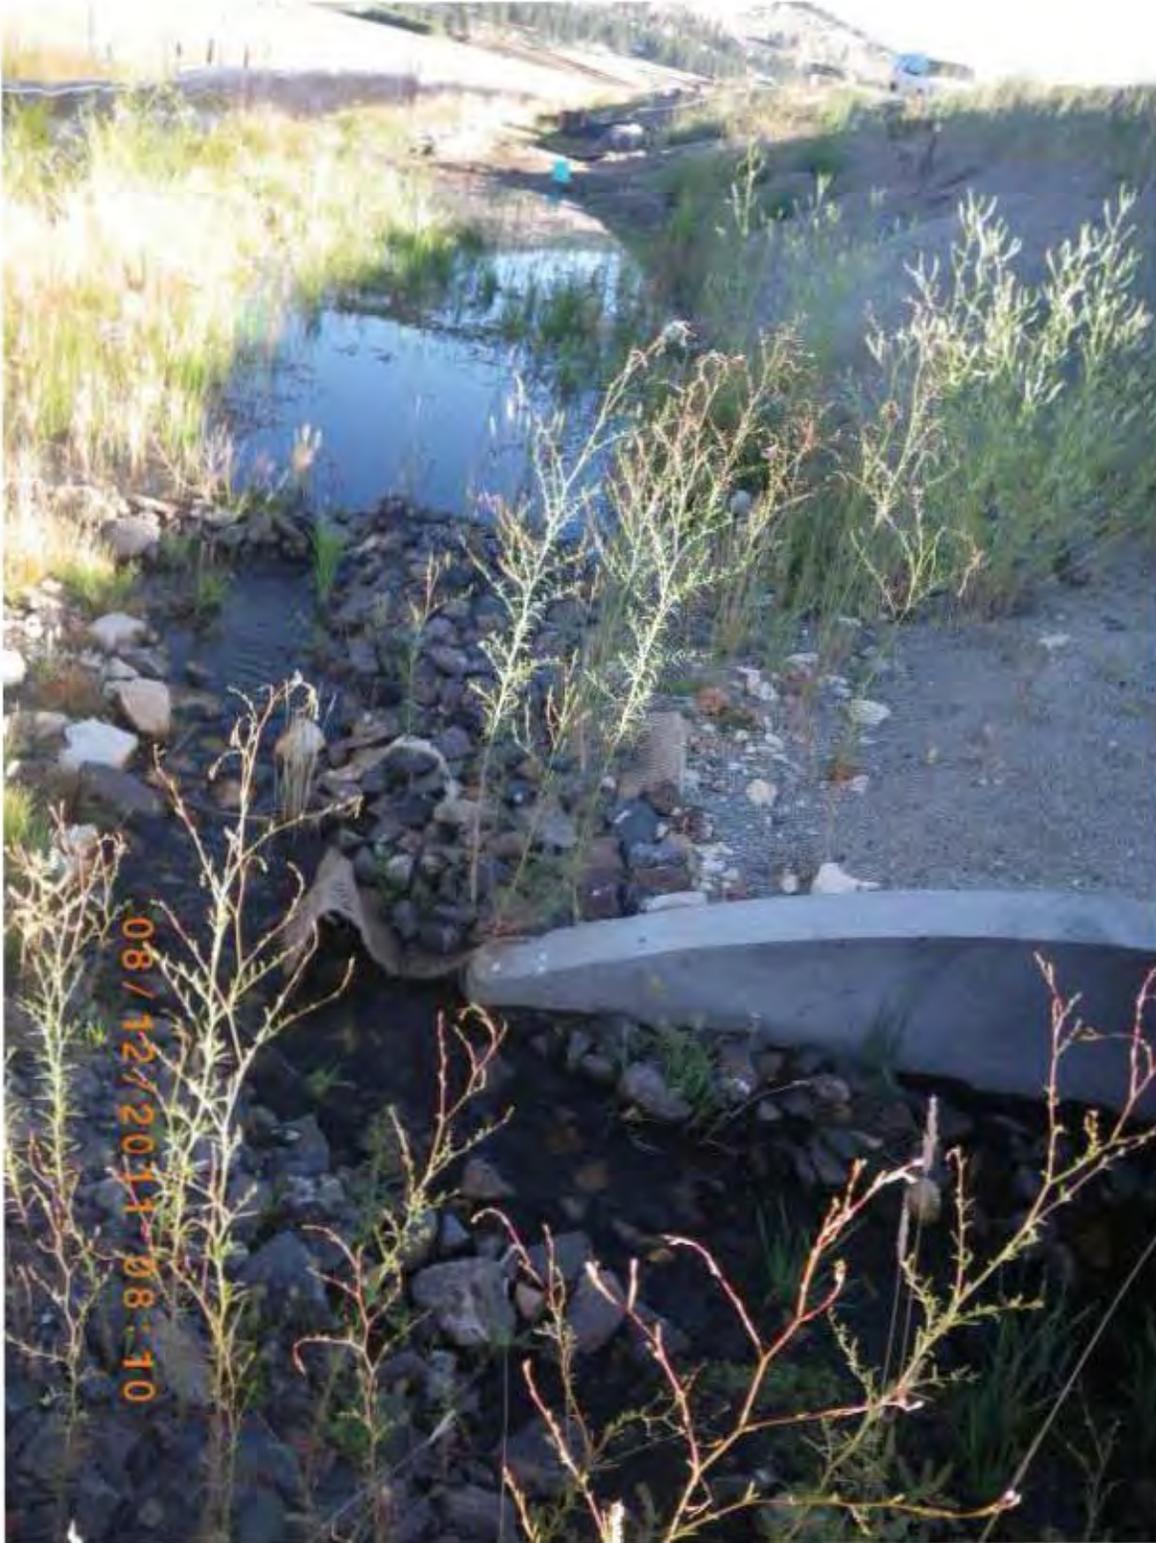
IMGP0208.JPG

**IMGP0208.JPG** – Water flowing along western edge of I-395 roadway. Note there is no silt fence at the toe of this slope. NDOT Contractors stated that the slope was too unstable and the wind through this area to high to use silt fence without damage or time-consuming maintenance. Instead of using silt fencing or other temporary erosion control BMPs, they have used drain pipes and gravel to direct flow off roadbed.

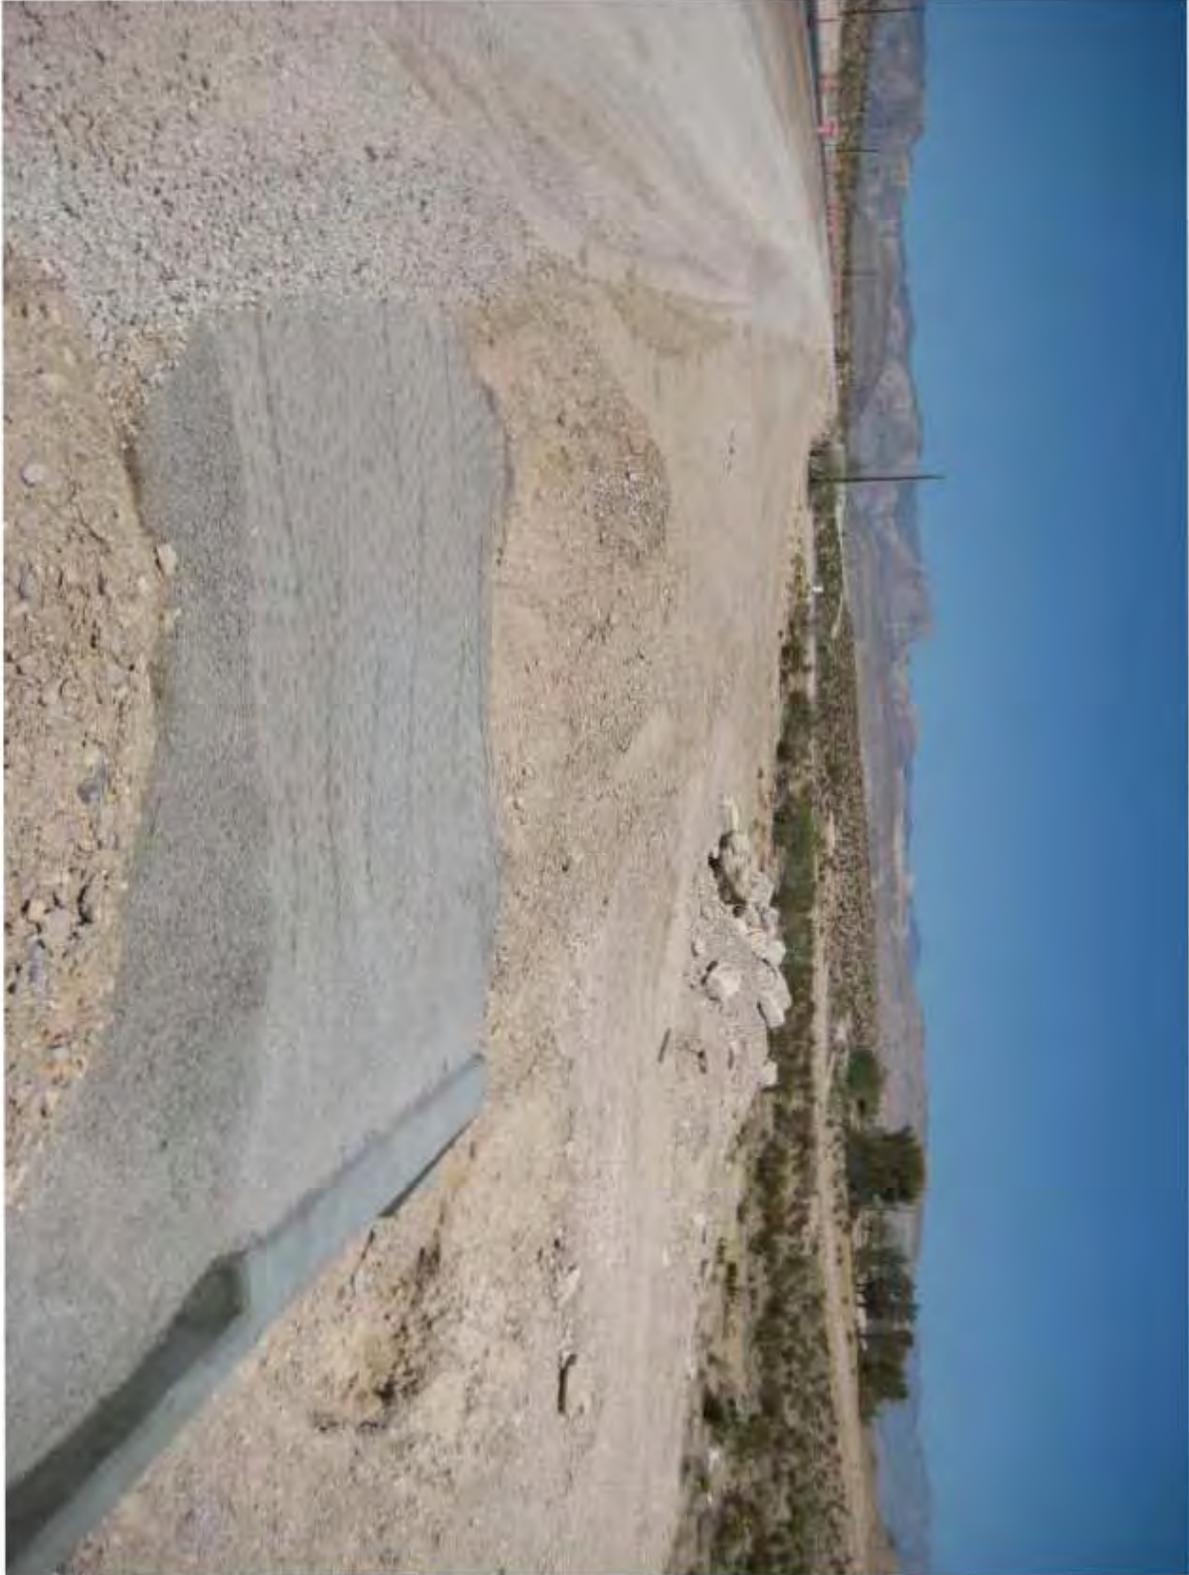
IMG\_4671.jpg

**IMG\_4671** - looking west, north side of highway. Example of BMPs improperly installed – waddles placed in wash. BMPs for all drainages were similarly installed incorrectly in channels.

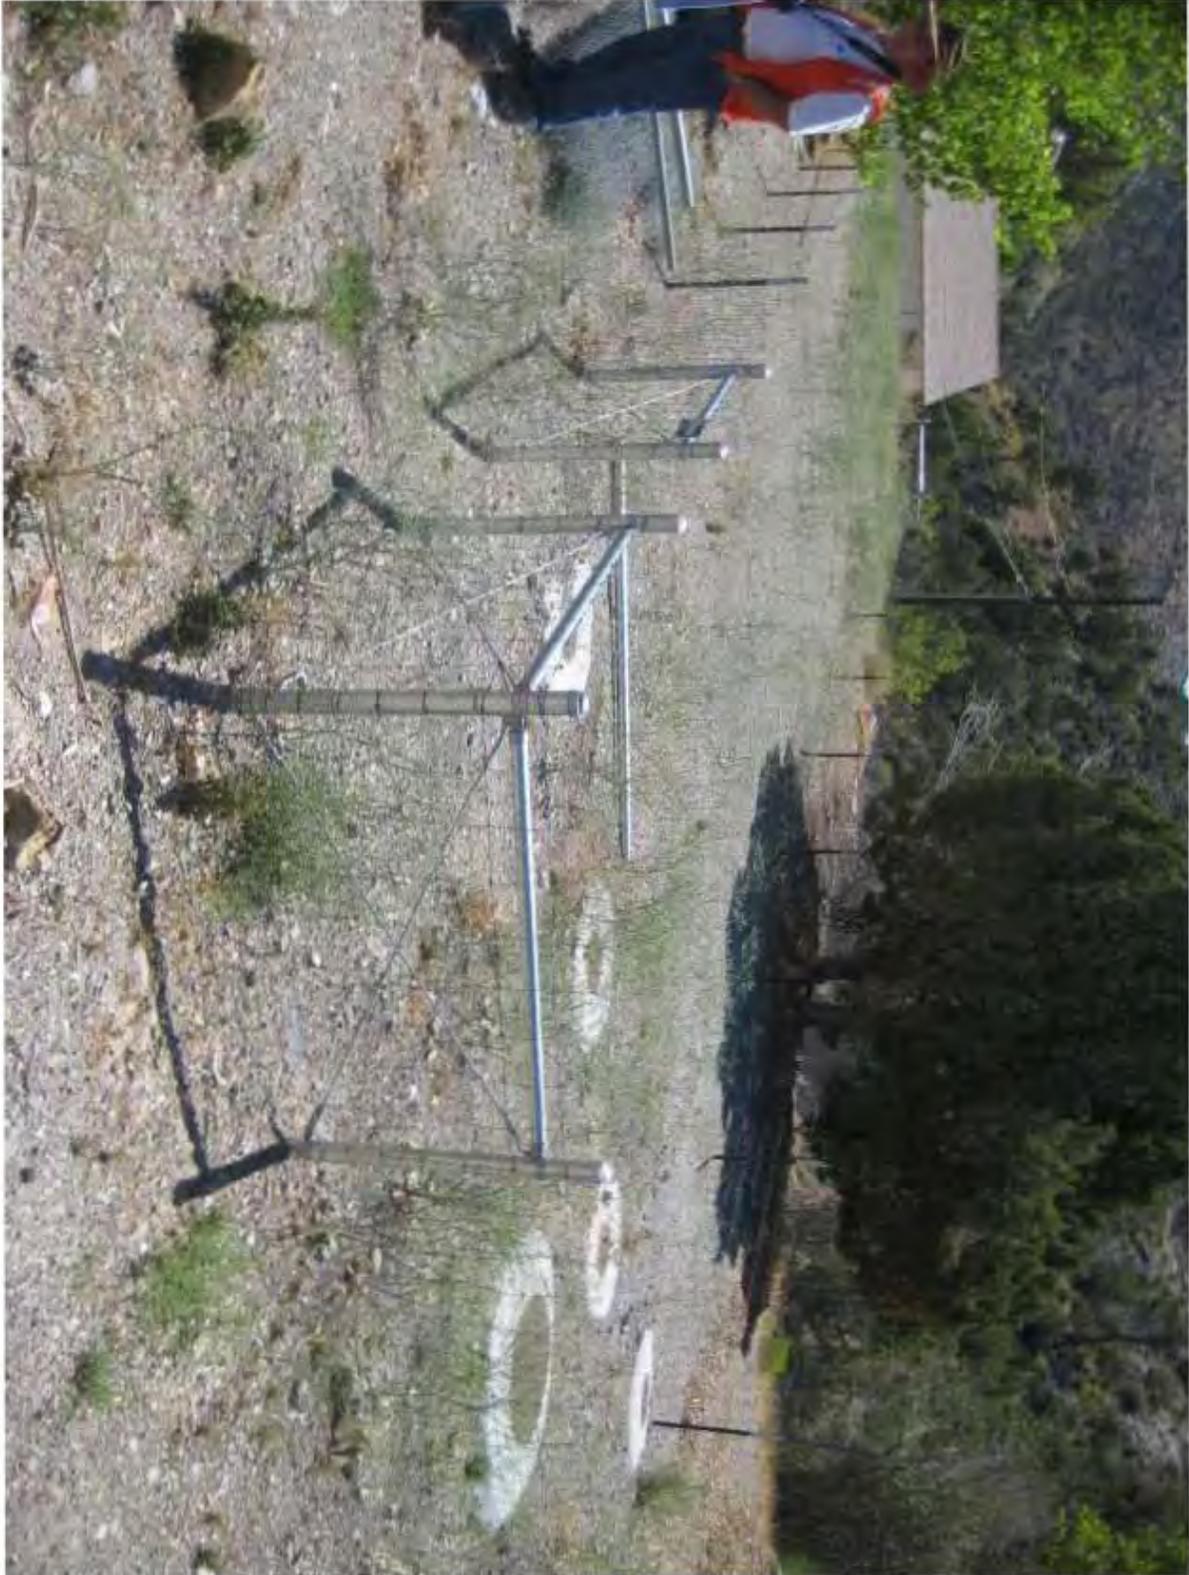
IMG\_4688.jpg

**IMG\_4688** – leach field from wash rack.

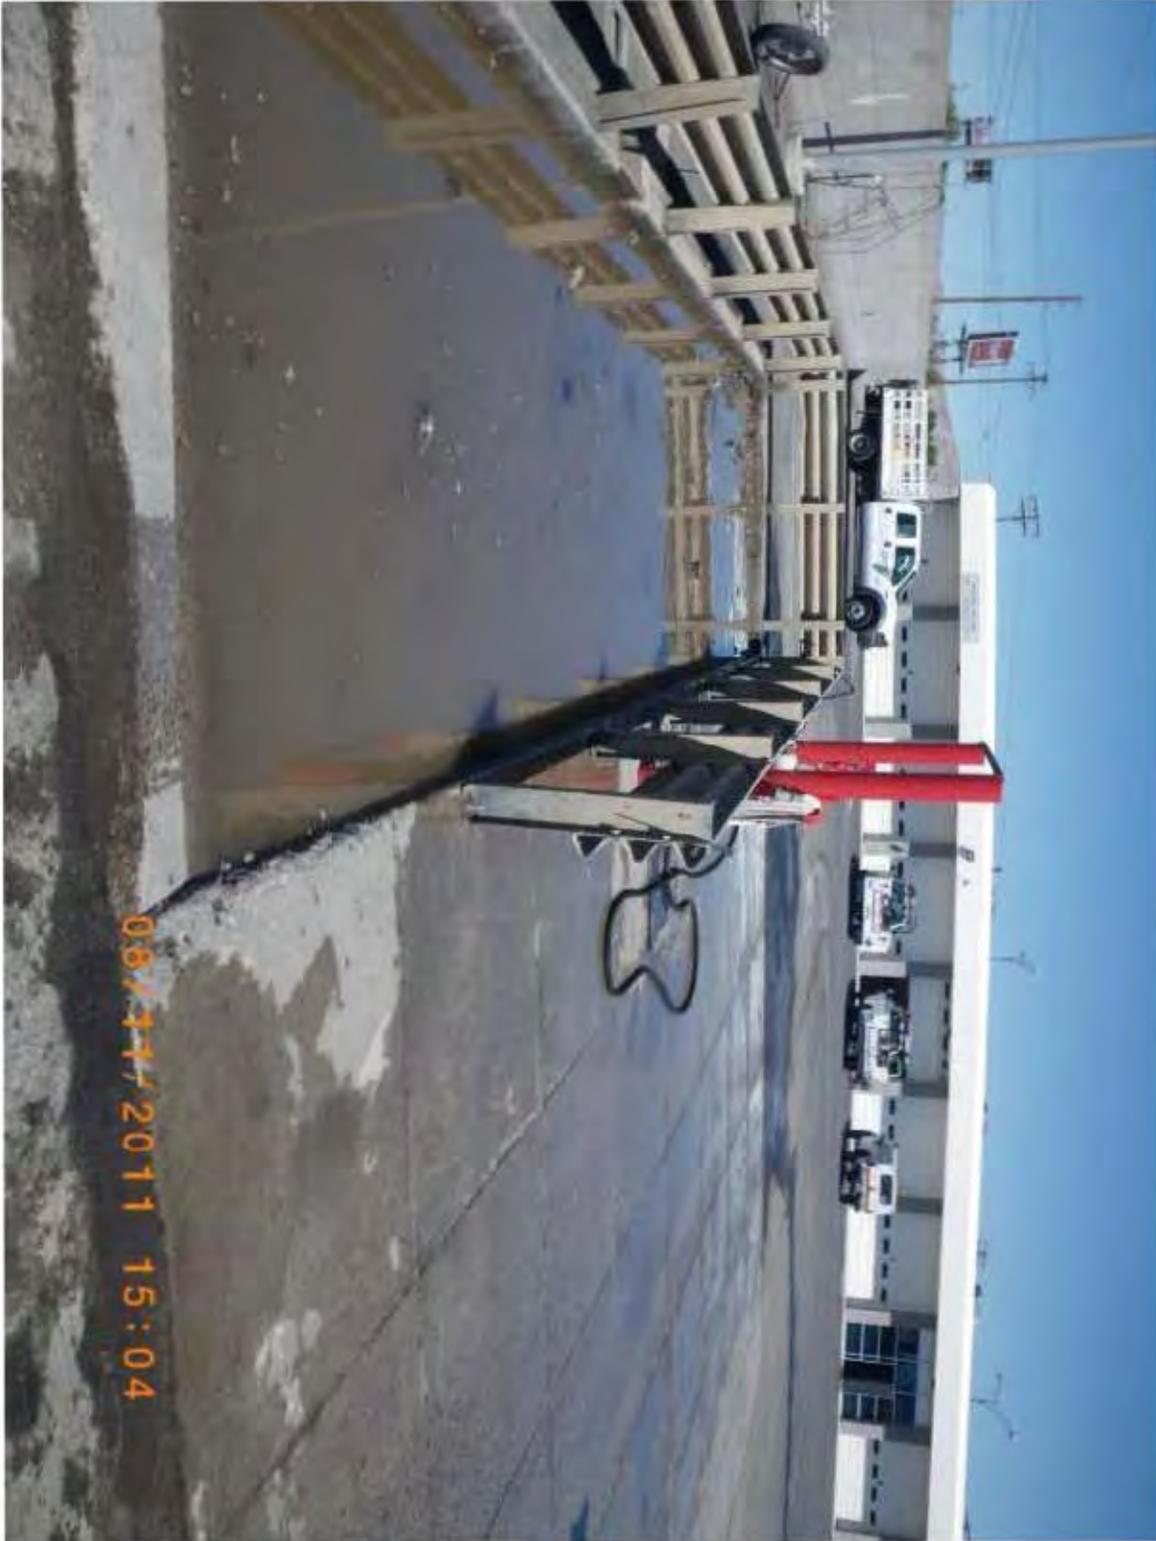
IMGP0186.JPG

- No SWPPP;
- Observed non-storm water discharges draining from an on-site tank truck (truck in distance of photo IMGP0188) to the ground and from its vehicle wash rack (photo IMGP0186). Both discharges were observed entering an unmarked on-site storm drain (photo IMGP0188);
- Observed a storm drain along the south eastern portion of the facility. Sandbags were partially blocking the storm drain inlet (photo IMGP0193). An NDOT representative looked over the fence to see if there was an apparent outlet, but he did not see one;
- Observed white staining on the asphalt from what appeared to be dry salt/brine solution along the asphalt/driveway surface near the drain but slightly to the west. This is consistent with the observation that NDOT was installing new brine mixing tanks in the vicinity (See photos IMGP0189, 0191, 0192);

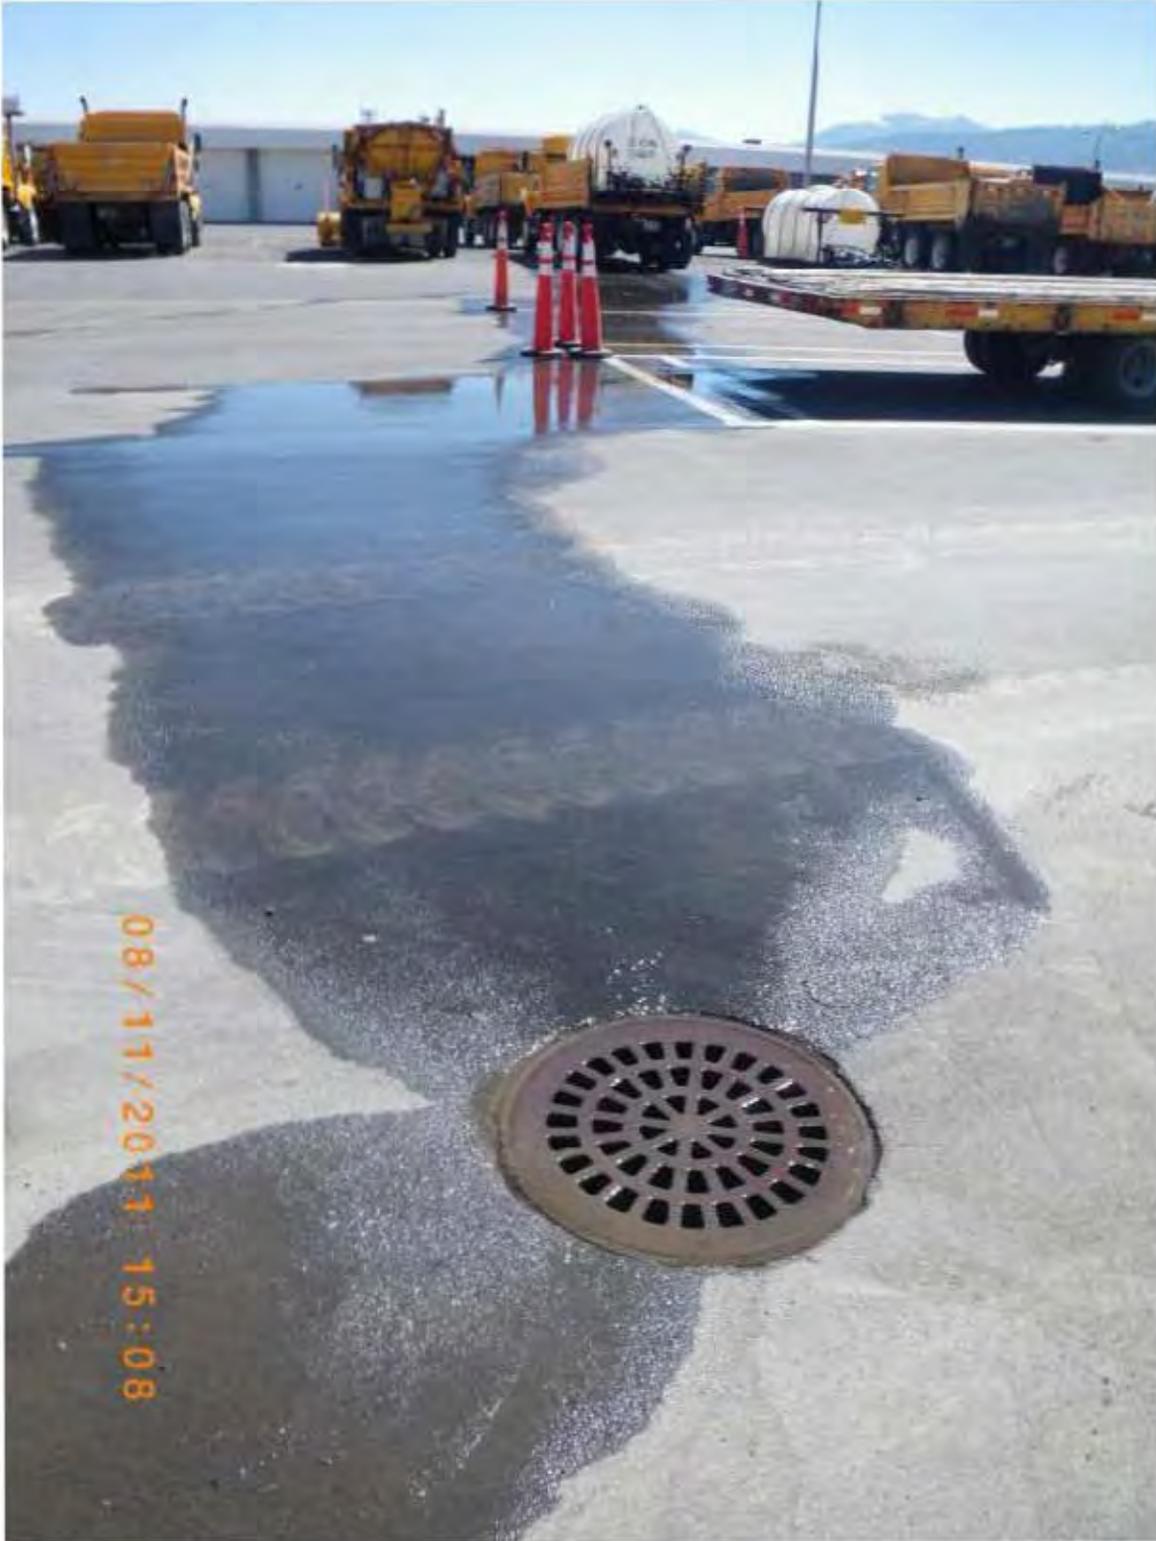
IMGP0188.JPG

**IMGP0188.JPG** – Reno Maintenance Facility (eastern portion) looking south at an on-site storm drain near the vehicle wash rack. Non-storm water entering the drain comes from two locations: a) from the truck holding the large white tank which had been discharging liquid at the time of the inspection and whose operator had just shut off the water valve immediately before this photo being taken; and b) from the truck wash pad to the north of where this photo was taken (see IMGP0186). Note that this drain (and all drains observed during the Reno Maintenance Facility Audit) did not have any markings to identify it or alert NDOT personnel that certain non-stormwater discharges are not allowed.

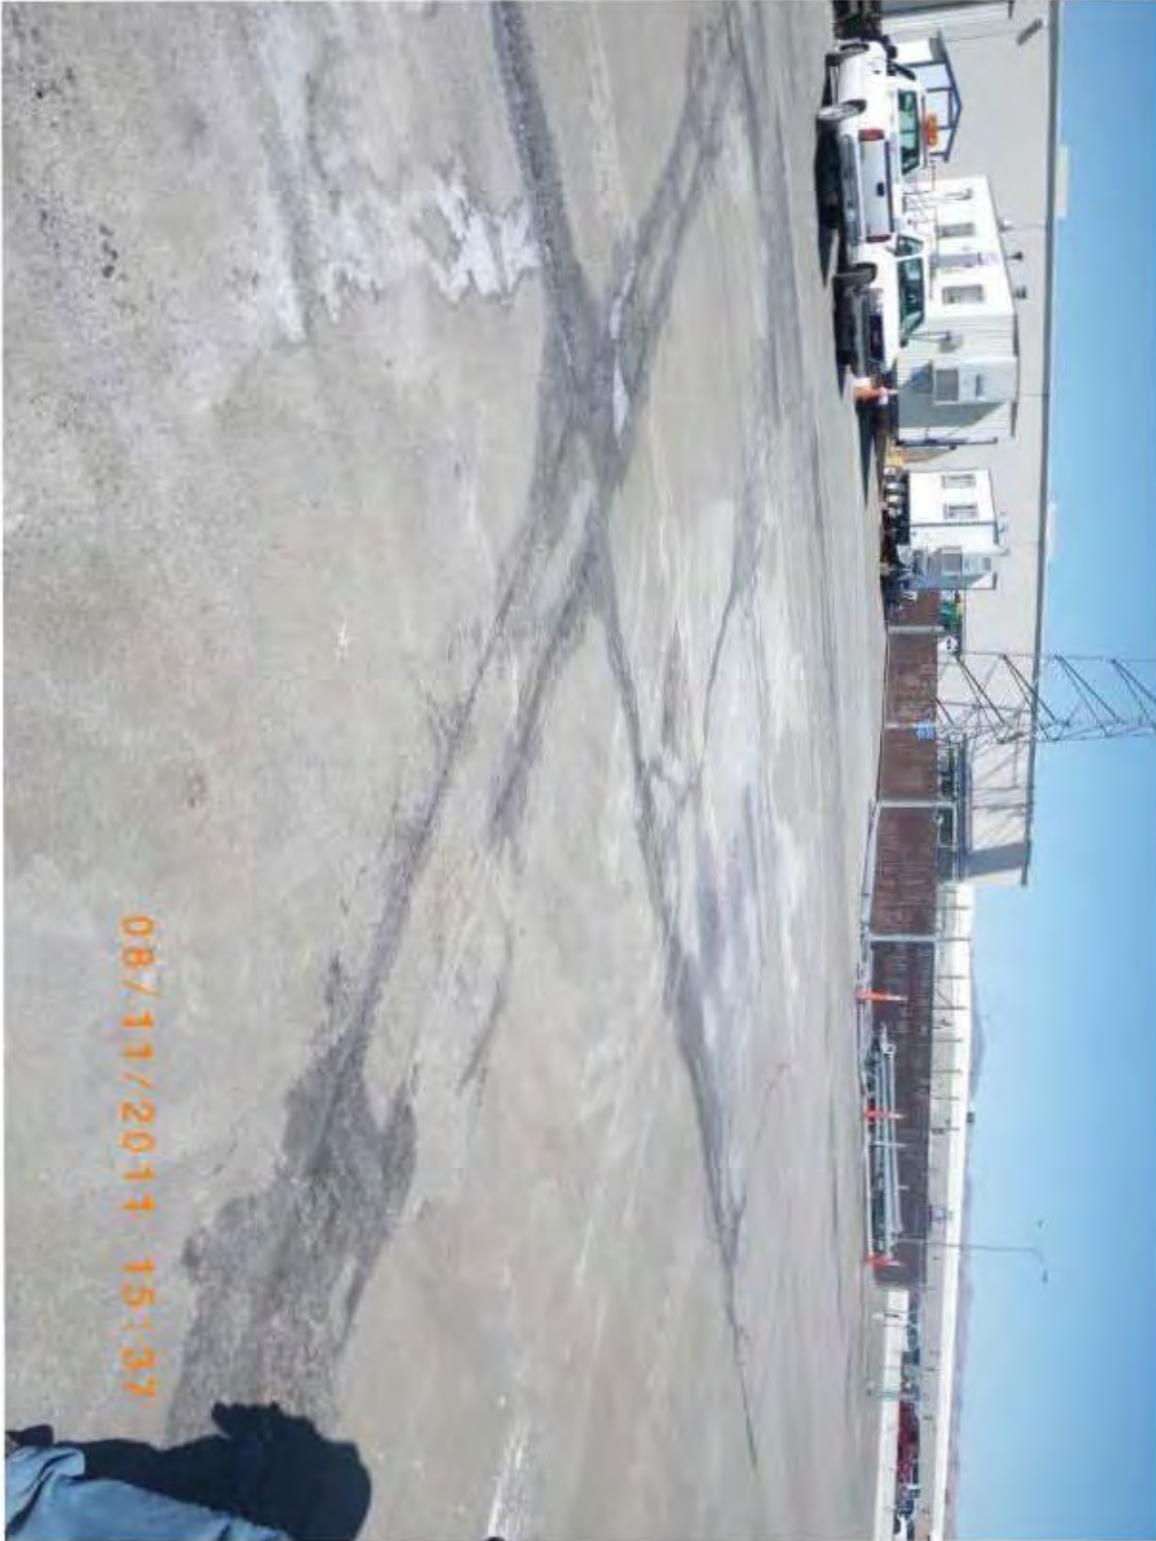
IMGP0189.JPG

**IMGP0189.JPG** – Looking northeast at brine/salt staining on ground outside brine mixing building (photo IMGP0190) at the NDOT Reno Maintenance Yard (western portion). The stains shown in this picture are in the same vicinity as the stains shown in photo IMGP0191 (note stacked pipes behind orange cones are the same as those seen in 0191).

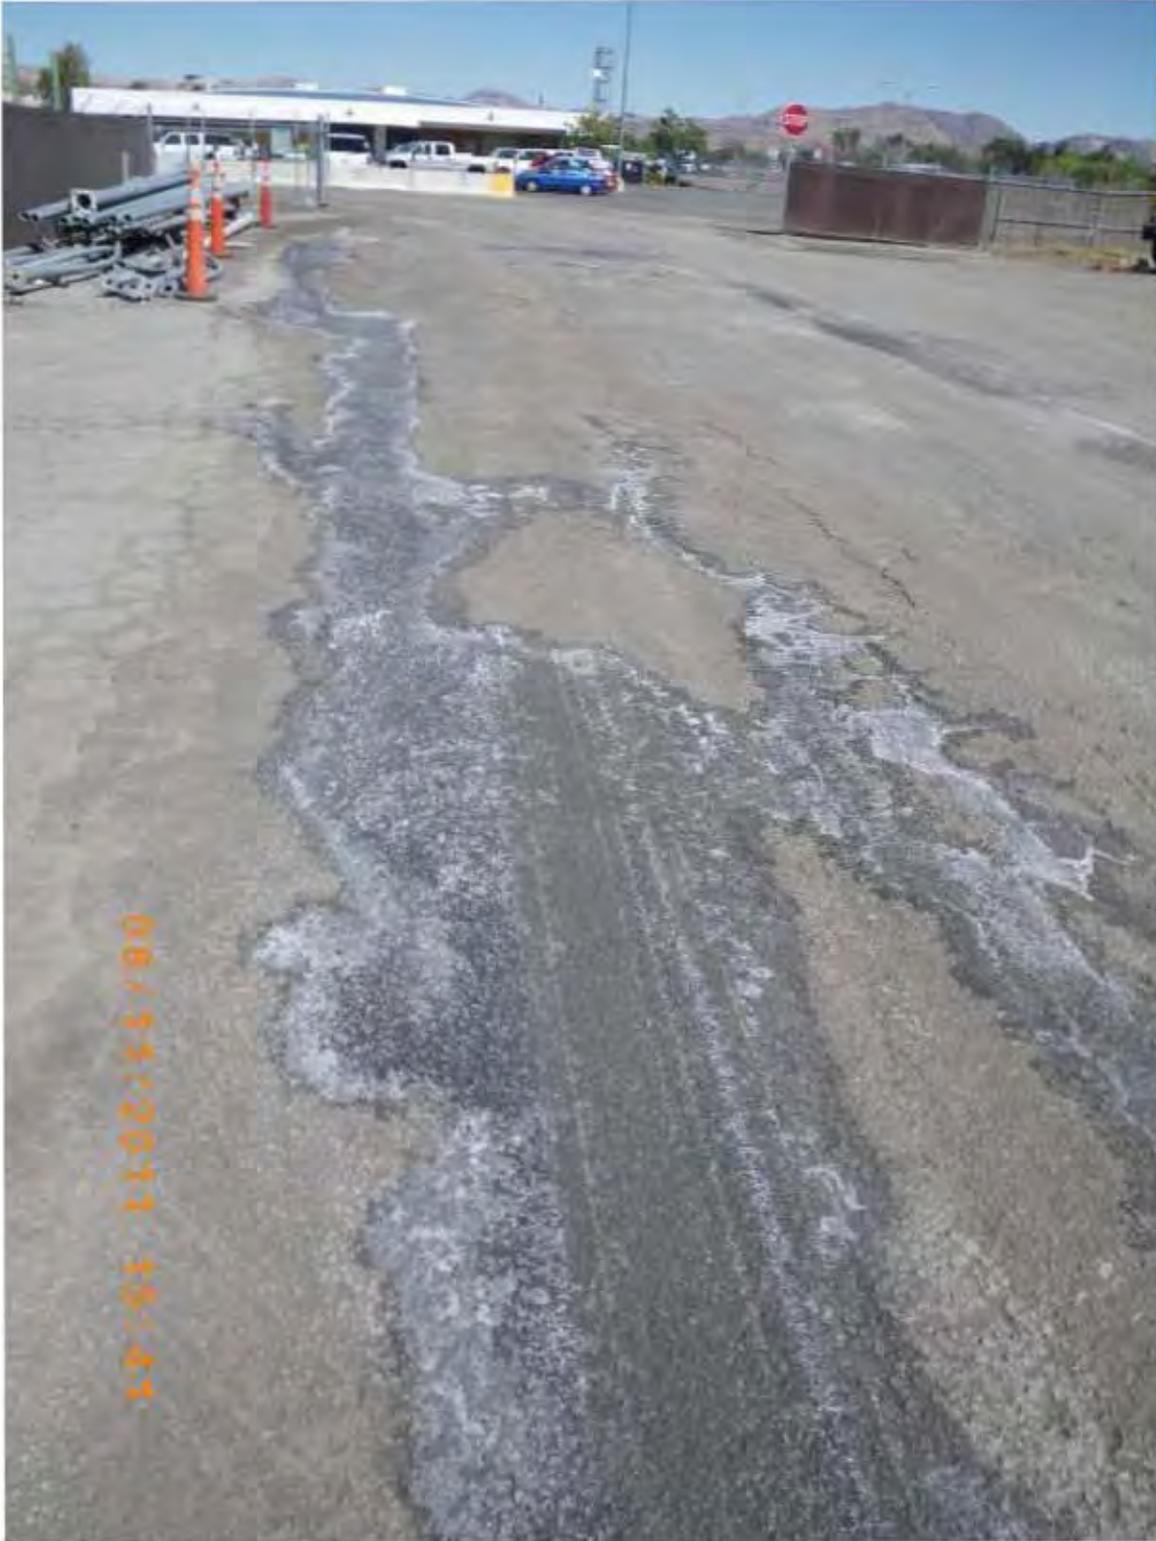
IMGP0191.JPG

**IMGP0191.JPG** – Looking east at NDOT Maintenance Yard (western portion). Brine staining on ground may have originated from recent brine tank maintenance and construction. See photo IMGP0190.
