UNITED STATES ENVIRONMENTAL PROTECTION AGENCY  
REGION IX  
75 Hawthorne Street  
San Francisco, CA 94105-3901

Enclosed is the U.S. Environmental Protection Agency's (EPA) report of the Nevada Department on the Transportation (NDOT) Storm Water Management Program (Program) Audit. Representatives from EPA Region 9 and the Nevada Department of Environmental Protection (NDEP) conducted the Audit from August 9 – 12, 2011.

**MS4 Audit Report**

## **NDOT MS4 Audit Photo Log – Carson City Maintenance Facility 8.10.2011**

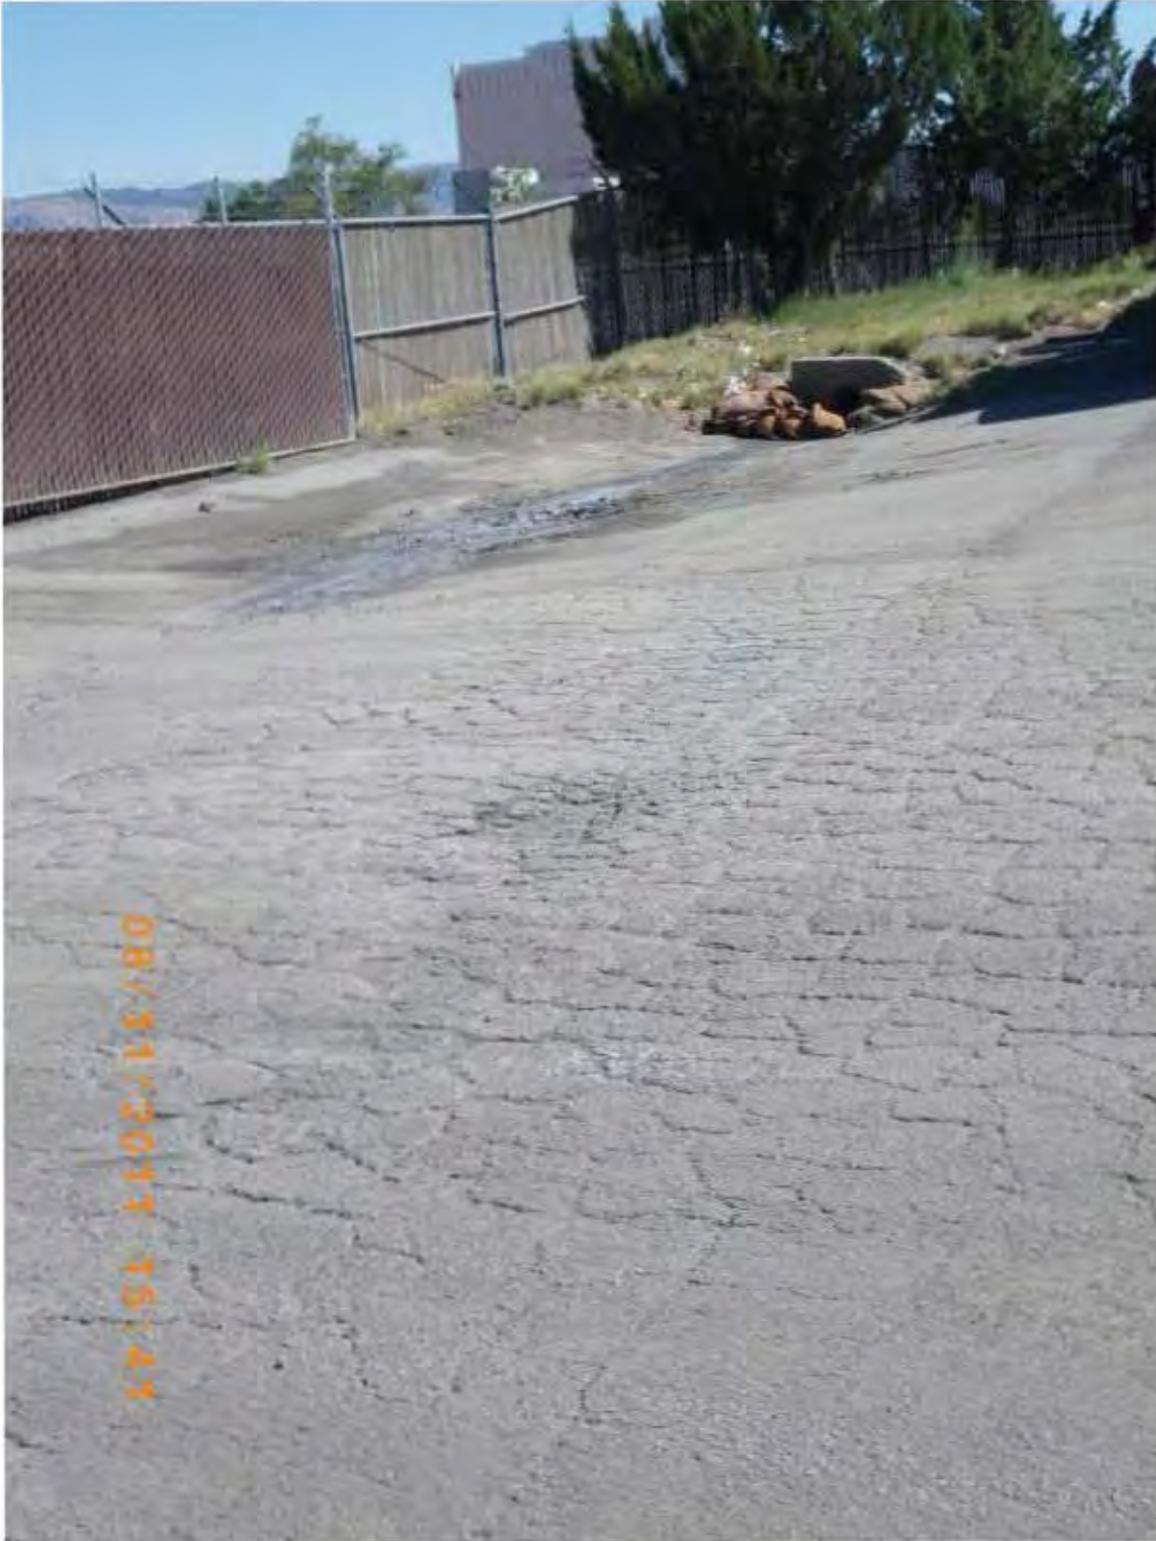
IMGP0192.JPG

**IMGP0192.JPG** – Picture looking southeast shows sandbags in place around drain shown in picture IMGP0193. Brine/salt staining shown on Maintenance Yard (western portion) ground in picture IMGP0191 is to the right but just out of this photo.

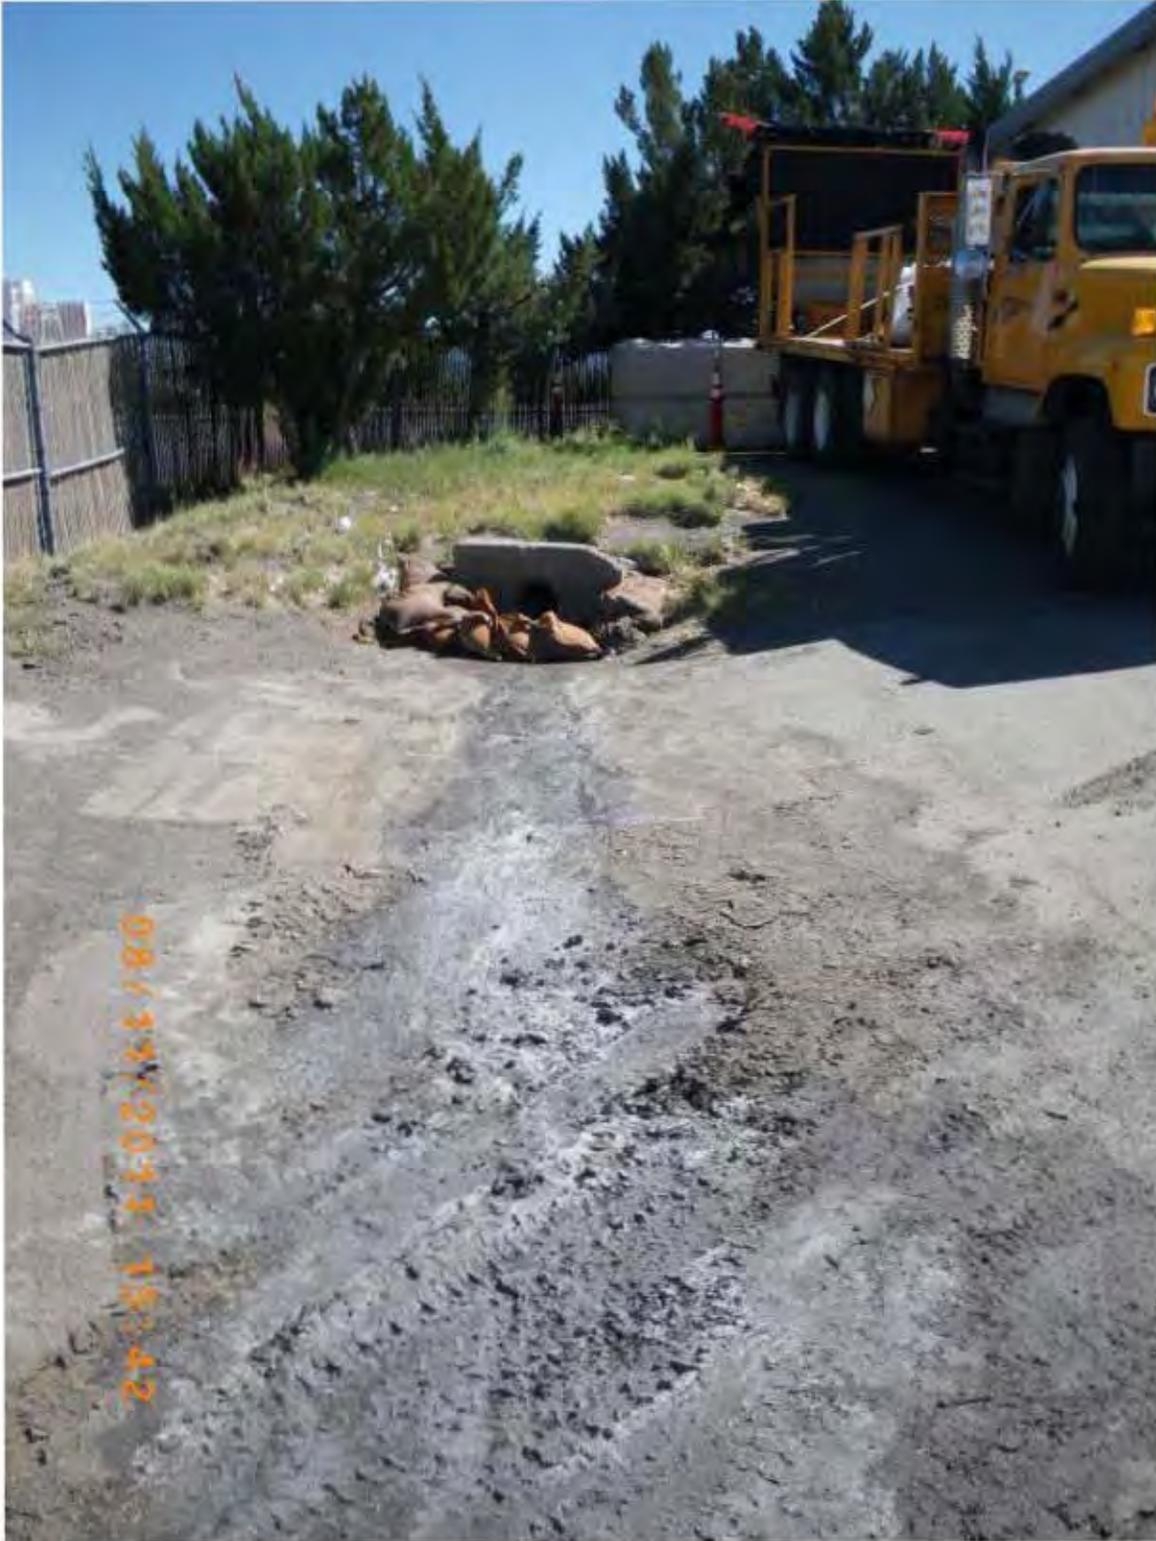
IMGP0193.JPG

**IMGP0193.JPG** – Looking south at wet sediment with salt/brine staining at the Reno Maintenance Yard (western portion). Drain in background is located along the southern edge of the property next to N. Kietzke Lane (NV Route 667) but to the east of drain shown in IMGP0195. Sandbags were in place to prevent some material from entering the drain. NDOT employees joining the inspection did not know the location of the outfall of this drain. The Truckee River is immediately to the south of the property, just across N. Kietzke Lane (NV Route 667).

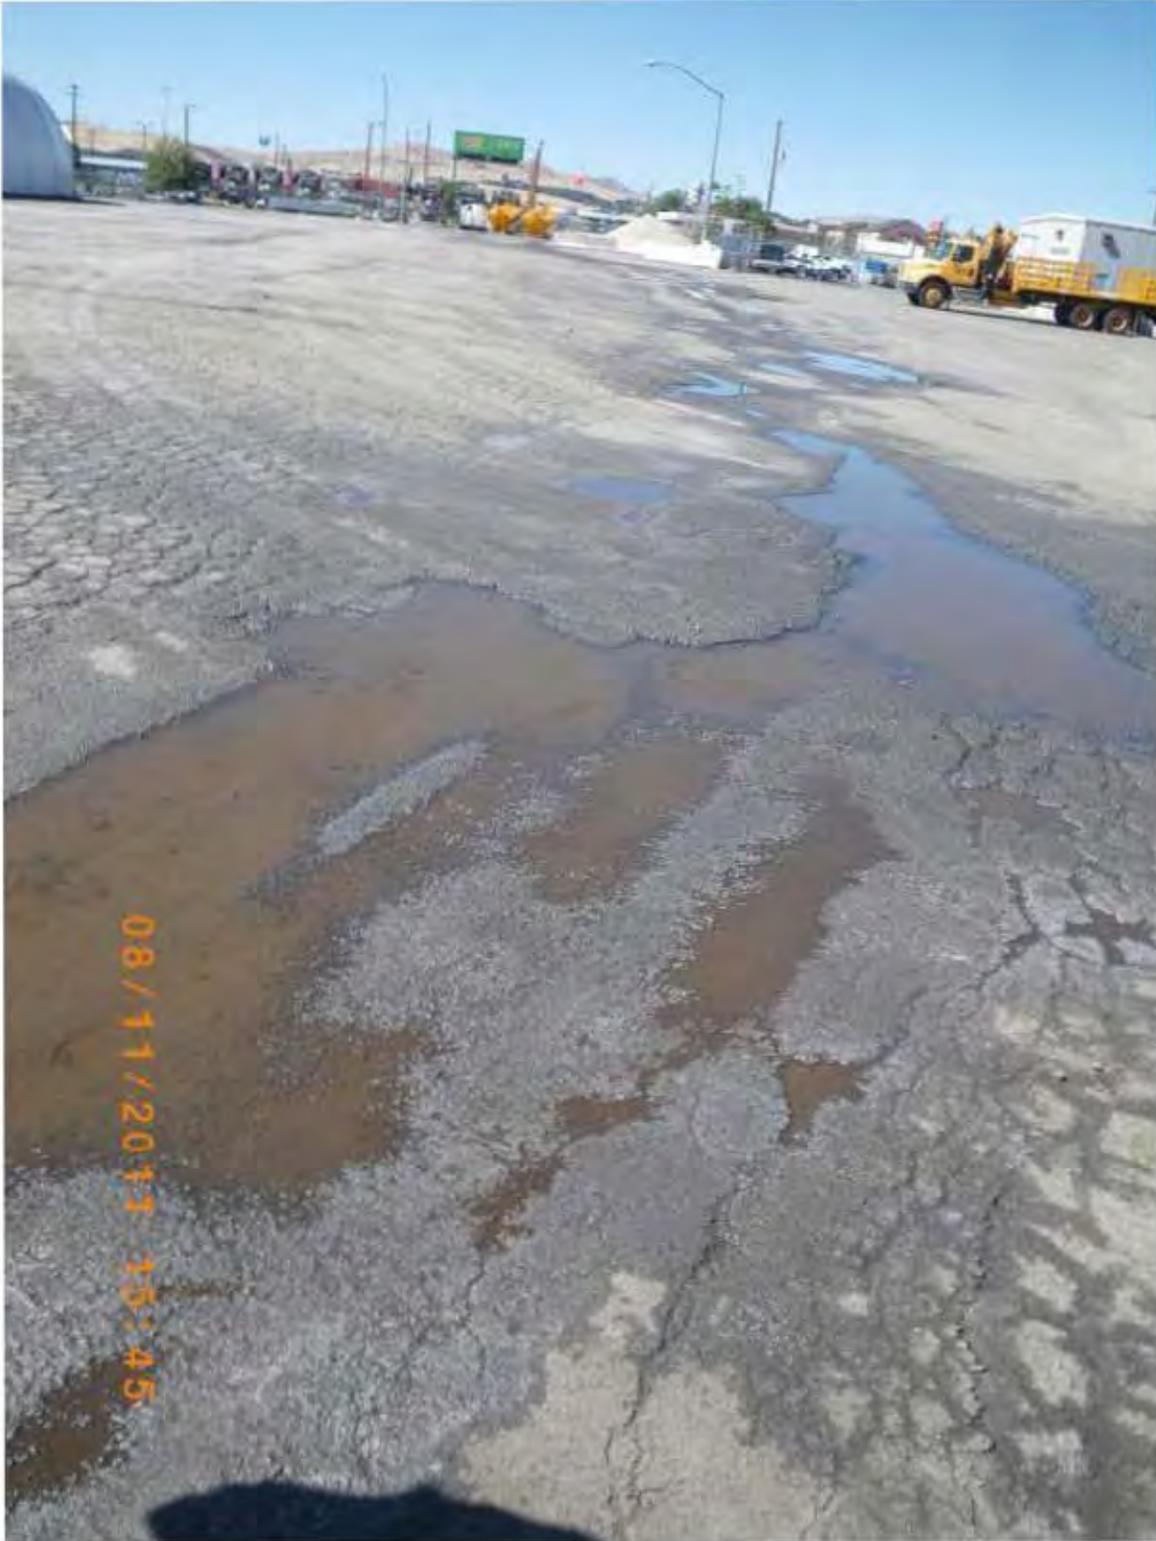
IMGP0194.JPG

- Observed discharge on the ground (IMGP0194) from a water truck filling station in the distance (IMGP0198). Water on the ground in photo IMGP0194 drained to an unmarked storm drain in far southwest corner of maintenance facility (IMGP0195). Furthermore, water shown in the drain includes waste water from a vactor decant site (IMGP0197) uphill from the drain. At the drain, BMPs were in place (e.g., straw waddles, sandbags, and sand/oil separator). NDOT representative stated that discharge from the drain (IMGP0196) goes directly to Truckee River (to the west) after passing through an oil/sand separator immediately downstream of the drain on the property line of the NDOT facility. We saw the vactor decant site and the indoor salt/sand storage facility (big tented structure in photo IMGP0198);

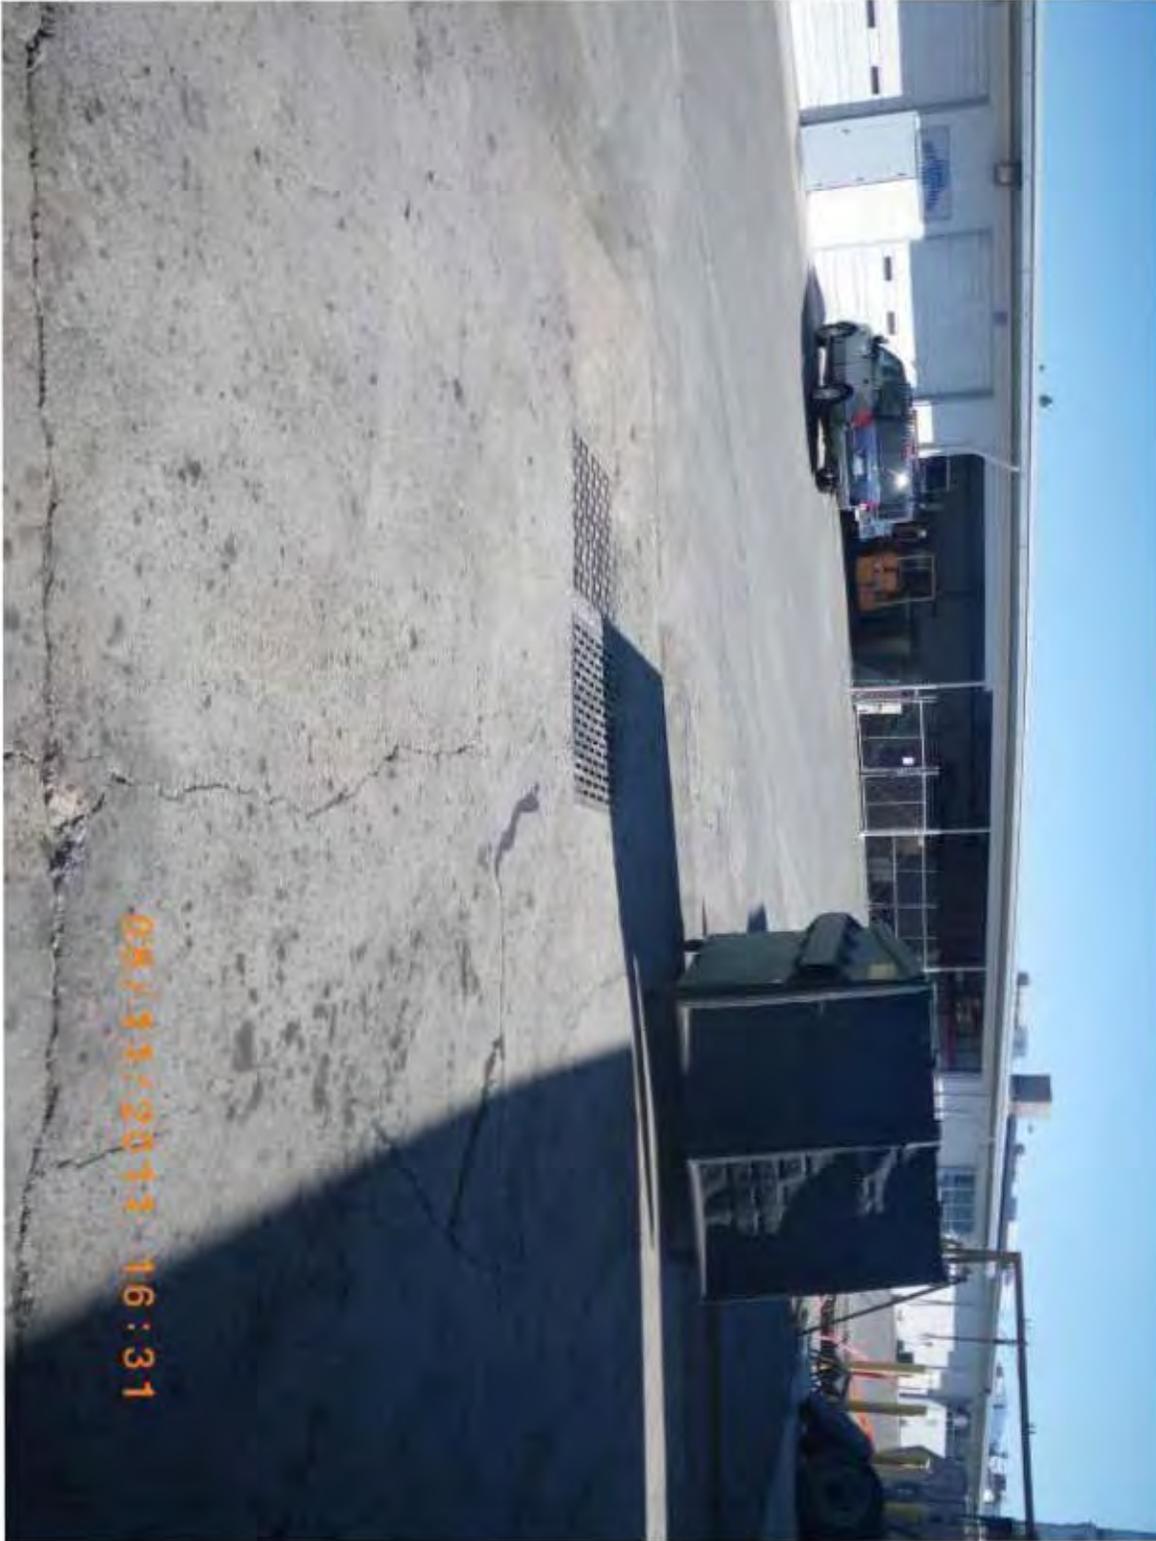
IMGP0199.JPG

**IMGP0199.JPG** – Wash Rack Drainage inlets at Reno Maintenance – Vehicle/Equipment Repair Shop. The Vehicle/Equipment repair shop is separately managed and across Galletti Way to the east from the Reno Maintenance Yard. The wash rack is not shown in the photo but is located slightly behind and to the right in the photo. The area was dry and no vehicles were being cleaned at the time.

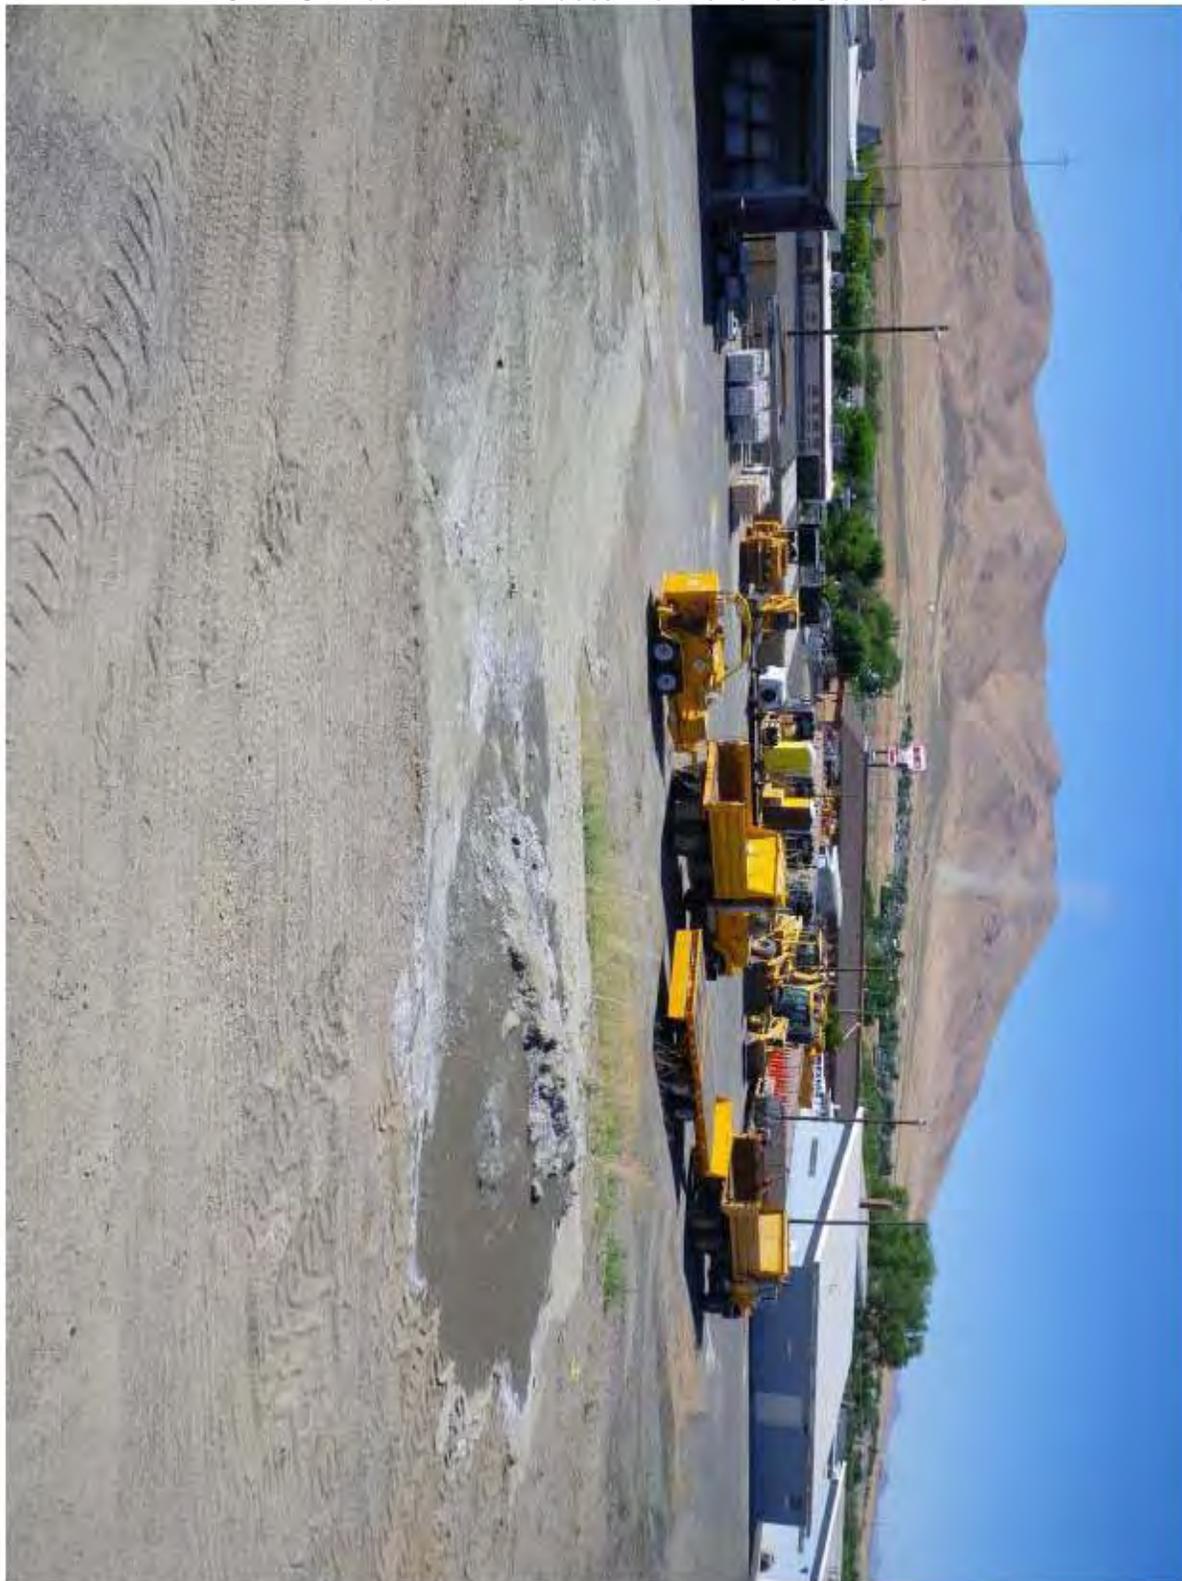
IMGP0682.JPG

**IMGP0682** – Wash rack and catchment basin. Inspection participants observed a vehicle get rinsed and that the site-engineering appropriately directed the rinsate to the catchment basin.

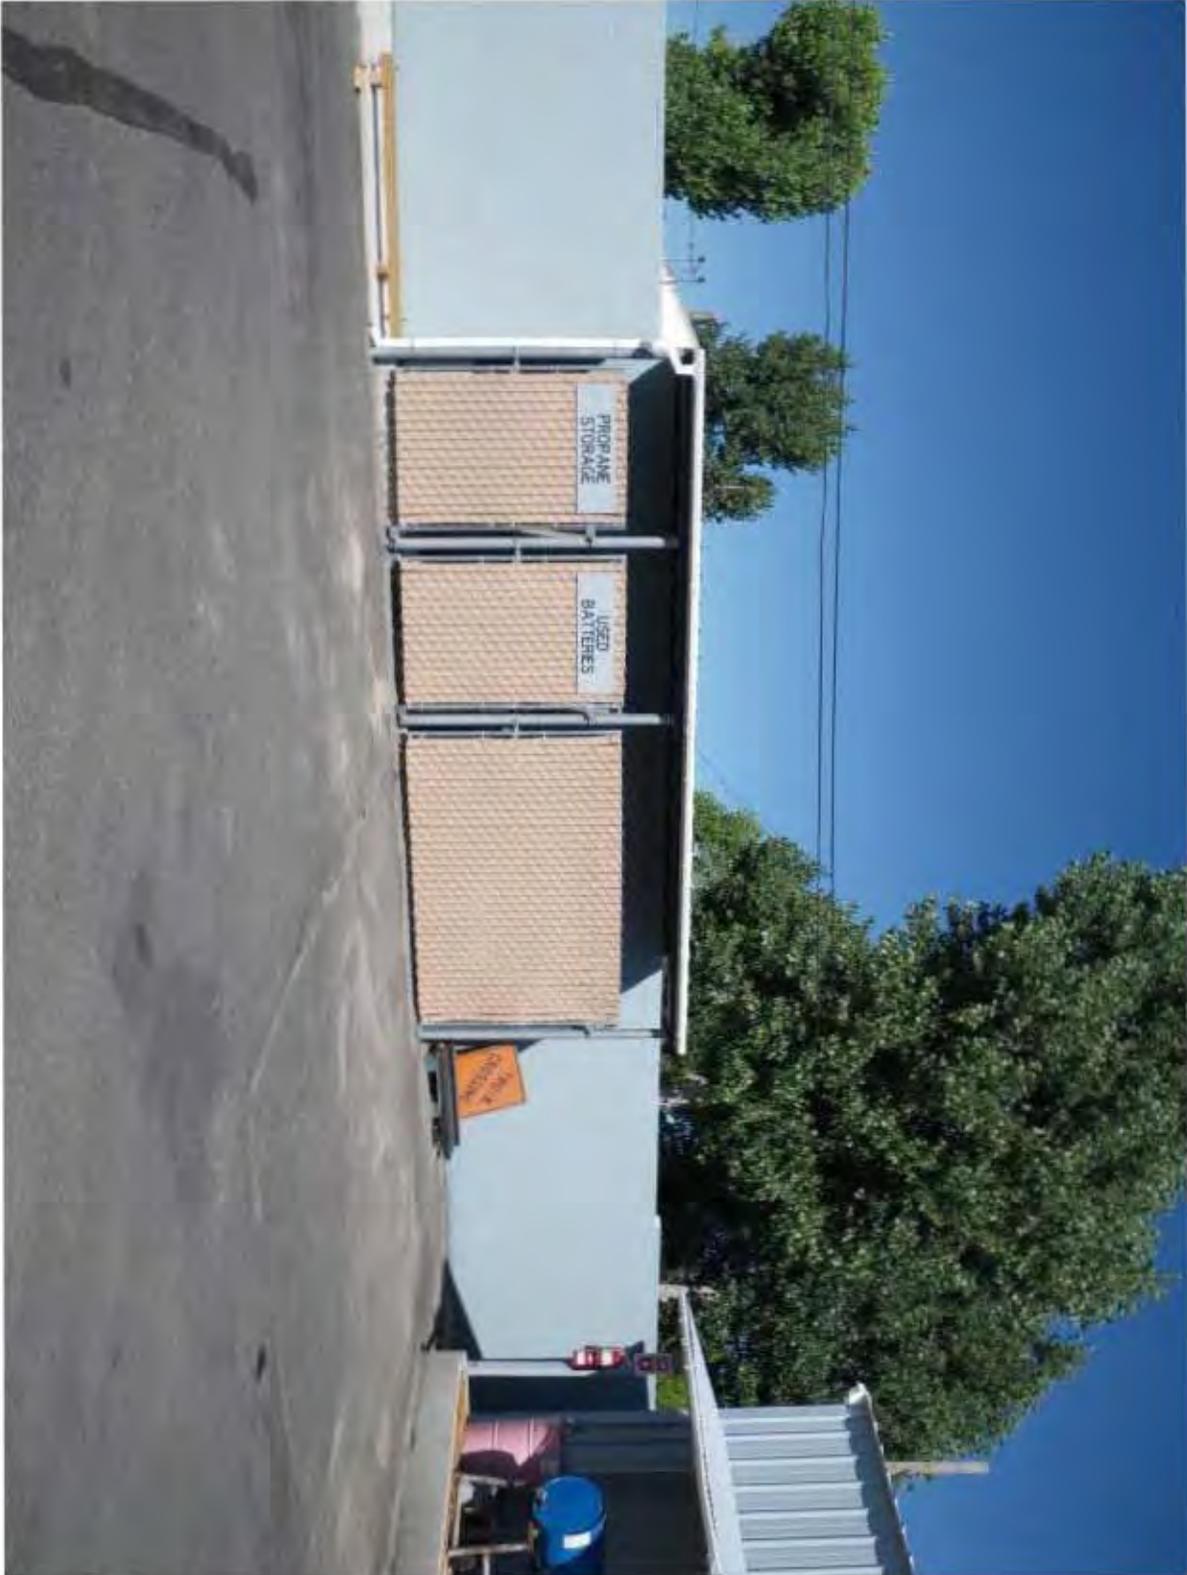
IMGP0684.JPG

**IMGP0684** – Covered and screened hazardous materials staging areas.

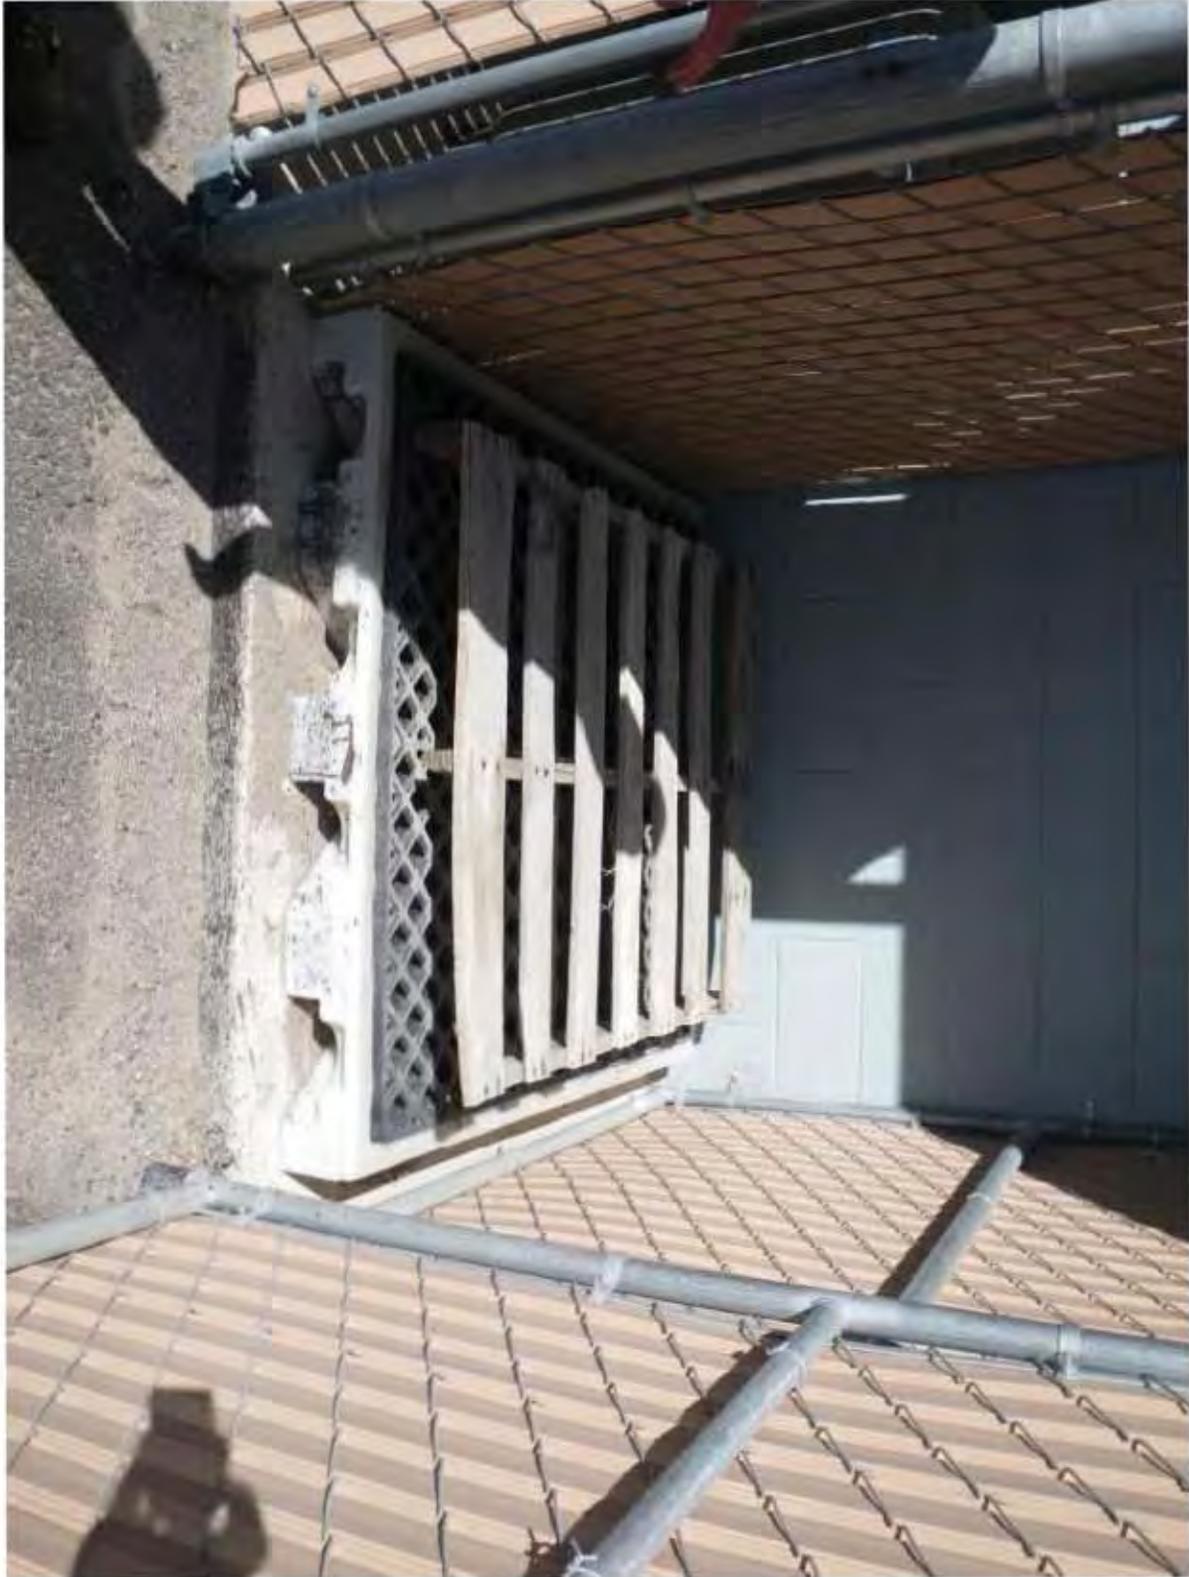
IMGP0686.JPG

**IMGP0686** – Secondary containment platform within the covered and screened hazardous materials staging area, used battery staging area is depicted.

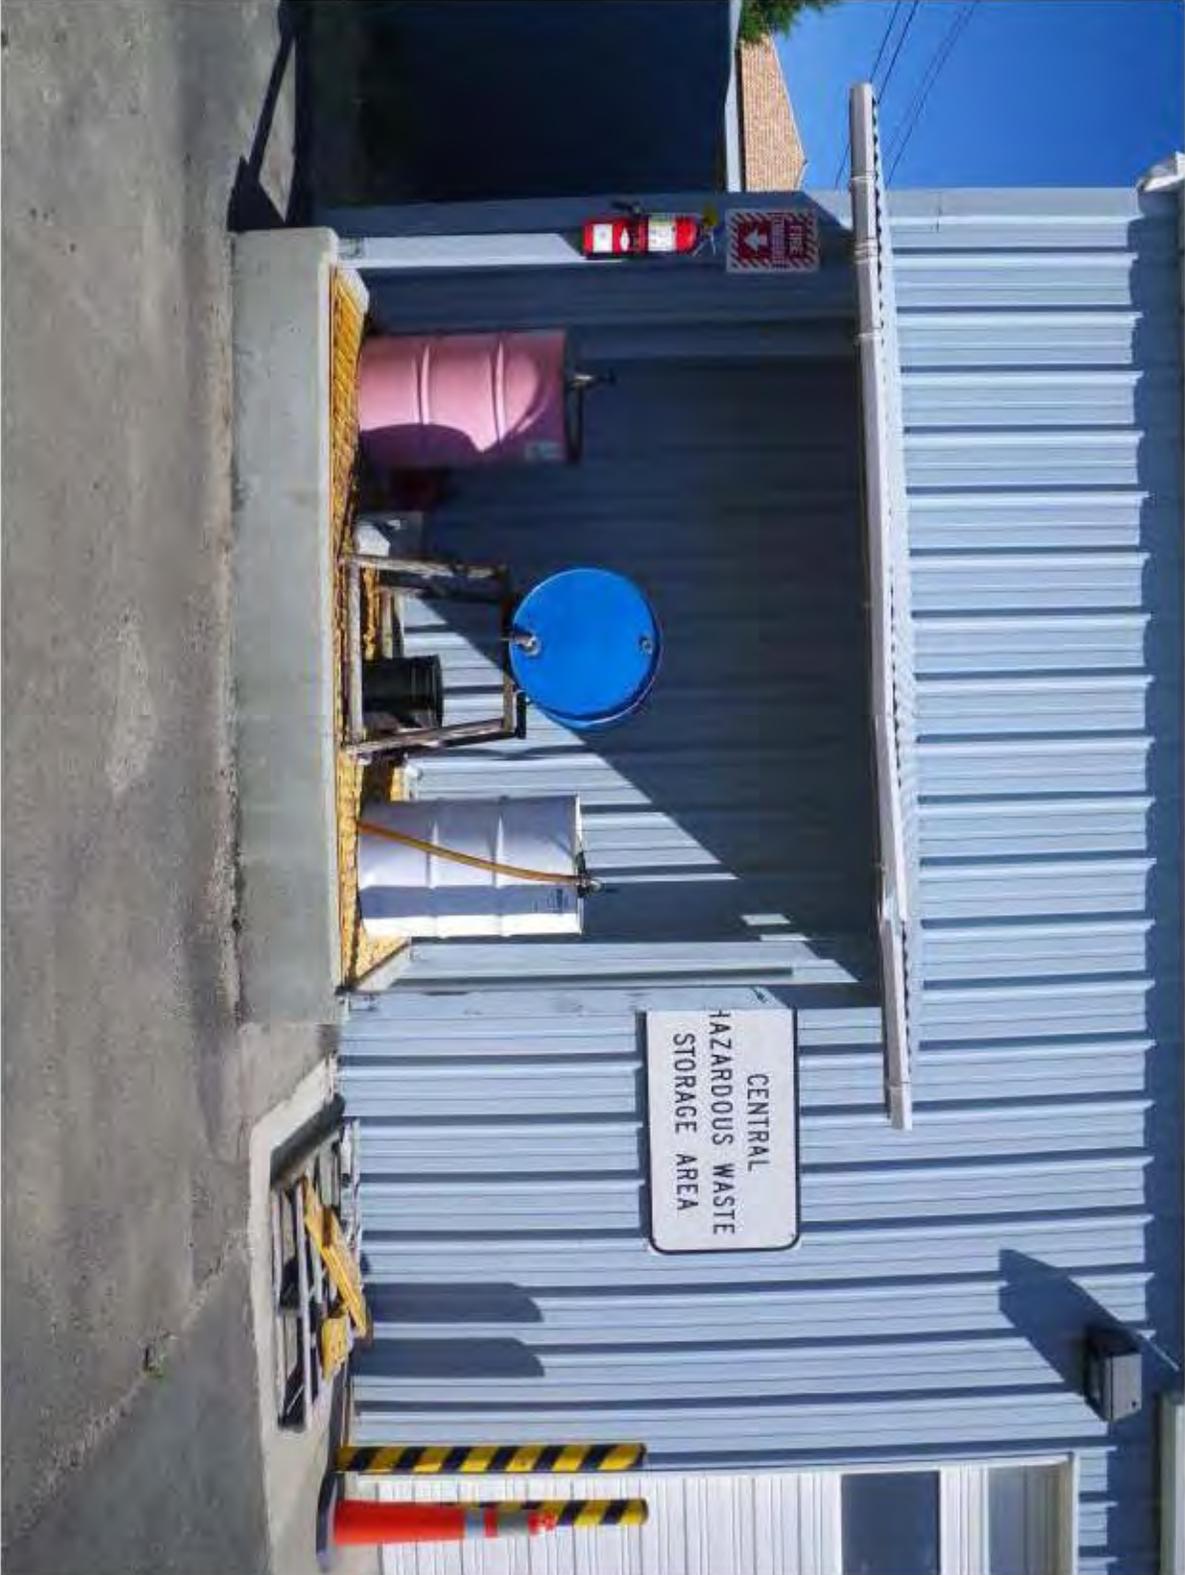
IMGP0687.JPG

**IMGP0687** – Covered and contained, central hazardous waste storage area.

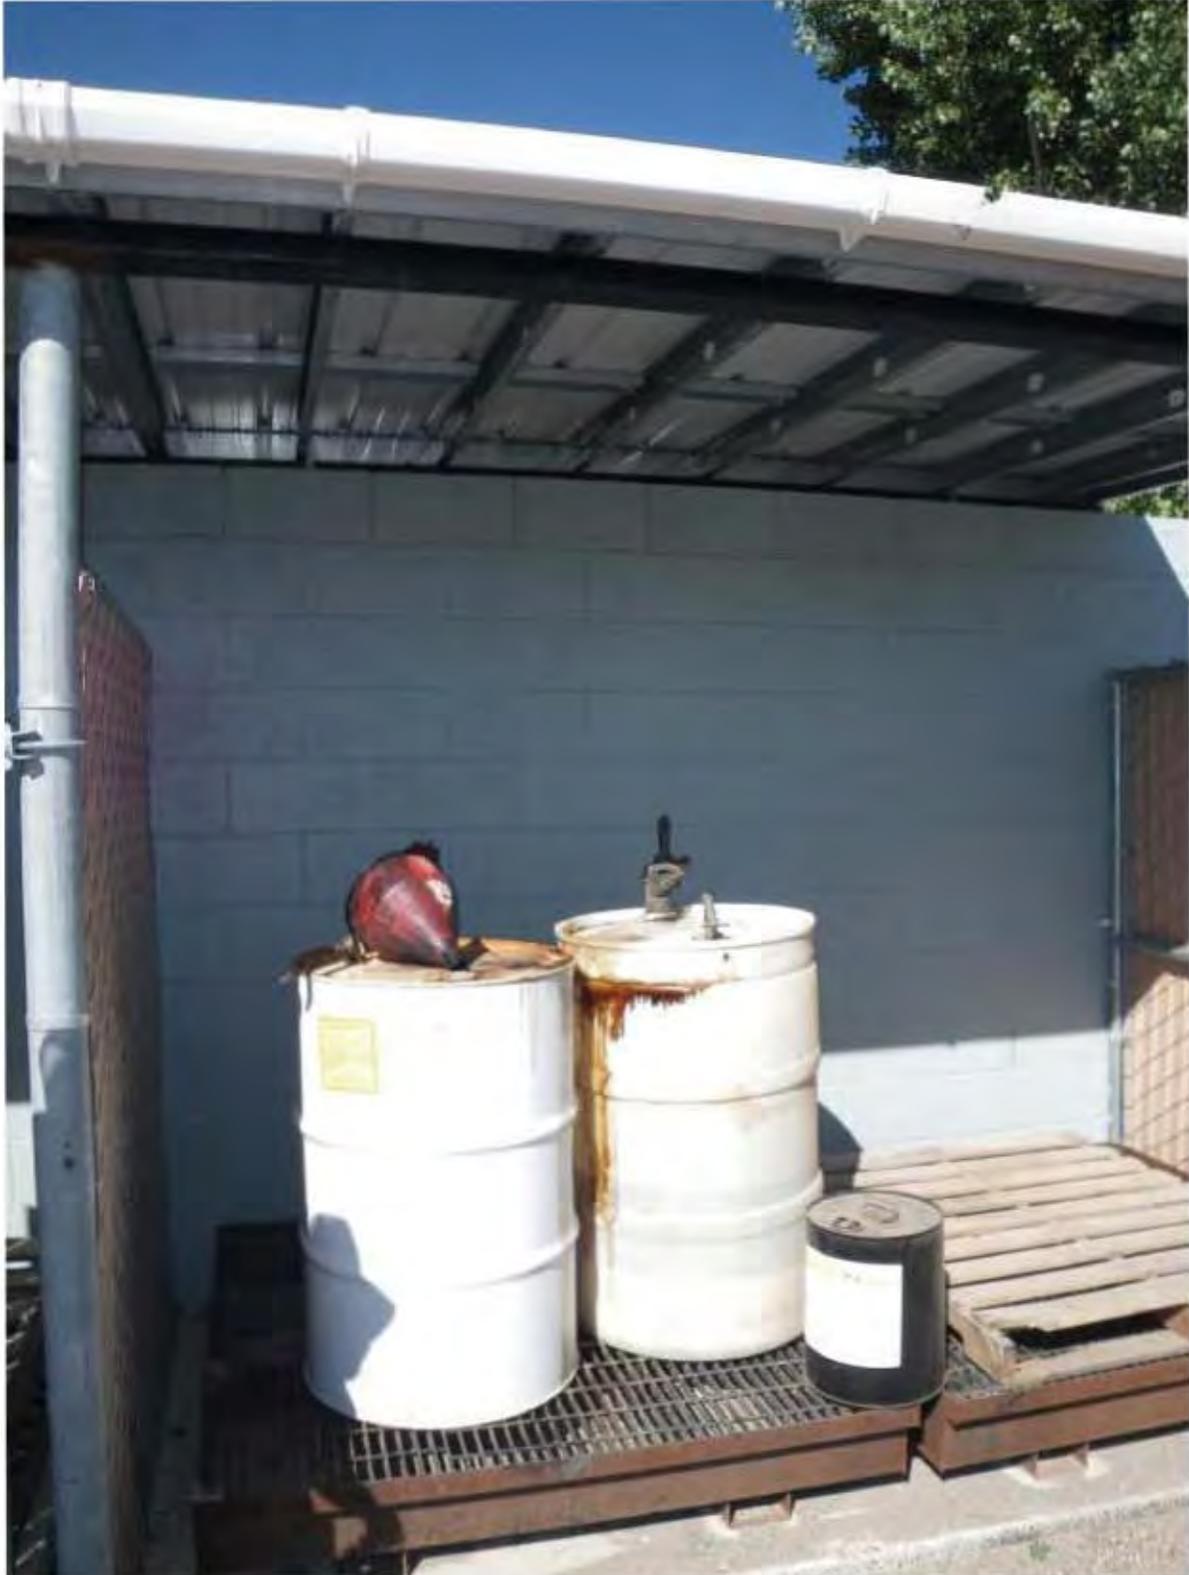
IMGP0688.JPG

**IMGP0688** – Used oil barrels on secondary containment platforms in the covered and screened hazardous materials staging area.

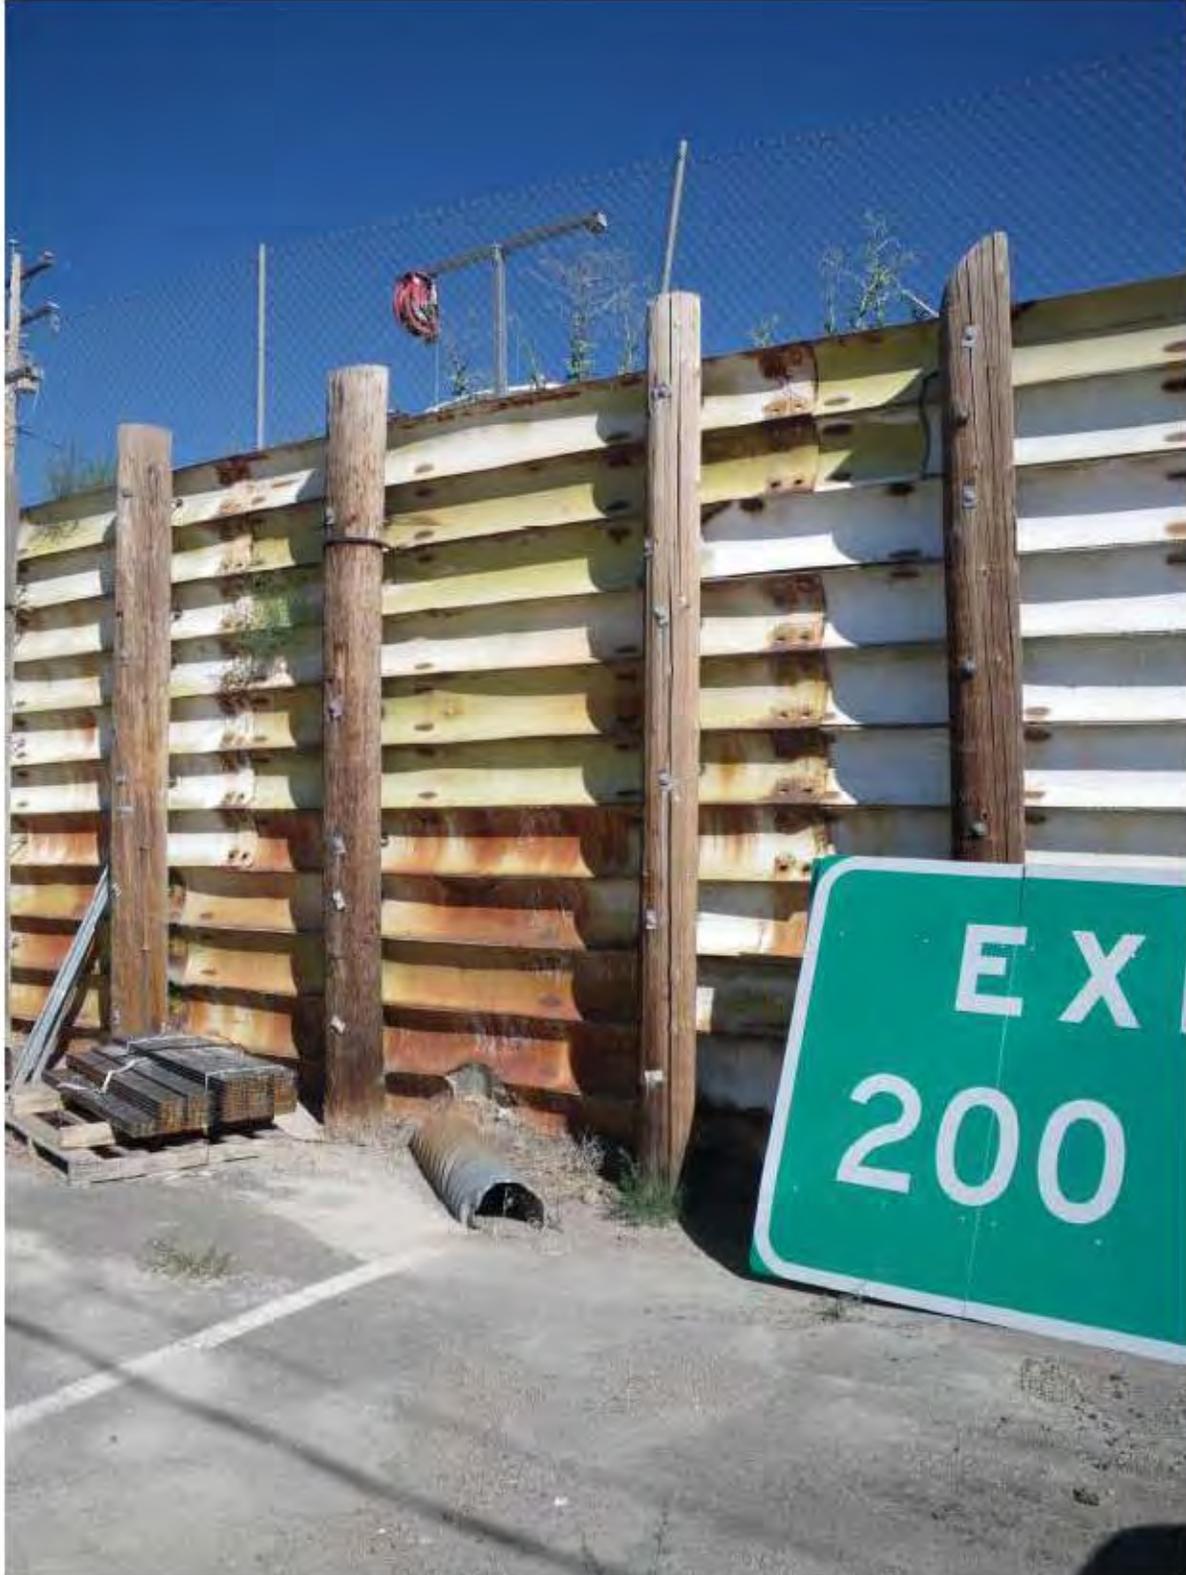
IMGP0691.JPG

**IMGP0691** – Outfall of the previous drop inlet to lower parking/staging area.

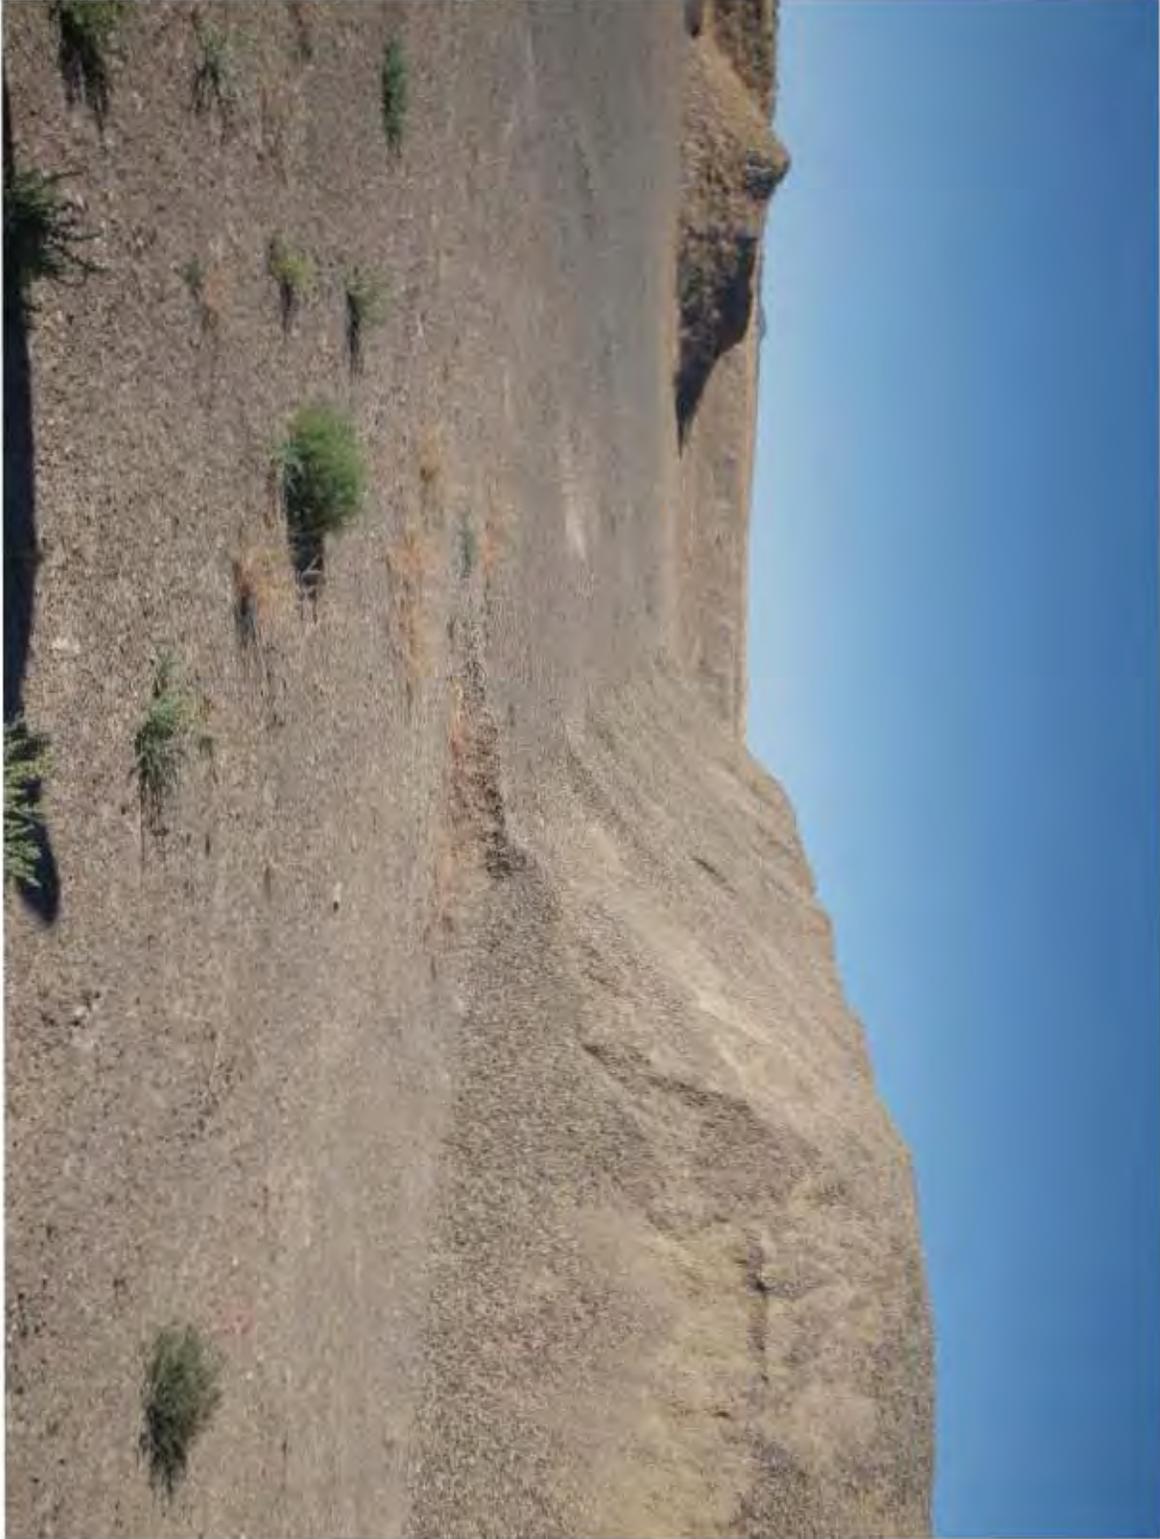
IMGP0706.JPG

NDOT MS4 Audit - Material Extraction Pit 8.11.11

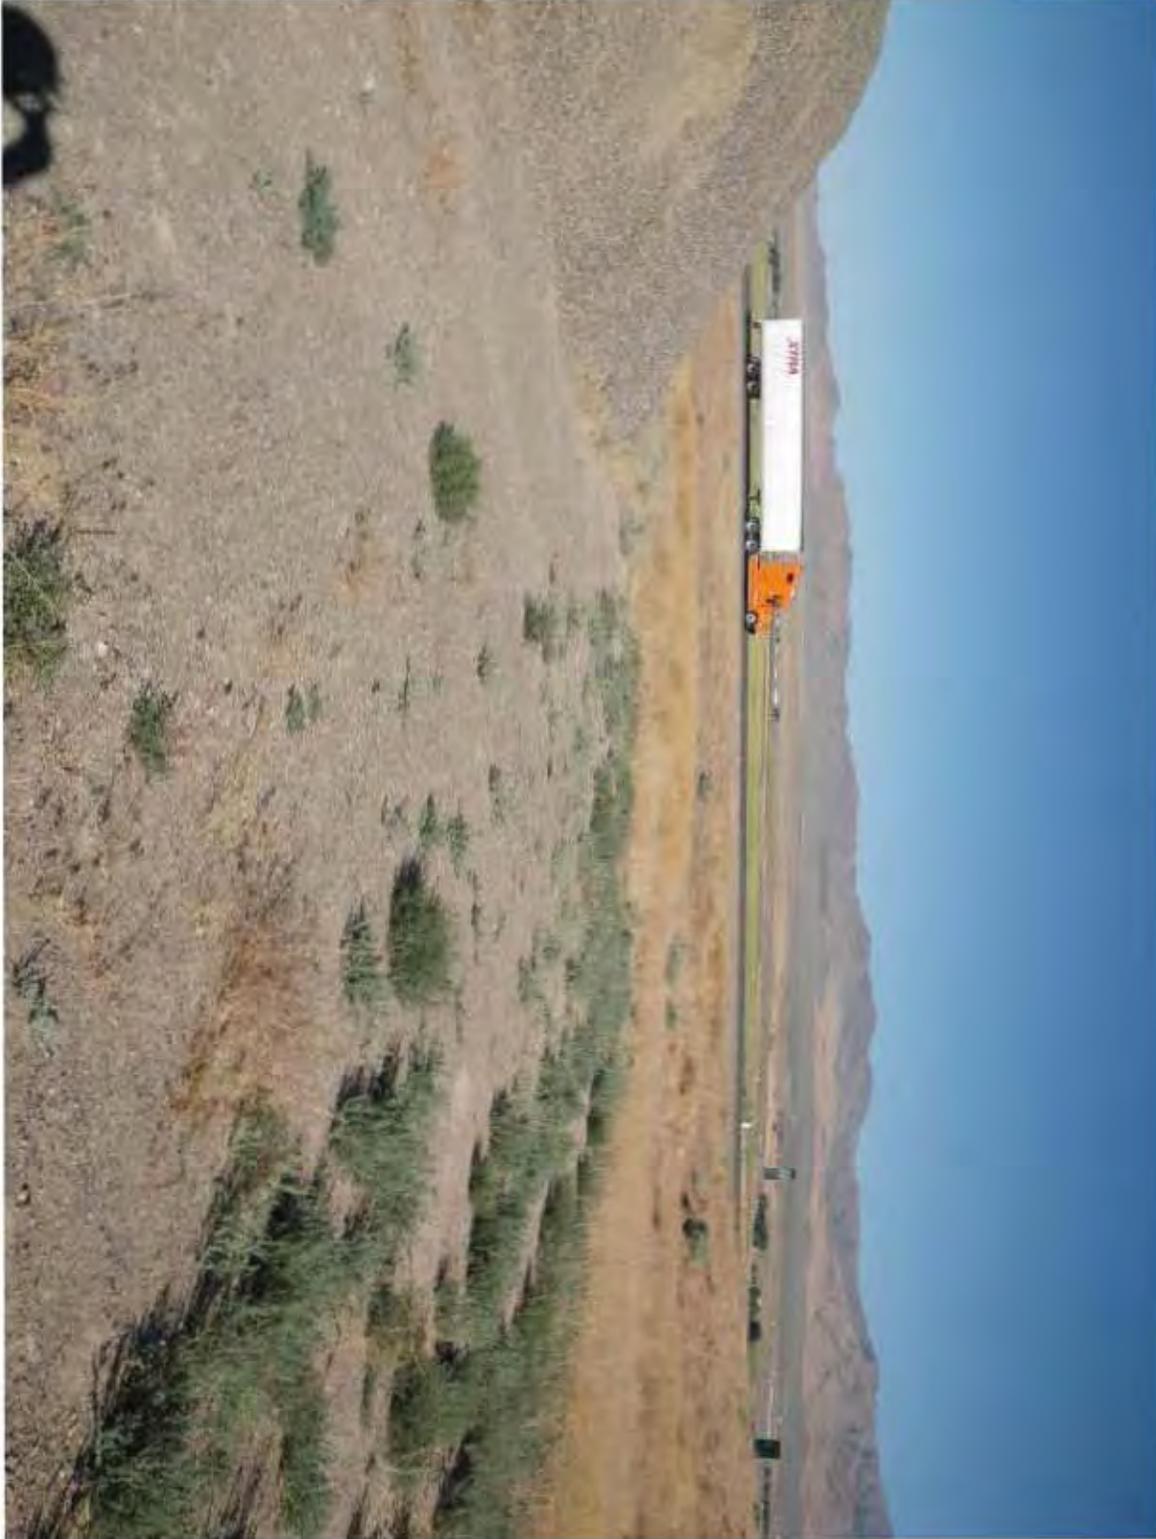
IMGP0707.JPG

NDOT MS4 Audit - Material Extraction Pit 8.11.11
