UNITED STATES ENVIRONMENTAL PROTECTION AGENCY  
REGION IX  
75 Hawthorne Street  
San Francisco, CA 94105-3901

Enclosed is the U.S. Environmental Protection Agency's (EPA) report of the Nevada Department on the Transportation (NDOT) Storm Water Management Program (Program) Audit. Representatives from EPA Region 9 and the Nevada Department of Environmental Protection (NDEP) conducted the Audit from August 9 – 12, 2011.

**MS4 Audit Report**

## **NDOT MS4 Audit Photo Log – Carson City Maintenance Facility 8.10.2011**

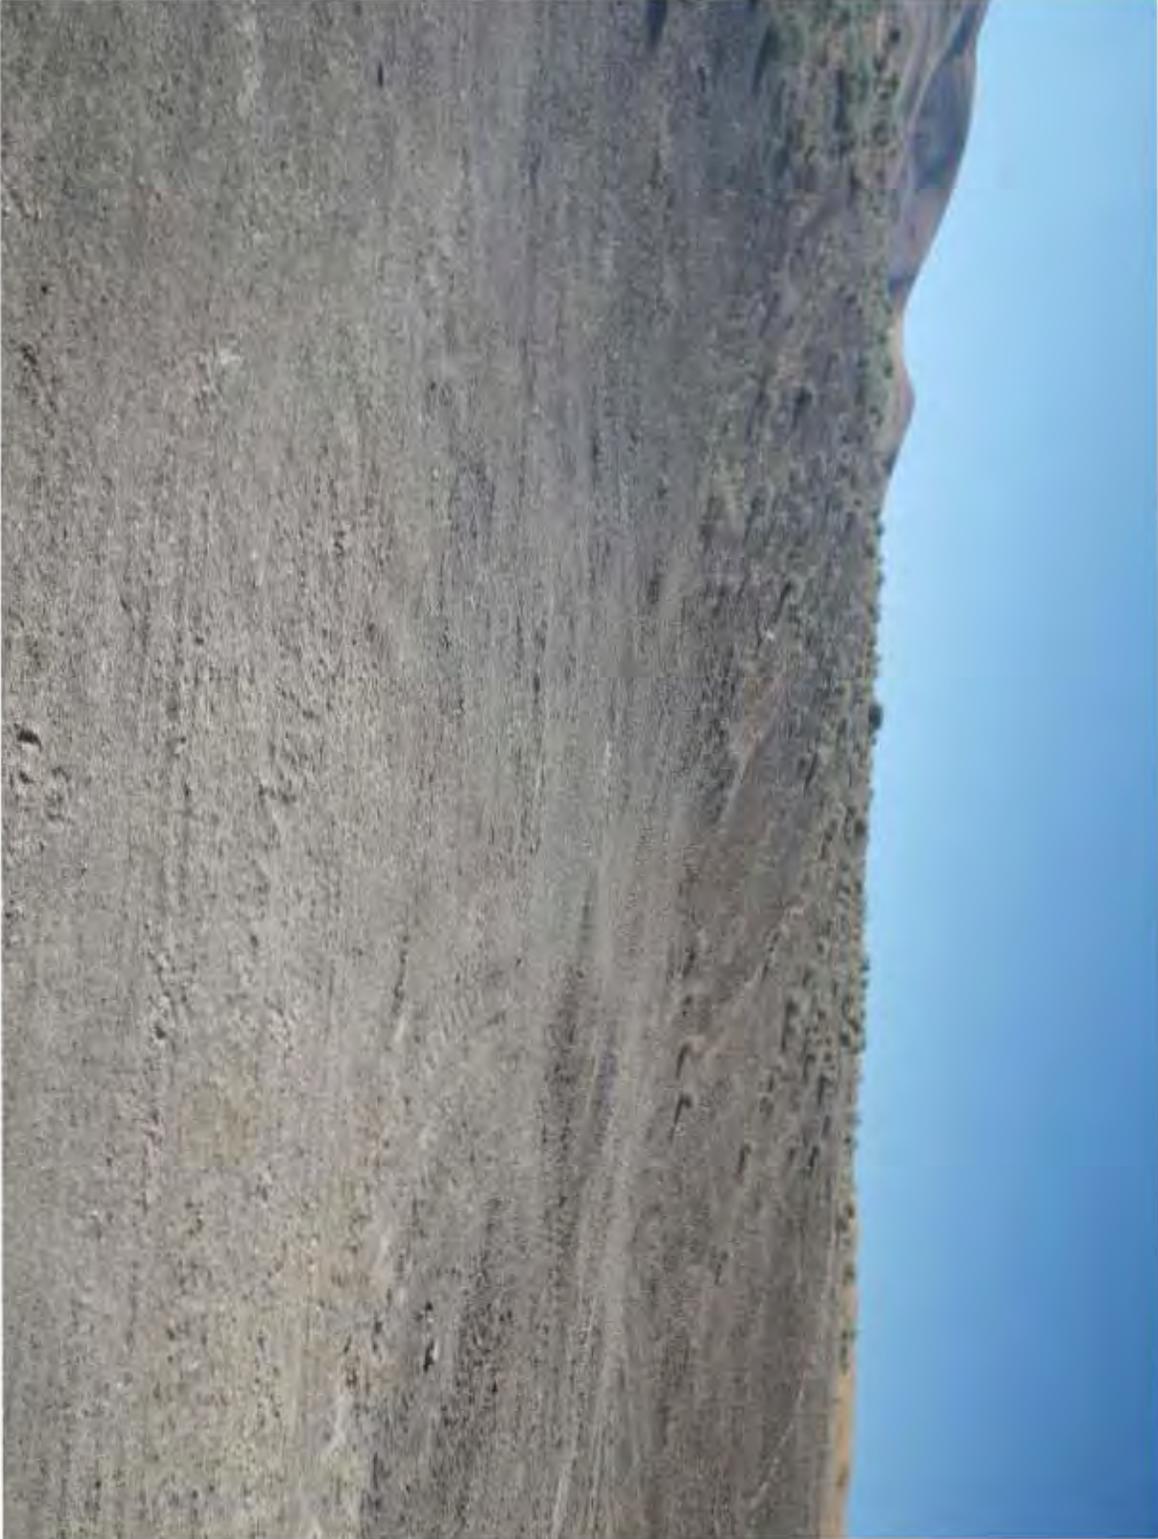
IMGP0708.JPG

NDOT MS4 Audit - Material Extraction Pit 8.11.11
