NPDES Storm Water Inspection Report

Facility Location Information			
Name/Location/ Mailing Address	Sims Metal Management (Sims) 699 Seaport Blvd. Redwood City, CA		
GPS Coordinates	Latitude	37° 30' 40.6"	Longitude 122° 12' 29.6"
Receiving Water(s)	Redwood Creek – Navigable estuary to San Francisco Bay		
	Name	Telephone	
Owner	Steven Shinn – Regional General Manager	510-412-5300	
Operator	Joe Barco – Operations General Manager	510-412-5300	
Environmental Coordinator	Matt Zeiter – On-site Rep	510-715-7569

General	
Inspection Objective, Attendees, and Opening Conference Summary.	<p>The inspection's objective was to determine compliance with the California Industrial General Permit No. CAS000001.</p> <p>In addition to EPA inspectors previously identified, the inspection was attended by Estuardo Montufar (650.372.6240) and Sabrina Mih (650.372.6235) with San Mateo County Environmental Health Services Division (Certified Unified Program Agencies – CUPA), and Matt Zieter (510.412.5300), Mariya Semeit (650.369.4161), Dale Leuer (650.369.4161), and Vistasp Patel (650.369.4161) with Sims Metals Management (Sims or Facility Representatives)</p> <p>Prior to commencing the inspection, an ope

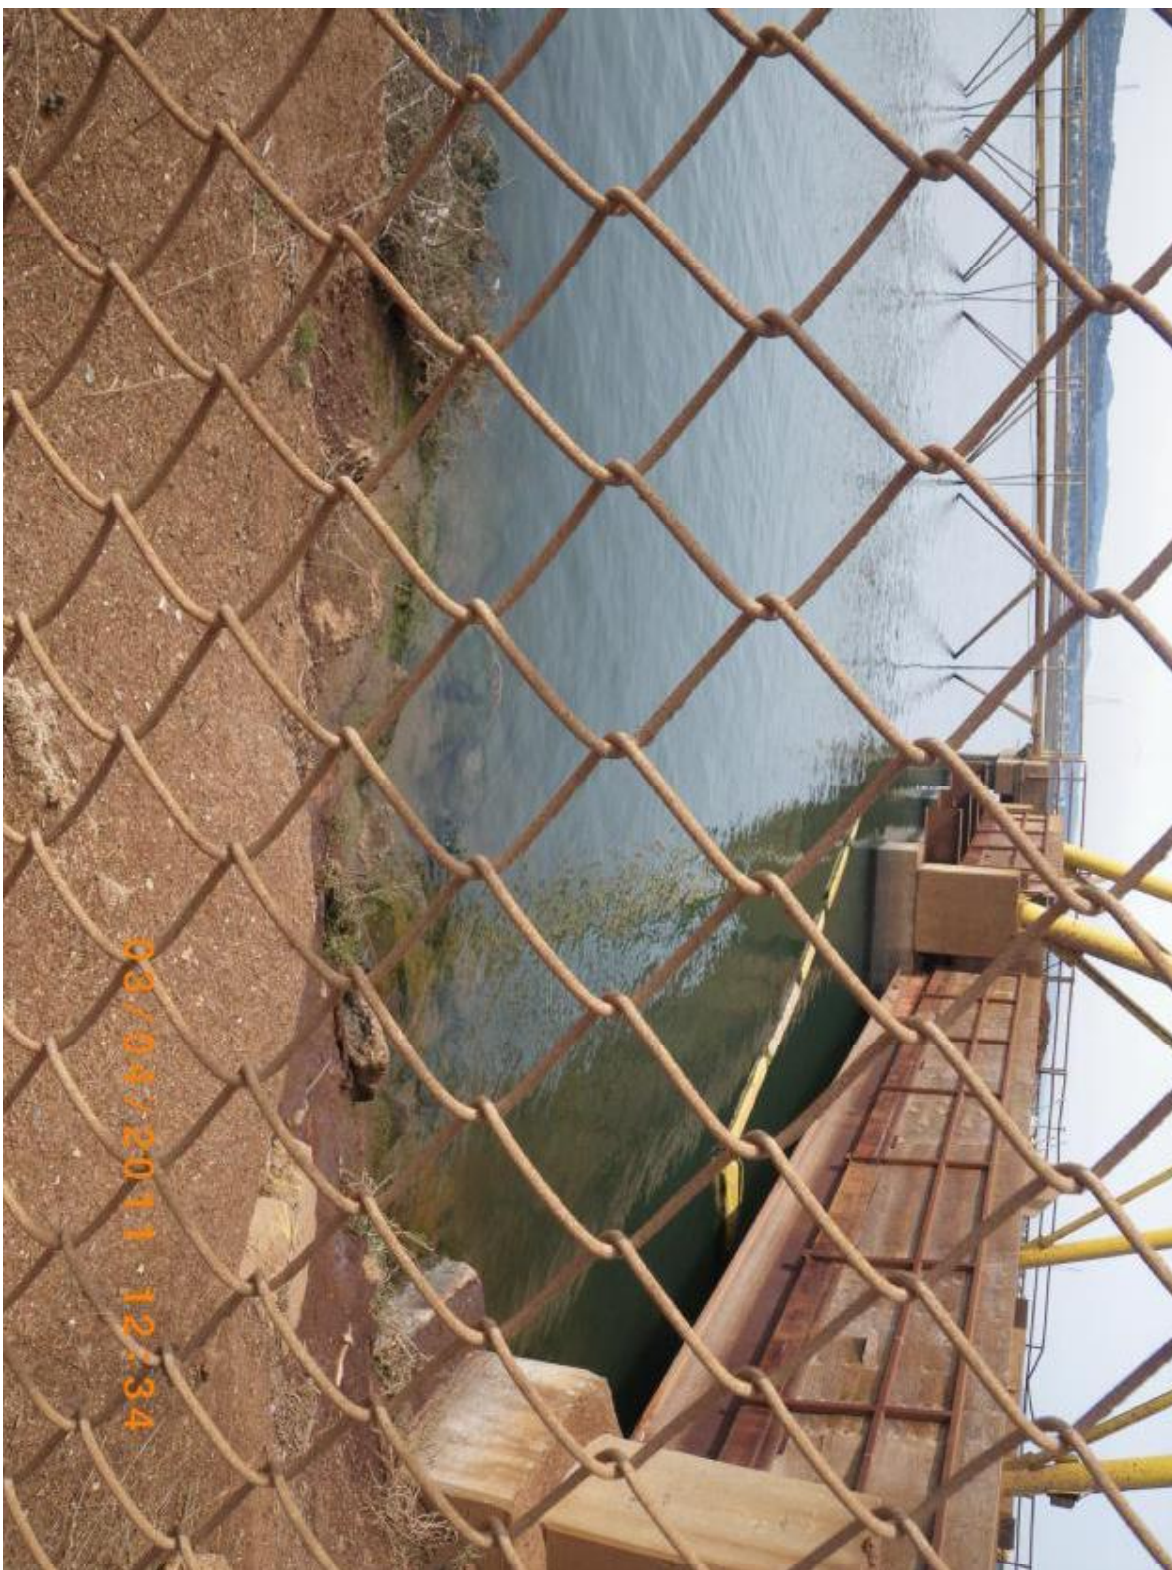
IMGP0256.JPG

IMGP0256 – Essentially the same as IMGP0255, though with greater focus on the water-line to demonstrate darkened sediments that were observed to come into contact with receiving waters by rising tides.

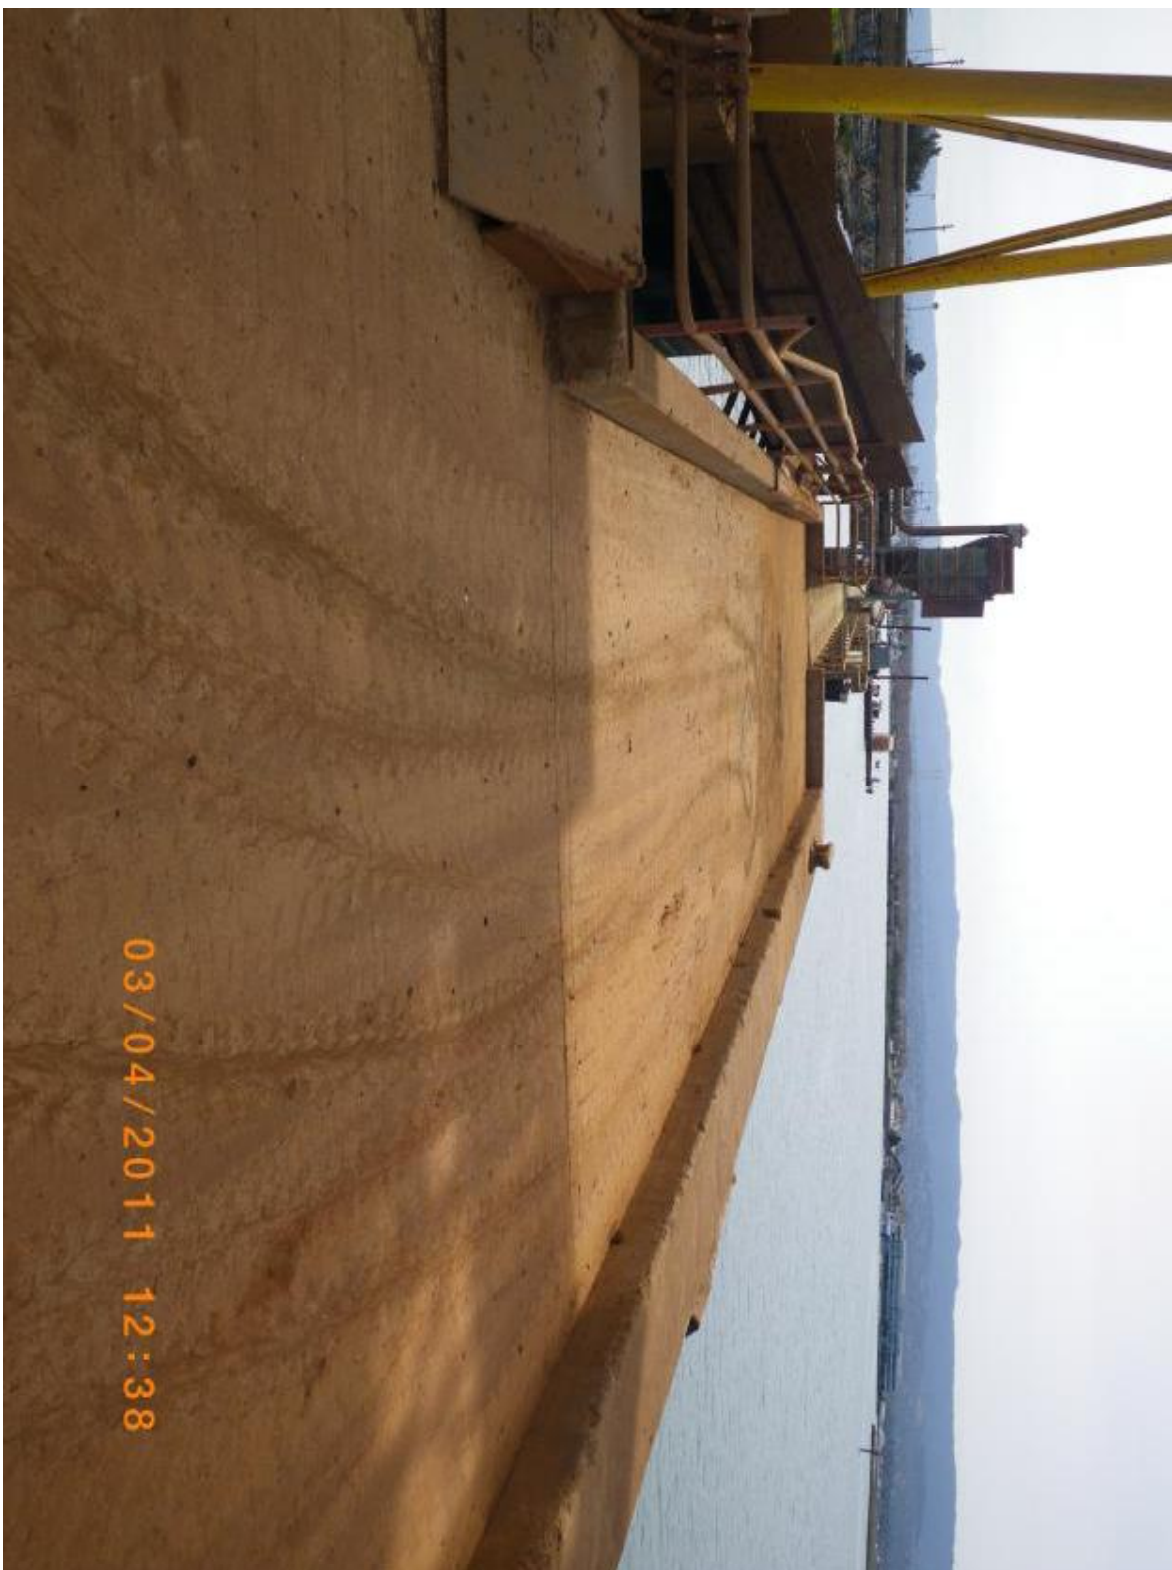
IMGP0259.JPG

IMGP0259 – This photo depicts the shared dock directly underneath the ship loading conveyor (facing south). Equipment tracks were observed from activities depicted in IMGP0242.

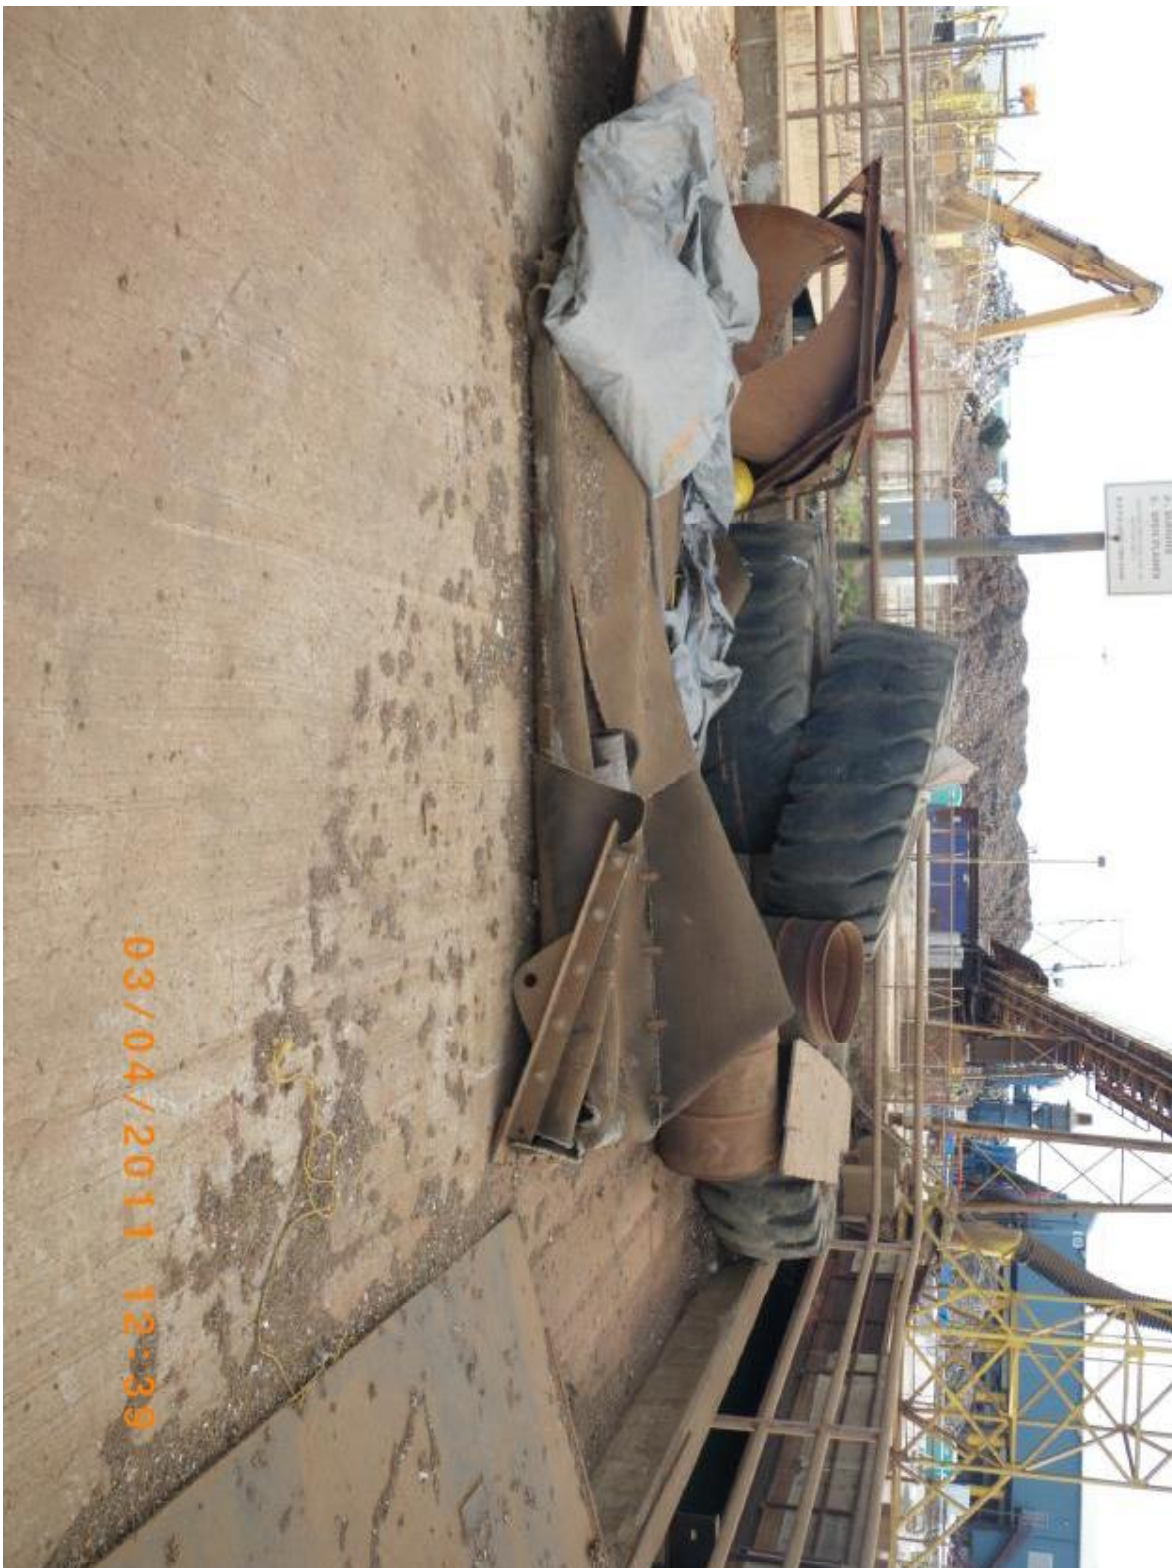
IMGP0260.JPG

IMGP0260 – Obsolete equipment was observed on the shared dock.

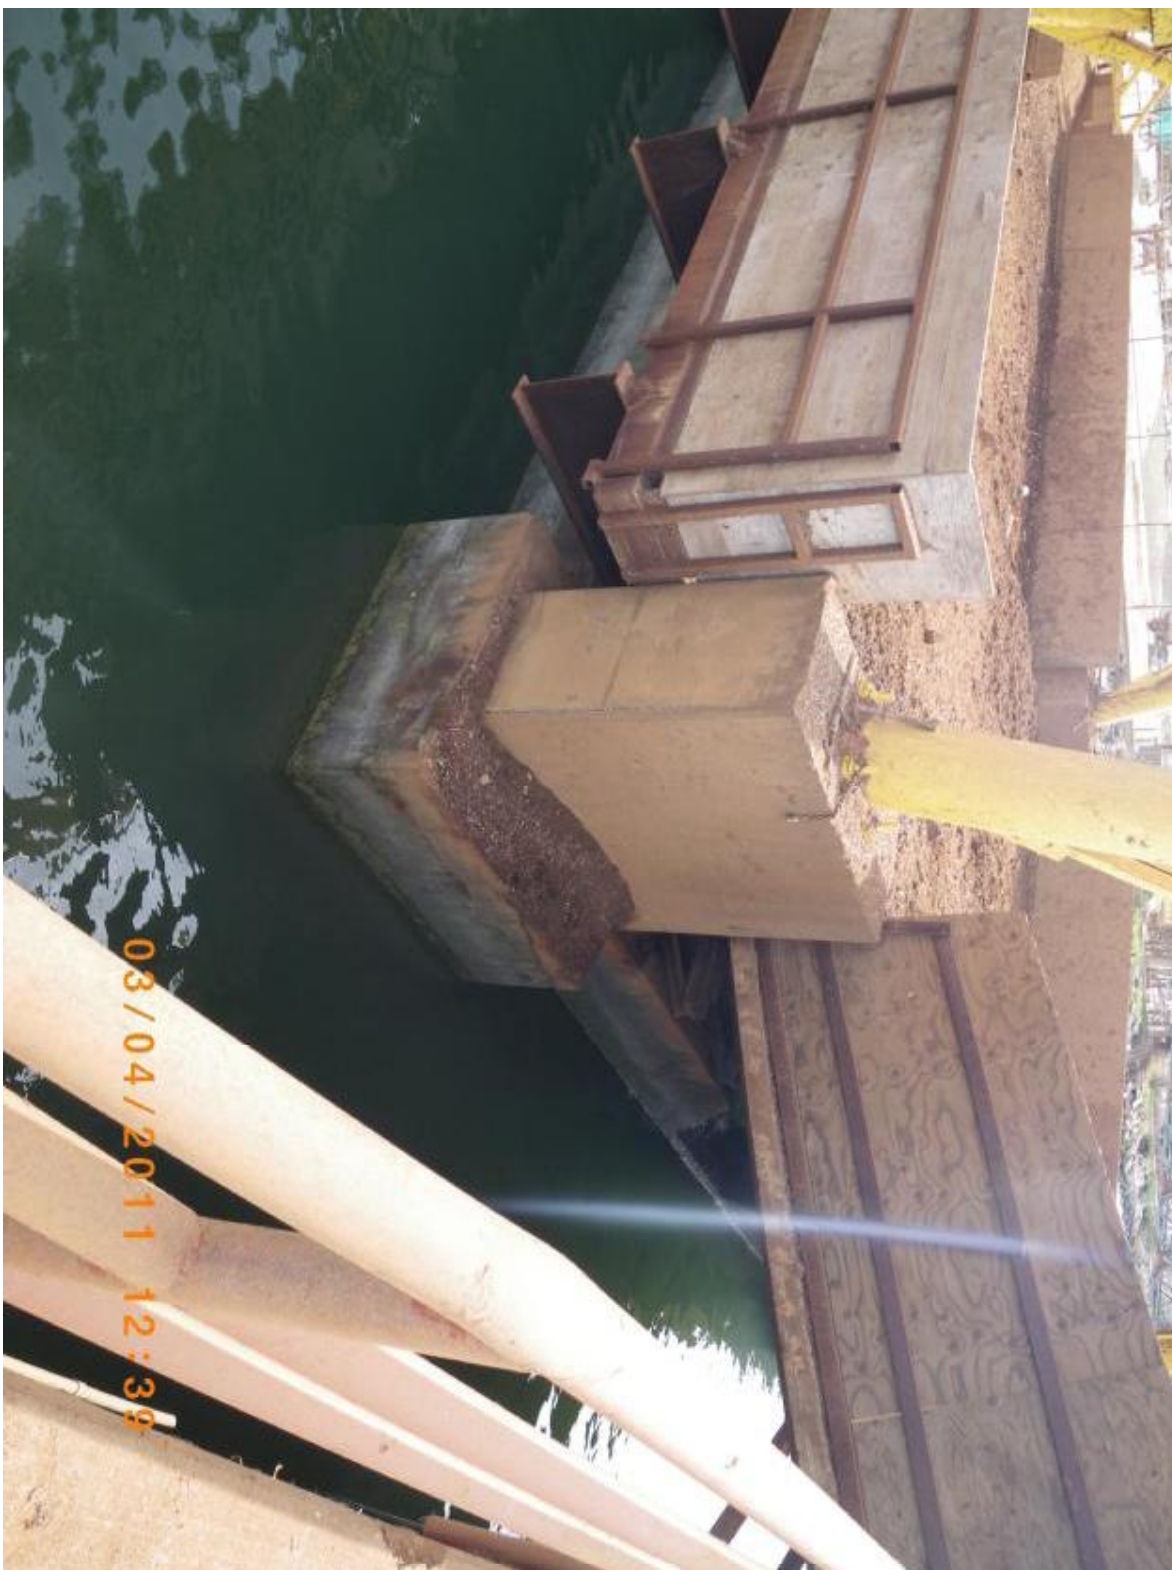
IMGP0261.JPG

IMGP0261 – Accumulated debris and gaps in containment walls on the catchment platform were observed. (North west footing of ship loading conveyor depicted.)

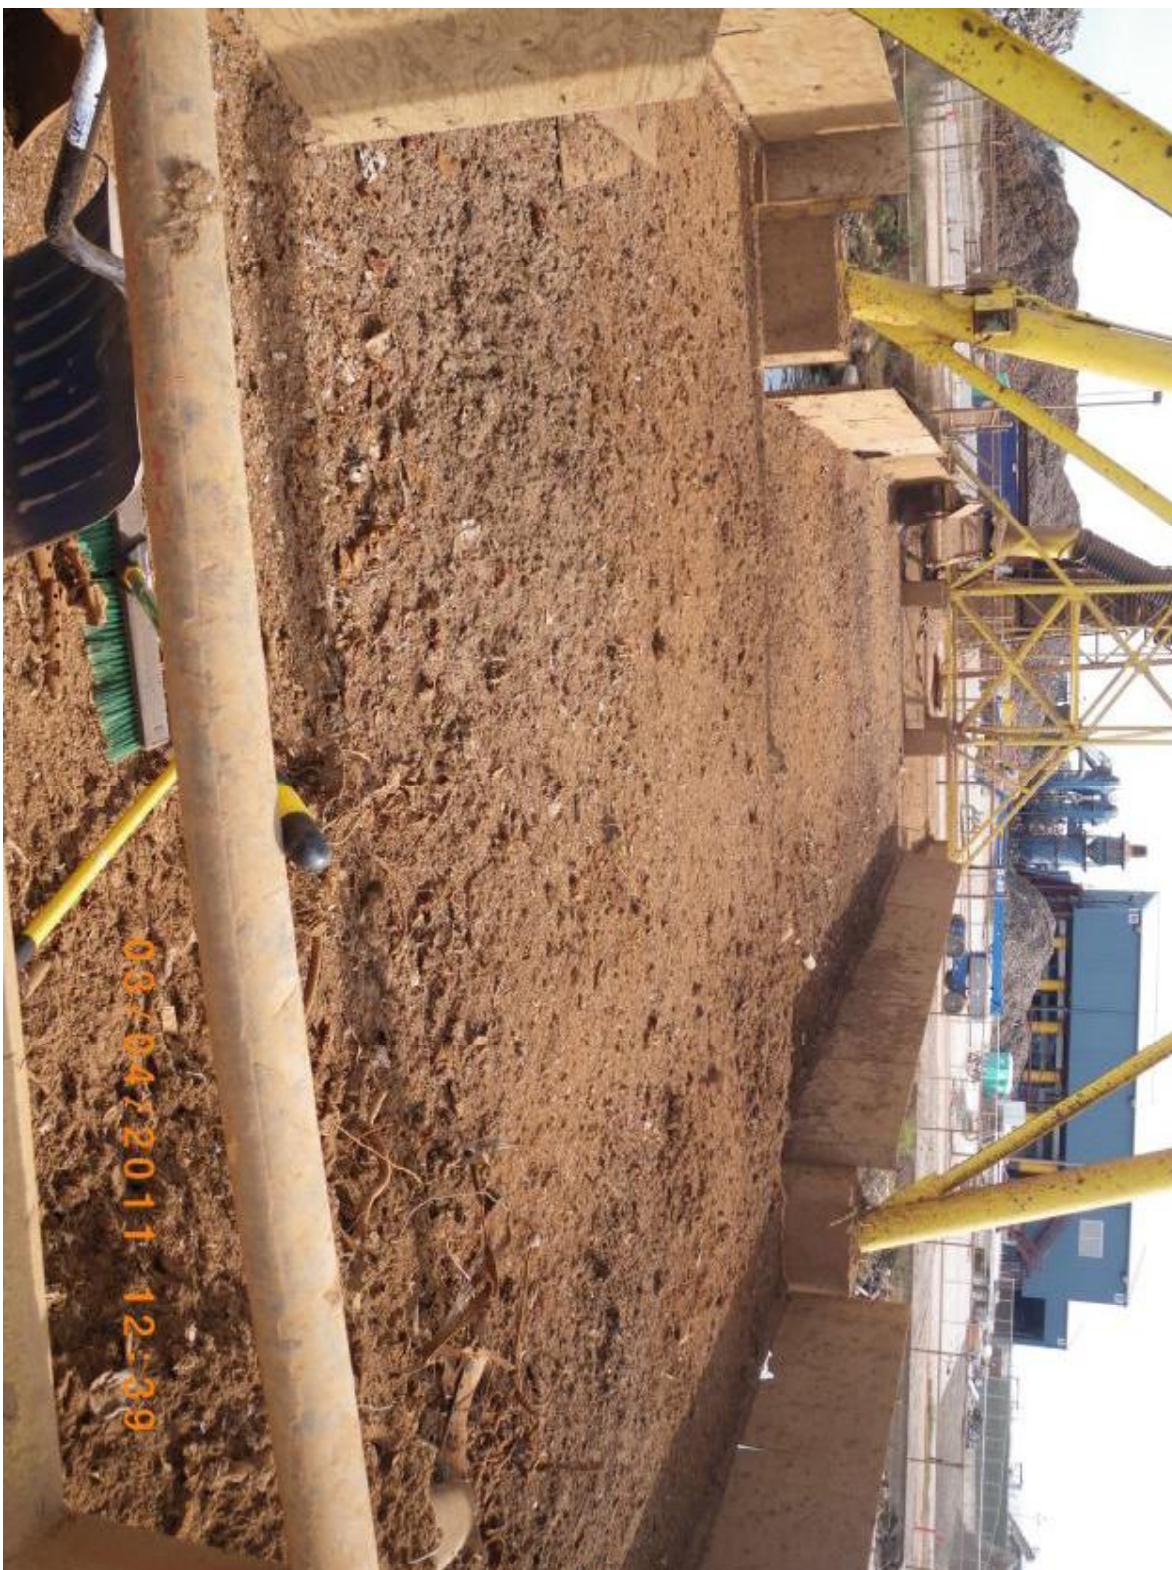
IMGP0262.JPG

IMGP0262 – Surface of the catchment platform with accumulated debris and gaps in the containment walls were observed. (Standing on the dock looking east towards the facility)

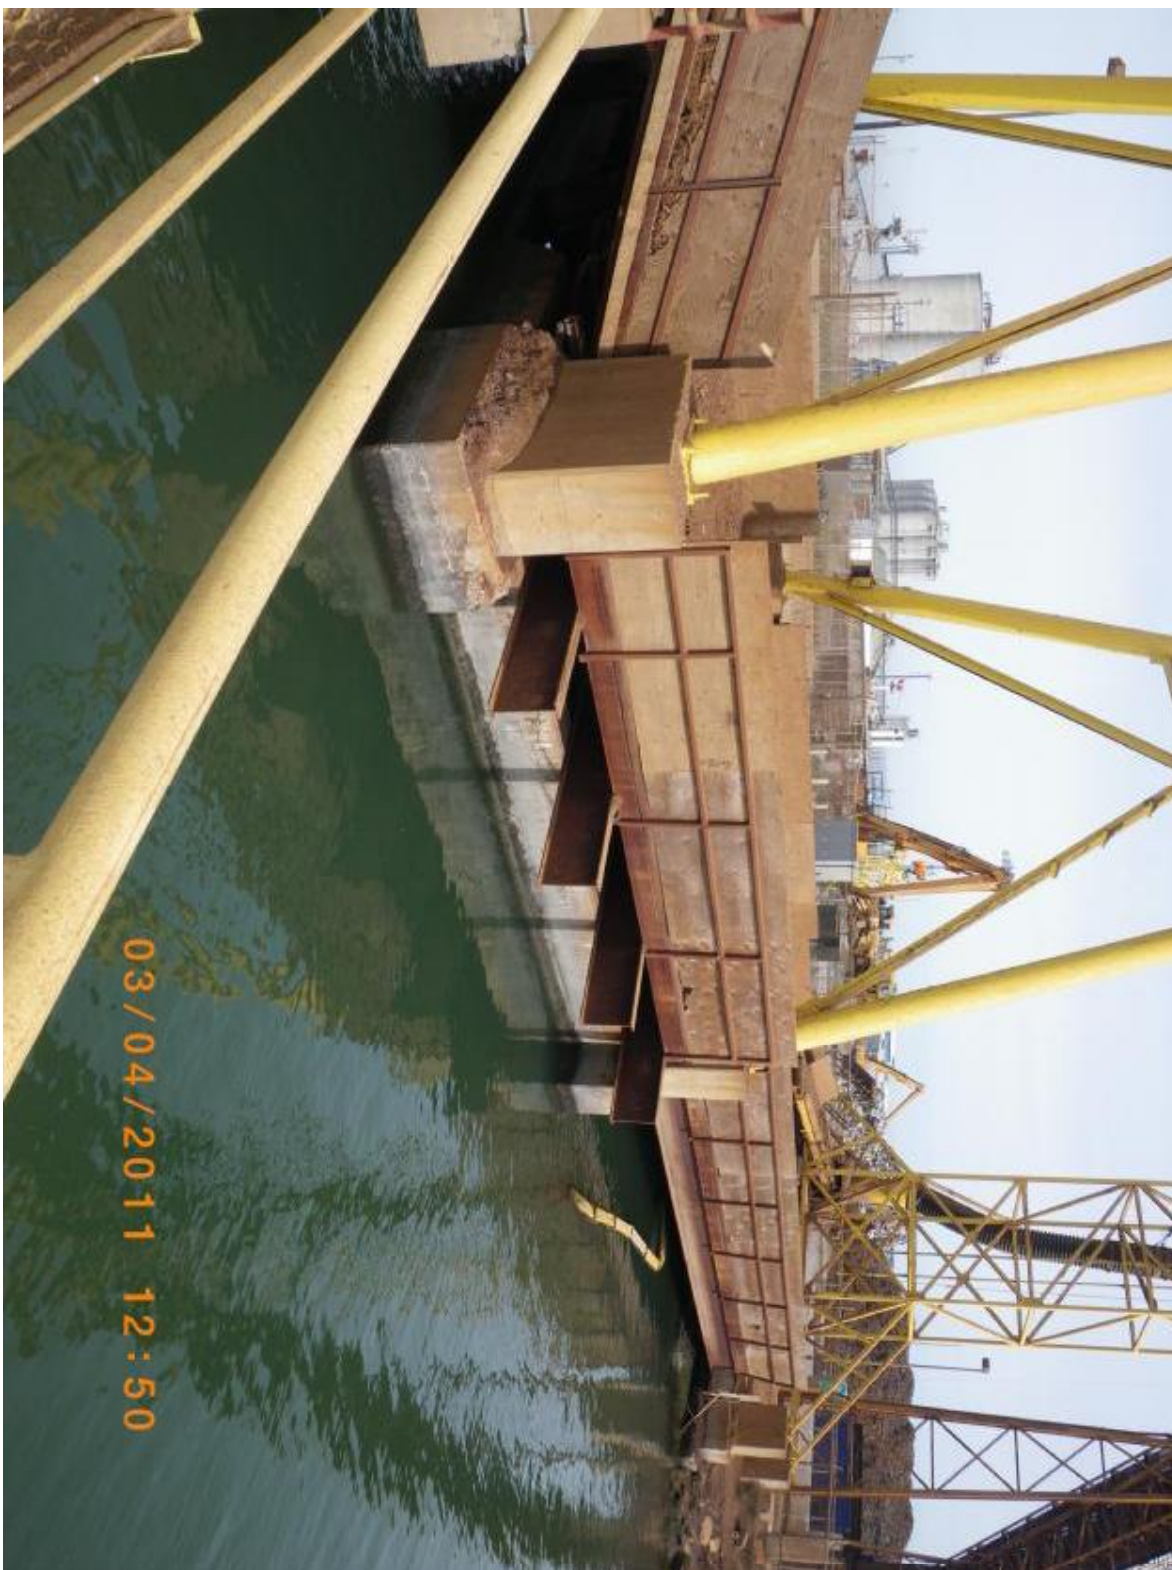
IMGP0263.JPG

IMGP0263 – South side of the catchment platform, looking north east, accumulated debris on footings and I-beams, and gaps in containment walls of the catchment platform were observed.

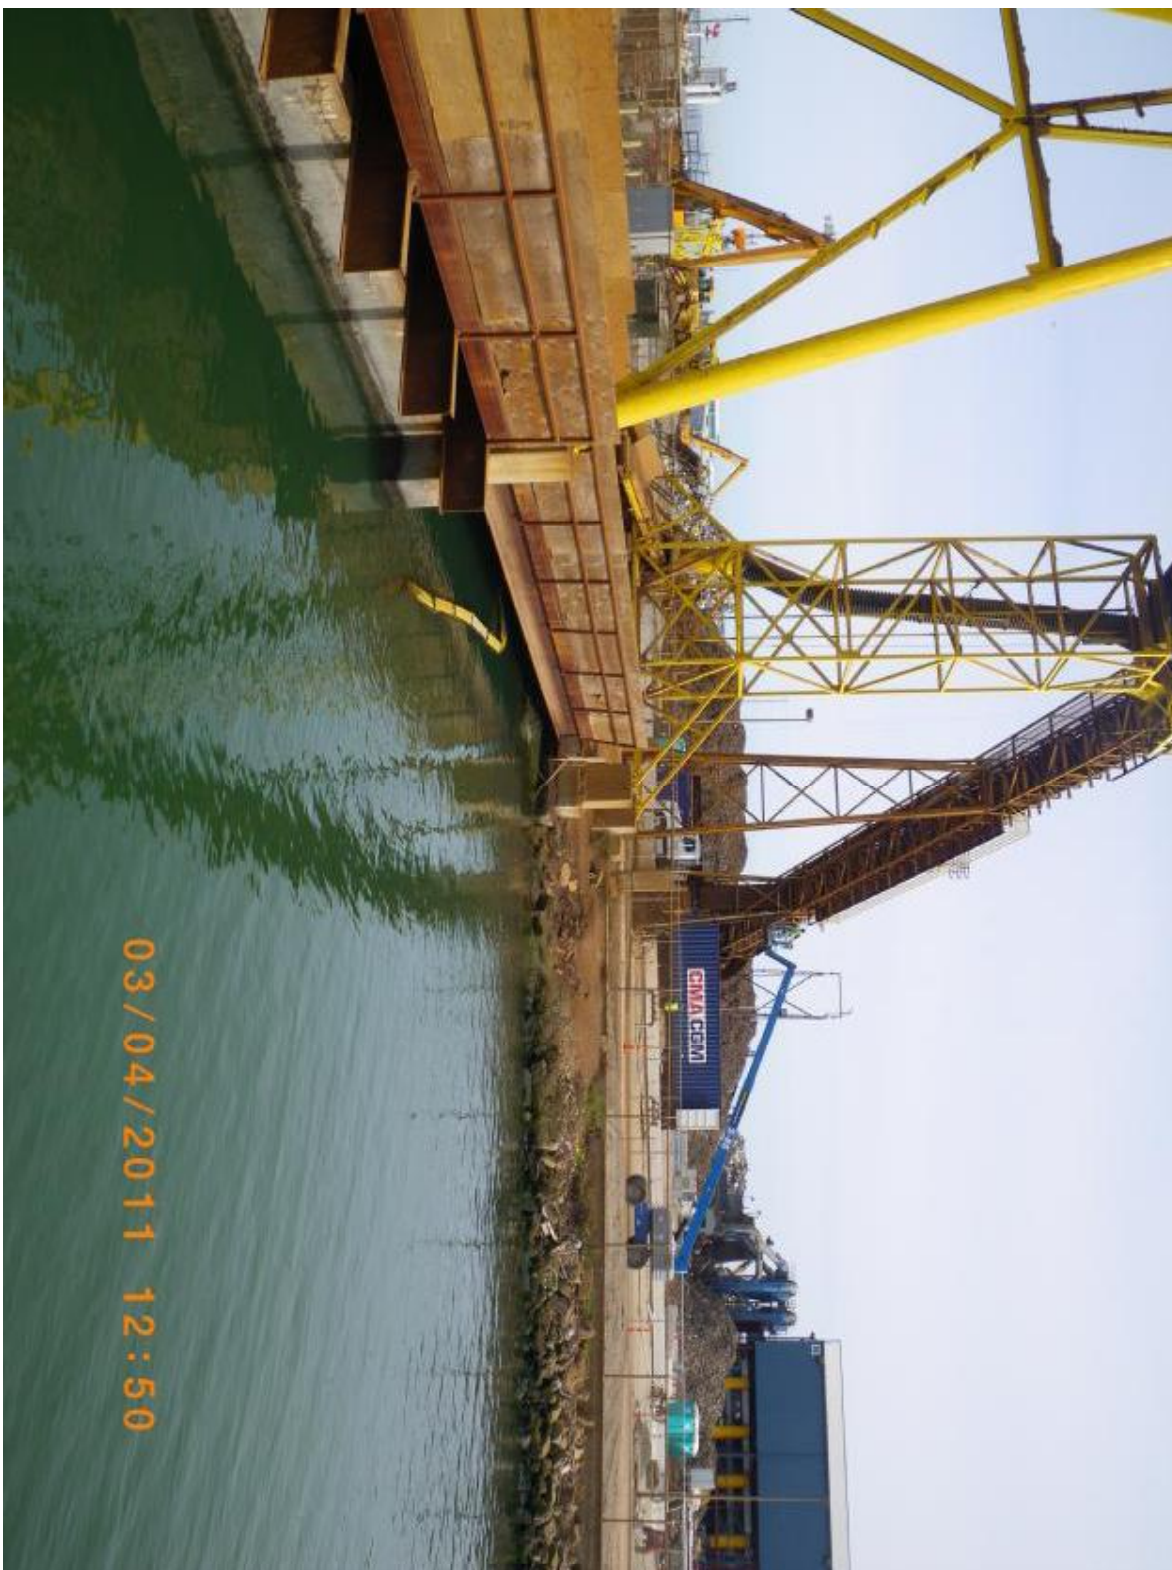
IMGP0264.JPG

IMGP0264 – Essentially the same as IMGP0263, though with greater focus on accumulated debris on the shore. Accumulated debris was also observed on the aerial portions of the ship loading conveyor structure.

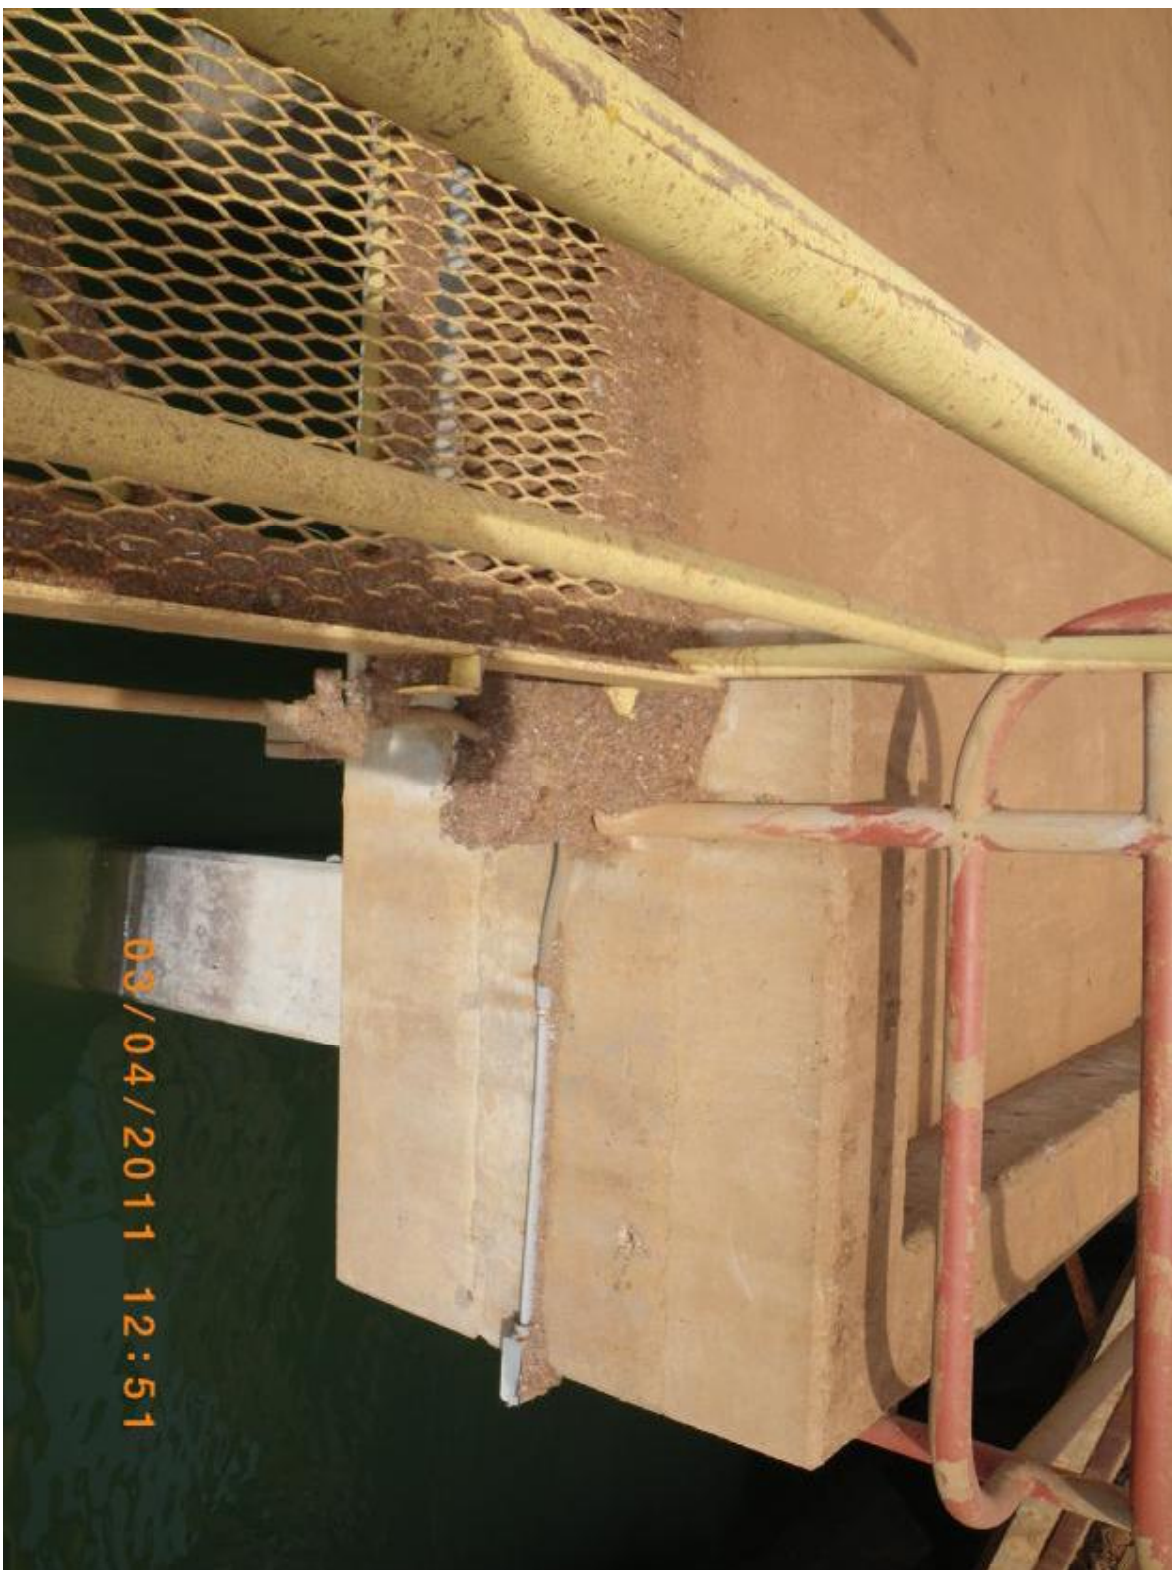
IMGP0266.JPG

IMGP0266 – Accumulated debris was observed on the east side of the catwalk structure to the south of the ship loading conveyor area, as well as on the electrical conduit and conduit box.

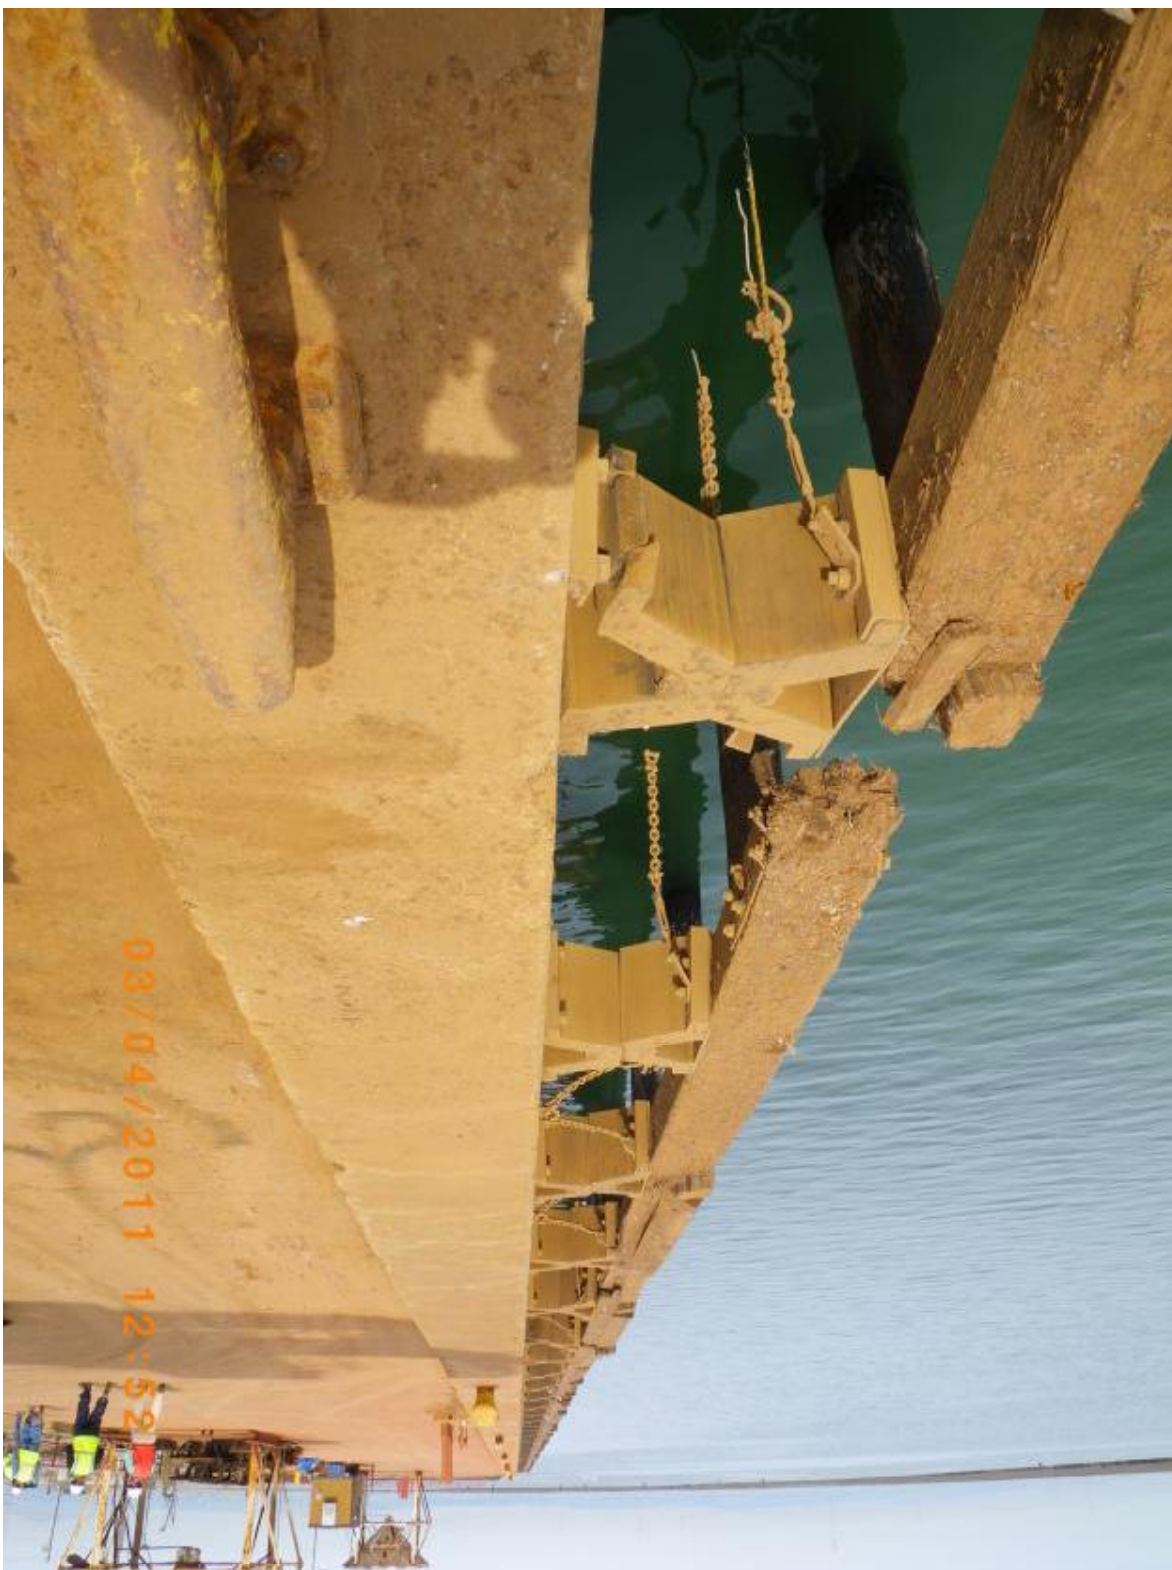
IMGP0267.JPG

IMGP0267 – Accumulated debris was observed along the dock bumper. (Photo taken of the area underneath the ship loading conveyor looking north.)

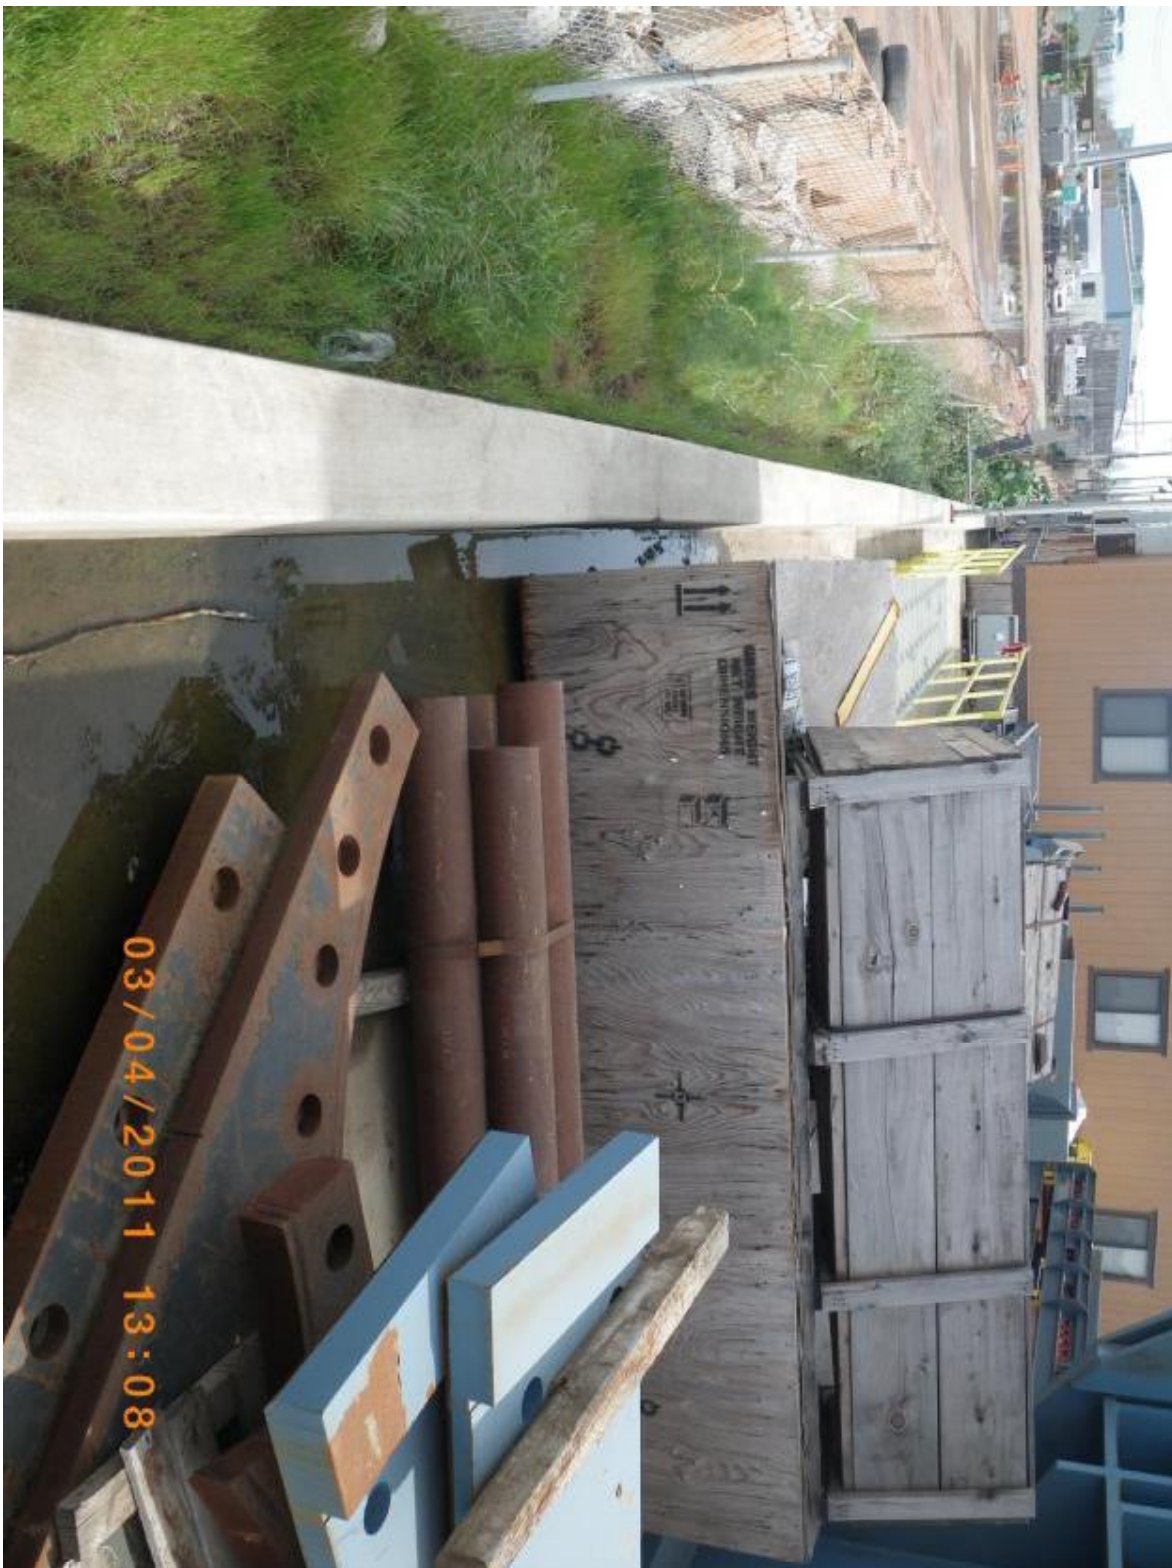
IMGP0275.JPG

IMGP0274 and 0275 – North west corner of the facility, berms, staged equipment and scattered debris were observed.

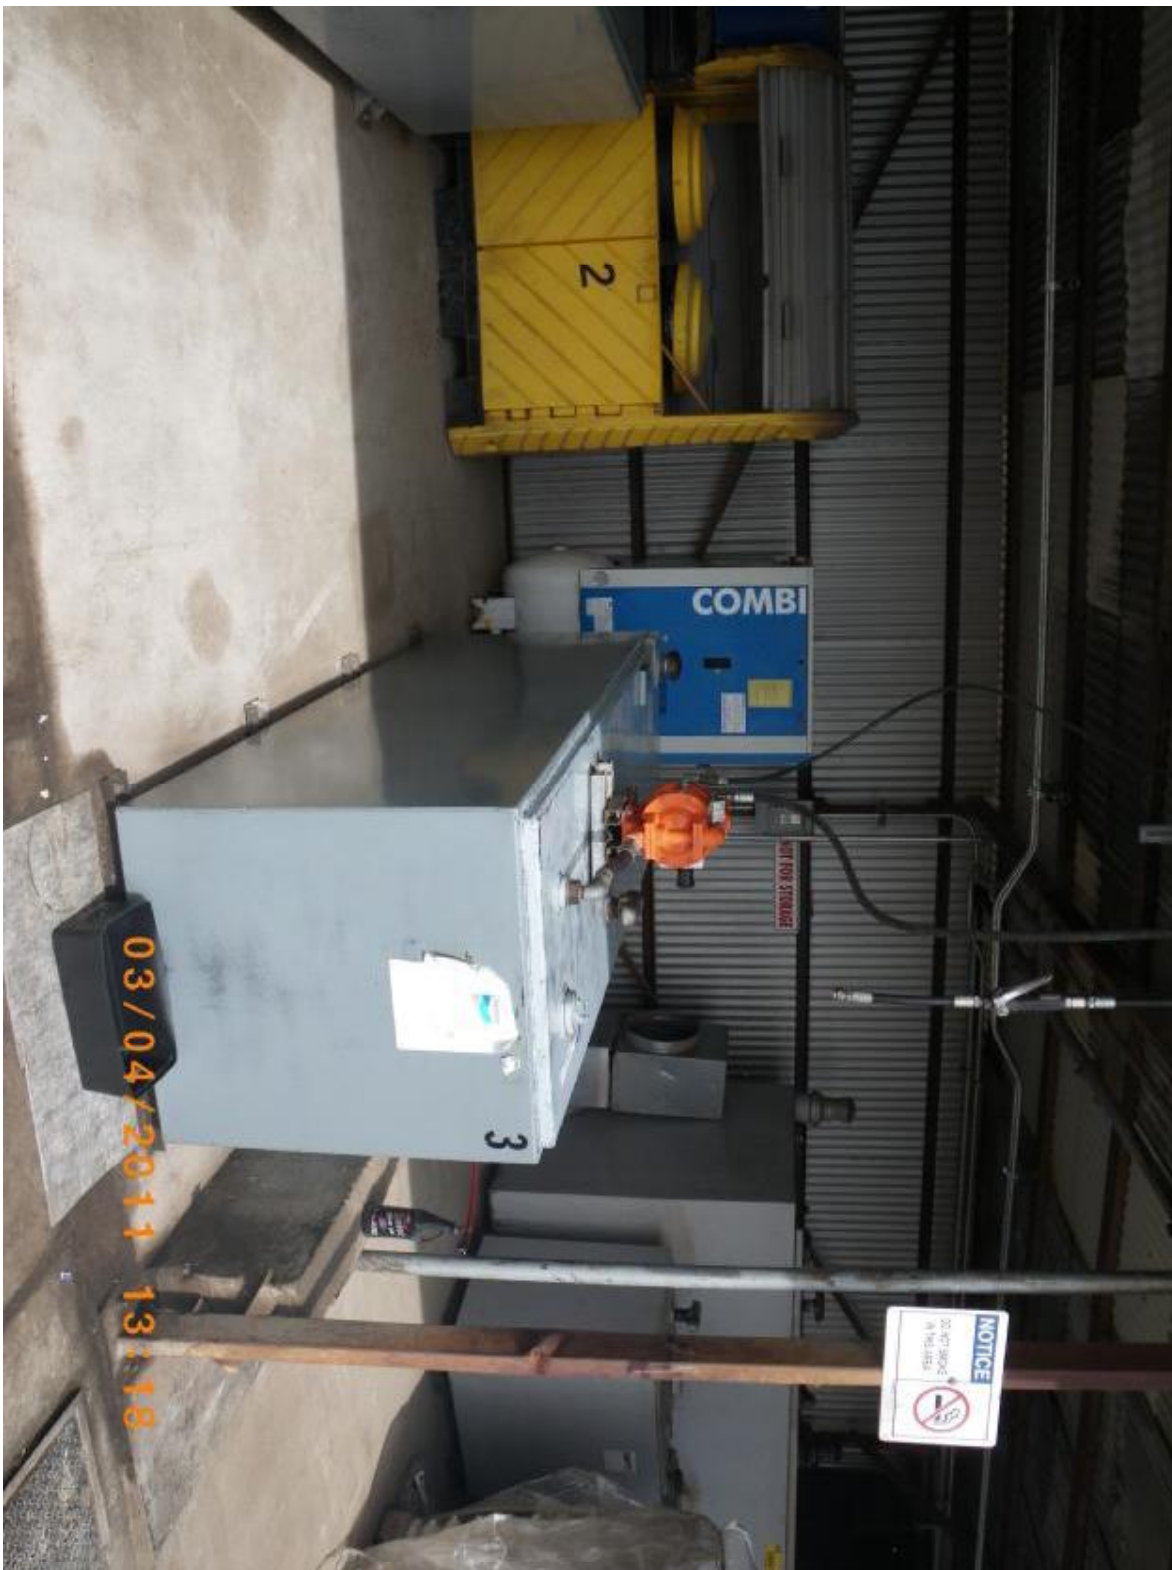
IMG0284.JPG

IMGP0283 and 0284 – Bulk oil ASTs, spill kit, and air compressor were observed under cover. Oil staining was observed around the grey oil tank.

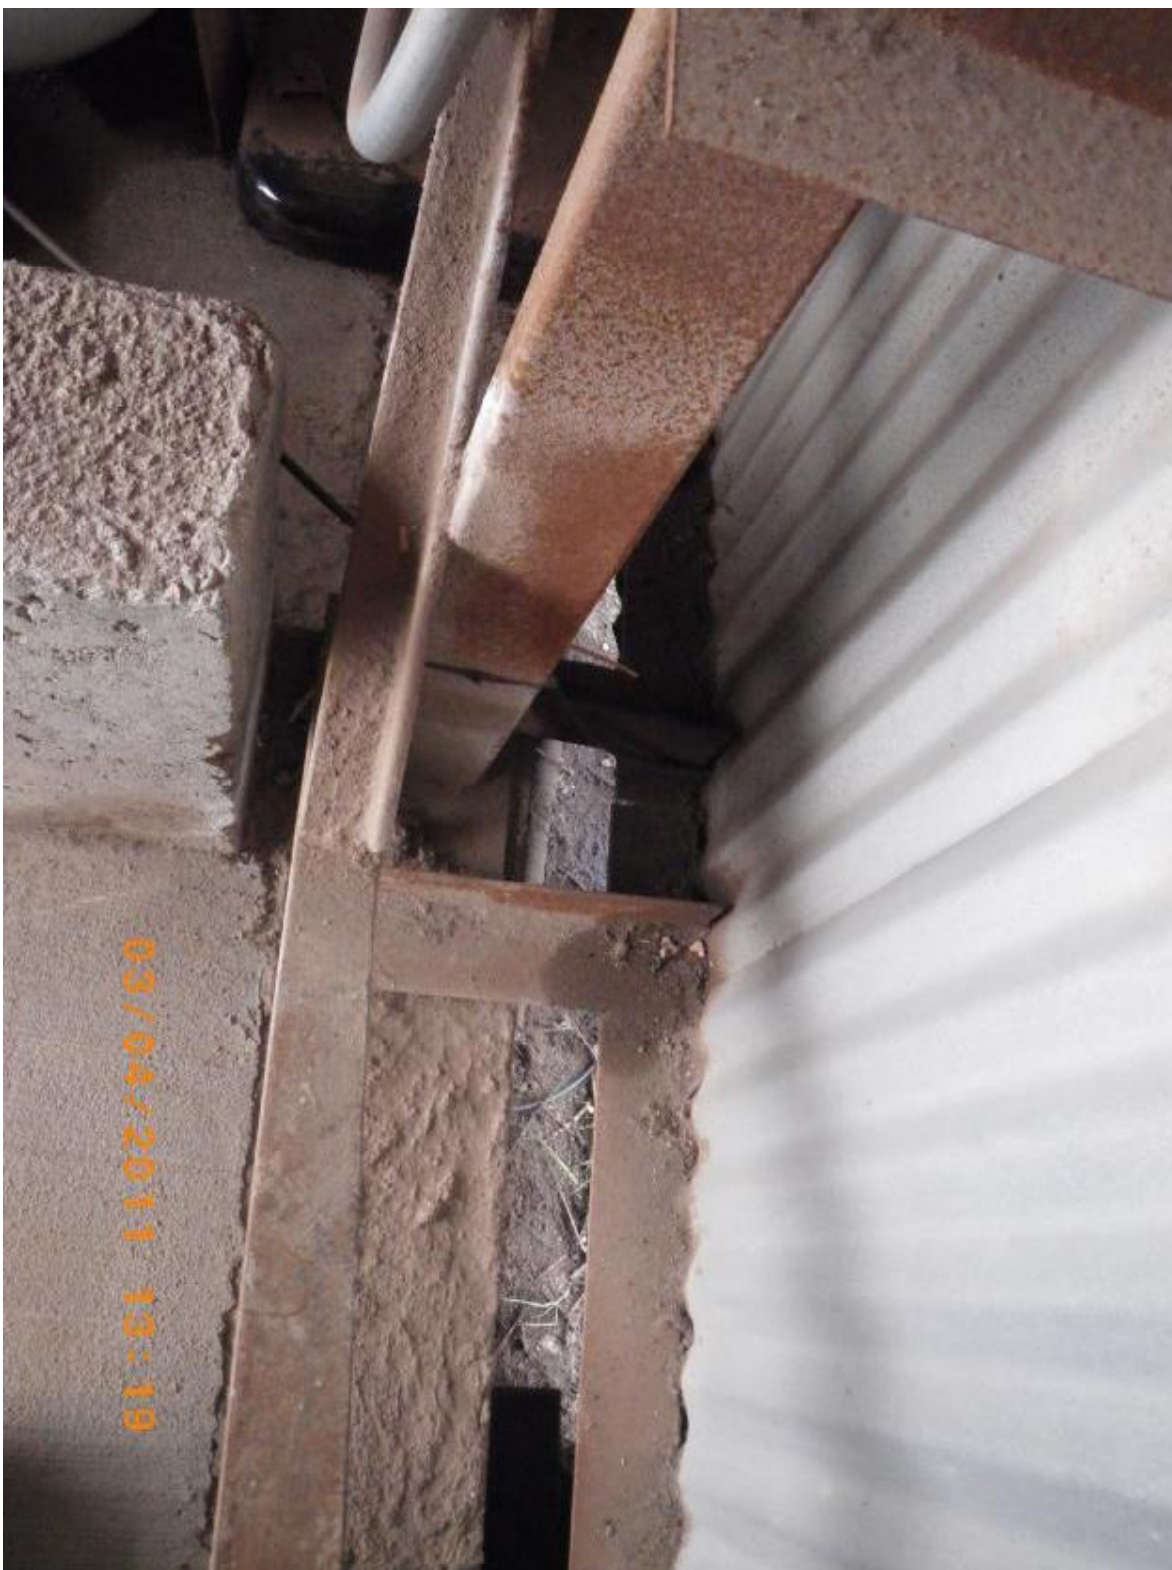
IMGP0285.JPG

IMGP0282 – Oil staining was observed on the exterior wall and earthen ground on the north side of the fueling and oiling depot. IMGP0285 and 0286 demonstrate that this area is exterior to the air compressor.

IMGP0285 and 0286 – Area behind the air compressor where oil staining was observed as mentioned regarding IMGP0282.
