NPDES Storm Water Inspection Report

Facility Location Information			
Name/Location/ Mailing Address	Sims Metal Management (Sims) 699 Seaport Blvd. Redwood City, CA		
GPS Coordinates	Latitude	37° 30' 40.6"	Longitude 122° 12' 29.6"
Receiving Water(s)	Redwood Creek – Navigable estuary to San Francisco Bay		
	Name	Telephone	
Owner	Steven Shinn – Regional General Manager	510-412-5300	
Operator	Joe Barco – Operations General Manager	510-412-5300	
Environmental Coordinator	Matt Zeiter – On-site Rep	510-715-7569

General	
Inspection Objective, Attendees, and Opening Conference Summary.	<p>The inspection's objective was to determine compliance with the California Industrial General Permit No. CAS000001.</p> <p>In addition to EPA inspectors previously identified, the inspection was attended by Estuardo Montufar (650.372.6240) and Sabrina Mih (650.372.6235) with San Mateo County Environmental Health Services Division (Certified Unified Program Agencies – CUPA), and Matt Zieter (510.412.5300), Mariya Semeit (650.369.4161), Dale Leuer (650.369.4161), and Vistasp Patel (650.369.4161) with Sims Metals Management (Sims or Facility Representatives)</p> <p>Prior to commencing the inspection, an ope

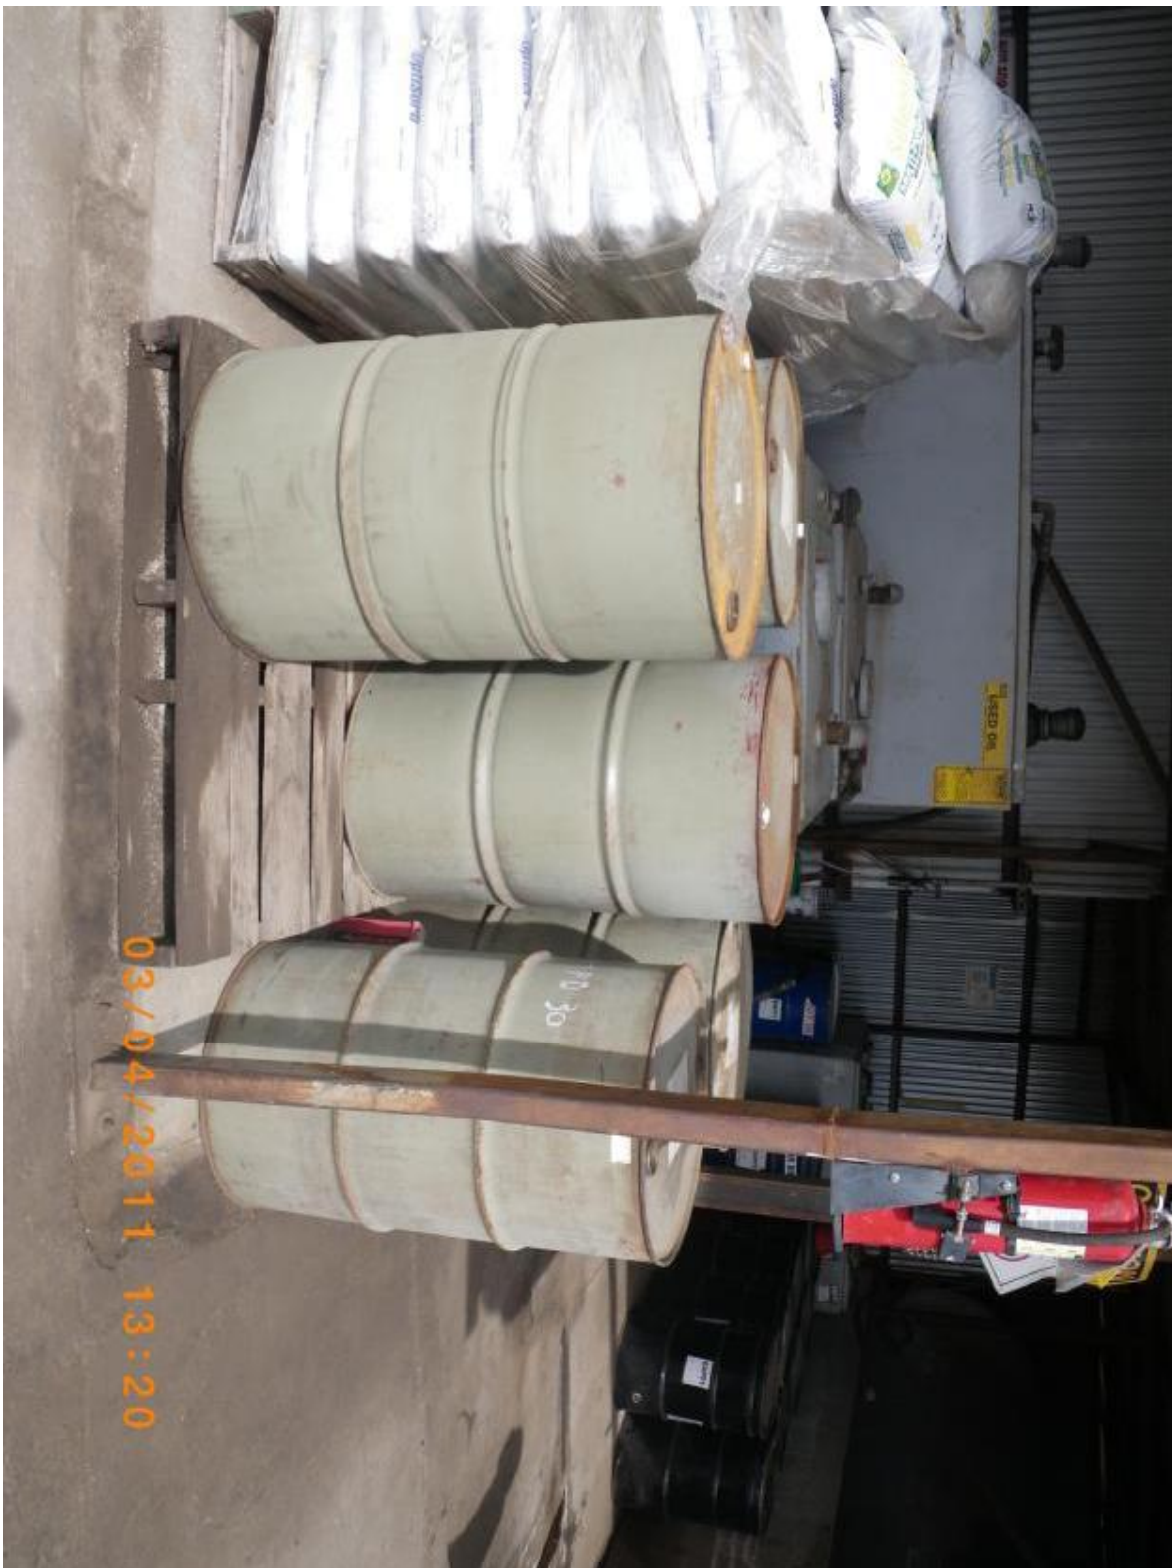
IMGP0287.JPG

IMGP0287 – Stock pile of absorbent material, drums and waste oil containers observed in the covered fueling and oiling depot.

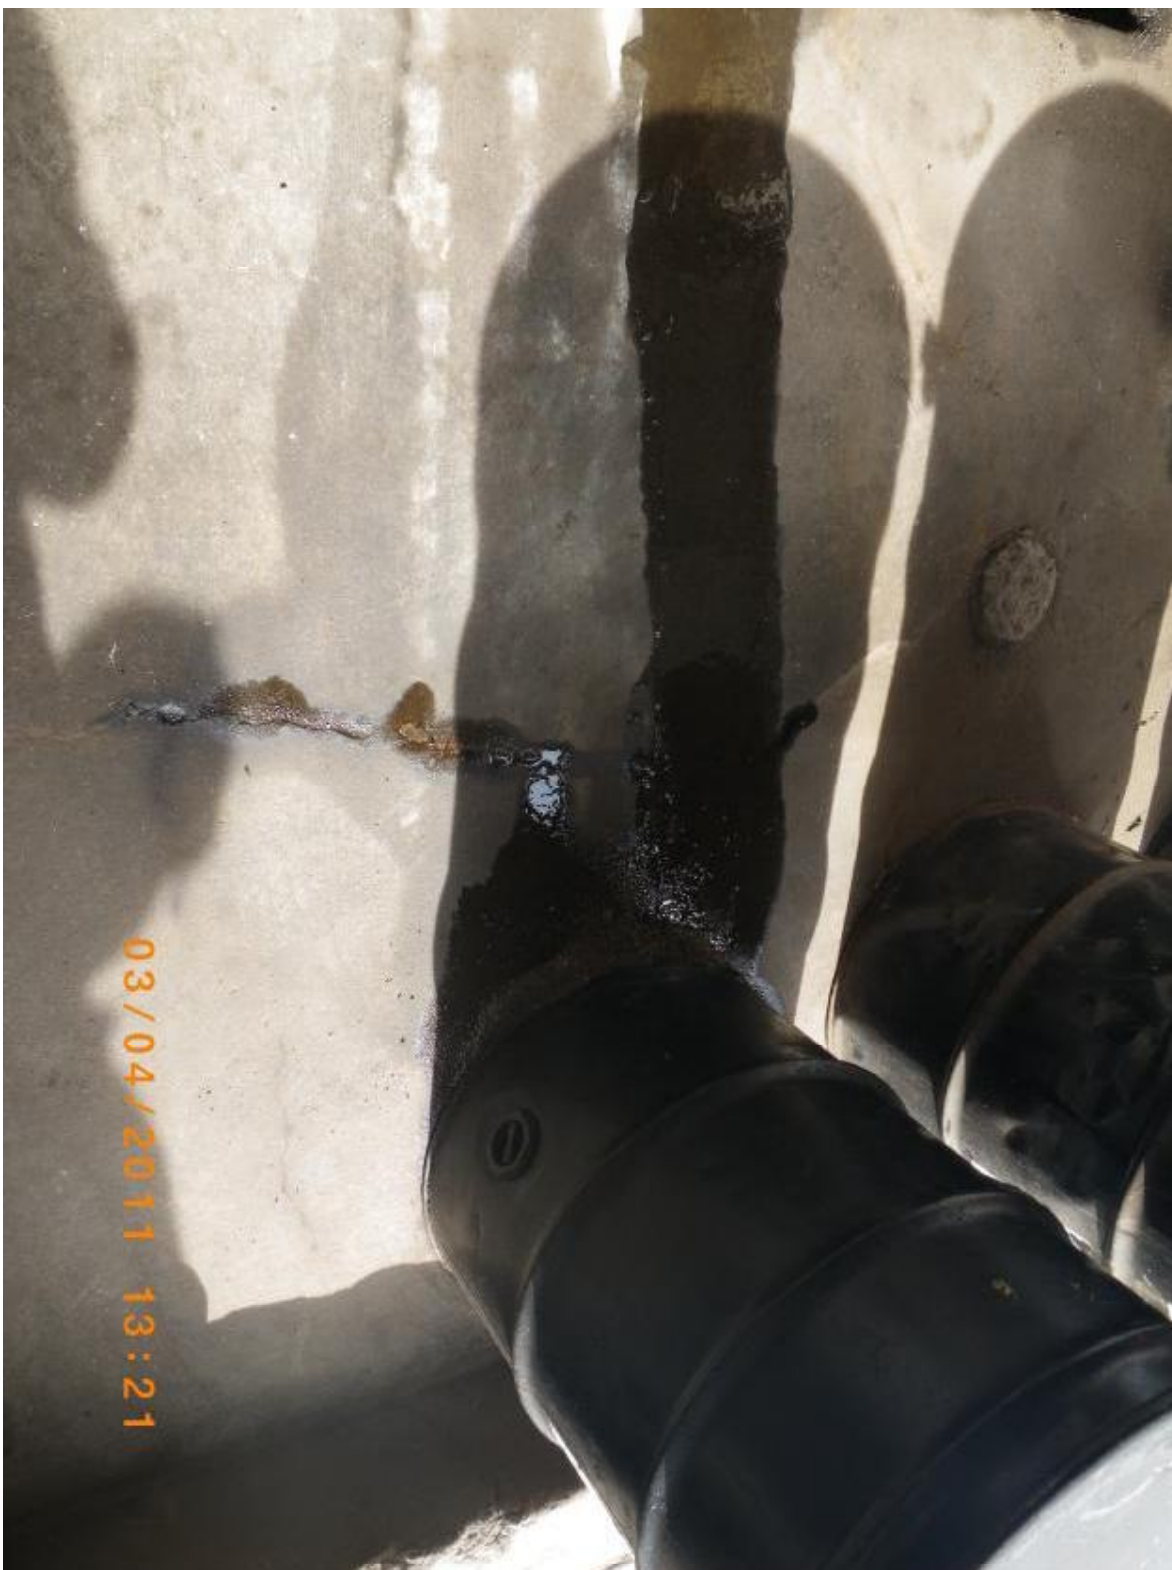
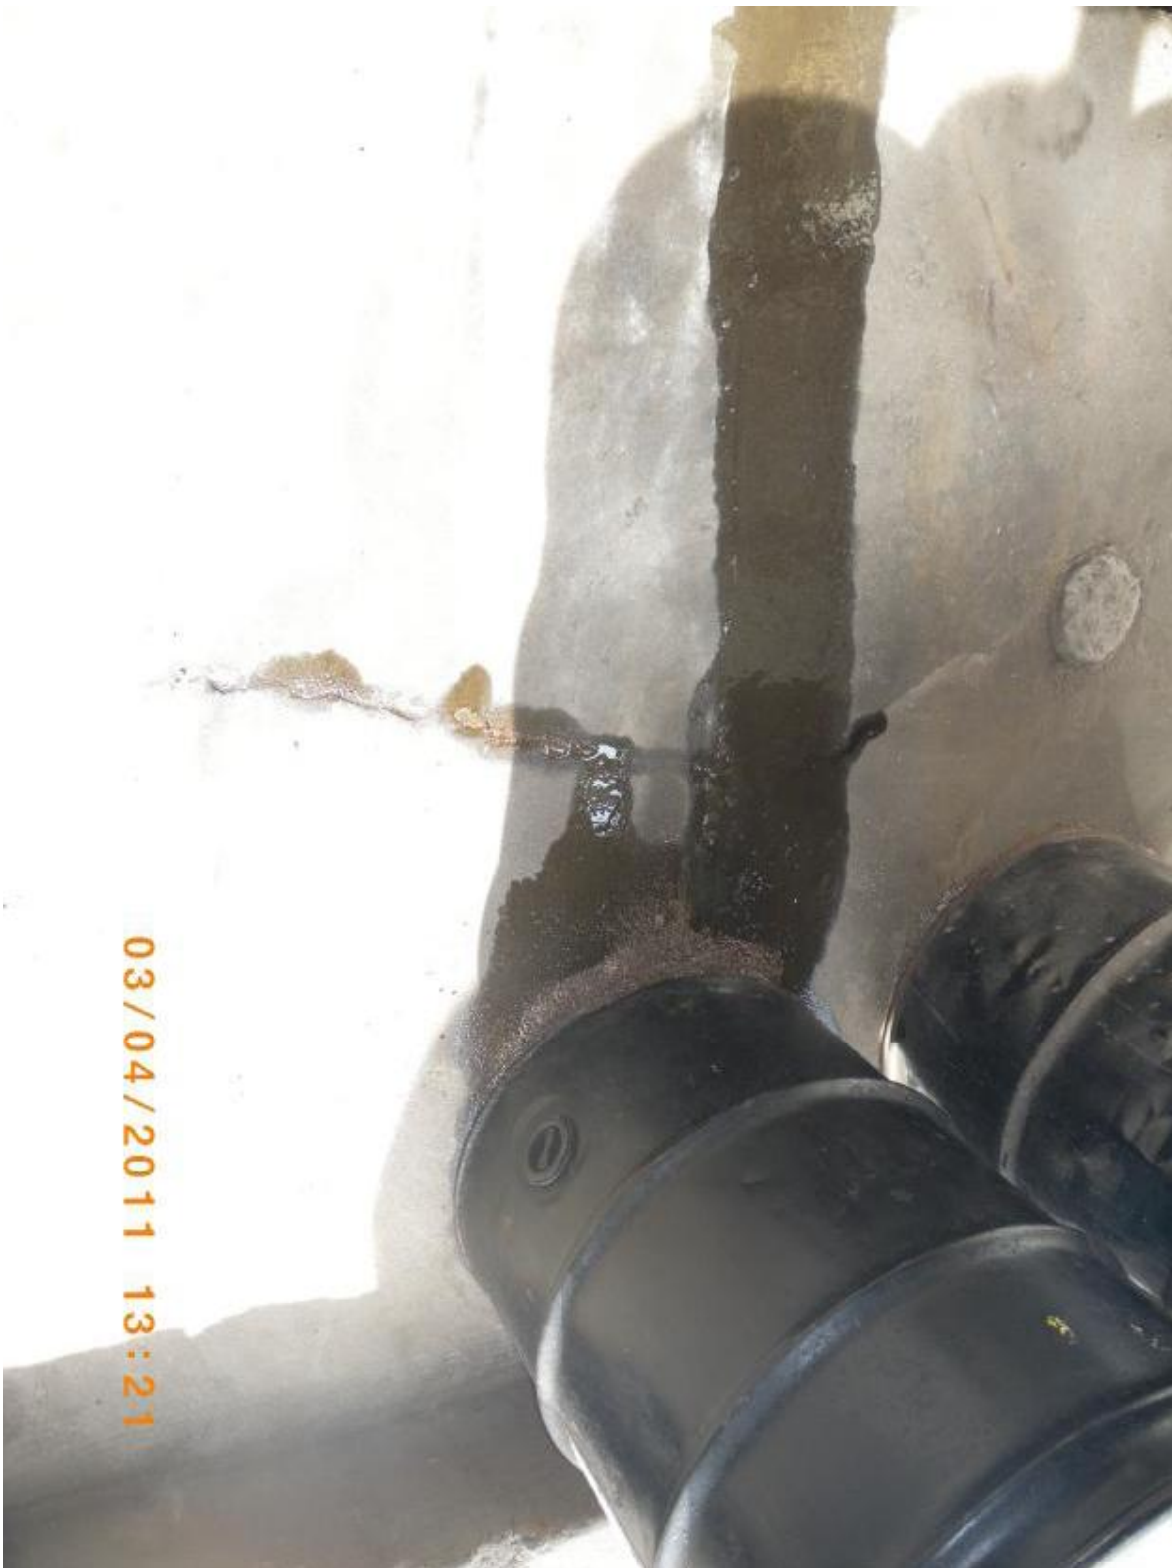
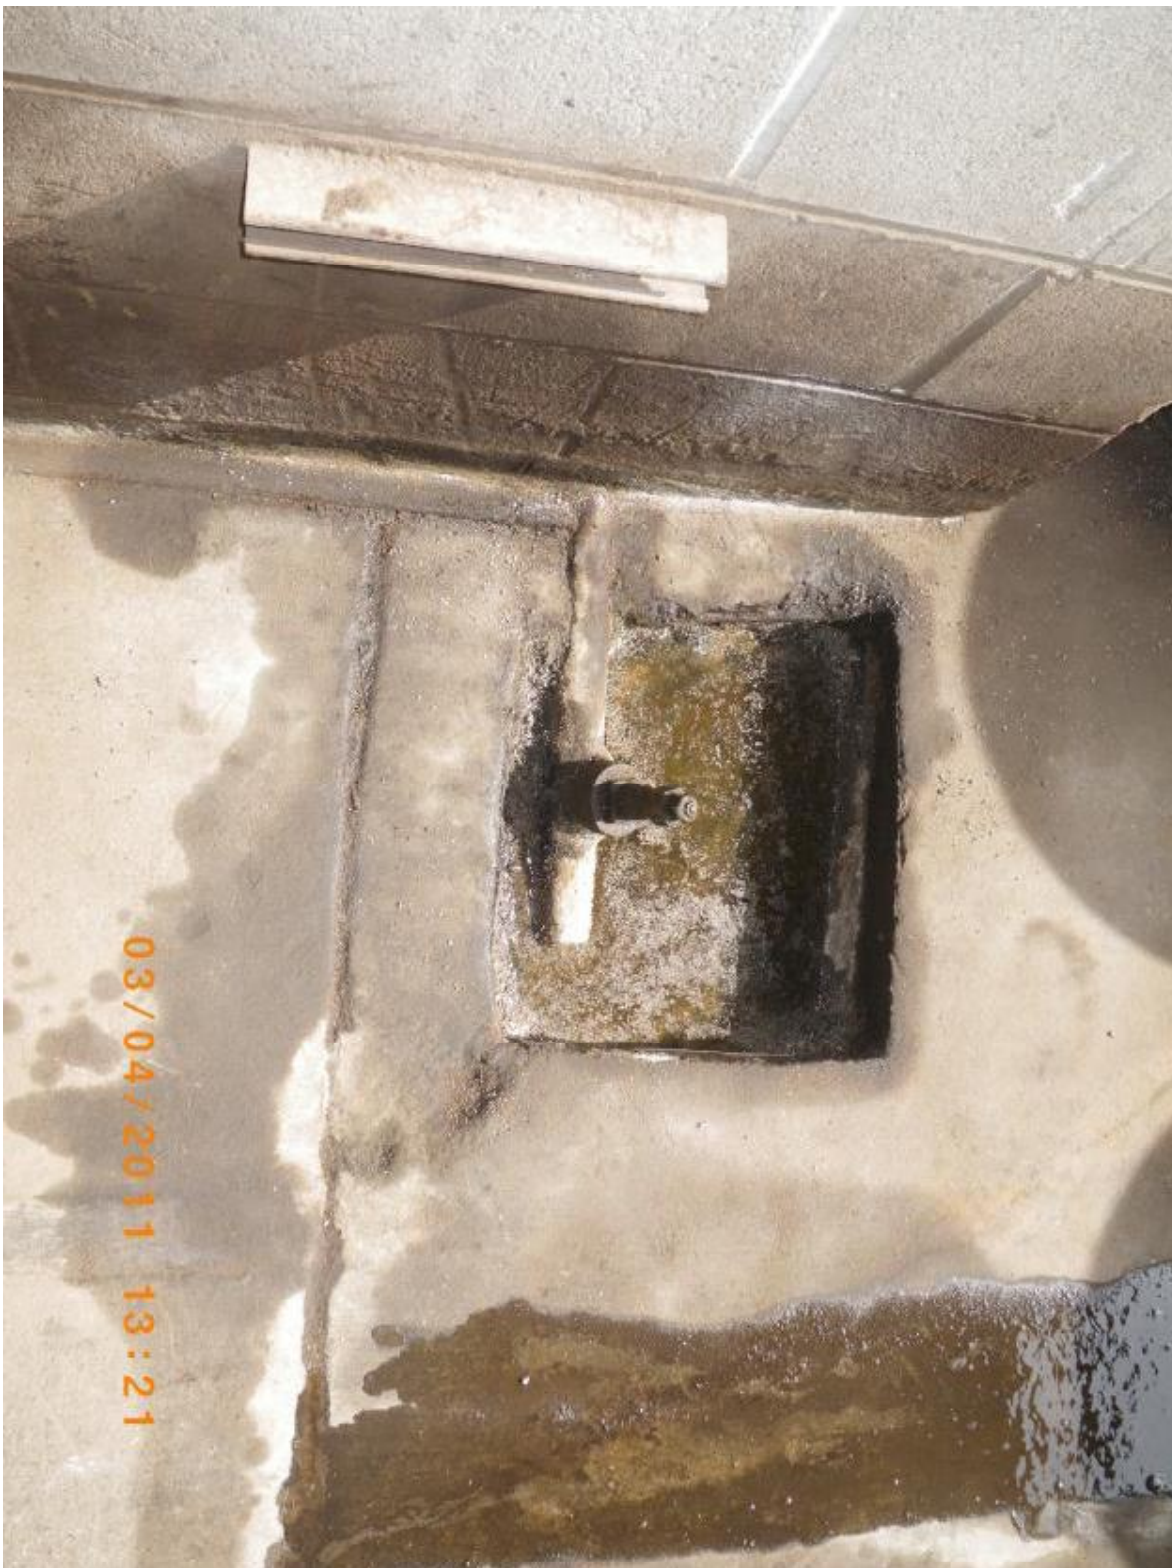
IMGP0288 thru 0293 – Oil lines, drums, and oil leaks observed within the covered fueling and oiling depot.

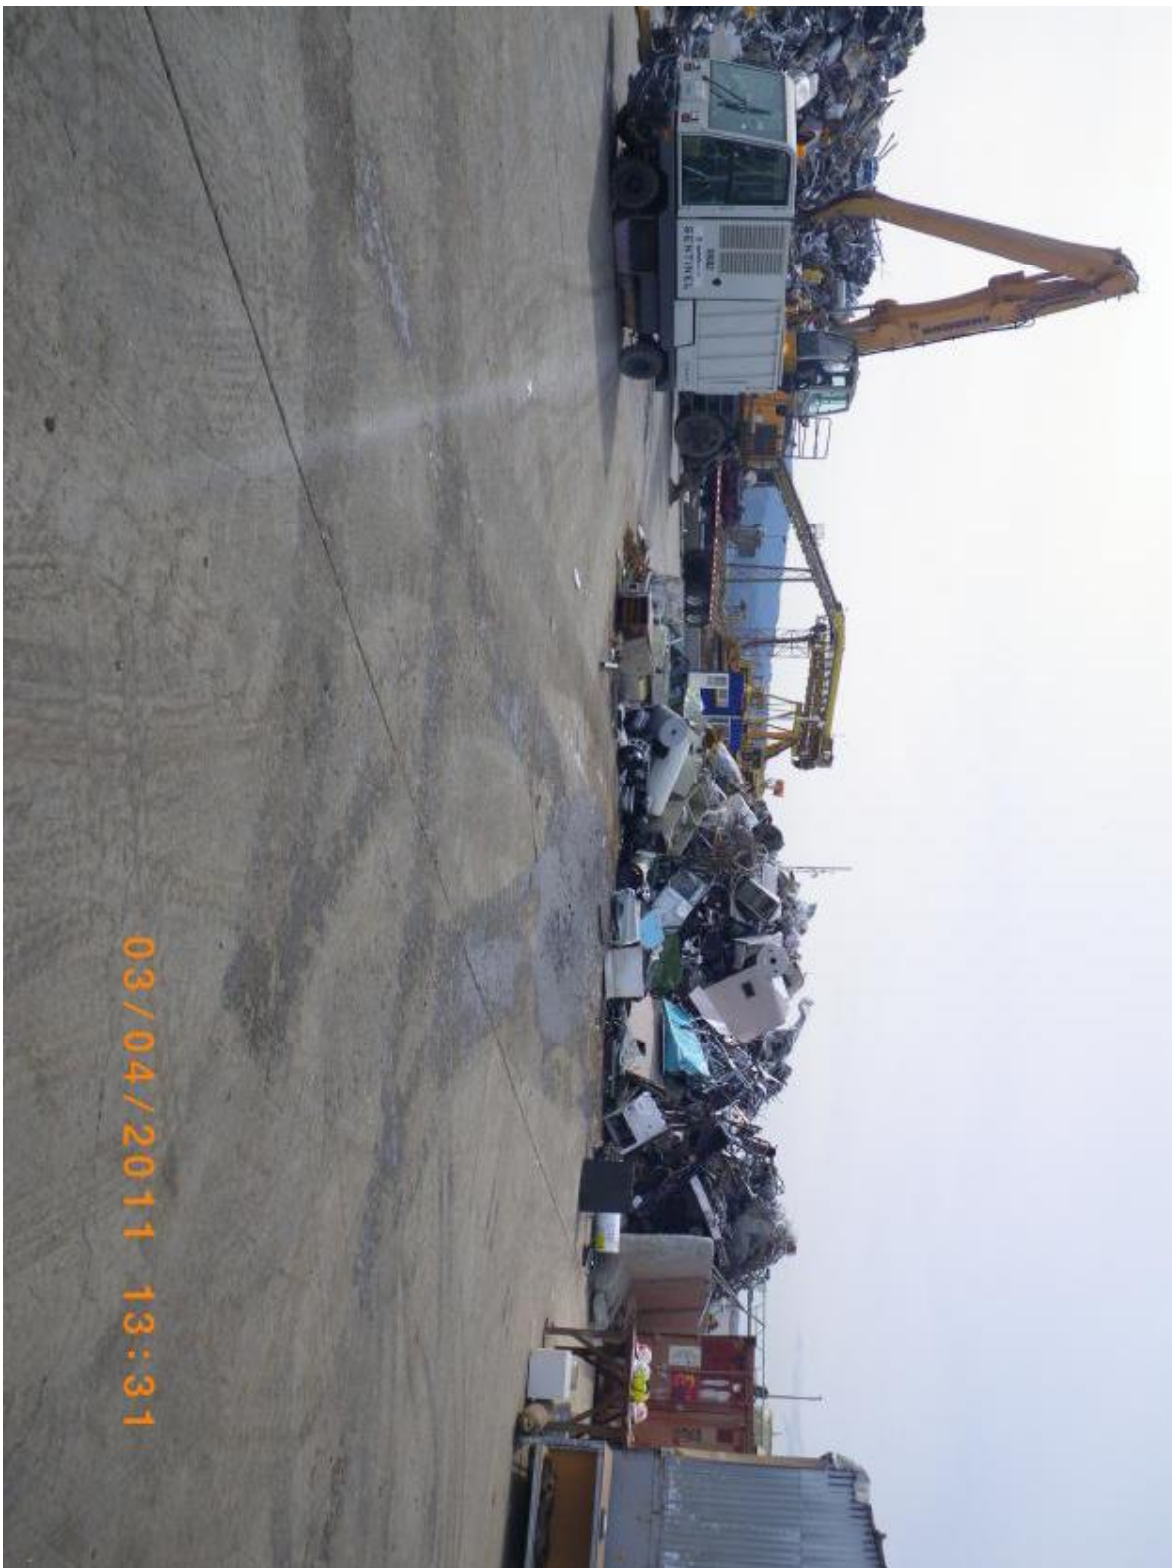
IMGP0302.JPG

IMGP0302 – Appliance processing yard with observed vehicle tracks across the driving surface (both wet and dry).
