**SEWAGE COLLECTION SYSTEM INSPECTION FORM  
Stege Sanitary District**

Inspection Date: March 30 – 31, 2009

Utility Name: Stege Sanitary District (SSD)		
Address: 7500 Schmidt Lane El Cerrito, CA 94530		
Contact Person: Douglas Humphrey		
Phone: 510/524-4667	Cell:	Fax: 510/524-4697
Email: doug@stegesd.dst.ca.us

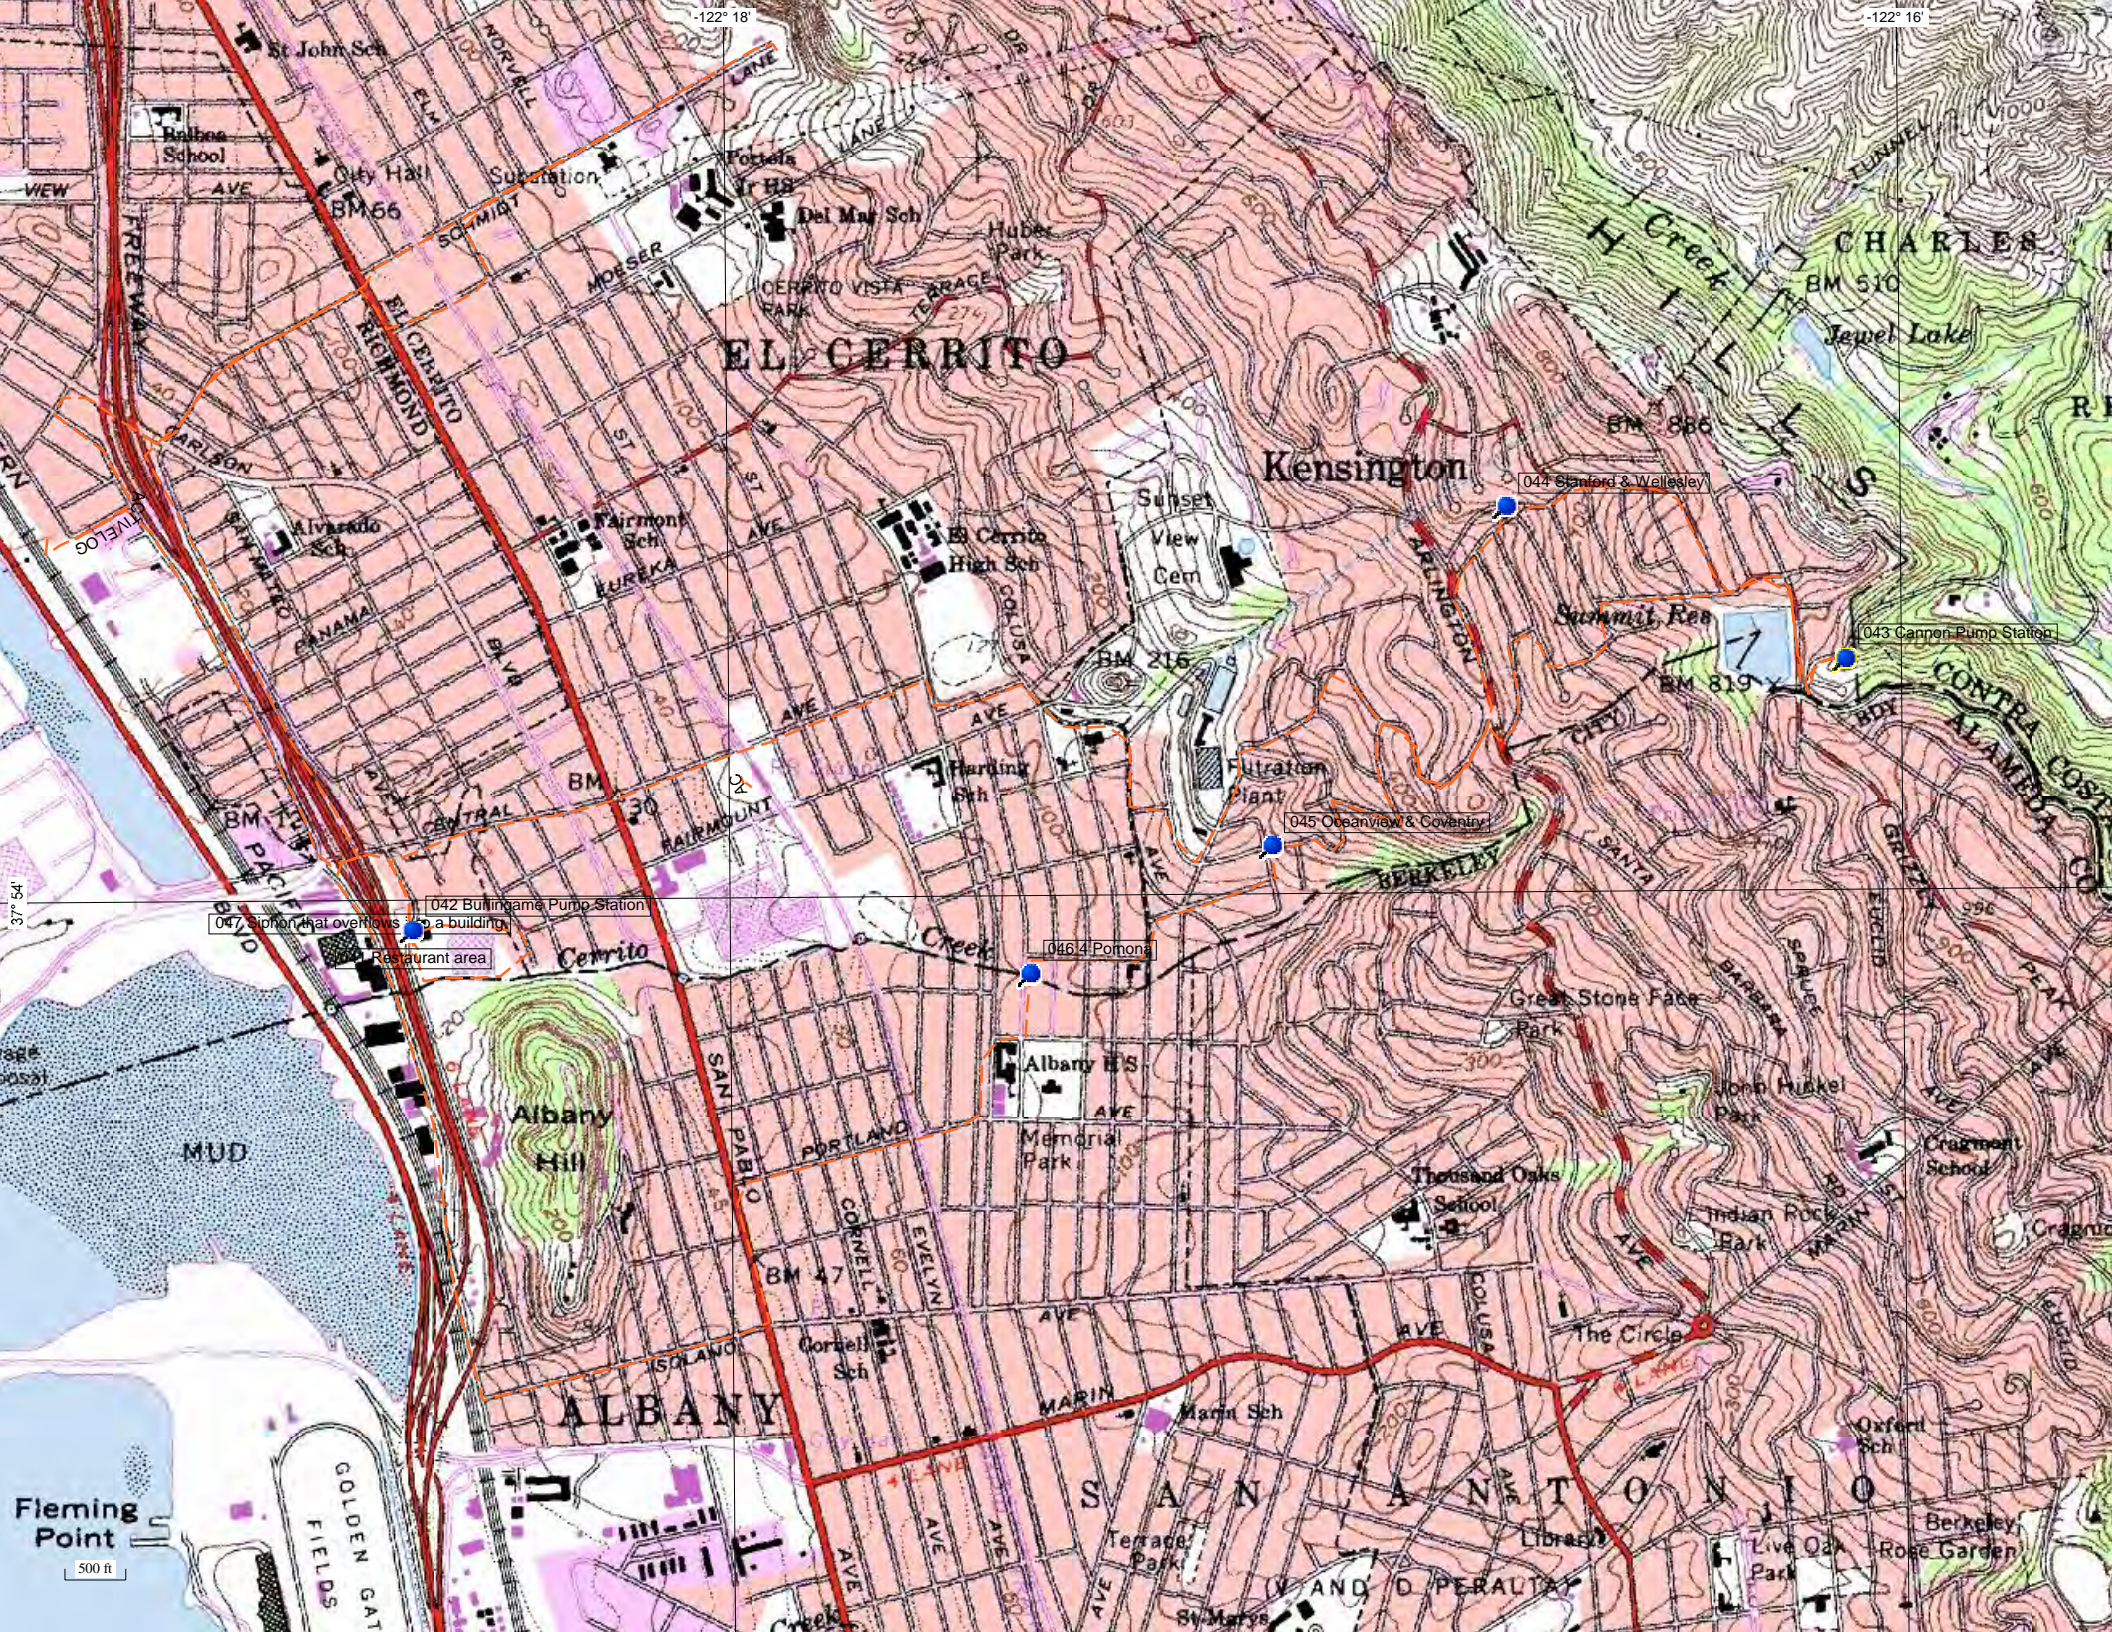
The inspection team visited the “4 Pomona” spill site (see Photo 10). This site also overflowed in 2004 and 2005. The manhole here is only two feet deep. SSD believes the spills occur because of an obstruction, but they have televised the pipes and not found an obstruction. SSD is continuing to investigate.

They have done three projects at the Stanford & Wellesley problem area. At the “4 Pomona” SSO location, the model indicates that the site can handle the flow, but it probably doesn’t account for the energy dissipation problem caused by its location at the end of a steep hill.

Photo 10 "4 Pomona" - capacity spill site
