**Memorandum**

**Date:** July 9, 2009  
**Subject:** Whitney Barrel Inspection, 256 Salem Street, Woburn, MA  
**From:** Joseph F. LeMay, RPM  
**To:** Cindy Lewis, EPA  
Susan Scott, EPA  
Heather Cote, EPA  
Jim Israel, EPA  
Bob Cianciarulo, EPA  
Jerry Keefe, EPA  
Dan Granz, EPA  
File

Superfund Records Center  
SITE: Wells G+H  
BREAK: 119  
OTHER: Whitney Barrel

**FIGURES – EPA Inspection of Whitney Barrel Property, Woburn, MA**

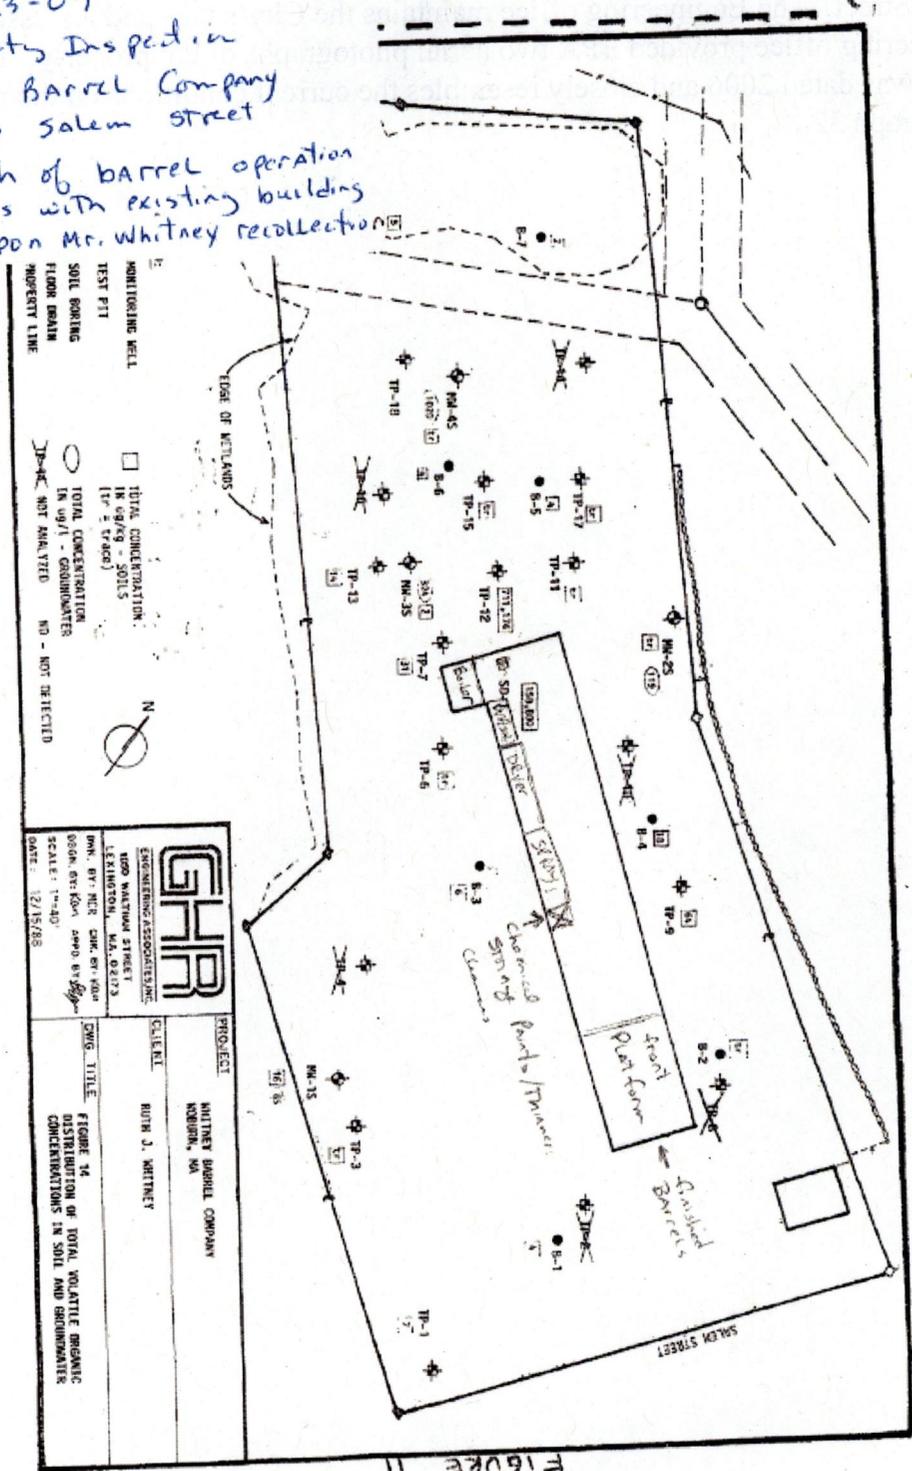
6-23-09  
 EPA Property Inspection  
 Whitney Barrel Company  
 256 Salem Street  
 EPA sketch of barrel operation  
 Locations with existing buildings  
 Based upon Mr. Whitney recollection

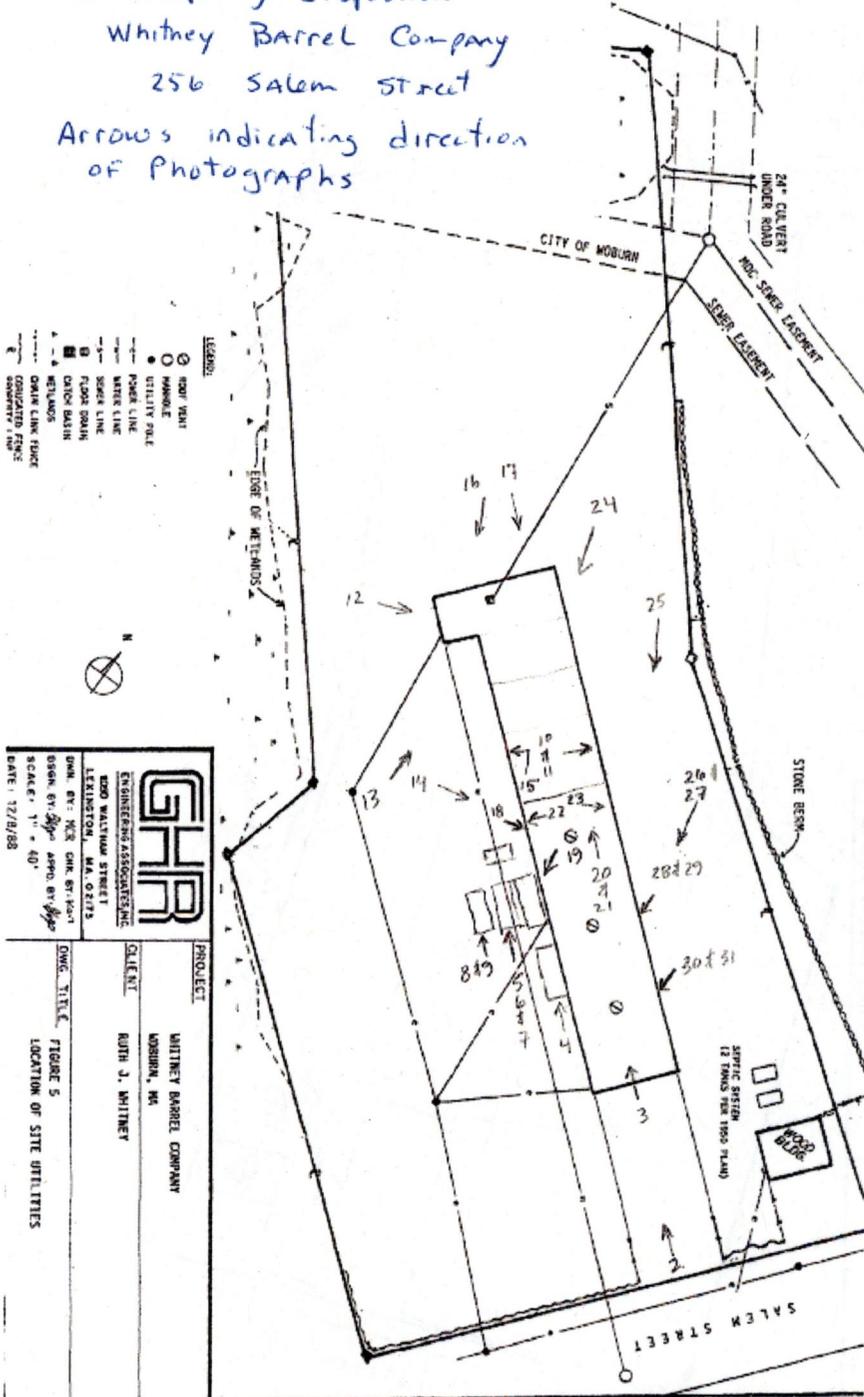
FIGURE 9

6-23-09  
 EPA Property Inspection  
 Whitney Barrel Company  
 256 Salem Street  
 Arrows indicating direction  
 of Photographs

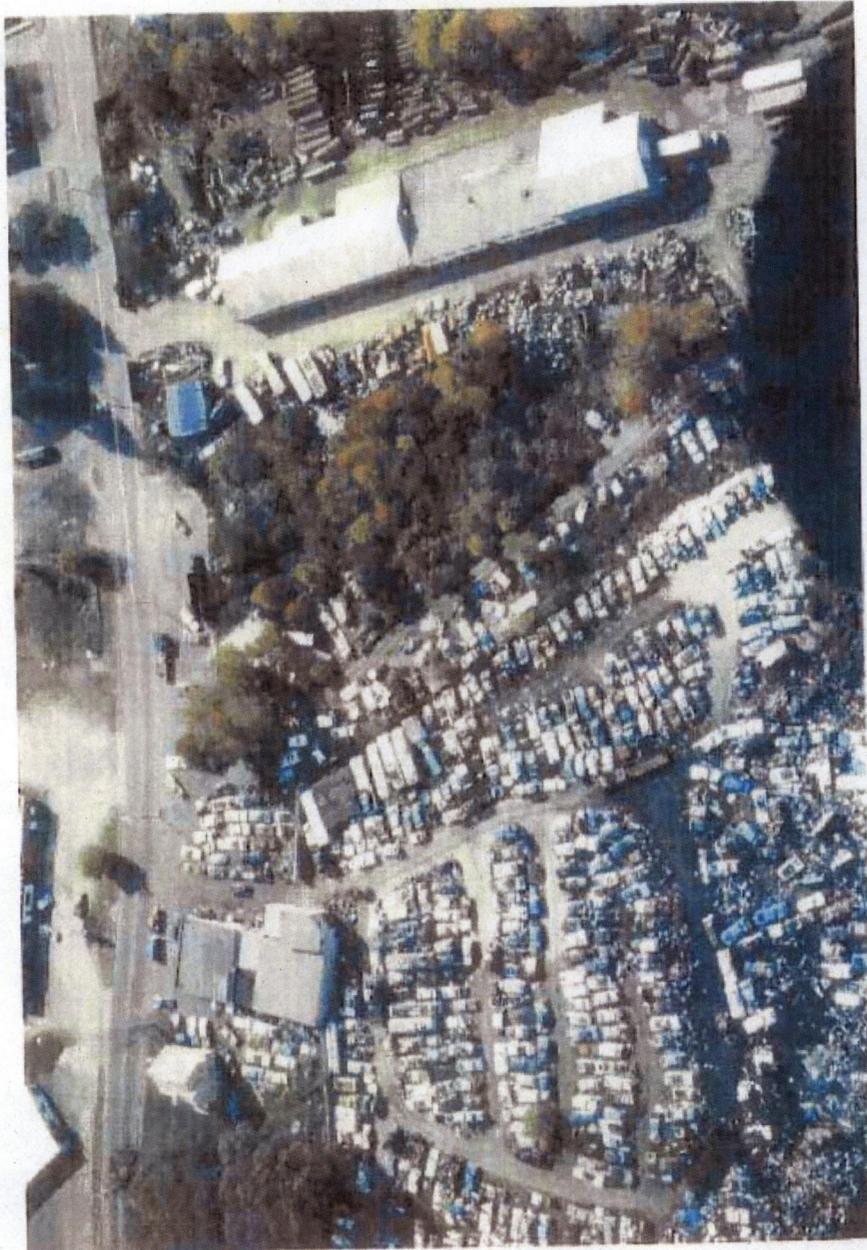
Photograph D-17

Aerial - Aberjona Auto Parts and Whitney  
Barrel Company; October 1971 (Photo by the  
Maburn Conservation Commission).  
D-17

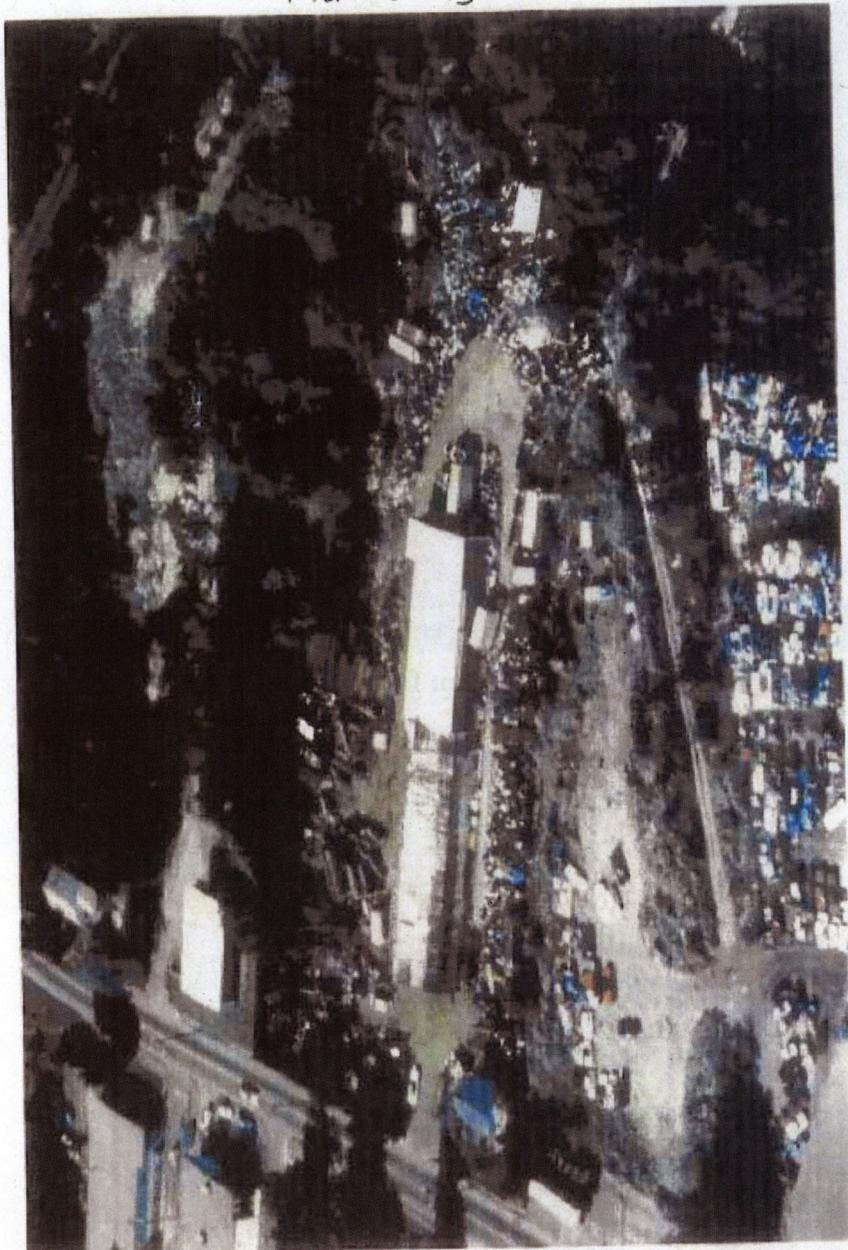
Photograph D-4

Whitney Barrel Company, Salem Street;  
September 1982 (Photo by John Merit).
