Restoration of Tidally Restricted Salt Marshes Rumney Marsh in Massachusetts:

Balancing Flood Protection with Marsh
Restoration by use of Self-Regulating Tidegates

Edward Reiner - EPA New England

New England Association of
Environmental Biologists
March 17, 2010
Newport, RI

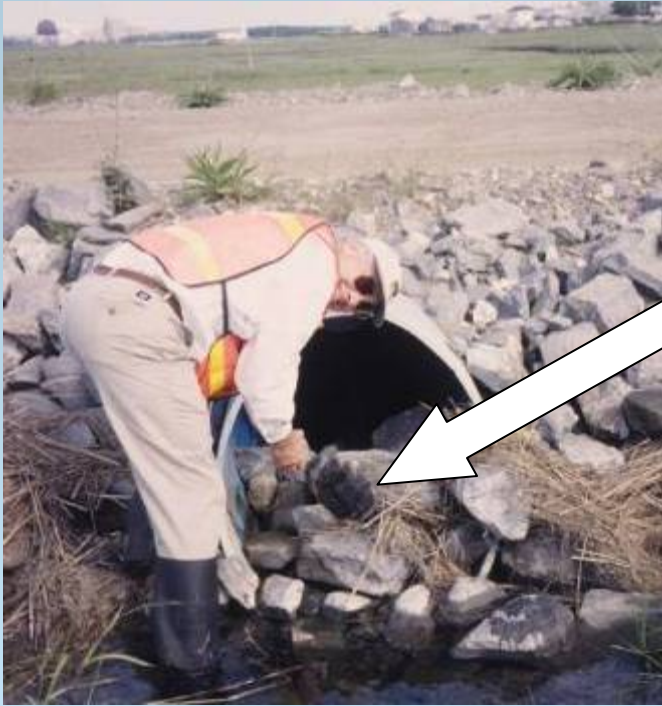
Vandalism

Rocks Block Pipe
