DEPARTMENT OF THE ARMY  
NEW ENGLAND DISTRICT  
CORPS OF ENGINEERS  
CONCORD, MASSACHUSETTS

INVESTIGATION OF LYMANSVILLE AND MANTON DAMS  
WOONASQUATUCKET RIVER, RHODE ISLAND

MAY, 2005

LYMANSVILLE AND MANTON DAMS  
WOONASQUATUCKET RIVER, RHODE ISLAND

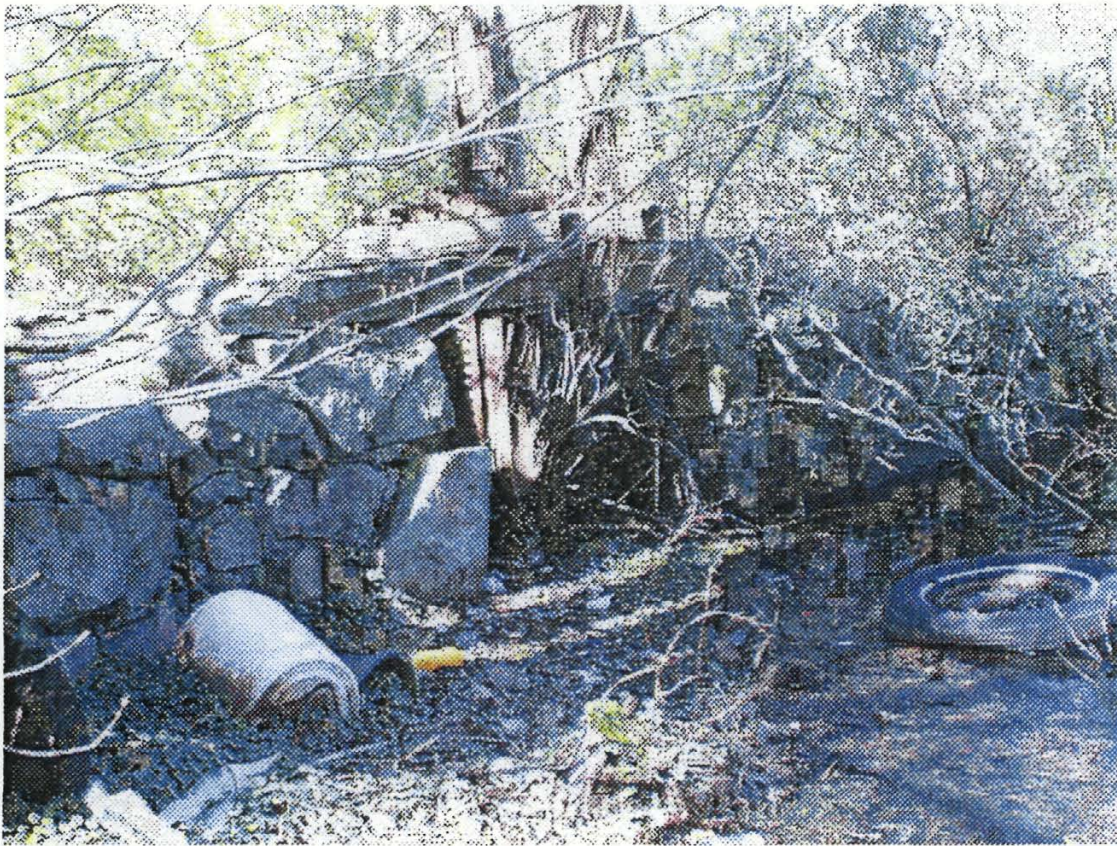
Photo 4 – Outlet works on left bank.

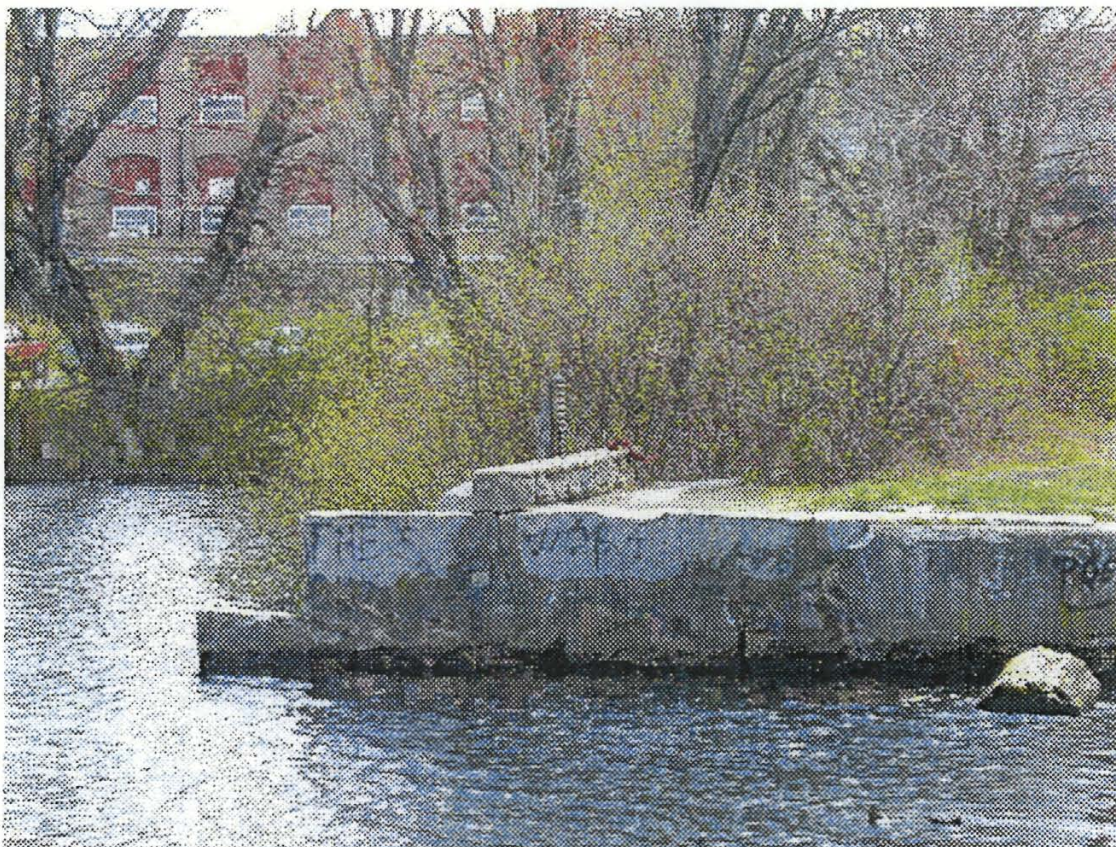
Photo 5 – View of outlet works on left end of spillway.

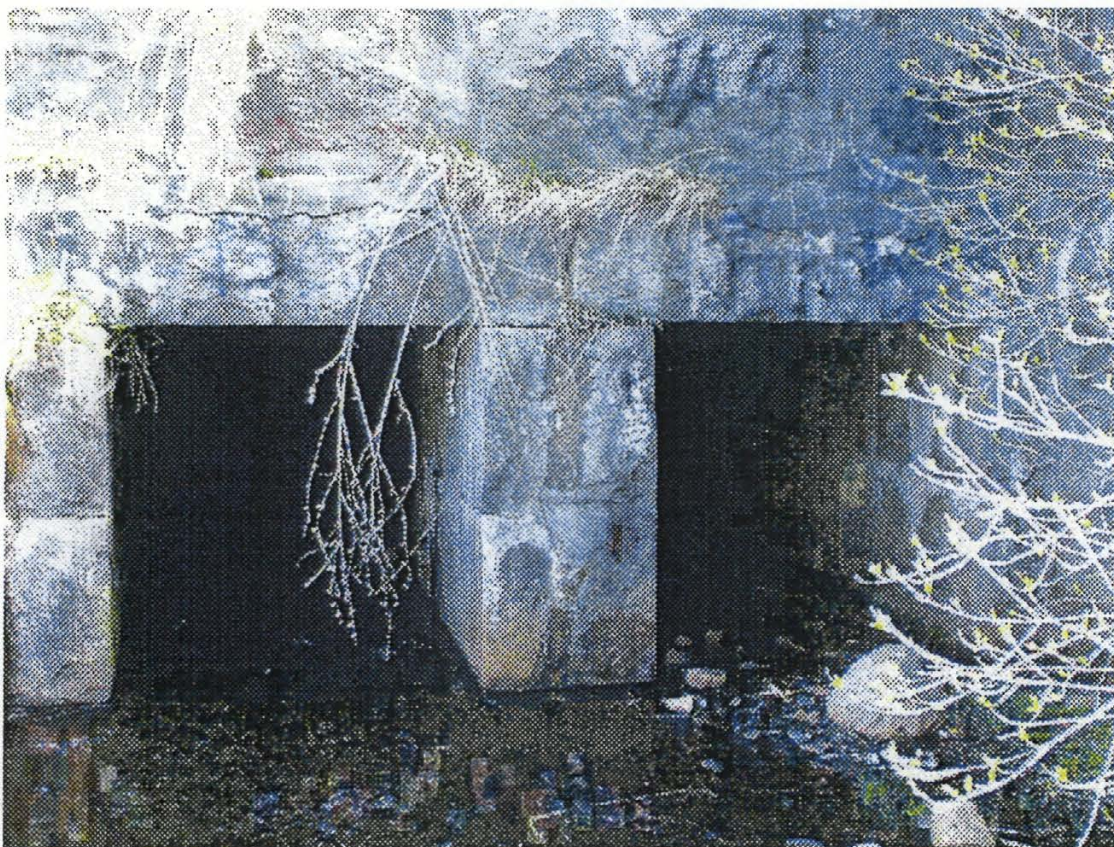
Photo 6 – Downstream end of outlet works on left side of spillway.

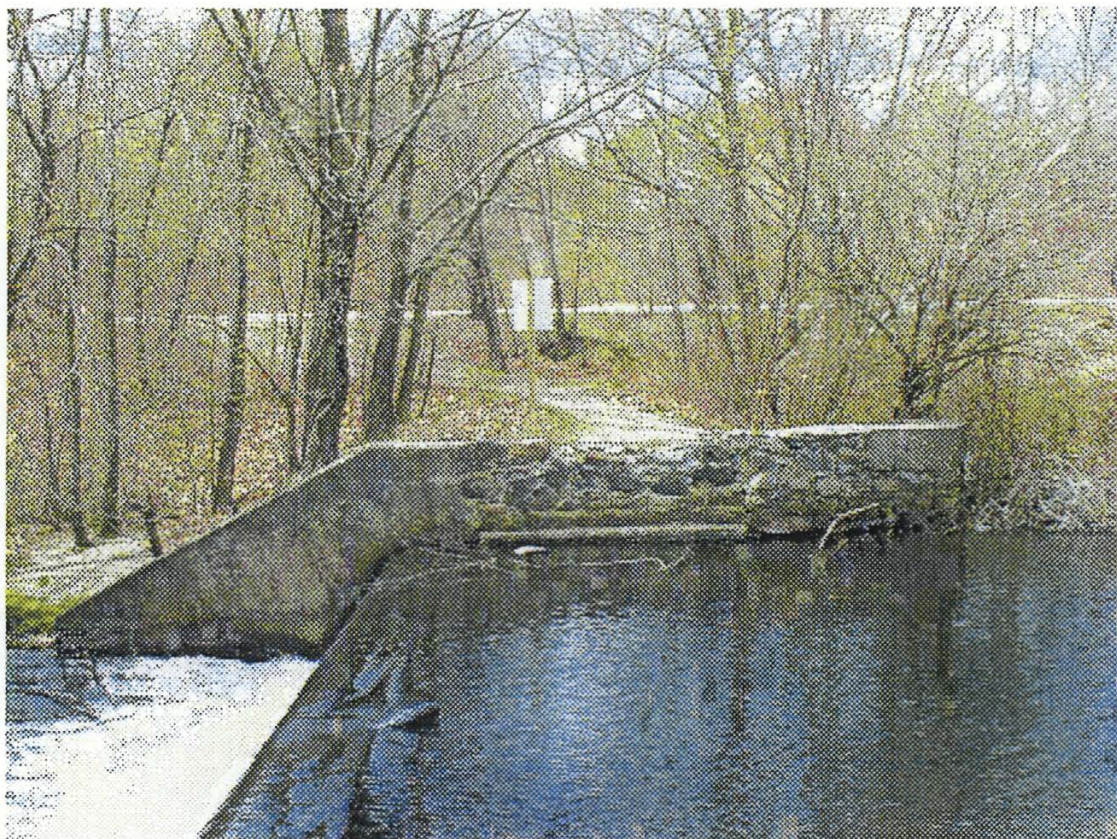
Photo 1 – Overview of right embankment from left.

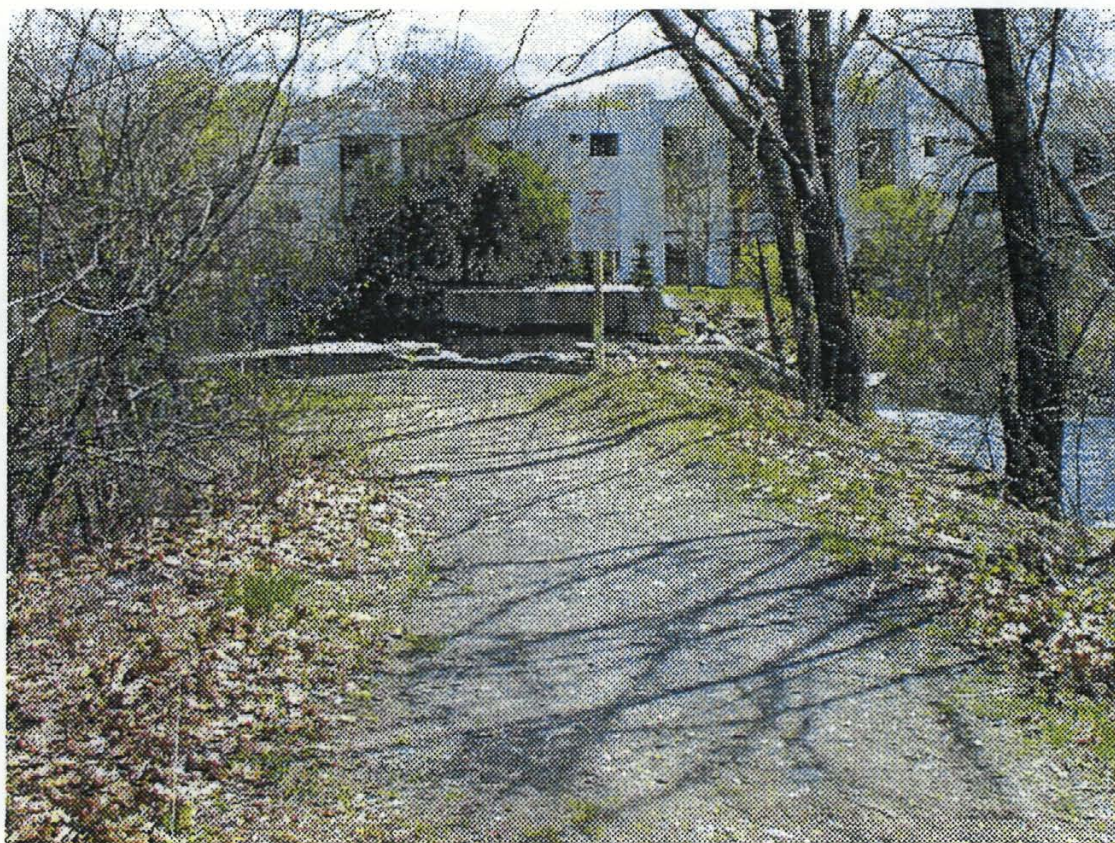
Photo 2 – Overview of right embankment looking towards spillway.

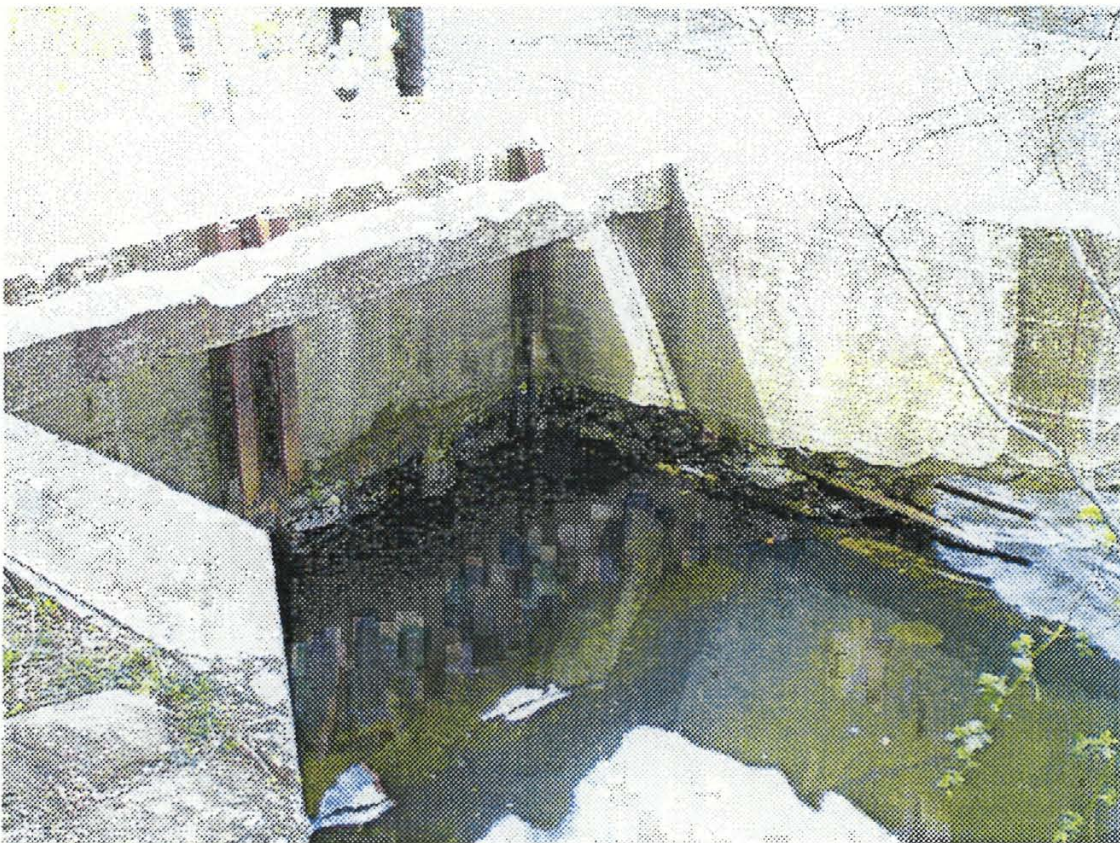
Photo 4 – Inlet to outlet works at left end of spillway.

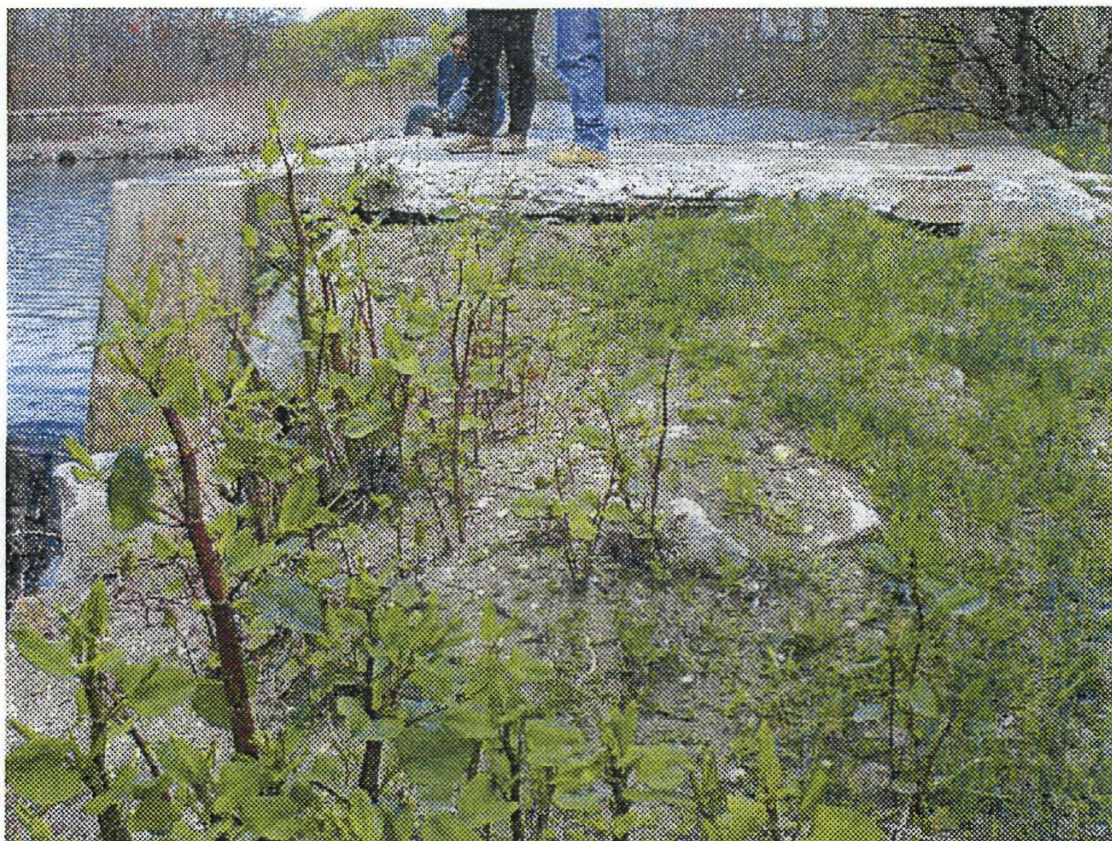
Photo 5 – Soil filling downstream side of outlet works.

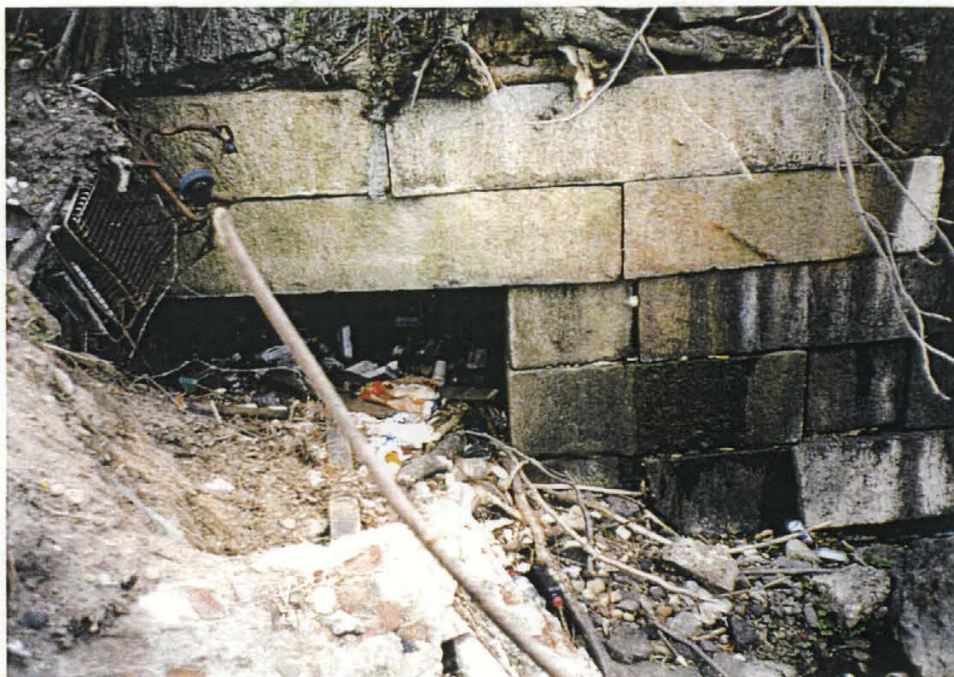
Photo 1: Debris almost completely fills the opening of the outlet structure located at the right side of the spillway.

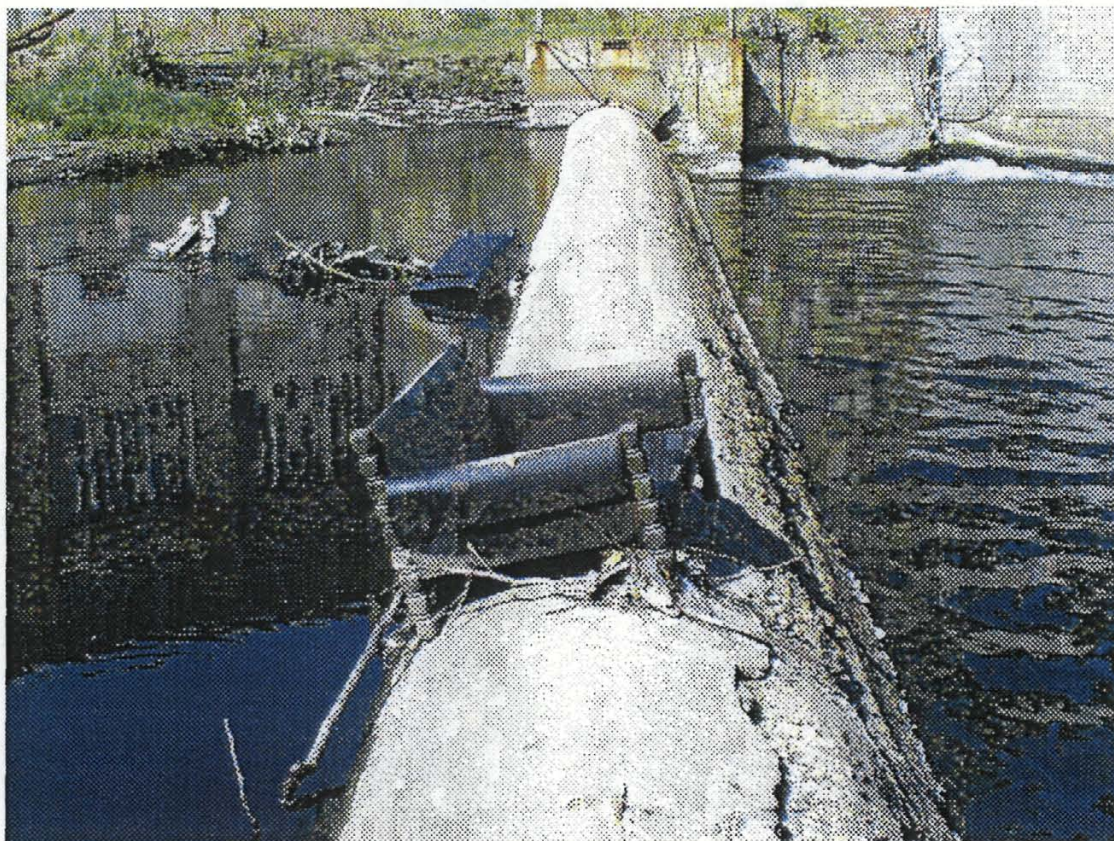
Photo 3 – Spillway from right bank.

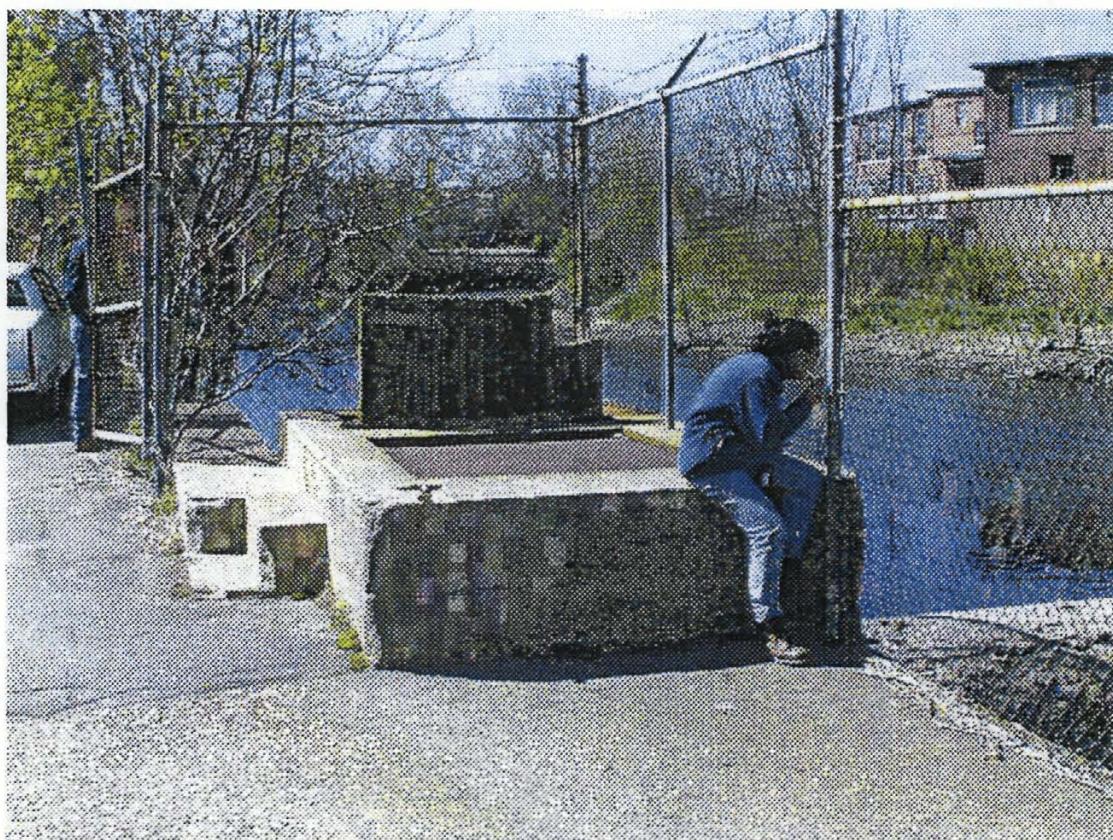
Photo 4 – Outlet works on right bank with raised wooded gate.

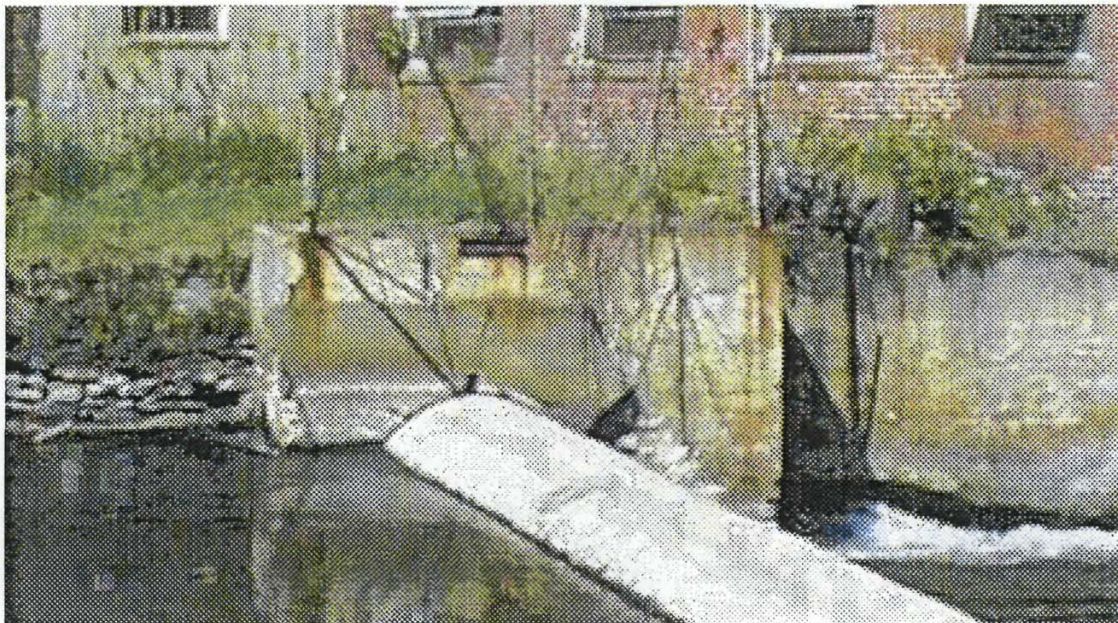
Photo 5 – Outlet works on left side of spillway.

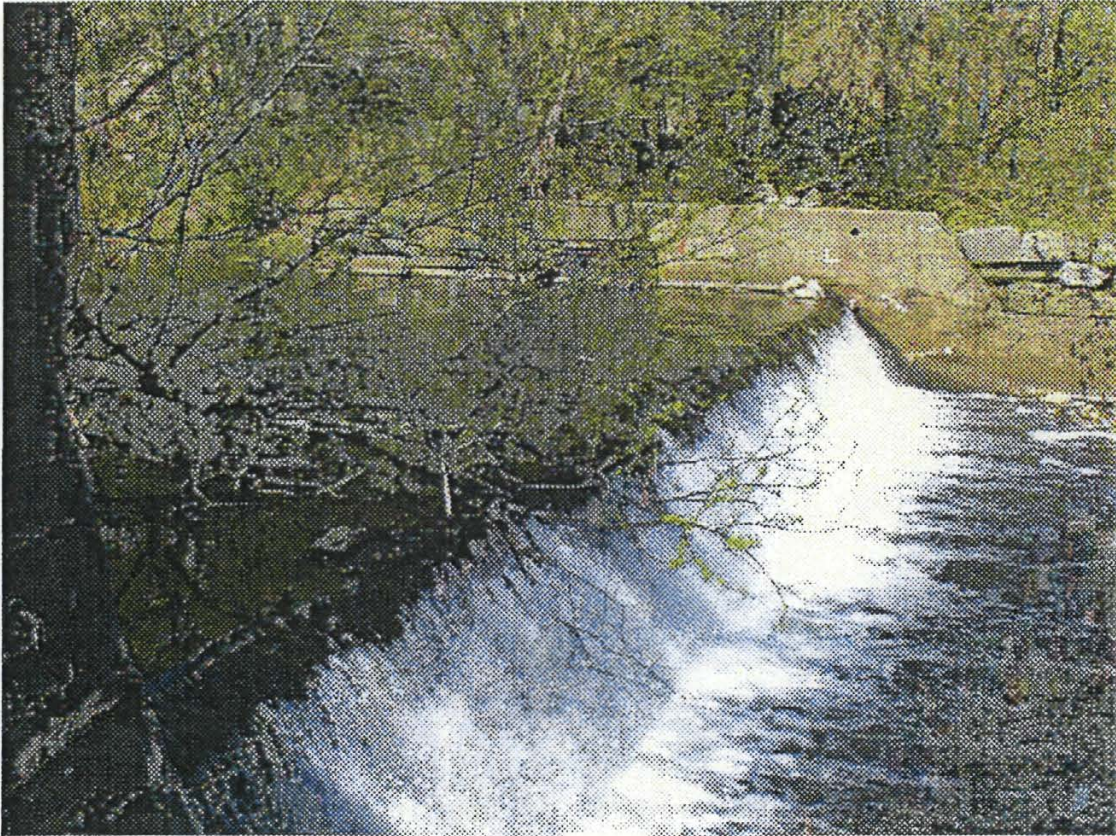
Photo 1 – Overview of dam from right bank.

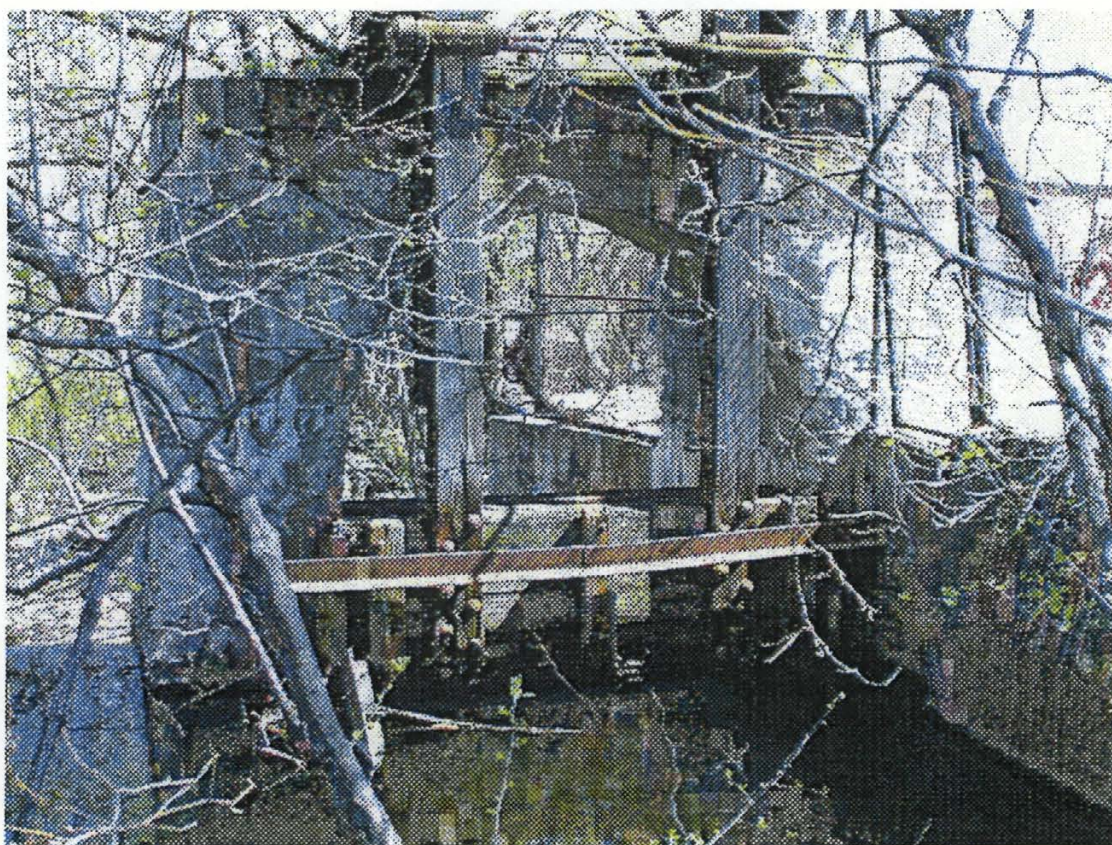
Photo 4 – Upstream view of outlet works on right bank.
