SITE: Centredale

CONTRACT NO. DACW33-01-D-0004

SUBMITTAL OF DELIVERABLE – Interim Final Letter Report, *October 2005 Storm Evaluation*, Centredale Manor Restoration Project Superfund Site

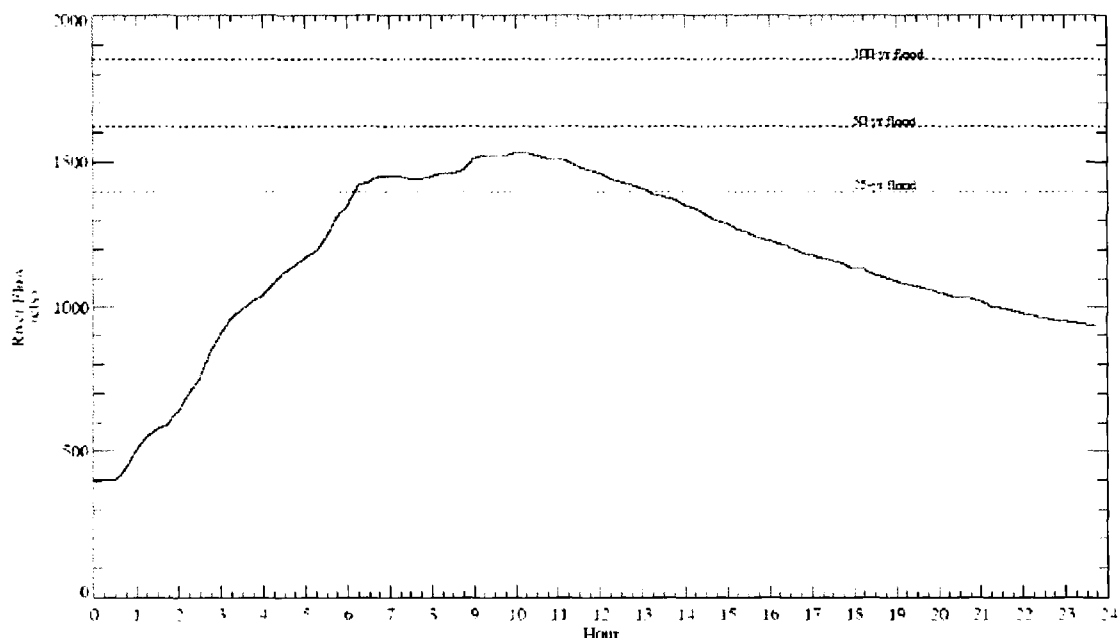
The October 15, 2005 flood was one of the largest high-flow events ever recorded at the USGS gauging station located at Centredale, RI, which has been in operation since October 1, 1942 (i.e., water year 1943). The hydrograph for the October 2005 flood, based on discharge data provided by the USGS (personal communication, Phillip J Zarriello, USGS, May 2006), is presented in Figure 2. The peak flow rate during the October 2005 flood, based on 15-minute discharge data, was 1,530 cfs. A flood frequency analysis was conducted by Maureen Corcoran of the U.S. Army Corps of Engineers (USACE) using historical data collected at the Centredale gauging station. The results of that analysis are presented in the sediment stability study (QEA, 2006), which evaluated the potential impacts of a range of floods (i.e., 5-, 10-, 25-, 50-, and 100-yr) on bed stability. Based on that flood frequency analysis, the peak flow rate during the October 2005 flood corresponds to a return period that ranges between 25 and 50 years (i.e., a probability that this flow rate will occur in a particular year that ranges between 2 and 4 percent).

**Figure 2. Hydrograph of the Woonasquatucket River at Centredale, RI on October 15, 2005.**

The peak flow rate during the October 2005 flood, based on 15-minute discharge data, is the highest discharge value measured at the Centredale gauging station during the 62-year period of record. The October 2005 peak discharge value is compared to the three highest annual peak flow rates recorded during the 62-year period in Table 1. Note that a high-flow event in 1998, which occurred on a day when the daily-average flow rate was 831 cfs, had a peak discharge that was approximately equal to the October 2005 peak value (i.e., about 1 percent difference).
