**PHOTODOCUMENTATION**  
**CENTREDALE MANOR RESTORATION PROJECT SUPERFUND SITE**  
**North Providence, Rhode Island**

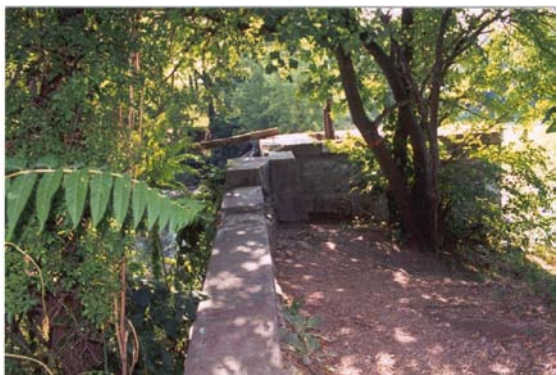
| Photograph | Date | View Point | View Direction | Description |
|---|---|---|---|---|
| | 08.13.2001 | East side of embankment, east of existing gate structure | W | Existing gate structure, prior to tree cutting and clearing activities |

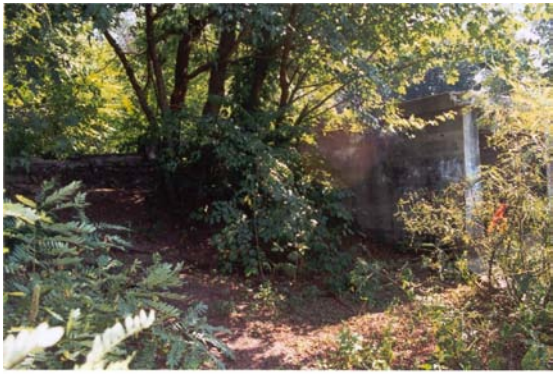
| Photograph | Date | View Point | View Direction | Description |
|---|---|---|---|---|
| | 08.13.2001 | East side of embankment, north of existing gate structure | S | Existing gate structure, prior to tree cutting and clearing activities |

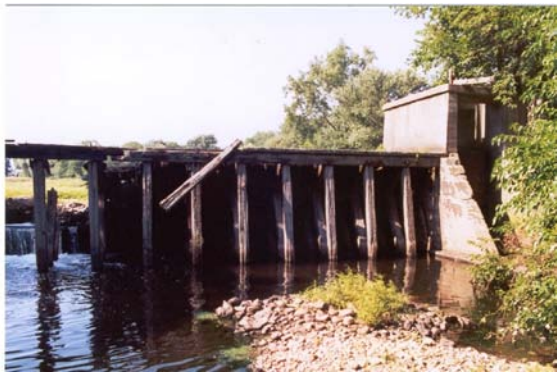
| Photograph | Date | View Point | View Direction | Description |
|---|---|---|---|---|
| | 08.13.2001 | Downstream of Allendale Dam and South of existing gate structure | NNE | Existing gate structure, prior to tree cutting and clearing activities |

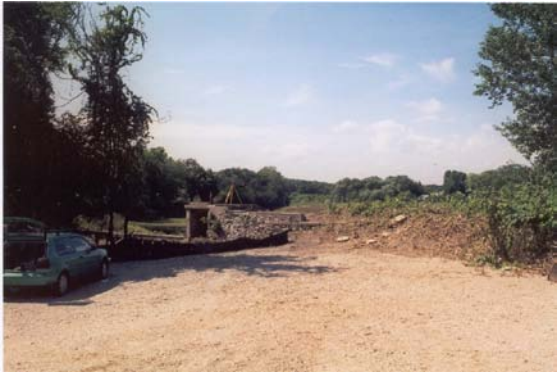
| Photograph | Date | View Point | View Direction | Description |
|---|---|---|---|---|
| | 08.15.2001 | Southeast of existing gate structure, standing in construction parking lot | NNW | Existing gate structure, following tree cutting and clearing activities |

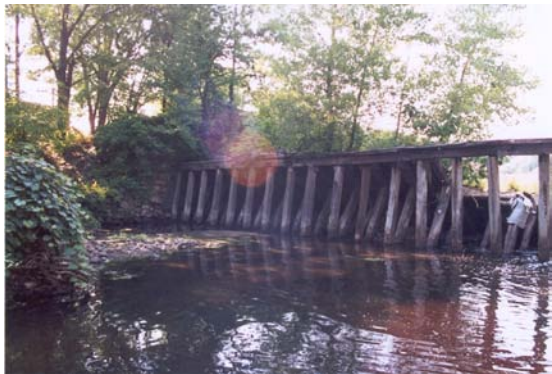
| Photograph | Date | View Point | View Direction | Description |
|---|---|---|---|---|
| | 08.13.2001 | Downstream of Allendale Dam | WNW | Allendale Dam abutting west embankment adjacent to the Town Asphalt Company Property, prior to tree cutting and clearing activities |

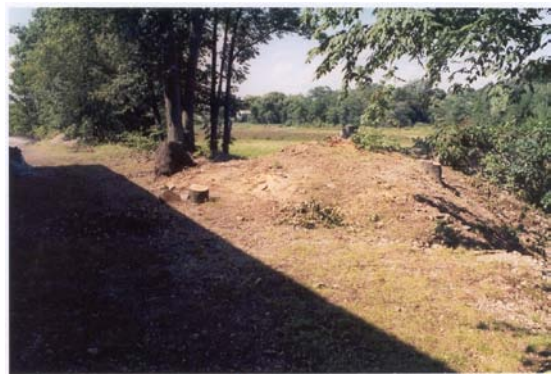
| Photograph | Date | View Point | View Direction | Description |
|---|---|---|---|---|
| | 08.14.2001 | The Town Asphalt Company property, above west embankment | NNE | The Town Asphalt Company property following tree cutting and clearing activities |

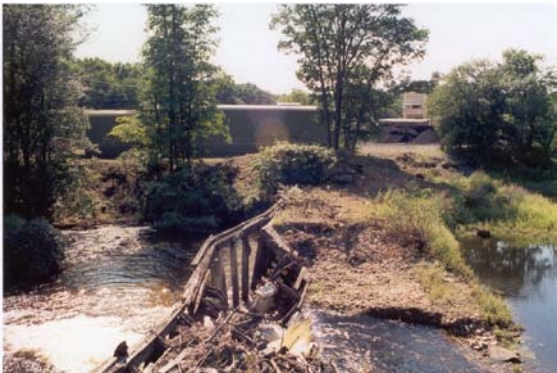
| Photograph | Date | View Point | View Direction | Description |
|---|---|---|---|---|
| | 08.14.2001 | Existing gate structure | W | View of the Town Asphalt Company property following tree cutting and clearing activities |

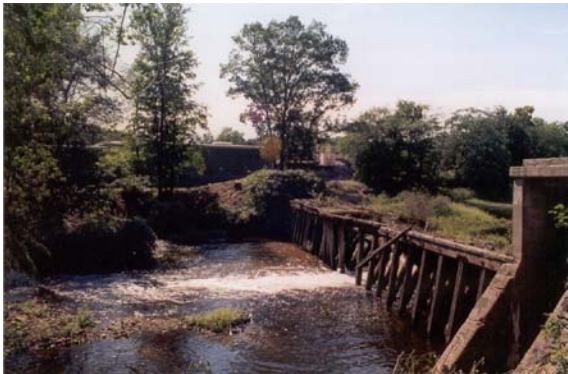
| Photograph | Date | View Point | View Direction | Description |
|---|---|---|---|---|
| | 08.14.2001 | East side of embankment | WNW | View of the Existing Allendale Dam structure and the Town Asphalt Company property following tree cutting and clearing activities |

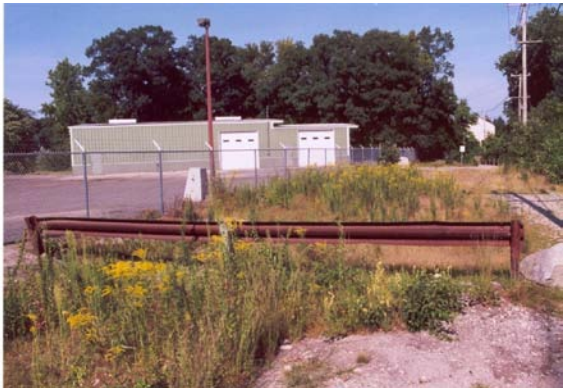
| Photograph | Date | View Point | View Direction | Description |
|---|---|---|---|---|
| | 08.14.2001 | East end of Allendale Avenue, adjacent to the Town Asphalt Company property | E | View of location of future containment pad, beyond guardrail |

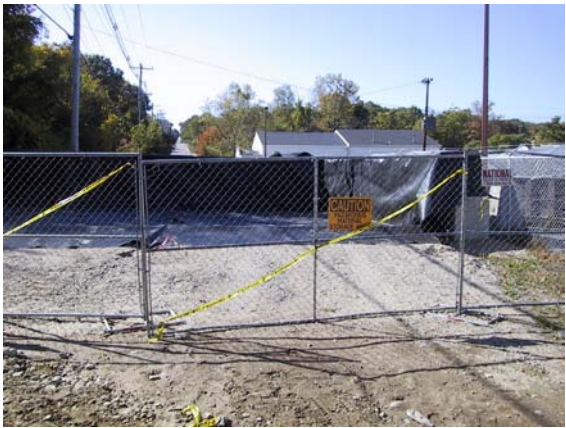
| Photograph | Date | View Point | View Direction | Description |
|---|---|---|---|---|
| | 10.11.2001 | South side of The Town Asphalt Company property | W | Containment pad surrounded by temporary chain-link fence |

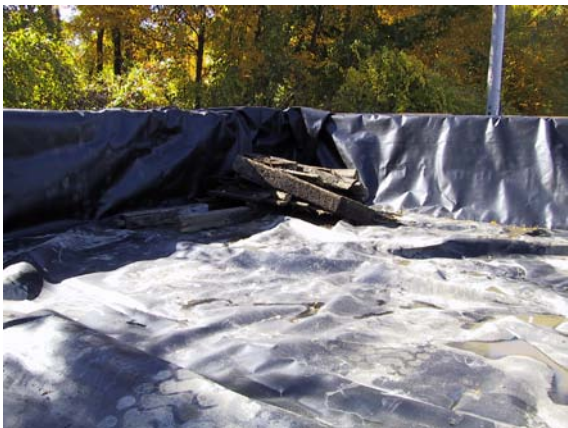
| Photograph | Date | View Point | View Direction | Description |
|---|---|---|---|---|
| | 10.16.2001 | The northeast corner of containment pad on The Town Asphalt Company property | SW | View of the lined containment pad; note the timber removed from the existing Allendale Dam structure temporarily stored on the containment pad liner |

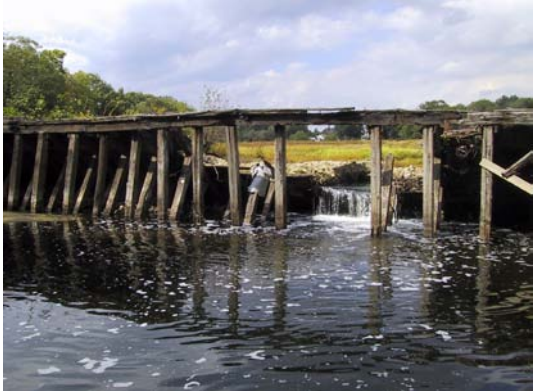
| Photograph | Date | View Point | View Direction | Description |
|---|---|---|---|---|
| | 09.19.2001 | South of existing Allendale Dam Structure | N | Former Allendale Dam Structure |

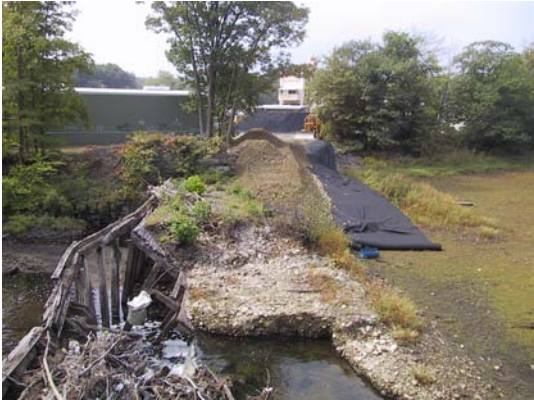
| Photograph | Date | View Point | View Direction | Description |
|---|---|---|---|---|
| | 09.24.2001 | Existing gate structure | W | Placement of filter fabric for upstream cofferdam |

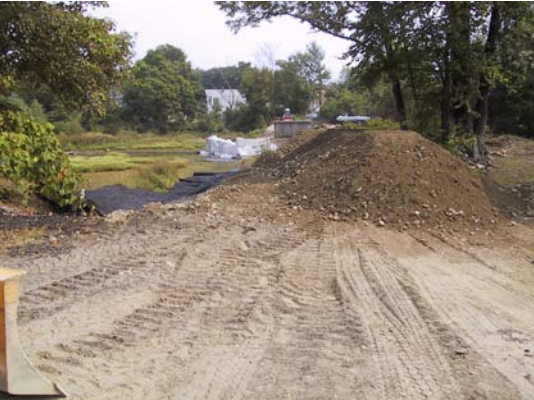
| Photograph | Date | View Point | View Direction | Description |
|---|---|---|---|---|
| | 09.24.2001 | East side of The Town Asphalt Company property | E | Placement of gravel for upstream cofferdam |

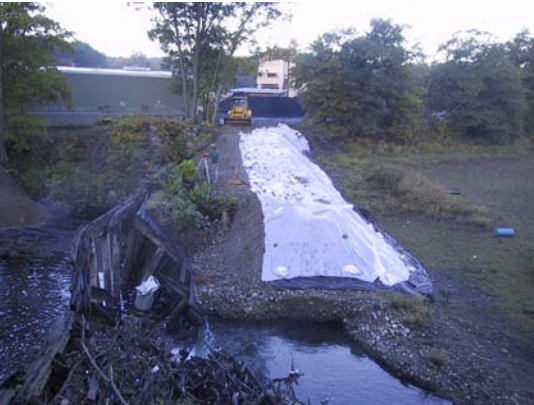
| Photograph | Date | View Point | View Direction | Description |
|---|---|---|---|---|
| | 09.26.2001 | Existing gate structure | W | Construction of upstream cofferdam |

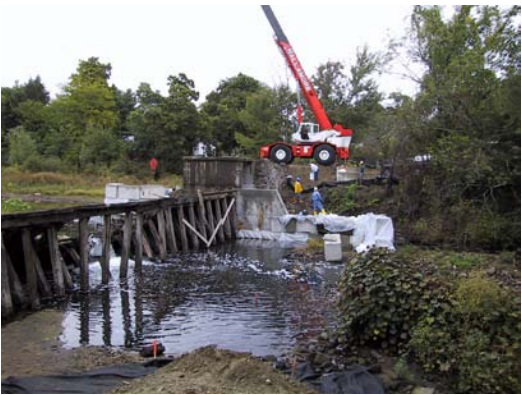
| Photograph | Date | View Point | View Direction | Description |
|---|---|---|---|---|
| | 10.01.2001 | The Town Asphalt Company property, along the west embankment | ENE | Placement of concrete block and plastic sheeting to divert water |

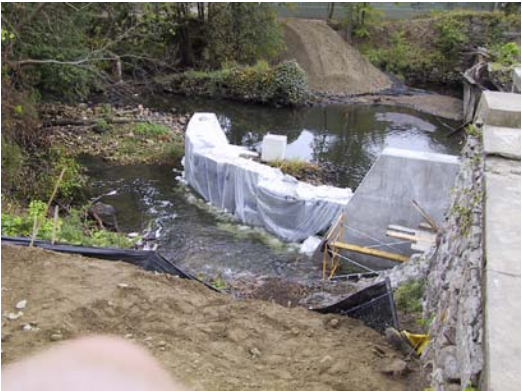
| Photograph | Date | View Point | View Direction | Description |
|---|---|---|---|---|
| | 10.01.2001 | Existing gate structure | WSW | Concrete block and plastic placed to divert water |

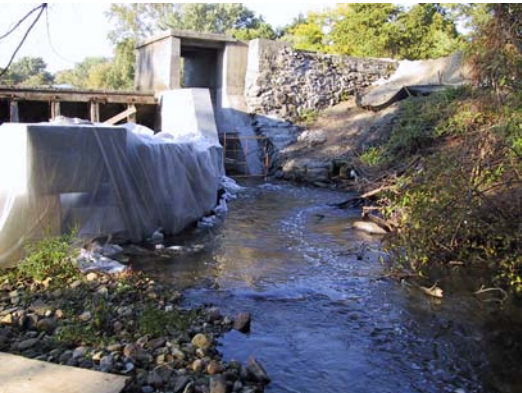
| Photograph | Date | View Point | View Direction | Description |
|---|---|---|---|---|
| | 10.04.2001 | Downstream of existing gate structure along east embankment | NNE | View of water diverted through gate structure and away from the existing Allendale Dam structure |

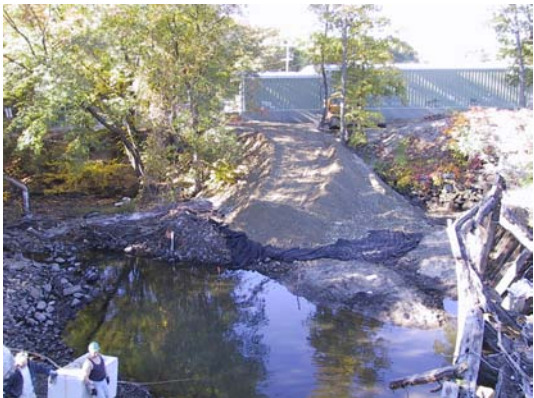
| Photograph | Date | View Point | View Direction | Description |
|---|---|---|---|---|
| | 10.09.2001 | Existing gate structure | W | Construction of downstream cofferdam; note filter fabric installed beneath gravel |

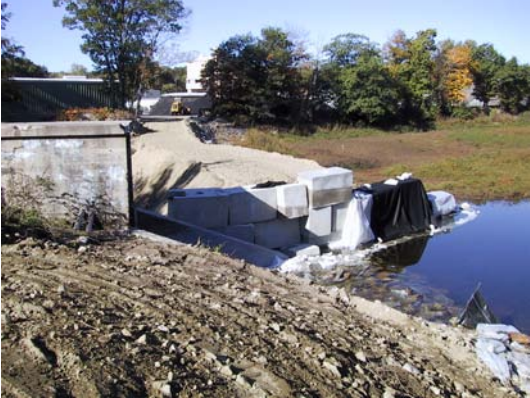
| Photograph | Date | View Point | View Direction | Description |
|---|---|---|---|---|
| | 10.09.2001 | North of existing gate structure, along east embankment | SW | View of upstream cofferdam and concrete block diverting water through existing gate structure |

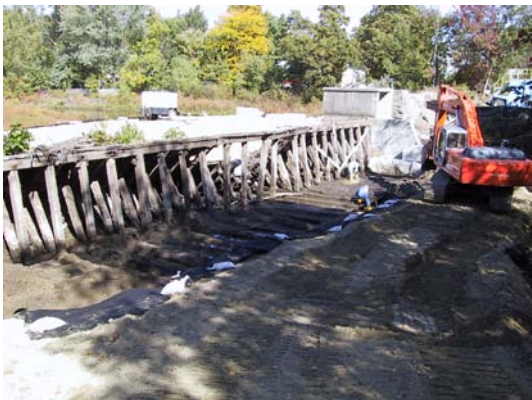
| Photograph | Date | View Point | View Direction | Description |
|---|---|---|---|---|
| | 10.11.2001 | Downstream cofferdam | E | Placement of sandbags along edge of downstream cofferdam |
