SITE: Centredale

Memorandum

Date: April 27, 2010

Subject: Post-flood Inspection of April, 15, 2010

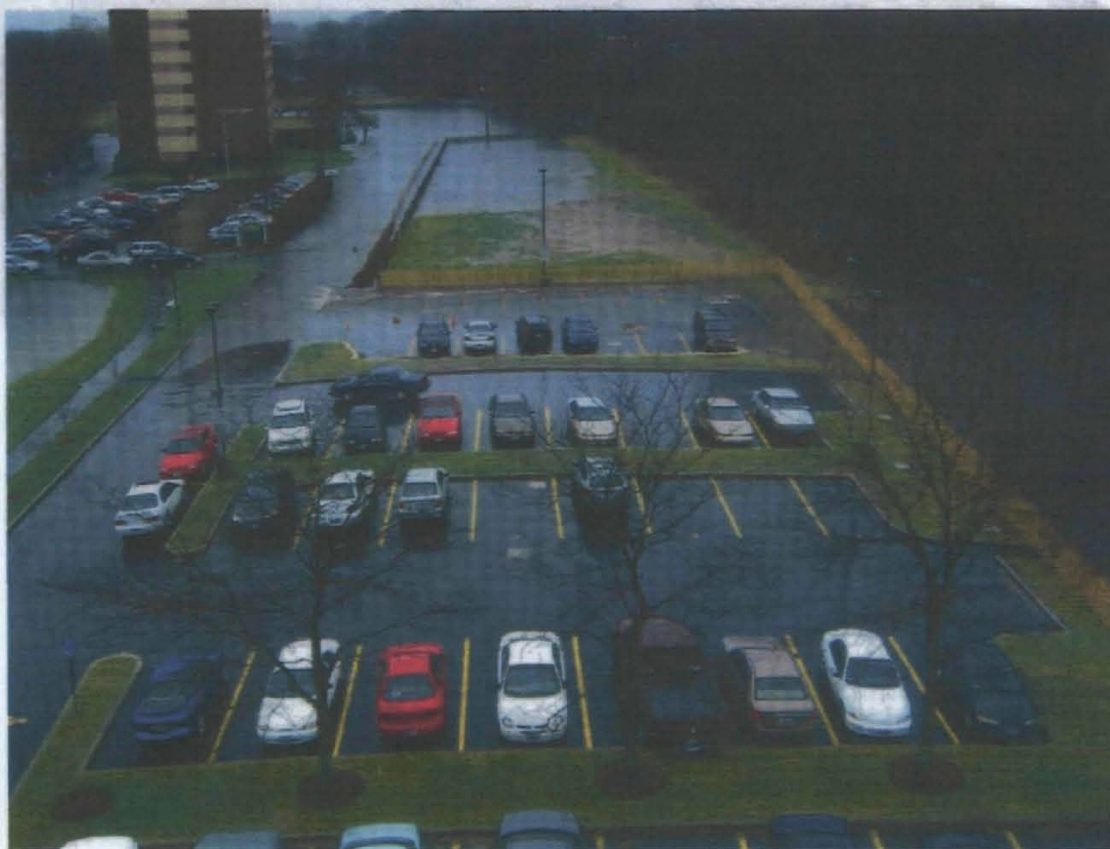
On April 15, 2010 OSC Ted Bazen met with David Scotti and Jeff Loureiro of LEA, Inc. at the Centredale Manor Restoration Project Site in North Providence, RI to observe, document and evaluate areas of erosion that were caused by the flooding event that had occurred on March 30, 2010 following very heavy rainfall. Photographs from LEA taken on March 30 documented that the Woonasquatucket River had overflowed its eastern bank near the southern end of the Brook Village parking lots. River water flowed down gradient, through a new cedar fence, over the clean backfill and topsoil that had been placed in the fall. The water then flowed toward the main driveway and across the northern Centredale Manor parking area before entering the standing water in the tailrace.

Some erosion occurred on the steepest gradients where water velocity was highest. Several fence posts washed out, causing three sections of new fence on the riverbank to collapse. This was likely caused by the turbulent flow of water around the posts, causing the soil to erode. Although some excavation had occurred in this area last fall, erosion did not penetrate the geosynthetic fabric that was placed over clean fill in this area.
