**CENTREDALE MANOR RESTORATION PROJECT  
IMPLEMENTATION OF INTERIM REMEDIAL ACTION  
NORTH PROVIDENCE, RHODE ISLAND**

**CONSTRUCTION COMPLETION  
CERTIFICATION REPORT**

**March 2014**

**CERCLIS ID No. RID981203755**

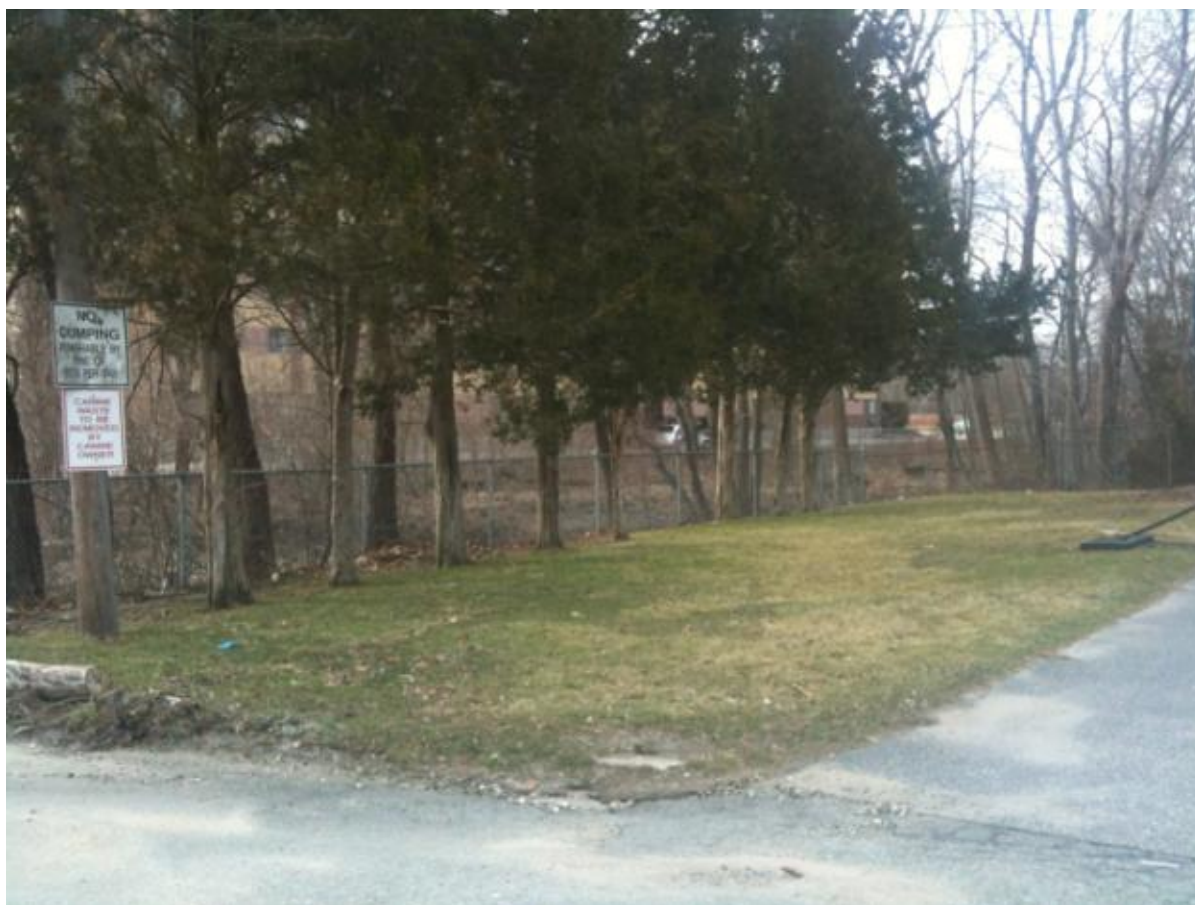
Lou Maccarone, Kelsey O'Neil, and Samantha Hogan met with Peter Pimentel on January 10, 2013. Mr. Pimentel has an existing EPA fence which runs along the tailrace cap; the fence is in good condition. Floodwaters occasionally rise through the fence, flooding his backyard up to the garage. Mr. Pimental has children and is concerned with their potential exposure to Dioxin. Ms. O'Neil gave him the contact information of someone at the ATSDR to help answer some of his dioxin exposure/health questions that we could not answer. He also mentioned that debris at the bottom of Grover Street results in flooding from stormwater runoff.

Based on this meeting and a subsequent site visit, the existing 85 LF chain link fence will be removed and a new 85 LF section of fence installed approximately ten LF to the east, to the west of a line of trees. The remaining area of the backyard between the relocated fence and the driveway will be covered with soil and grass seed (approximately 1,900 square feet).

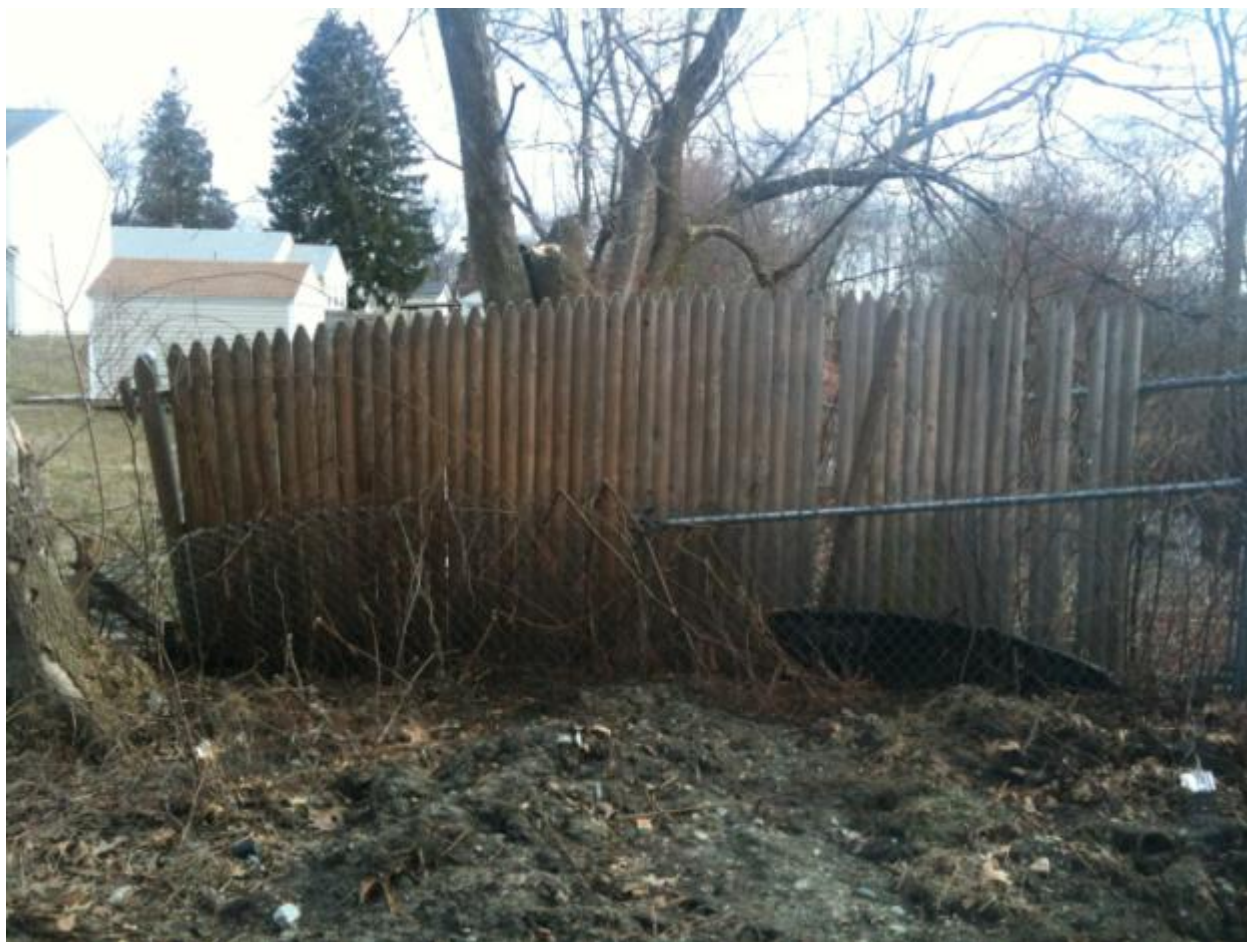
Lou Maccarone, Emily Zimmerman, and Samantha Hogan met with Suzanne and Paul LaPlume on February 13, 2013. There is an existing stockade fence surrounding the property. A portion of the fence along the northern property boundary is damaged, along with an adjacent section of chain link fence.

Based on this meeting and a subsequent site visit, the existing chain link fence along the tailrace will be removed, as well as a damaged section of fence adjacent to Grover Street. Approximately 170 LF of new chain link fence will be installed approximately 15 feet east of the existing fence. A large tree branch will be removed, and a plastic playhouse will need to be relocated prior to work.

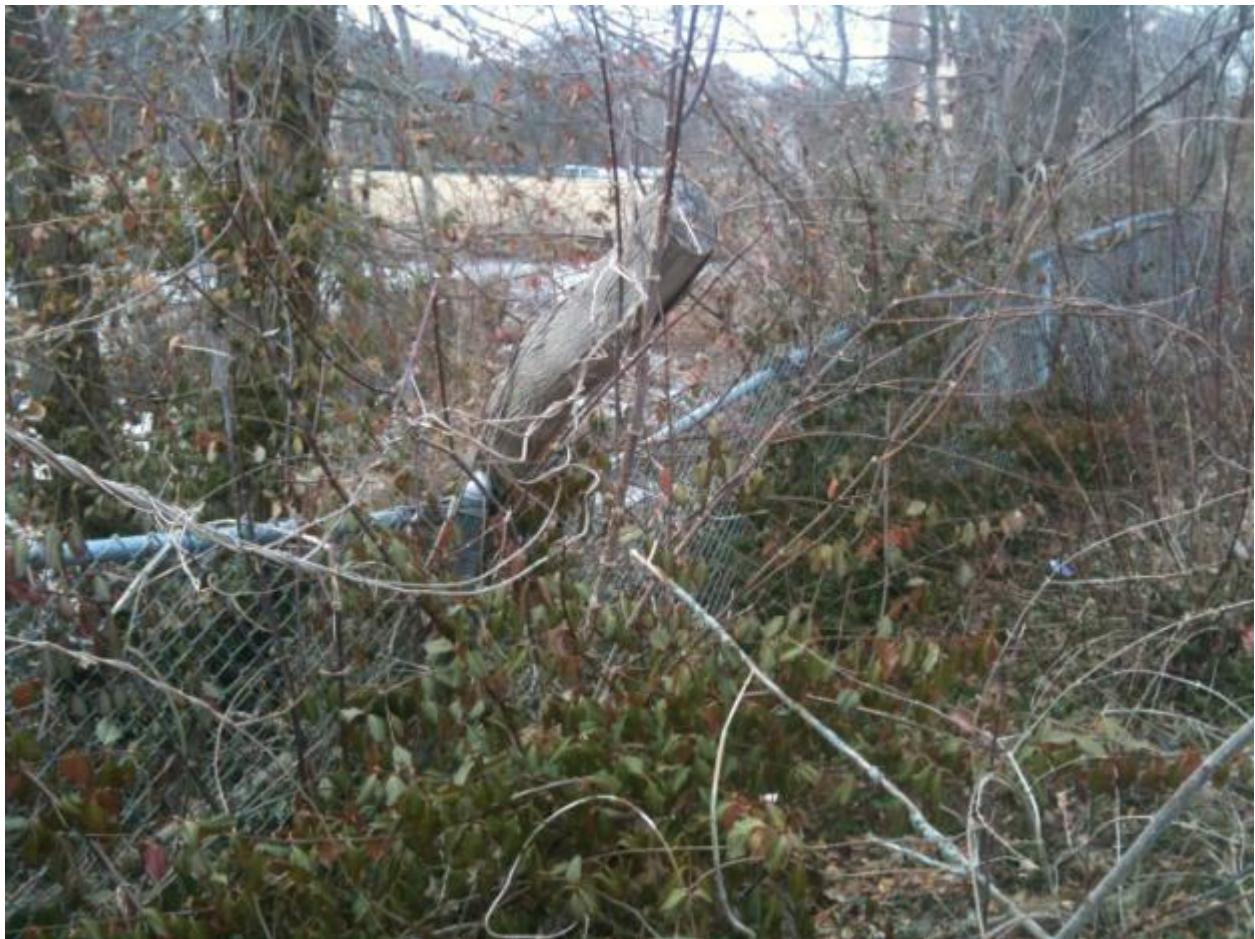
The existing EPA chain link fence is heavily overgrown with vegetation, and somewhat damaged by fallen trees. Based on mapping, the existing fence is inland of the floodplain.

Vegetation will be cleared from the fence and damaged portions of the fence will be replaced. New signage will also be installed.

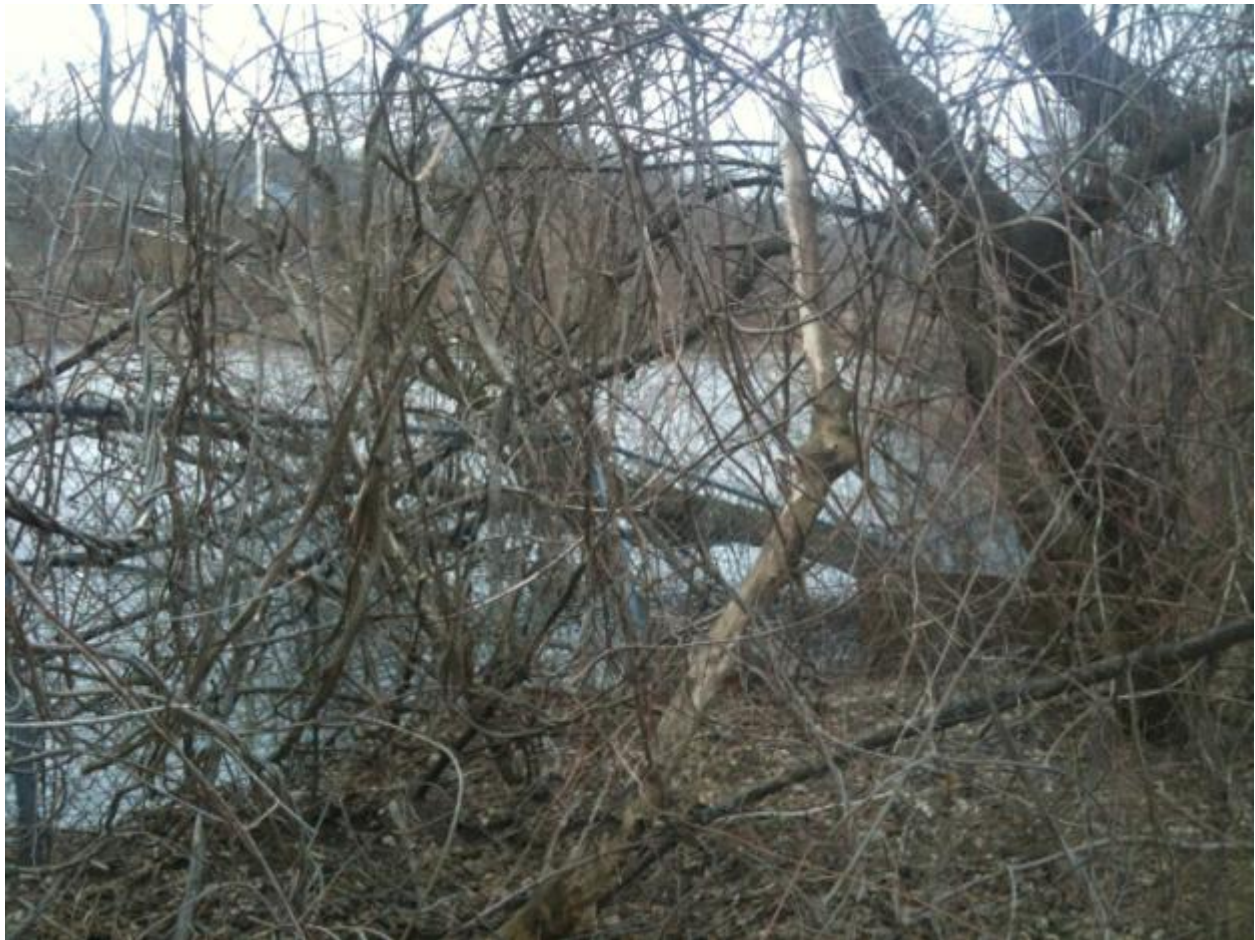
The existing approximately 45 LF chain link fence at the western end of the Stevens Street is damaged due to heavy overgrowth and a fallen tree. The damaged fence will be repaired or replaced, as required. Significant vegetation clearing is required prior to repair or replacement.

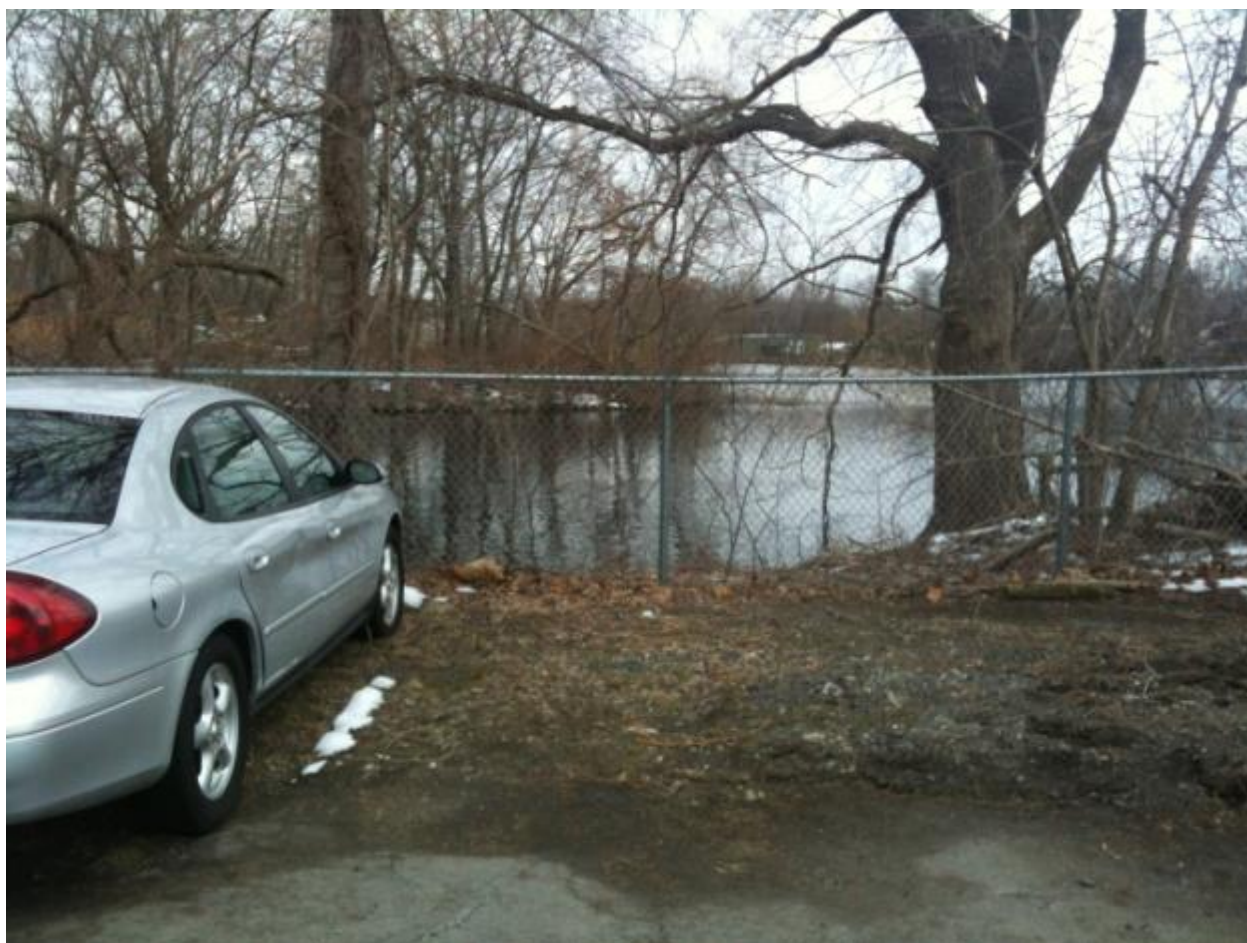
The existing chain link fence is in good condition. The mapped floodplain is approximately 25 LF inland of the existing fence; however, the fence cannot be moved that far inland as the driveway to 15 Centerdale Avenue is approximately 12 LF feet inland of the existing fence.

Based on a site visit, the existing fence will be removed, an approximately 12 LF section of chain link fence will be installed along the western edge of pavement, a 30 LF section with a gate and signage will be installed along the southern edge of pavement, and an 8 LF section will be installed along the eastern edge of pavement. An unregistered car is sometimes parked adjacent to the fence and may need to be moved prior to installation of the fence.

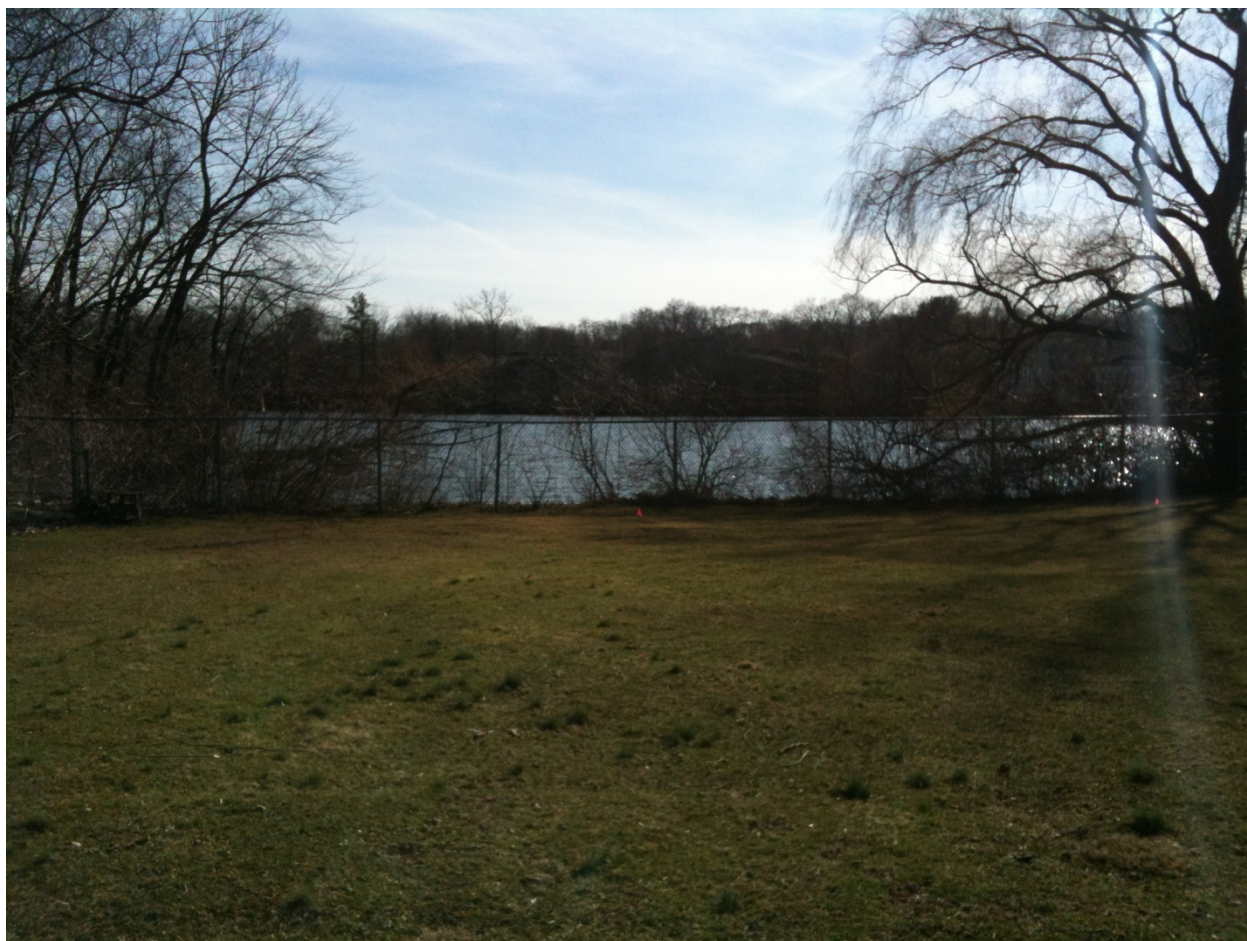
Jim Murphy and Samantha Hogan met with Michelle Dunn on January 8, 2013. There is an existing EPA fence along the river on the property. Ms. Dunn stated that there is some minor flooding of her large backyard.

Based on this meeting and a subsequent site visit, the existing fence will be removed and an approximately 70 foot section of new chain link fence with a double gate will be installed along the mapped floodplain boundary.

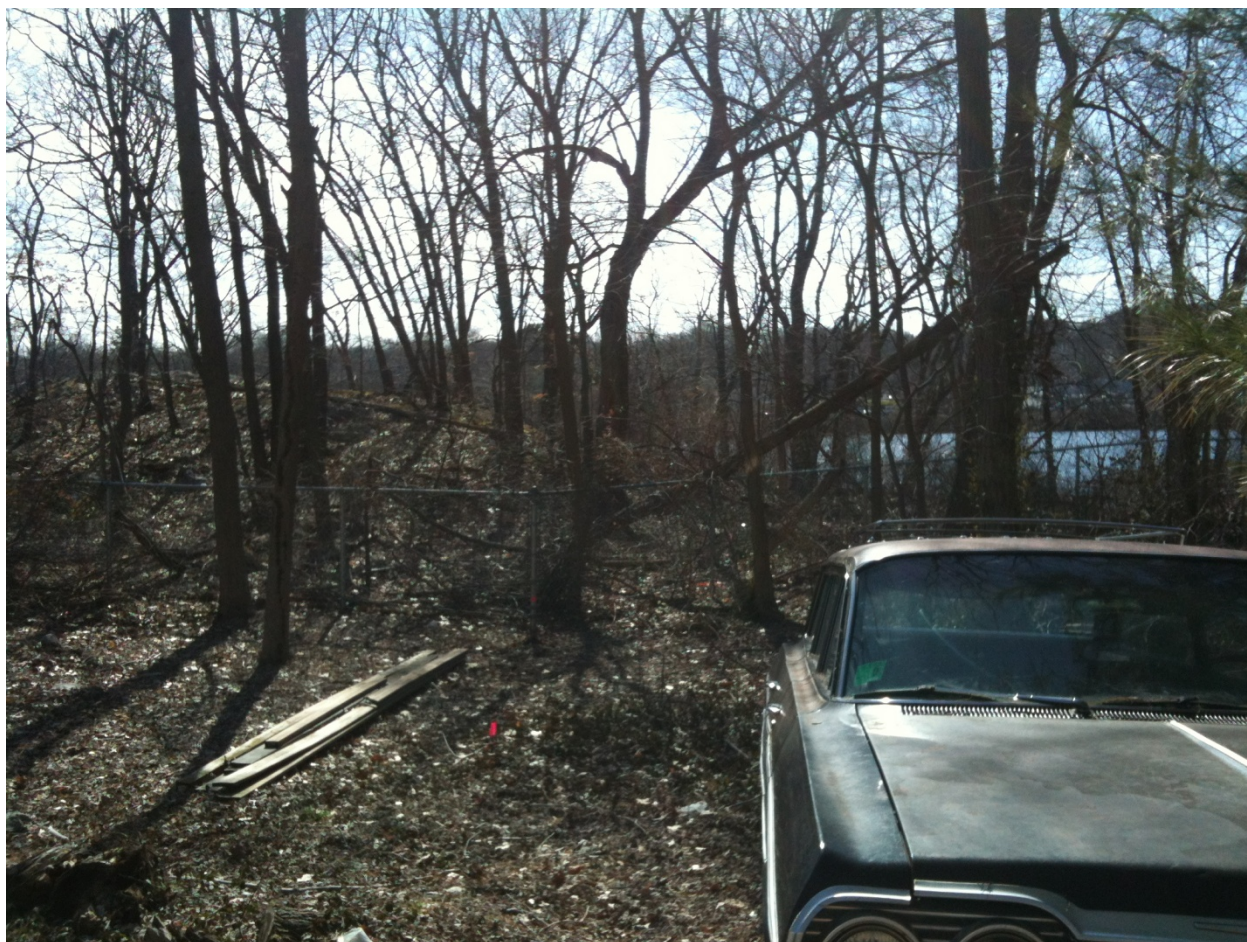
Lou Maccarone, Jim Murphy, and Samantha Hogan met with Gordon Gibau on January 8, 2013. There is an existing EPA fence located on the property. Mr. Gibau did not indicate that regular flooding beyond the existing fence occurred, however, he is amenable to relocating the current fencing. He also requested some minor brush clearing, that we are amenable to performing.

Based on the meeting, floodplain mapping, and subsequent site visit, the existing fence will be removed and a new approximately 85 LF section of fence with a gate will be installed along the mapped floodplain boundary. Minor brush clearing will also be performed.

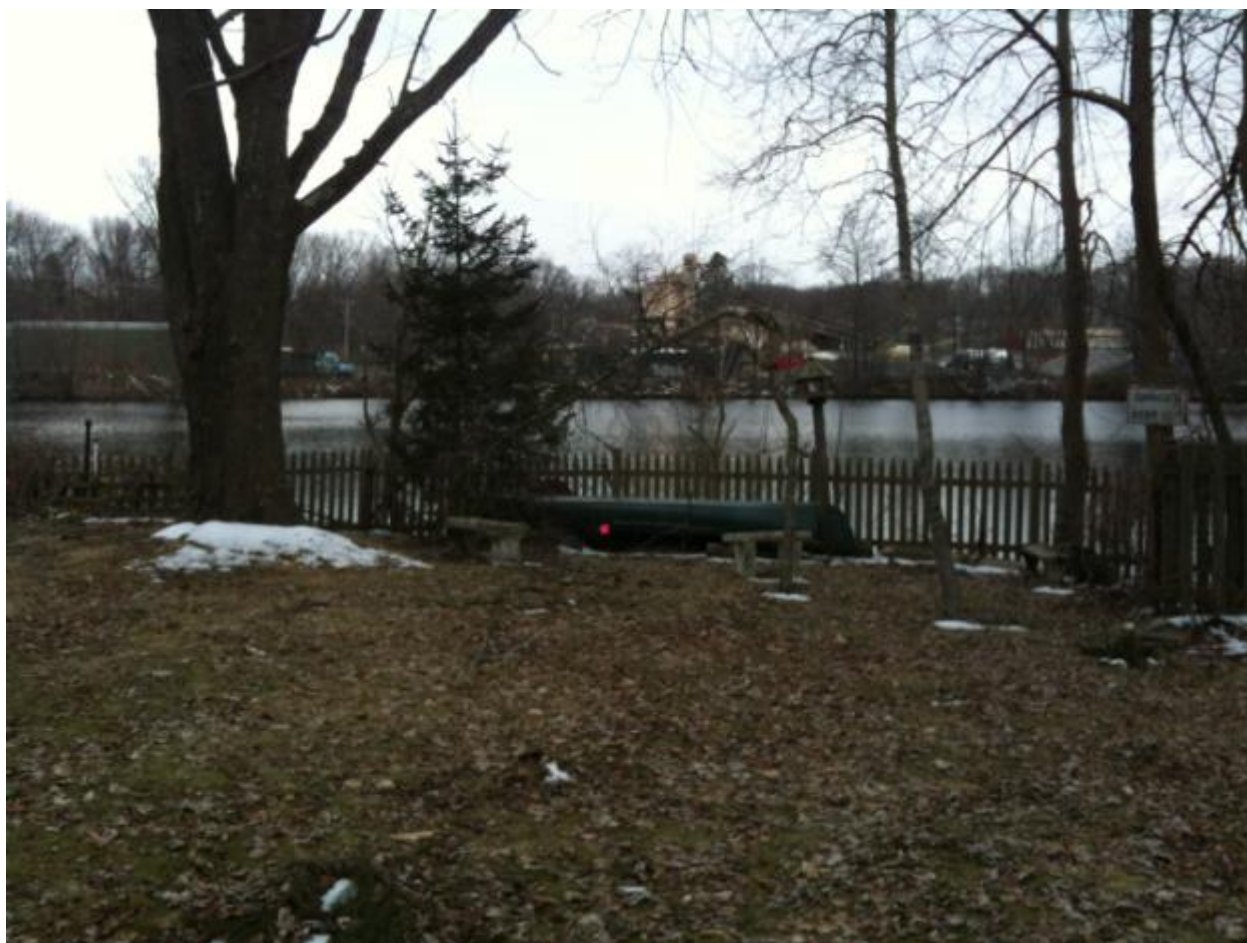
Lou Maccarone, Jim Murphy, and Samantha Hogan met with Mary Jane Davidow on January 8, 2013. Ms. Davidow has an existing wooden EPA fence along the riverfront on her property; the fence is in fair condition. She experiences some flooding of her property during storm events. She is amenable to installing a new fence along the floodplain boundary, as long as it is a wood fence.

Based on this conversation and subsequent site visit, approximately 110 LF of existing fence will be removed and approximately 150 feet of new wooden fence with a gate will be installed along the floodplain boundary.

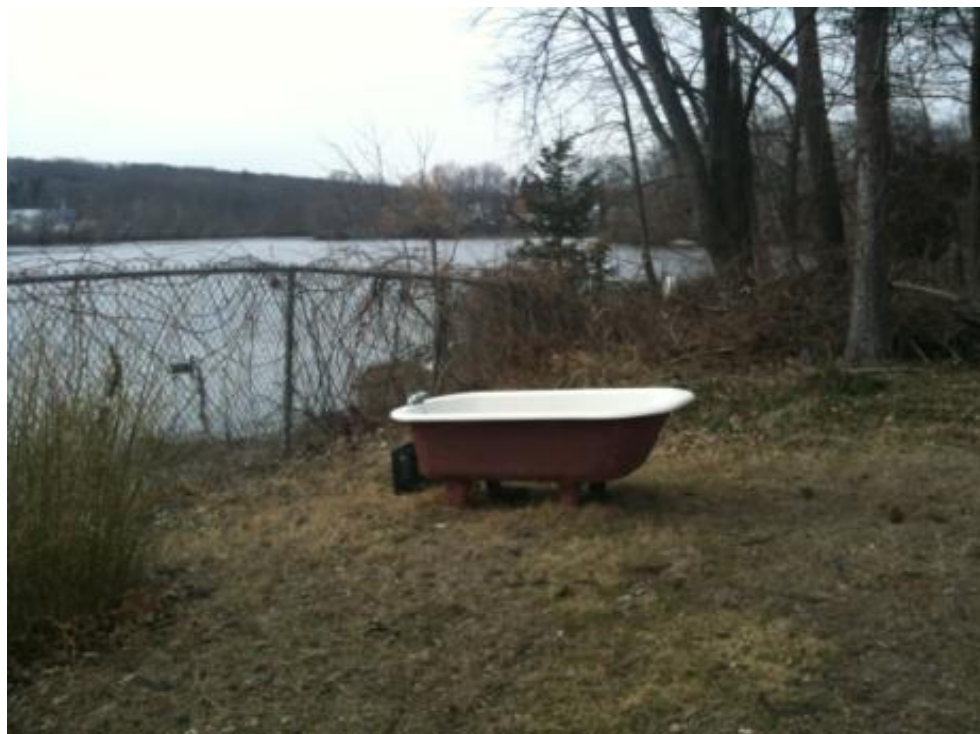
Lou Maccarone, Jim Murphy, and Samantha Hogan met with Michael and Carol Bissanti on January 9, 2013. Mr. and Mrs. Bissanti have an existing chain link EPA fence along the riverfront on their property. The existing fence is in good condition and floodwaters to not overtop the bank it is located on, however, there is a large hole cut in the fence. Mr. and Mrs. Bissanti would like a new wooden fence, similar to the fence located on the adjacent property to the north (524 Woonasquatucket Avenue) with a gate installed. Because the approximately 130foot section of fence would be replaced rather than relocated, it is likely that the existing metal posts could be reused.

Based on this conversation and subsequent site visit, the approximately 130 LF existing chain link fence will be replaced with a new wooden fence and gate. Prior to installation, materials and debris stored behind the garage as well as a cast-iron tub will need to be relocated, and vegetation overgrowing the fence will need to be cleared. In addition, Mr. Maccarone will discuss the property owners' concerns about the asphalt plant with DEM.

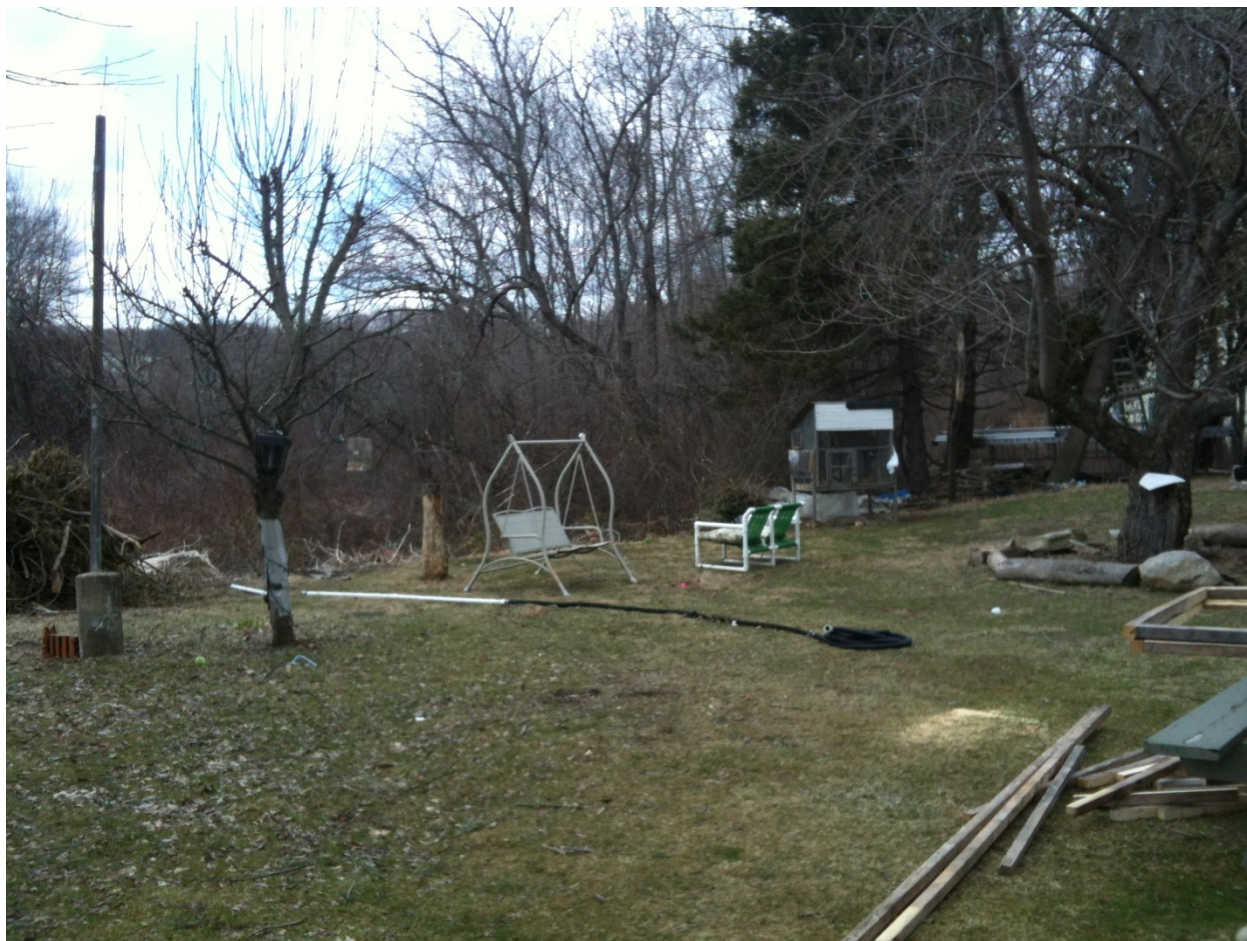
Carmen Nunez signed an access agreement that was left at her door, and personal contact with Ms. Nunez has not been made. Based on mapping, a significant portion of the yard is located within the floodplain.

Based on a site visit and subsequent meeting with Lou Maccarone, approximately 305 LF chain link fence will be installed along the northern property boundary and the west and southern boundary of the grass portion of the yard.

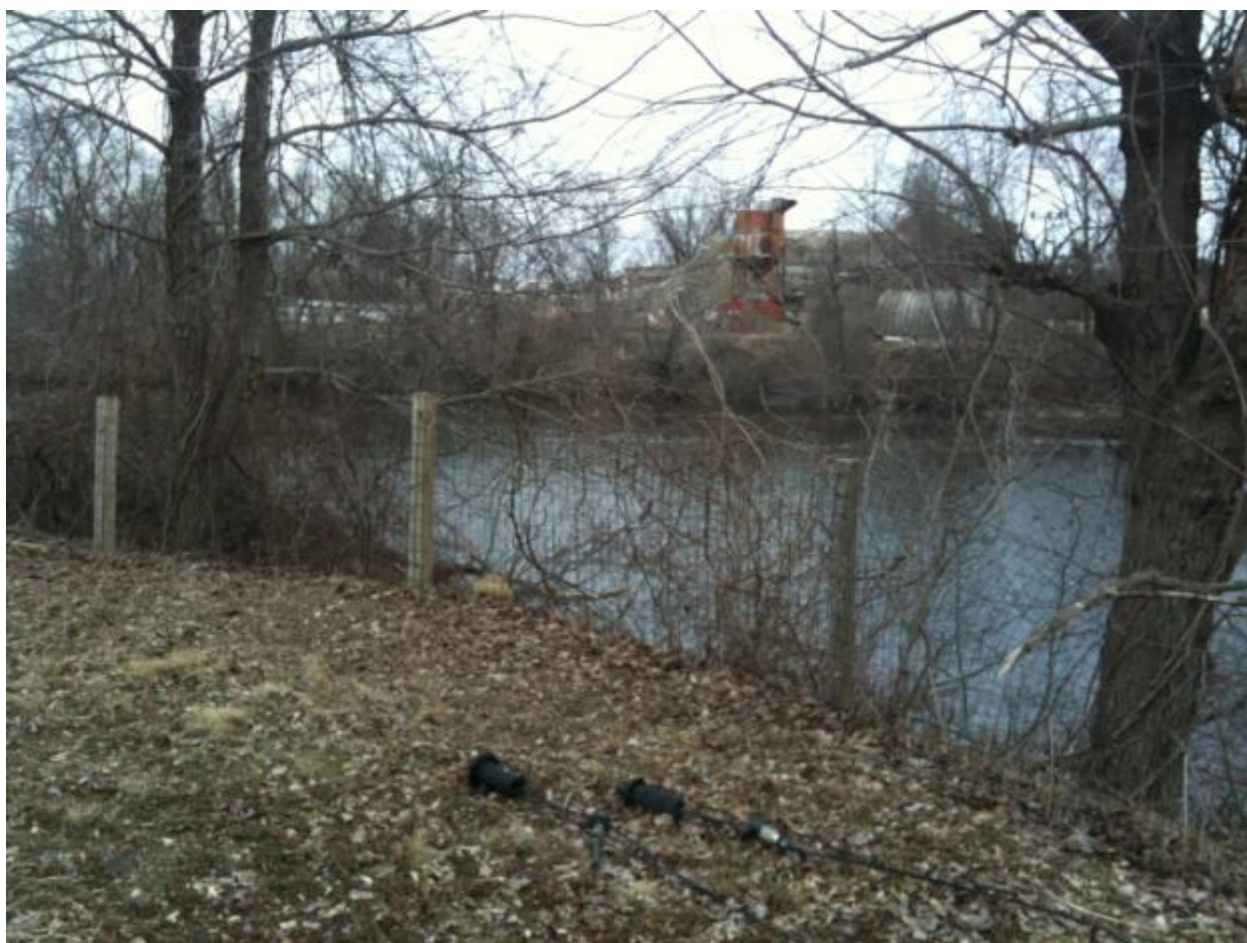
Diane Lariviere signed an access agreement that was left at her door on January 23, 2013. Currently, there is no fence on the property. Emily Zimmerman spoke with Ms. Lariviere on the phone, and she was amenable to installing a chain link fence. During a subsequent site visit, a chicken wire fence along the rear of the property was observed.

Based on the phone conversation and site visit, approximately 95 LF of existing chicken wire fence will be removed and a new chain link fence installed in the same location.

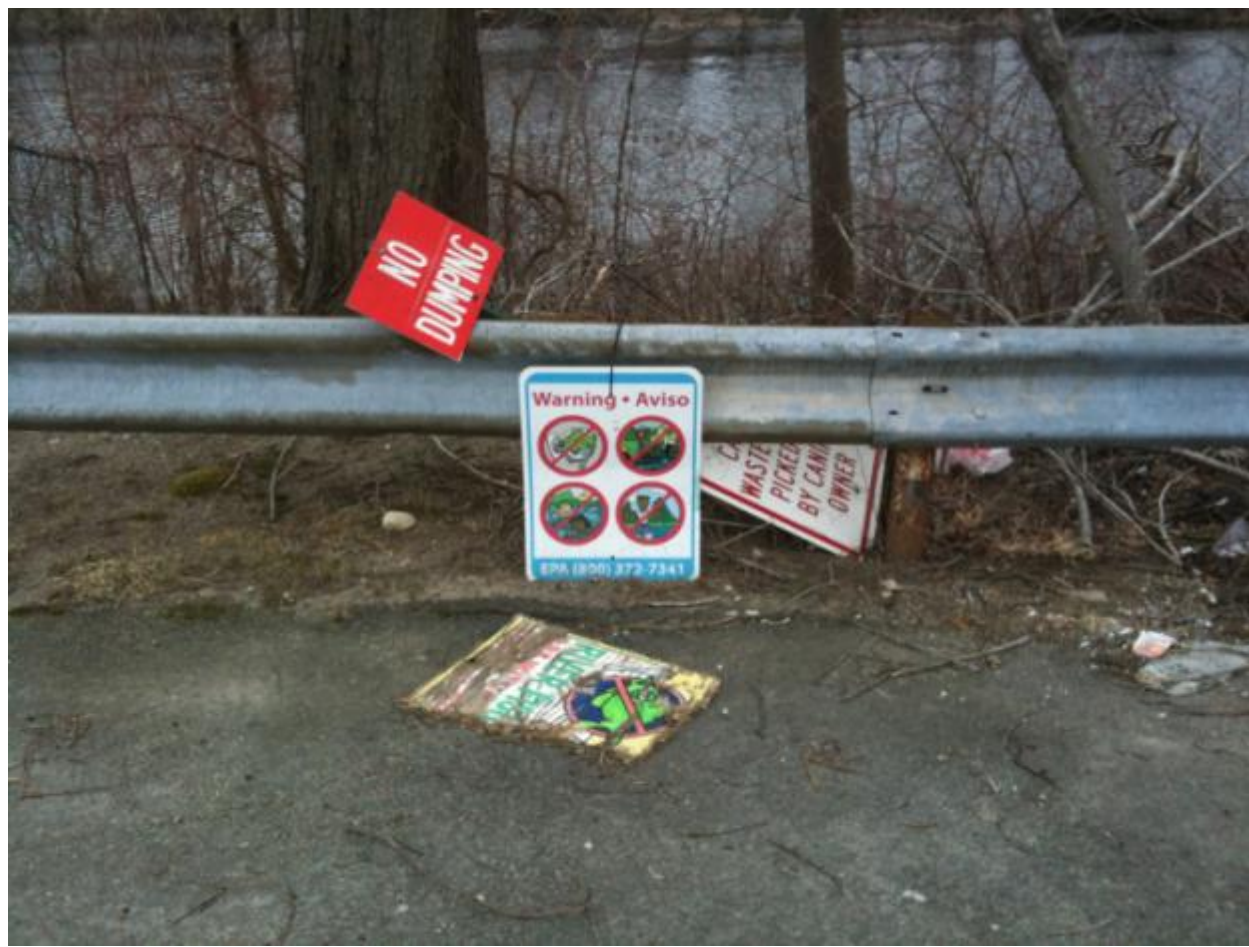
There is currently no fence at the end of the Zambarano Avenue ROW. A metal guardrail is located at the edge of pavement. Based on mapping, the end of the ROW is located within the floodplain.

A new approximately 35 LF section of chain link fence with a gate will be installed perpendicular to the ROW, just west of the guardrail, between existing fences located at 37 Zambarano Avenue to the south and 36 Zambarano Avenue to the north. New signage will also be installed.

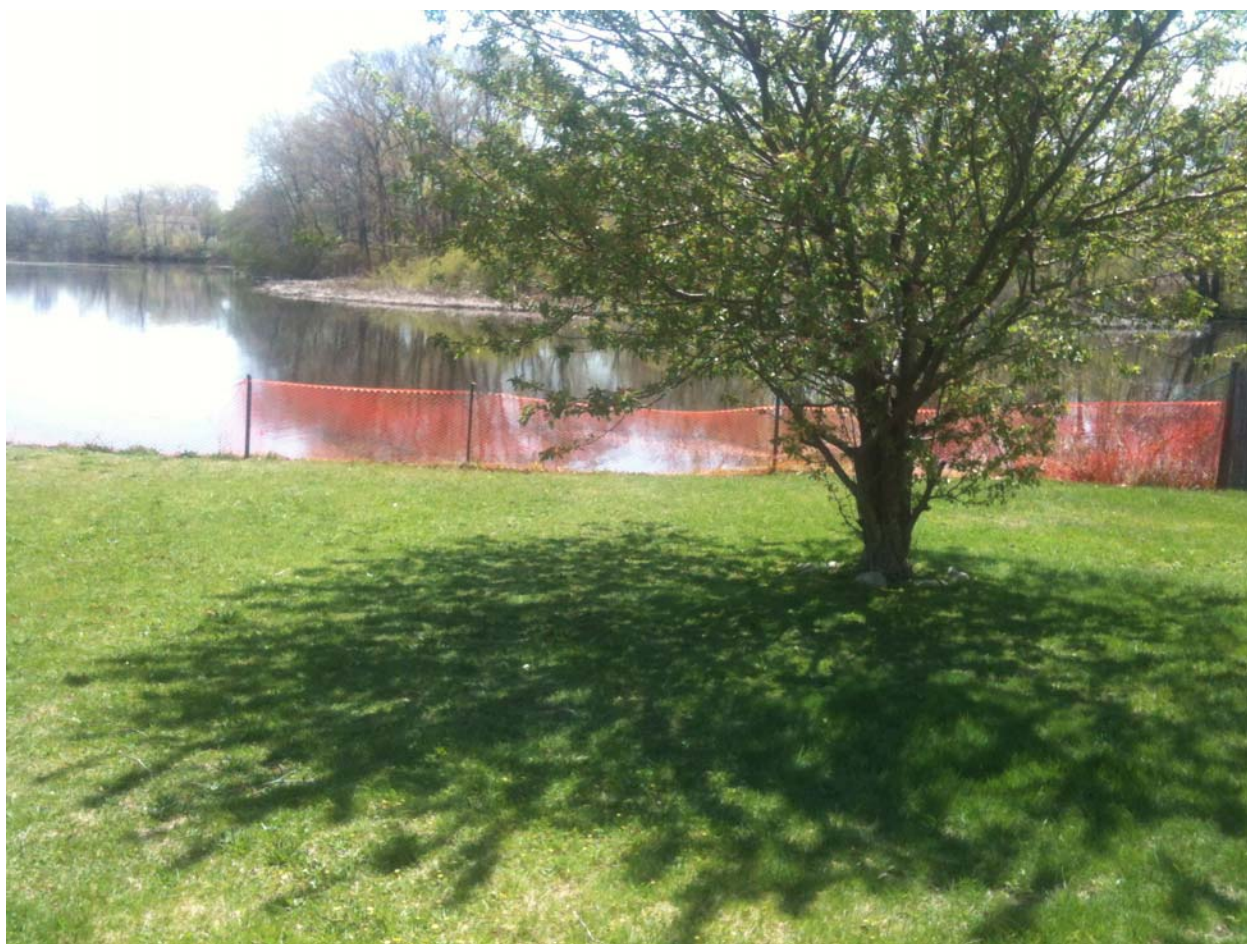
Lou Maccarone and Samantha Hogan met with Paul Santurri, the Facilities Manager of the Fogarty Center who manages the property along with another representative of the Fogarty Center on April 29, 2013. There is an existing snow fence along the riverfront. Mr. Santurri was amenable to removal of the snow fence and installation of a new chain link fence and cover.

Based on this meeting and site visit, approximately 20 LF of snow fence will be removed and replaced with new chain link fence, connecting with the existing wood stockade fence along the northern property boundary. In addition, approximately 875 SF of loam and seed will be placed on the mapped floodplain boundary.

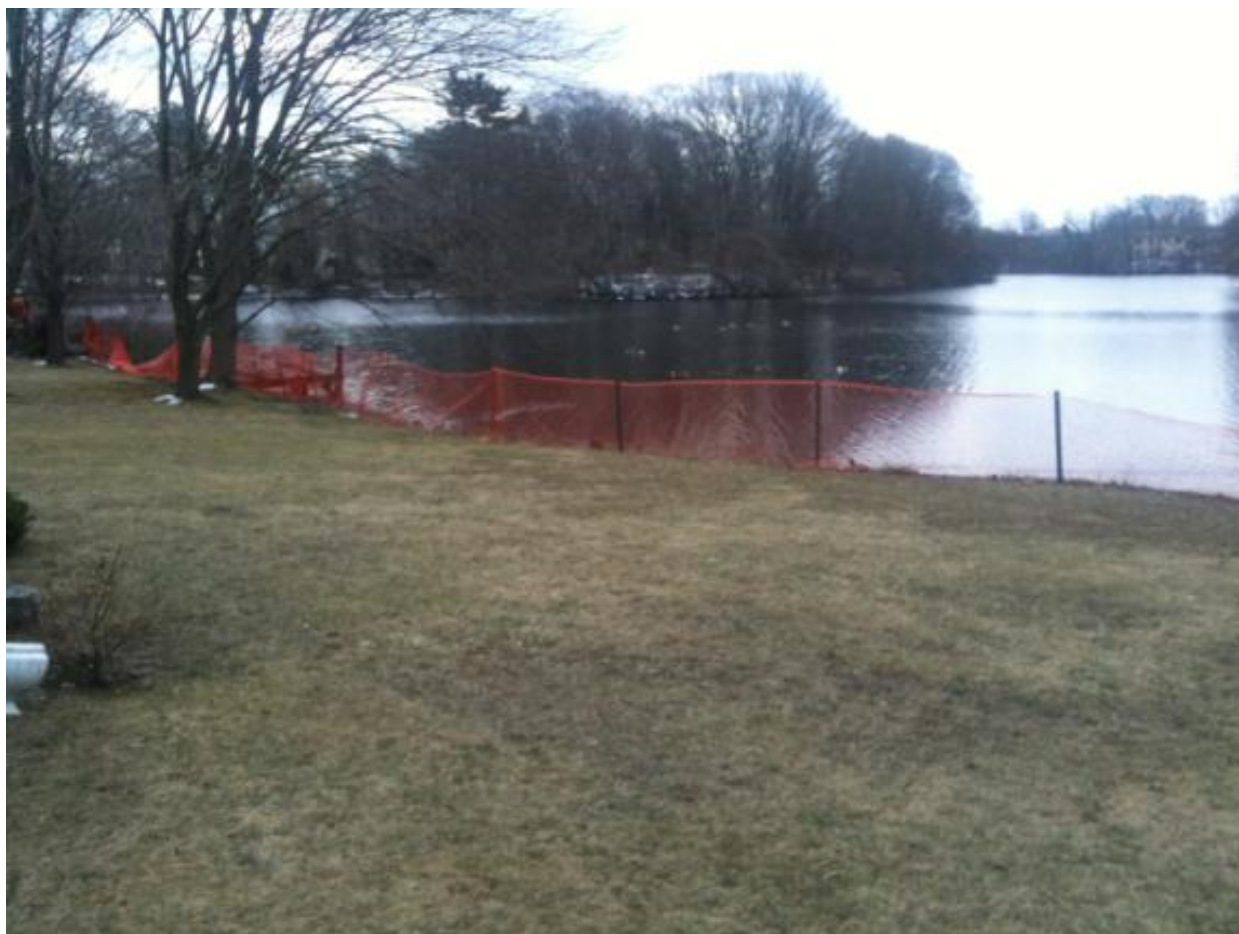
Lou Maccarone, Emily Zimmerman, and Samantha Hogan met with Mary McCoy on January 23, 2013. There is currently a plastic snow fence along the riverfront on the property to deter Canadian Geese from the yard. According to Mrs. McCoy, floodwater rose up approximately four feet during the 2010 floods. When they first moved into the house, flood waters rose up further, almost to the house itself.

Based on this conversation and a subsequent site visit, approximately 2,800 SF of loam and seed will be placed between the rear of the patio adjacent to the house and the riverbank, and approximately 80 LF of new chain link fence will be installed 4 LF inland of the existing snow fence.

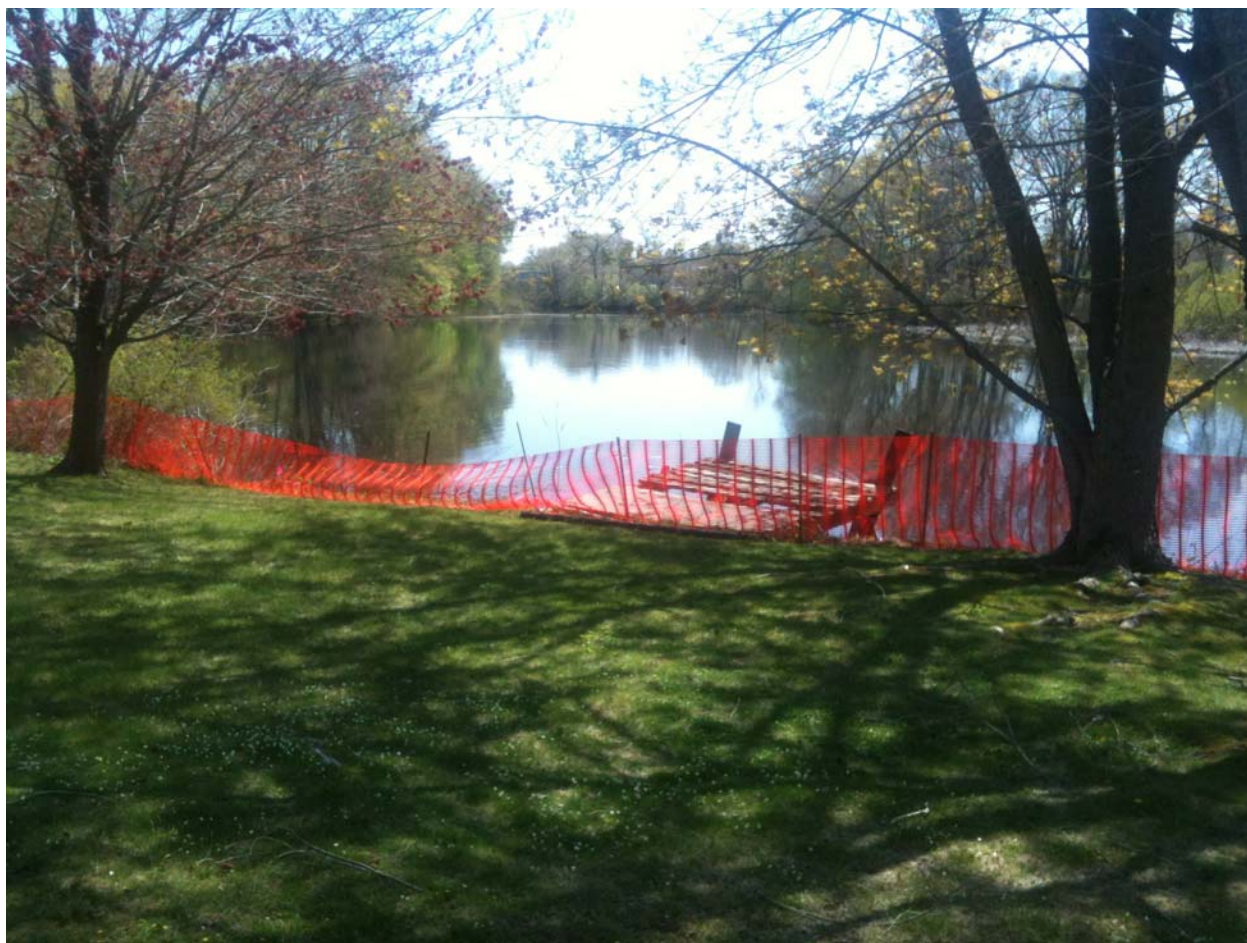
Lou Maccarone, Emily Zimmerman, and Samantha Hogan met with Anthony Campanelli on January 23, 2013. There is currently a snow fence along the riverbank. According to Mr. Campanelli during flood events water comes up to the back of his first shed.

The approximately 75 LF of snow fence will be removed and a new chain link fence, with a gate, will be installed along the riverbank. Approximately 750 SF of loam and seed will be placed between the back of the shed and the new fence.

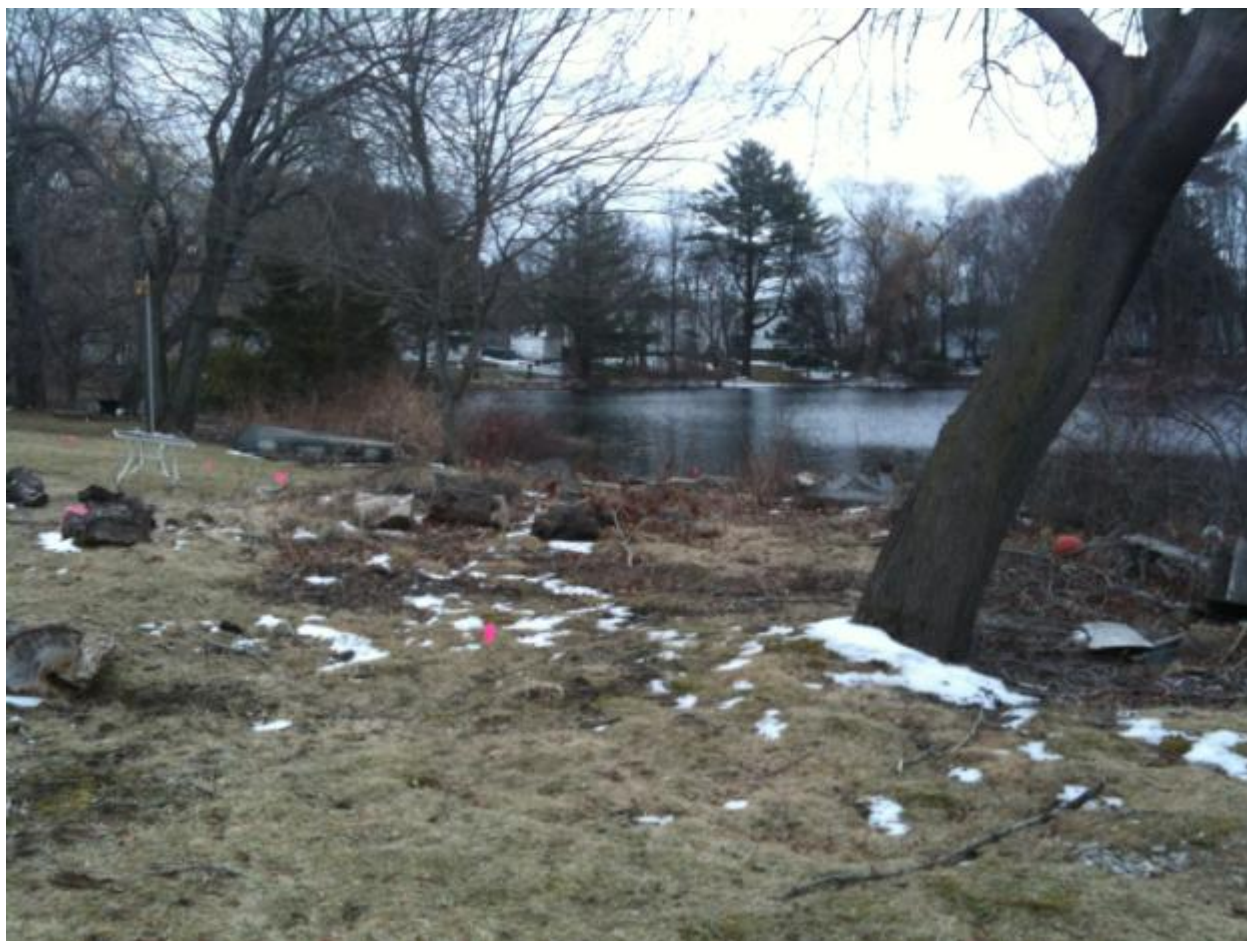
Lou Maccarone, Emily Zimmerman, and Clayton Carlisle met with the Cinquegrana brothers on February 5, 2013. The property currently has no fence, and approximately half of the yard floods during large rainstorms.

Based on this conversation and a subsequent site visit, approximately 170 LF of chain link fence with a double gate will be installed along the river and approximately 4,500 SF of the yard that has flooded in the past will be covered and seeded. There is a significant amount of debris and equipment located along the western property boundary that will need to be moved and/or disposed of prior to installation of cover.

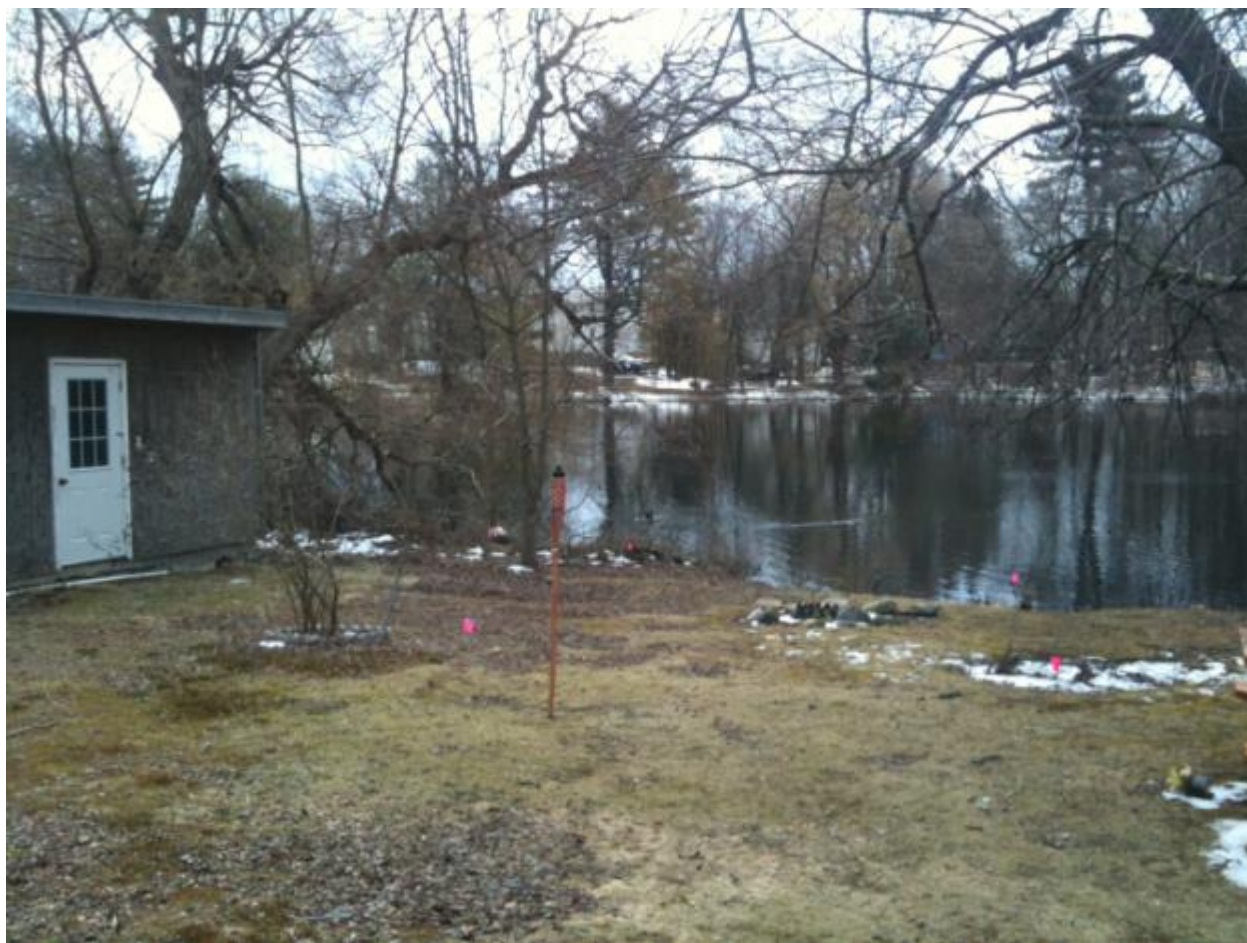
Lou Maccarone, Emily Zimmerman, and Samantha Hogan met with Mrs. And Mr. Minutelli on February 13, 2013. According to the Minutellis, approximately half of the backyard flooded during the 2010 floods. They were amenable to installation of a fence with a gate along the river, and installation of loam and seed on the portion of the yard that floods.

Based on this conversation and a subsequent site visit, an approximately 100 LF of chain link fence with a double gate and an approximately 2,150 SF area of loam and seed will be placed on the portion of the yard that floods.
