**CENTREDALE MANOR RESTORATION PROJECT  
IMPLEMENTATION OF INTERIM REMEDIAL ACTION  
NORTH PROVIDENCE, RHODE ISLAND**

**CONSTRUCTION COMPLETION  
CERTIFICATION REPORT**

**March 2014**

**CERCLIS ID No. RID981203755**

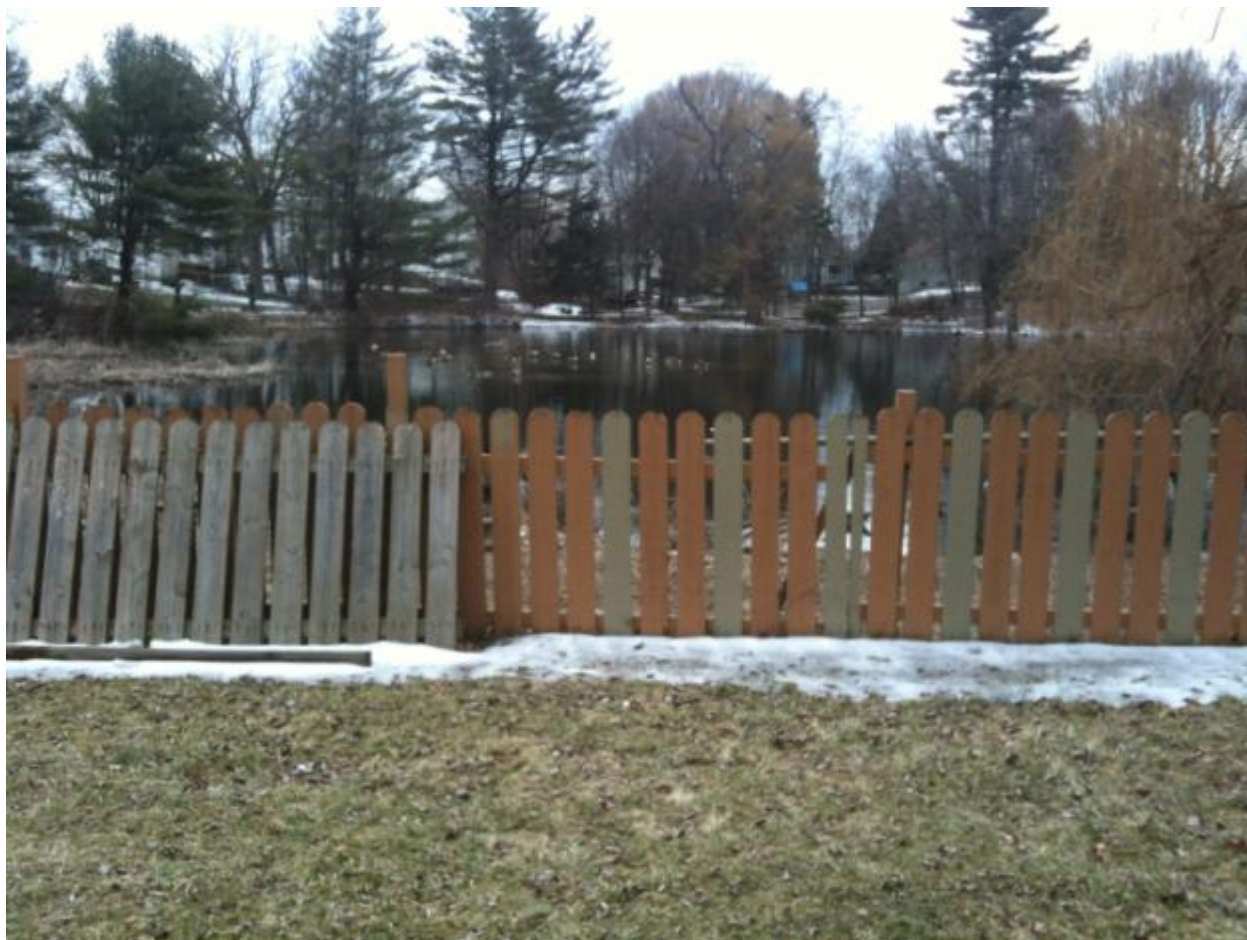
Lou Maccarone, Emily Zimmerman, and Samantha Hogan met with property owner Rhonda Simmons' father on January 23, 2013. There is an existing fence in the backyard, partially consisting of chain link and partially build of wood picket fence. According to Mr. Simmons, during the 2010 flood water came up approximately 10 inches into the yard, to a pine tree. Ms. Simmons was amenable to installing new chain link fencing and soil cover.

Based on this conversation and a subsequent site visit: the existing wooden fence will be removed, an approximately 60 LF section of new chain link fence will be installed between the two sections of existing chain link fence, and loam & seed will be installed on an approximately 1,500 SF area of the yard. Before installation of loam and seed, debris along the western property boundary, consisting primarily of construction materials, will need to be moved or disposed of.

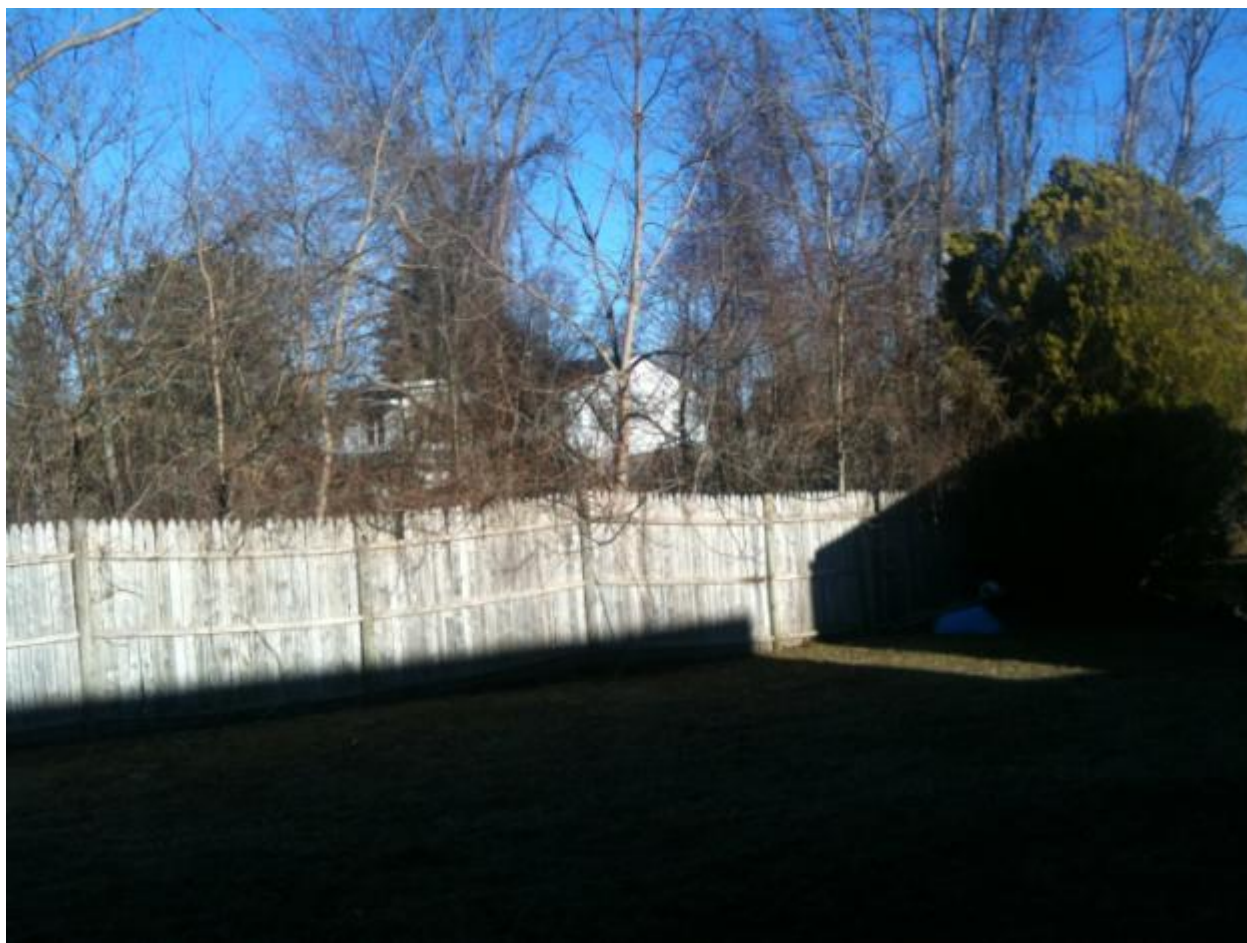
**Owner Name:** Beverly Jesuino

Lou Maccarone, Emily Zimmerman and Samantha Hogan met with Beverly Jesuino on January 22, 2013. The backyard is completely fenced with wood stockade fencing; however, the floodplain covers approximately half of the backyard. Ms. Jesuino was amenable to replacing the wood fence at the rear of the property with a chain link fence and a gate, and installing soil cover and seed.

Based on this meeting, along with a subsequent telephone conversation and site visit, approximately 55 LF of existing wood stockade fence along the rear of the property and 5 LF along the southern property boundary will be removed and replaced with 4-foot high chain link fence and gate. The northern 15 LF portion of the wooden fence will not be replaced, as Ms. Jesuino will be constructing a shed in this location. Approximately 1,660 SF of loam and seed will be installed, between the fence and the rear of the garage, pending approval by Ms. Jesuino of the materials proposed for use as cover.

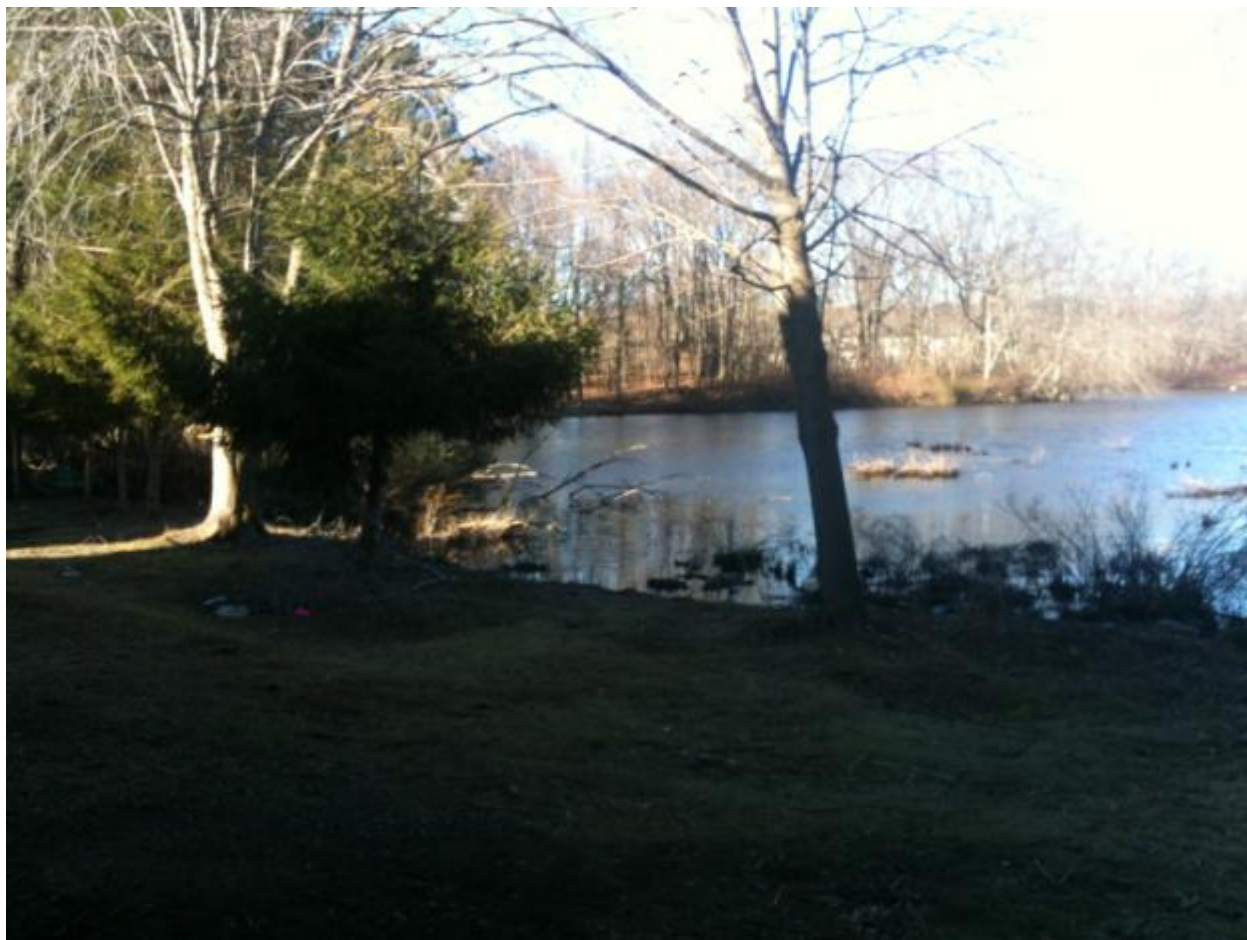
**Owner Name:** Edgardo Fragoso

On January 23, 2013 Lou Maccarone, Emily Zimmerman, and Samantha Hogan met with Mr. Fragoso's wife, Geovany Ramos. The couple has children who play near and sometimes in the river. Mrs. Ramos was amenable to installing a fence with a gate at the rear of the property and adding soil and re-seeding part of the back yard.

Based on this conversation and subsequent site visit, an approximately 105 LF section of chain link fence will be installed adjacent to the river and approximately 1,500 SF of loam and seed will be placed over the existing grass.

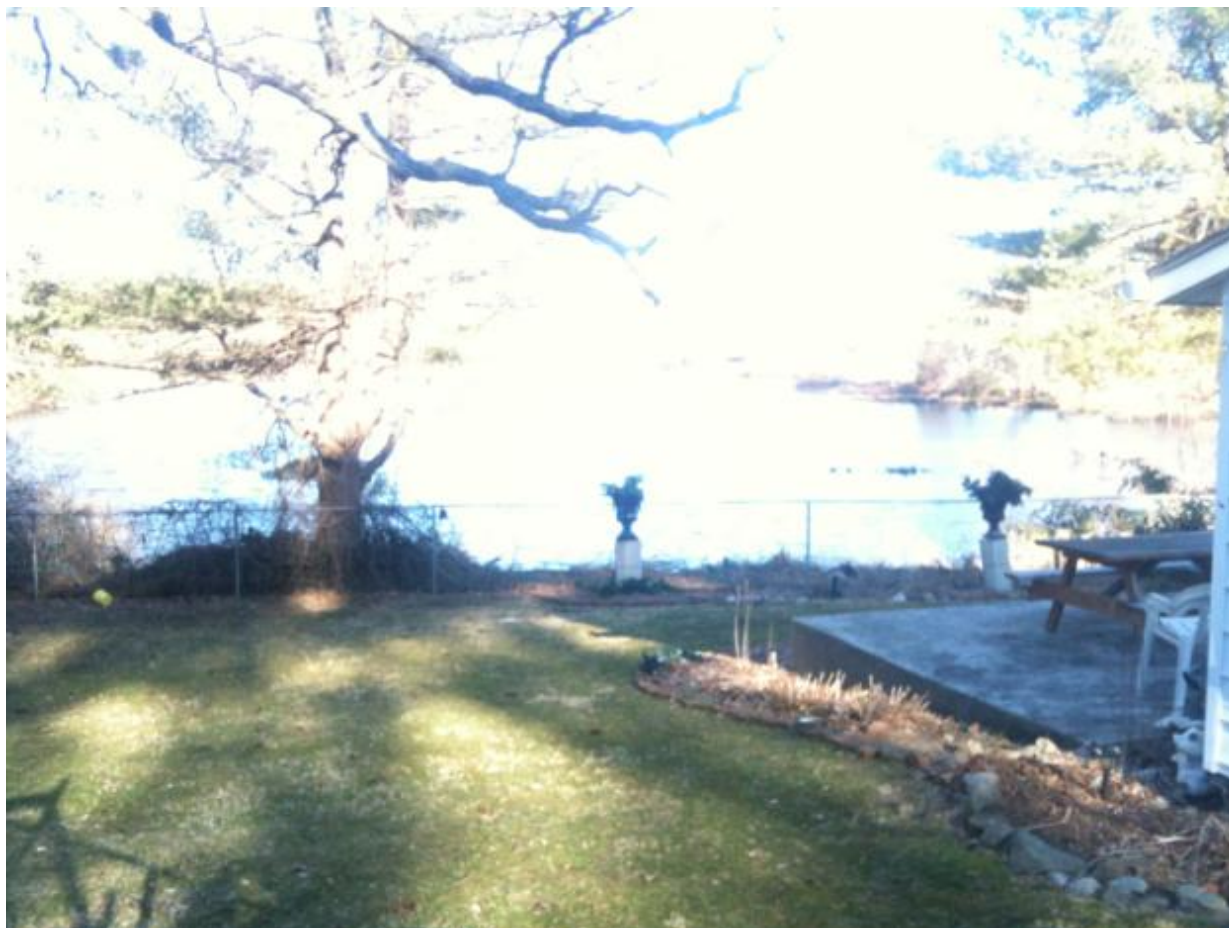
**Owner Name:** Nelly Shiranian

Lou Maccarone, Emily Zimmerman, and Samantha Hogan met with Nelly Shiranian on Janary 22, 2013. Ms. Shiranian has an existing chain link fence along the riverbank. She indicated that during the 2010 floods waters came up to this fence. Ms. Shiranian was amenable to replacing the existing fence with a new chain link fence and gate.

Based on this conversation and a subsequent site visit and discussion with Ms. Shiranian, one gate will be installed in the existing fence near the northern property boundary, a portion of the fence located towards the southern property boundary will be removed and a new approximately 45 LF section of fence installed along the southern property boundary, and a portion of fence with a second gate will be installed between the existing fence and the garage. New fence will be green coated chain link to match the existing fence. Ms. Shiranian also expressed some concern about large branches falling off a large tree located near the fence along the river; the tree will be inspected to see if any branches should be removed to prevent future damage to the fence.

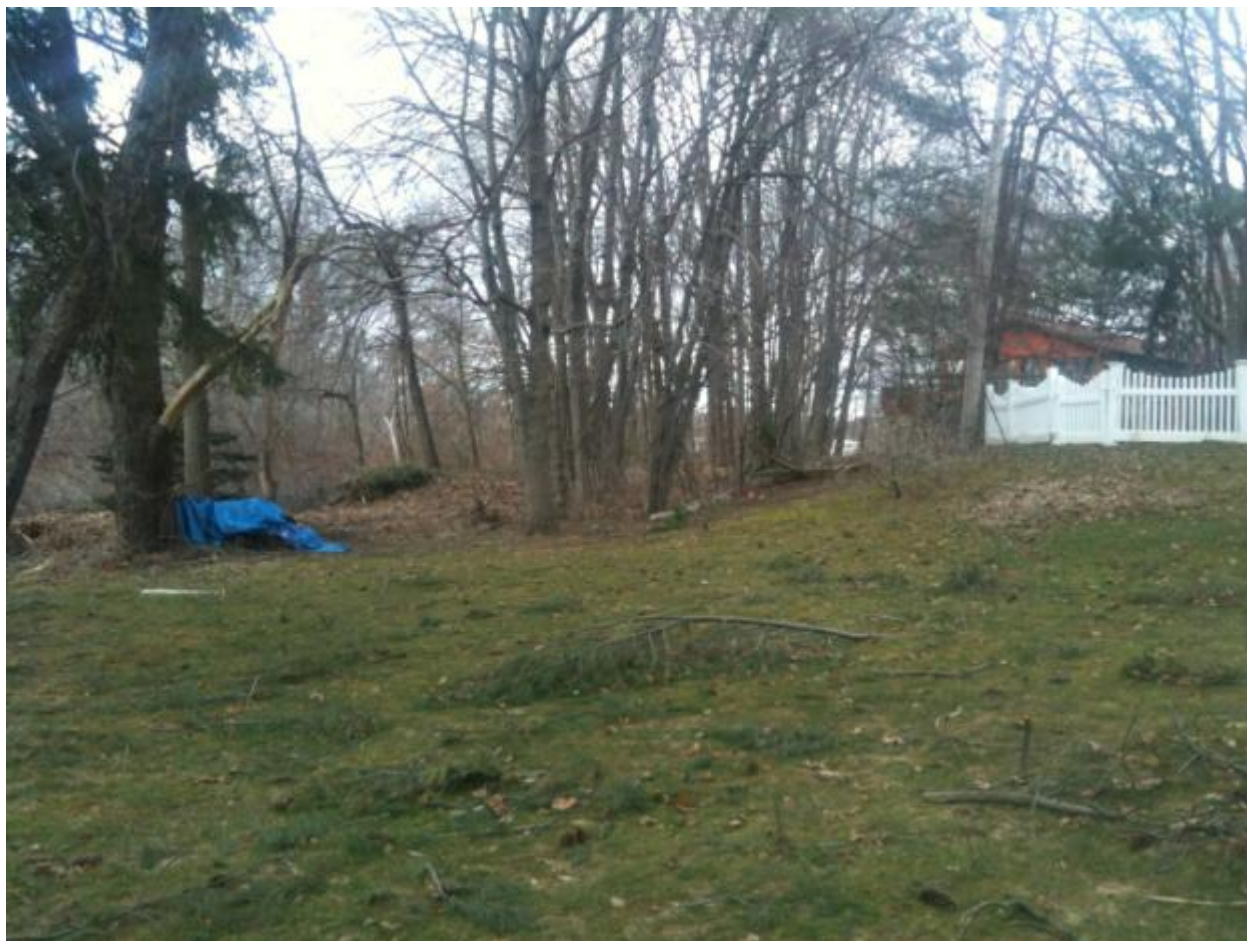
**Owner Name:** Town of North Providence

There is an existing white vinyl fence located near the edge of pavement of the Oak St. ROW. The property owner to the south appears to make use of the ROW to the west of the fence, evidenced by it being maintained along with the backyard, and a stack of firewood within the ROW. Based on mapping, a portion of the ROW near the river is within the floodplain.

Based on observations and mapping, approximately 1,160 SF of loam and seed will be installed within the mapped floodplain.

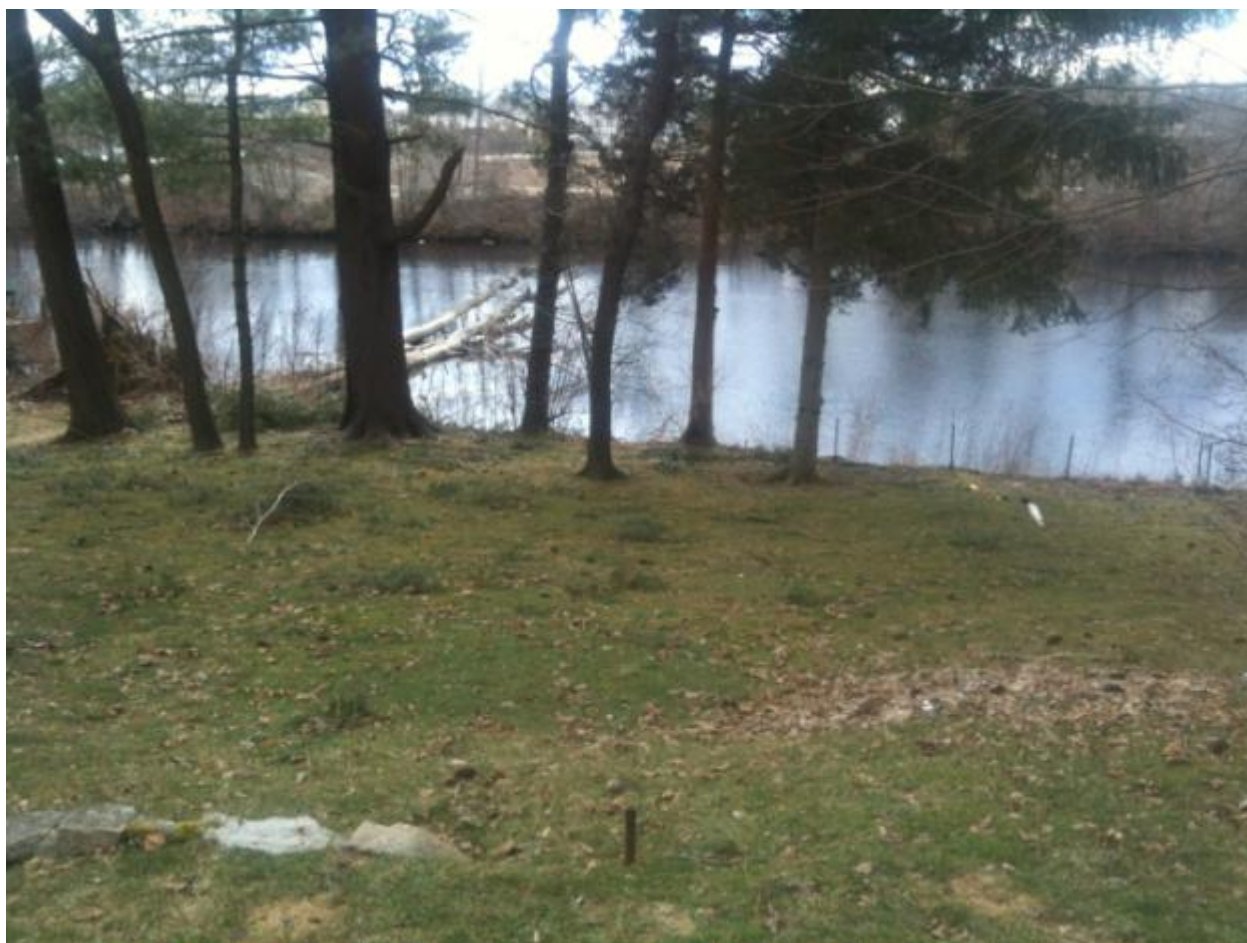
**Owner Name:** Raymond Pellegrino, Jr.

Lou Maccarone and Samantha Hogan met with Mr. Pellegrino. There is currently no fence on the property and there is a fallen tree in the back yard that goes into the water. Mr. Pellegrino was amenable to installation of to place soil cover and seed on a portion of the backyard.

Based on this meeting and a subsequent site visit, the fallen tree will be removed, and approximately 1,635 SF of loam and seed will be installed.

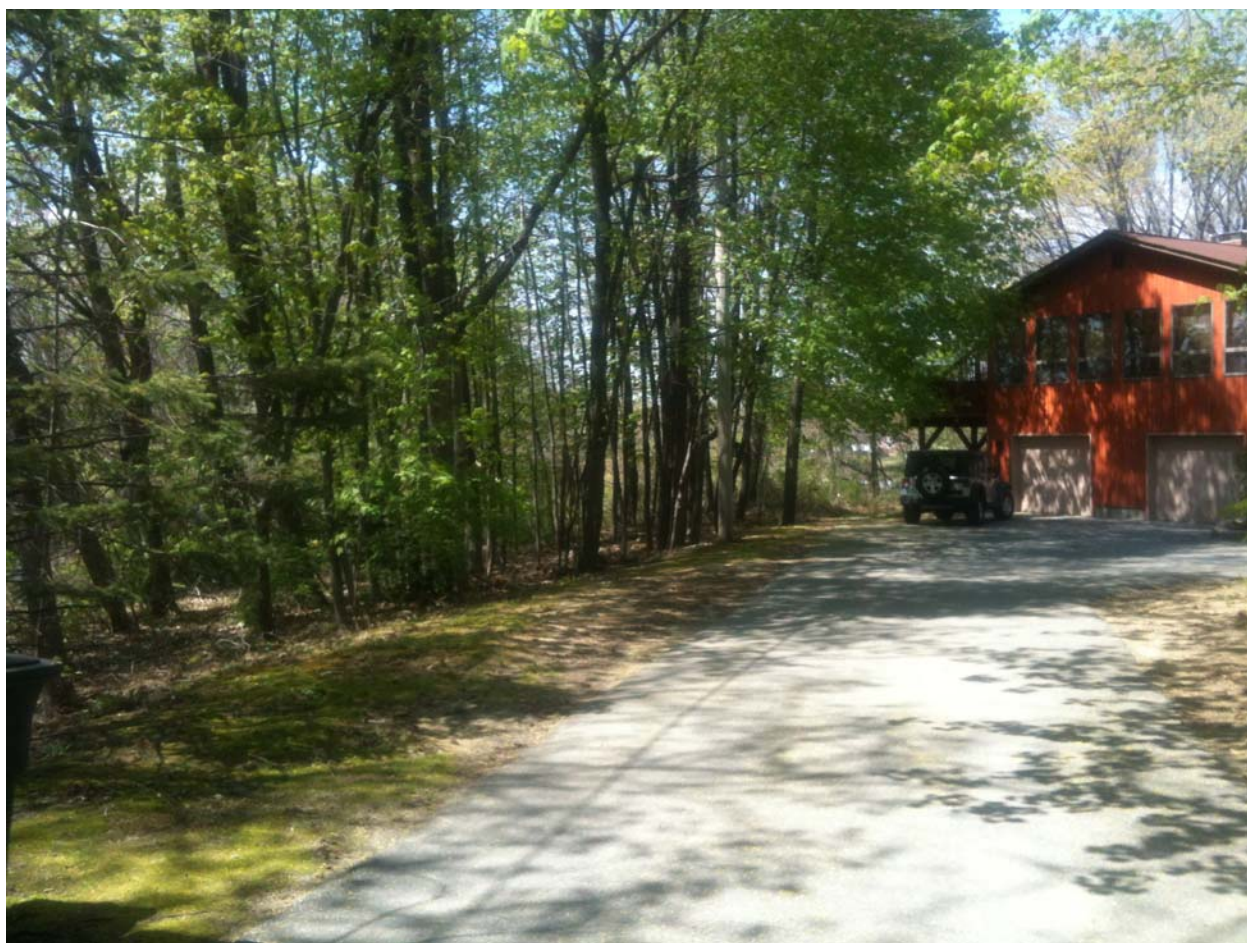
**Owner Name:** Denise Cassisi  
**Address:** 33 Oak St.  
**Plat/Lot:** 11-577  
**Access Agreement Status:** Signed

The property does not have an existing fence, however, the entire perimeter of the property within the floodplain is wooded. Based on a telephone conversation with Ms. Cassisi, the wooded portions of the property are not used.

Based on this conversation and a subsequent site visit, no work is proposed for this property.

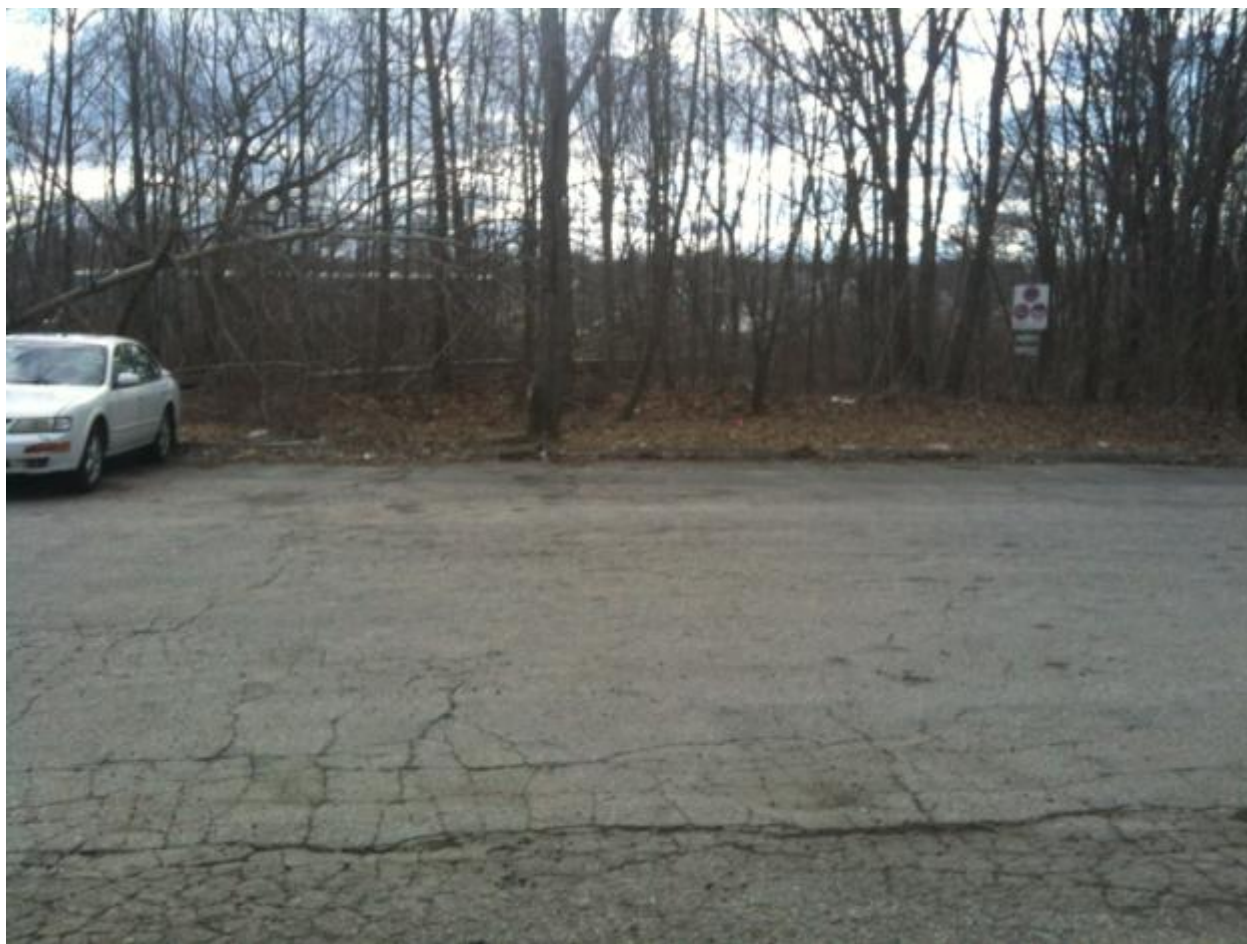
**Owner Name:** 1 Eric Place Condominium/Rick McCluskie, Jr. (property manager)

Lou Maccarone, Emily Zimmerman, and Samantha Hogan met with Mr. McCluskie at his office on January 23, 2013. Mr. McCluskie was amenable to installing a fence along the tree line at the edge of the condominium's parking lot.

Based on this conversation and a subsequent site visit, approximately 90 LF of chain link fence with a gate will be installed along the rear property line.

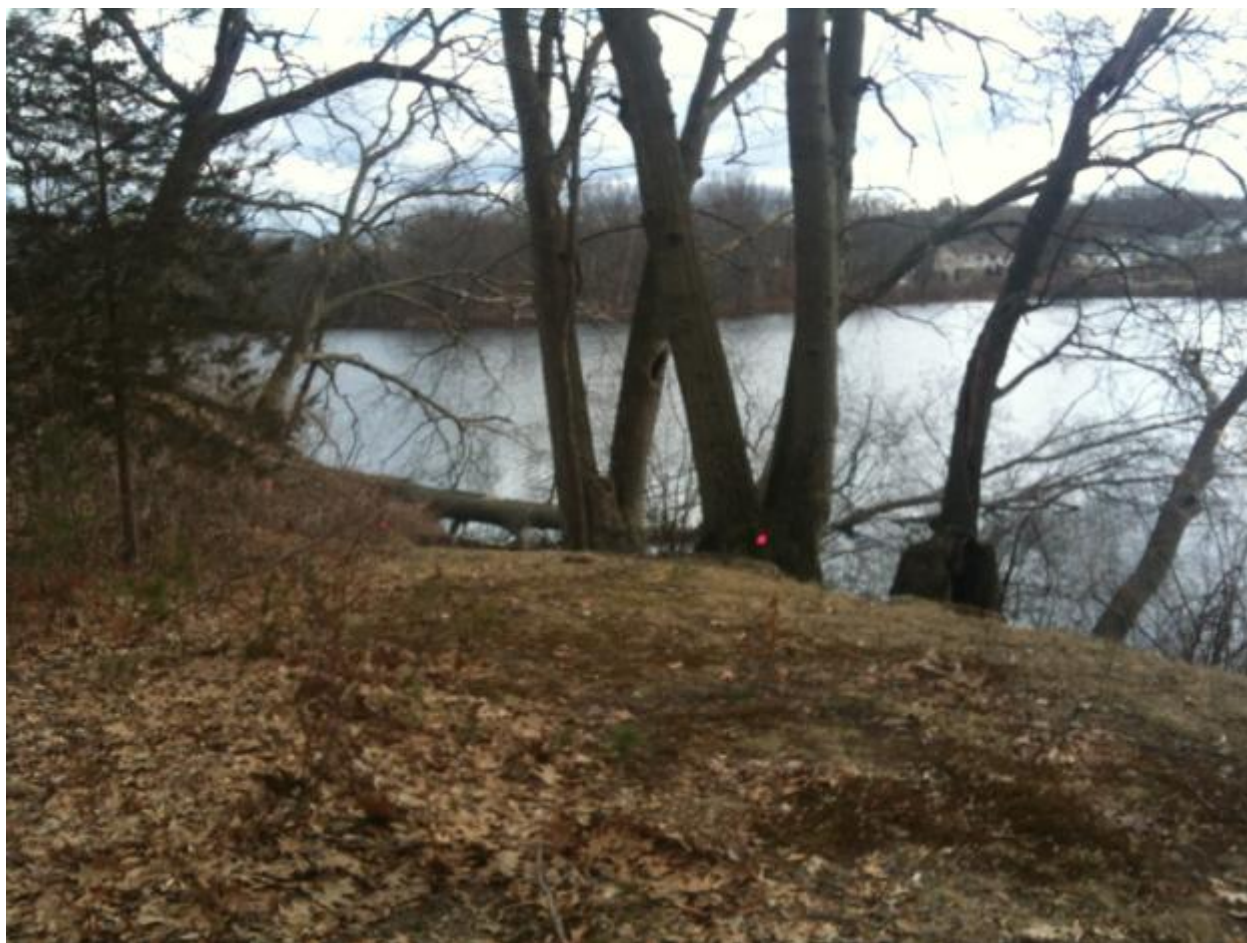
**Owner Name:** Sandra Laurie

Lou Maccarone, Emily Zimmerman, and Clayton Carlisle met with Sandra Laurie on February 5, 2013. Ms. Laurie owns two lots, separated by the Water Street ROW. Neither of the lots are currently fenced, however, a retaining wall on Plat 10 Lot 75 keeps floodwaters from encroaching on the property. Ms. Laurie is amenable to installing a chain link fence on Plat 10 Lot 74.

Based on this meeting and a subsequent site visit, an approximately 90 LF section of fence will be installed approximately 20 LF inland of the riverbank, adjacent to a line of trees.

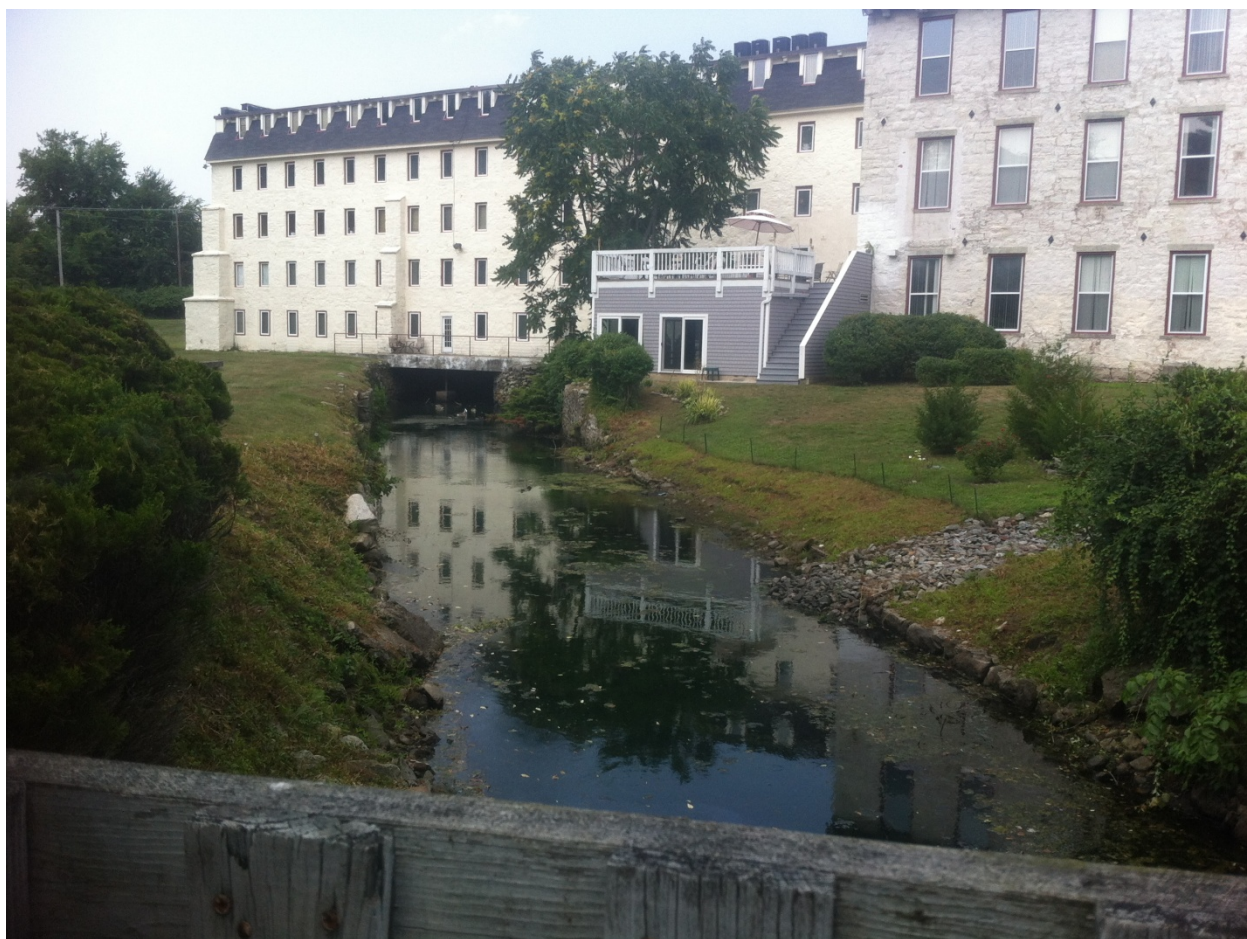
Lou Maccarone and Samantha Hogan met with Ryan Rezendes, the president of the Allendale Mill Condominium Association, on July 19, 2013. An old tailrace extends north from the Woonasquatucket River, under the condominium building, an historic mill. The floodplain extends over the eastern bank of the tailrace. Access to the tailrace from the west is limited due to a retaining wall with a steep drop off; however, access is possible from a gentle slope on the eastern side of the tailrace.

Based on this meeting, an approximately 160 LF section of new chainlink fence will be installed along the floodplain on the east side of the tailrace.
