Enbridge Incorporated  
Hazardous Liquid Pipeline Rupture and Release  
Marshall, Michigan  
July 25, 2010

NTSB/PAR-12/01  
PB2012-916501

# Pipeline Accident Report

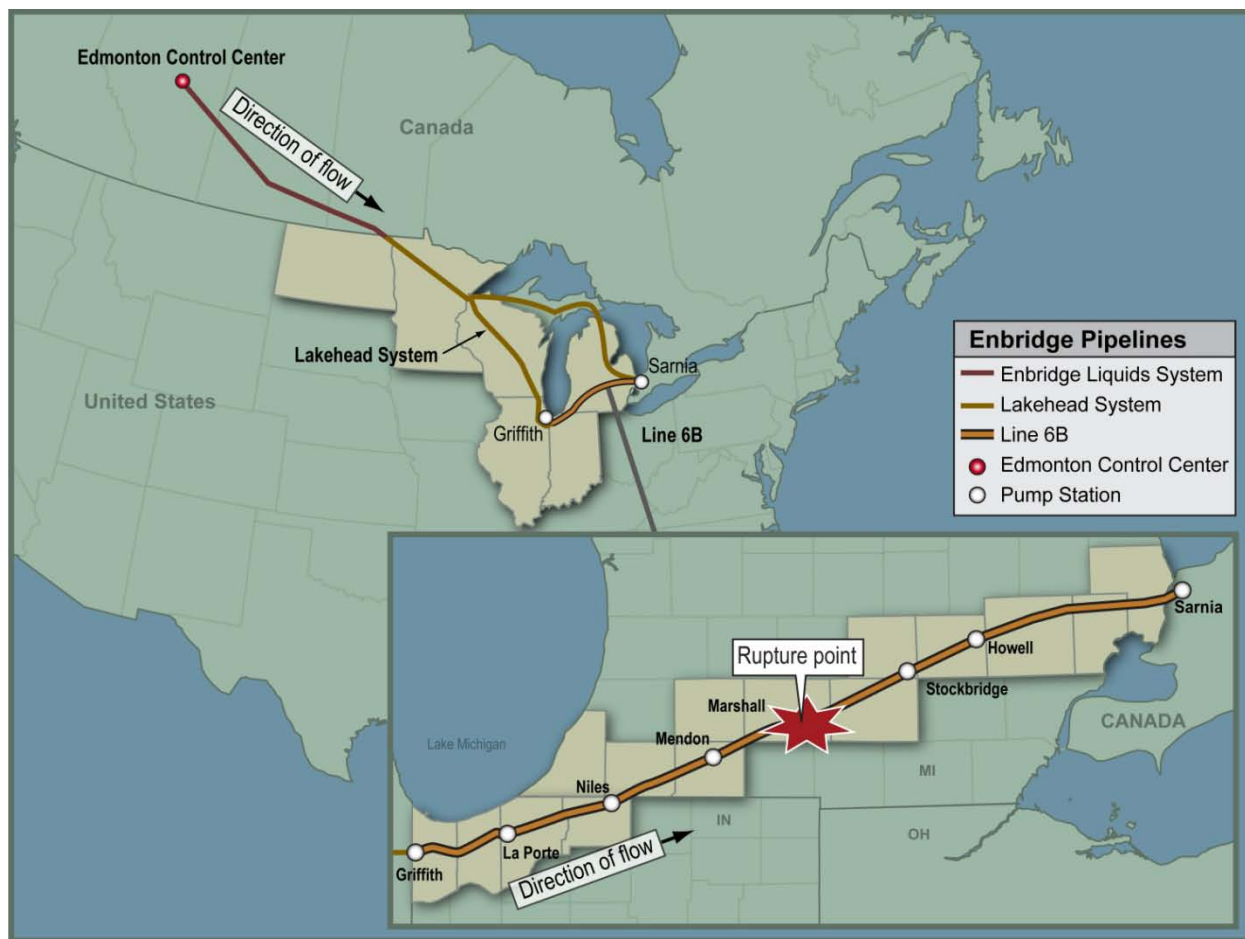
**Figure 1.** Enbridge's Liquids System and the 1,900-mile Lakehead System (the U.S. portion). Inset shows Line 6B, the 293-mile extension from Griffith to Sarnia installed in 1969.

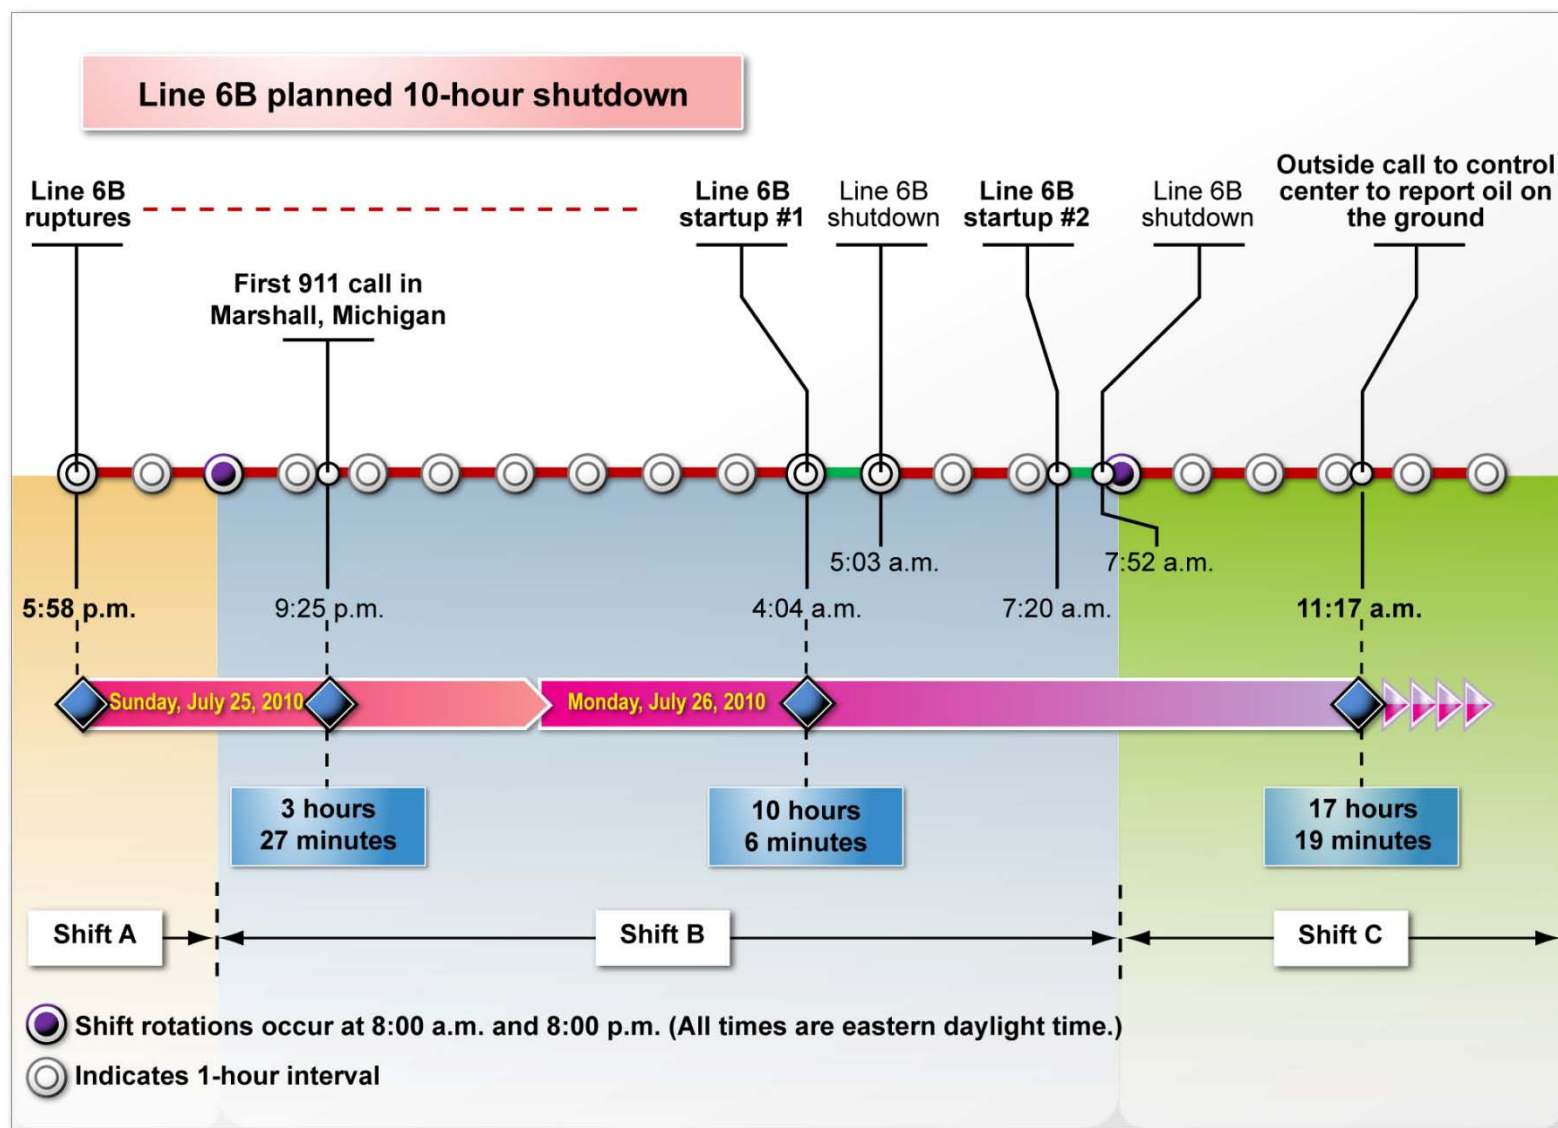
**Figure 5.** Key events timeline of the Line 6B rupture in Marshall, Michigan, showing the events from the time of rupture on July 25, 2010, to the time of discovery on July 26, 2010.

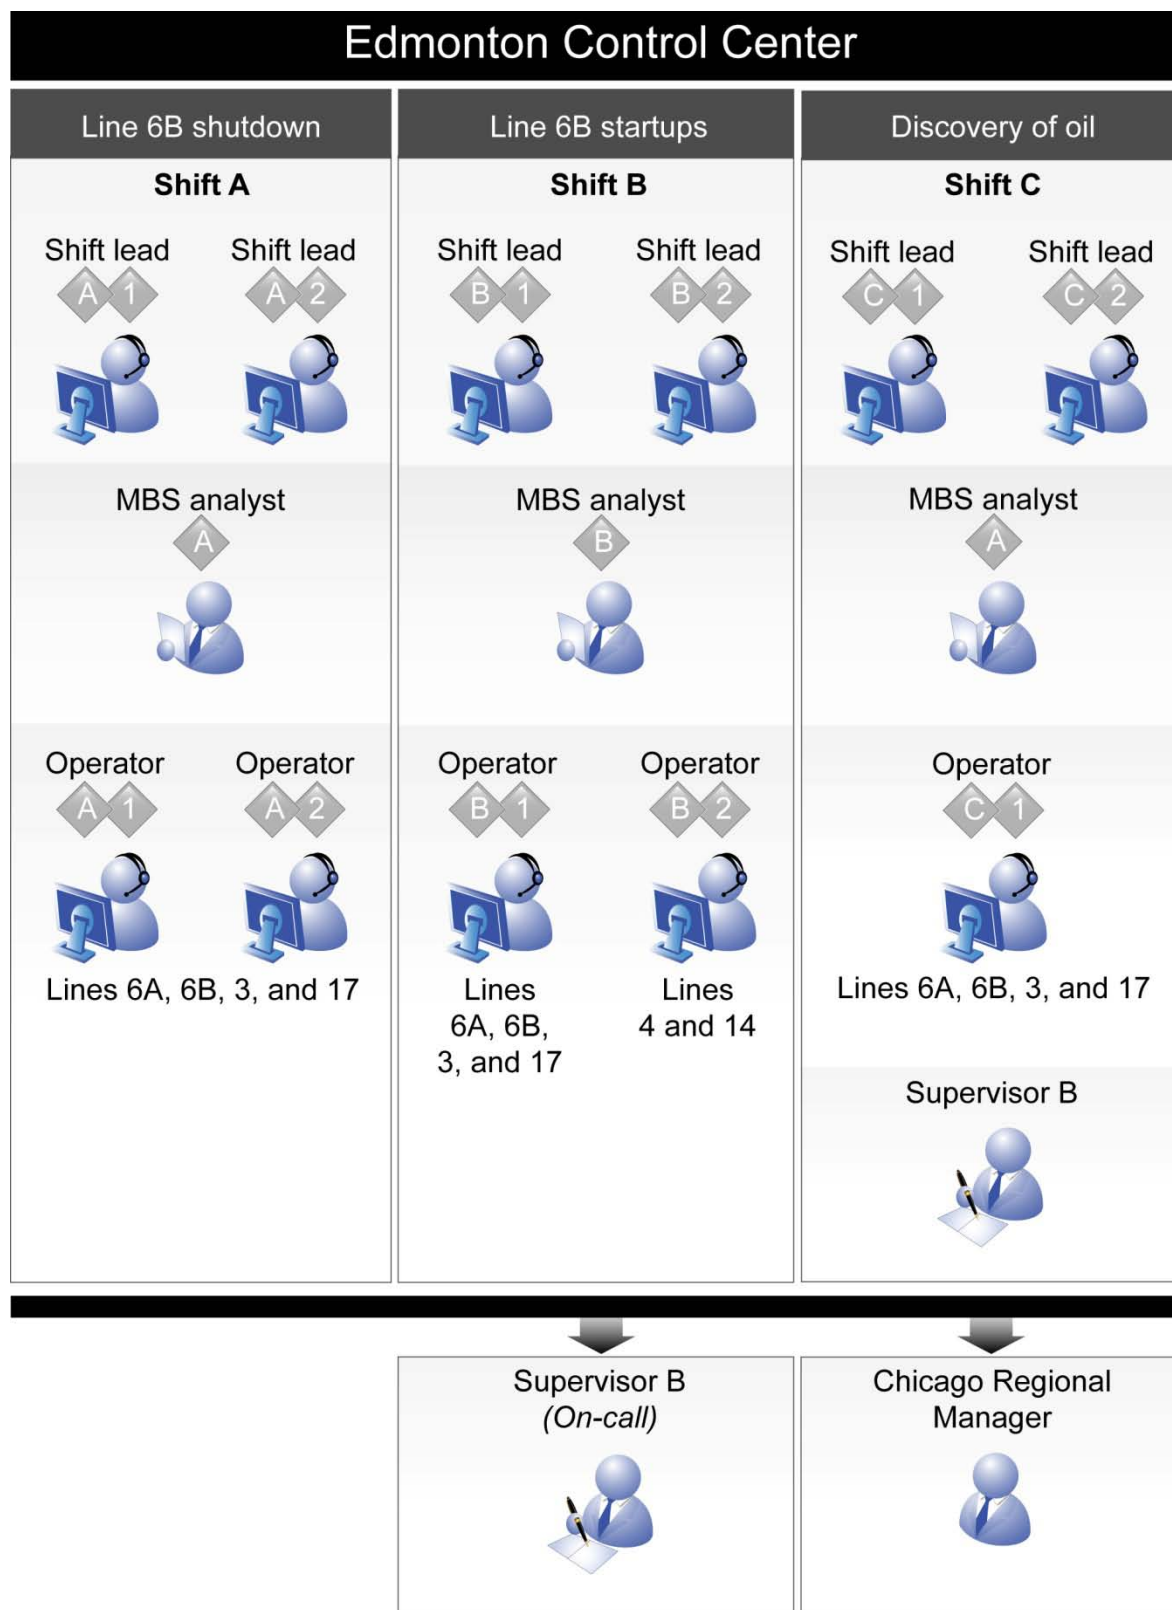
**Figure 6.** Key Enbridge staff involved in the 17-hour accident sequence. MBS refers to Material Balance System.

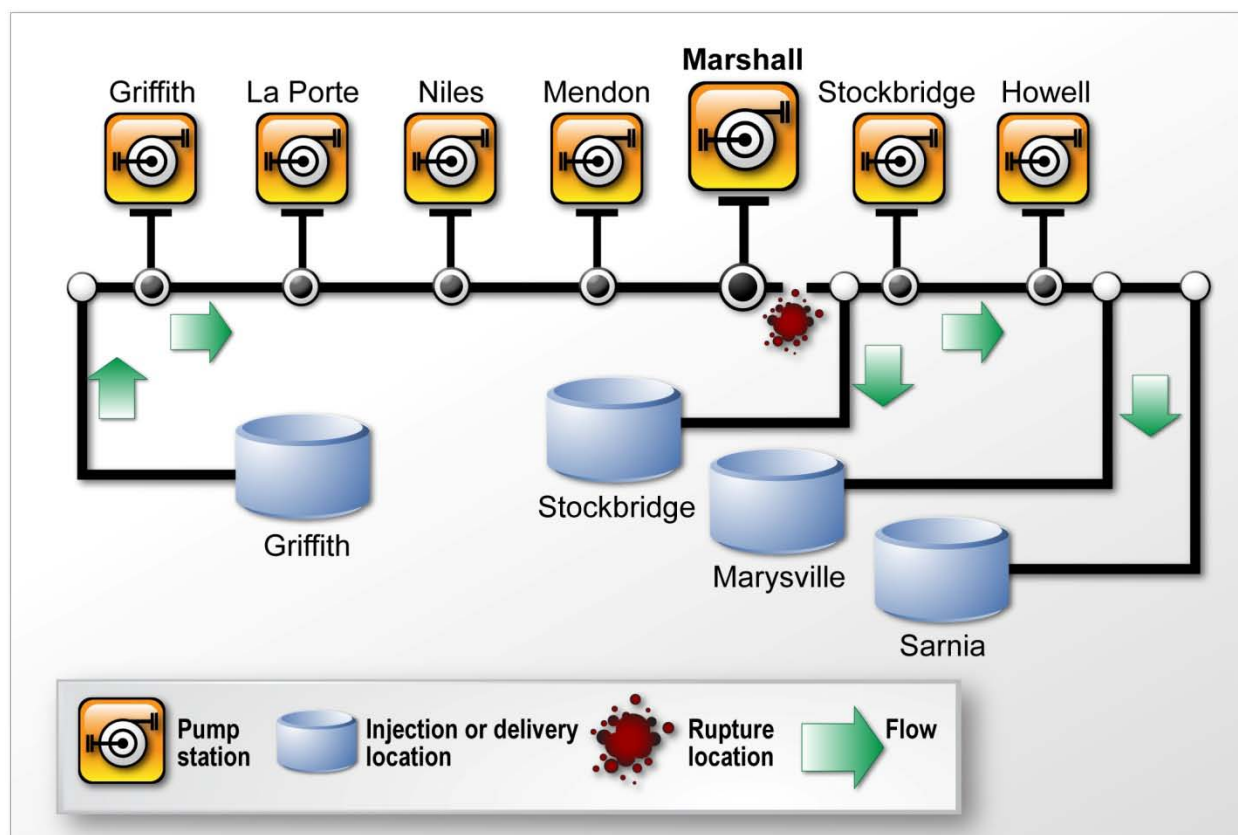
**Figure 7.** Simplified schematic of Line 6B, showing pump stations and delivery locations.

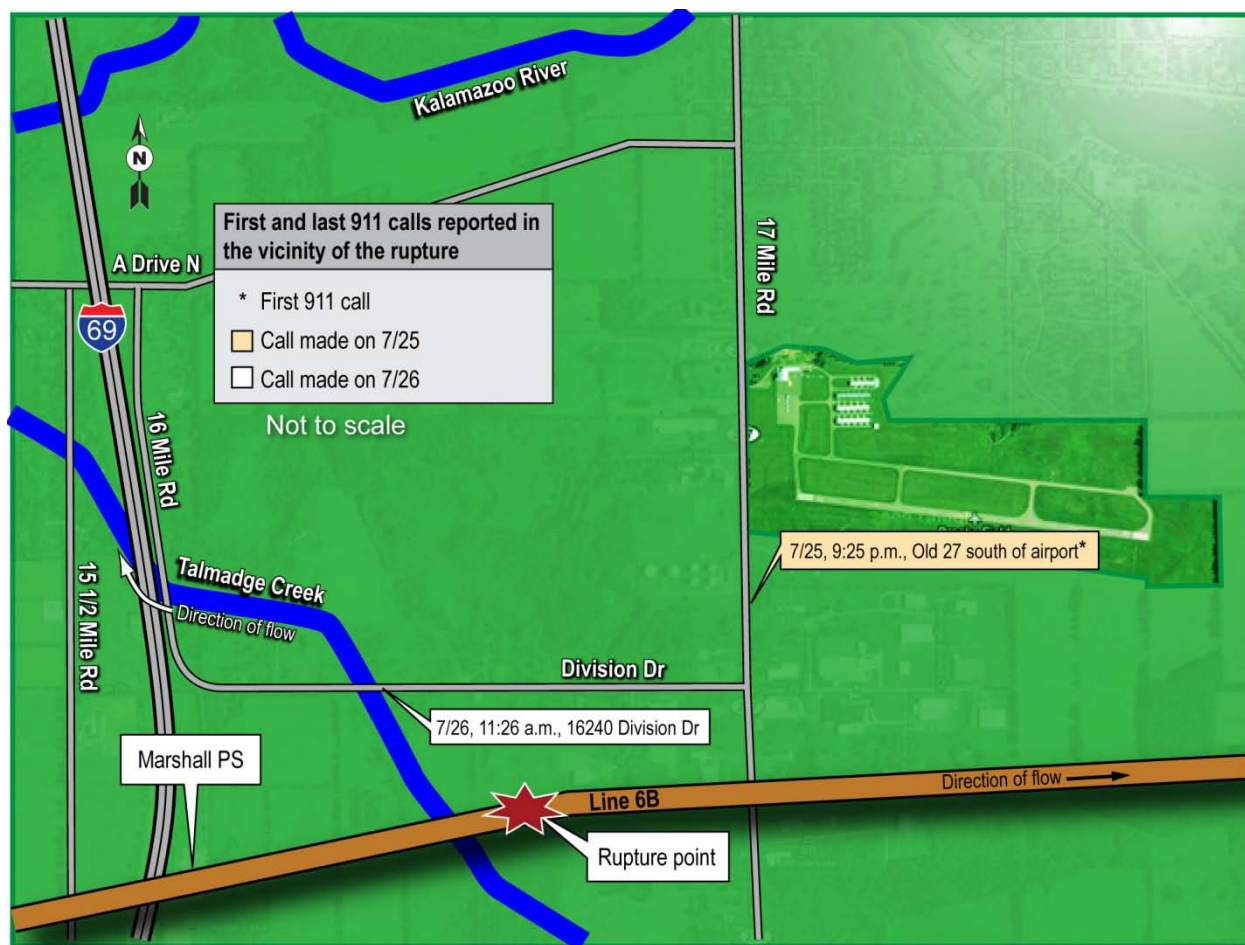
**Figure 8.** Emergency response and 911 calls from nearby residents. First and last calls are noted.

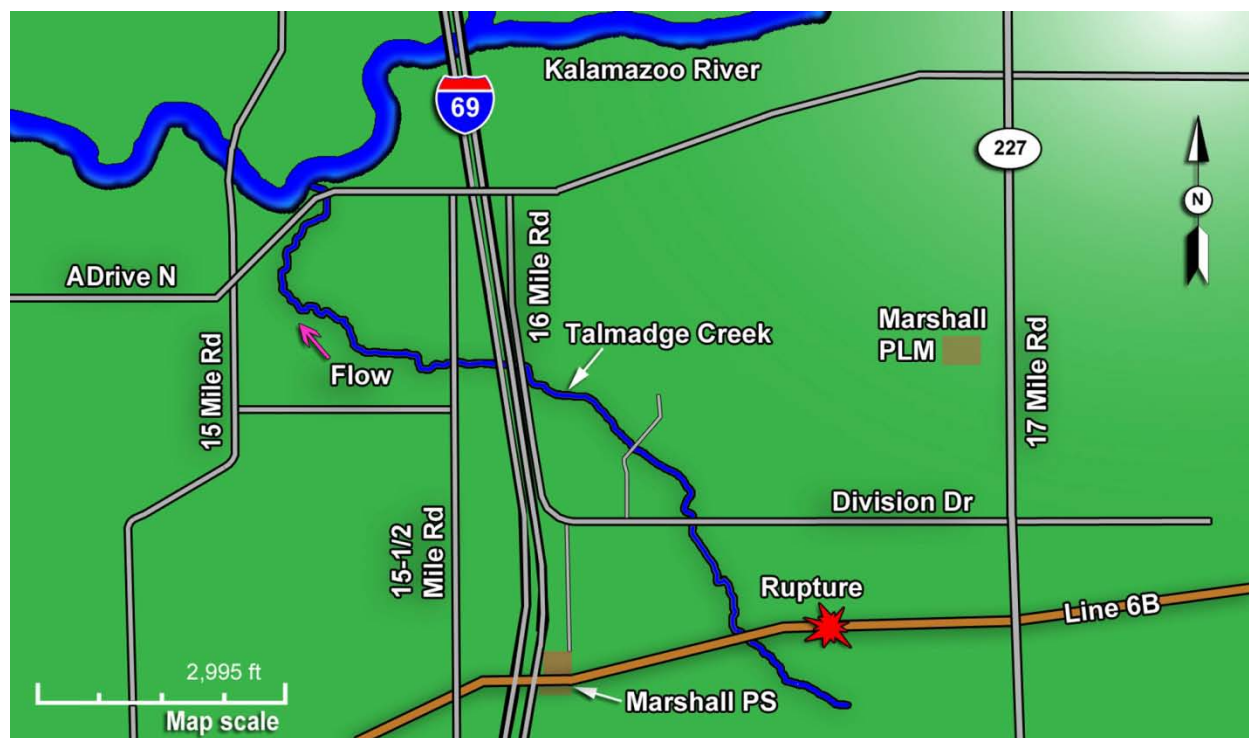
**Figure 9.** Area between rupture site and the Kalamazoo River where first responders concentrated efforts to contain the released oil.

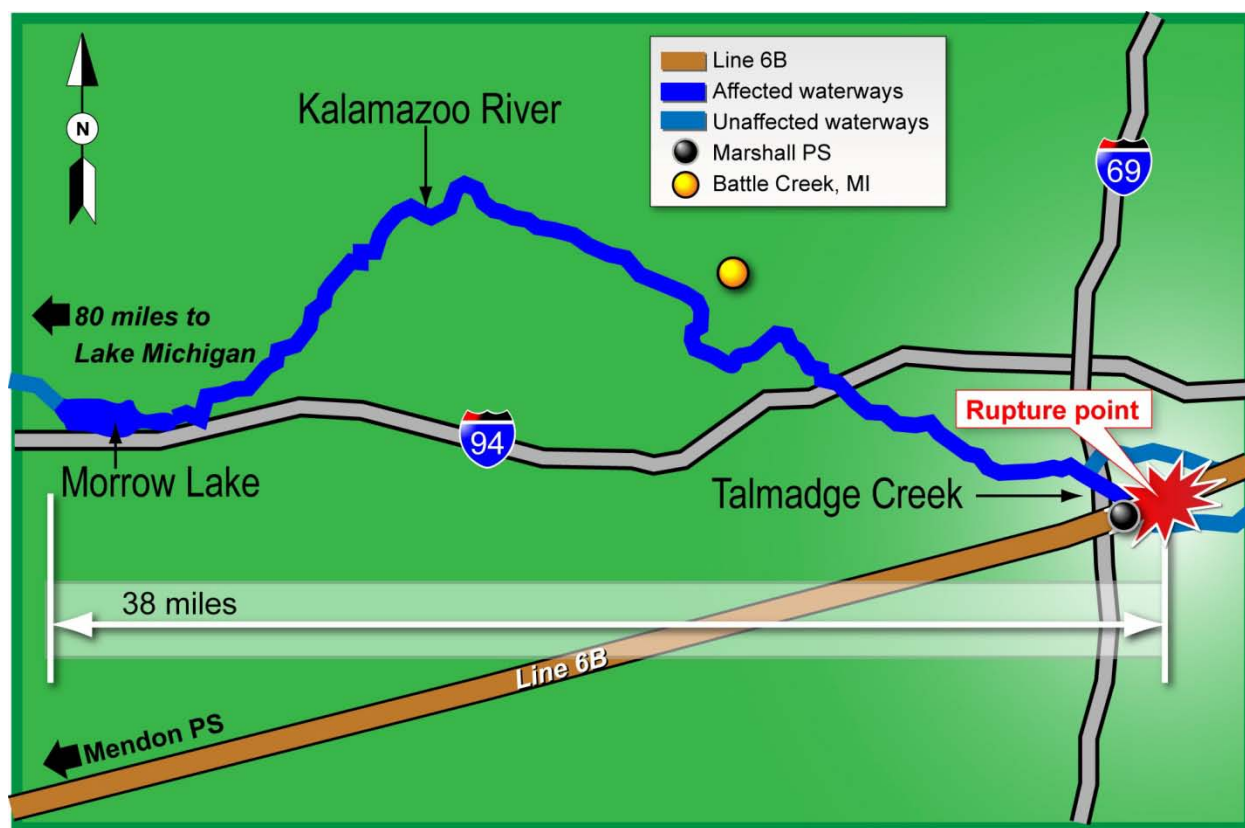
**Figure 19.** Map showing rupture location and affected waterways from Talmadge Creek to Morrow Lake.
