# Situation Photo Log

Monday, July 16, 2012

Kalamazoo River / Enbridge Spill

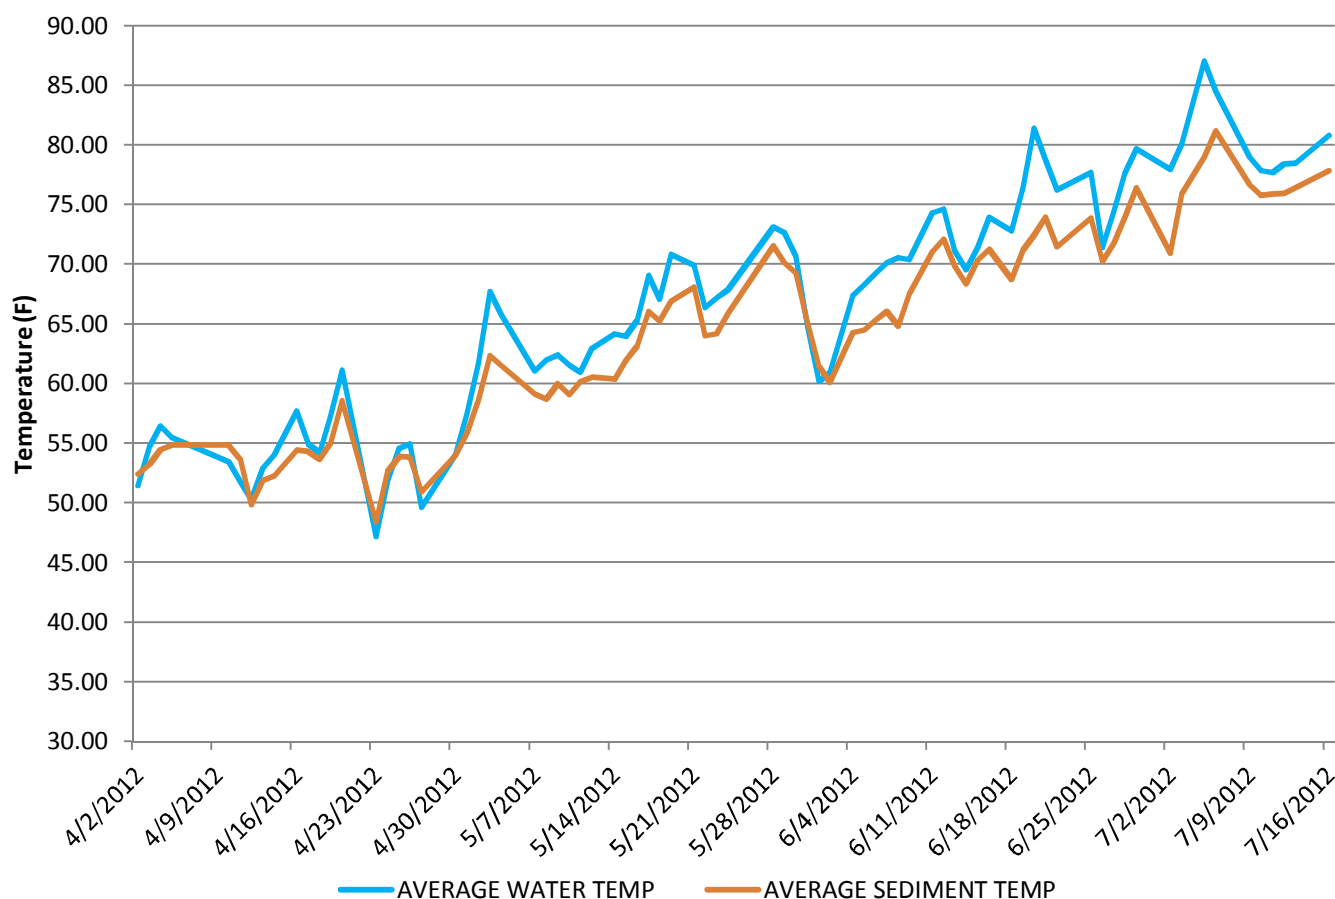
### Water and Sediment Temperature

Conditions: Sunny

Ambient Air Temperature High: 92° F

Average River Water Temperature: 80.79° F

Average River Sediment Temperature: 77.83° F
