# Situation Update

January 30, 2013

# Submerged Oil Science

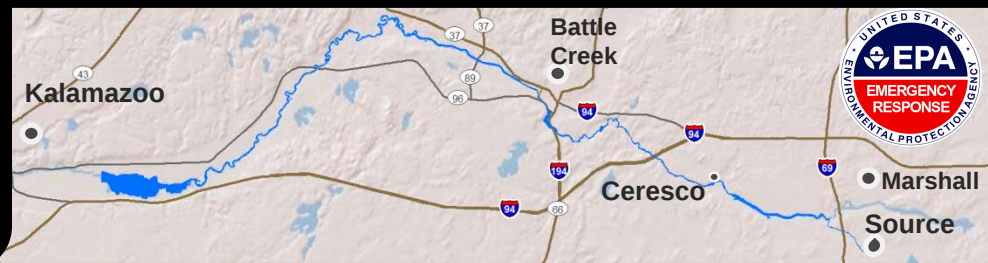
UV Assessment of hexane sheen tests  
01.28.2013

- 7 Tests Evaluated
- 3 Tests were positive for UV Florescence
- UV Florescence observed from tests at MP 6.60 RDB, MP 36.30 LDB, and MP 36.5 RDB
