**GROUNDWATER CONTAMINATION AND SINKHOLE COLLAPSE
INDUCED BY LEAKY IMPOUNDMENTS
IN SOLUBLE ROCK TERRAIN**

By Thomas J. Aley
James H. Williams
James W. Massello

1972

MISSOURI GEOLOGICAL SURVEY AND WATER RESOURCES

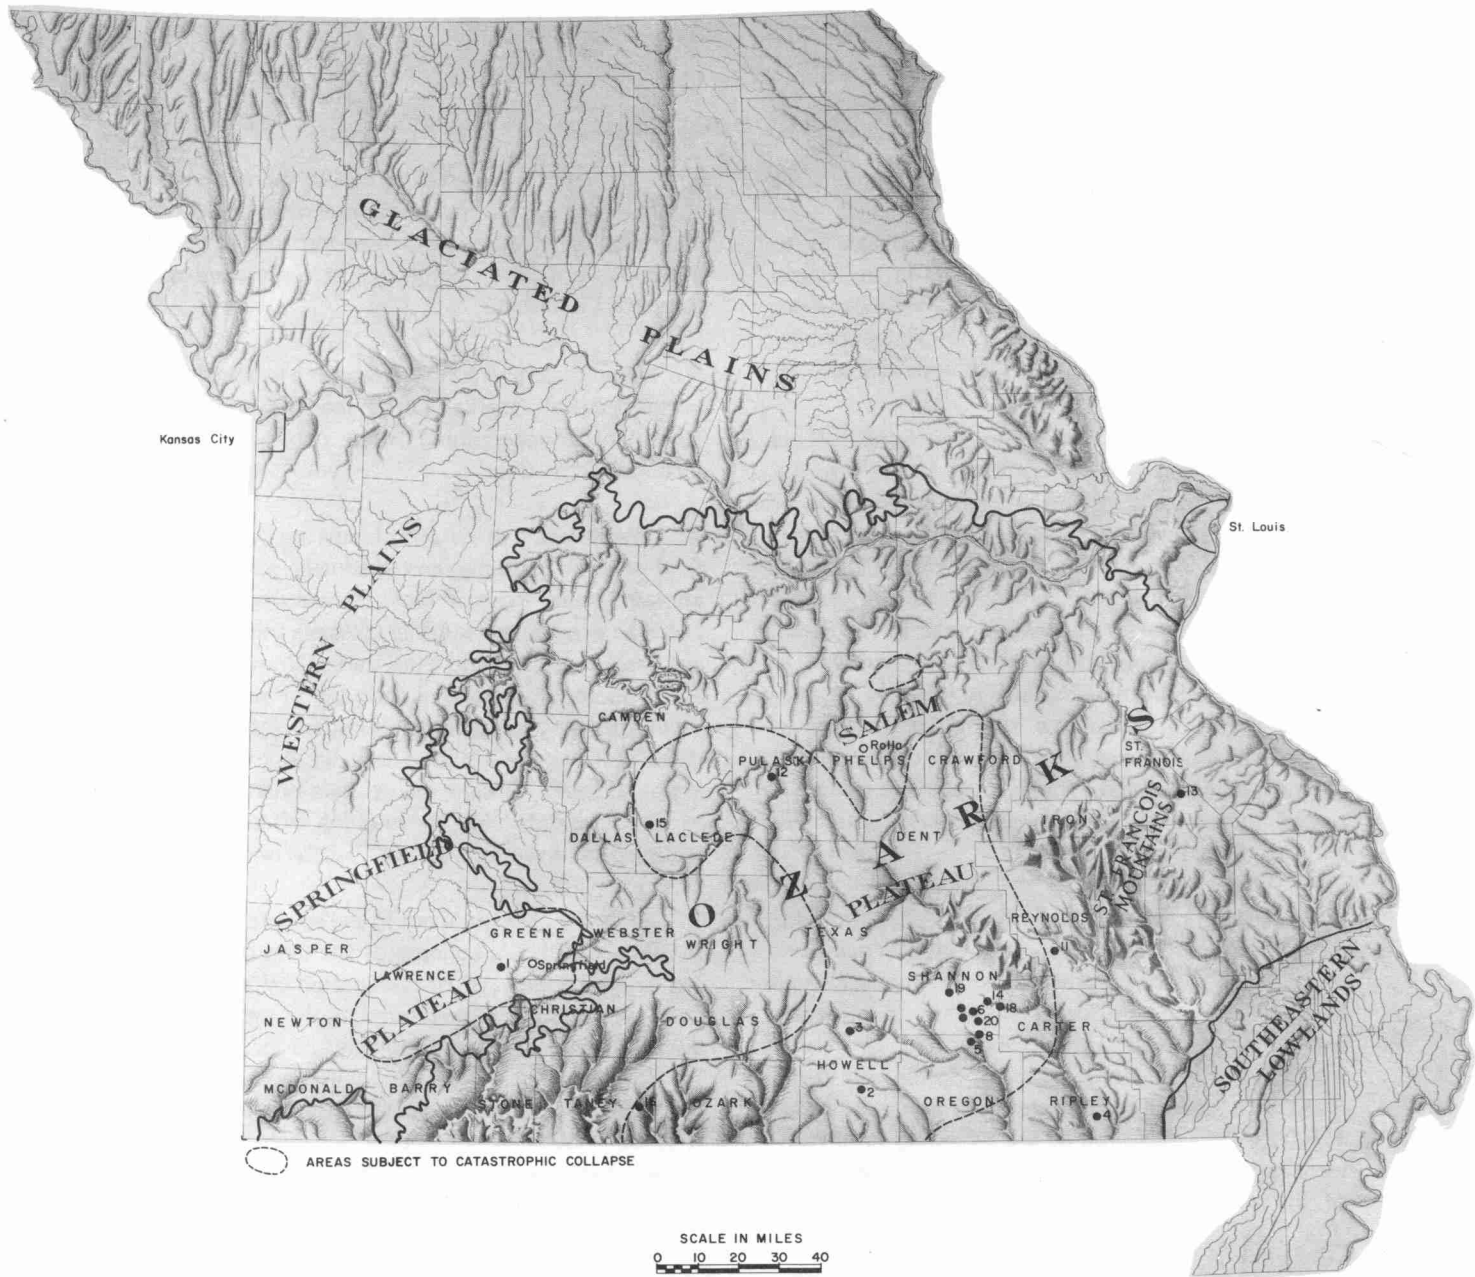
Figure 1

Areas in Missouri that are particularly subject to catastrophic sinkhole collapse. Sites of collapses and groundwater contamination investigated for case history analyses are also shown.
